# **The Physical and Biological Effects of Engineered Logjams (ELJs) in the Elwha River, Washington**

*Executive Summary*

*Salmon Recovery Funding Board (SRFB)  
Interagency Committee for Outdoor Recreation (IAC)*

April 1, 2007

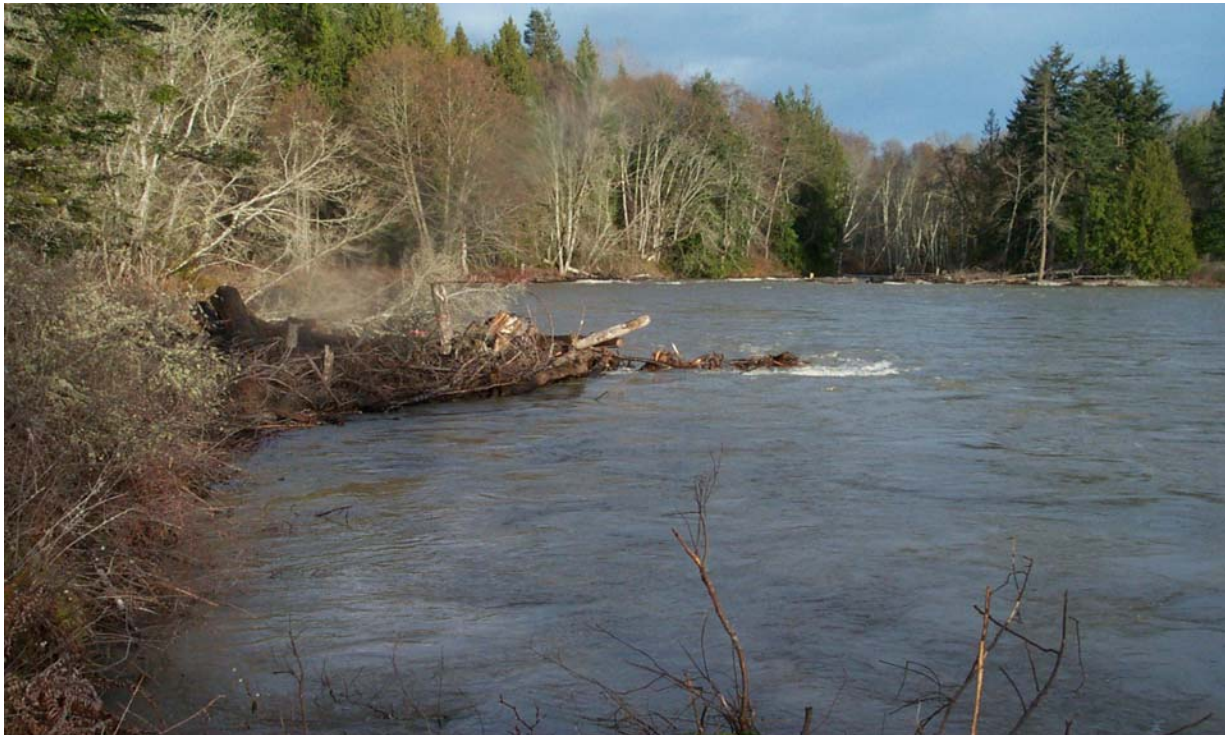
Figure 47. Elwha River engineered logjam #99-3, winter 2002. Photo taken from left bank looking North (downstream) at inlet to HRC.

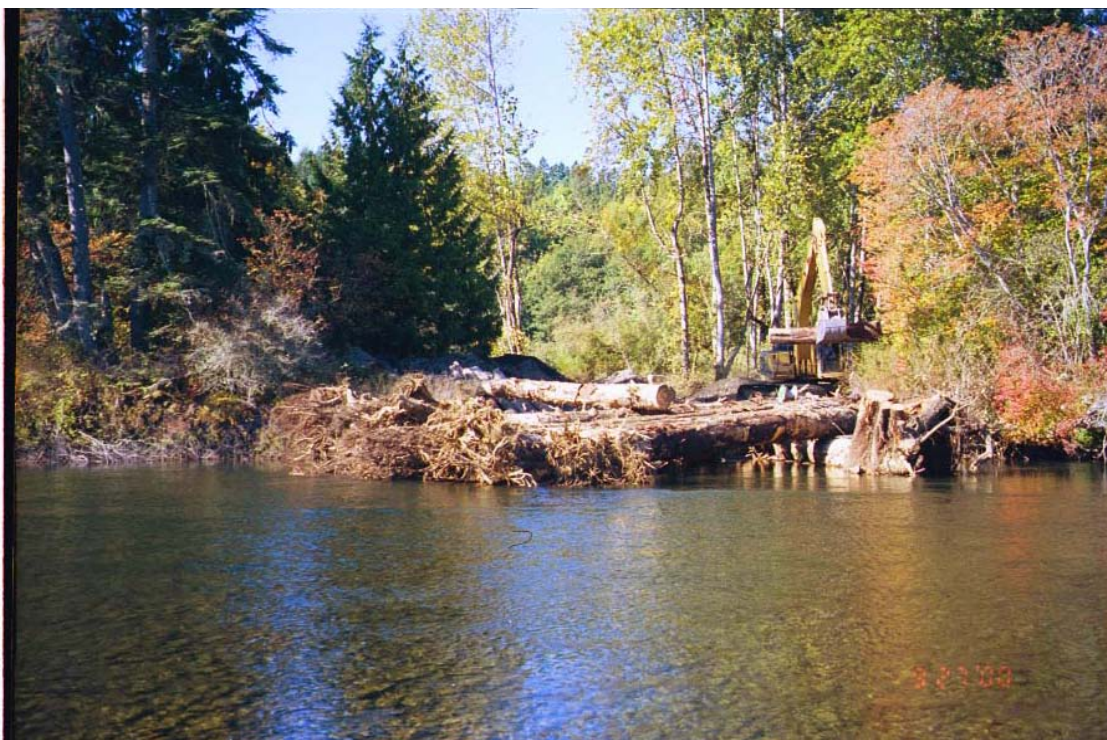
Figure 48. Elwha River engineered logjam #00-2 located along left bank of Sisson property, during construction, fall 2000. Photo is taken from gravel bar looking West across the river.

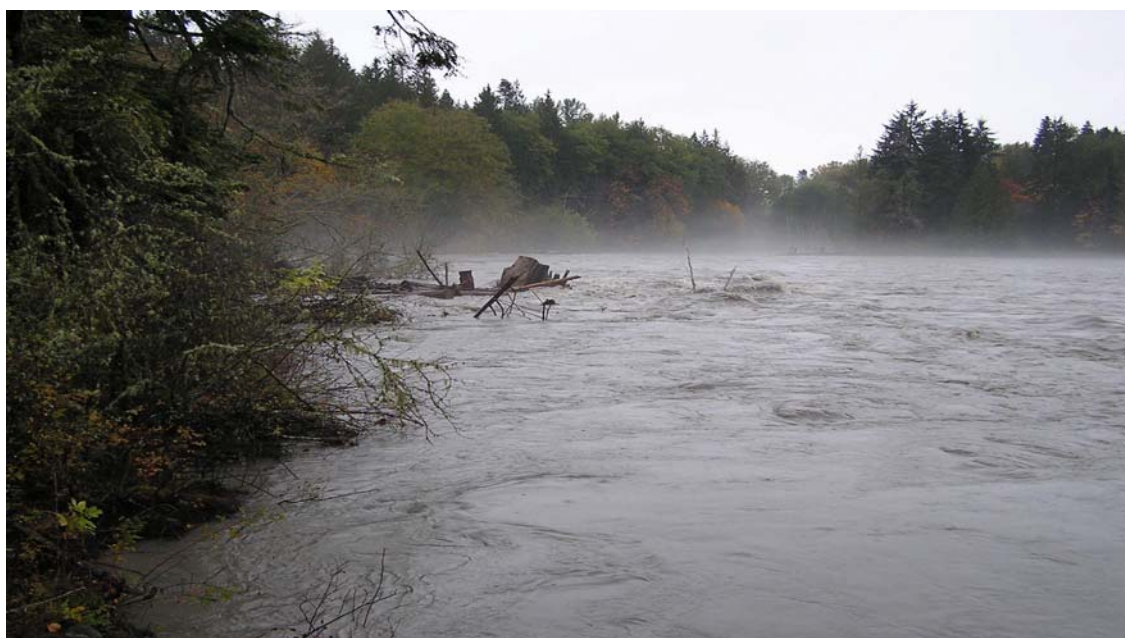
Figure 49. Elwha River engineered logjam #00-2 during October 2003 flood. Photo taken from left bank looking North (downstream).

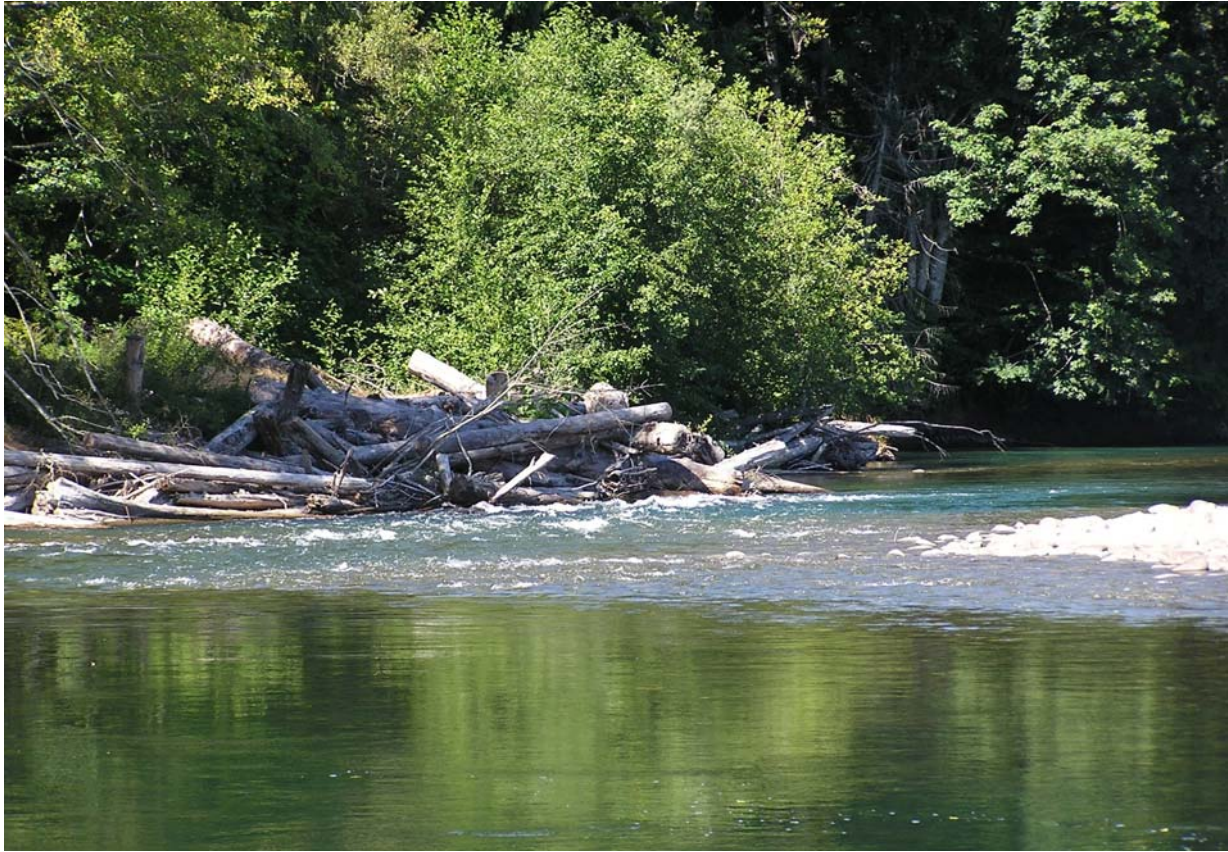
Figure 50. Elwha engineered logjam #99-6, summer 2005, located along left bank immediately upstream of HRC inlet. Photo taken from cobble bar looking Northwest (downstream).

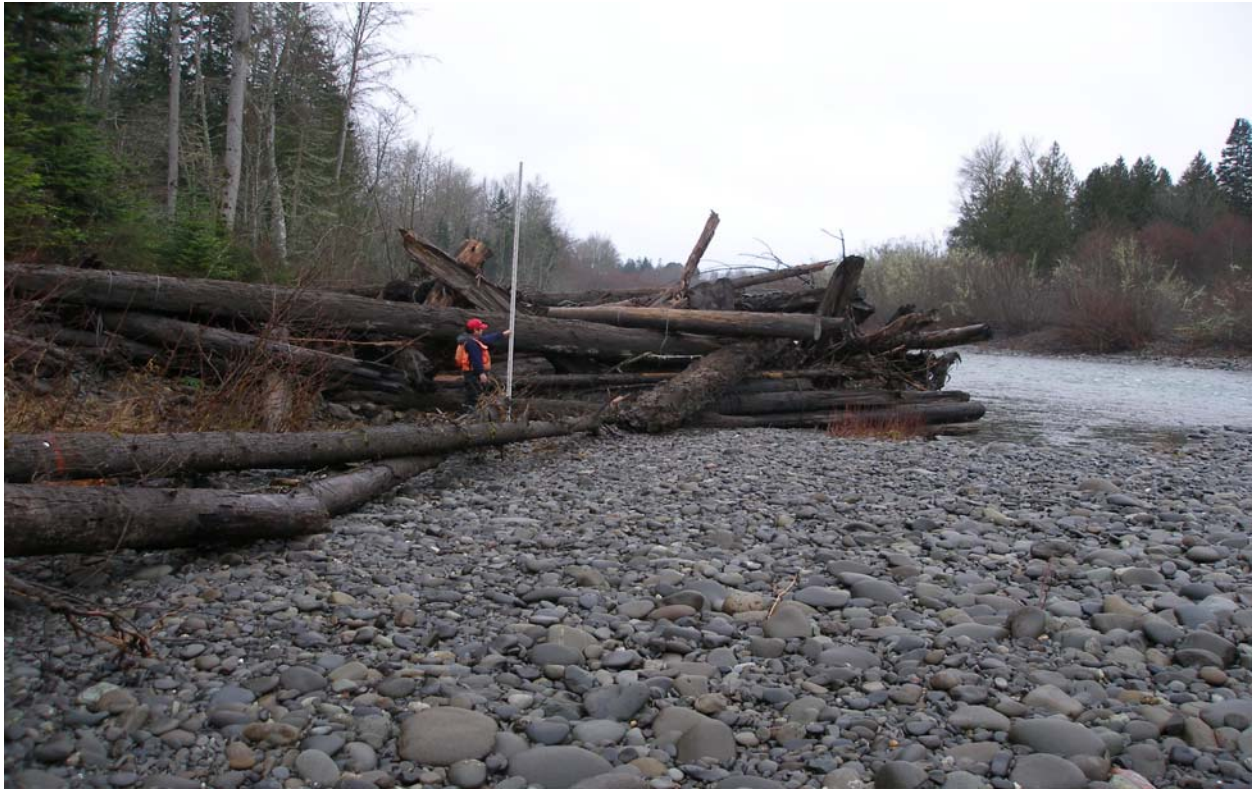
Figure 51. Elwha engineered logjam #04-1 situated along the left bank of the EMC immediately downstream of where a HRC distributary channel re-enters the EMC, winter 2007. Photo taken from left bank of EMC looking Northwest (downstream).

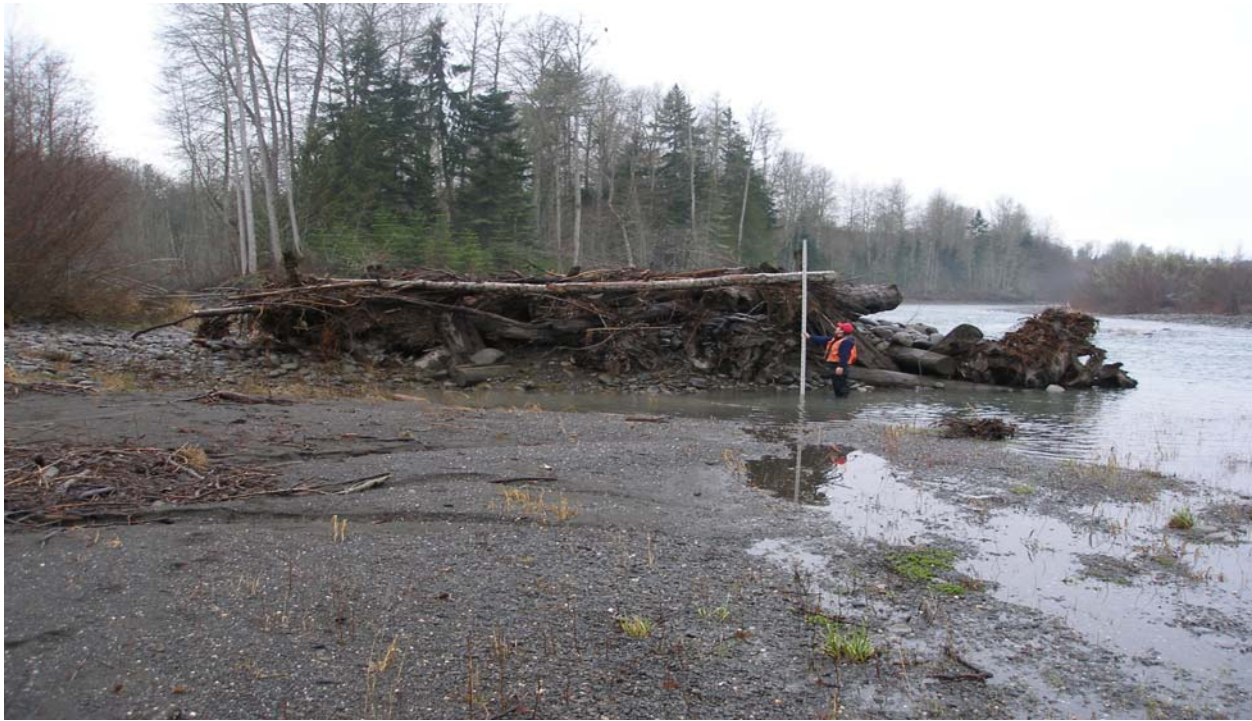
Figure 52. Elwha engineered logjam #04-2 situated along the left bank of the EMC immediately downstream of where a HRC distributary channel re-enters the EMC (visible on left), winter 2007. Photo taken from left bank of EMC looking North (downstream).

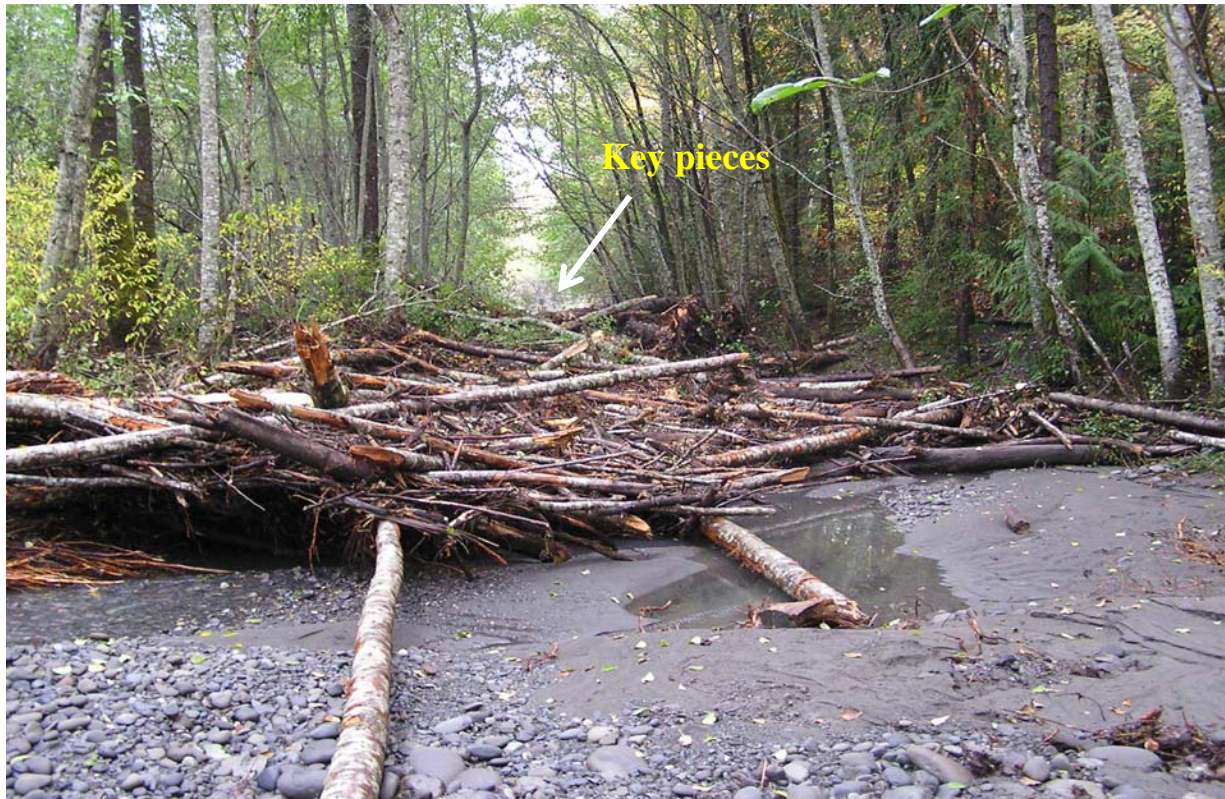
Figure 53. Logjam formation upstream of 2003 unanchored key pieces placed in Side Channel 5. Photo taken after October 2004 flood flow, looking Northeast (downstream). Alder trees visible in photo are racked up on key pieces and were eroded from upstream floodplain as Side Channel 5 increased in size due to flood flows. The side channel is almost devoid of wood upstream of this location. ELJ 00-1 is located at inlet to Side Channel 5 and may have contributed to the increase in flow down the side channel.
