SHACKLEFORD CREEK RESTORATION PROJECT
Agreement #14-48-0001-95732
Project # 95-JITW-05

WATER QUALITY PROJECT

Completed by,

The Siskiyou Resource Conservation District
Gary Black
PO Box 268
Etna, CA 96027
(530) 467-3975 -Phone
(530) 467-5617 -Fax

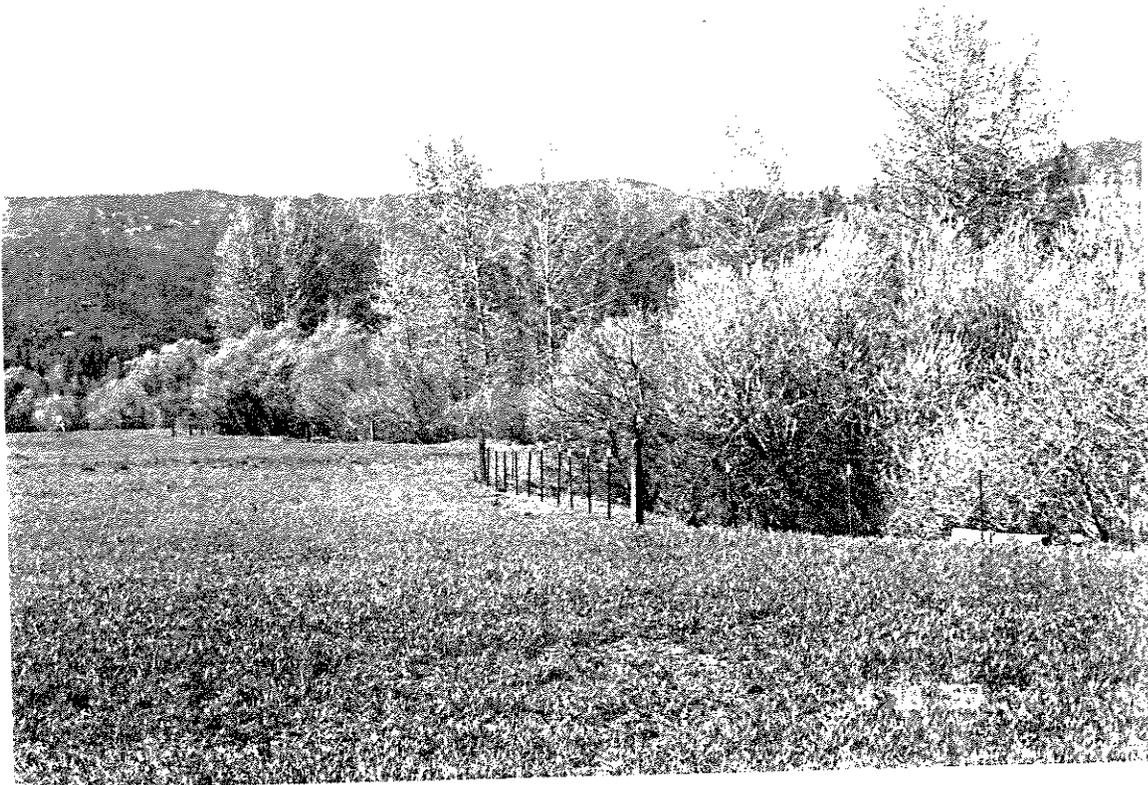
Riparian fencing along the west side of Mill Creek on Dews' property.

Fencing: The Shackleford Creek Project allowed the RCD to install 3,600 feet of new fencing along Mill Creek. The specific reach of Mill Creek where the fencing was

The fencing was installed to meet NRCS fencing specifications. The placement of the fence allows an approximate average riparian area width of 350 feet. RCD staff observed excellent opportunities for natural riparian regeneration. An abundance of young alder, willow and a few cottonwood were found throughout the newly established riparian area. We expect the riparian area to rebound almost immediately due to excellent seed sources, a high, stable water table and new riparian protection provided by the fencing. The fencing provided by the Shackelford Restoration Project is a portion of a larger fencing program which has installed 1.7 miles of riparian fencing on Mill Creek and .9 miles on Shackelford. The fencing will protect existing riparian areas and provide opportunity for increased riparian establishment.

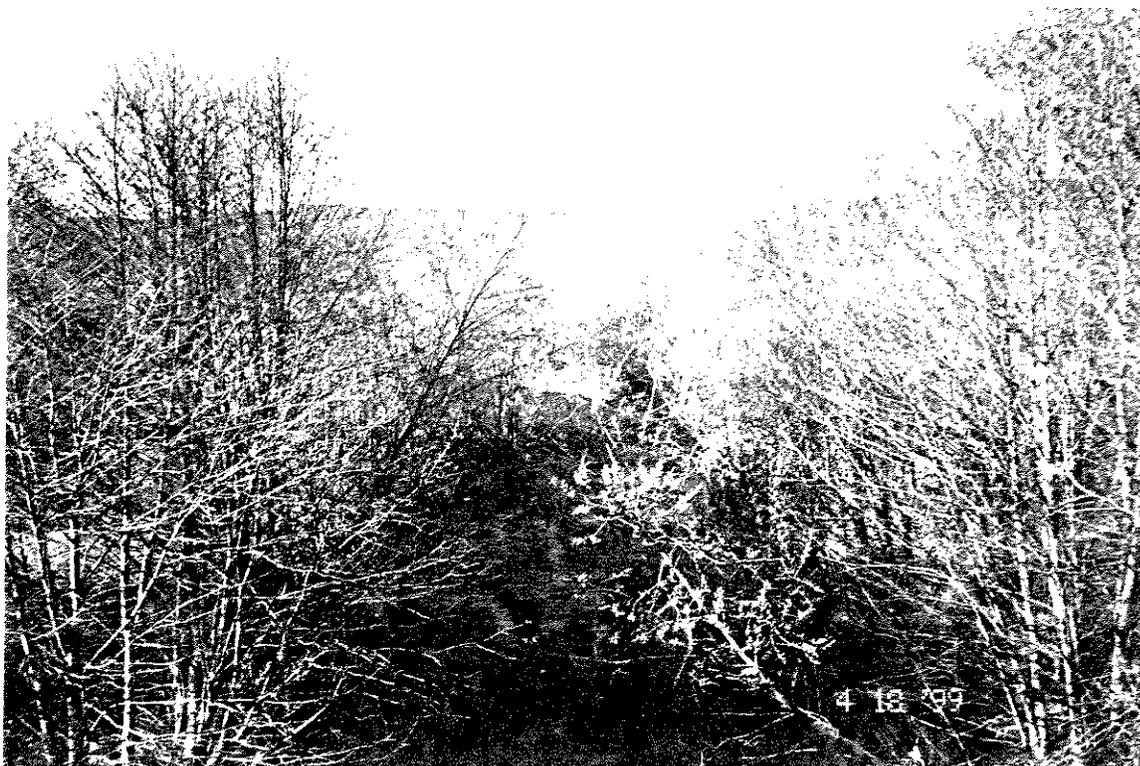
Mill Creek off of Quartz Valley Road Bridge which now has riparian fencing.
