SCOTT RIVER

LANDOWNER RIPARIAN PLANTING PROJECT:

A RIPARIAN IMPROVEMENT PROJECT

PROJECT IDENTIFICATION # 97-PARTNERS-02

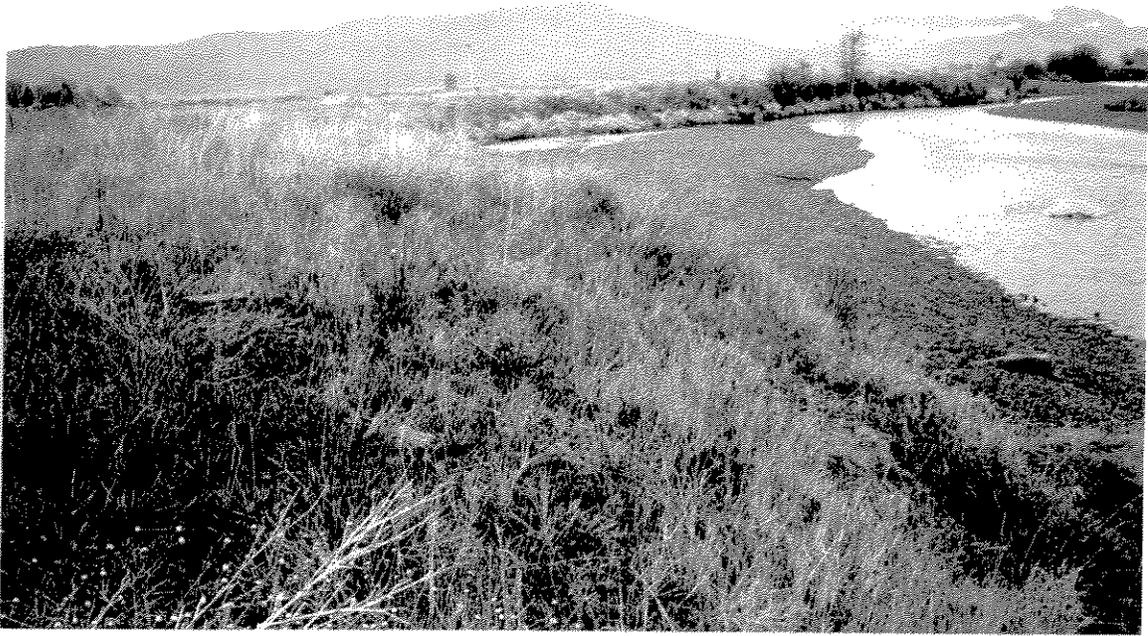
**Post Planting Evaluation:** We did not achieve the success we have been used to using this planting style. We should have budgeted for browse protection. We feel the difficulty of the site combined with the excessive browsing caused a significant percentage of fatality. After the second season, the survival rate was 42% and only 10% of the surviving trees had grown beyond the browse level.

Site #1: Photo of typical surviving trees after two growing seasons. Notice broken tips from browse.

budgeted. The RCD will now install mulch and provide browse protection on all future projects where browse is probable. We feel the damage due to deer browse was the most significant impact affecting the survival rate.

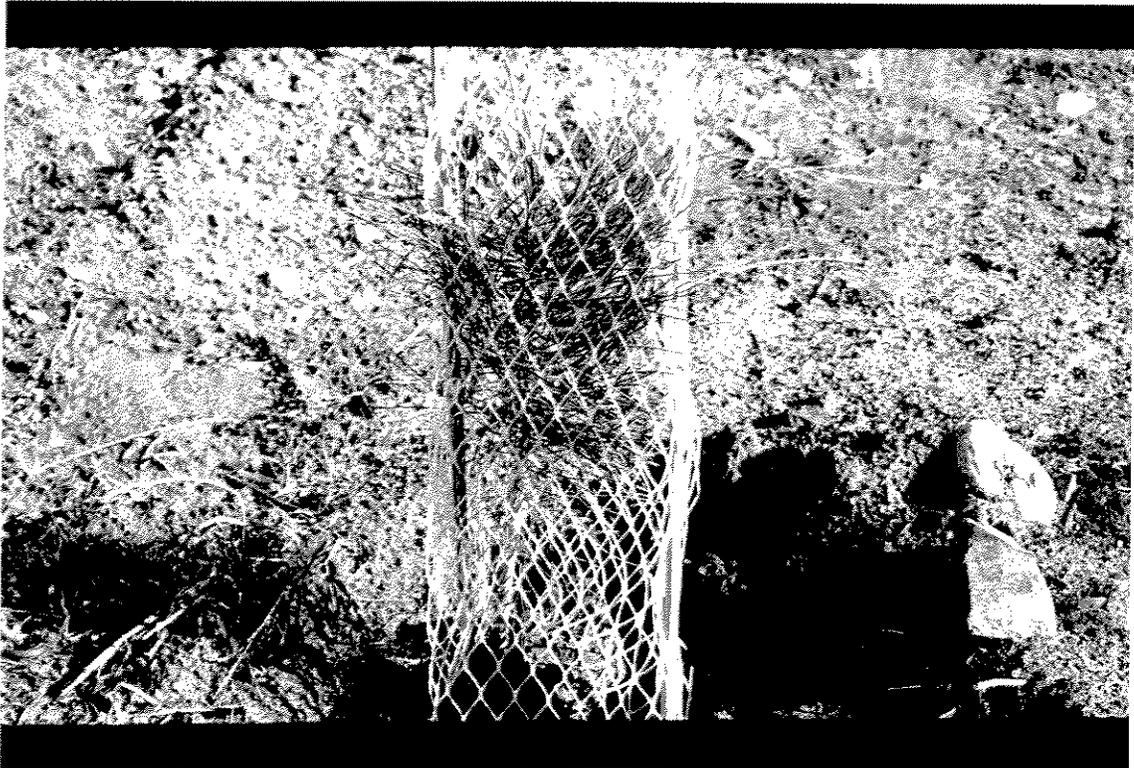
Wildlife Affects: Deer browsing or beaver damage was not an issue at this site. The trees grew very well throughout the summer. During the early fall when the migrating deer herds moved from the Marble mountains to the valley floor, significant browsing occurred. However, the trees were strong enough to handle the browse. The pine trees also look excellent and appear to be established.

Site #3: Conifer tree which was planted in 1999 as a two year old tree.
