# SCOTT RIVER RIPARIAN RESTORATION PROJECT II

Contracted by:  
Siskiyou Resource Conservation District  
Gary Black  
PO Box 268  
Etna, CA 96027

**Abstract:** The goal of the Scott River Riparian Restoration II Project is to improve and expand riparian and cold water habitat throughout a 5.0 river mile section of the Scott River by planting 35 acres of riparian area. The project was funded by the USFWS - Jobs in the woods program, USFWS - Klamath Restoration Act, and the National Fish and Wildlife Foundation. The project reach of the Scott River is important to the watershed's fisheries due to cool summer flows and prime spawning habitat. Although the reach has some positive aspects, there are also problems present as well. Much of the project reach has an overly wide and unstable active channel due to excessive bed load created by millions of yards of mining tailings located up stream from the project.

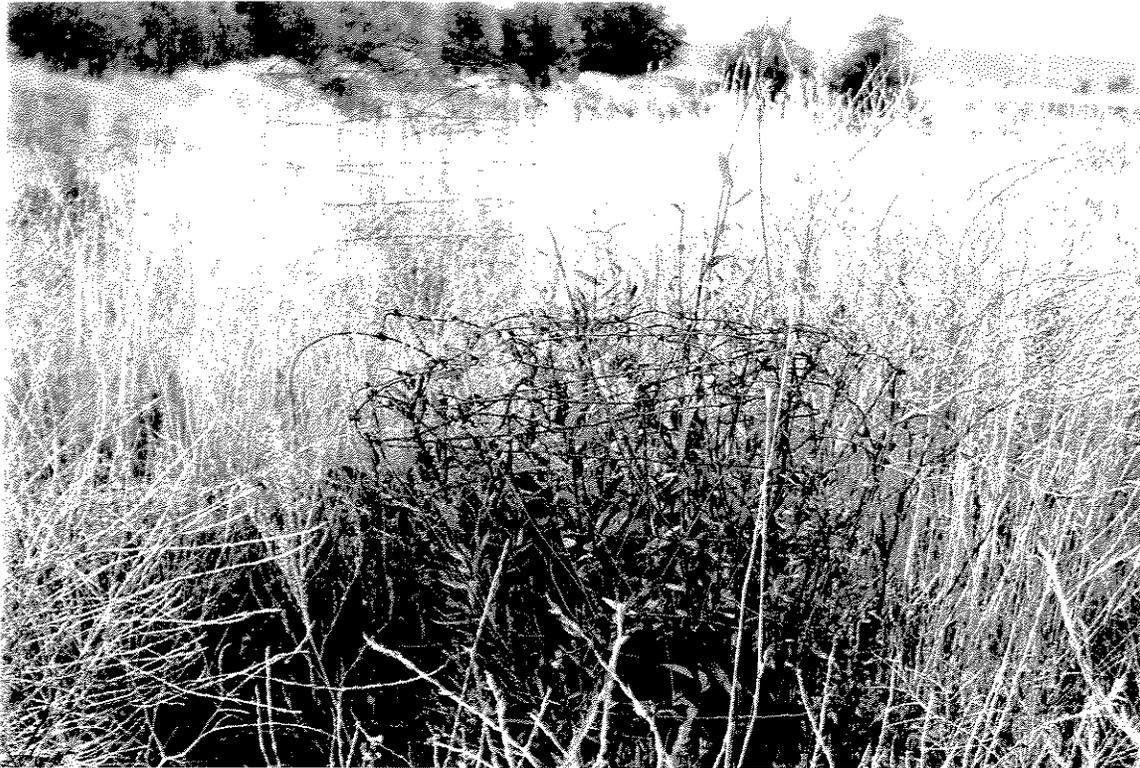
Willow growth when page wire cages are used (one season growth). 14 acres of trees were planted in the project area (1.3 river miles) at a density ranging from 140-220 trees per acre. *Site #11*

Planting Conditions: Good soil, some gravel layers, annual and perennial grass ground cover, stable water table at about 10-12 feet deep, deer browse cages added in 2000. 1999 planting survival was poor due to lack of browse cages. 2000 survival was good.

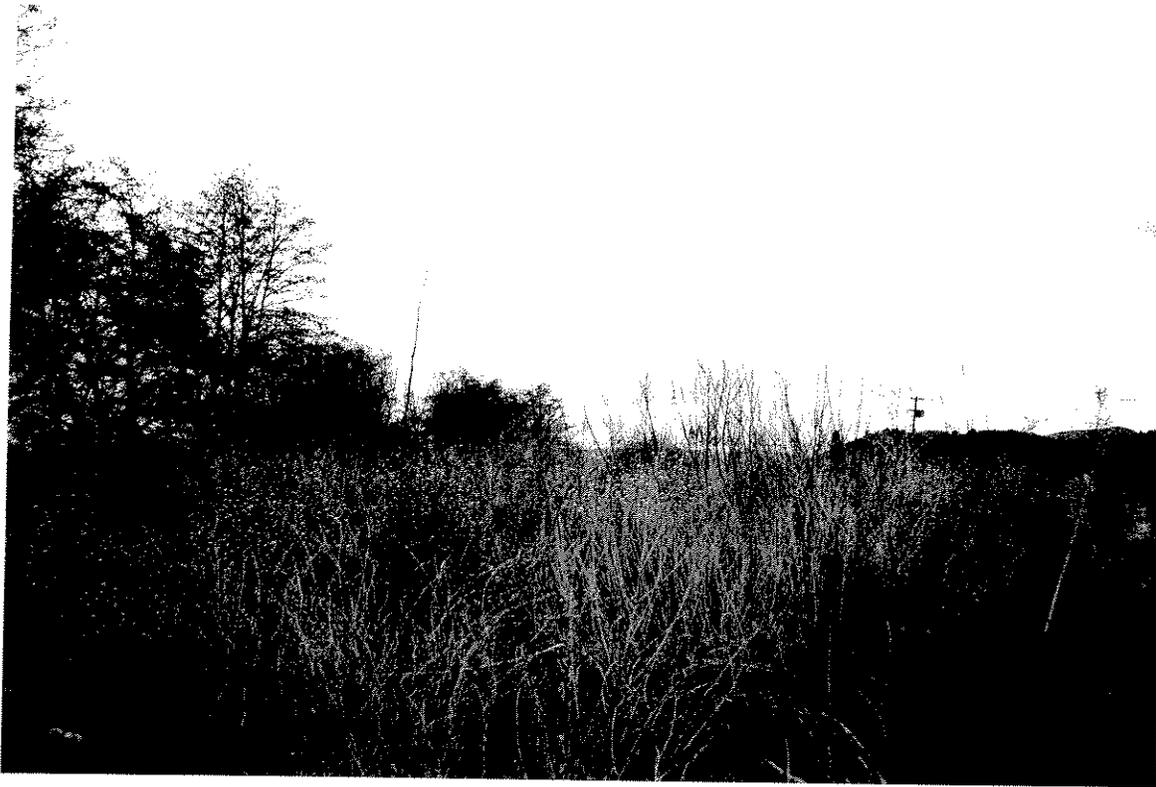
Cottonwood and willow cuttings getting above the browse and competition levels (Site #6).

Planting Conditions: Poor soil, unconsolidated gravel, little to no annual grass ground cover, Fluctuating water table at about 8-10 feet deep, heavy browse concerns (cages were installed)
