Klamath River Riparian Fence Project Final Report

Cooperator: **PacifiCorp**
Cooperative Agreement: **14-48-11333-99-J065**
Project numbers: **99-319(h)-IV-06**
Date of report: **January 29, 2001**

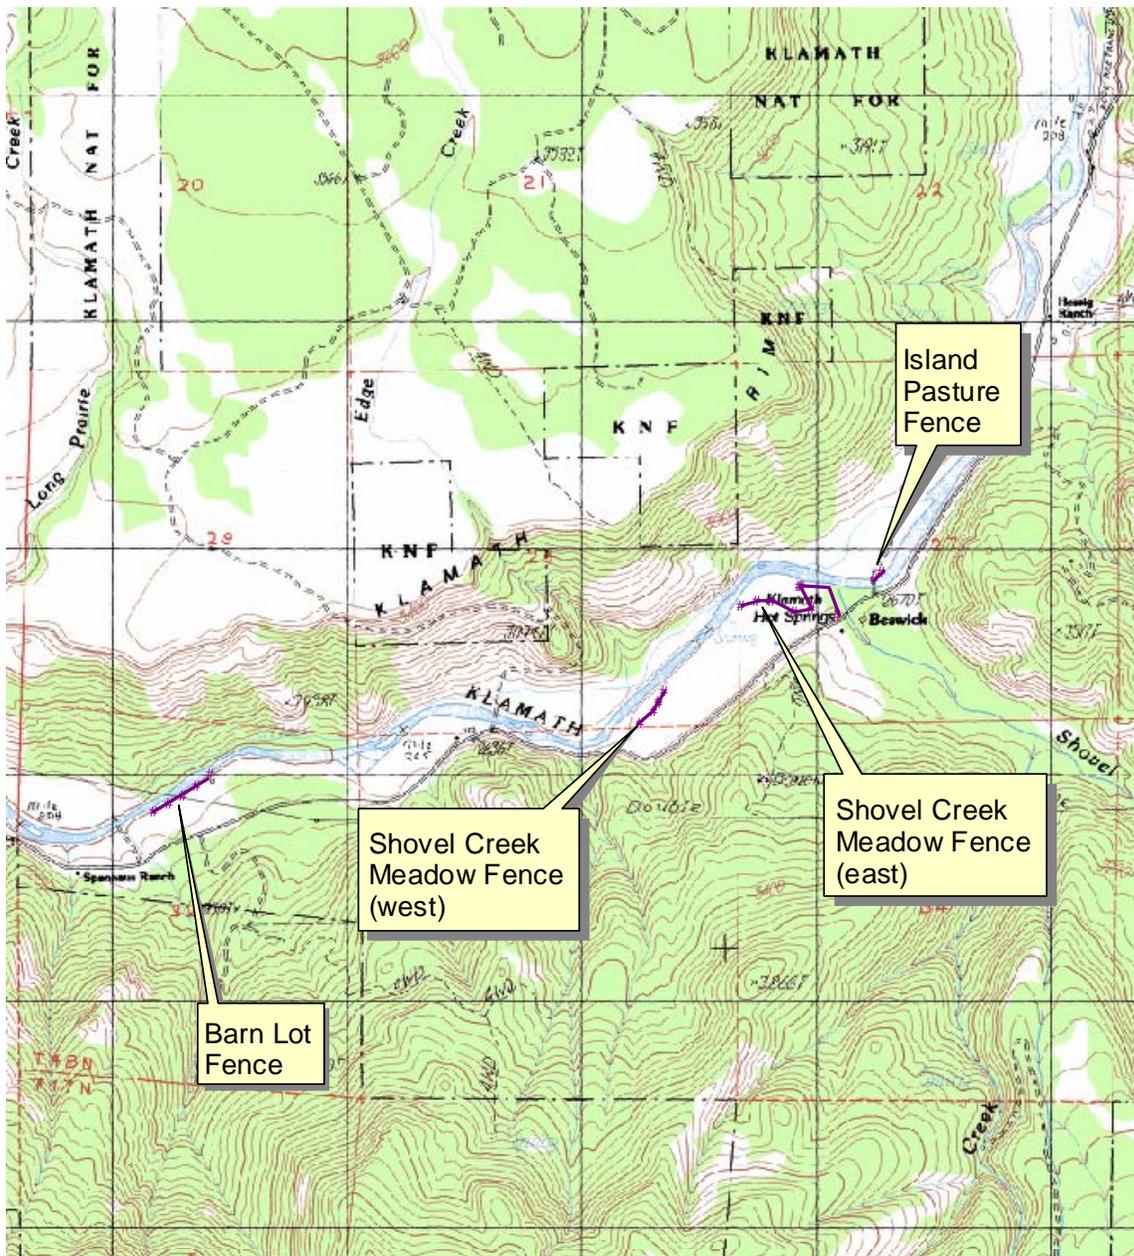
Figure 1. Klamath Riparian Fence Project

Fences were constructed in 3 main pastures (Figure 1). A local rancher was contracted to build the fences.

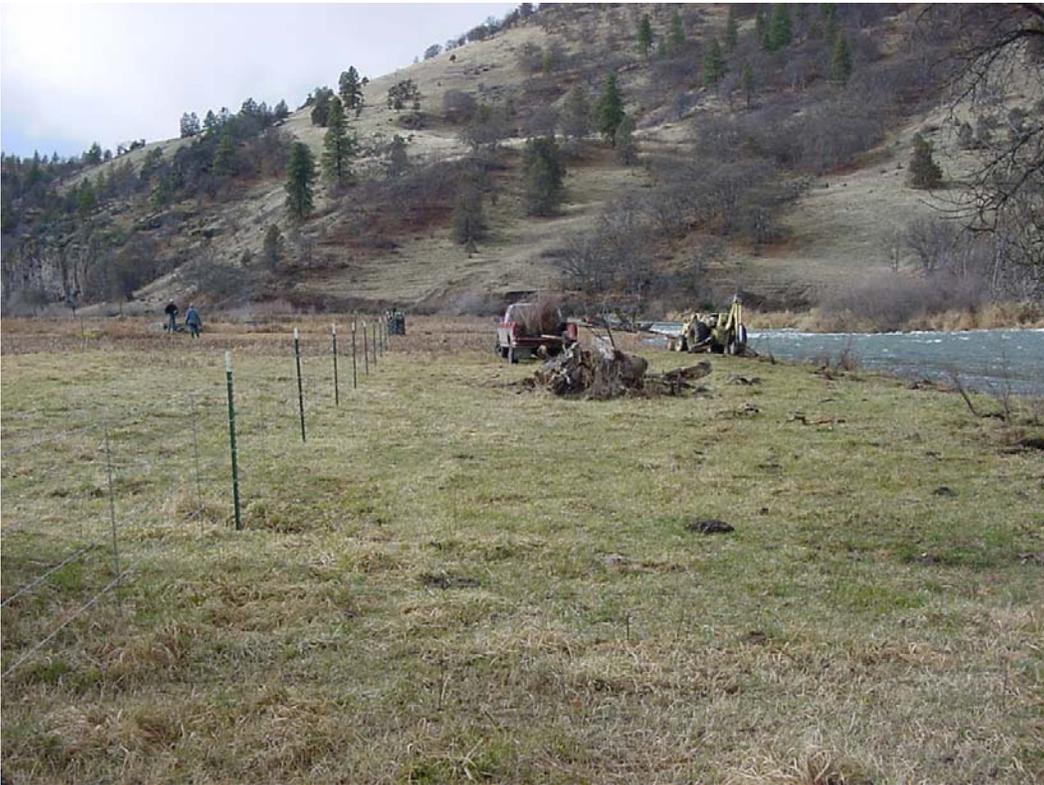
Figure 2. Riparian fence at Shovel Creek Meadow (east side).

The east fence segment consists of approximately 2313 ft of 4-strand wire fence beginning at a steep bank near the middle of the pasture and ending at the fence along the county road. The fence follows the Klamath River but jogs widely to the south to include a section of emergent wetland. It follows a small creek to the county road. One wire access gate and one fisherman gate were included in this segment.

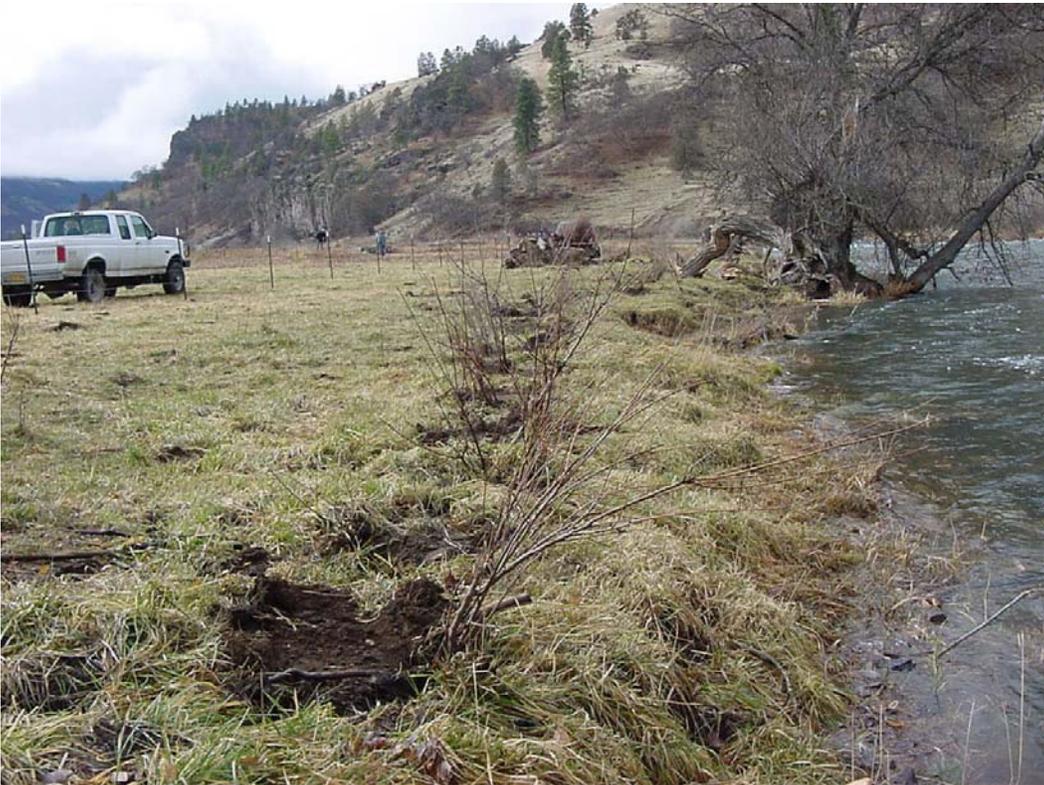
Figure 3. Riparian plantings in Shovel Creek Meadow (east side).

Willows were transplanted along the river at the Shovel Creek Meadow (Figure 3) and Barn Lot fencing sites. In the Shovel Creek Meadow site, one or two rows of willows were planted along the riverbank with an approximate spacing of 3 feet. A backhoe with a narrow bucket was used to dig most of the planting holes due to the rocky substrate. Weather conditions were good for planting (cool and raining).

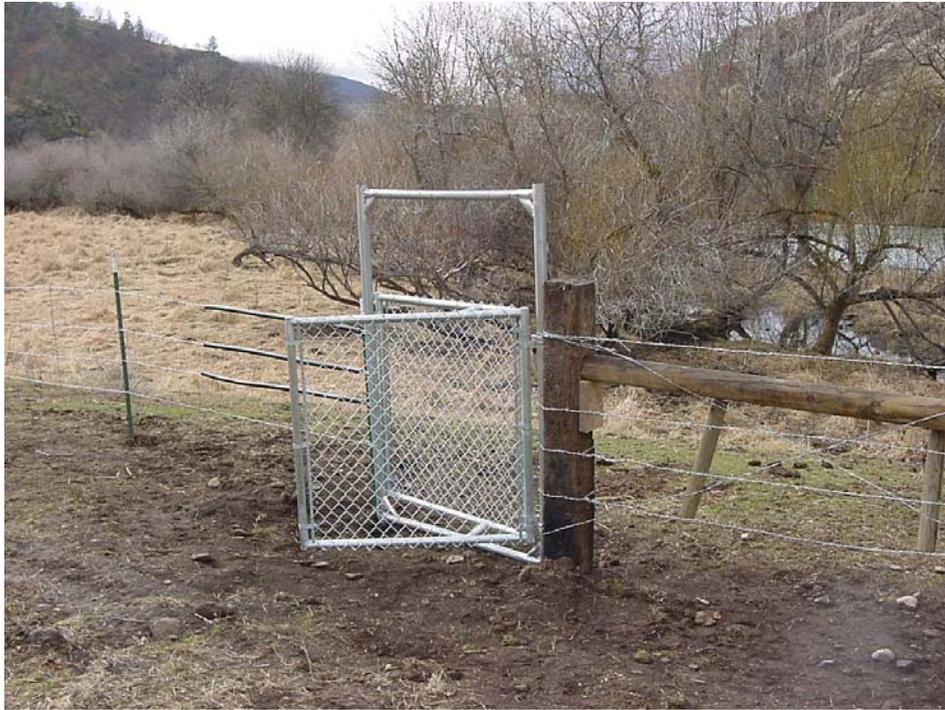
Figure 4. Fisherman gate on riparian fence at Shovel Creek Meadow (west side). Fisherman gates were installed to prevent damage to the fence from public access. Top crossbar clearance is approximately 6-ft high.

Two fence segments were constructed in this pasture. The west fence consists of approximately 600 ft of 4-strand wire that ties the existing west pasture boundary fence to a point on the shoreline where the steep bank forms a natural barrier to livestock. A fisherman gate and a wire access gate were included in this segment.

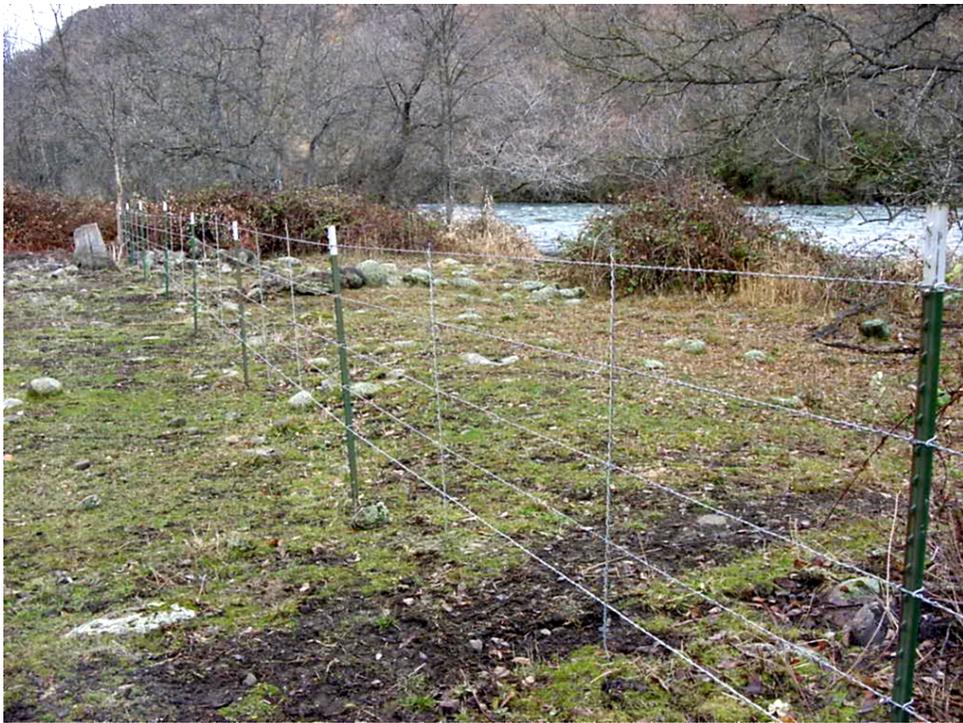
Figure 5. Riparian fence at Owens Pasture.

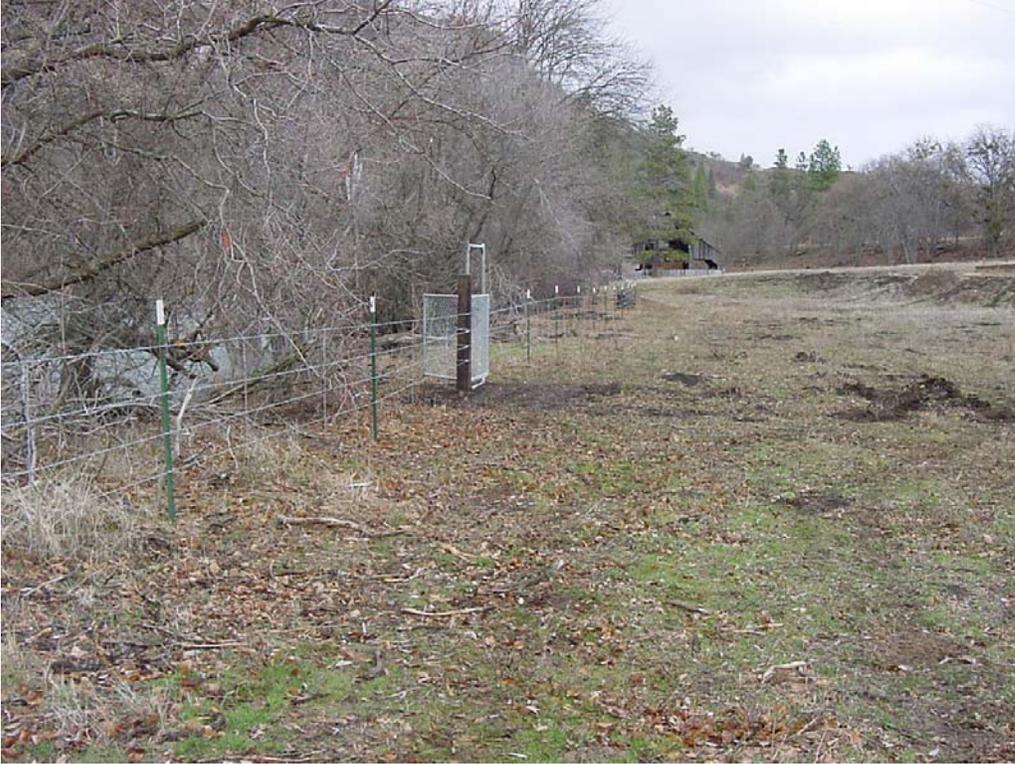
Figure 6. Riparian fence at Barn Lot Pasture showing fisherman gate.

Approximately 1013 ft of 4-strand wire fencing was constructed along the Klamath River, from the center of the pasture to the existing fence at the east end. One fisherman gate and one wire gate were included.
