Partners for Wildlife Program

Springs Enhancement

Agreement #14-48-11333-99-G135

Habitat Restoration Springs Enhancement

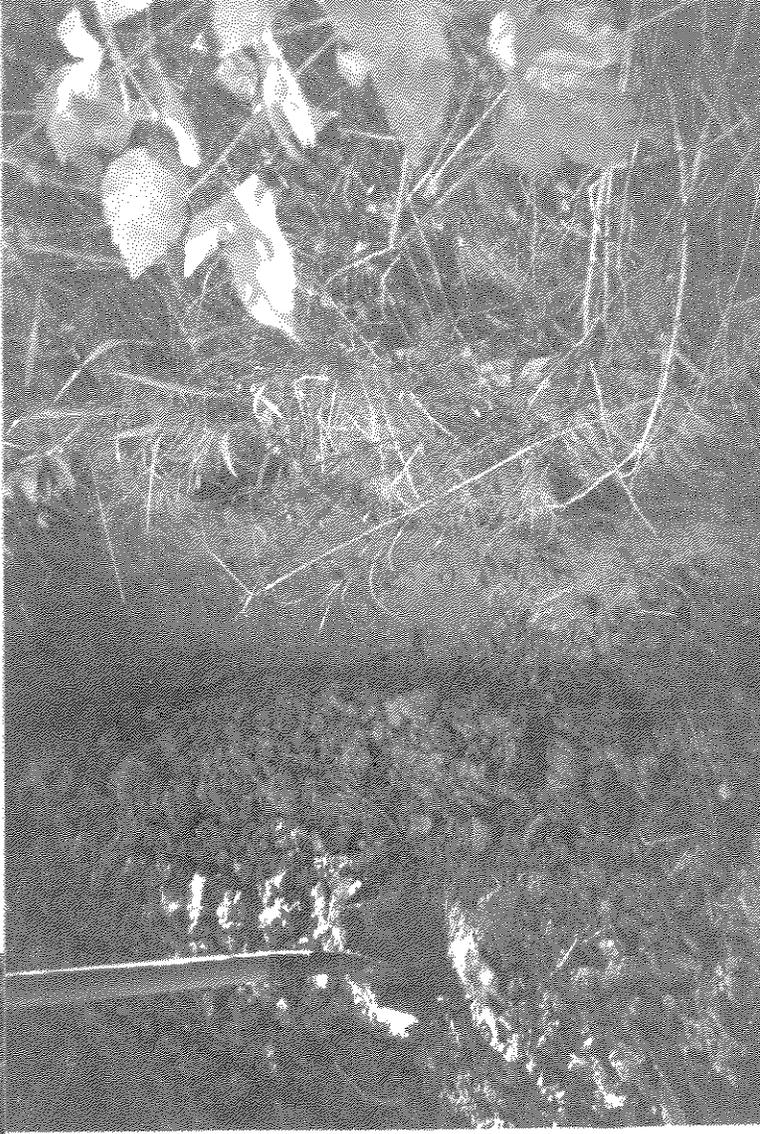
1b

Site 1

View of trenched trough

The trough is 30" deep, 18" wide by 12" long. (see photos #1b, 2b and 3 b) The bottom of the trough is lined with 4" of concrete mixed by hand and poured to create a concave bowl. This concave bowl is 2" deep. (see photos 1e and 2c) This bowl is designed as an impenetratable barrier so that all water collected will have no other way to go except out the collection port.

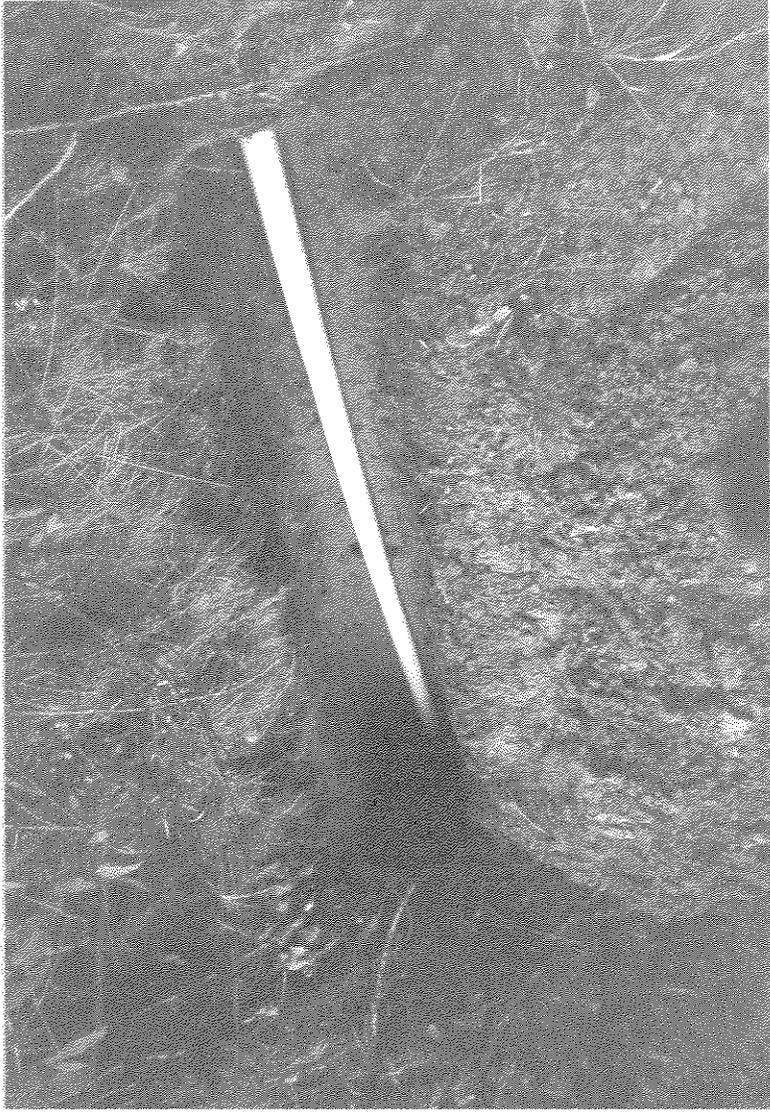
IC

Site 1

Depth and length of trench

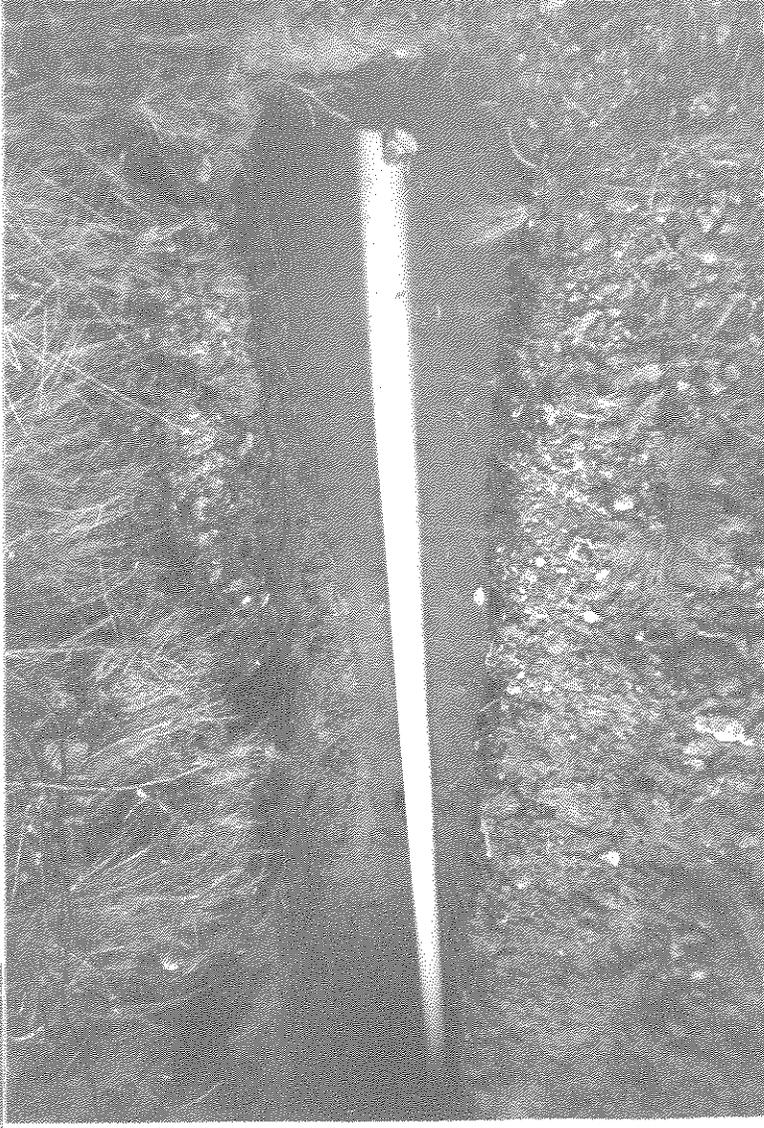
id

Site 1

Collection pipe in trench
with water seeping in

In the center of this trough is a 2" pvc pipe that has been manually drilled out with 1/2" and 1/4" holes on the bottom and sides, spaced 3" apart the full length of the pipe, which is 10' long. (see photo #1d) At either the end or the center of the trough, the discharge port is damned so that water only runs out the discharge port. This pipe is elevated above the concrete barrier by 1". Gravel, that is 1" diameter, is then poured around the pipe and above it to a depth of 3". Above that, another layer of 2" to 3" diameter gravel is filled another 17". (photos 1e and 2d) Then, it is topped with 3" of dried fern fronds that were gathered in the area. (photos #1f and 2f) To seal it, the soil that was dug to make the trough covers over the fern fronds to a depth of 6". The remaining soil material is fanned out to give the area a finished look. (photo#2h)

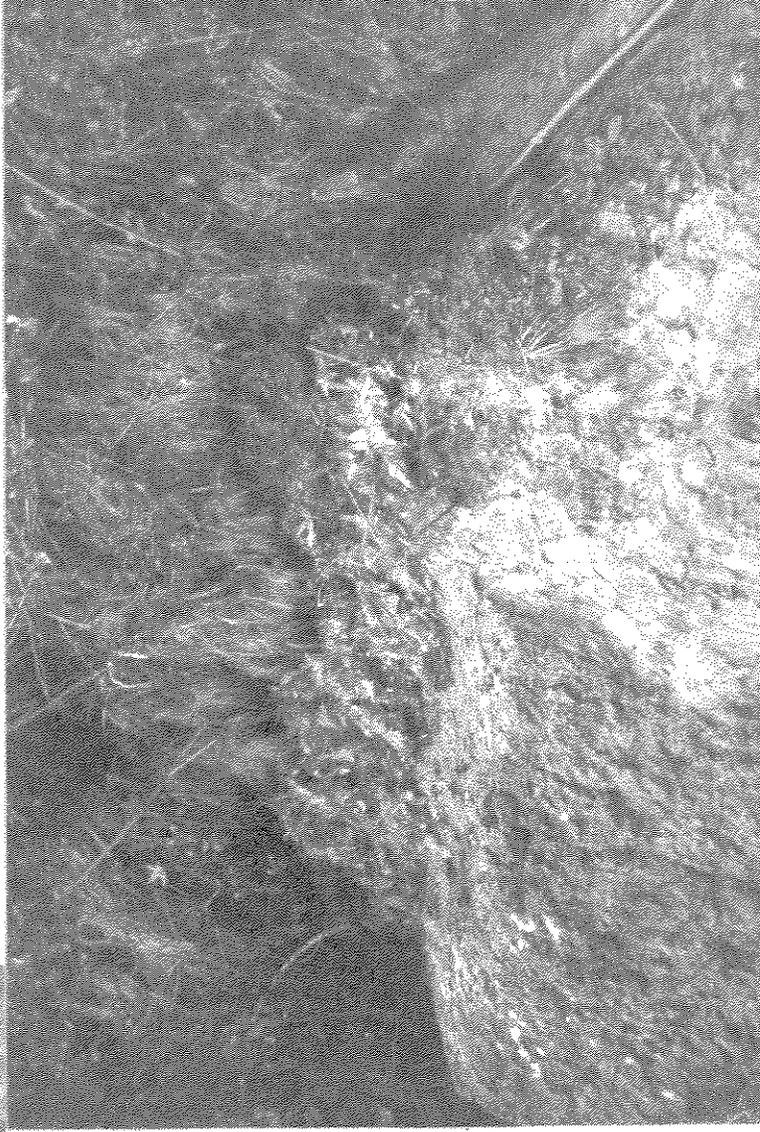
ie

Site 1

Trench with concrete barrier,
pipe in center, and gravel

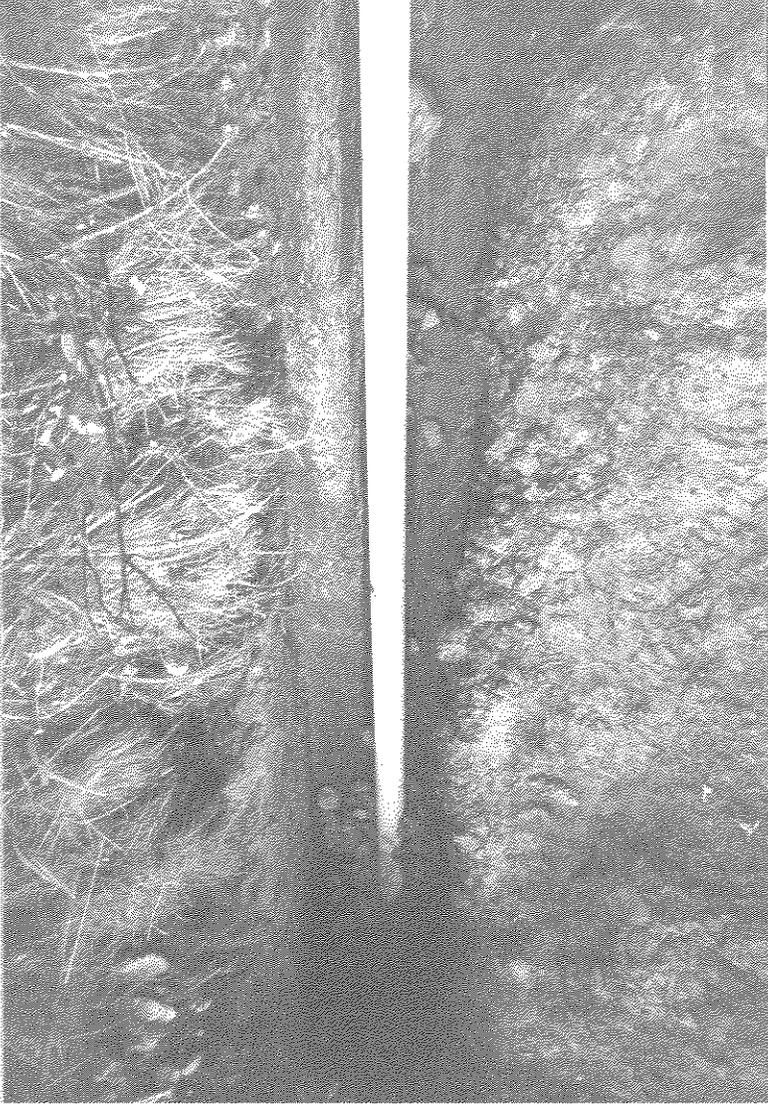
if

Site 1

Trench filled with gravel
and fern fronds to keep soil out

The overflow will be reduced outside the dam from 2" pvc to 1" and carried by 1" polyethylene pipe buried underground to a point where there is a transition from polyethylene to galvanized pipe before it is exposed above ground to the storage tank. (photos #1f, 2c, 2d and 2e) The storage tank is a 100 gallon aqua pot that is 18" deep by 5' in diameter. This tank is placed on level ground and a rock cladding is mounded around it. This will help protect the tank and aid in making it available to small animals. (photos #1g, 1h, 2g, 2i, 3c and 3d) Also, two of the tanks were fitted with redwood shelves and ramps for easier access and egress.

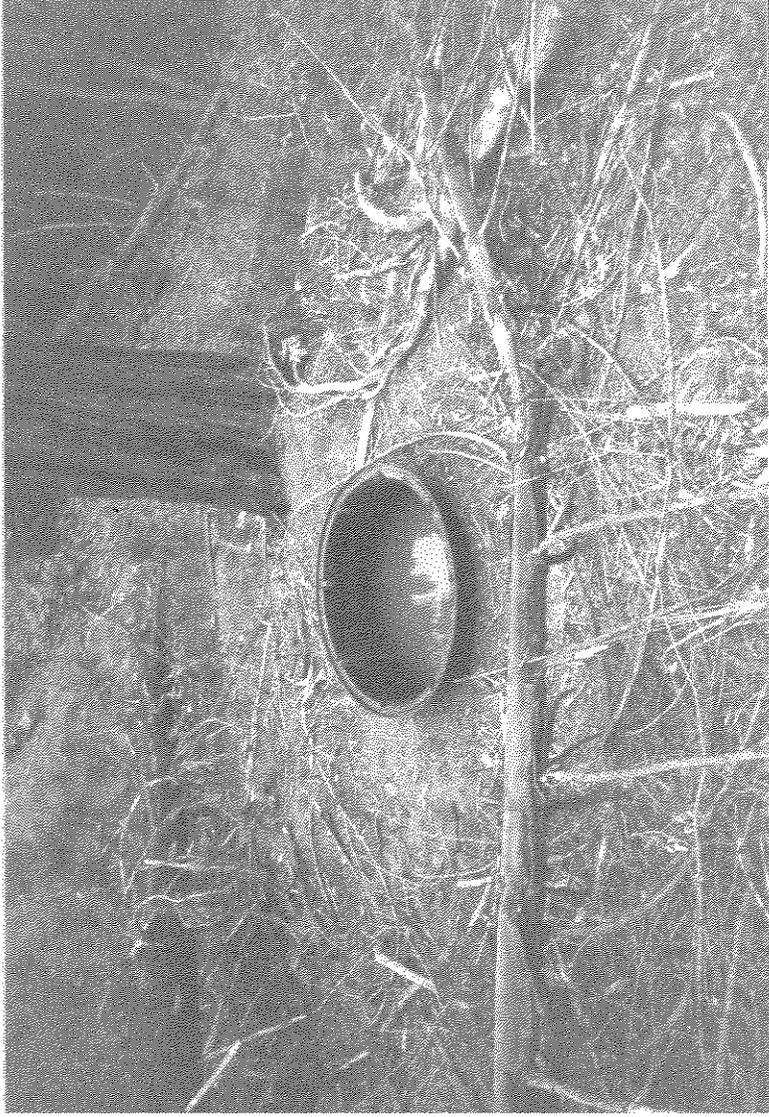
ig

Site 1

Tank placement with water

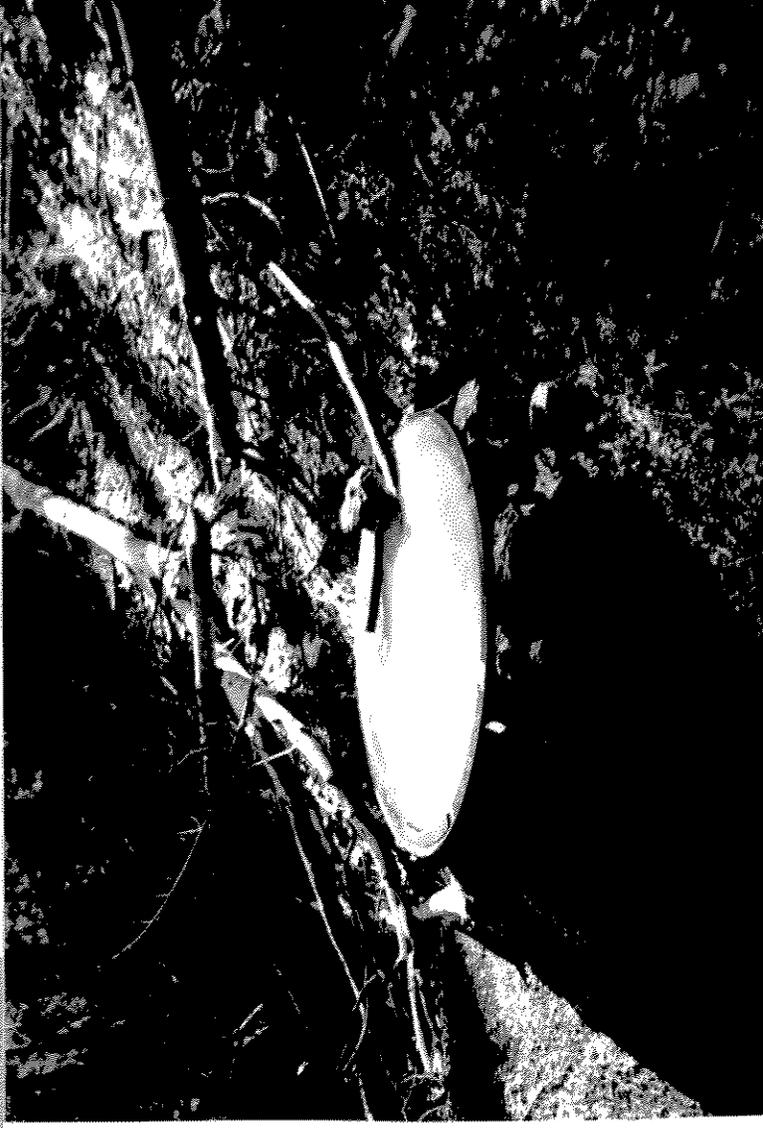
ih

Site 1

Filled tank with rock cladding

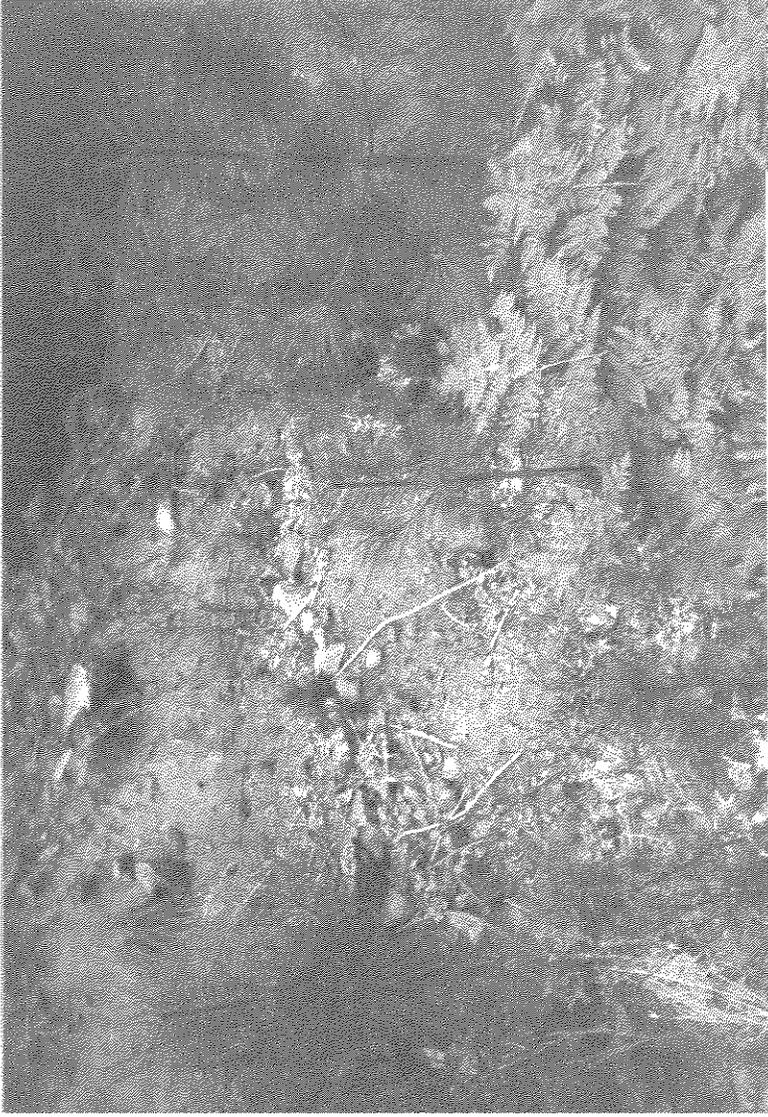
Site 2

Before start of project

The method employed here is manual labor, utilizing shovels and picks to trench a trough in the ground, to concentrate layers of seeps into this trough. (see photos #1a, 2a and 3a, taken prior to the start of the project)

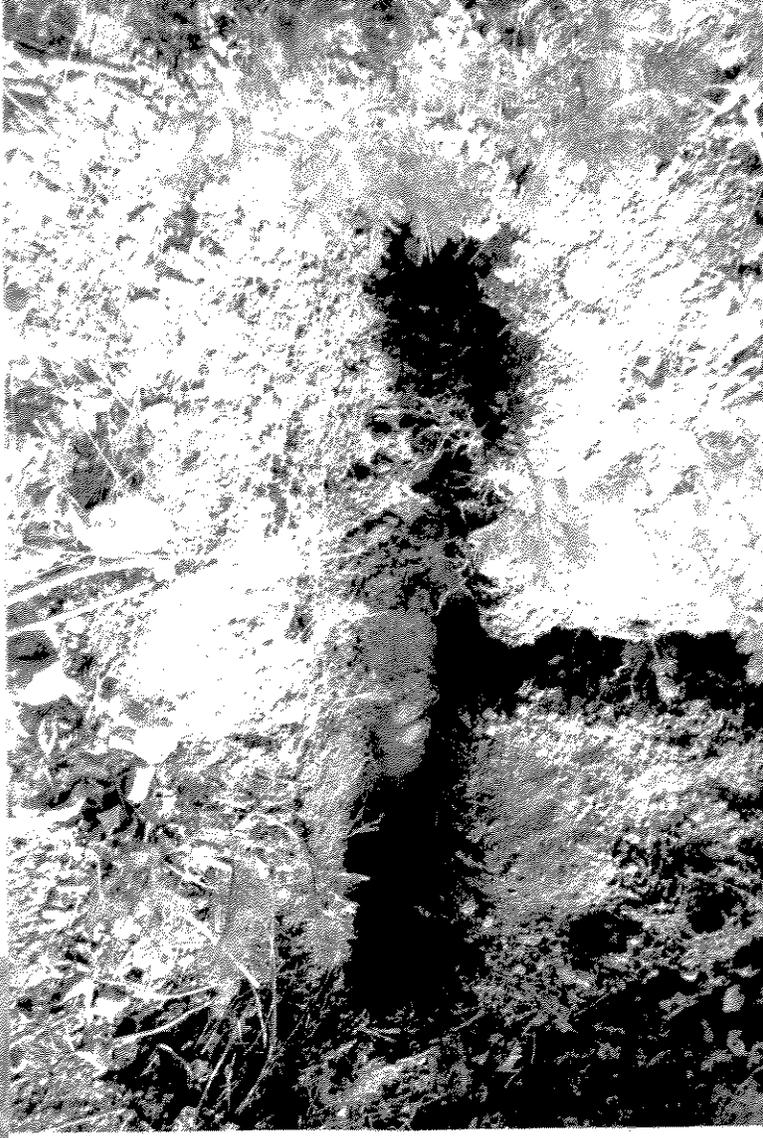
2b

Site 2

Depth of trench

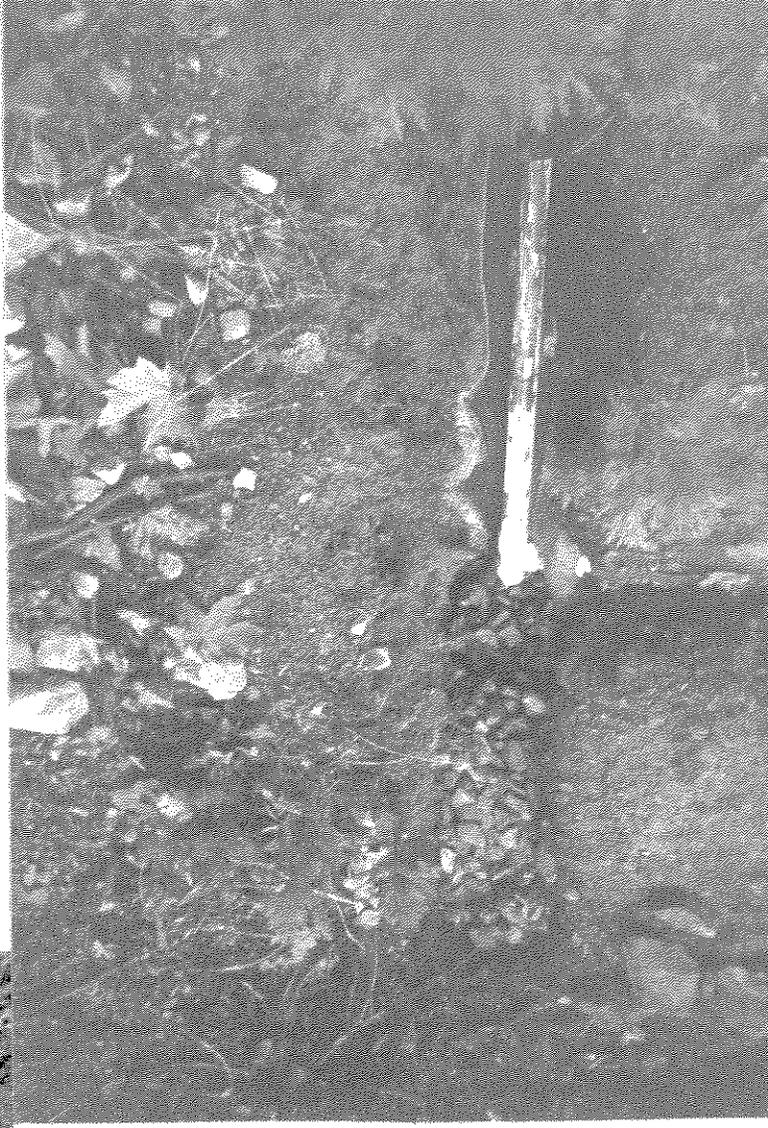
2c

Site 2

Trench with concrete barrier,
pipe centered and dammed port

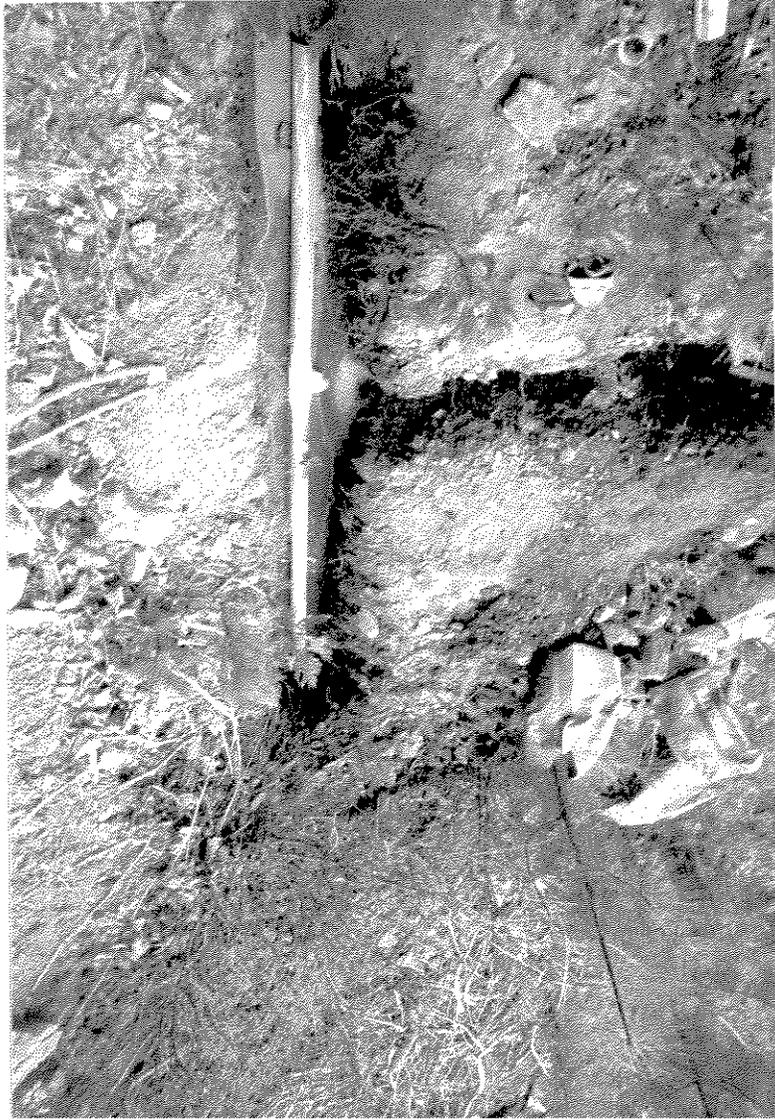
2d

Site 2

Trench with pipe, water and gravel

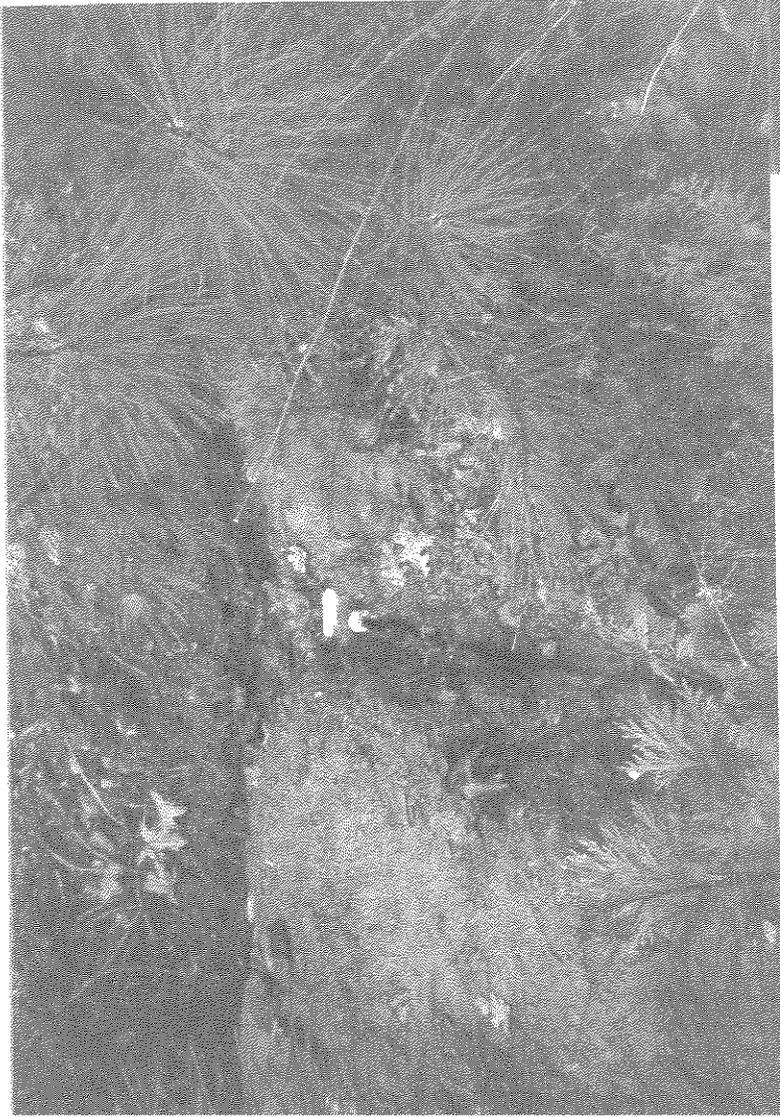
2e

Site 2

Trench with collection feed
and poly pipe

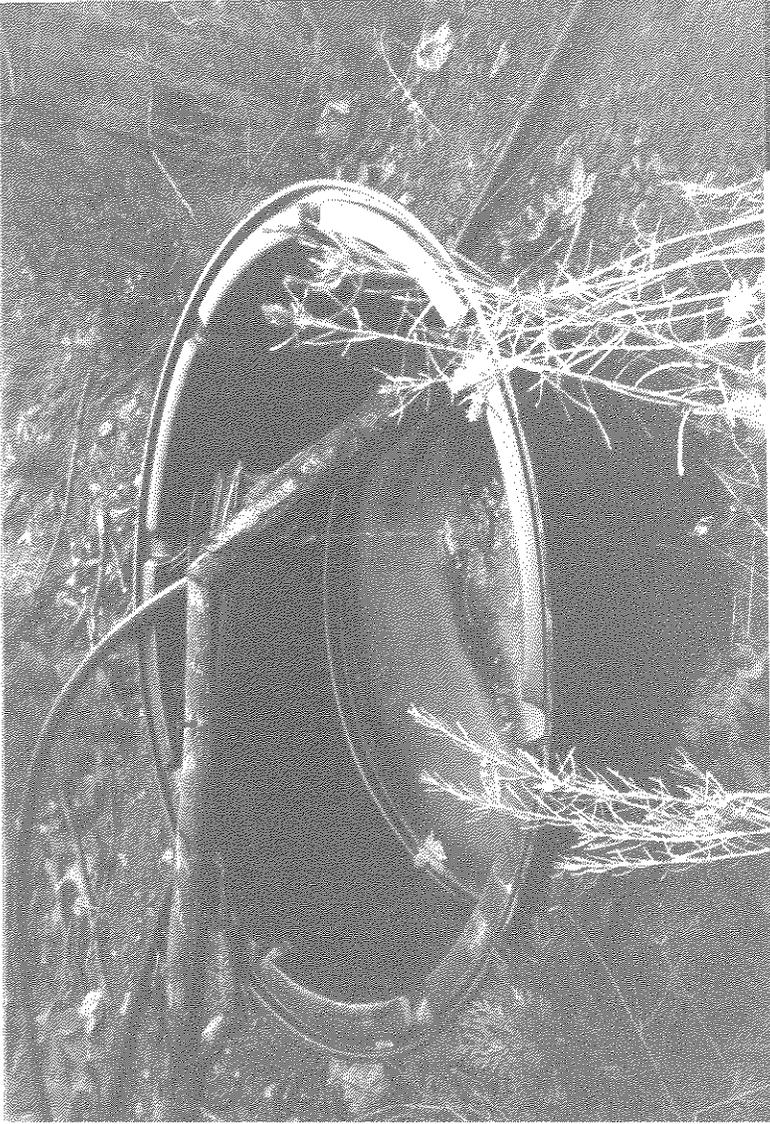
2g

Site 2

Tank placement
with water flowing into tank

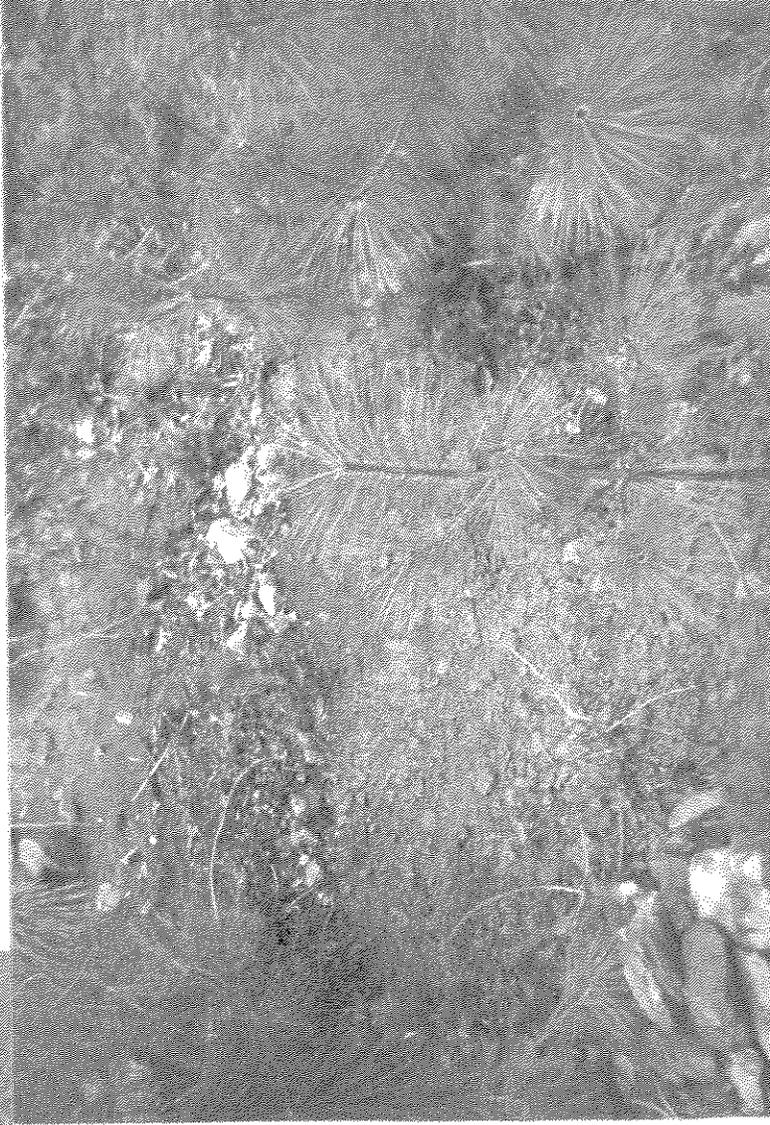
2h

Site 2

Trench filled over
covering fronds, and feathered soil

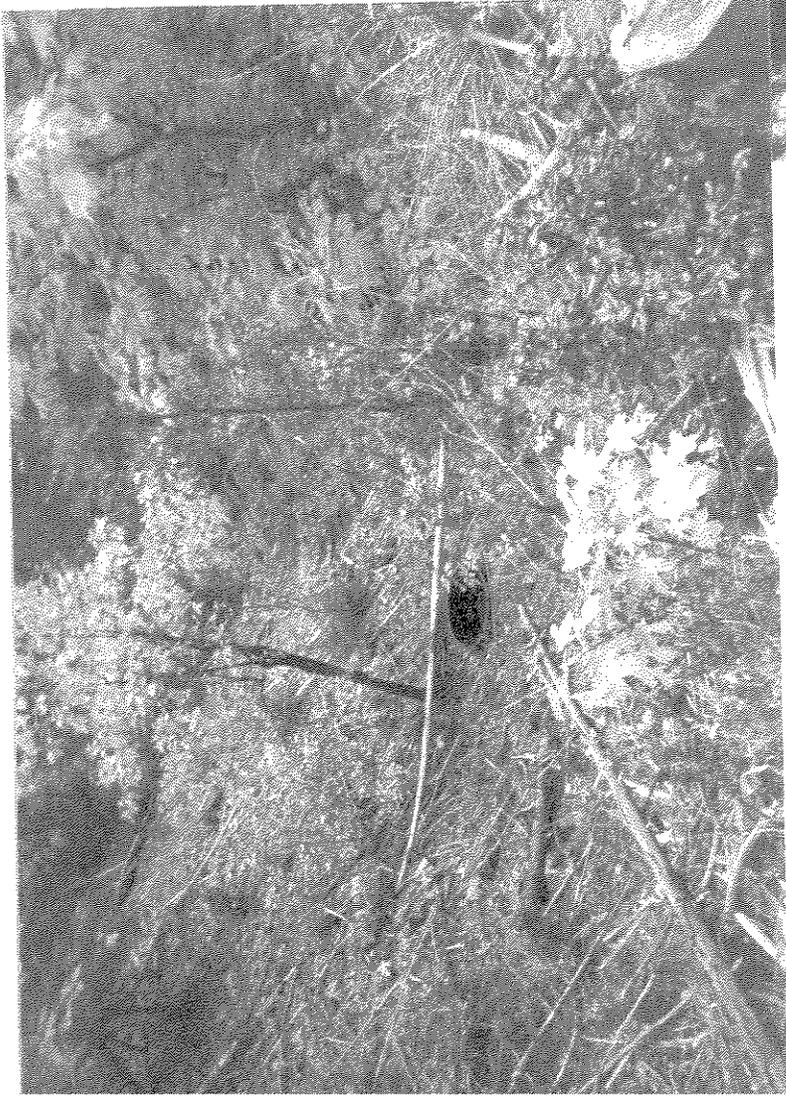
3c

Site 3

Placement of tank

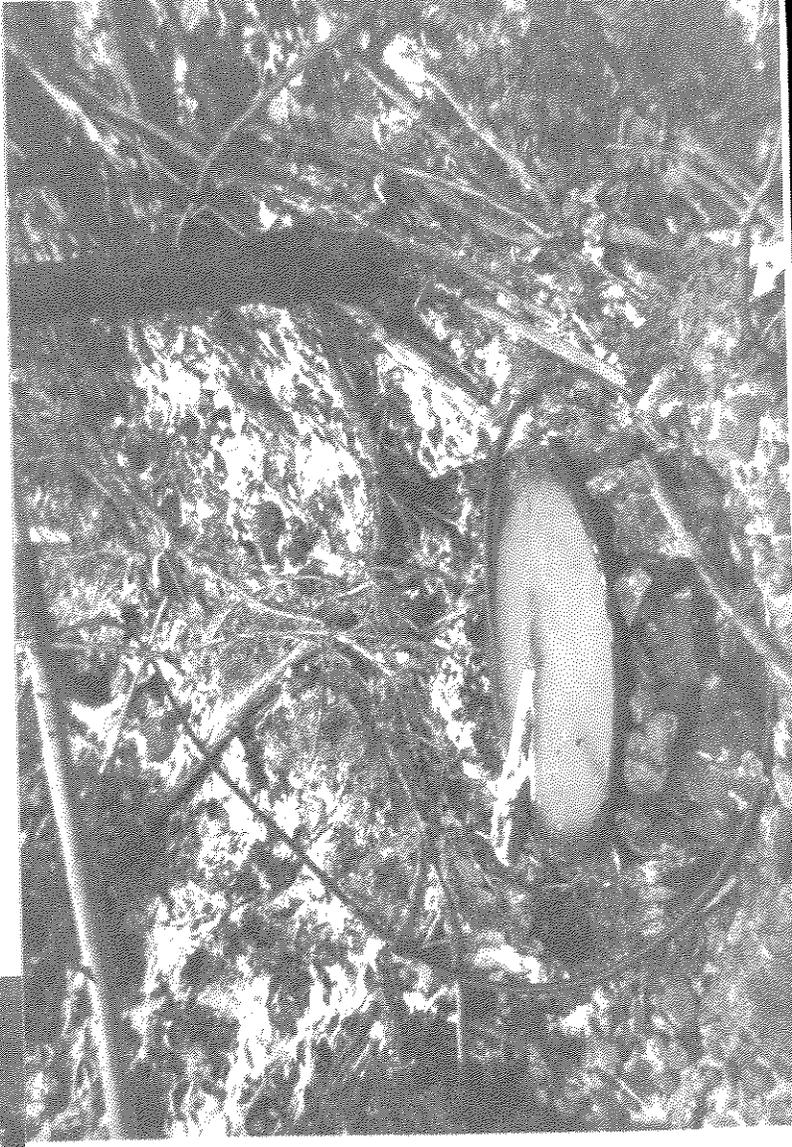
3d

Site 3

Placement of tank with rock cladding,
filled with water
