**YUROK TRIBE**  
Watershed Restoration Department

**2001 BLUE CREEK WATERSHED RESTORATION  
IMPLEMENTATION FINAL REPORT**

*Prepared for:*  
*U.S. Fish & Wildlife*  
*Agreement# 14-48-11333-00-J008*  
*Project # 2000-HR-09*  
*By:*  
*Yurok Tribe*

**2001 BLUE CREEK  
WATERSHED RESTORATION  
IMPLEMENTATION AND TRAINING PROGRAM**

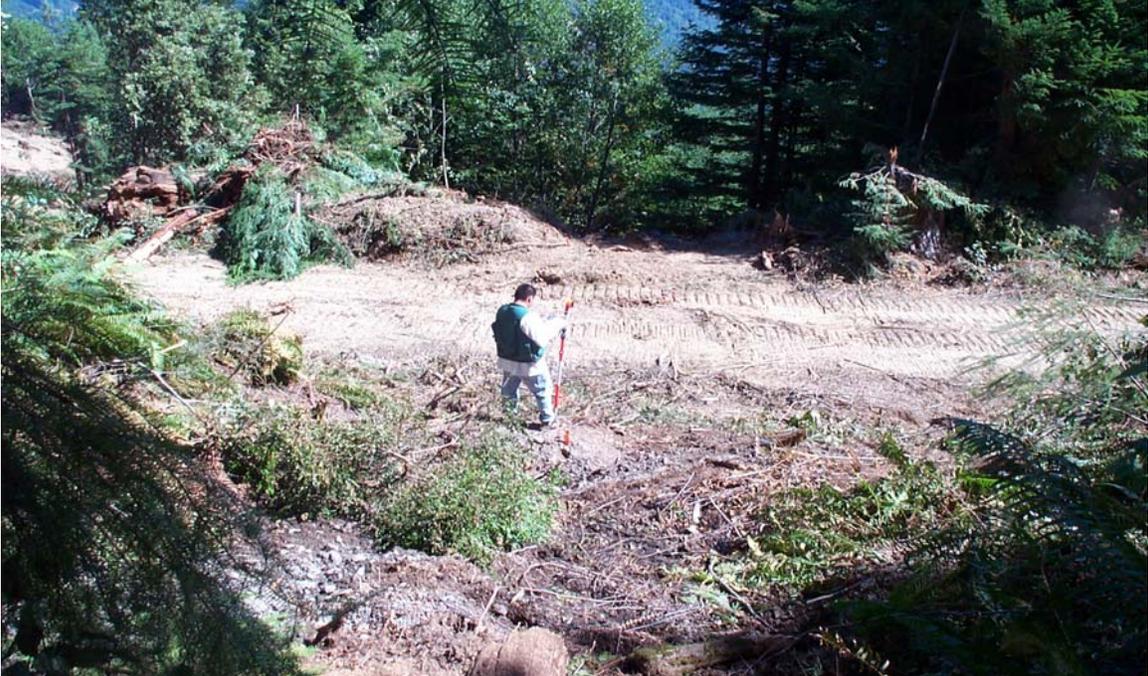
Pre-photo of Rx 4 (Stream crossing) on the B-922 road.

Stream crossings were excavated to original width, depth and slope to expose natural channel morphology. Side slopes were excavated and filled to match original contours above and below the road.

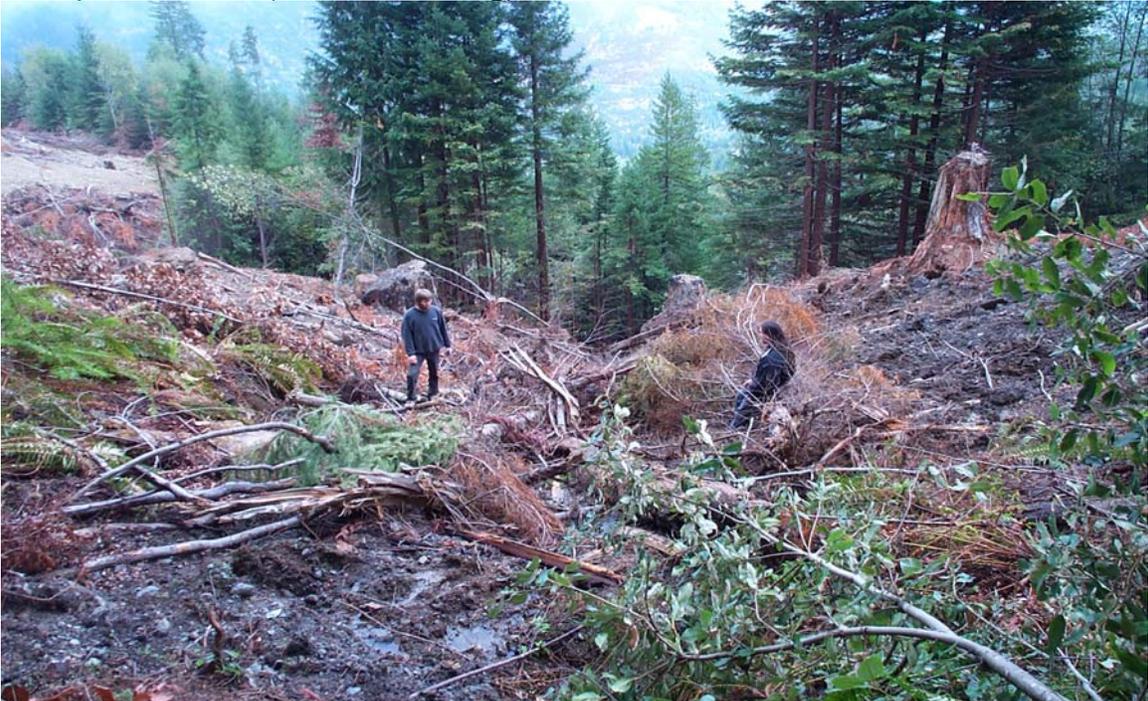
Post-photo of Rx4 (Stream crossing) on the B-922 road.

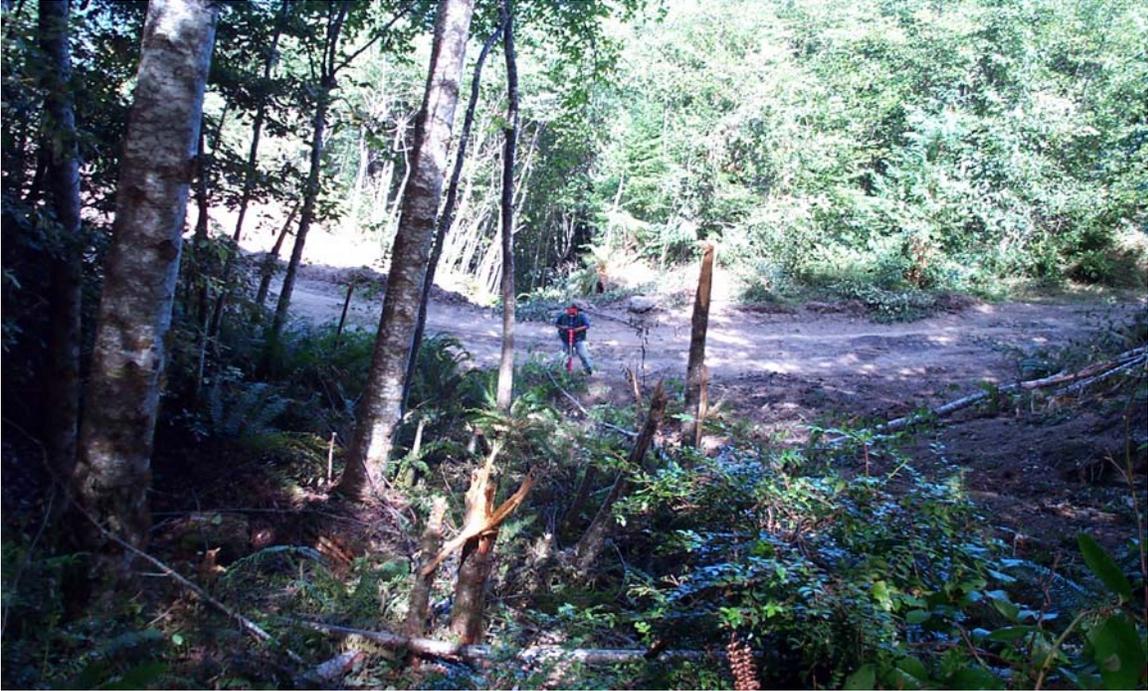
Pre-photo of Rx 5 (Stream crossing) on the B-922 road.

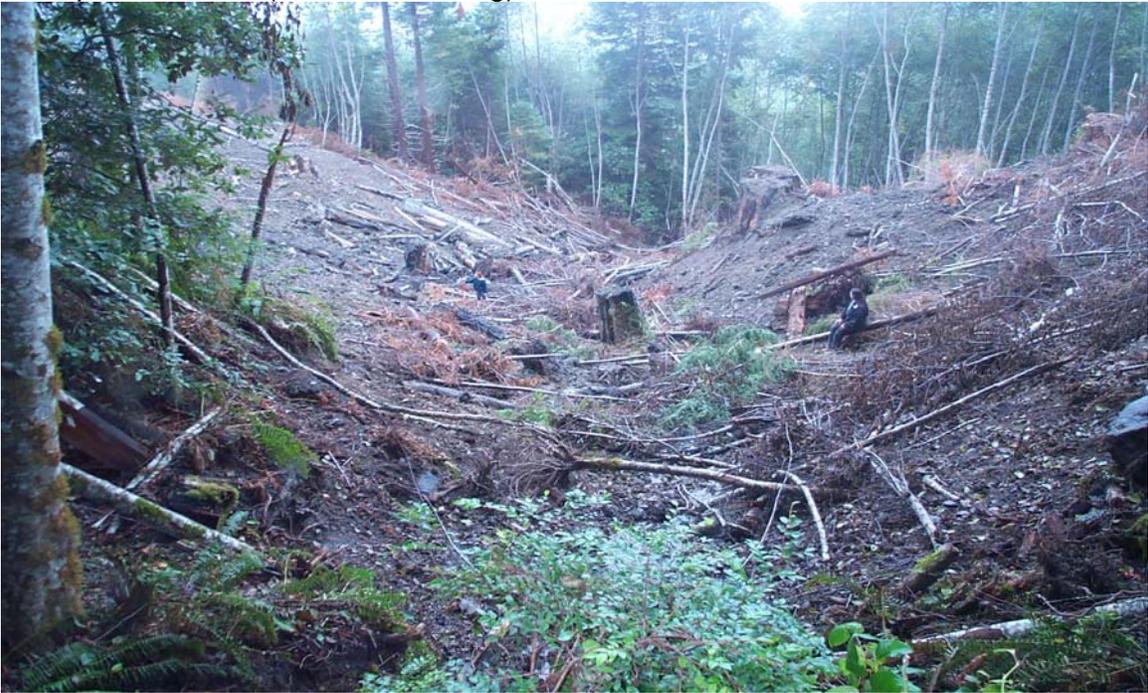
Post-photo of Rx5 (Stream crossing) on the B-922 road.

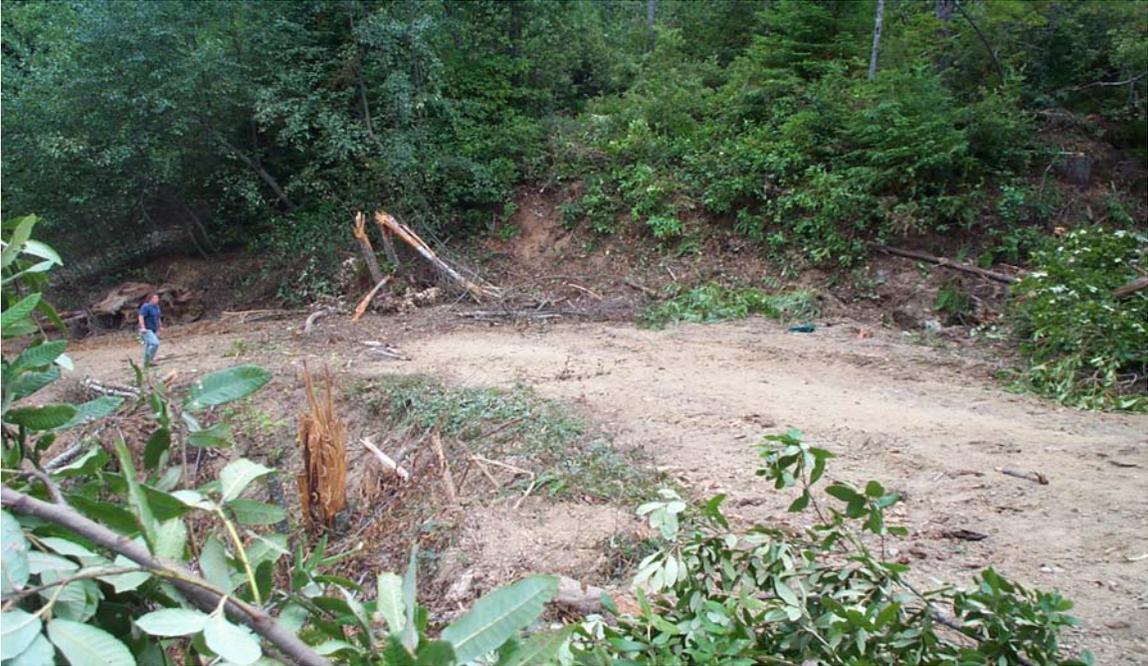
Pre-photo of Rx3 (Stream crossing) on the B-922-D road.

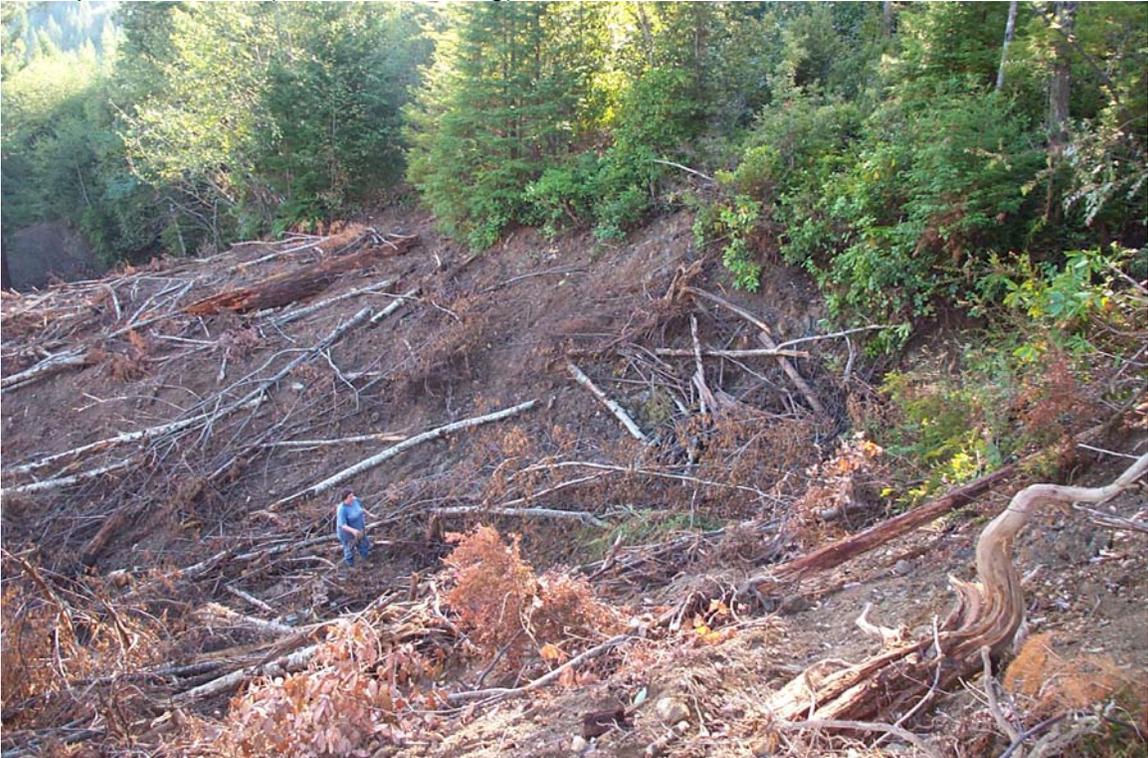
Post-photo of Rx3 (Stream crossing) on the B-922-D road.

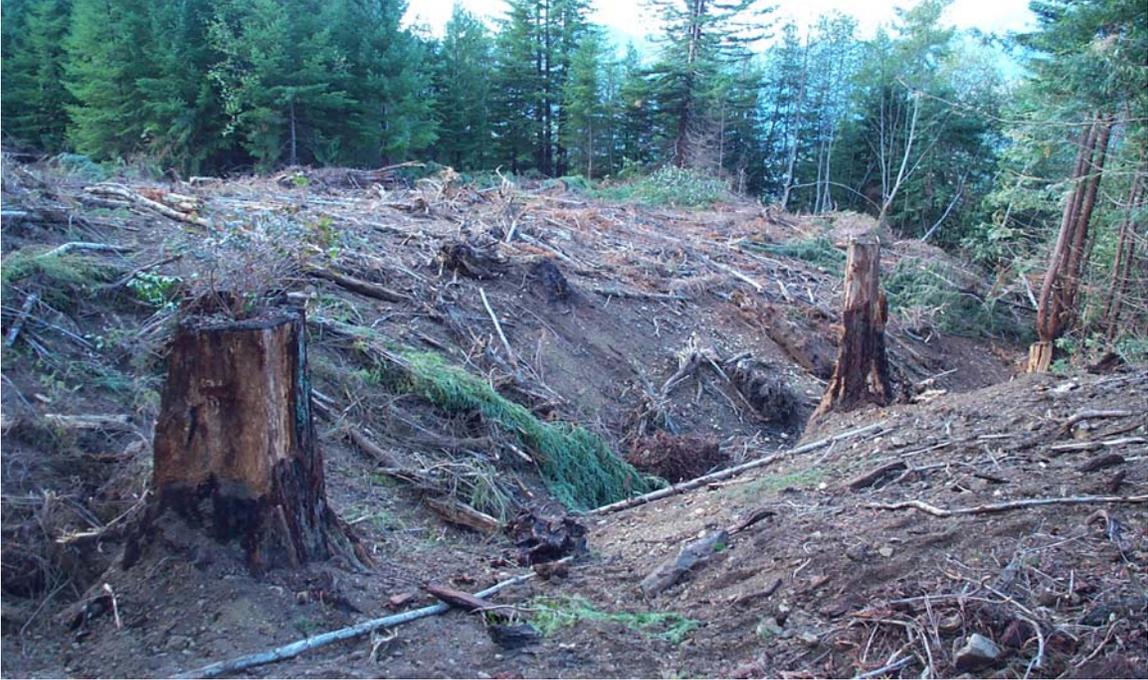
Post-photo of Rx1 (Stream crossing) on the B-922-C road.

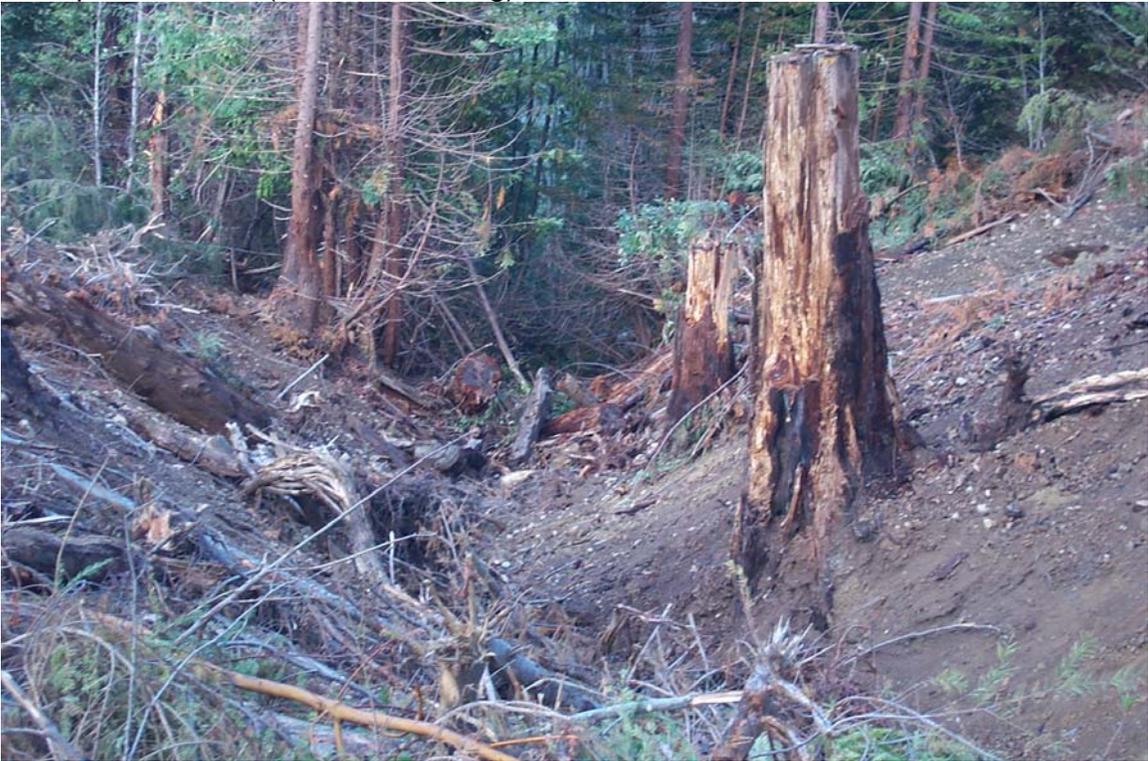
Post-photo of Rx1 (Stream crossing) on the B-922-C road.
