YUROK TRIBE
Watershed Restoration Department

2004 Blue Creek Implementation Final Report

Project Competition Date 10/25/04

**2004 BLUE CREEK
WATERSHED RESTORATION
IMPLEMENTATION AND TRAINING PROGRAM**

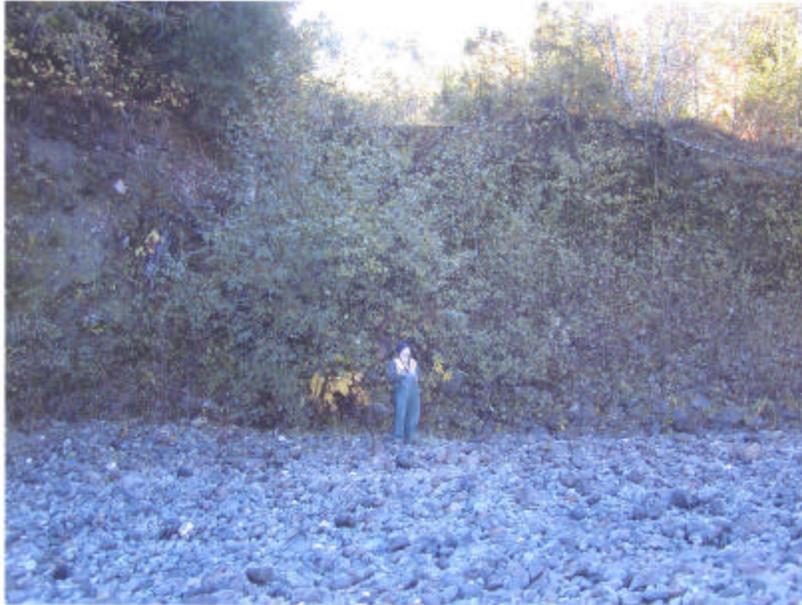
Unfinished Access: Location of point of access.

Some other issues that stumbled the department in the field were changing and creating access into the work areas. Their previous director had designed this project to be accessed from a completely unlogistical point adding 20 to 25 miles of travel for project vehicles including pickups, dump trucks, fuel trucks, and lowboys. So with a little help and advice from some of our regulatory agencies we changed our approach to access our work site from across the bottom rather than haul all the way around to the top and then back down to the bottom. We used bridges instead of culverts when rebuilding this access to minimize impact to two already washed out stream crossing (figure 9 and appendix A) one of the final situations that firmly sticks out in mind of this season is that this years project contained one of our biggest endhaul shows we have ever conducted. Site #5 on the PC 14 according to the pre survey there was approximately 6500 cubic yards. Upon completion of post surveys of this site we had removed approximately 20,000 yards of fill and 95% of that dirt needed to be end hauled $\frac{3}{4}$ of a mile down the road. With our recently purchased dump truck working frantically, and bad weather getting closer everyday we realized that our late start due to permitting hurdles wasn't going to allow us to continue this project to completion with only one dump truck. So it was decided that we needed more trucks. Then to add insult to injury when we started looking for dump trucks to rent or contract with it seemed as though every truck in the world was unavailable. Eventually we got more trucks to help, even though we had to incur extra cost to get them here from across the state. We finished our site and moved on before bad weather set in, but it was a learning experience that won't soon be forgotten.

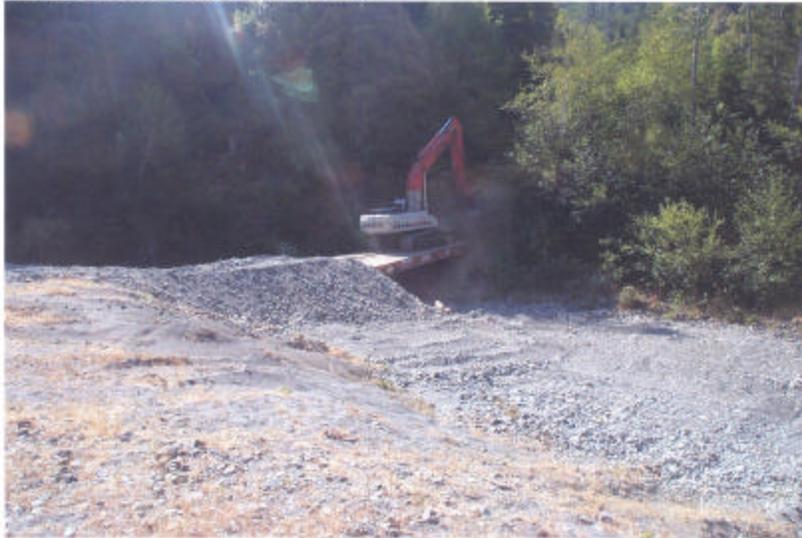
Finished Access: Created point of access.

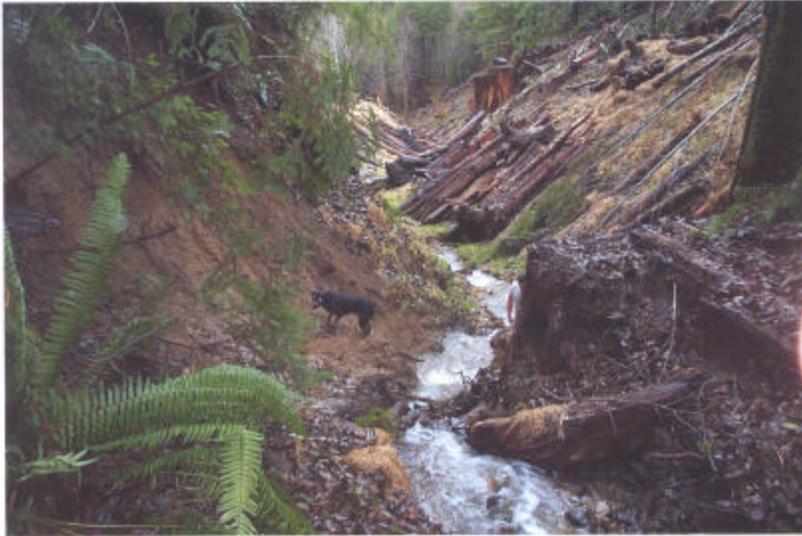
UES Site #5.

The following pictures are of various sites from this years decommissioning project. These photos were taken after our first big storm, and are a product of the on going monitoring project watershed conducts of their finished work.
