Lower Klamath River Sub-basin
Planning and Coordination

Final Report

Project Number 2001-PC-11

Lower Klamath River Sub-basin Watershed Restoration Plan

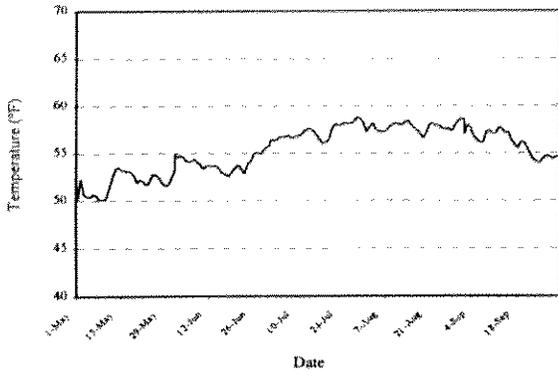
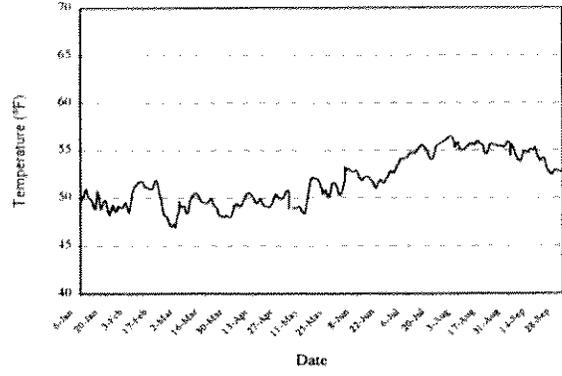
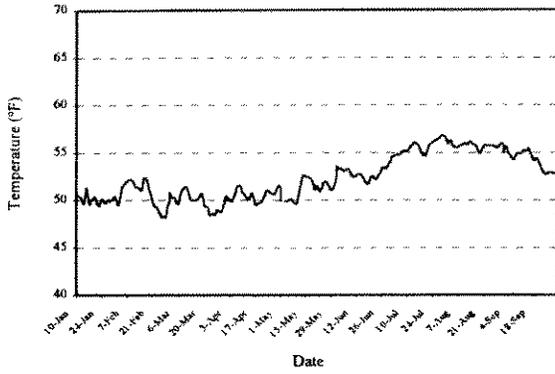
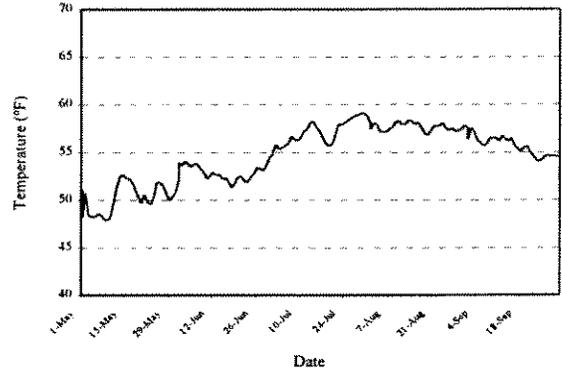
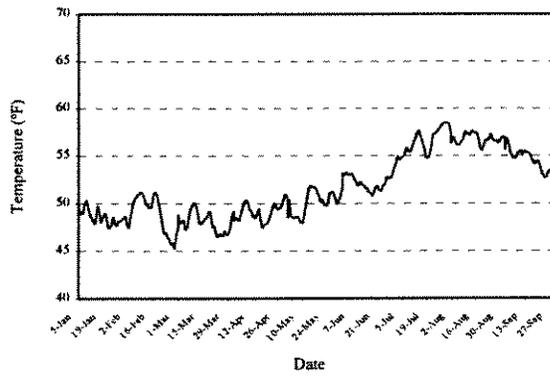
McGarvey Creek, May-September, 1996

Omegaar Creek, January-September, 1996

Tarup Creek, January-September, 1996

Bear Creek, May-September, 1996

Surpur Creek, January-September, 1996

Figure 2. Average daily stream temperature, selected lower Klamath tributaries, 1996.

YTFP initiated a large-scale water temperature-monitoring program in the Lower Klamath tributaries beginning in 1995. These activities were undertaken in order to assess whether water temperatures are a limiting factor to survival and/or health of tributary salmonid populations. To date, five years of monitoring have revealed that tributary water temperature consistently remains within acceptable tolerances identified for the salmonid species present (Figures 2-4) (Bell 1991). The annual variation in average daily water temperature is less than 10°F in the majority of the Lower Klamath tributaries, with the summer maximum temperature never exceeding 60°F in most of these watersheds (Figure 1). Lower Blue Creek contains the highest recorded summer water temperatures of all monitored tributaries (Figures 3-4), which is likely due to Blue Creek's large size, open canopy and reduced channel confinement found in the lower reaches. Despite these elevated temperatures, Lower Blue Creek water temperatures still fall within acceptable tolerances throughout the year.

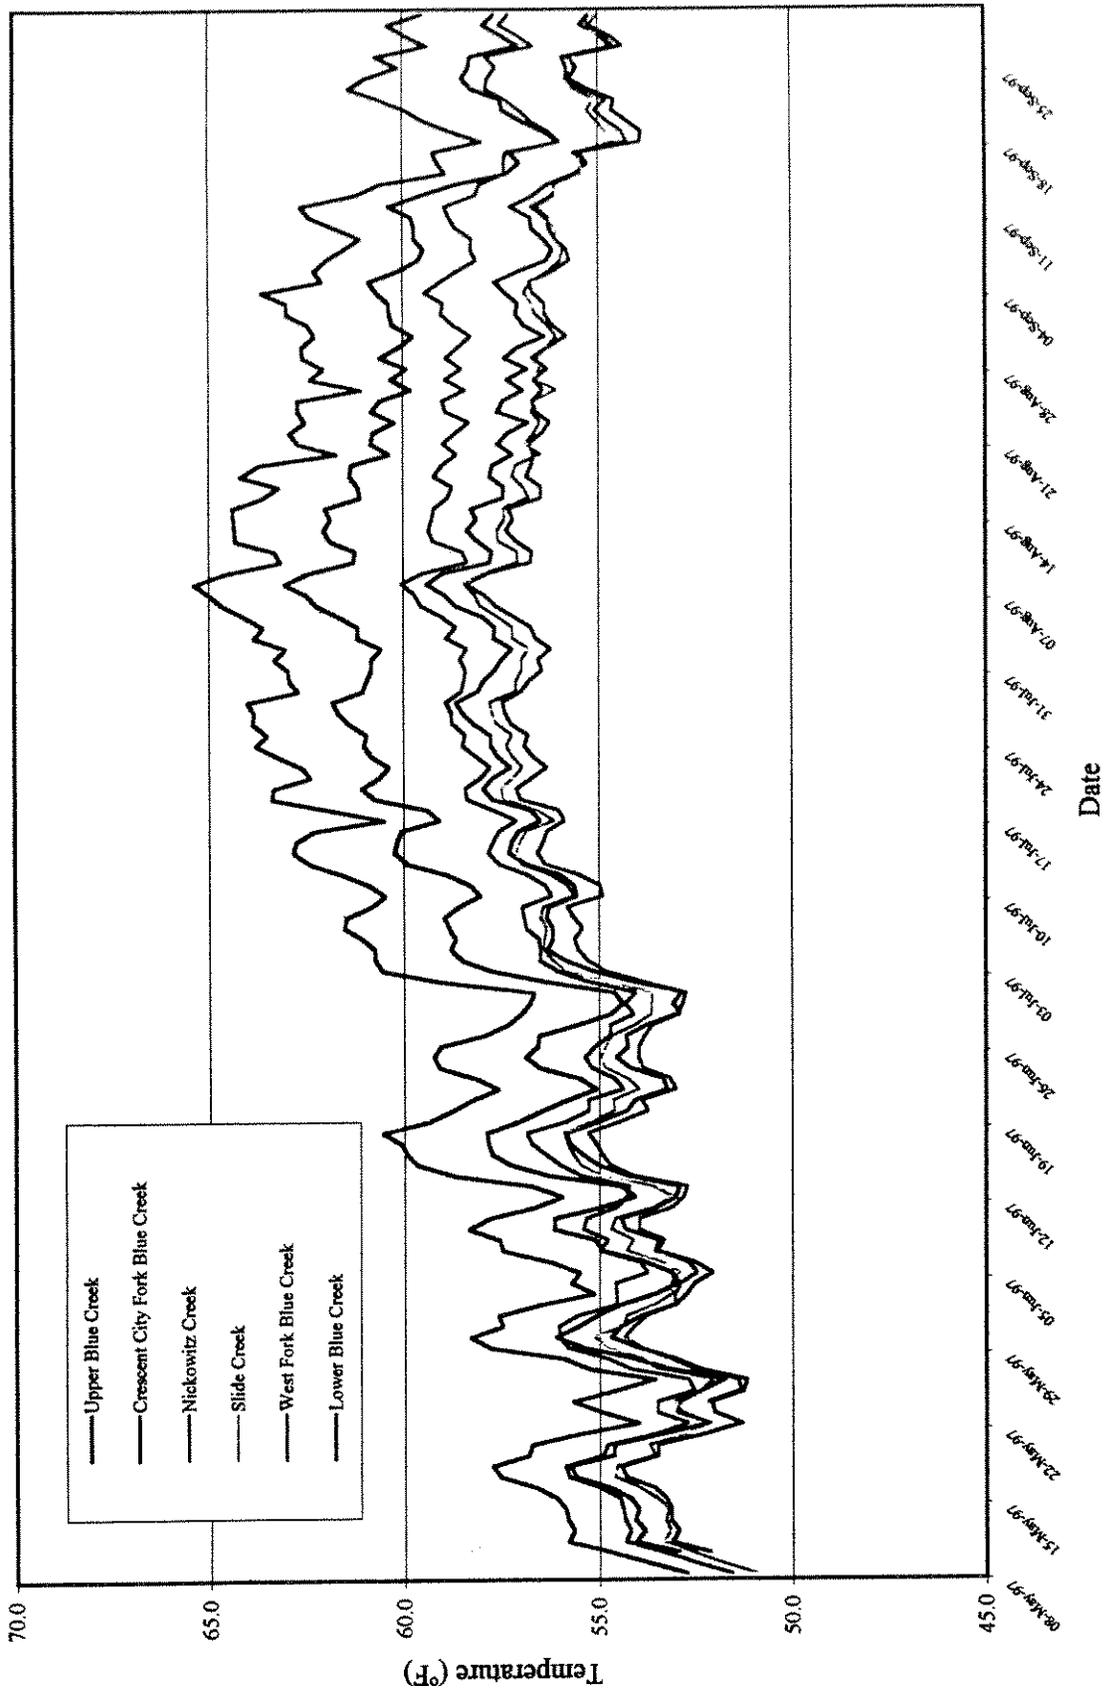
Figure 3. Average daily water temperature, Blue Creek and selected tributaries, lower Klamath River, California, May - September, 1997.

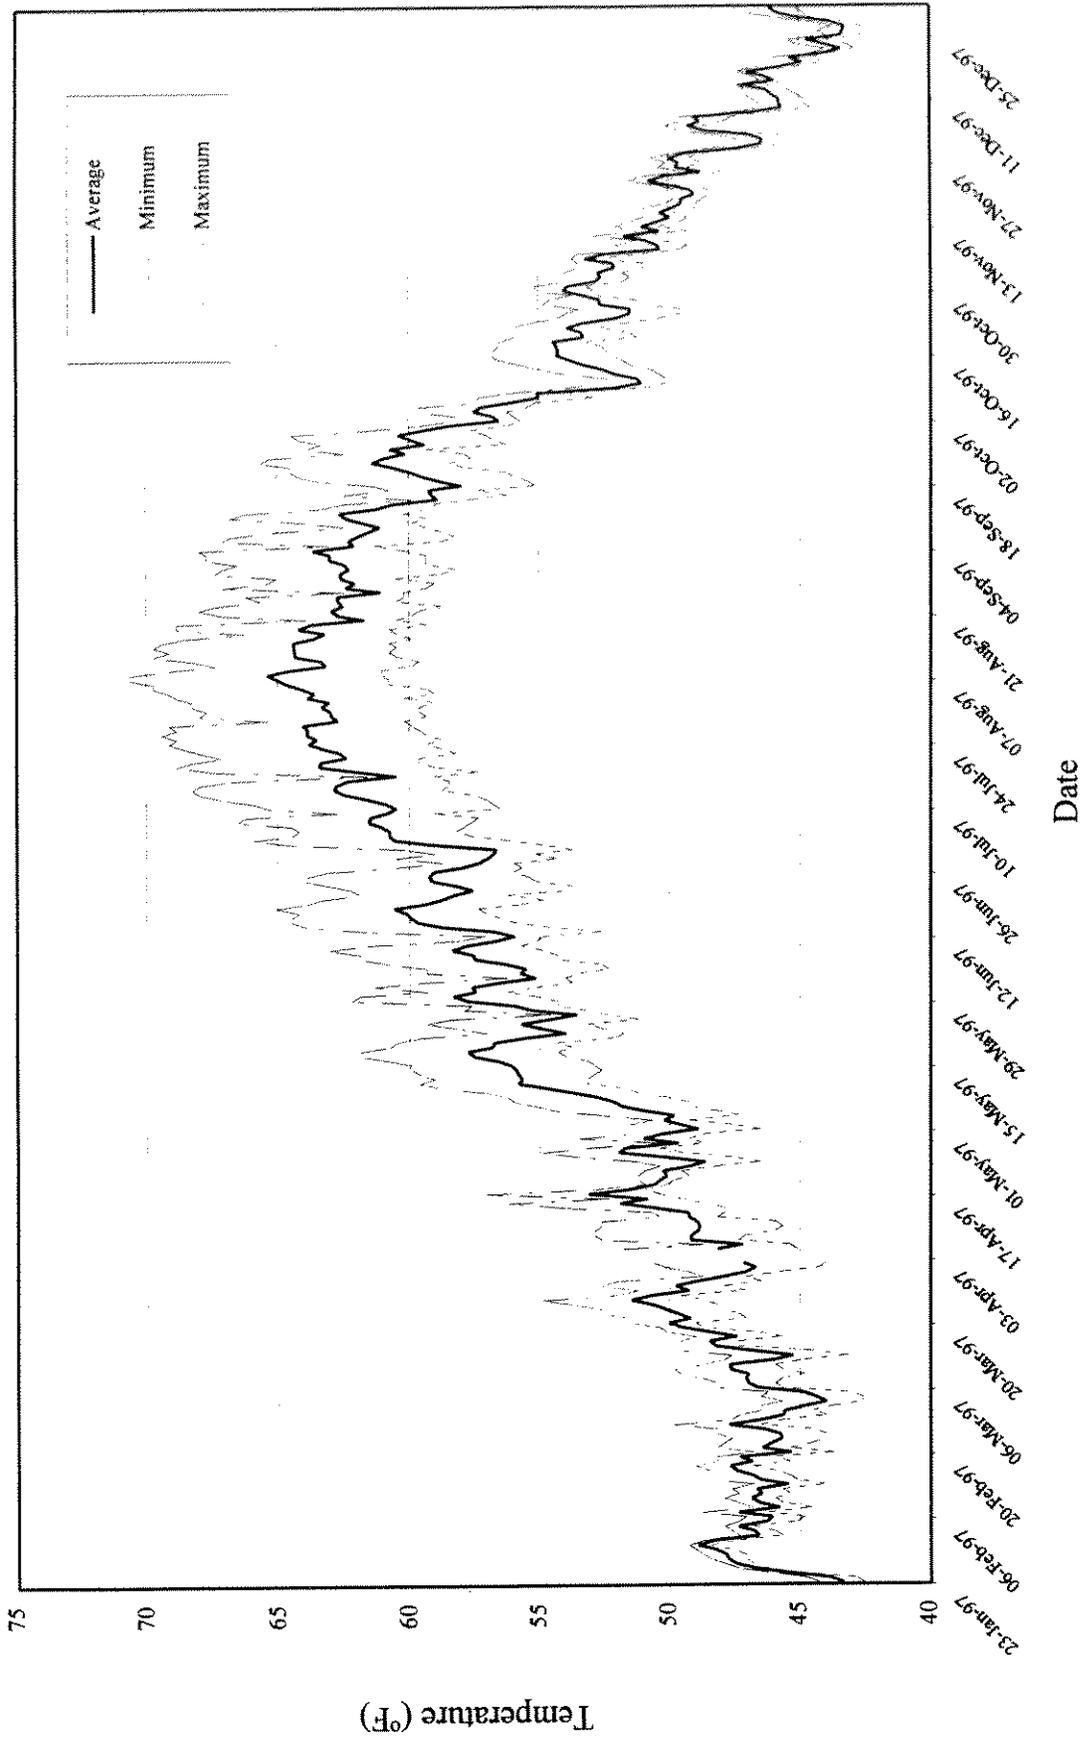
Figure 4. Daily average, maximum, and minimum water temperature, lower Blue Creek, lower Klamath River, California, 1997.

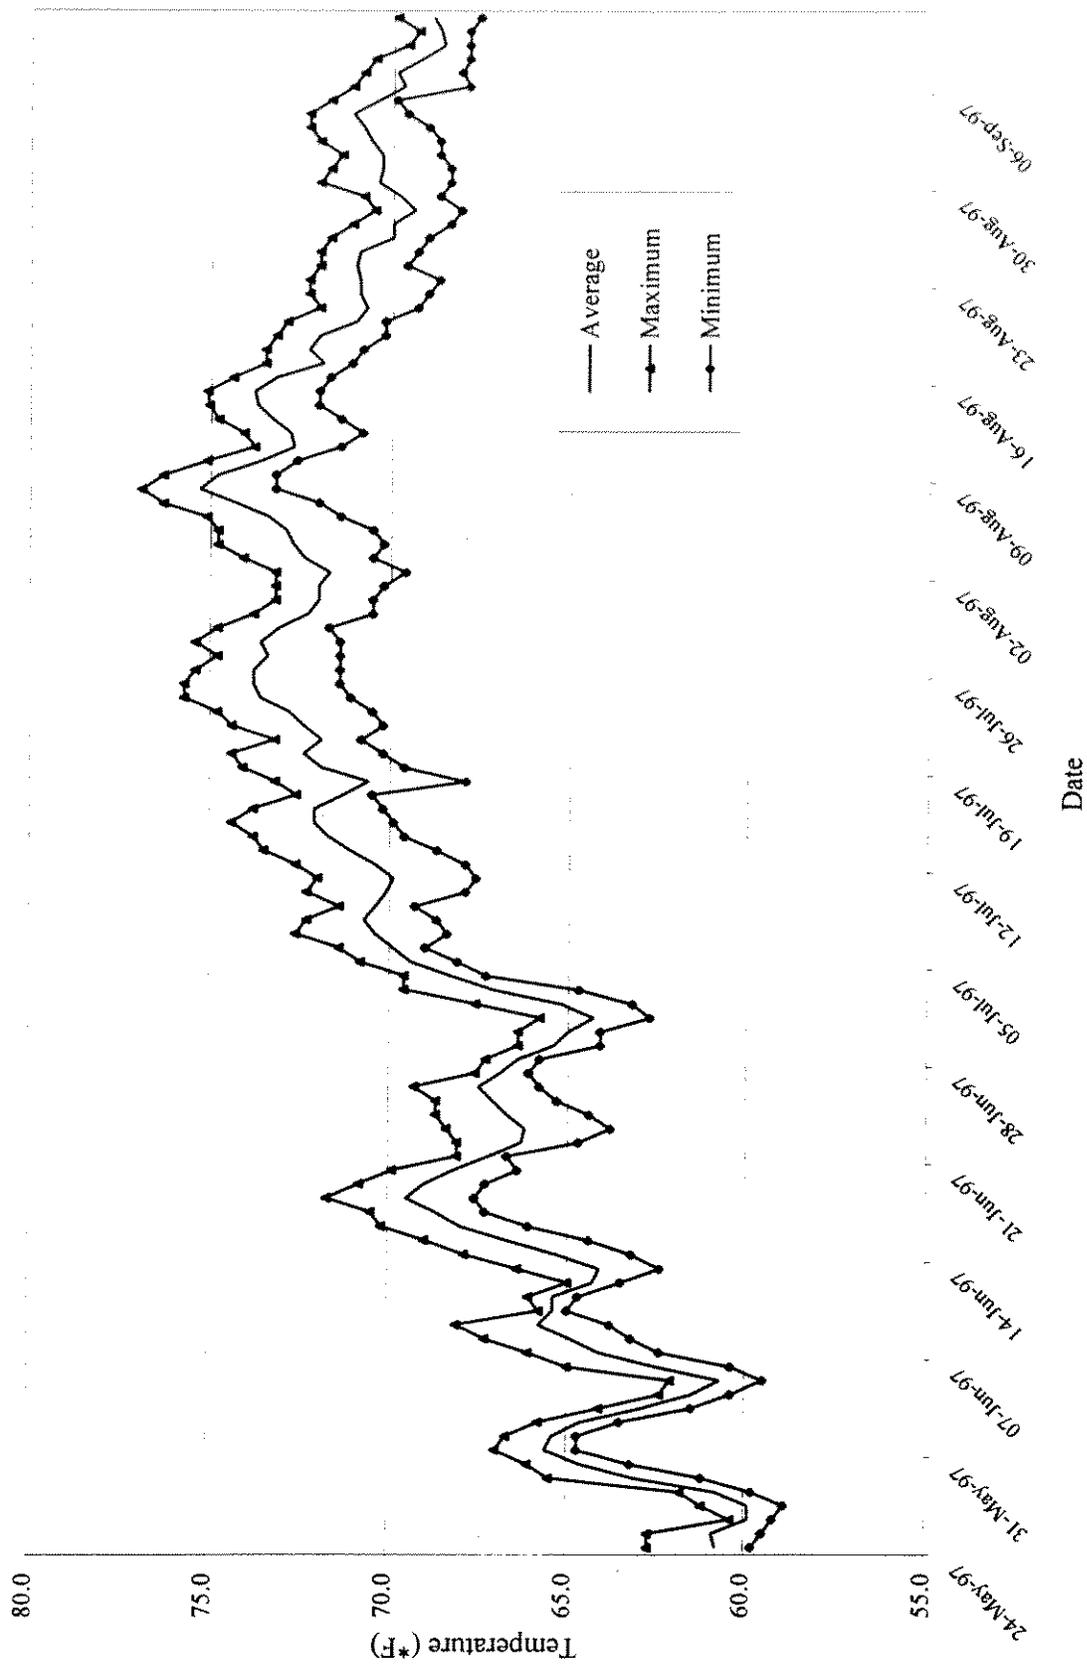
Figure 5. Average daily, maximum & minimum water temperature, lower Klamath River near Omagaar Creek, May - September, 1997.

Once emigrating salmonids have exited Lower Klamath tributaries, however, they must contend with summer water temperature in the mainstem Lower Klamath River that often exceeds upper temperature thresholds for salmonids (Figure 5). In addition to high water temperature, mainstem dissolved oxygen levels may fall below those considered acceptable for rearing juvenile salmonids, although insufficient data exists to make this determination.

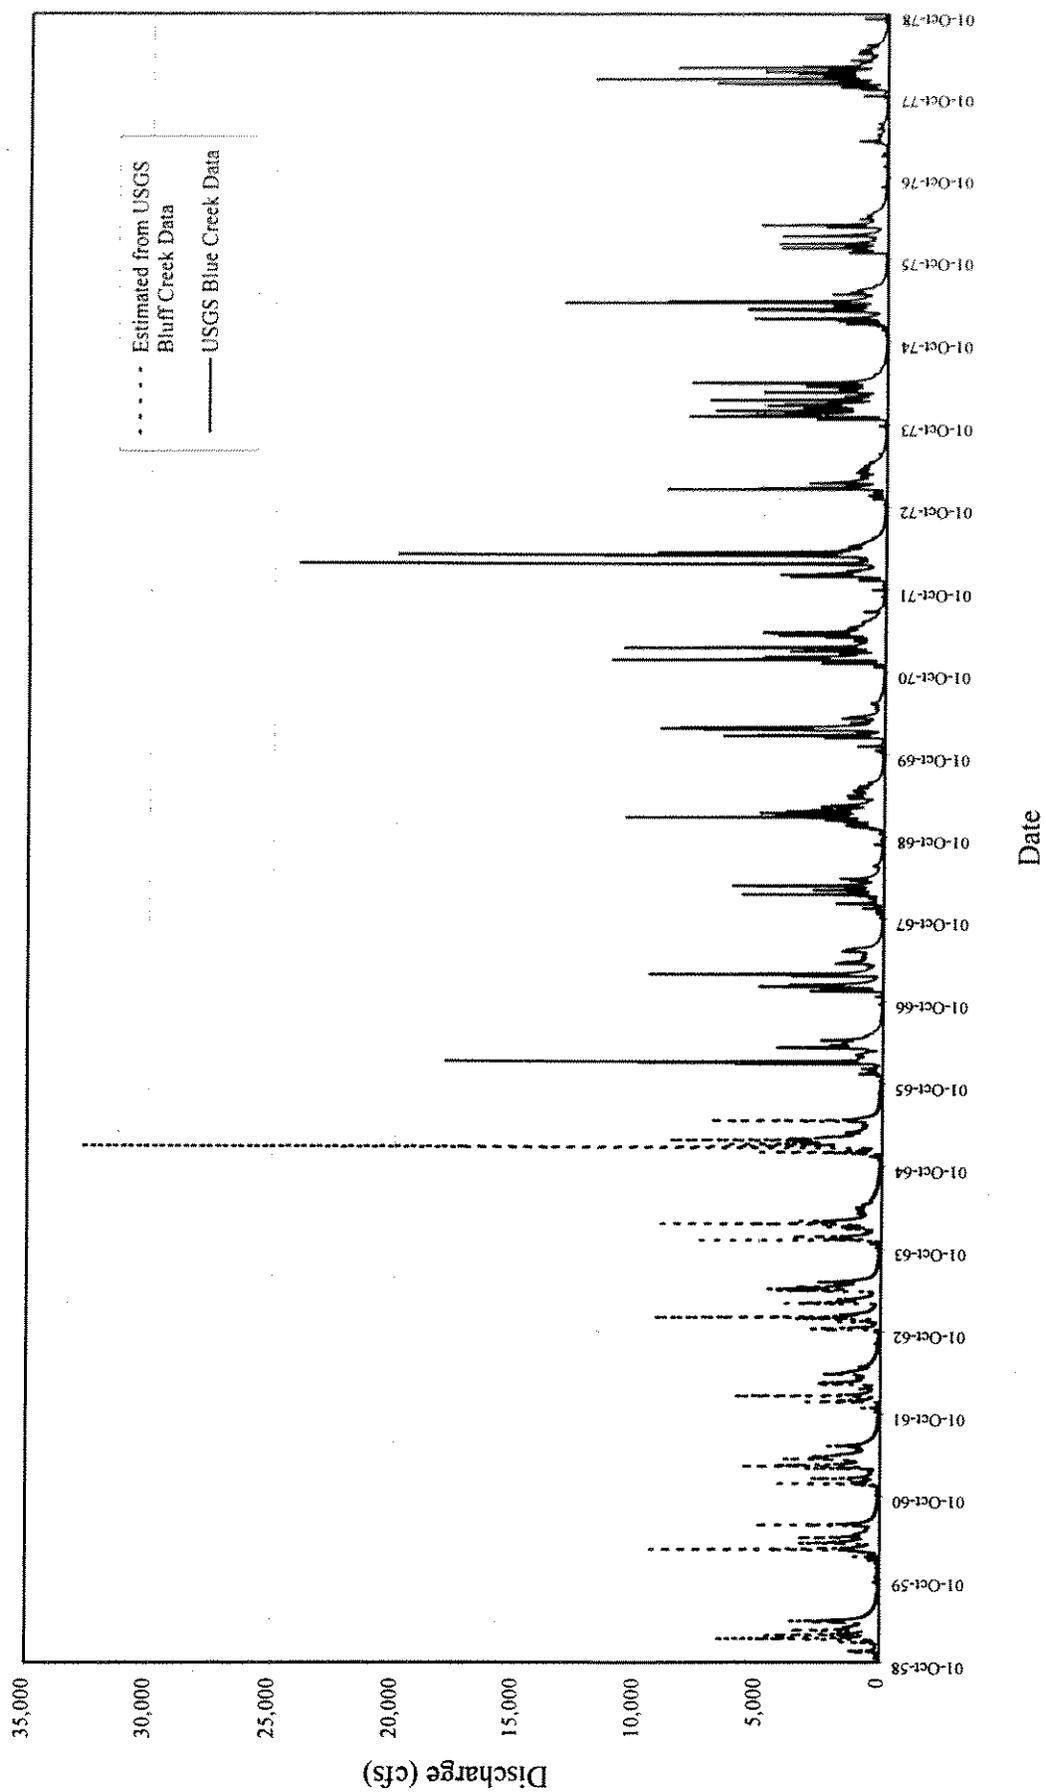
Figure 6. Average daily stream discharge, lower Blue Creek, Lower Klamath River, California, 1958-1978.

The Lower Klamath sub-basin receives the highest level of precipitation in the Klamath Basin, with average annual rainfall of up to 100 inches, 75% of which occurs between November and March (Helley and LaMarche 1973). Historic US Geological Survey (USGS) stream discharge data for Lower Klamath tributaries is only available for Lower Blue Creek for the period 1965-1978. This data reveals both the extreme annual flow fluctuations that occur in the Lower Klamath basin, as well as the wide range of annual peak flows that occurred during the period of record. Average daily stream discharge over this period ranged from 43 cubic feet per second (cfs) on November 1, 1965 to 24,000 cfs on March 2, 1972 (Figure 6). Peak flow levels during this period exceeded 30,000 cfs on three different occasions and routinely exceeded 10,000 cfs (USGS historic flow data). The extreme flood event of December 22, 1964, although outside the period of record, was estimated to peak at 48,000 cfs (USGS historic flow data). The recurrence interval of this flood event, based on geomorphic evidence as well as radiocarbon analysis and tree ring counts of material entrained in historic Blue Creek flood deposits, is estimated to be at least 100 years (Helley and LaMarche 1973).

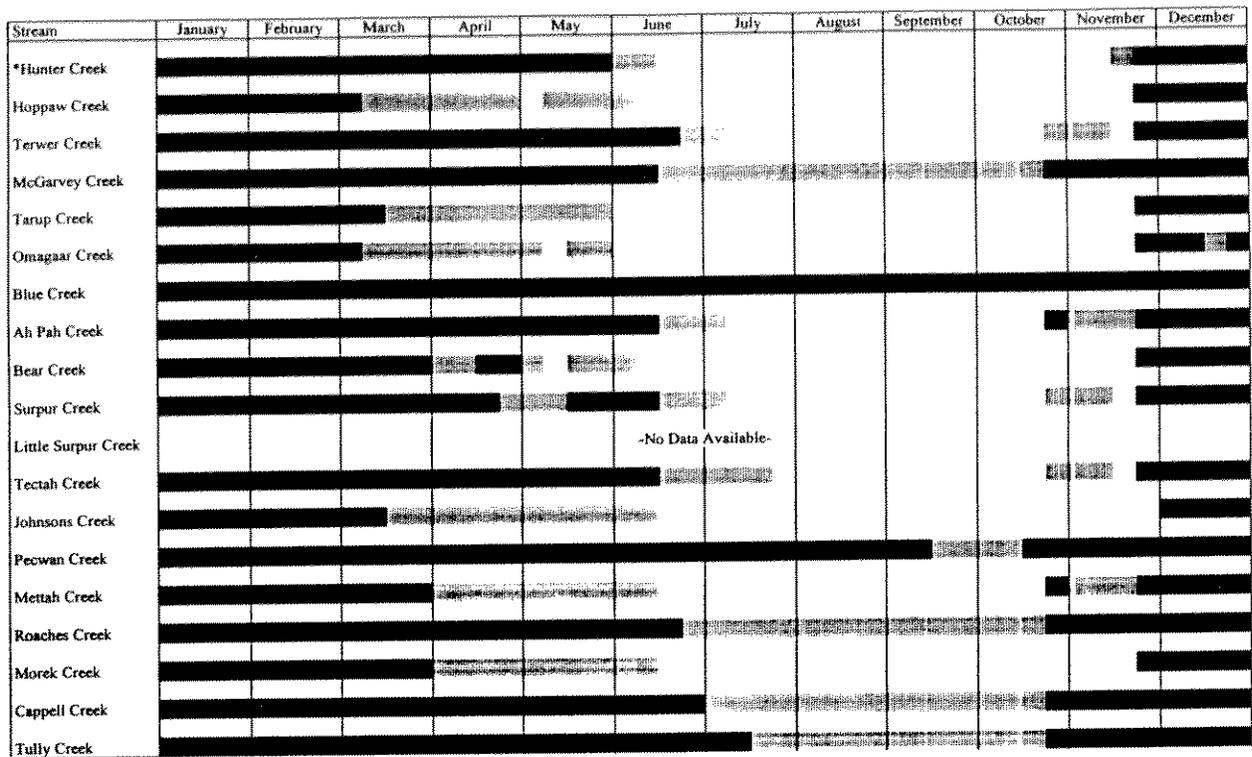
Legend: ■ - Unimpaired Access at Mouth ▨ - Access at Mouth Questionable due to Low Flow □ - Access at Mouth Not Possible
 * - Hunter Creek subsurface flow area begins above Highway 101 bridge (~creek mile 1.0) rather than at the mouth

Figure 7. Fish access periodicity in lower Klamath River tributaries, California, 1996.

To better assess the severity of this problem for each of the Lower Klamath tributaries, the Hab/Bio division initiated a stream mouth access monitoring program in 1996. This monitoring effort, which has been conducted continuously to date, involves visiting the confluence of each tributary via jetboat and/or vehicle and assessing flow level and fish access feasibility on a weekly basis throughout the year. Summaries of fish access periodicity for each Lower Klamath tributary for 1996-1999 are located in Figures 7-10.

Blue Creek is the only Lower Klamath tributary that maintains year-round fish access from the mainstem Klamath (Figures 7-10). Five other tributaries have maintained year-round flow during at least one of the four years. Of these five, only Tully Creek maintained perennial flow during all four years and none of the five provided perennial

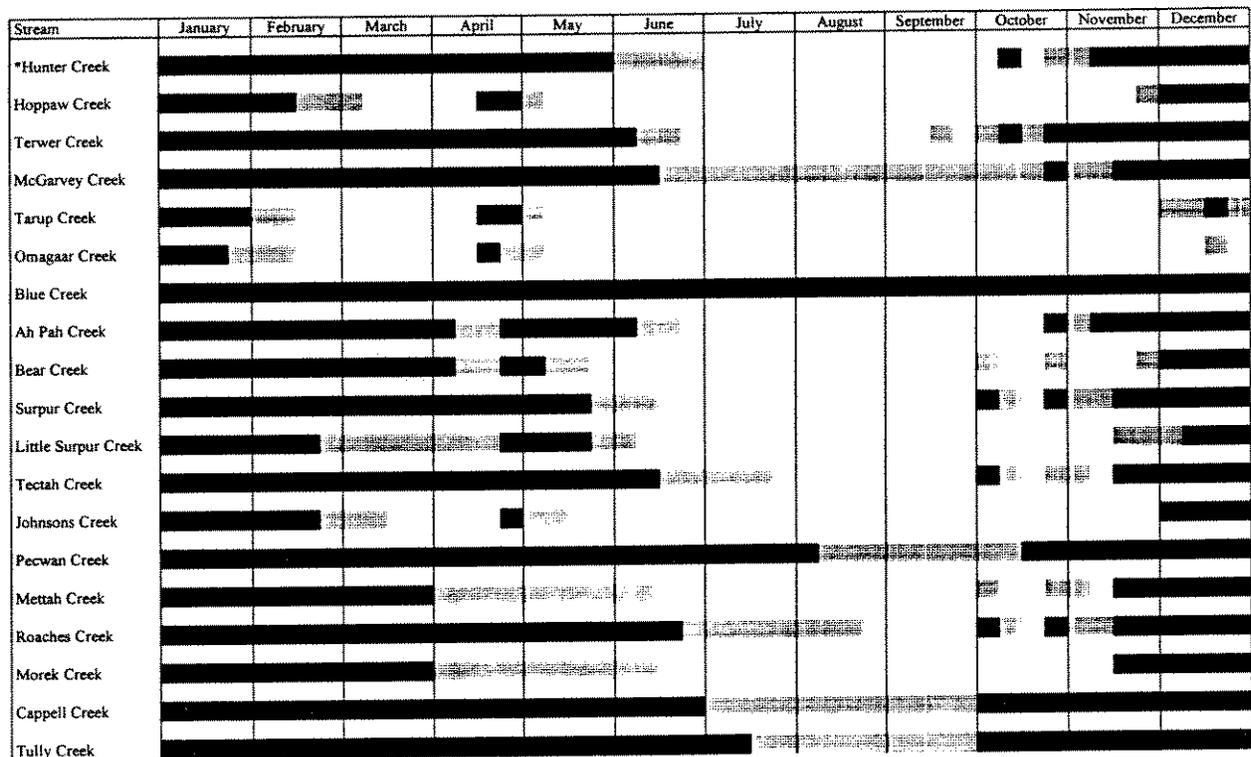
Legend: ■ - Unimpaired Access at Mouth ▨ - Access at Mouth Questionable due to Low Flow □ - Access at Mouth Not Possible
 * - Hunter Creek subsurface flow area begins above Highway 101 bridge (~creek mile 1.0) rather than at the mouth

Figure 8. Fish access periodicity in lower Klamath River tributaries, California, 1997.

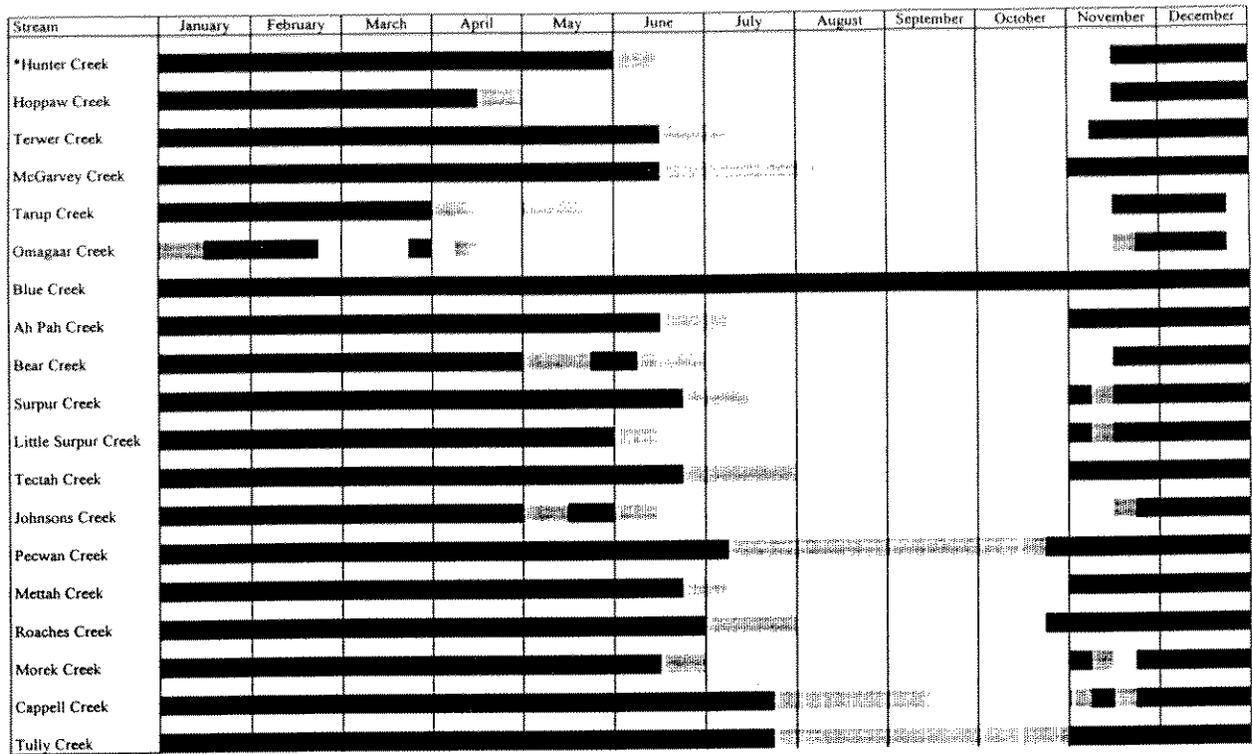
Legend: ■ - Unimpaired Access at Mouth ■ - Access at Mouth Questionable due to Low Flow □ - Access at Mouth Not Possible
 * - Hunter Creek subsurface flow area begins above Highway 101 bridge (~creek mile 1.0) rather than at the mouth

Figure 9. Fish access peridodicity in lower Klamath River tributaries, California, 1998.

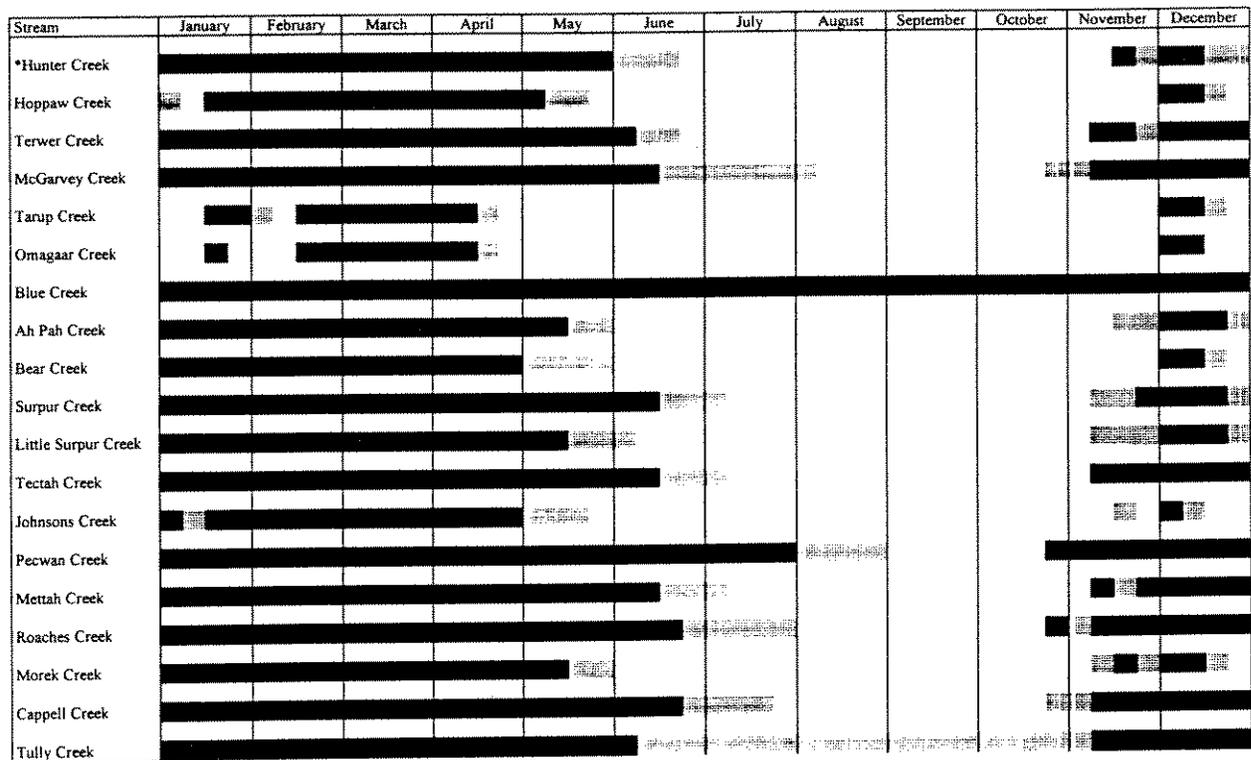
Legend: ■ - Unimpaired Access at Mouth ■ - Access at Mouth Questionable due to Low Flow □ - Access at Mouth Not Possible
 * - Hunter Creek subsurface flow area begins above Highway 101 bridge (~creek mile 1.0) rather than at the mouth

Figure 10. Fish access peridodicity in lower Klamath River tributaries, California, 1999.

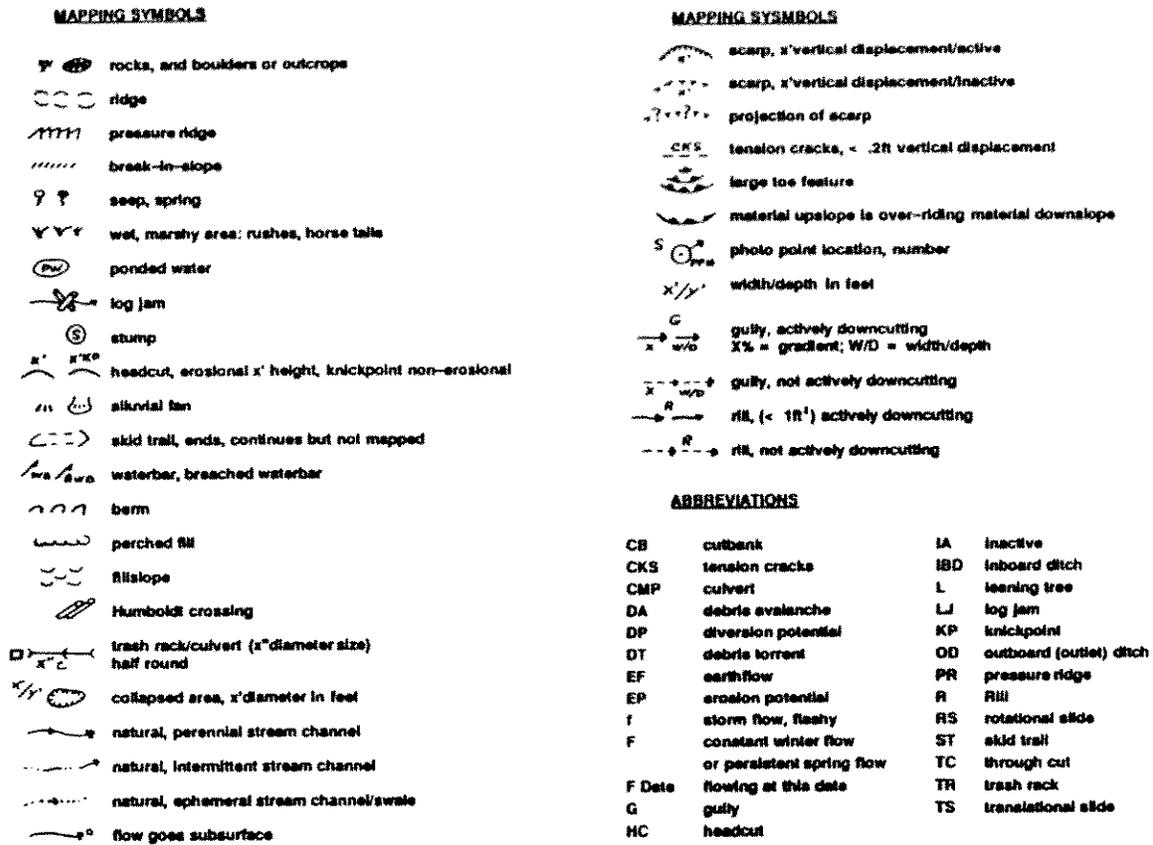
Figure 12. Symbols used for identifying geomorphic features on erosion site field maps.

Other information that is noted on the location map includes the site number, type of site, erosion potential, erosional features such as landslides, debris torrents, washed out stream crossings, springs/seeps, and all culvert locations (including ditch-relief culverts). Landmark-features, such as dry swales, landings, and old-growth snags/stumps were sometimes added for location-reference in the field. Some of the symbols used for mapping these features are shown on the in Figure 12 (symbols adapted from Redwood National Park's Restoration Department).

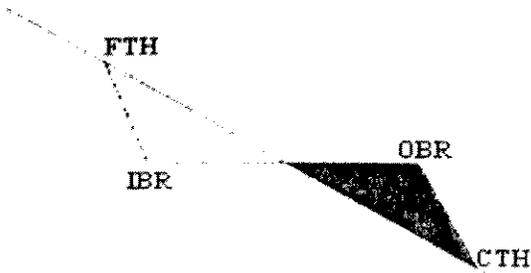
OS:
Outslope- Unstable fill material and local storage provide for complete natural recontouring.

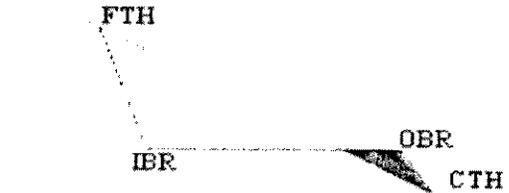
FOS:
Fill Outslope- Unstable fill material does not provide complete outsloping and additional fill may be imported.

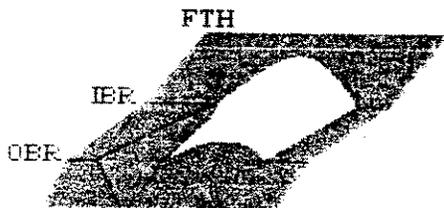
XRD:
Cross Road Drain- Full Excavation is not required, usually occurs around a spring or wet area.

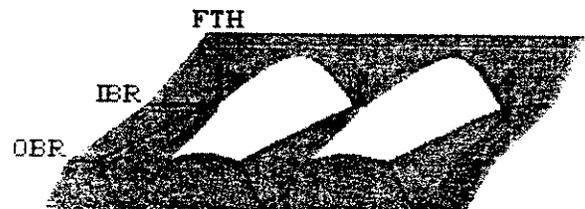
ROS:
Rolling Outslope- The road is dipped to accommodate multiple wet areas.

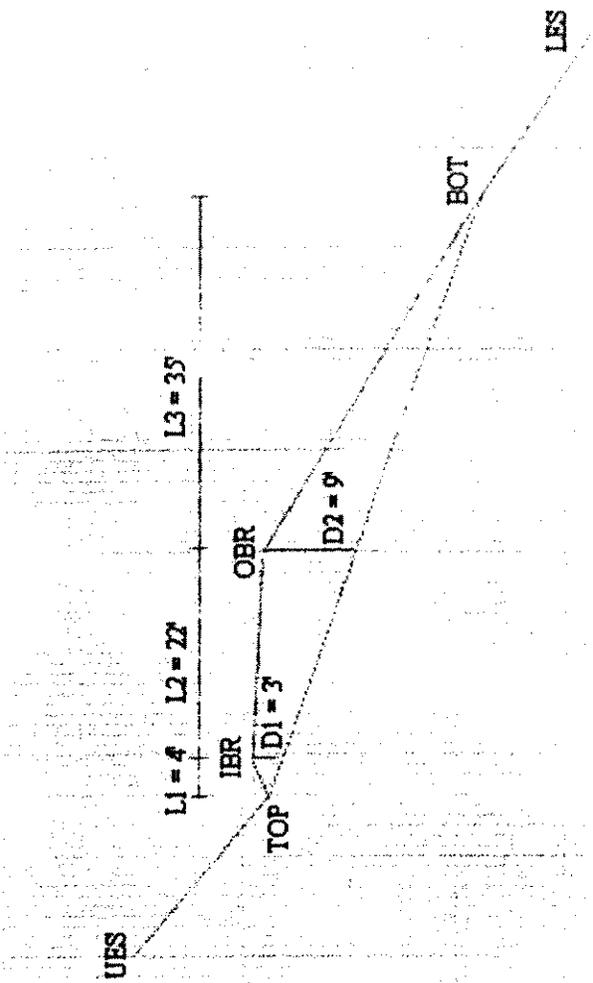
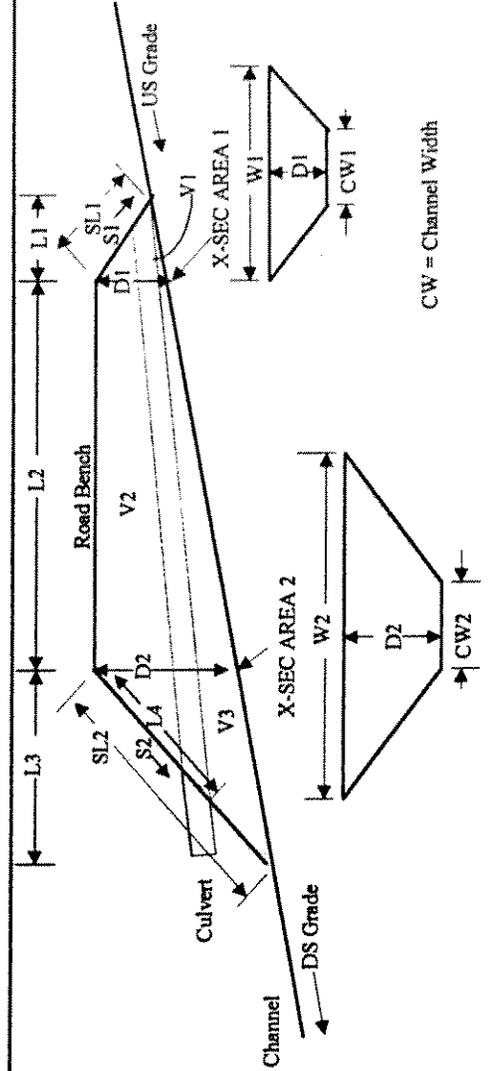
Example of Road Profile and Measurements

CW = Channel Width

Figure 14. Example of an upslope treatment site profile and fill volume worksheet.

4. Excavation Volume = _____ $\text{ft}^3 / 27 =$ _____ yd^3
