Proceedings of the Conference on
**DECOMPOSED GRANITIC SOILS:
PROBLEMS AND SOLUTIONS**

October 21-23, 1992, Redding, California

Sari Sommarstrom, Ph.D.
*Conference Coordinator &
Proceedings Editor*

UNIVERSITY EXTENSION
University of California, Davis 95616-8727

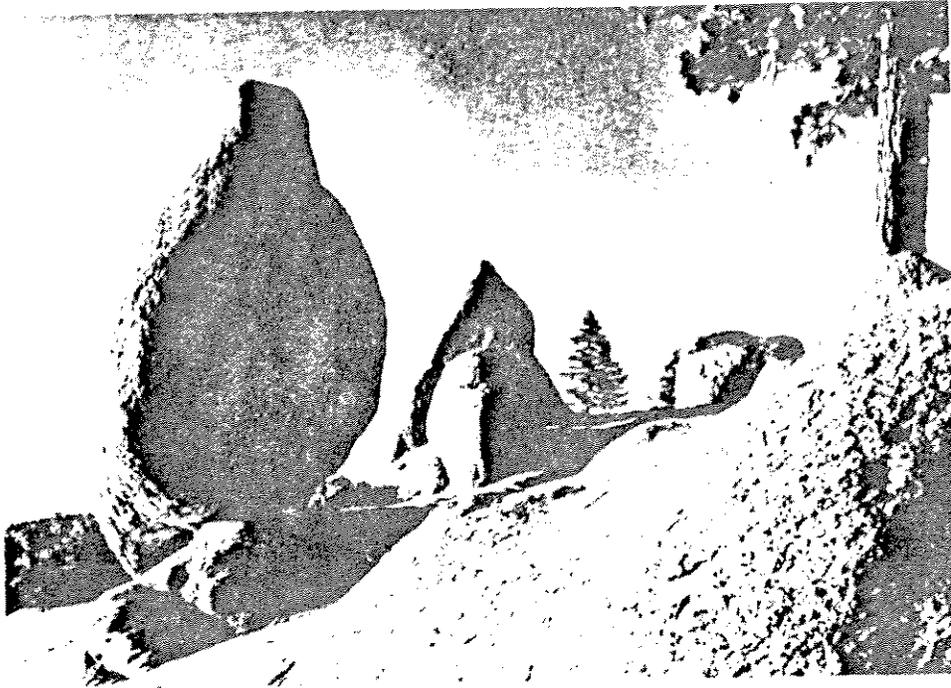
Photo 4. Exfoliation developed in decomposed granitic rock. This exfoliation causes the spheroidal weathering typical of core-stones. *Photo by J. Hildinger.*

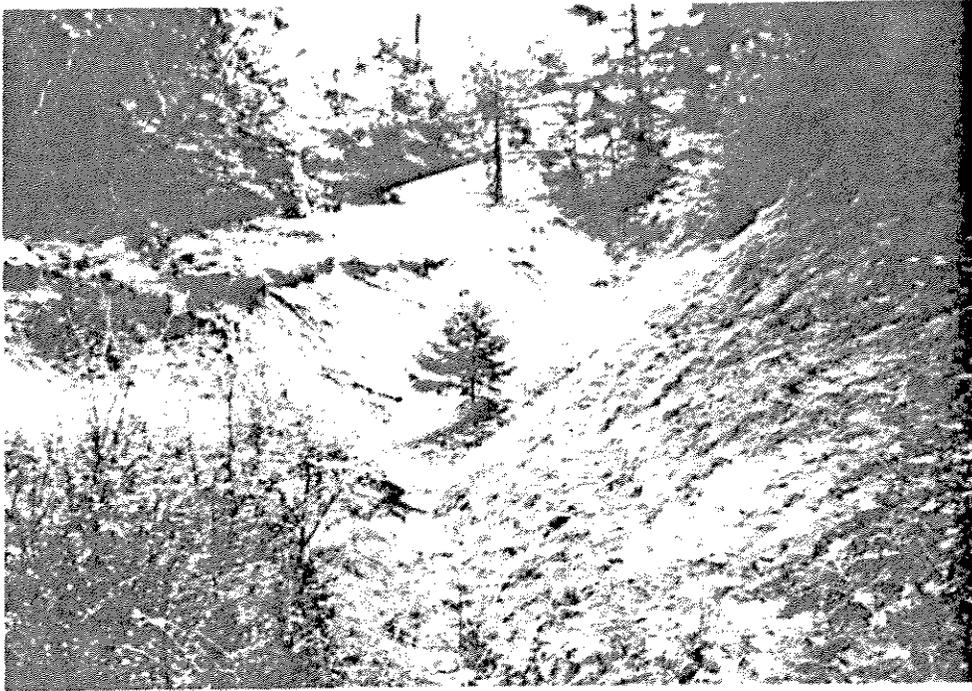
Figure 3. Where inside ditches collect and concentrate runoff, gullies can form along roads and below culvert out-falls.

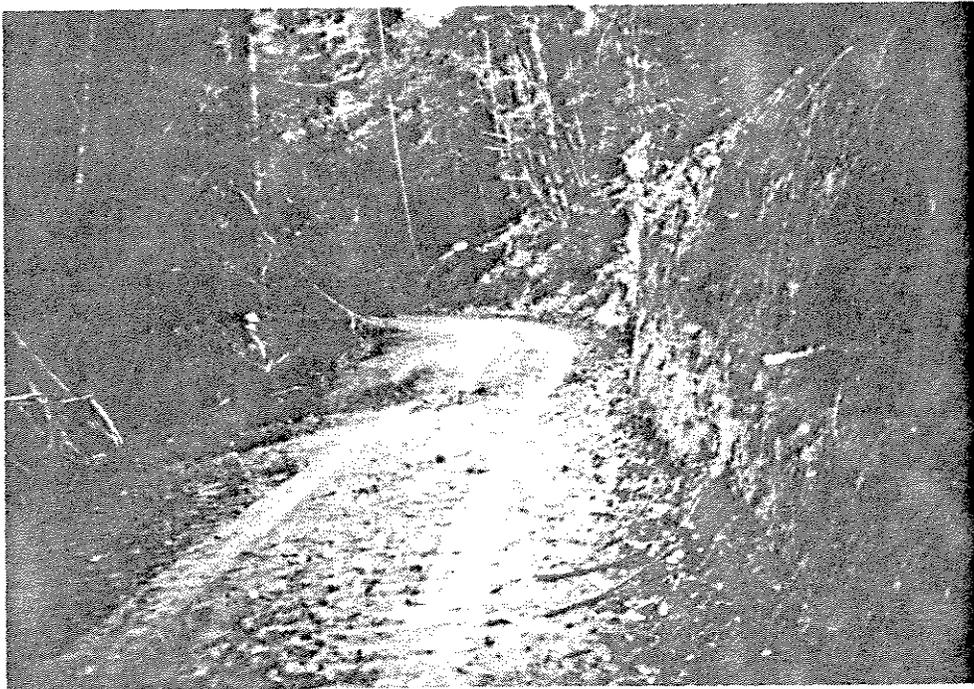
Figure 4. An out-sloped road drained by broad rolling dips reduces the chance of water concentration.

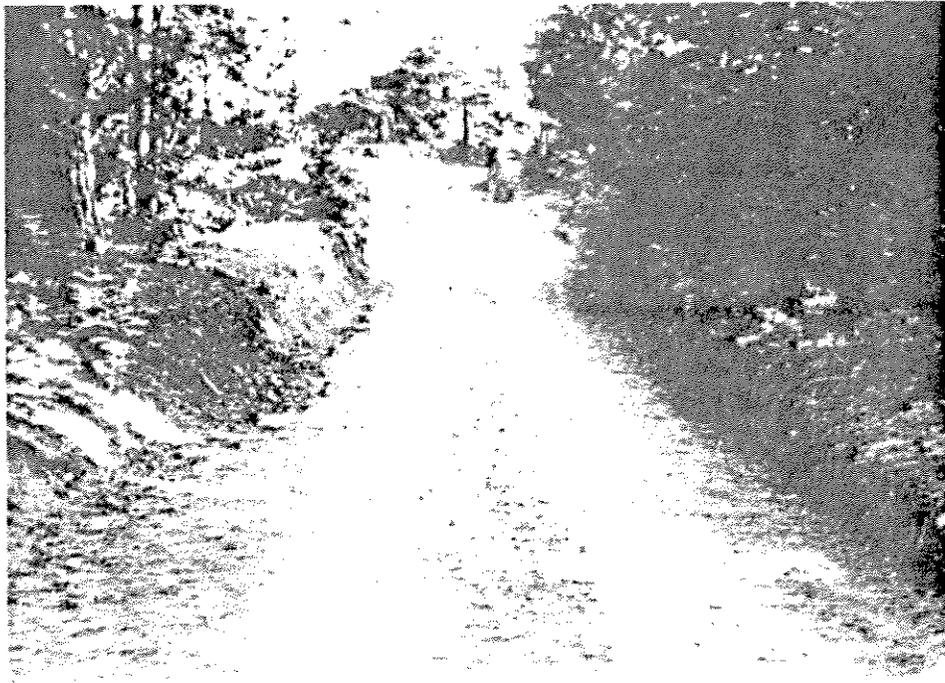
Photo 3. Aggregate surfaced road with rolling dip (background).

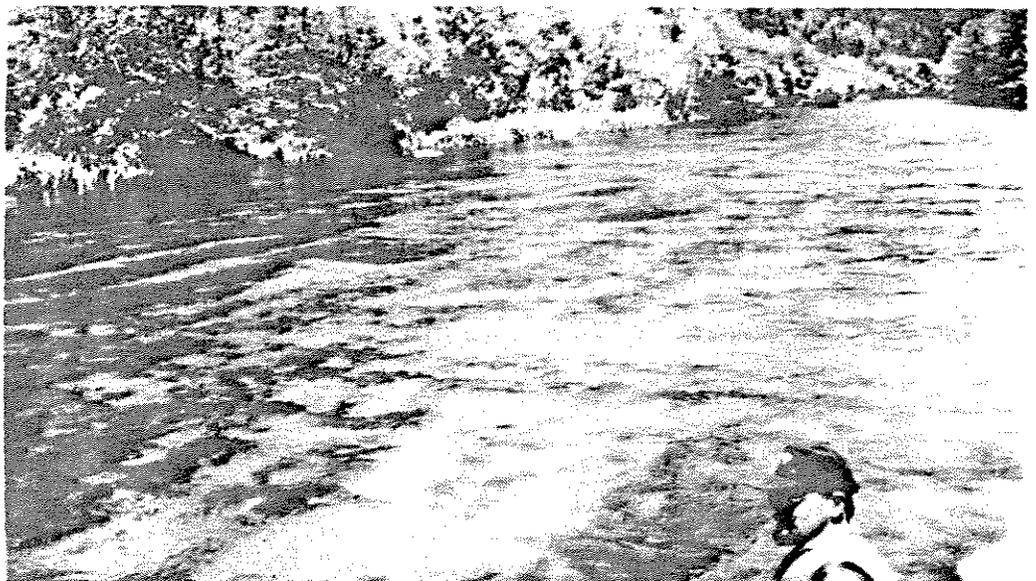
Figure 4. Photograph showing sand stripes on bed at Steelbridge site immediately following controlled release, 1991. Photo by Kondolf.

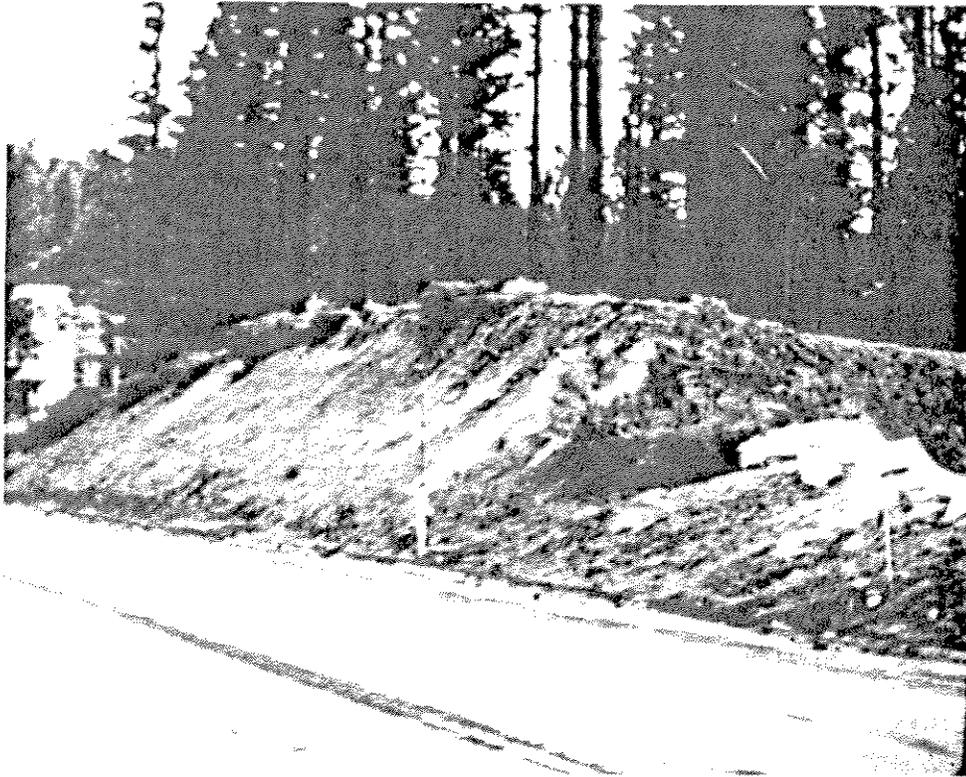
Figure 2. Bare roadcut on Pioneer Trail, El Dorado County, 1989, before revegetation. This roadcut had remained devoid of vegetation for nearly 30 years, despite an earlier attempt to revegetate it in the early 1980's.

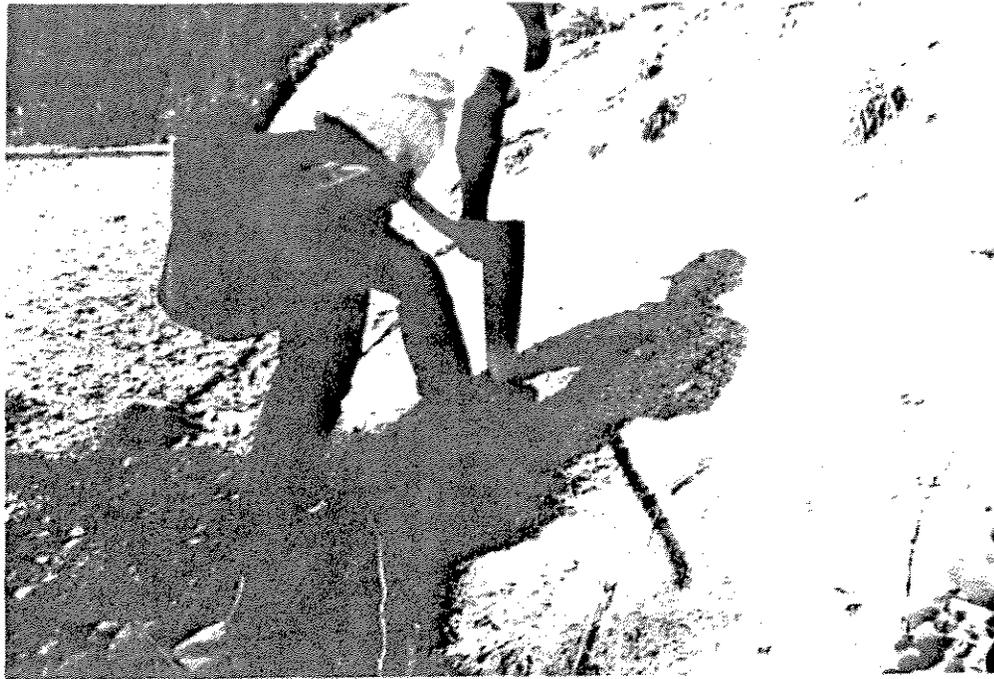
Figure 1. Commercial planting crew member using hoe-dad to plant pine seedling in granitic road cut.

Seedlings and methods used by the forest industry tend to be the lowest cost way of getting the most successful possible reforestation of a site, because of the economic restraints placed on company management. For example, foresters for Fruit Growers Supply Company out of Hilt, California decided to revegetate bare decomposed granitic cut and fill slopes along access roads near Etna, California (Figures 1 and 2). Using their regular containerized ponderosa pine planting stock and a commercial planting crew, they planted approximately 20,000 ponderosa pine on 4-6 foot spacing. At a cost of \$0.13 per seedling, and \$0.17 for planting (including administrative costs), this works out to about \$0.30 per planted seedling or about \$522.00 per acre. The second year survival on this particular planting is around 90%.

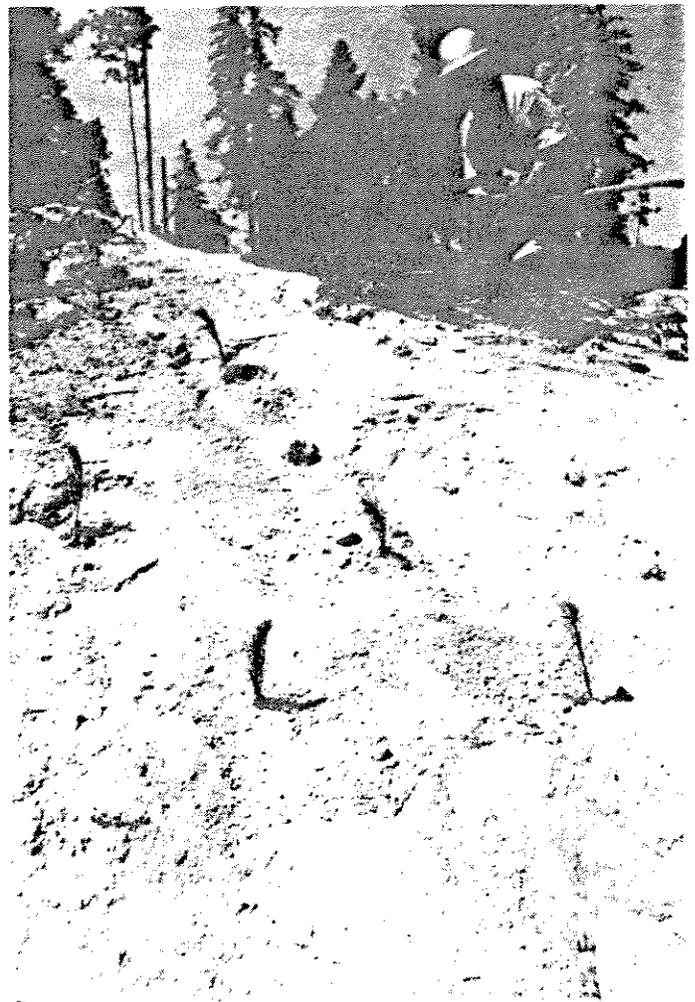
Figure 2. Example of spacing for ponderosa pine seedlings on granitic road cut. After one year, these seedlings have had a 90% survival rate.

The short-term benefits of this planting are limited to a small amount of mechanical stabilization of the slope by the stems of the trees. However, potential long-term benefits are a deeply penetrating root system and a permanent needle mulch cover which will effectively eliminate erosion (Megahan, 1974). This result is in contrast to many grass seed and erosion blanket applications where the short-term benefits are great, but the long-term benefits are
