Stonybrook Creek
Fish Passage Assessment

Alameda County
Public Works Agency

MICHAEL LOVE

APRIL 6, 2001

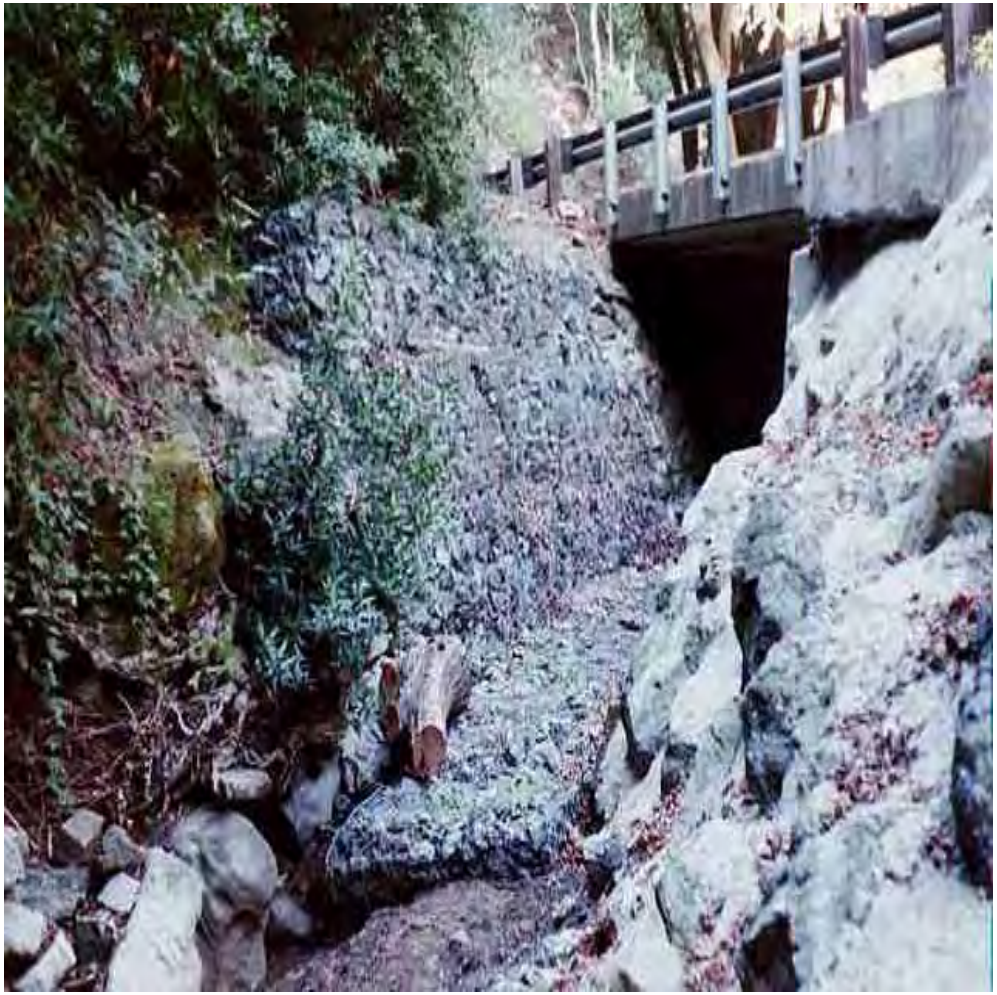
The outlet apron on Stobk#4 has recently been rebuilt with a gabion floor and retaining wall. The gabion floor has already failed in several locations and creates an upstream migration barrier to all fish due to its steepness (greater than 6%). Alternatives for achieving passage of steelhead and large rainbow trout at Stobk#4 could involve replacing the gabion floor with concrete and installing a series of weirs throughout the entire crossing.

Outlet of Road-Crossing with Gabions

between the two crossings, they should be considered for barrier remediation at the same time. The preferred option for providing fish passage at both of these road-crossings is to replace them with bridges or open bottom arches spanning the active channel.
