ASBESTOS AND LEAD-BASED PAINT

SURVEY REPORT

NAF MIDWAY ISLAND

Ogden Project #CTO 125
TSC Project #865

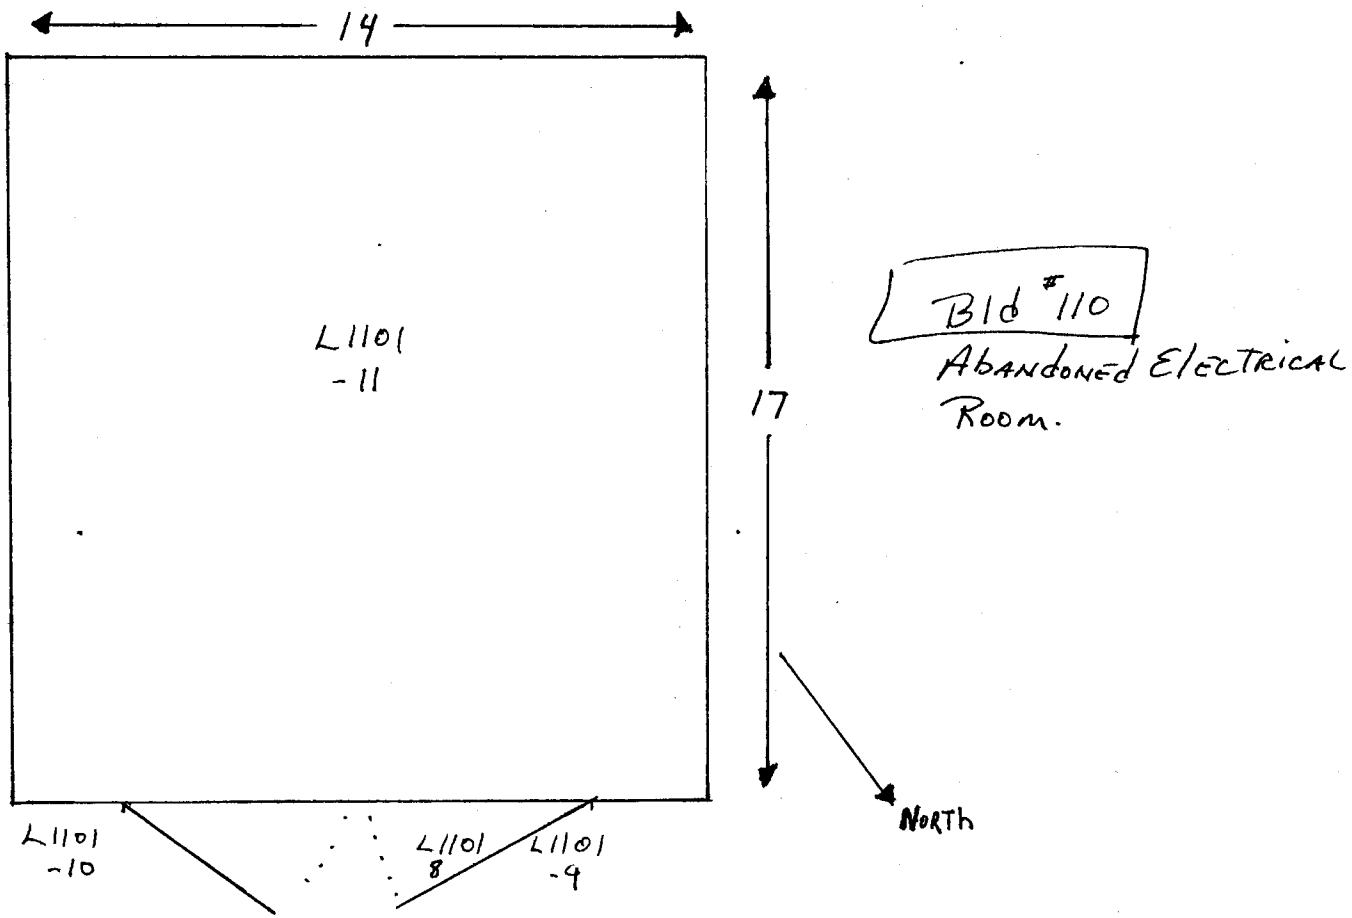
14
17
L1101
-11
L1101
-10
L1101
8
L1101
-9
NORTH
Bld #110
Abandoned Electrical
Room.

SAMPLE ID NO	SAMPLE LOCATION / DESCRIPTION	ANALYTICAL RESULTS (PPM)	CONDITION	AMOUNT
L1101-8	Interior northeast Green paint on door	22,575.1	Poor	75 sq. ft.
L1101-9	Exterior northeast Brown paint on door	2,622.1	Poor	75 sq. ft.
L1101-10	Exterior northeast Off-white paint walls	5,296.8	Fair	800 sq. ft.
L1101-11	Interior Gray paint on voltage box	2,962.5	Good	180 sq. ft. (paint is on multiple voltage boxes)

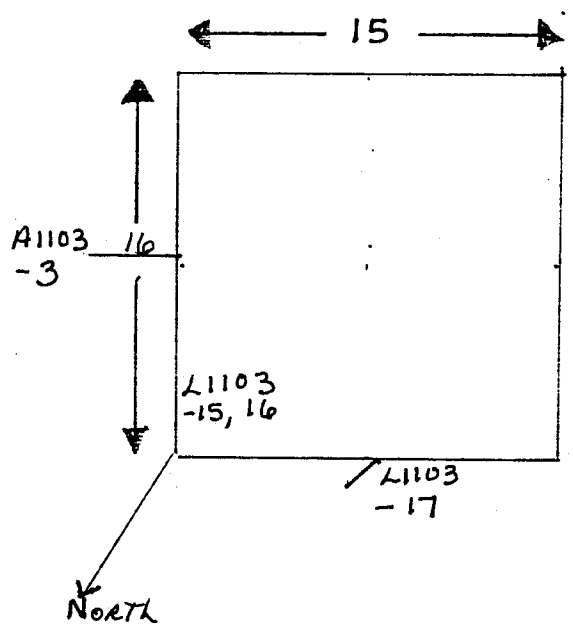
Bld # 140

ELECTRICAL
Sub STA.

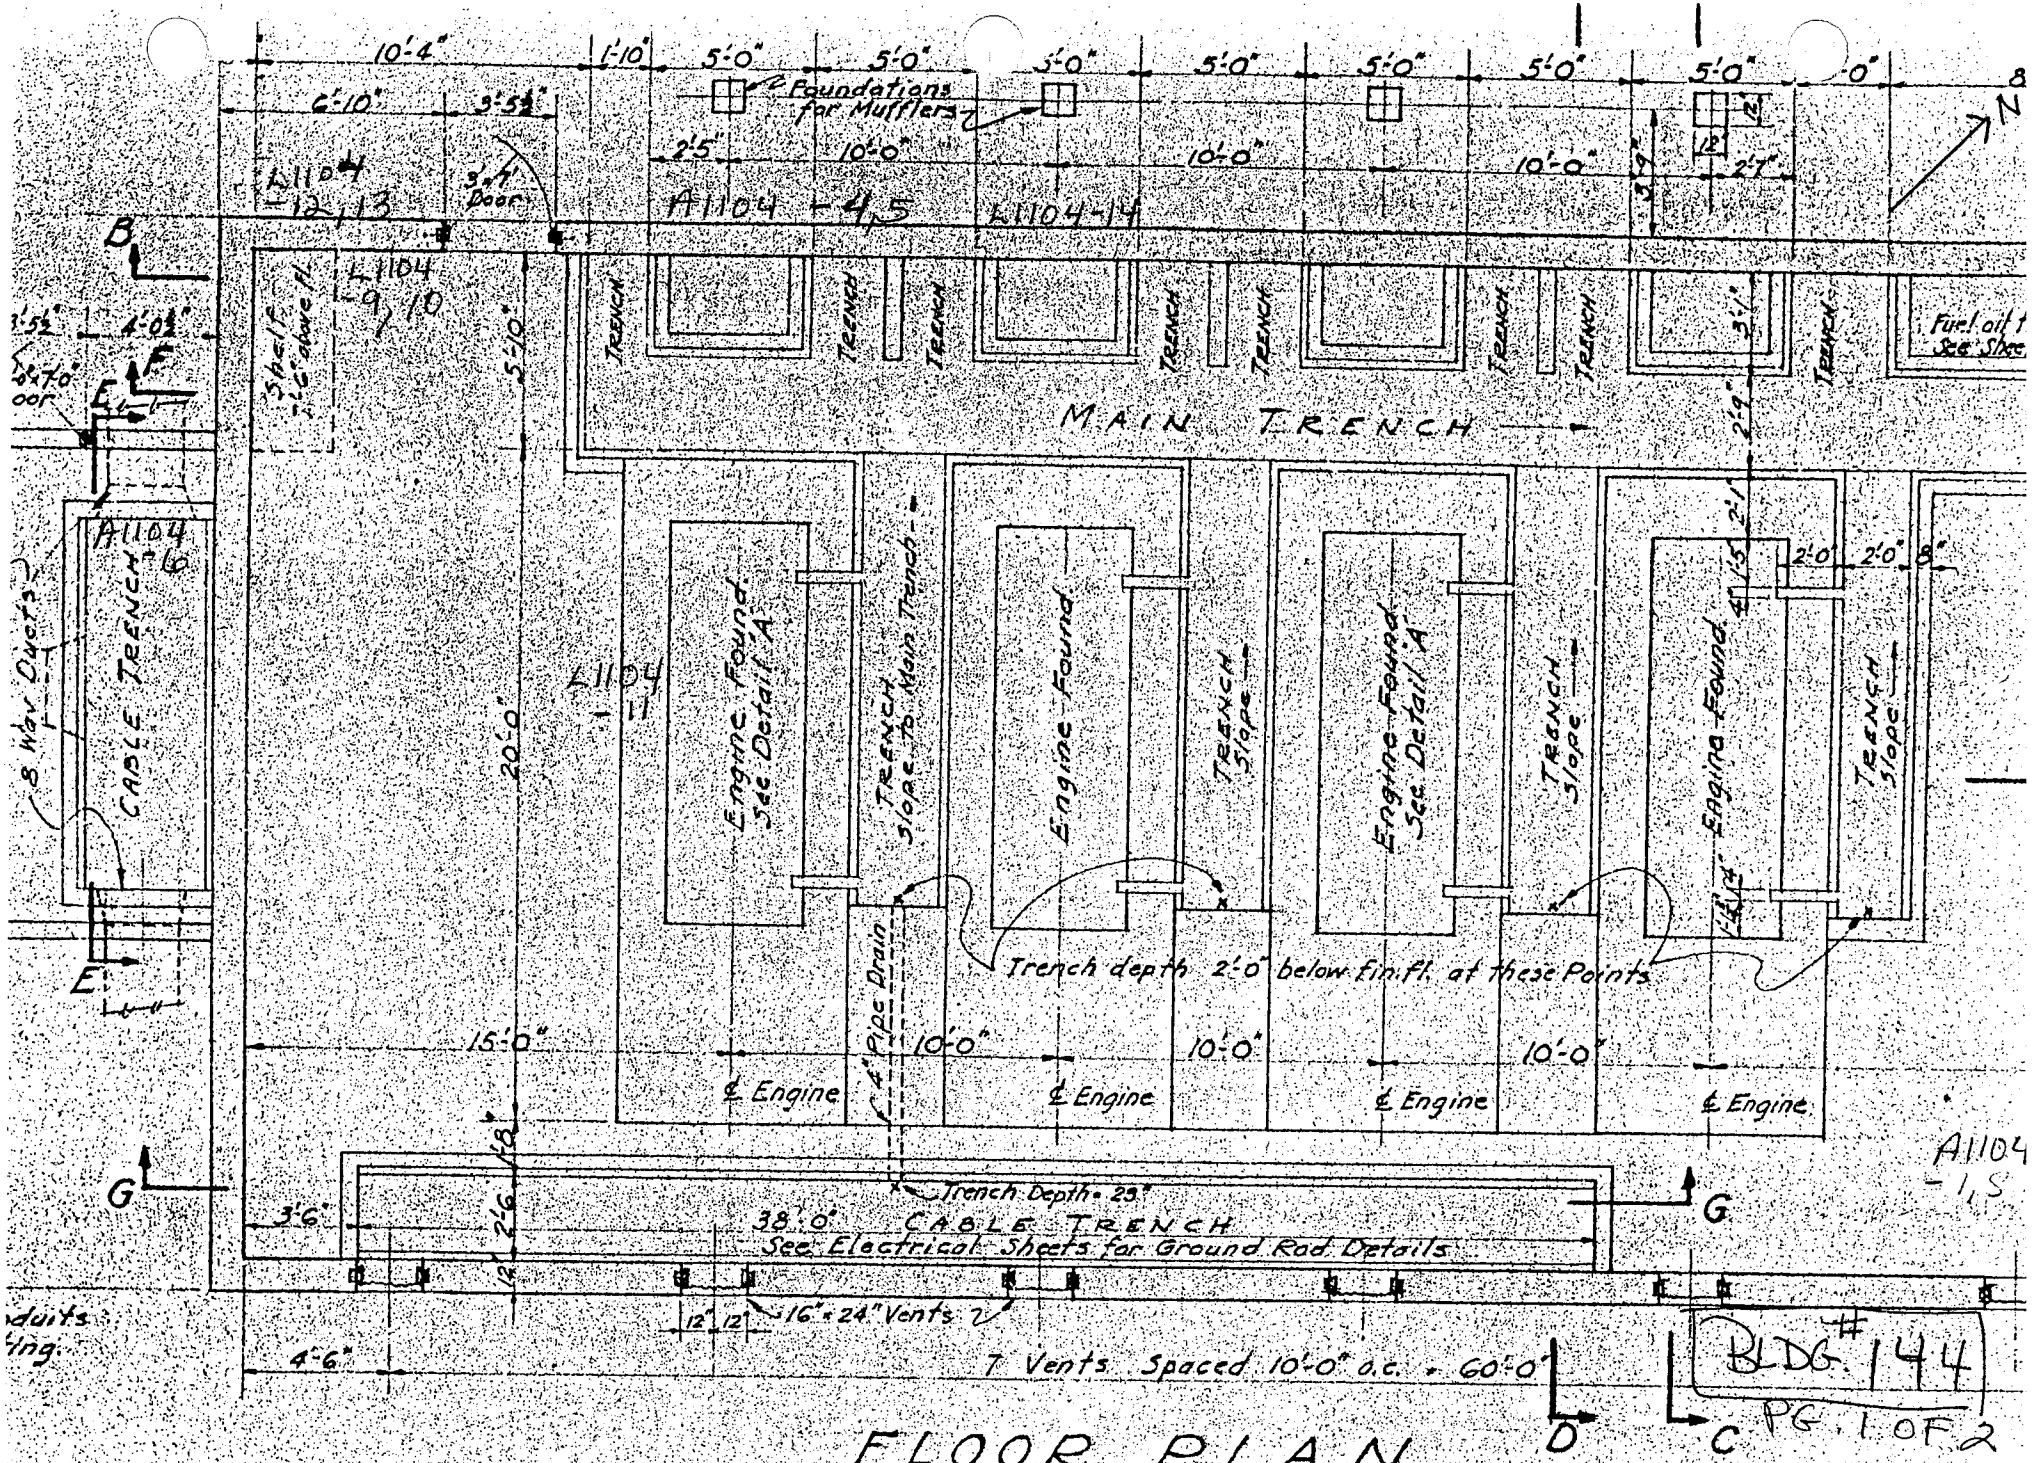
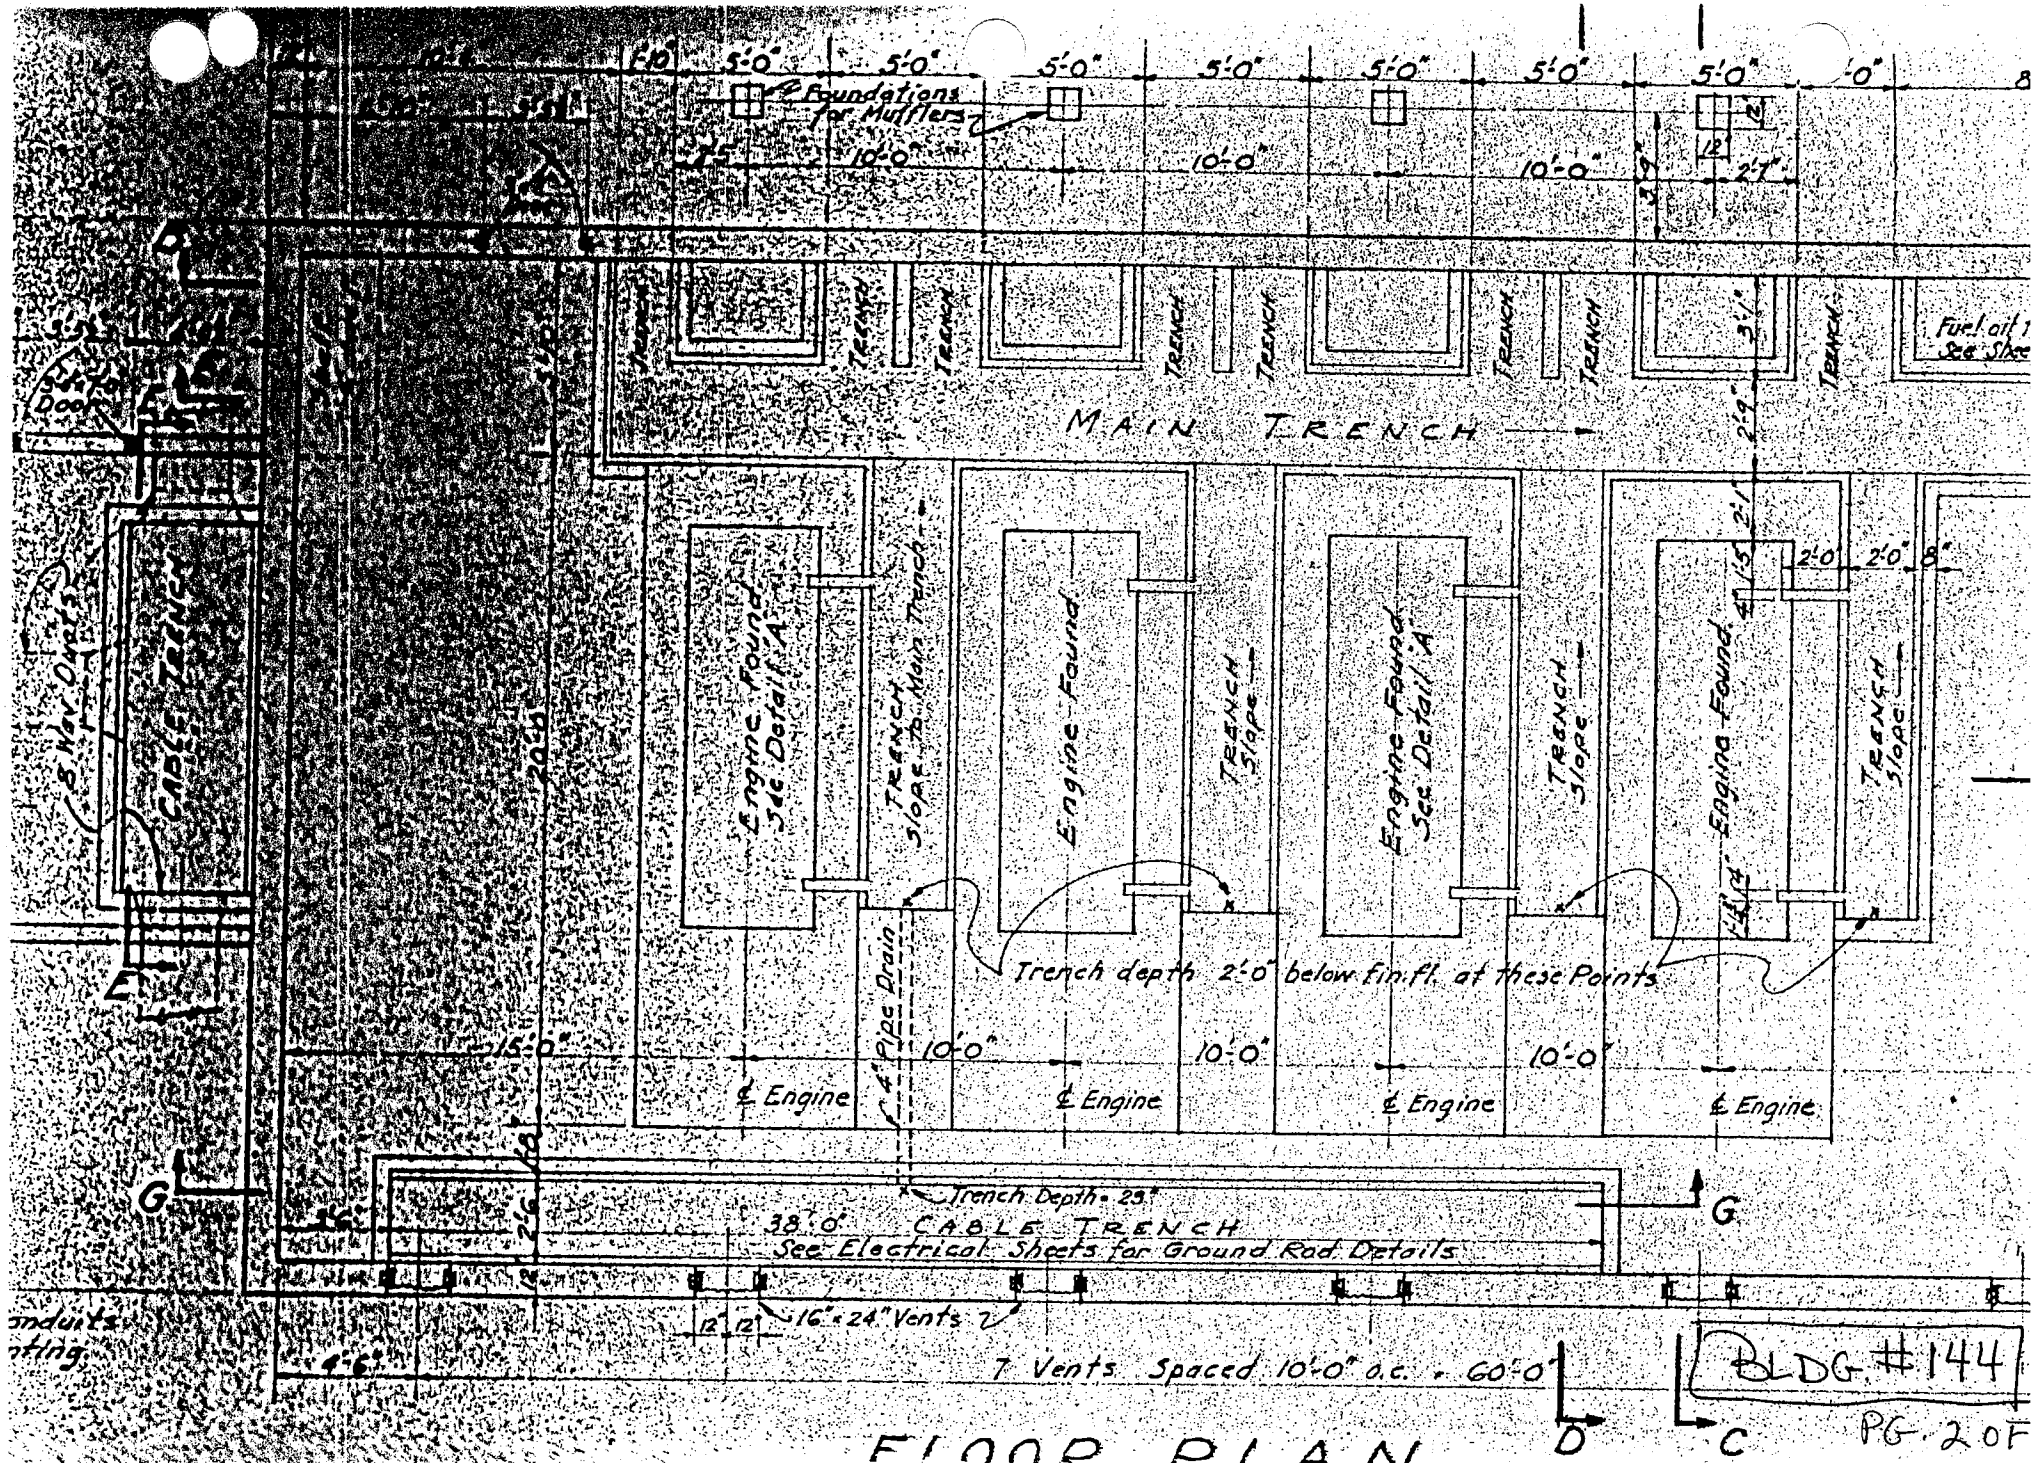
1600 KW Power Plant

SAMPLE ID NO	SAMPLE LOCATION / DESCRIPTION	ANALYTICAL RESULTS (PPM)	CONDITION	AMOUNT
L1104-9	Interior west wall Dark gray paint on wall	3,498.8	Poor	3,500 sq. ft.
L1104-10	Interior west wall Red/orange paint on sprinkler	132,236.8	Poor	150 lin. ft
L1104-11	Interior west engine Light gray paint on diesel engine generator	4,111.3	Poor	1,400 sq. ft..
L1104-12	Exterior west wall Light gray paint on wall	4,765.1	Poor	1,000 sq. ft.
L1004-13	Exterior northwest wall White and blue paint on pipes	3,441.6	Poor	100 sq. ft.
L1004-14	Exterior west end chiller Silver paint on chiller	1,010.0	Fair	300 sq. ft.

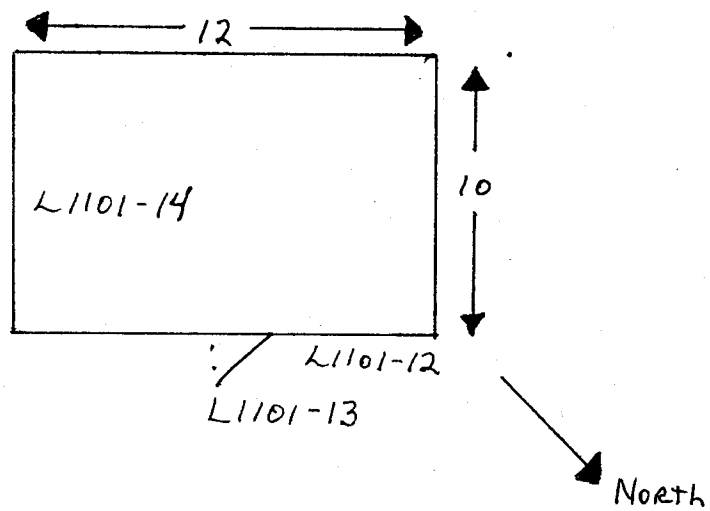
Bld. # 170

SAMPLE ID NO	SAMPLE LOCATION / DESCRIPTION	ANALYTICAL RESULTS (PPM)	CONDITION	AMOUNT
L1101-12	Exterior north side Beige paint on block wall	187.2	Fair	450 sq. ft.
L1101-13	Exterior north side Brown with green (below) paint on door	15,119.1	Fair	150 sq. ft.
L1101-14	Interior center of room Gray paint on voltage box	37,372.4	Good	25 sq. ft.

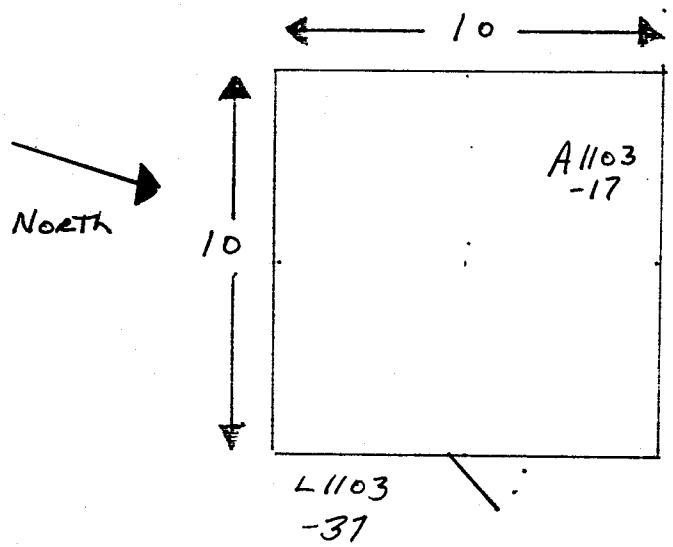
Bld #175

SAMPLE ID NO	SAMPLE LOCATION / DESCRIPTION	ANALYTICAL RESULTS (PPM)	CONDITION	AMOUNT
L1103-37	Exterior east side Yellow paint on wall	21,416.7	Poor	150 sq. ft.

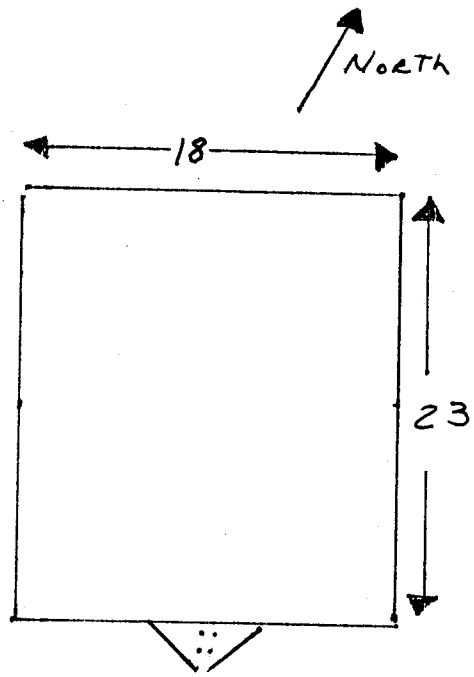
Bld # 180

SAMPLE ID NO	SAMPLE LOCATION / DESCRIPTION	ANALYTICAL RESULTS (PPM)	CONDITION	AMOUNT
No sample collected	No paint on interior walls or ceiling	N/A		
No sample collected	Interior beam Green paint, 6 beams - same as sample L1103-2, building 5361	4,445.2	Fair	150 lin. ft. of beams
No sample collected	Interior voltage box Gray paint - same as sample L1102-16, building 400	471.5	Good	100 sq. ft.
No sample collected	Exterior block Peach paint - same as sample L1103-27, building 174	4,906.3	Fair	900 sq. ft.

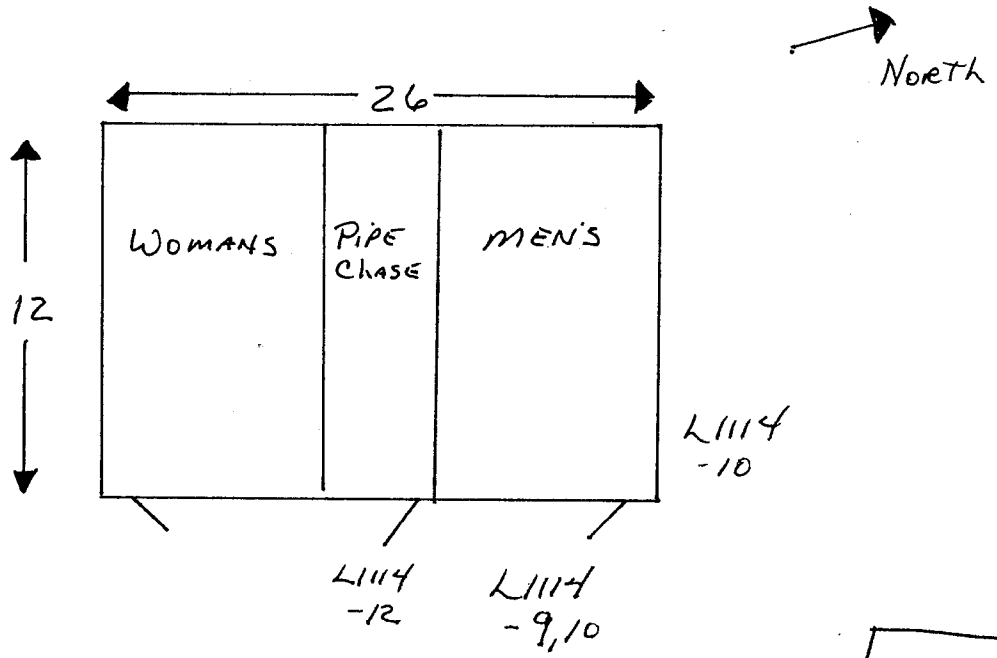
Bld # 181

SAMPLE ID NO	SAMPLE LOCATION / DESCRIPTION	ANALYTICAL RESULTS (PPM)	CONDITION	AMOUNT
	EXTERIOR:			
L1114-9	Men's restroom north side Red paint on floor	200.0	Fair	350 sq. ft.
L1114-10	East wall Off-white paint	476.0	Good	1,400 sq. ft. Inside and outside
L1114-11	East side of men's restroom Brown paint on door	90.1	Fair	125 sq. ft.
L1114-12	East side of pipe chase room Blue paint on door	7,368.7	Poor	75 sq. ft.

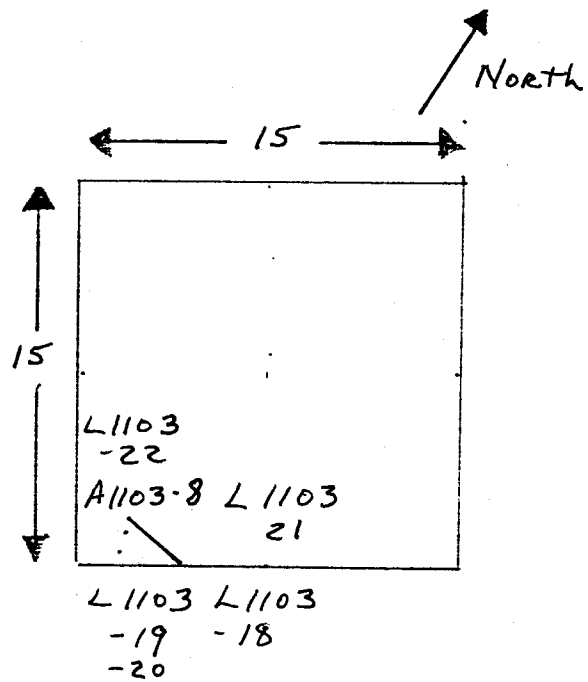
Bld #189

SAMPLE ID NO	SAMPLE LOCATION / DESCRIPTION	ANALYTICAL RESULTS (PPM)	CONDITION	AMOUNT
L1103-18	Exterior south side Off-white paint on wood wall	13,578.9	Poor	700 sq. ft.
L1103-19	Exterior south side Brown paint on door and trim	33,125.0	Poor	150 sq. ft.
L1103-20	Exterior south side Red deck paint on sidewalk	31,875.0	Poor	100 sq. ft.
L1103-21	Interior south side Gray deck paint	4,822.6	Poor	225 sq. ft.
L1103-22	Interior west wall White paint on wall	21,760.2	Poor	800 sq. ft.

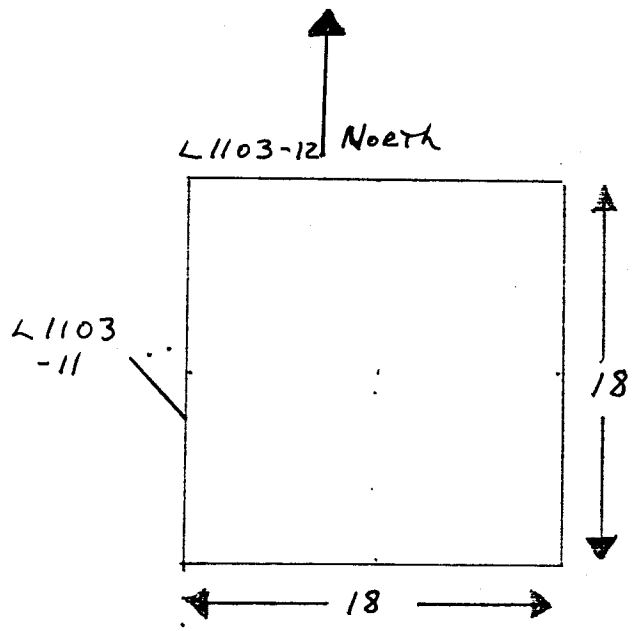
Bld 200
Electrical
Sub STA

SAMPLE ID NO	SAMPLE LOCATION / DESCRIPTION	ANALYTICAL RESULTS (PPM)	CONDITION	AMOUNT
No sample collected	No paint on interior walls or ceiling	N/A		
L1103-11	Exterior west side Brown paint on door	11,898.7	Good	125 sq. ft.
No sample collected	Interior voltage boxes Gray paint - same as sample L1102-16, building 400	471.5	Good	200 sq. ft.
L1103-12	Exterior north corner White paint on block wall	105.5	Good	800 sq. ft.

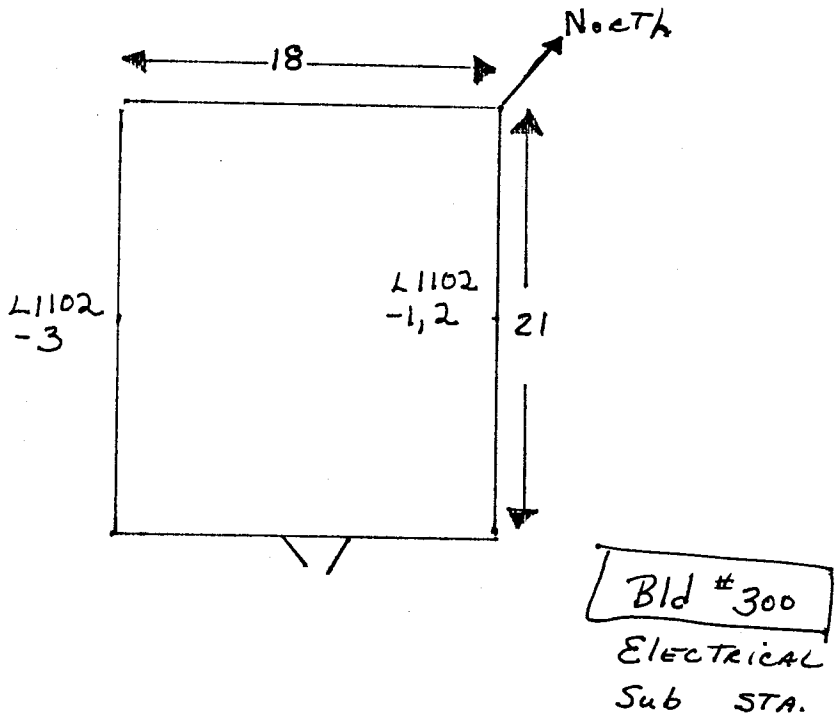
SAMPLE ID NO	SAMPLE LOCATION / DESCRIPTION	ANALYTICAL RESULTS (PPM)	CONDITION	AMOUNT
L1102-1	Interior east wall Off-white paint on wall	57.8	Good	1,600 sq. ft.
L1102-2	Interior Gray paint on electrical switch	7,835.0	Good	50 sq. ft.
L1102-3	Roof west side Green paint on transite roof	15,051.5	Poor	400 sq. ft.

North
18
21
L1102
-3
L1102
-1, 2
Bld #300
Electrical
Sub STA.

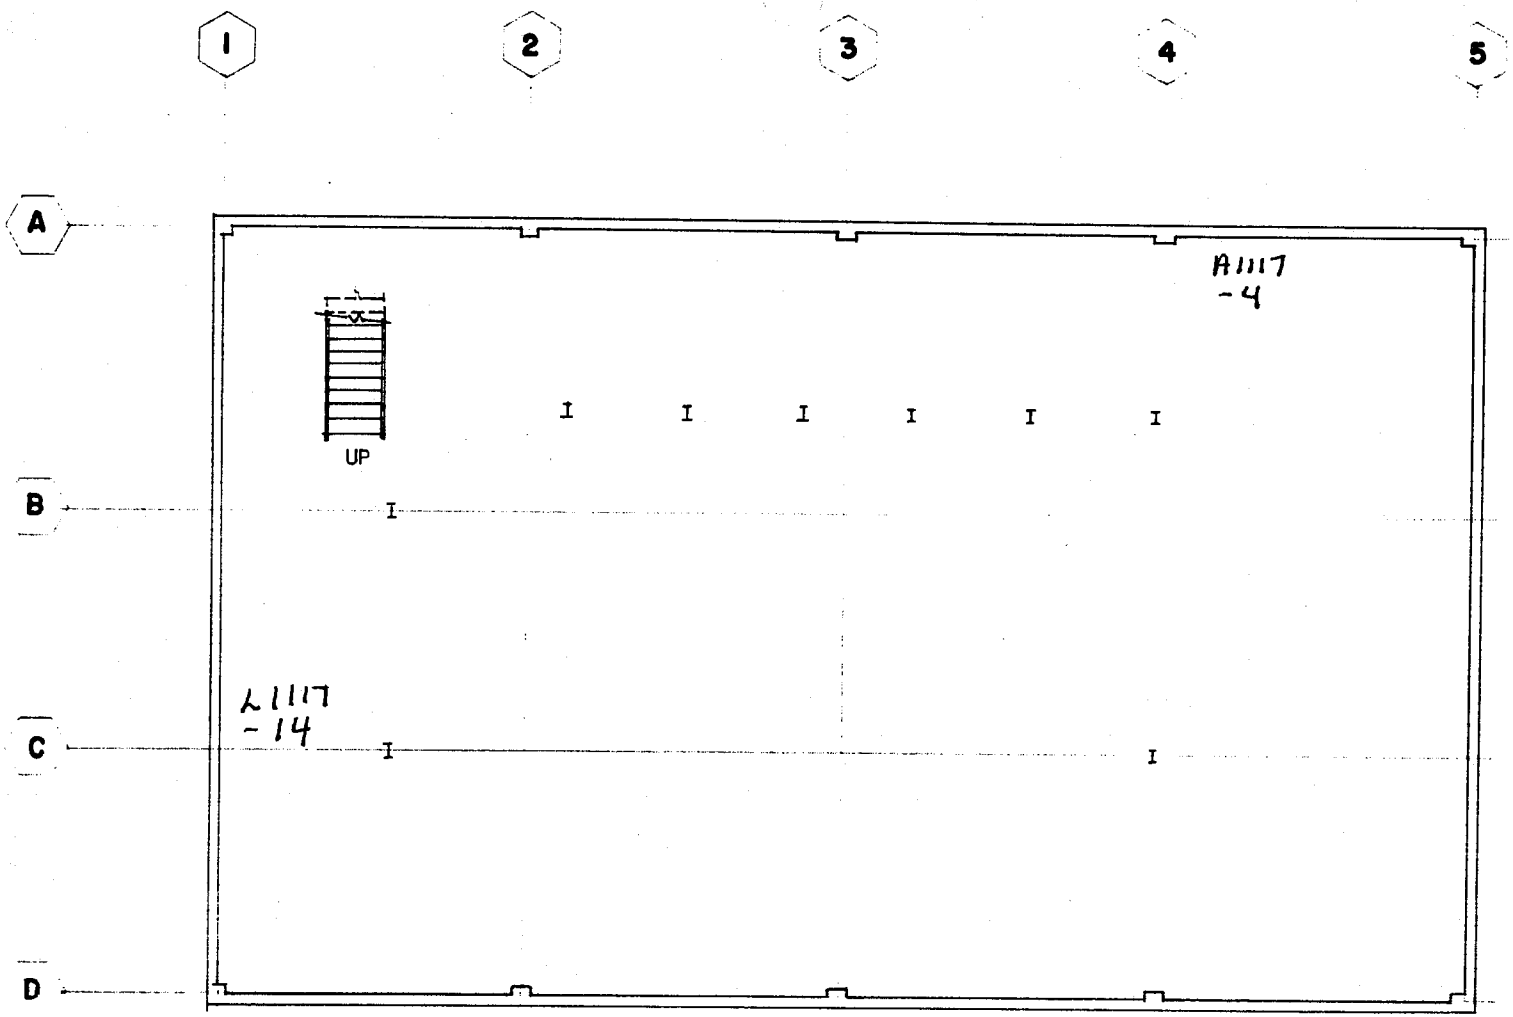
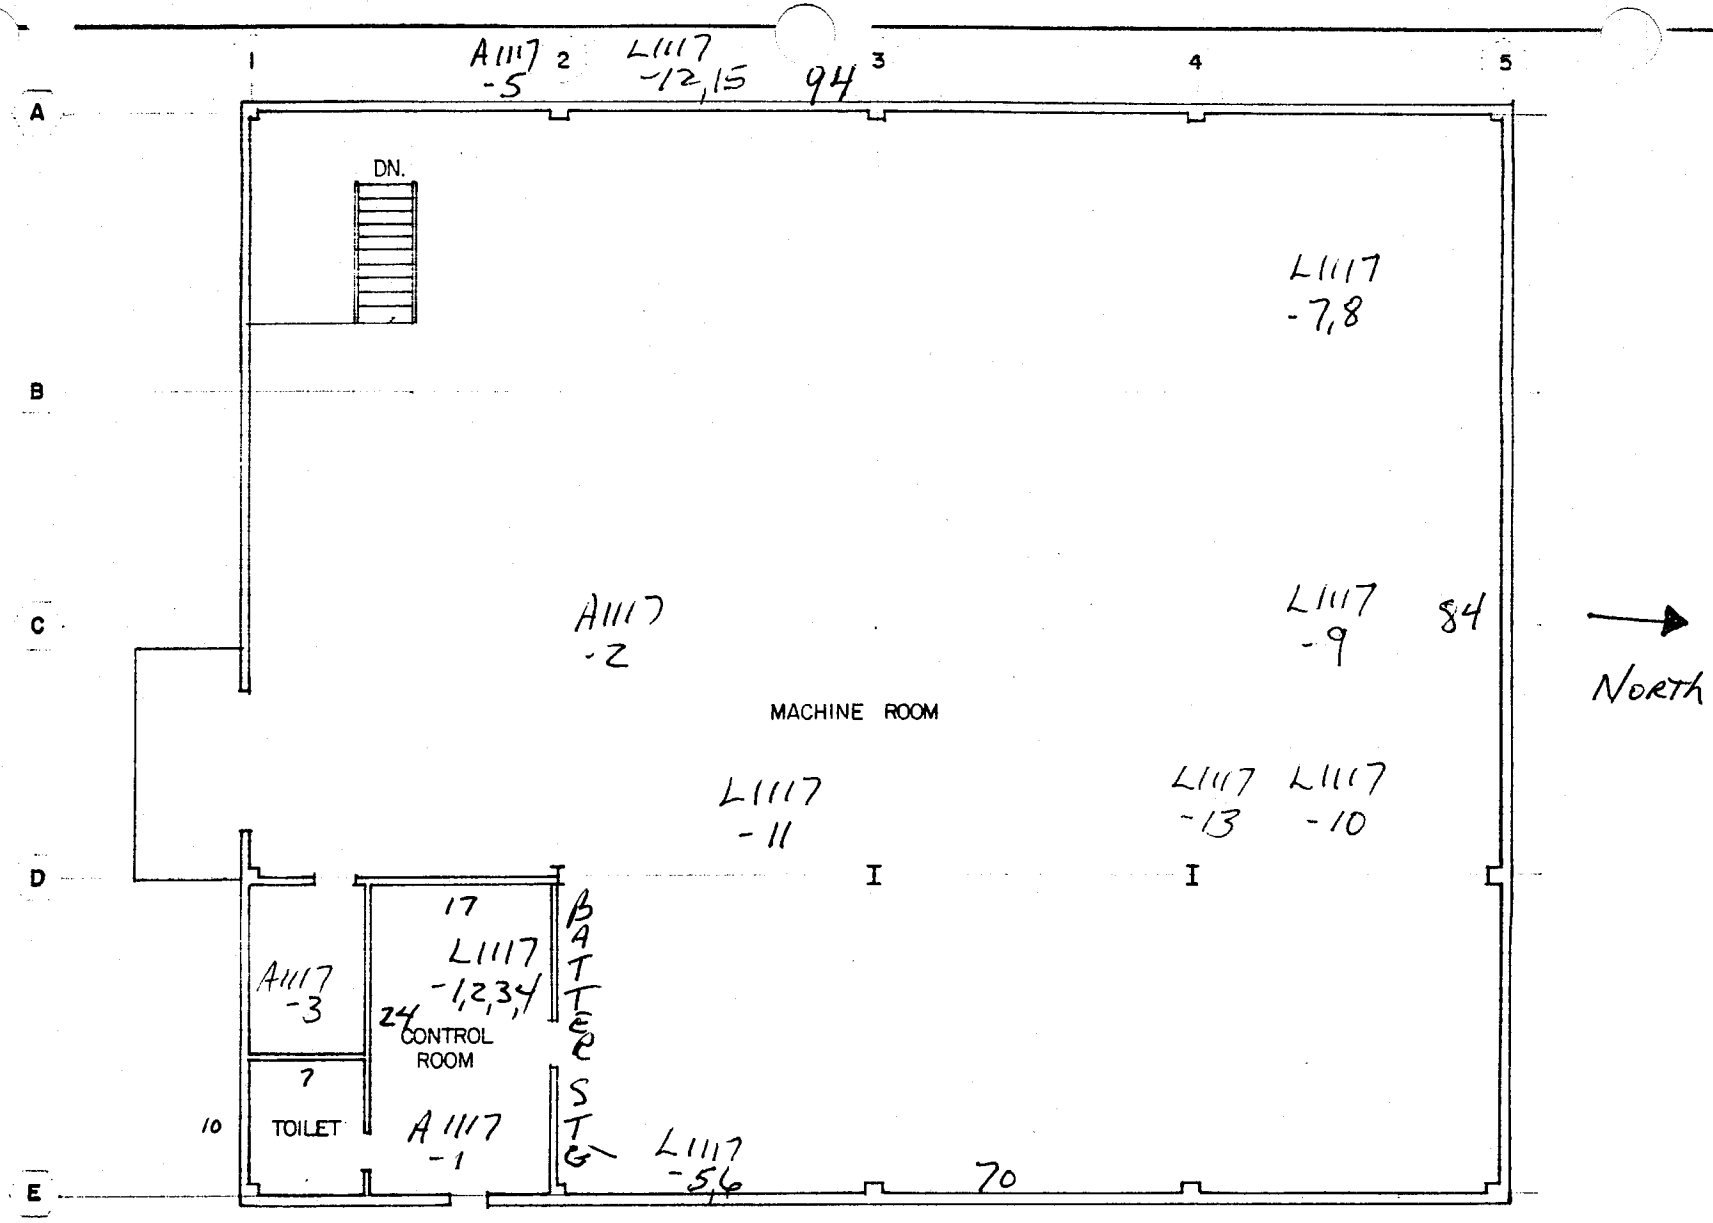
POWER PLANT, BLDG. 309

SAMPLE ID NO	SAMPLE LOCATION / DESCRIPTION	ANALYTICAL RESULTS (PPM)	CONDITION	AMOUNT
L1117-12	Catwalk southwest side Orange paint on handrail	658,611.1	Good	3,000 sq. ft.
L1117-13	Machine room northwest side Silver paint on exhaust pipes of engine	12,417.6	Good	10,000 sq. ft.
	1ST FLOOR:			
L1117-14	Interior southside by valve Red paint on fire system	90,079.4	Good	500 sq. ft.
L1117-15	Exterior southwest side by catwalk White paint on wall	18,097.8	Fair	15,000 sq. ft.

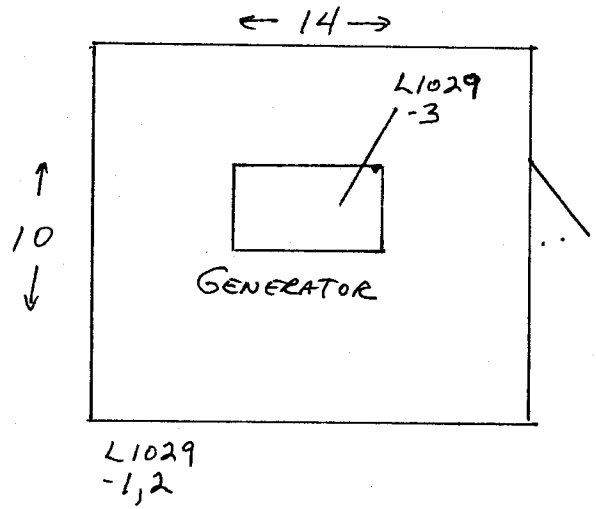
Bld#332

SAMPLE ID NO	SAMPLE LOCATION / DESCRIPTION	ANALYTICAL RESULTS (PPM)	CONDITION	AMOUNT
L1029-1	Exterior east side Off-white paint on block wall	395.7	Good	500 sq. ft.
L1029-2	Exterior east side Brown paint on bottom trim	137.0	Fair	50 sq. ft.
L1029-3	Interior center of room Green paint on generator	43,452.4	Good	25 sq. ft.

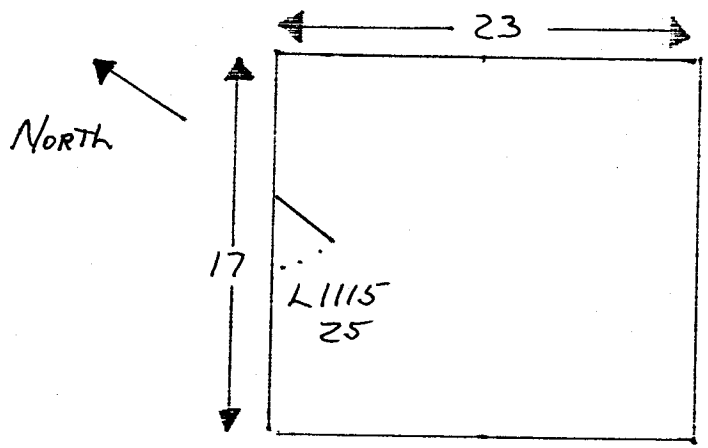
Bld # 340

SAMPLE ID NO	SAMPLE LOCATION / DESCRIPTION	ANALYTICAL RESULTS (PPM)	CONDITION	AMOUNT
L1115-25	Exterior north side Brown paint on door	27,371.1	Poor	150 sq. ft.
No sample collected	Exterior Off-white paint on wall Same as sample L1115-23, building 9149	N/A	Good	750 sq. ft.

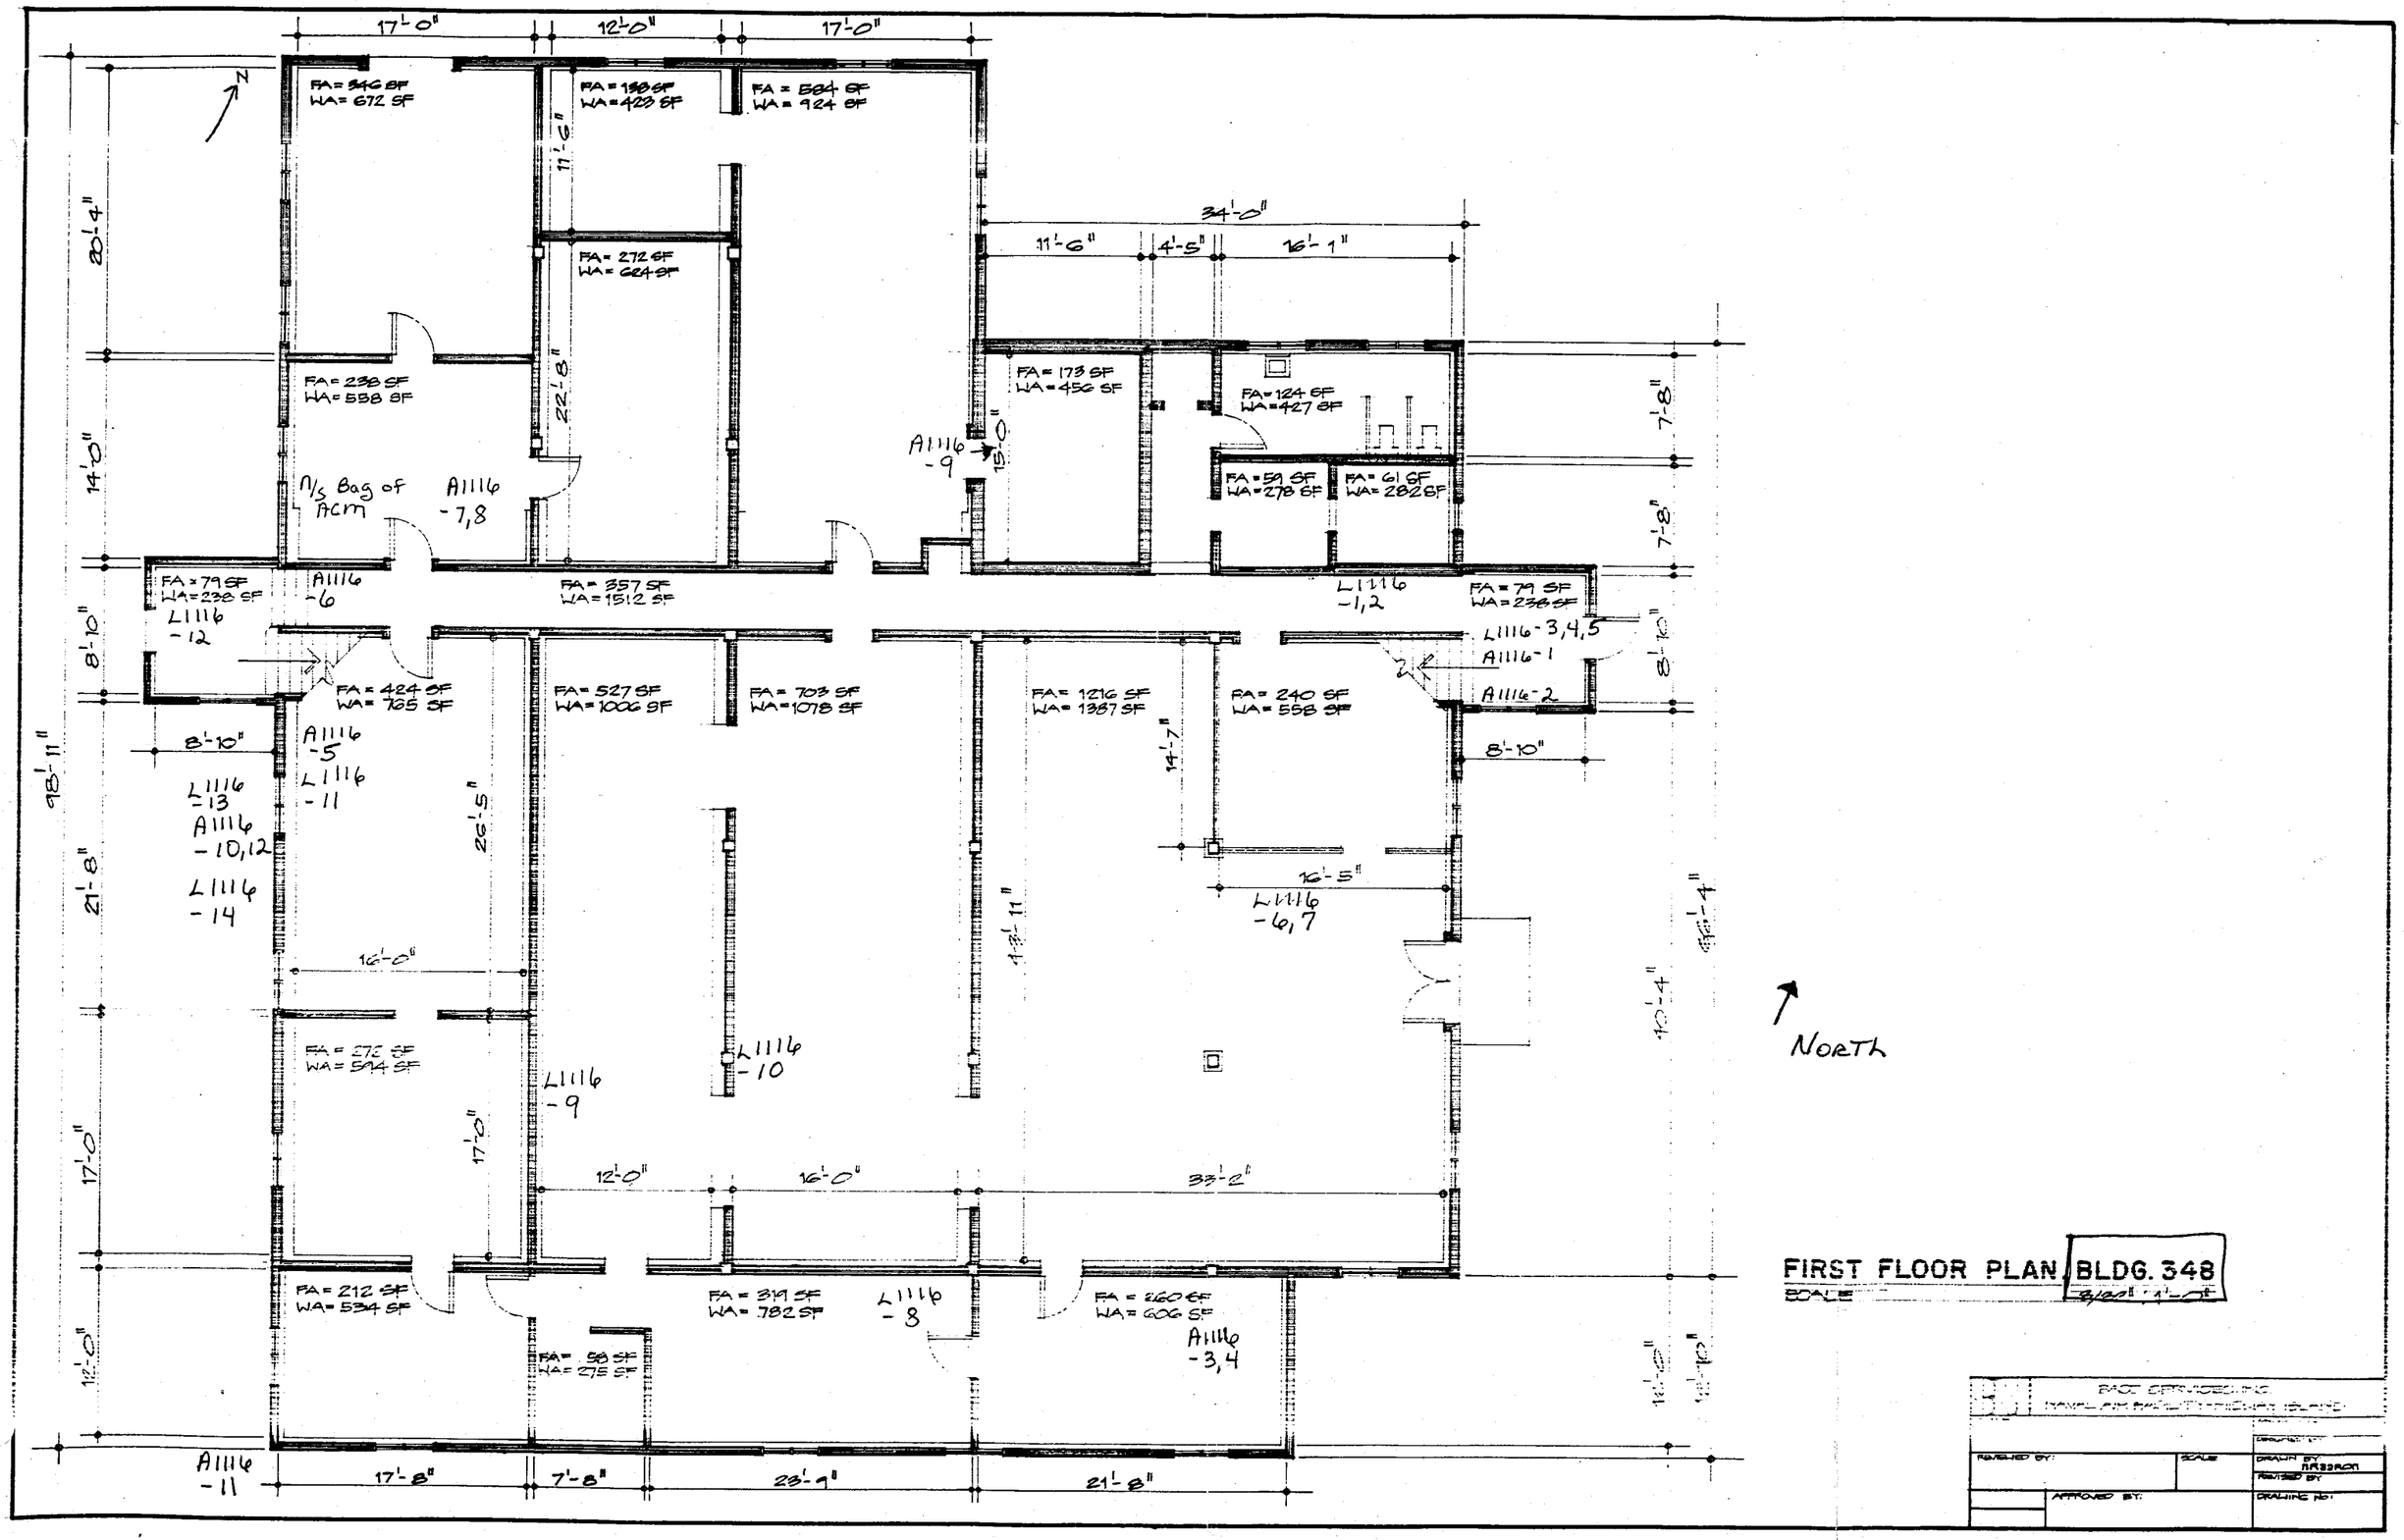
SAMPLE ID NO	SAMPLE LOCATION / DESCRIPTION	ANALYTICAL RESULTS	FRIABLE	CONDITION	AMOUNT
	INTERIOR 1ST FLOOR:				
A1116-1	East hallway Green with beige streaks 9" x 9" floor tile	Tile - 2% Chrysotile Mastic - 5% Chrysotile	No	Fair	7,200 sq. ft.
A1116-2	East stairwell Black stairtread	None detected	No	Good	150 sq. ft.
A1116-3	Southeast side Black with beige and green streaks 9" x 9" floor tile	Tile - 8% Chrysotile Mastic - 0% Chrysotile	No	Fair	2,000 sq. ft.
A1116-4	Southeast side Drywall and tape	None detected	Yes	Poor	25,000 sq. ft.
A1116-5	Southwest side Red with white streaks 9" x 9" floor tile	Tile - 12% Chrysotile Mastic - 2% Chrysotile	No	Fair	700 sq. ft.
A1116-6	West side Black stairtread	None detected	No	Poor	50 sq. ft.
A1116-7	West side 1' x 1' ceiling tile and mastic	None detected	No	Fair	800 sq. ft.
A1116-8	West side Brown with orange and white streaks 9" x 9" floor tile	<1% Chrysotile	No	Fair	800 sq. ft.

A1116-9	SAFC Room Gray with white streaks 9" x 9" floor tile	<1% Chrysotile	No	Fair	25 sq. ft.
No sample collected	Tagged with asbestos tag: One torn bag of asbestos cloth; cloth wrap (improperly bagged): Notified Safety	N/A

17'-0"
12'-0"
17'-0"
FA = 546 SF
WA = 672 SF
FA = 198 SF
WA = 423 SF
FA = 584 SF
WA = 924 SF
11'-6"
FA = 272 SF
WA = 624 SF
34'-0"
11'-6"
4'-5"
16'-1"
20'-4"
FA = 238 SF
WA = 558 SF
22'-8"
FA = 173 SF
WA = 456 SF
FA = 124 SF
WA = 427 SF
A1116
-9
15'-0"
7'-8"
14'-0"
N/S Bag of ACM
A1116
-7,8
FA = 59 SF
WA = 278 SF
FA = 61 SF
WA = 282 SF
7'-8"
FA = 79 SF
WA = 238 SF
A1116
-6
FA = 357 SF
WA = 1512 SF
L1116
-1,2
FA = 79 SF
WA = 238 SF
L1116
-12
L1116-3,4,5
A1116-1
8'-10"
8'-10"
FA = 424 SF
WA = 725 SF
FA = 527 SF
WA = 1006 SF
FA = 703 SF
WA = 1078 SF
FA = 1216 SF
WA = 1387 SF
FA = 240 SF
WA = 558 SF
A1116-2
8'-10"
8'-10"
A1116
-5
L1116
-11
98'-11"
L1116
-13
A1116
-10,12
L1116
-14
26'-5"
14'-7"
16'-5"
L1116
-6,7
21'-8"
16'-0"
11'-8"
40'-4"
40'-4"
FA = 272 SF
WA = 594 SF
L1116
-9
L1116
-10
17'-0"
17'-0"
12'-0"
16'-0"
33'-2"
NORTH
FA = 212 SF
WA = 534 SF
FA = 319 SF
WA = 782 SF
L1116
-8
FA = 260 SF
WA = 606 SF
A1116
-3,4
FA = 58 SF
WA = 275 SF
12'-0"
12'-0"
12'-10"
A1116
-11
17'-8"
7'-8"
23'-9"
21'-8"
FIRST FLOOR PLAN BLDG. 348

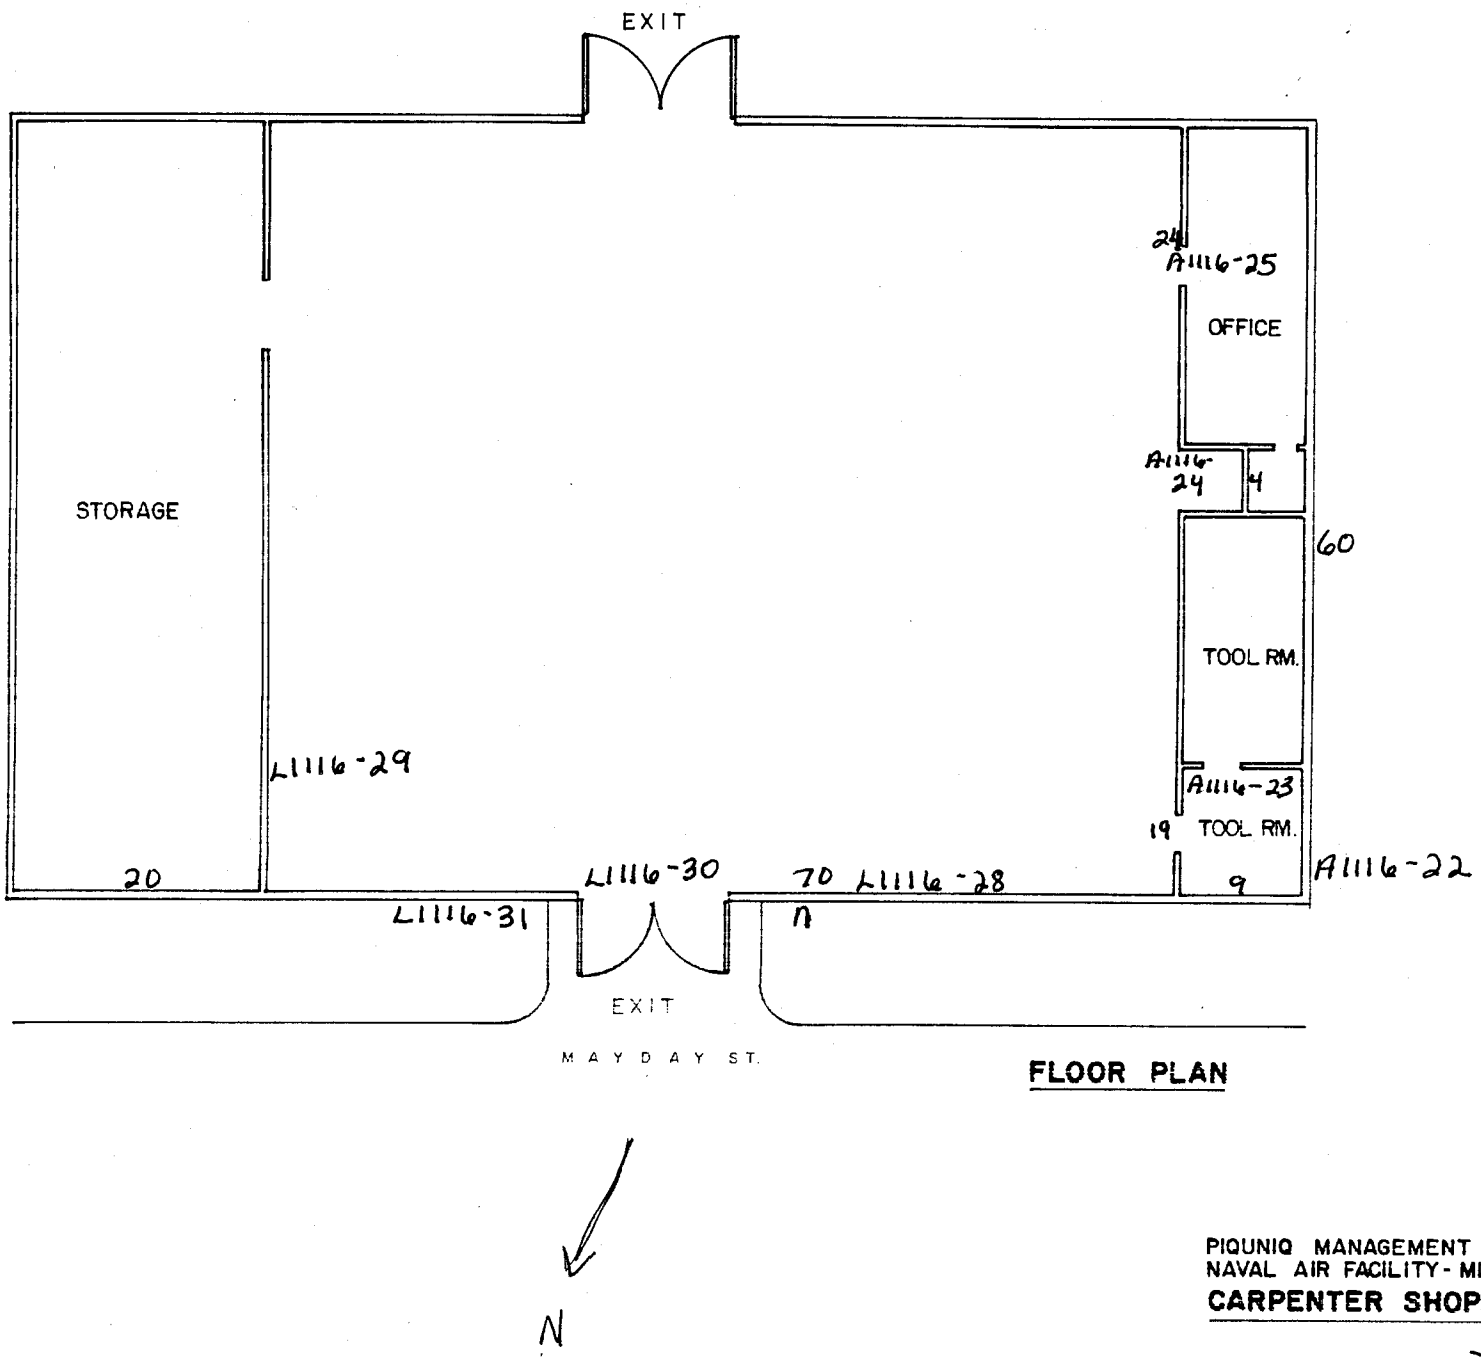
PIQUNIQ MANAGEMENT CORPORATION
NAVAL AIR FACILITY - MIDWAY ISLAND
CARPENTER SHOP, B. 353

SAMPLE ID NO	SAMPLE LOCATION / DESCRIPTION	ANALYTICAL RESULTS	FRIABLE	CONDITION	AMOUNT
A1116-22	Roof northwest side Roof core	None detected	No	Good	6,000 sq. ft.
	INTERIOR:				
A1116-23	East side Green with white and dark green flecks: 9" x 9" floor tile	Tile - 2% Chrysotile Mastic - 8% Chrysotile	No	Good	288 sq. ft.
A1116-24	Sink room east side Beige with white 12" x 12" floor tile	None detected	No	Good	25 sq. ft.
A1116-25	Office east side Brown with white 9" x 9" floor tile under carpet	<1% Chrysotile	No	Fair	225 sq. ft.

SAMPLE ID NO	SAMPLE LOCATION / DESCRIPTION	ANALYTICAL RESULTS (PPM)	CONDITION	AMOUNT
	INTERIOR:			
L1116-28	Work shop north wall Off-white paint on wall and ceiling	1,670.8	Fair	9,900 sq. ft.
L1116-29	Workshop east wall Blue paint	159,948.9	Good	1,500 sq. ft.
L1116-30	Workshop door north side Brown paint	124,833.3	Poor	1,500 sq. ft.
	EXTERIOR:			
L1116-31	North side Off-white paint on wall	692.3	Good	3,850 sq. ft.
