ASBESTOS AND LEAD-BASED PAINT

SURVEY REPORT

NAF MIDWAY ISLAND

Ogden Project #CTO 125
TSC Project #865

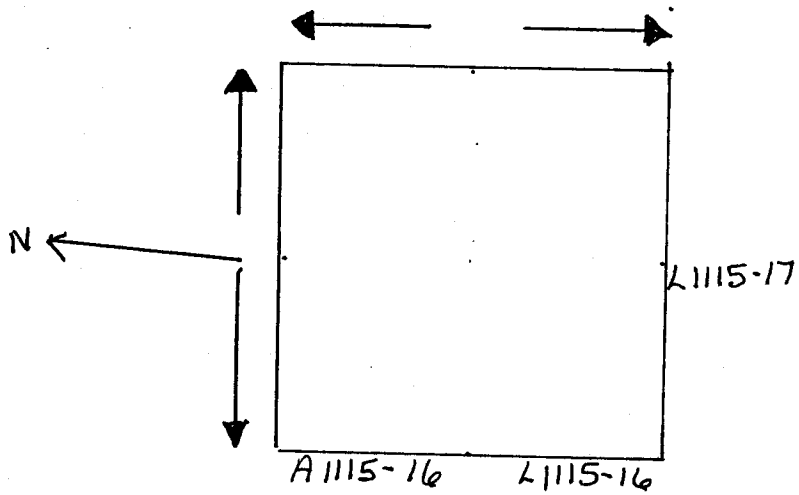
BLDG #354 / Power Plant

SAMPLE ID NO	SAMPLE LOCATION / DESCRIPTION	ANALYTICAL RESULTS	FRIABLE	CONDITION	AMOUNT
No sample collected	East side exterior Transit panels Same as sample A1114-4, building 3512	20% Chrysotile	No	Fair	300 sq. ft.
No sample collected	Exterior Corrugated transite panel Same as sample A1027-27, building 5182	45% Chrysotile	No	Fair	700 sq. ft.
A1115-16	West side exterior Concrete	None detected	No	Poor	Unknown
	Note: The building is not safe for entry; doors are welded closed.

SAMPLE ID NO	SAMPLE LOCATION / DESCRIPTION	ANALYTICAL RESULTS (PPM)	CONDITION	AMOUNT
L1115-16	Exterior west side Green paint on wall	47,032.9	Poor	Unknown
L1115-17	Exterior south side Red paint on concrete pad	4,708.8	Poor	150 sq. ft.

~~Doors~~ Welded Closed

Unsafe to be Close to

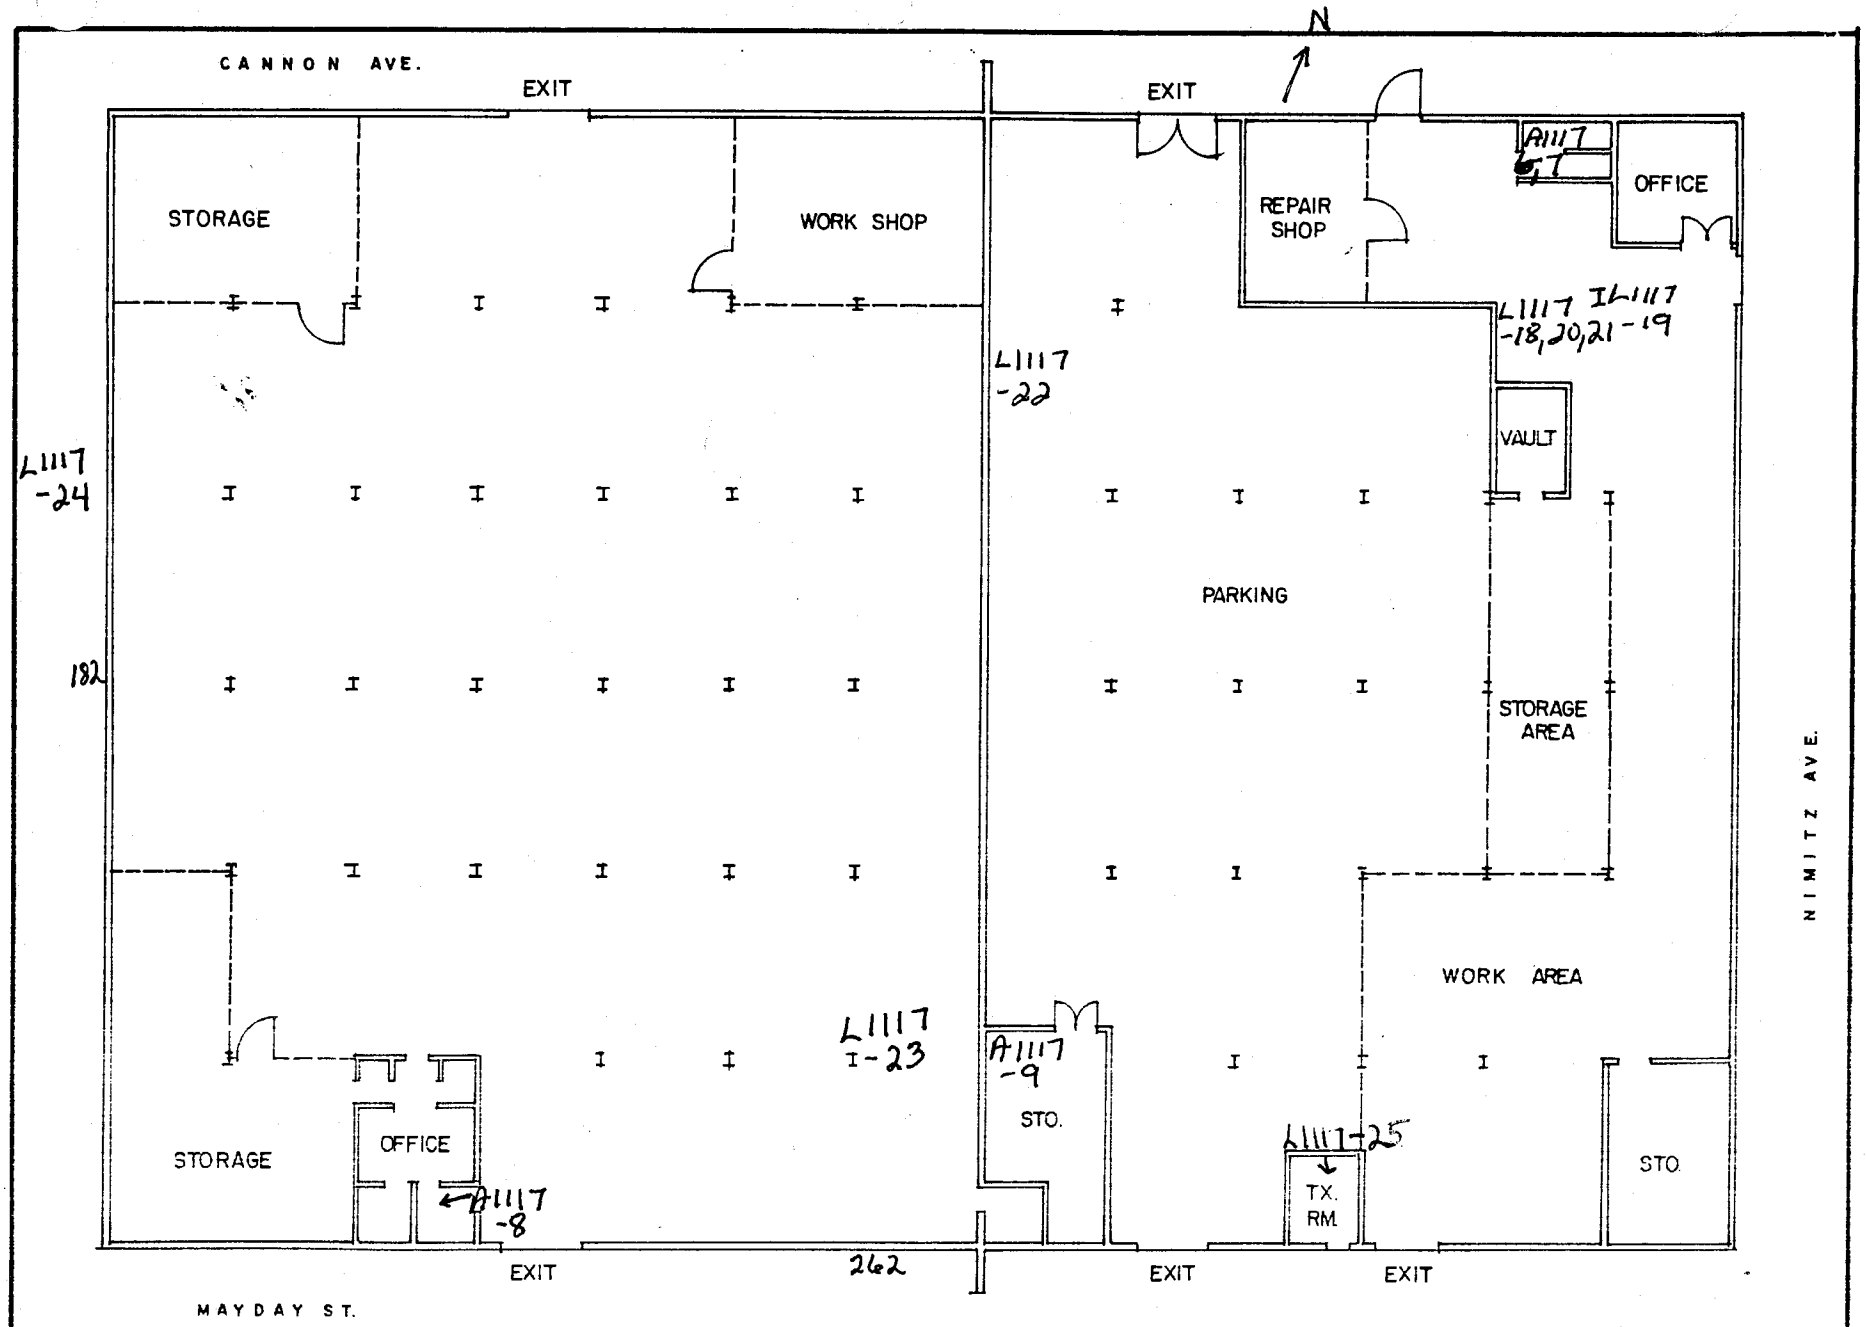
PIQUNIQ MANAGEMENT CORPORATION
NAVAL AIR FACILITY - MIDWAY ISLAND
ELECTRICAL SHOP/PARKING GARAGE
BLDG. NO. 356

SAMPLE ID NO	SAMPLE LOCATION / DESCRIPTION	ANALYTICAL RESULTS	FRIABLE	CONDITION	AMOUNT
	INTERIOR:				
A1117-6	Restroom north side 2' x 4' suspended ceiling tile	None detected	Yes	Good	120 sq. ft.
A1117-7	Restroom north side Off-white with brown & white flecks 12" x 12" floor tile	None detected	No	Good	400 sq. ft.
A1117-8	Office southwest side Green with white streaks 9" x 9" floor tile	None detected	No	Good	120 sq. ft.
A1117-9	Storage room Black with white streaks 9" x 9" floor tile	1-2% Chrysotile	No	Poor	1,000 sq. ft.
	ROOF:				
A1126-3	Core and rock northwest side	None detected	No	Good	48,000 sq. ft.
A1126-4	Tar on vent east side	3% Chrysotile	No	Good	200 sq. ft.

SAMPLE ID NO	SAMPLE LOCATION / DESCRIPTION	ANALYTICAL RESULTS (PPM)	CONDITION	AMOUNT
	INTERIOR:			
L1116-18	Wall dividing parking and vault northeast side Off-white paint on wall	89,804.7	Fair	4,800 sq. ft.
L1116-19	Northeast side White paint on beam	34,763.9	Fair	2,700 sq. ft.
L1116-20	Wall dividing parking and vault northeast side White paint	13,750.0	Good	2,400 sq. ft.
L1116-21	Ceiling northeast side Yellow paint	11,473.7	Poor	12,000 sq. ft.
L1116-22	Center north end wall White paint	1,194.0	Fair	6,200 sq. ft.
L1116-23	Southwest side Brown paint on beam	10,940.7	Good	2,700 sq. ft.
L1116-25	Electrical room south side Gray paint on wall	34,541.7	Fair	1,400 sq. ft.
	EXTERIOR:			
L1116-24	Southwest side Off-white paint on wall	7,306.7	Fair	3,600 sq. ft.

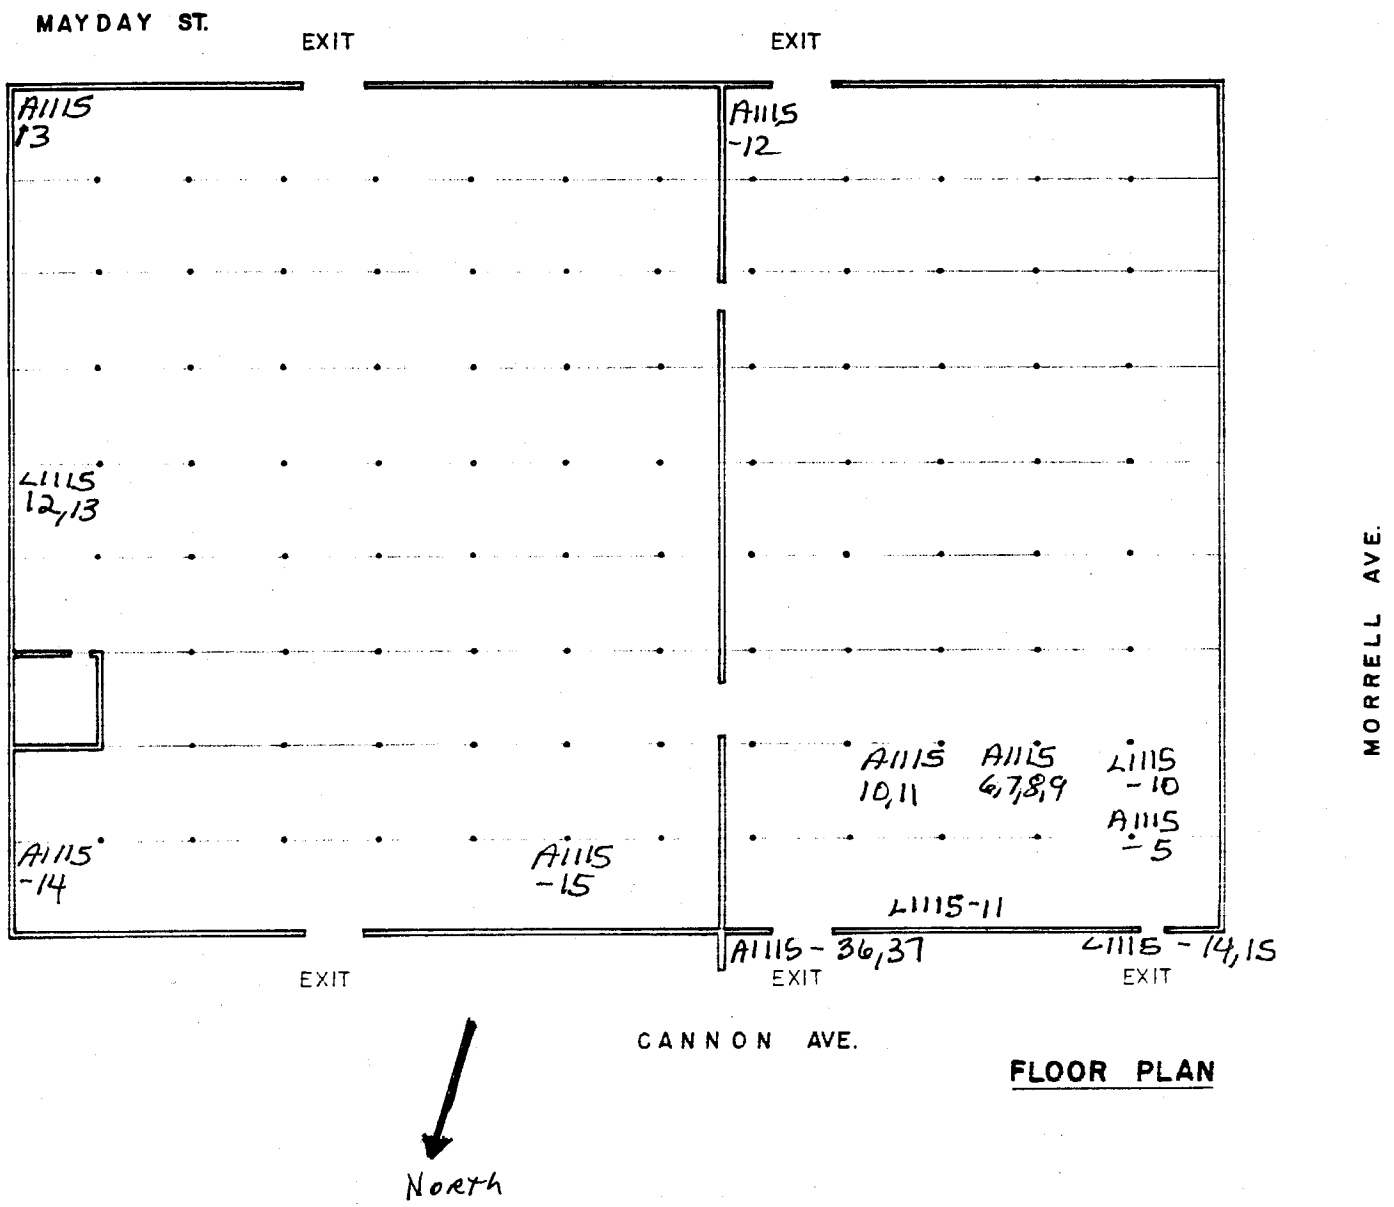
PIQUNIQ MANAGEMENT CORPORATION
NAVAL AIR FACILITY - MIDWAY ISLAND
SKI WAREHOUSE, BLDG. 393

SAMPLE ID NO	SAMPLE LOCATION / DESCRIPTION	ANALYTICAL RESULTS	FRIABLE	CONDITION	AMOUNT
	INTERIOR:				
A1115-5	West wall Concrete lower section of wall	None detected	No	Fair	4,500 lin. ft.
A1115-6	Northwest side - new roll Tar paper	None detected	No	Good	1 roll
A1115-7	Northwest side - new roll Tar paper with yellow stripes	None detected	No	Good	1 roll
A1115-8	Northwest side - new roll Black rolled shingles	None detected	No	Good	1 roll
A1115-9	Northwest side - new roll Black with white rock rolled shingle	None detected	No	Good	1 roll
A1115-10	Northwest side Burgundy with orange and white streaks: 9" x 9" floor tile	Tile - 6% Chrysotile Mastic - 5% Chrysotile	~~Fair~~ NO	Poor	300 sq. ft.
A1115-11	Northwest side Brown with white and orange streaks 9" x 9" floor tile	Tile - None detected Mastic - 1% Chrysotile	No	Poor	150 sq. ft.
A1115-12	Southwest side Black with white streaks 9" x 9" floor tile (2 layers on top)	Tile - 3% Chrysotile Mastic - 20% Chrysotile	No	Fair	140 sq. ft.

SAMPLE ID NO	SAMPLE LOCATION / DESCRIPTION	ANALYTICAL RESULTS (PPM)	CONDITION	AMOUNT
	INTERIOR:			
L1115-10	West wall White paint	360.6	Fair	42,000 sq. ft.
L1115-11	North wall Light green paint on beam	1,152.6	Fair	300 sq. ft.
L1115-12	East wall Dark green paint	8,940.2	Fair	500 sq. ft.
L1115-13	East wall White paint	2,998.5	Fair	11,000 sq. ft.
	EXTERIOR:			
L1115-14	North wall Off-white paint	43,596.9	Fair	14,000 sq. ft.
L1115-15	Northwest door Brown paint	32,708.3	Fair	400 sq. ft.

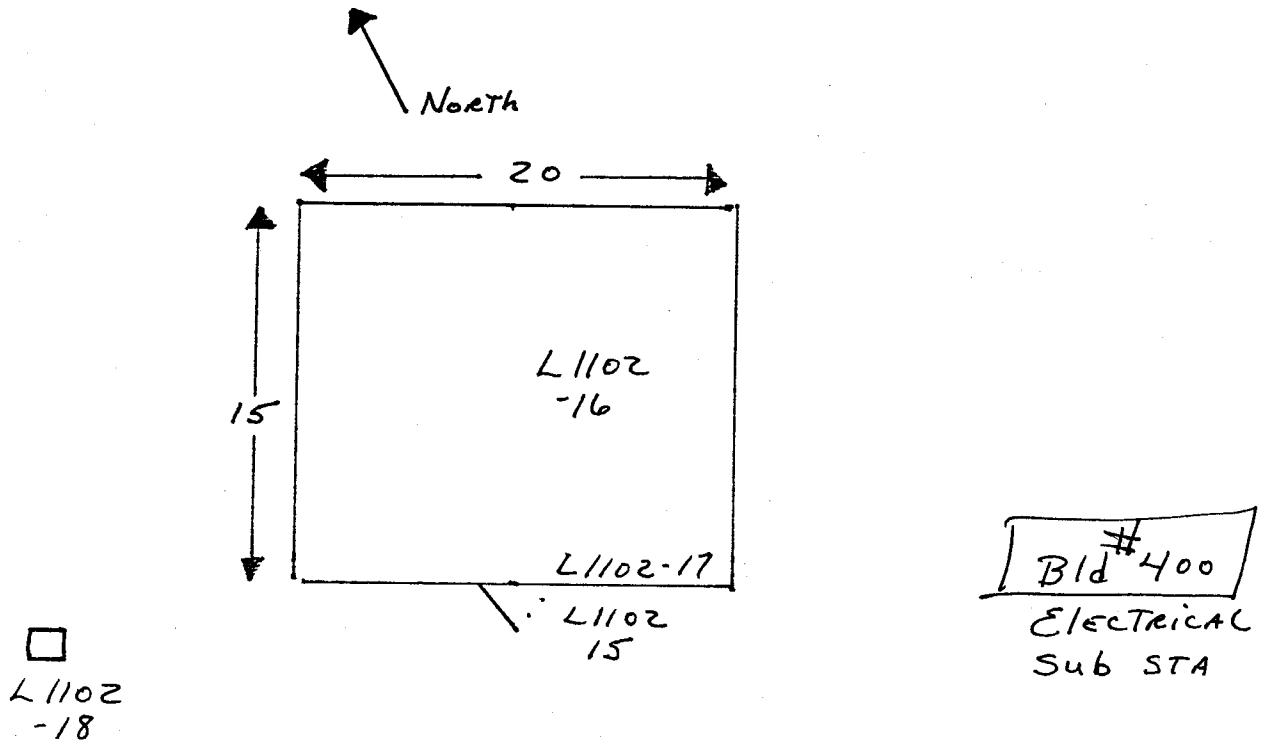
SAMPLE ID NO.	SAMPLE LOCATION / DESCRIPTION	ANALYTICAL RESULTS (PPM)	CONDITION	AMOUNT
L1102-15	Interior south door Brown paint on door and trim	5,380.0	Fair	275 sq. ft.
L1102-16	Interior east side Gray paint on voltage boxes	471.5	Good	100 sq. ft.
L1102-17	Interior south wall Off-white paint on wall	128.0	Good	1,550 sq. ft.
L1102-18	Exterior west of building 400 Orange paint on pole stand, 15 ft.	75,800.0	Poor	25 sq. ft.

North
20
15
L1102
-16
L1102-17
L1102
15
L1102
-18
Bld #400
Electrical
Sub STA

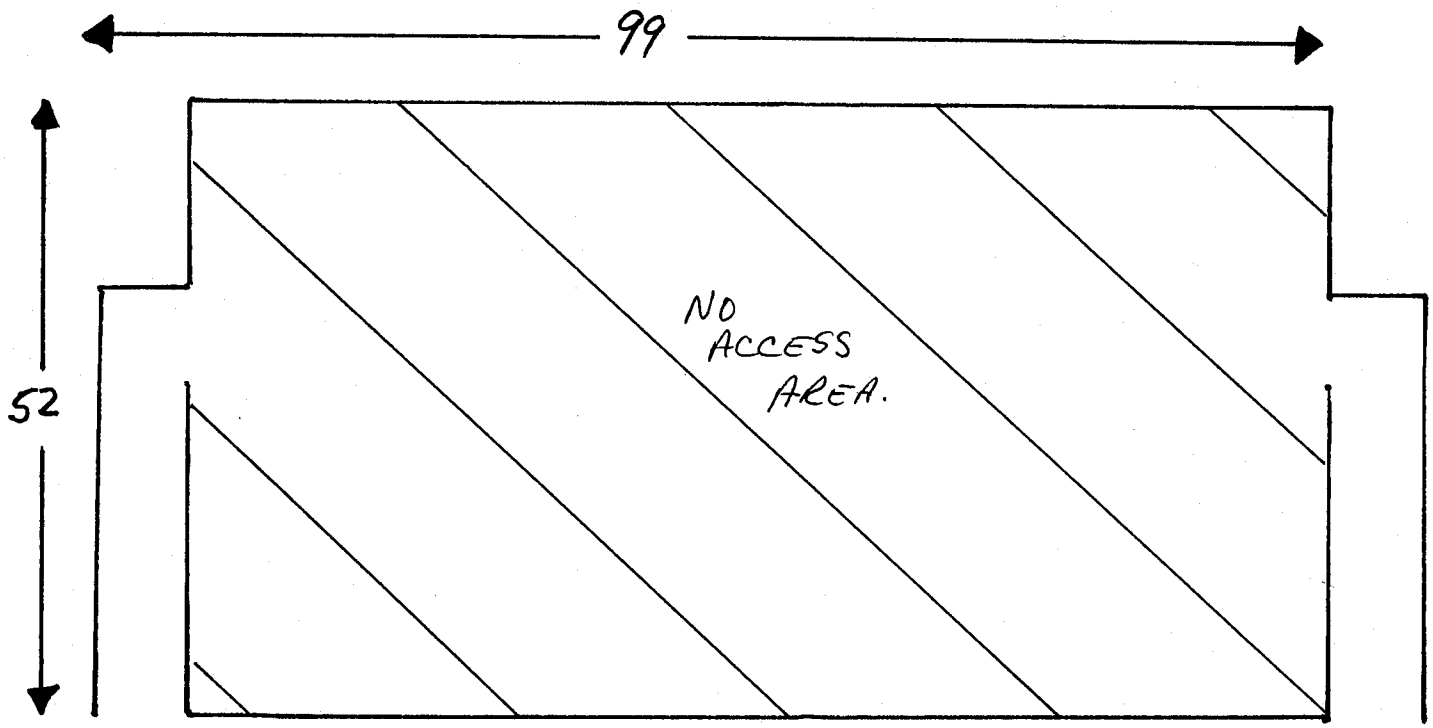
Bld #521
Comm. CTR.

SAMPLE ID NO	SAMPLE LOCATION / DESCRIPTION	ANALYTICAL RESULTS (PPM)	CONDITION	AMOUNT
	EXTERIOR:			
L1112-3	North end White paint on wall	1,401.4	Poor	8,000 sq. ft.
L1112-4	North end Green paint on door	17,335.6	Poor	2,000 sq. ft.
L1112-8	Northwest side Gray paint on air handler	18,239.7	Poor	100 sq. ft.
	INTERIOR:			
L1112-5	Northwest wall White paint	6,018.5	Poor	Unknown
L1112-6	Northwest wall Light green paint	5,313.9	Poor	Unknown
L1112-7	Southwest wall Light green paint	2,991.6	Poor	Unknown
	Note: 1st floor unsafe for entry

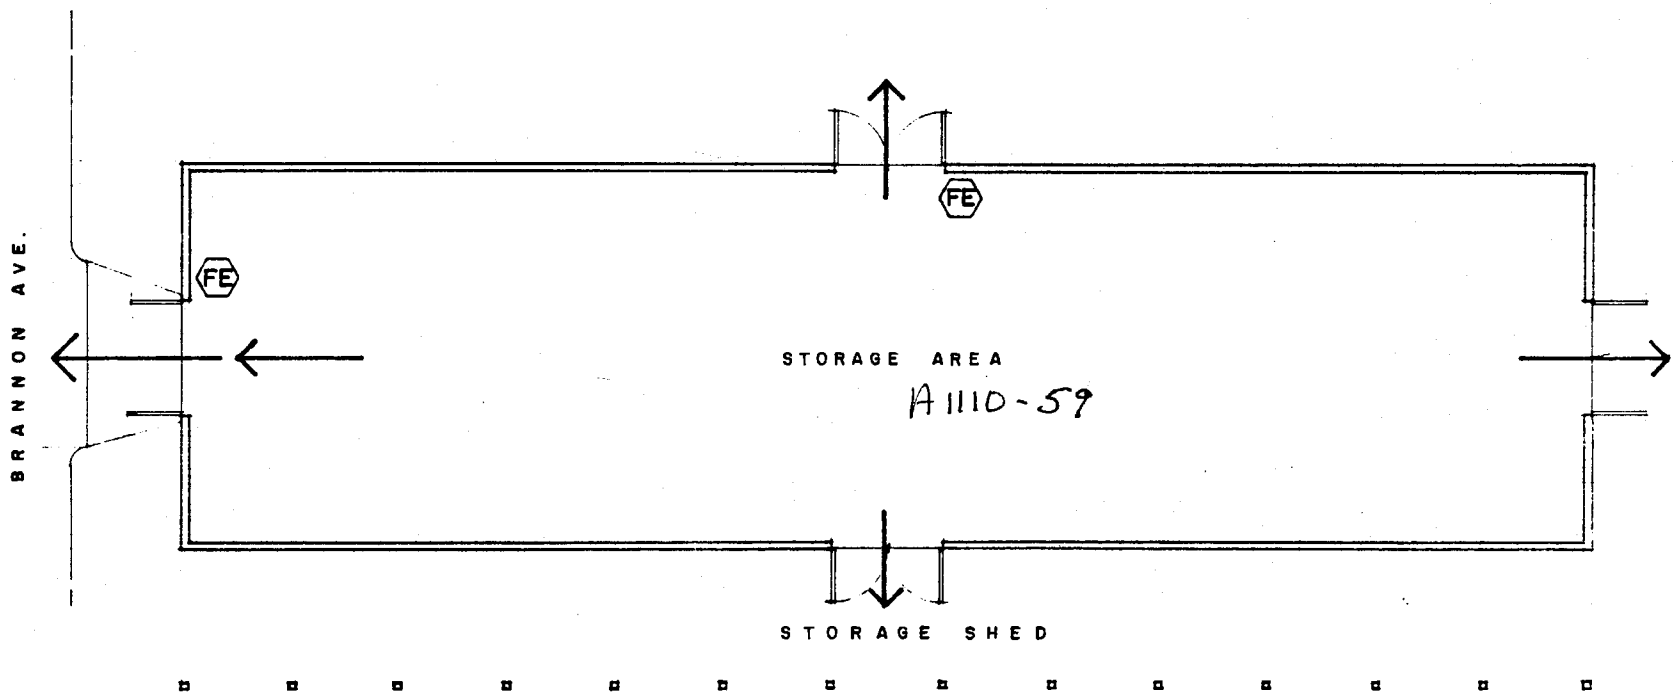
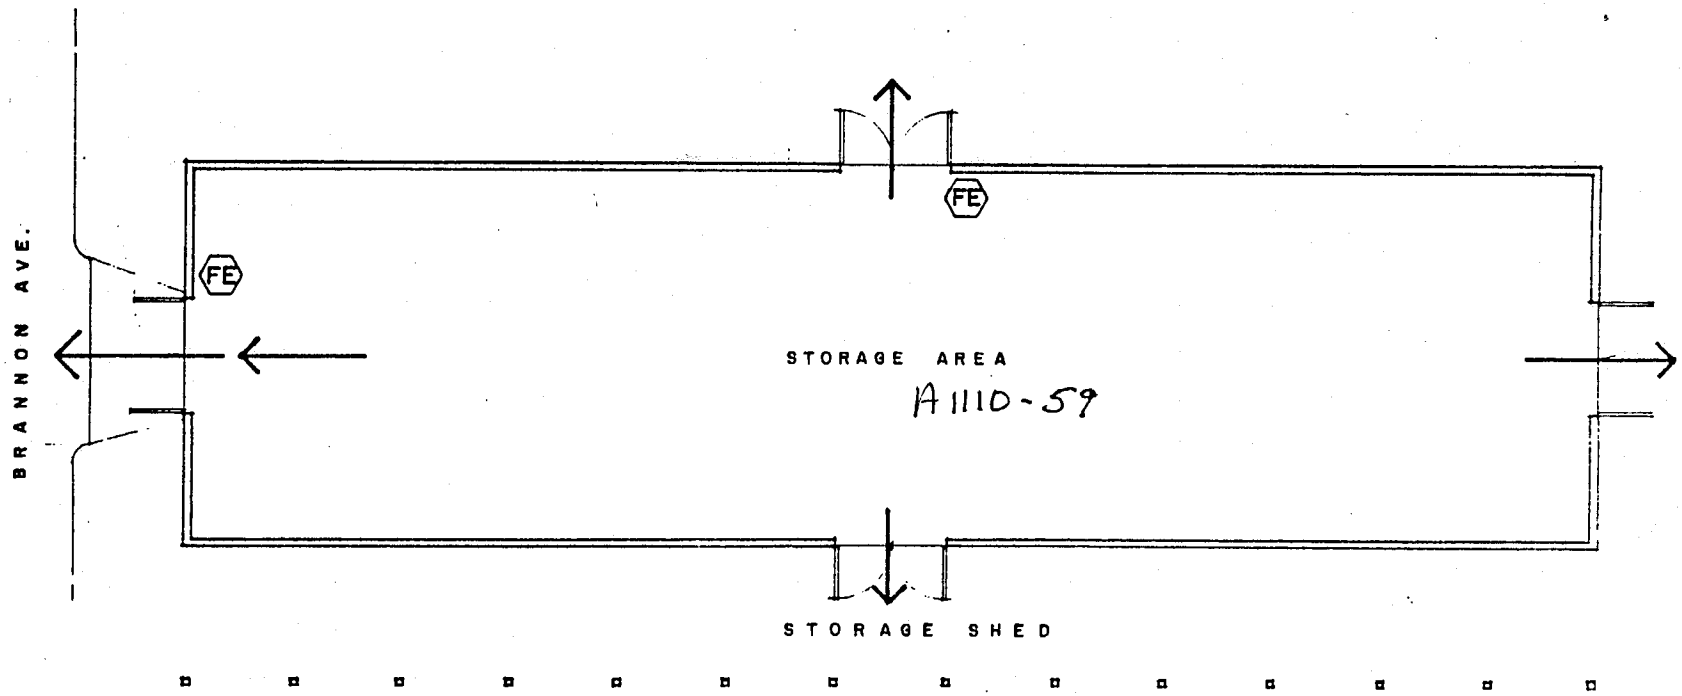
PAINT STORAGE | **BLDG. 576**
PG. 1 OF 2

SAMPLE ID NO	SAMPLE LOCATION / DESCRIPTION	ANALYTICAL RESULTS (PPM)	CONDITION	AMOUNT
No sample collected	No paint	N/A

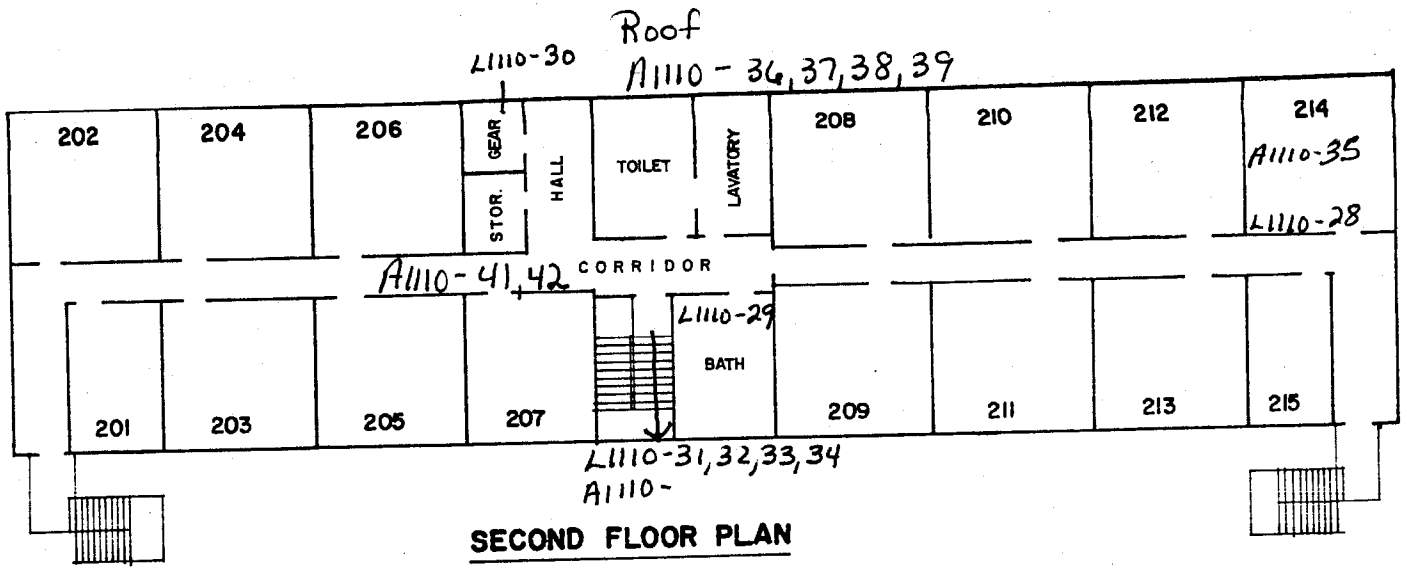
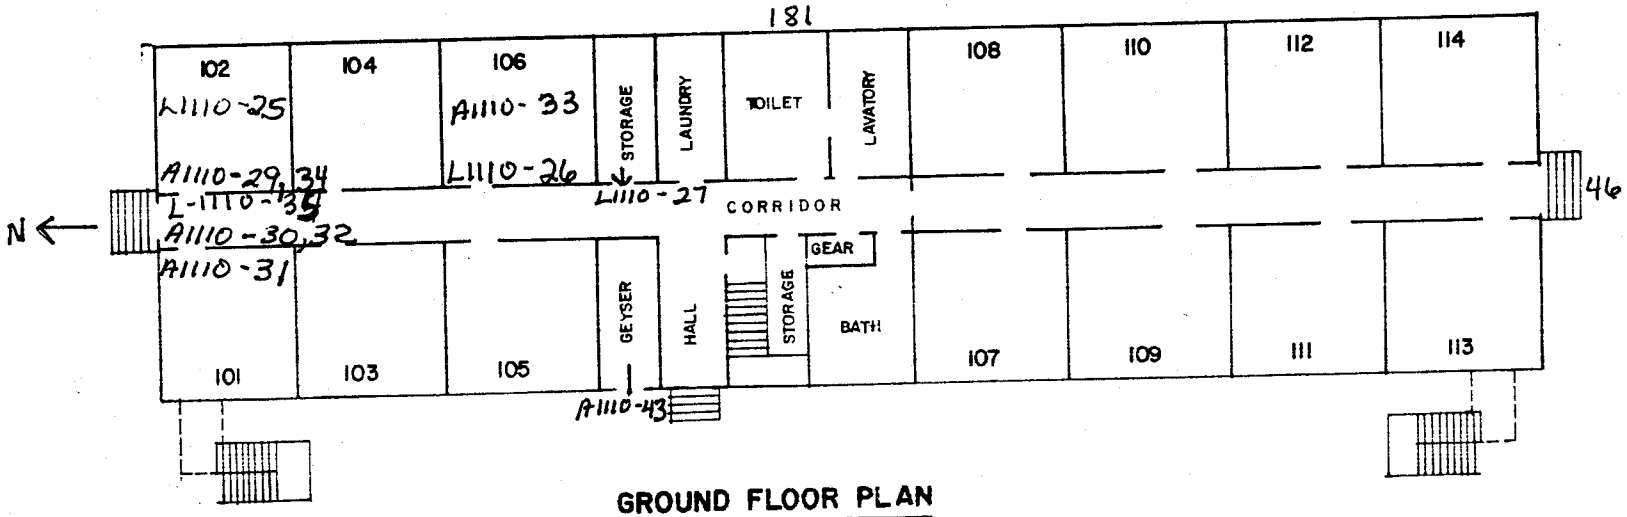
SAMPLE ID NO	SAMPLE LOCATION / DESCRIPTION	ANALYTICAL RESULTS (PPM)	CONDITION	AMOUNT
	INTERIOR:			
L1110-25	Room 102 1st floor White paint on wall	1,238.5	Fair	9,000 sq. ft.
L1110-26	Room 106 1st floor Green paint on wall	835.0	Fair	4,000 sq. ft.
L1110-27	Storage 1st floor Mauve paint on wall	560.4	Fair	2,000 sq. ft.
L1110-28	Room 214 west wall 2nd floor White paint	108.0	Fair	15,000 sq. ft.
L1110-29	Shower room south wall 2nd floor Yellow paint	81.4	Poor	2,000 sq. ft.
L1110-30	Gear room north wall 2nd floor Green paint	14,278.3	Poor	600 sq. ft.
L1110-31	Stairwell 2nd floor Red paint on trim	13,489.6	Poor	150 sq. ft.
L1110-32	Stairwell 2nd floor Pink paint on wall	12,171.7	Poor	1,600 sq. ft.
L1110-33	Stairwell 2nd floor Yellow paint on handrail	4,208.1	Poor	50 sq. ft.
L1110-34	Stairwell 2nd floor Black paint on steps and floor	316.5	Poor	1,000 sq. ft.
L1110-35	Corridor north end 1st floor Beige paint on overhead deck	6,641.4	Fair	19,000 sq. ft.

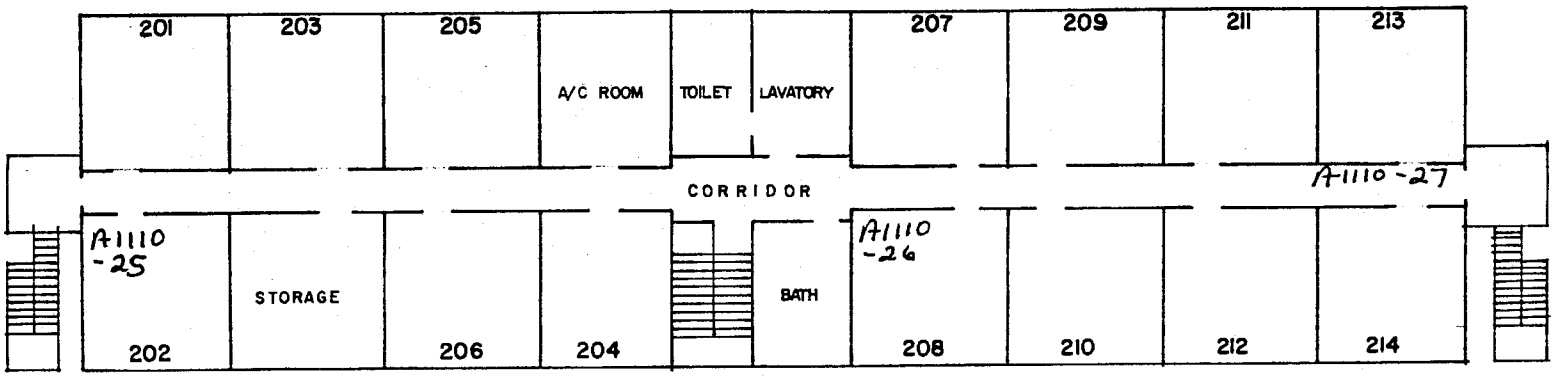
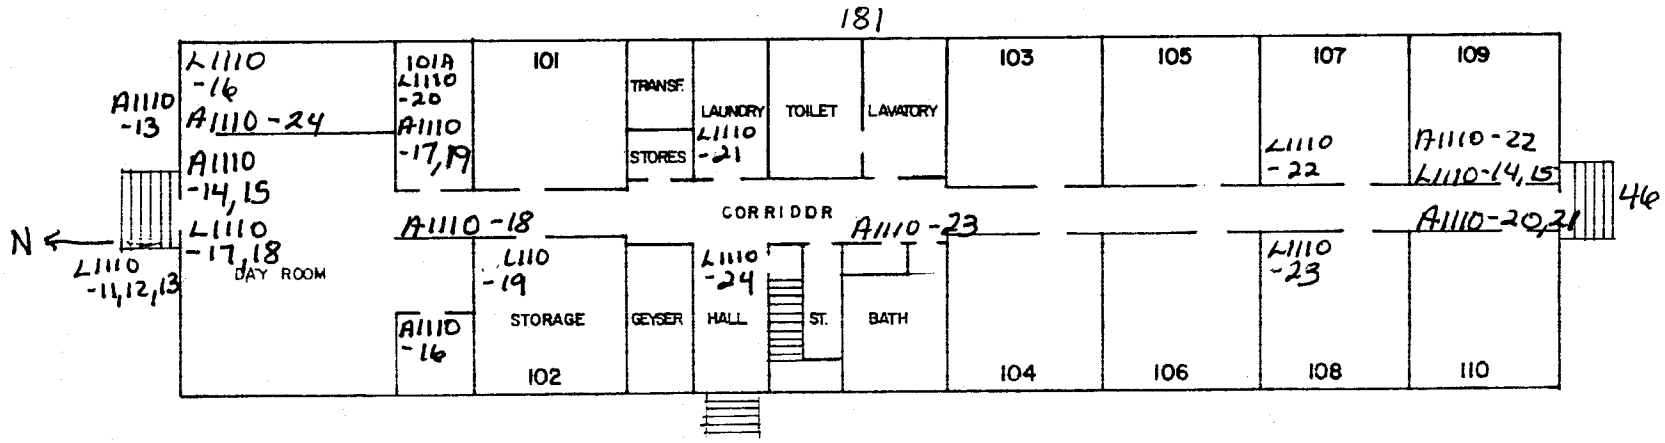
PIQUNIQ MANAGEMENT CORPORATION
NAVAL AIR FACILITY- MIDWAY ISLAND
BARRACKS BLDG. NO. 579

SAMPLE ID NO	SAMPLE LOCATION / DESCRIPTION	ANALYTICAL RESULTS (PPM)	CONDITION	AMOUNT
	EXTERIOR:			
L1110-11	Steps north end 1st floor Red deck paint	17,287.2	Poor	3,500 sq. ft.
L1110-12	North end 1st floor Off-white paint on wall	26,461.0	Good	12,000 sq. ft.
L1110-13	North end 1st floor Brown paint on door	274.2	Good	1,200 sq. ft.
L1110-37	Air handler north side Silver paint on air handler	31,134.0	Fair	250 sq. ft.
	INTERIOR:			
L1110-14	Room 109 south end 1st floor Yellow paint on door frame	28,020.8	Poor	400 sq. ft.
L1110-15	Room 109 south end 1st floor Black paint on door frame	51,630.4	Poor	940 sq. ft.
L1110-16	East of day room north end Peach paint on wall	512.8	Fair	1,500 sq. ft.
L1110-17	Day room north end White paint on wall	210.7	Fair	3,600 sq. ft.
L1110-18	Day room north end Blue paint on door frame	2,275.3	Fair	1,000 sq. ft.
L1110-19	Room 102 north end Beige paint on door frame	14,770.4	Fair	18,600 sq. ft.

SAMPLE ID NO	SAMPLE LOCATION / DESCRIPTION	ANALYTICAL RESULTS (PPM)	CONDITION	AMOUNT
L1110-21	Laundry room northeast end Blue paint on wall	673.4	Fair	600 sq. ft.
L1110-22	Room 107 south end Blue/green paint on wall	438.5	Fair	600 sq. ft.
L1110-23	Room 108 south end Red paint on door frame	20,478.7	Fair	200 sq. ft.
L1110-24	Stairwell 1st floor Black paint	243.5	Fair	400 sq. ft.
No sample collected	1st floor Beige paint on overhead deck Same as sample L1110-35, building 578	6,641.4	Fair	19,000 sq. ft.

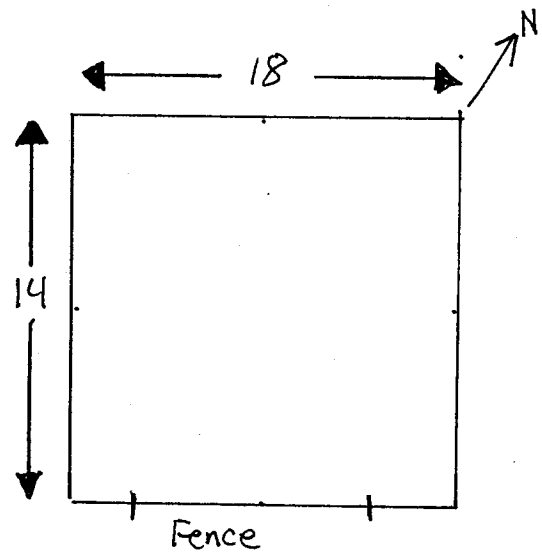
BLDG.# 580 Hazardous Materials Storage Shed

SAMPLE ID NO	SAMPLE LOCATION / DESCRIPTION	ANALYTICAL RESULTS	FRIABLE	CONDITION	AMOUNT
No sample collected	Roof Corrugated transite panel on roof	Transite is known to contain asbestos	No	Good	250 sq. ft.

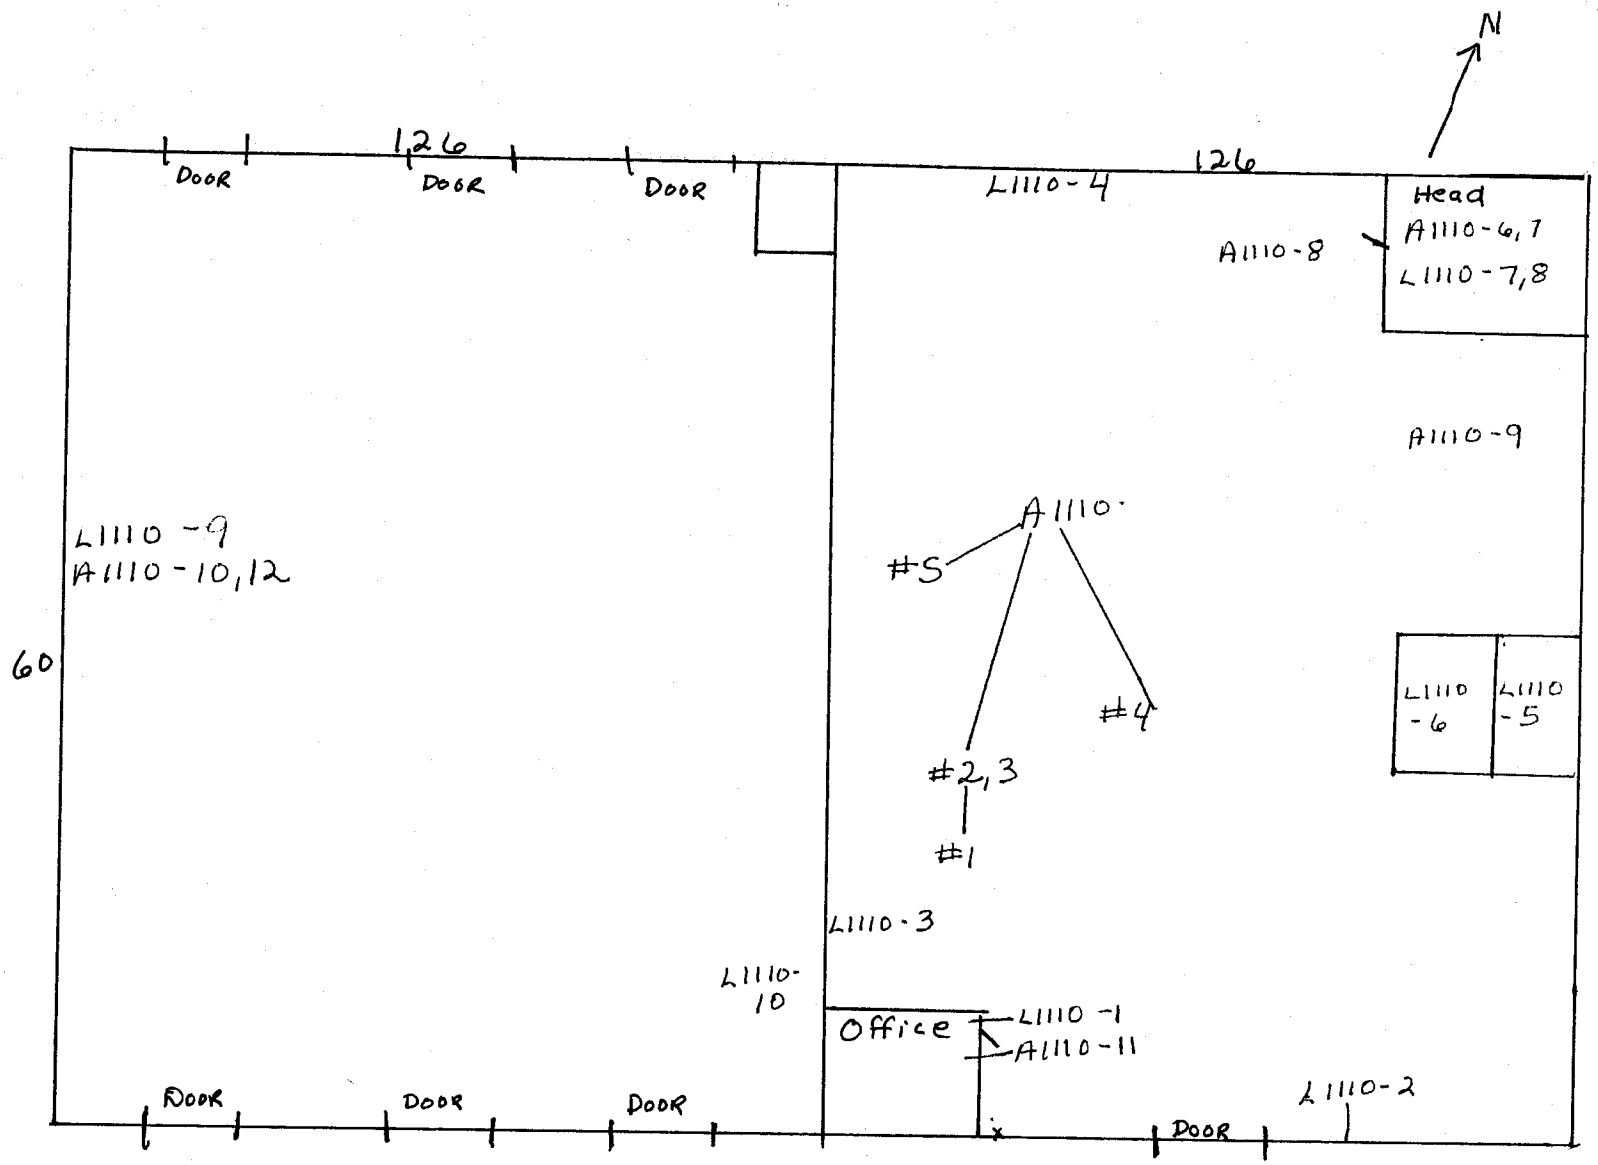
BLDG. #586 Crash Fire Rescue

SAMPLE ID NO	SAMPLE LOCATION / DESCRIPTION	ANALYTICAL RESULTS	FRIABLE	CONDITION	AMOUNT
	INTERIOR:				
A1110-1	Southwest end Green with beige flecks 9" x 9" floor tile	Tile - 10% Chrysotile Mastic - 6% Chrysotile	No	Poor	7,000 sq. ft. mixed with the following Samples: A1110-1, 2, 3, 4, 5, 6, 7 and 8
A1110-2	Southwest end Black 9" x 9" floor tile	Tile - 8% Chrysotile Mastic - None detected	No	Poor	
A1110-3	Southwest end Red 9" x 9" floor tile (over A1110-2)	Tile - 12% Chrysotile Mastic - None detected	No	Poor	
A1110-4	Northwest end Green 9" x 9" floor tile	Tile - 3% Chrysotile Mastic - 2% Chrysotile	No	Poor	See A1110-1
A1110-5	Northwest end Beige with orange 12" x 12" floor tile on top of A1110-4	<1% Chrysotile	No	Poor	See A1110-1
A1110-6	Restroom north end Beige 12" x 12" floor tile	<1% Chrysotile	No	Poor	See A1110-1
A1110-7	Restroom north end Brown 12" x 12" floor tile	Tile - 8% Chrysotile Mastic - None detected	No	Poor	See A1110-1

SAMPLE ID NO	SAMPLE LOCATION / DESCRIPTION	ANALYTICAL RESULTS (PPM)	CONDITION	AMOUNT
	INTERIOR:			
L1110-1	South side Dark blue paint on wall	396.6	Fair	400 sq. ft.
L1110-2	South side Green paint on wall	8,145.2	Poor	8,000 sq. ft.
L1110-3	Southeast side White paint on wall	13,252.7	Poor	1,200 sq. ft.
L1110-4	North side White over green paint on wall	2,070.1	Poor	2,500 sq. ft.
L1110-5	North side Black paint on wall	40,390.6	Poor	2,000 sq. ft.
L1110-6	North side Blue paint on door jamb	218,831.5	Poor	75 sq. ft.
L1110-7	Restroom north side Blue paint on wall	10,184.2	Poor	700 sq. ft.
L1110-8	Restroom north side Beige paint on wall	1,887.4	Poor	500 sq. ft.
L1110-9	West wall Red and white paint	17,842.1	Poor	8,000 sq. ft.
L1110-10	Southwest wall White with blue paint	10,263.1	Poor	2,000 sq. ft.

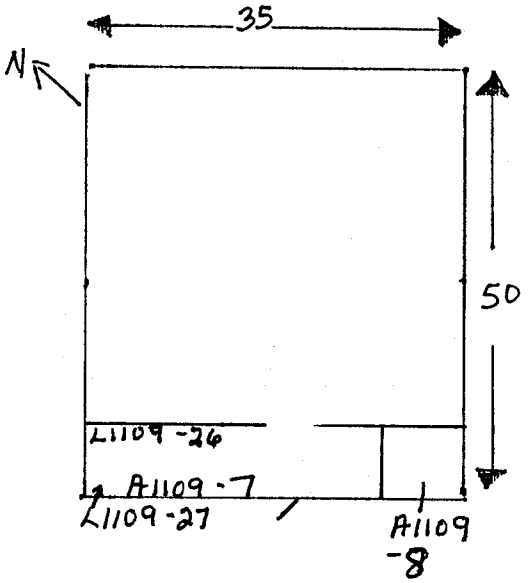
BLDG. # 594 Storage Room

Sample ID No	Sample Location / Description	Analytical Results	Friable	Condition	Amount
A1109-7	Interior northwest side Gray 9" x 9" floor tile	Tile - 6% Chrysotile Mastic - 10% Chrysotile	No	Poor	240 sq. ft.
A1109-8	Interior south side Red 9" x 9" floor tile	Tile - 4% Chrysotile Mastic - 3% Chrysotile	No	Poor	100 sq. ft.

SAMPLE ID NO	SAMPLE LOCATION / DESCRIPTION	ANALYTICAL RESULTS (PPM)	CONDITION	AMOUNT
L1109-26	Interior north wall Green paint	875.3	Poor	800 sq. ft.
L1109-27	Interior west wall White paint on trim	339,898.9	Poor	700 sq. ft.
No sample collected	Exterior Silver paint Same as sample L1109-23, building 596	1,169.4	Fair	2,600 sq. ft.

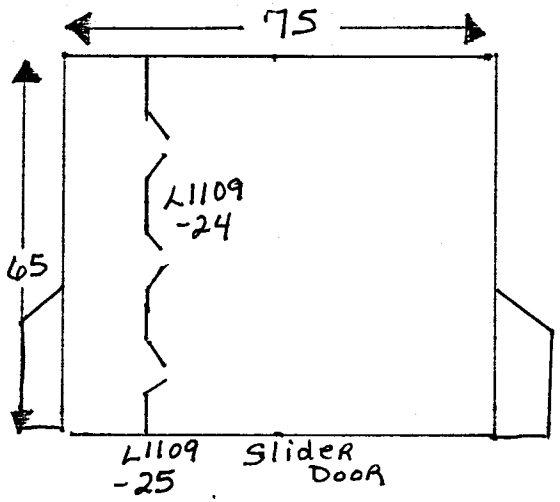
Bld # 595
607th Supply
Squadron
Hanger

SAMPLE ID NO	SAMPLE LOCATION / DESCRIPTION	ANALYTICAL RESULTS (PPM)	CONDITION	AMOUNT
L1109-28	Interior south side Celery green paint on door (entire interior)	5,065.8	Fair	13,000 sq. ft.
L1109-25	Exterior south side Gray paint on door (entire roof and building)	767.2	Poor	13,000 sq. ft.

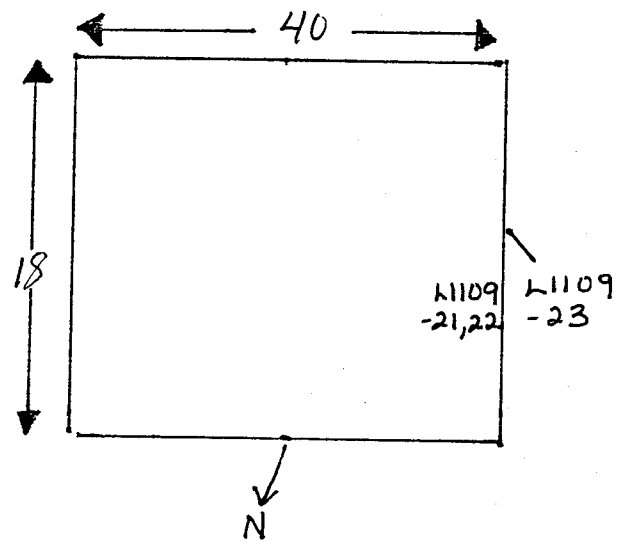
BLDG.# 596 607 Supply Squadron

SAMPLE ID NO	SAMPLE LOCATION / DESCRIPTION	ANALYTICAL RESULTS (PPM)	CONDITION	AMOUNT
L1109-21	Interior west wall Light green paint	522.0	Poor	2,800 sq. ft.
L1109-22	Interior west wall Red paint	2,357.8	Poor	25 sq. ft.
L1109-23	Exterior west wall Silver paint	1,169.4	Poor	2,800 sq. ft.
