Oxon Run, Washington, D.C. Watershed and Stream Assessment

CBFO-S03-03

September 2003

Stream Habitat Assessment and Restoration Program
U.S. Fish and Wildlife Service
Chesapeake Bay Field Office

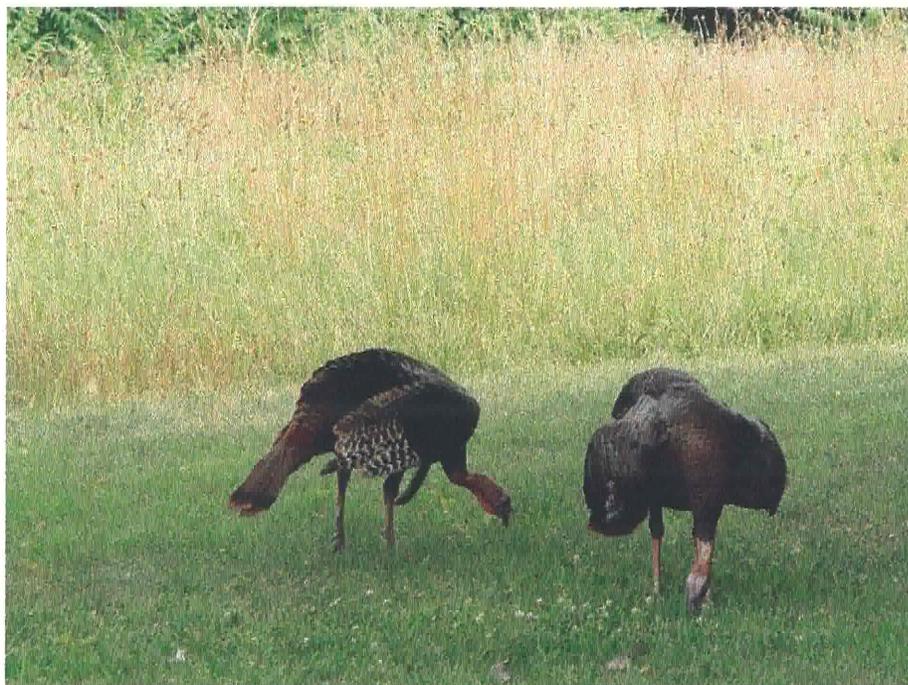
Photo 23. Riparian zones serve as an important habitat in developed areas. A flock of wild turkey live in the Upper Reach of Oxon Run.

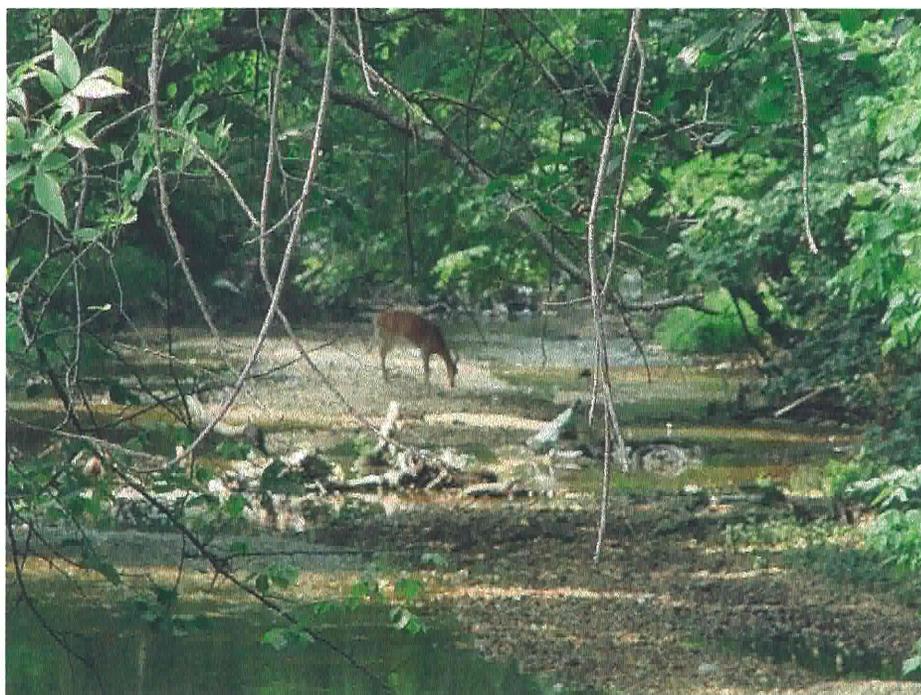
Photo 24. Whitetail deer roam through the Lower Reach, which is contiguous with some larger National Park Service properties.

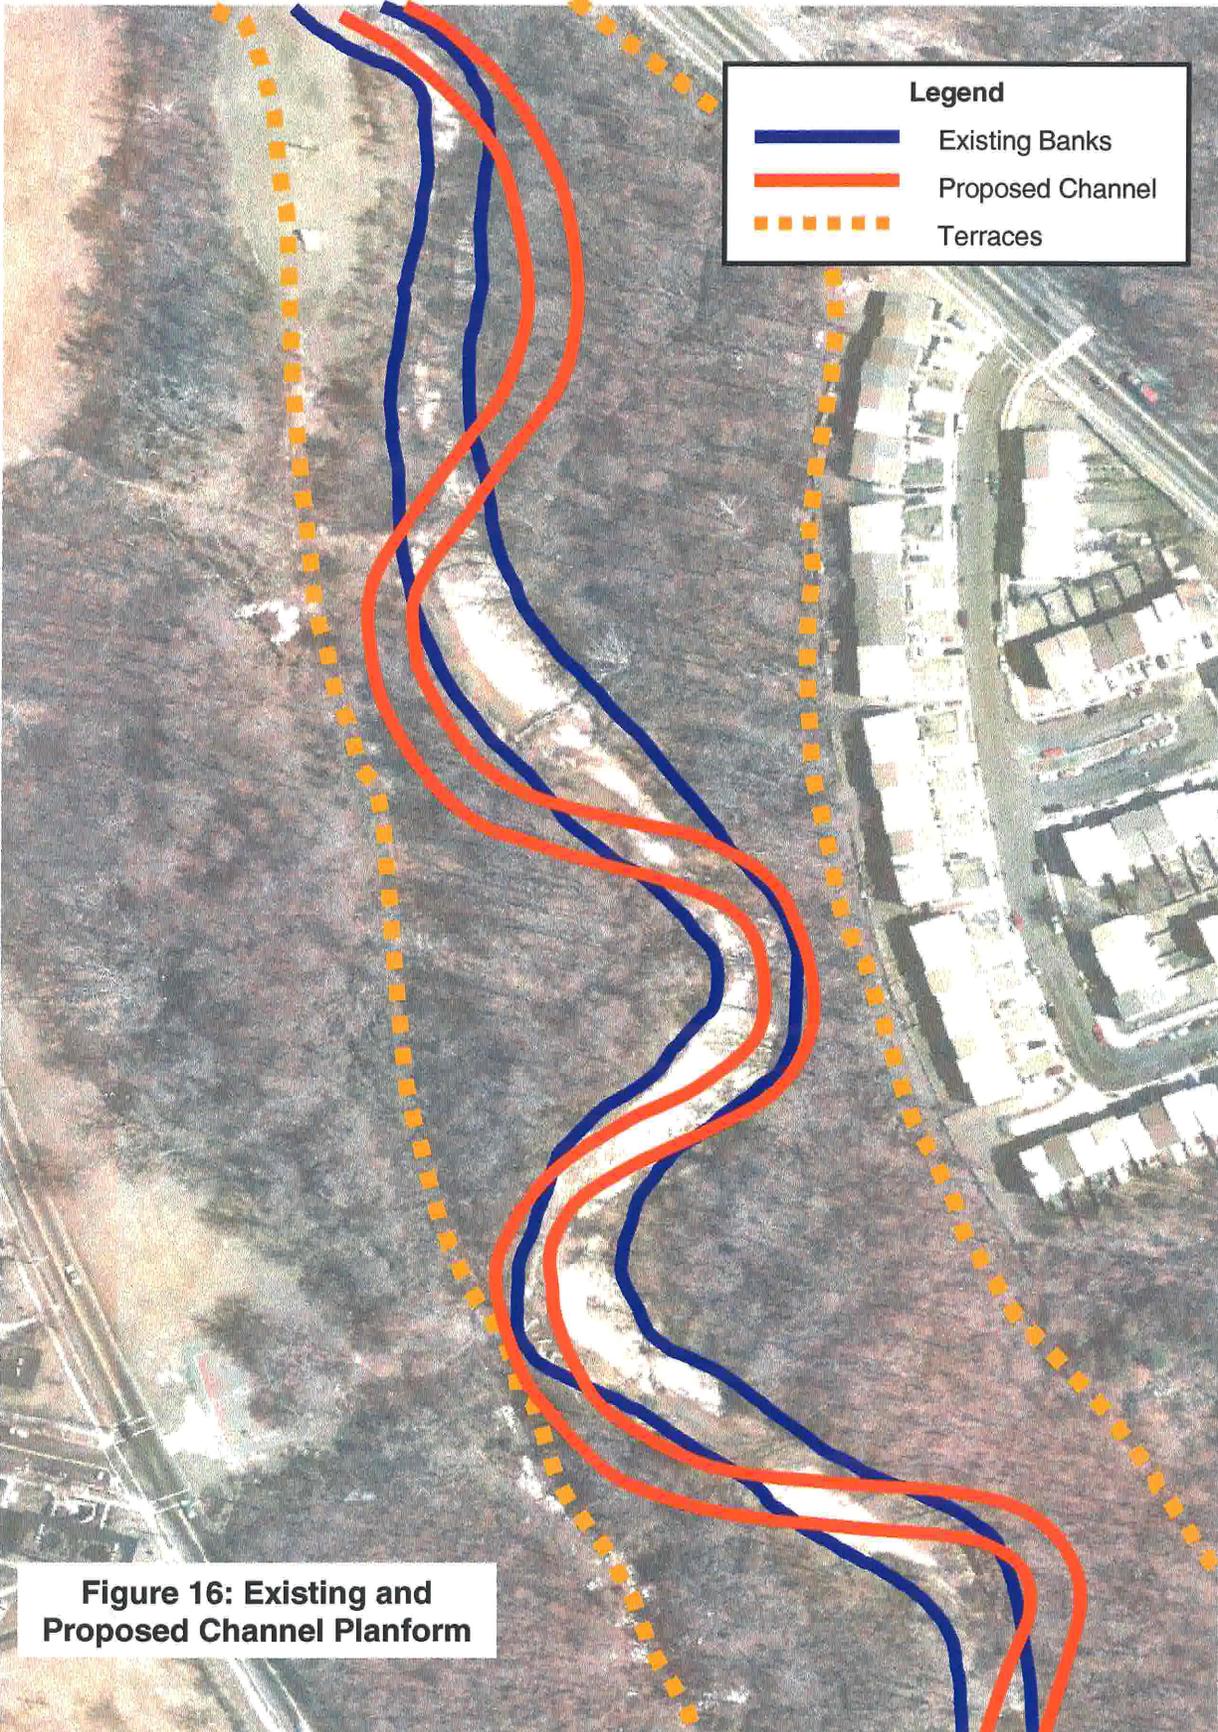
Figure 16: Existing and Proposed Channel Platform

Figure 16 provides an illustration of changes in planform associated with stream restoration. The Service will develop detailed plans, tailored to the constraints and opportunities in each reach, during the design phase. The proposed planform increases channel sinuosity and channel length by increasing the curvature of channel meanders. The initial planform layouts must be

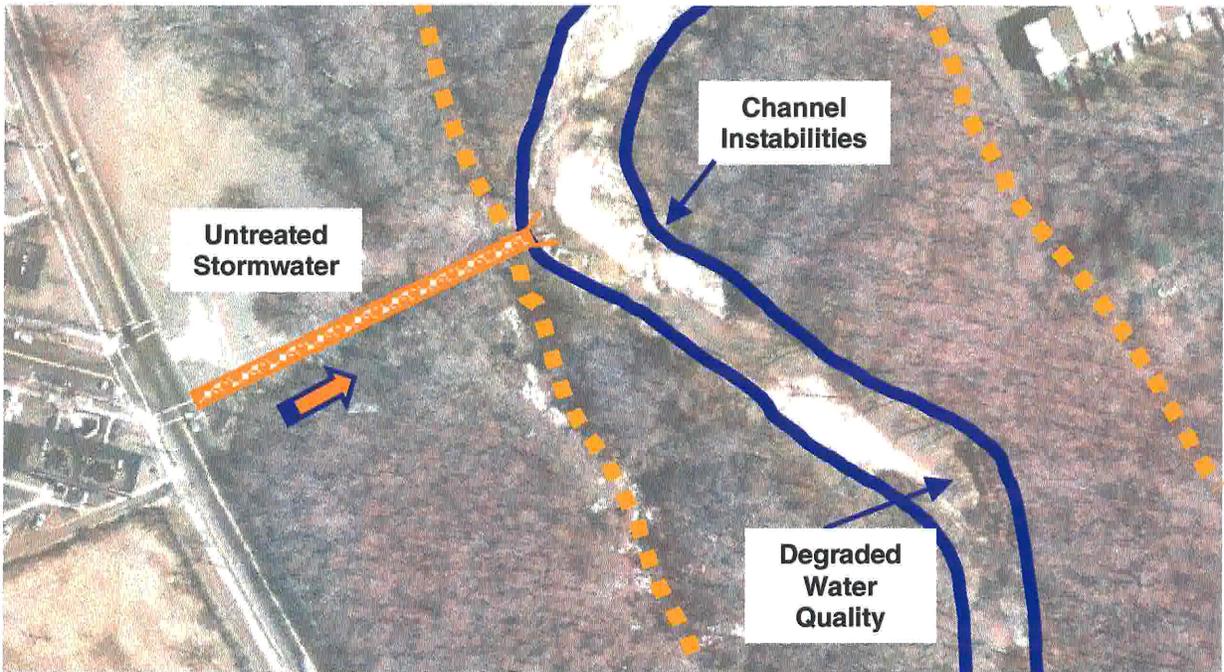
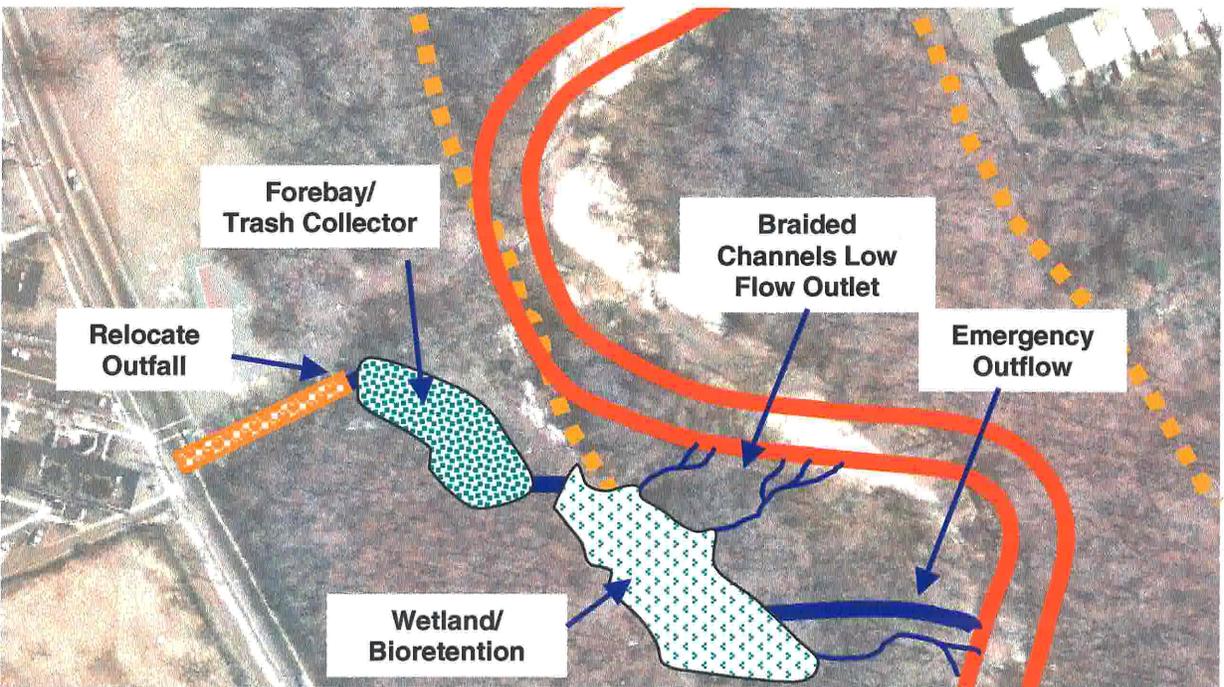
Figure 18: Concept for Stormwater Retrofit

The goal of stormwater management retrofit is to improve the quality of water discharged to Oxon Run, reduce flashiness of stormwater discharges, and provide groundwater recharge to the maximum extent possible. Site-specific designs are required. Details of the design depend on the vertical and horizontal alignment of storm sewers with respect to the width and elevation of riparian corridor adjacent to the stream. Figure 18 illustrates a conceptual layout of a retrofit for one stormwater outfall. Under existing conditions, the outfall, located on the outside of a meander bend, creates significant bank instabilities due to the orientation of the outfall jet with respect to the stream. Under proposed conditions, the outfall would be relocated from the stream to create overland flow between the outfall and the stream. Flow from the pipe would pass through a stormwater management forebay designed to capture litter and trash. If possible, infiltration would be provided as well. Overflow from the forebay would pass through an over bank wetland or bio retention area. Again, the intention is to provide water quality treatment, opportunities for infiltration, and a small amount of peak storage. Discharge from the wetland would be through a series of small braided channels. The intention of the small channels is to spread the flow across the reach to minimize impacts to flow hydraulics on the stream. An emergency channel provides flow relief for large discharges and protects the smaller outfall channels.
