**PINE HILL RUN, ST. MARY'S COUNTY, MARYLAND  
WATERSHED AND STREAM ASSESSMENT PATUXENT RIVER NAVAL  
AIR STATION**

Stream Habitat Assessment and Restoration Program  
U.S. Fish and Wildlife Service  
Chesapeake Bay Field Office

CBFO-S04-05

Annapolis, MD  
October 2005

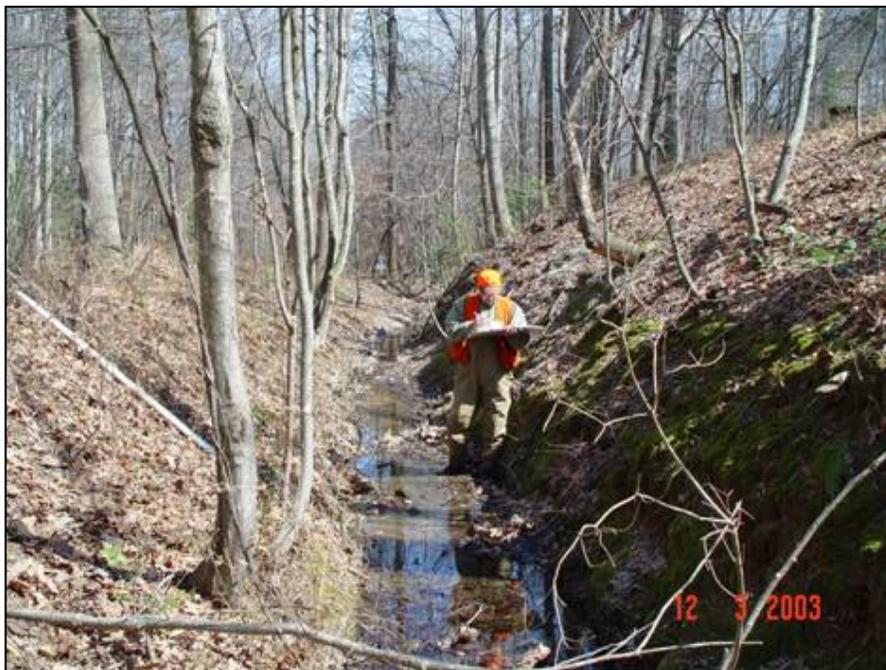
Rosgen A type streams represent approximately 0.8 percent of the total stream length within the watershed (Photograph 1). These are steep, entrenched and confined streams that are highly sensitive to disturbance and have a poor recovery potential. A stream that is entrenched has a small floodplain width (*i.e.*, a steep stream with a narrow valley) and a stream that is slightly entrenched has a large floodplain width. These stream types are found in the headwaters areas of this watershed.

Photograph 1. Example of Rosgen A type stream.

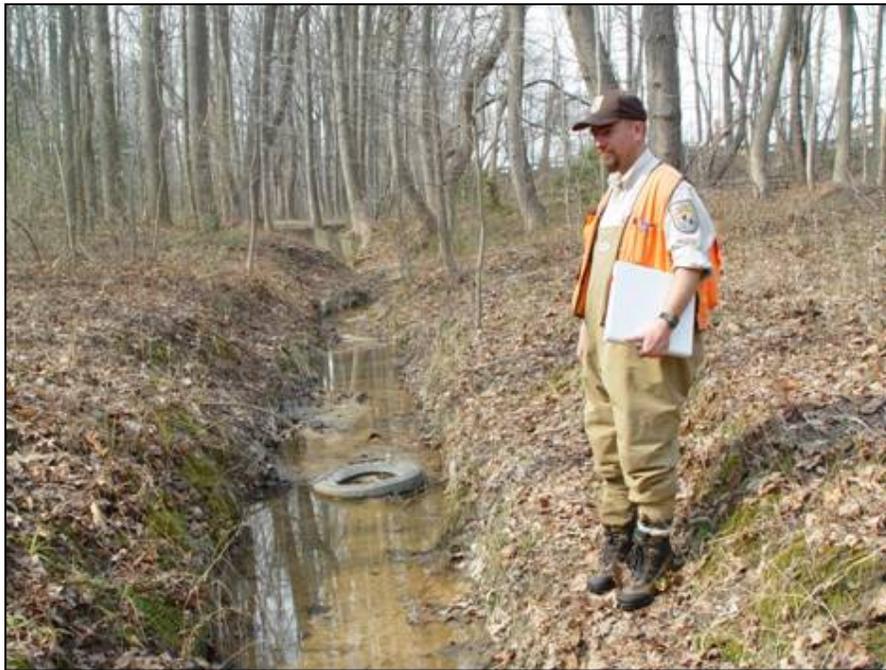
Rosgen B type streams represent approximately 13.3 percent of the total stream length within the watershed (Photograph 2). They are moderately entrenched, low sinuosity streams with a slope of two to four percent that are moderately sensitive to change and have an excellent recovery potential. Sinuosity is defined as the ratio of the stream length to valley length. A stream with high sinuosity has many meandering bends and a stream with low sinuosity is nearly straight. These stream types are also generally found in the tributary and headwater areas of this watershed.

Photograph 2. Example of Rosgen B type stream.

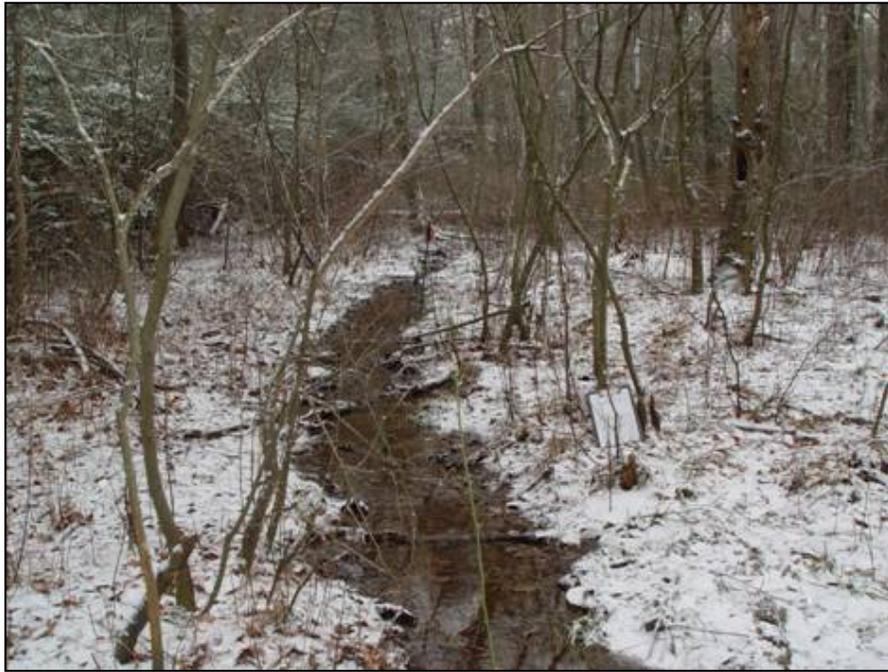
Rosgen C type streams represent approximately 6.1 percent of the total stream length within the watershed (Photograph 3). They are slightly entrenched, low gradient, meandering riffle/pool channels with a well developed floodplain that are highly sensitive to disturbance but they have a good recovery potential. These stream types are generally found where there are low valley slopes and relatively large floodplain areas.

Photograph 3. Example of Rosgen C type stream.

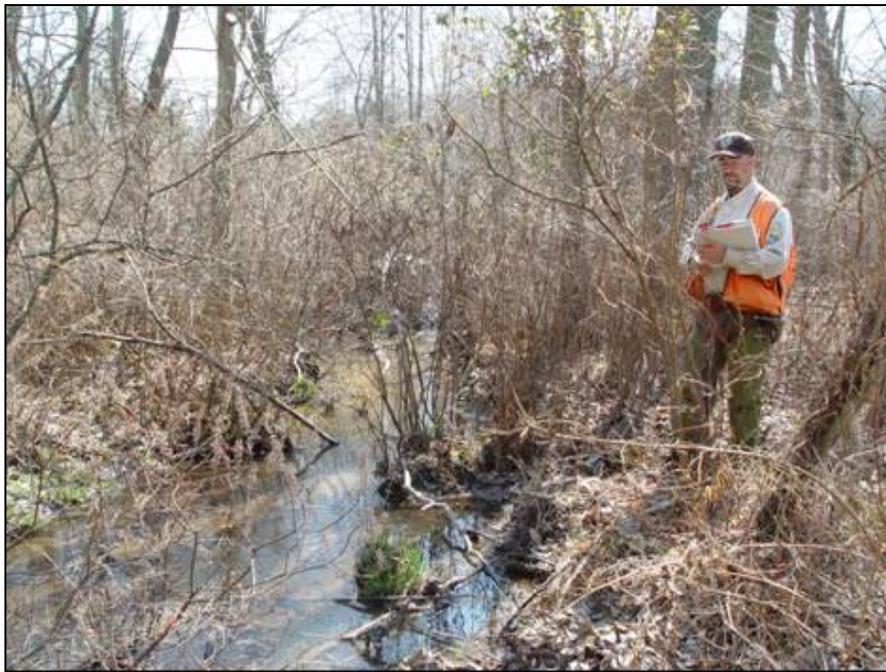
Rosgen DA type streams represent approximately 11.0 percent of the total stream length within the watershed (Photograph 5). They are stable braided (multiple channels), low width/depth ratio channels found in well-developed floodplains that are moderately sensitive to disturbance and have a good recovery potential.

Photograph 5. Example of Rosgen DA type stream. The photo only shows one channel of the DA, but many channels exist across the floodplain.

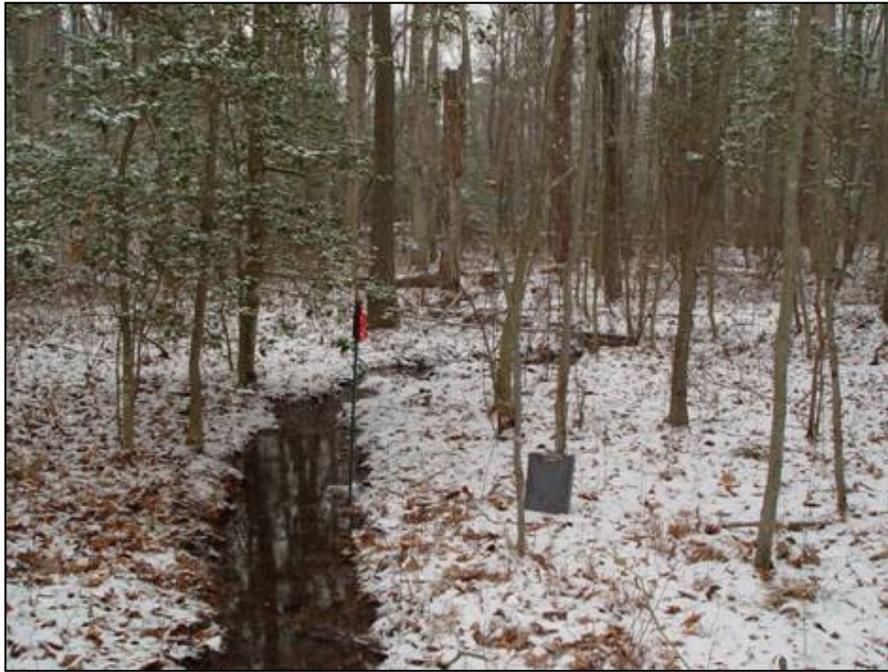
Rosgen E type streams represent approximately 18.2 percent of the total stream length within the watershed (Photograph 6). They are slightly entrenched, low gradient, and meandering channels with low width/depth ratios and well developed floodplains that are highly sensitive to disturbance but have good recovery potential. Width/depth ratio is defined as the ratio of the bankfull surface width to the mean depth of the bankfull channel. Streams with high width/depth ratios are wide and shallow and streams with low width/depth ratios are narrow and deep. These E type reaches are also generally found where there are low valley slopes and relatively large floodplain areas.

Photograph 6. Example of Rosgen E type stream.
