# Watts Branch, Washington, D.C.

## Natural Resources Conservation Service Stream Stabilization Monitoring Report

CBFO-S05-04

*October 2005*

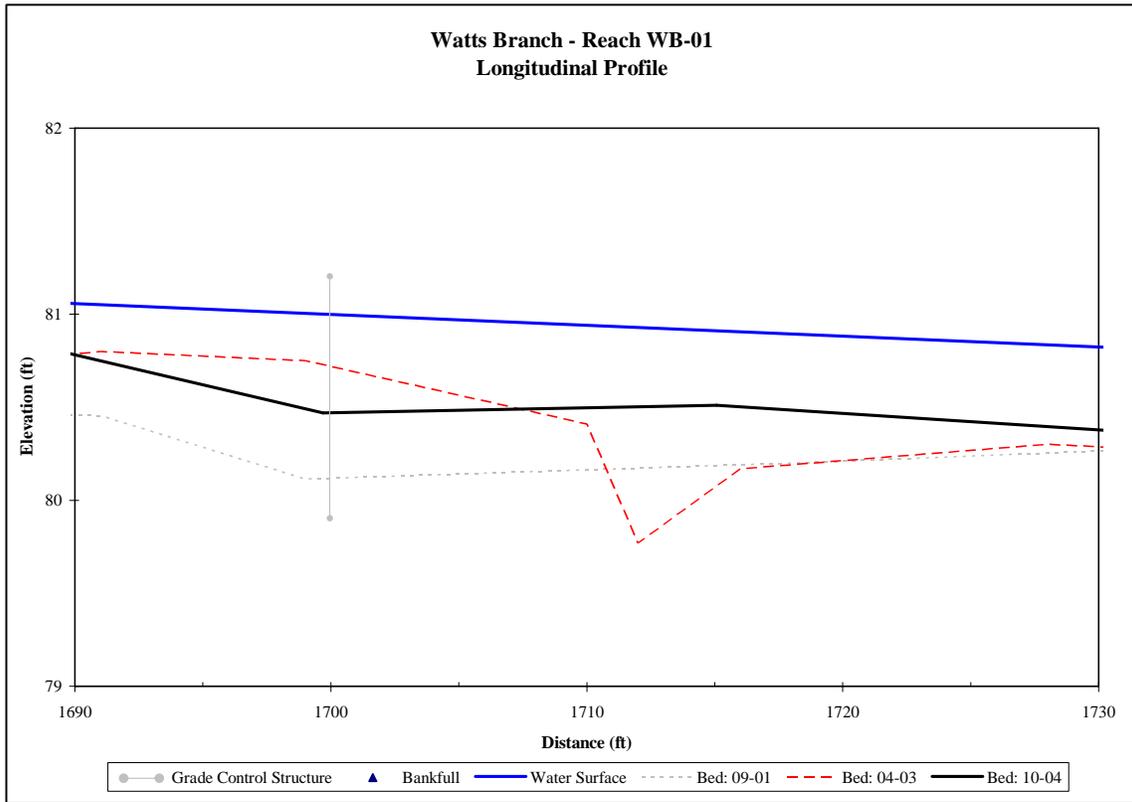
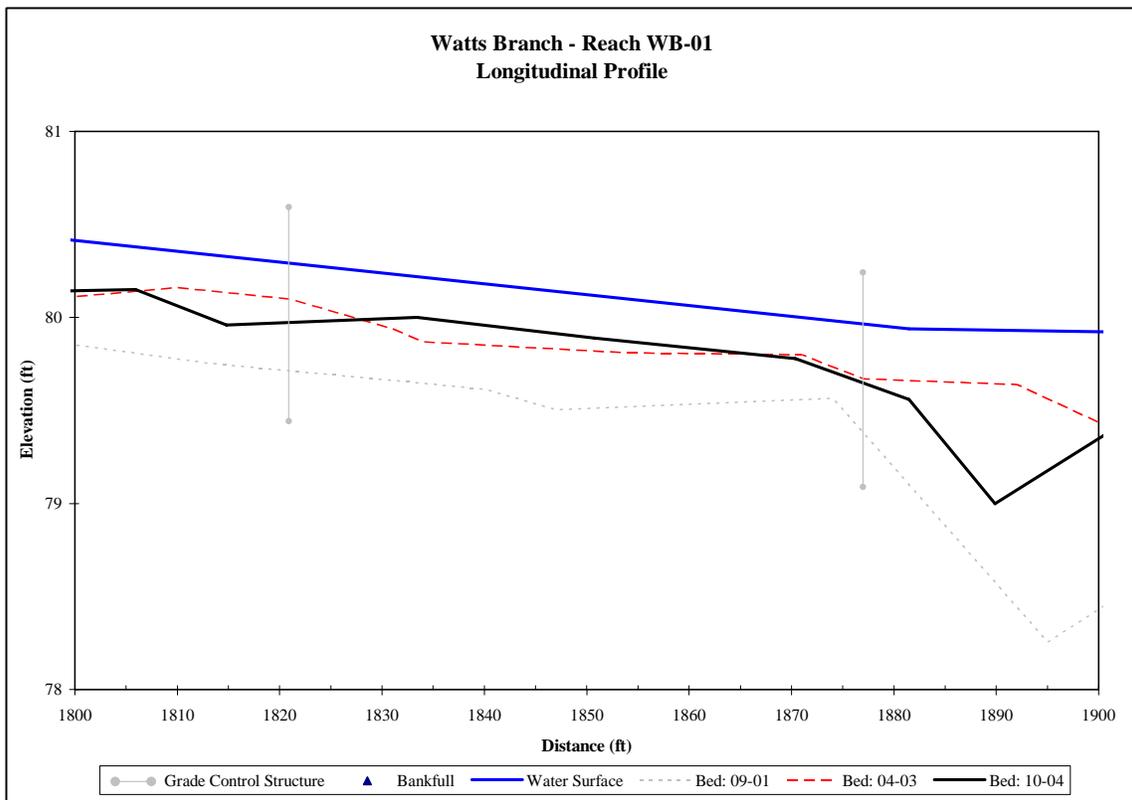
**Figure 4d. Longitudinal Profile Enlargement Plots**

In general, vertical adjustments at grade control structures reflected the overall adjustments observed in the upper, middle, and lower sections of the study reaches. For the 2001 and 2003 longitudinal profile overlay, the Service observed scour near the grade control structures, in the upper and middle sections, ranging from 0.09 feet to 1.62 feet. The Service also observed minor areas of aggradation in these sections. The Service observed significant aggradation at the grade control structures in the lower section, ranging from 0.10 feet to 1.38 feet.

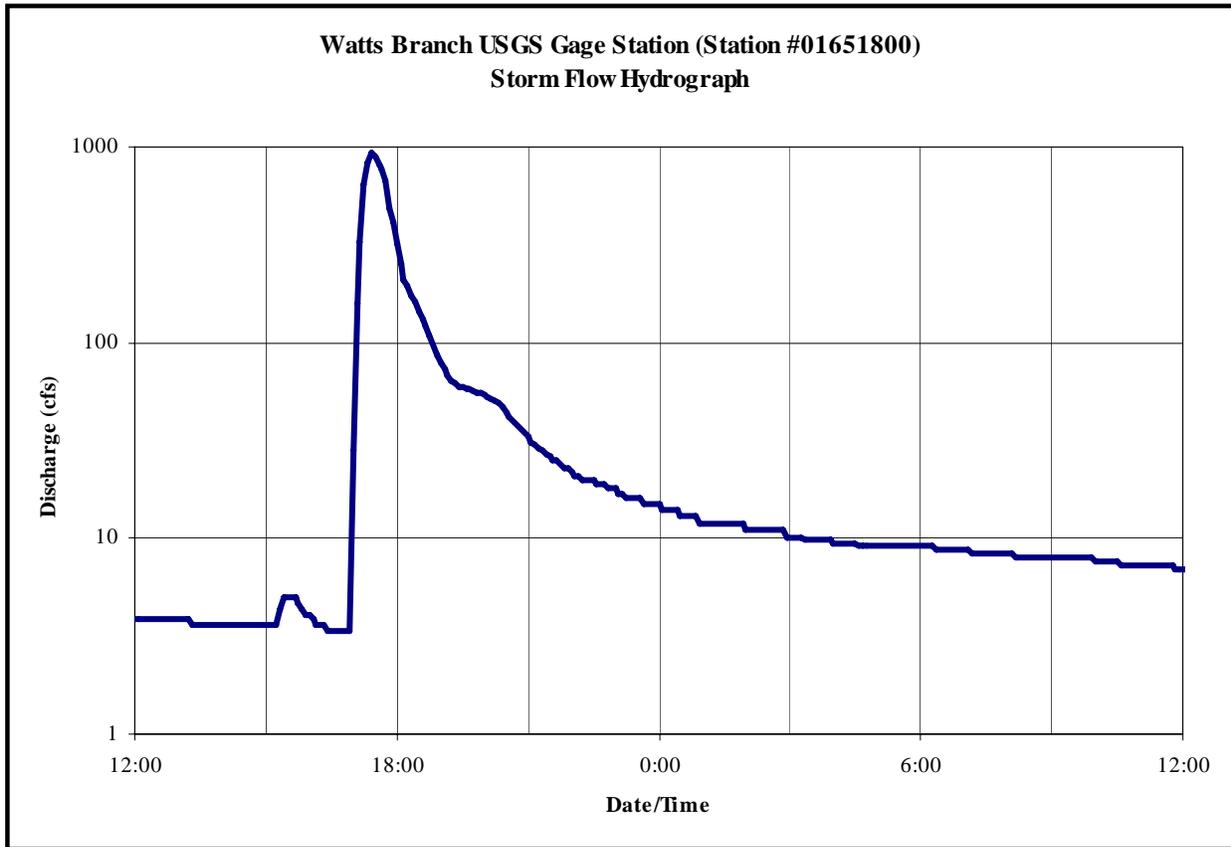
**Figure 5. Typical Hydrograph for Watts Branch**

In addition, pools in Watts Branch may be prone to accumulating sediment, because of the flashiness of the hydrograph. The slope of the rising limb of the Watts Branch hydrograph is steep and the duration of the peak is short, and the recession limb is extended with a shallow slope (Figure 5). The peak of the hydrograph typically performs most of the sediment transport and maintenance of the channel dimensions. However, the recession limb of the Watts Branch hydrograph appears to perform more sediment transport, because of the short duration of the peak and the increased duration of the recession limb. Pools may fill in under these conditions, because the duration of the peak is insufficient to maintain pool depths. In addition, the lower sediment transport capacity during the recession limb may result in sediment accumulating in pools.

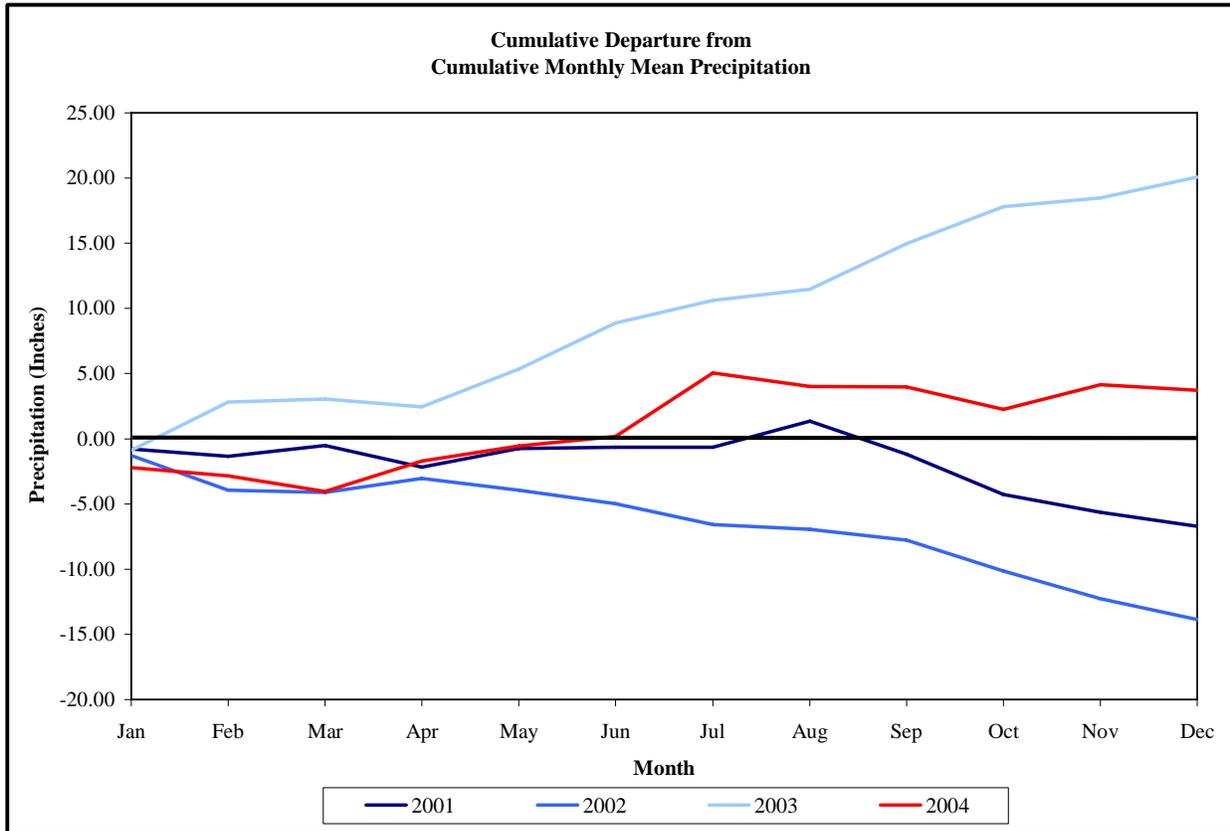
**Figure 6. Monthly Precipitation Departure from Baltimore – Washington International Airport**

A potential reason for the increased streambed adjustments, in the upper and middle sections, is the higher than average discharges for 2003. The 2003 mean annual discharge was 7.65 cfs, which is well above the mean annual discharge for the period of record (*i.e.*, 4.57 cfs). In addition, the 2003 peak discharge (*i.e.*, 1000 cfs) was close to the mean peak discharge for the period of record. The increase in discharge was supported by the higher than average precipitation for the previous year (Figure 6). The Service acquired total monthly precipitation data from the National Oceanic and Atmospheric Administration weather station at the Baltimore – Washington International Airport. The total annual precipitation for 2003 was 61.96 inches, which is 1.48 times higher than the average precipitation for this area (*i.e.*, 41.86 inches). The increase in mean annual discharge may explain some of the vertical adjustments, because the higher and more frequent flows increase sediment transport competency, which can result in changes in the stream channel.
