Daniels Run Stream Restoration Fairfax, Virginia

Survey and Alternative Analysis Report

CBFO-S06-04
July 2006

By: Richard R. Starr and Christopher K. Eng

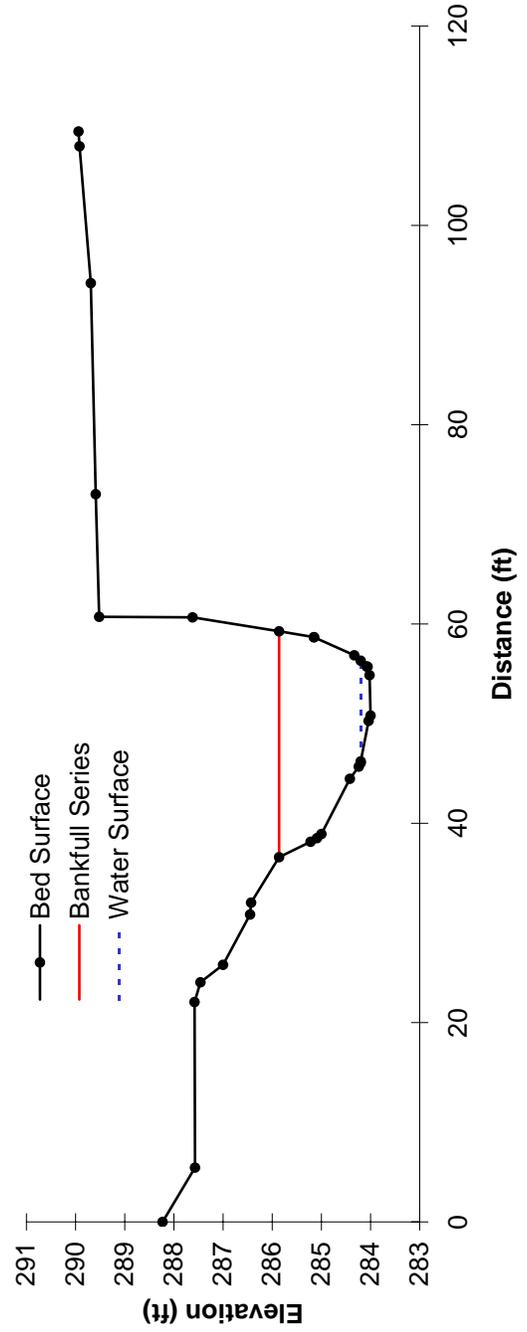
DANIELS RUN DOWNSTREAM REACH

STREAM: Daniels Run
REACH & XS: XS 4 (Downstream Reach)
DATE: 05/28/06
CREW: RRS, CE, KF
DATA: KF
QA/QC: CE

Width (ft)	Cross-Sectional Area (Sq.ft)	Mean Depth (ft)	Maximum Depth (ft)	Wetted Perimeter (ft)	Hydraulic Radius (ft)	Identifier	Distance (ft)	Elevation (ft)

22.67	31.44	1.39	1.86	23.43	1.34			
10.10	1.36	0.14	0.20	10.13	0.13			
Bankfull								
Water Surface								
Identifier	Distance (ft)	Elevation (ft)	Identifier	Distance (ft)	Elevation (ft)	Identifier	Distance (ft)	Elevation (ft)
GS	0.0	288.23	CS	50.3	284.04	GS	109.4	289.94
GS	5.5	287.57	CS	50.8	284.00			
GS	22.1	287.58	CS	54.9	284.02			
SLP BRK	24.1	287.46	CS	55.7	284.06			
SLP BRK	25.8	287.00	CS	55.7	284.08			
SLP BRK	30.9	286.45	REW	56.3	284.20			
SLP BRK	32.0	286.43	CS	56.9	284.33			
LBF	36.6	285.86	SLP BRK	58.7	285.15			
SLP BRK	38.2	285.22	SLP BRK	58.7	285.15			
CS	38.5	285.09	RBF	59.3	285.86			
CS	38.9	285.00	SLP BRK	60.7	287.62			
CS	44.5	284.42	GS	60.7	289.52			
CS	45.7	284.24	GS	73.0	289.59			
CS	46.1	284.20	GS	94.2	289.69			
LEW	46.2	284.20	GS	107.9	289.92

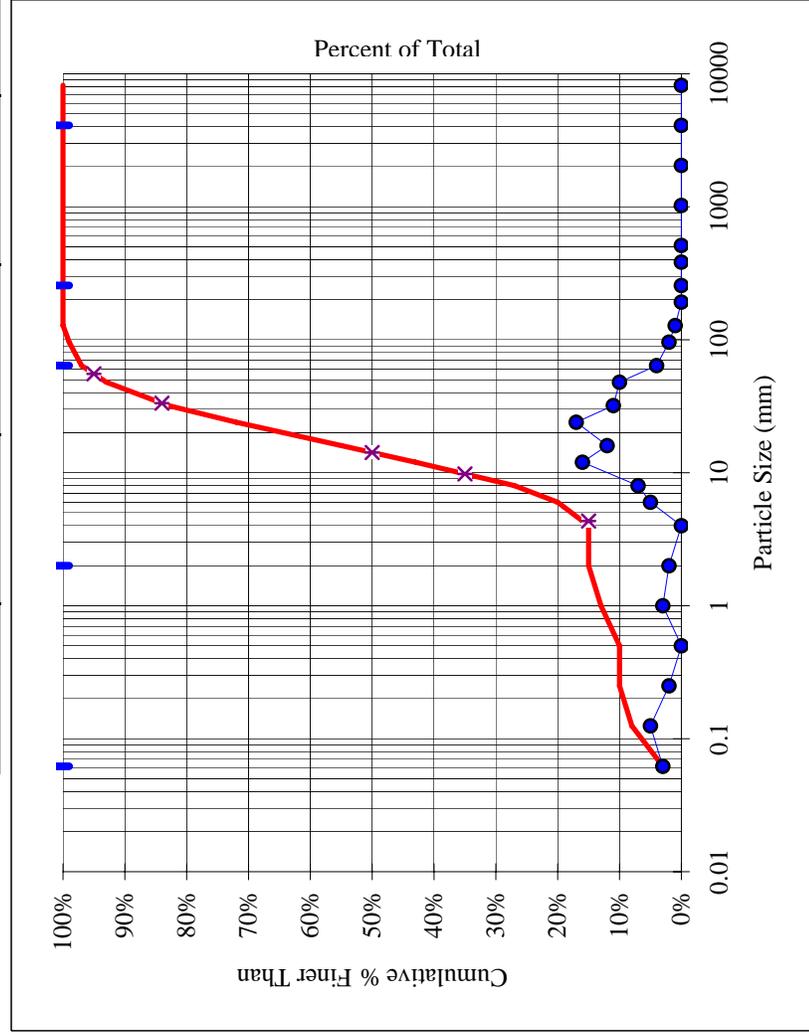
DANIELS RUN - REACH AVERAGE PEBBLE COUNT

STREAM NAME: Daniels Run
USGS ID #:
FWS ID #:
DATE: 4/6/2006
CREW: CE, KF

Particle Size Distribution (mm)	D16	D35	D50	D84	D95
	4.34	9.80	14.19	33.32	55.43

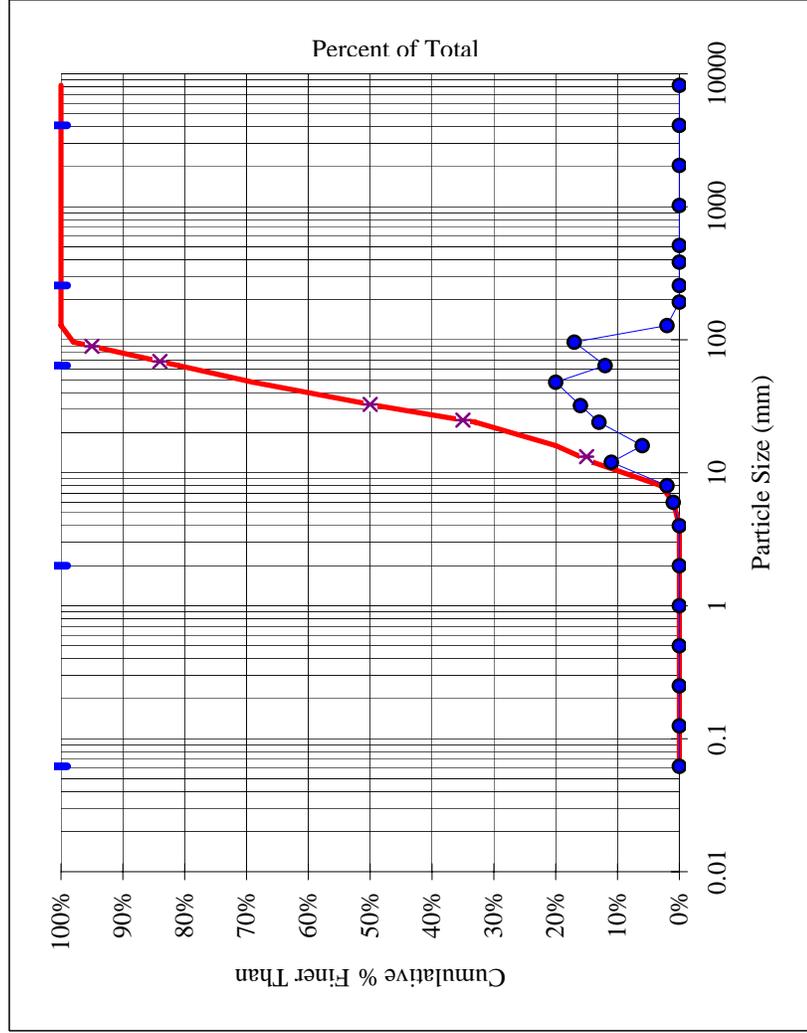
DANIELS RUN - UPSTREAM RIFFLE PEBBLE COUNT

STREAM NAME: Daniels Run
USGS ID #:
FWS ID #:
DATE: 4/6/2006
CREW: CE, KF

Particle Size Distribution (mm)	D16	D35	D50	D84	D95
	13.21	24.88	32.66	68.75	89.37

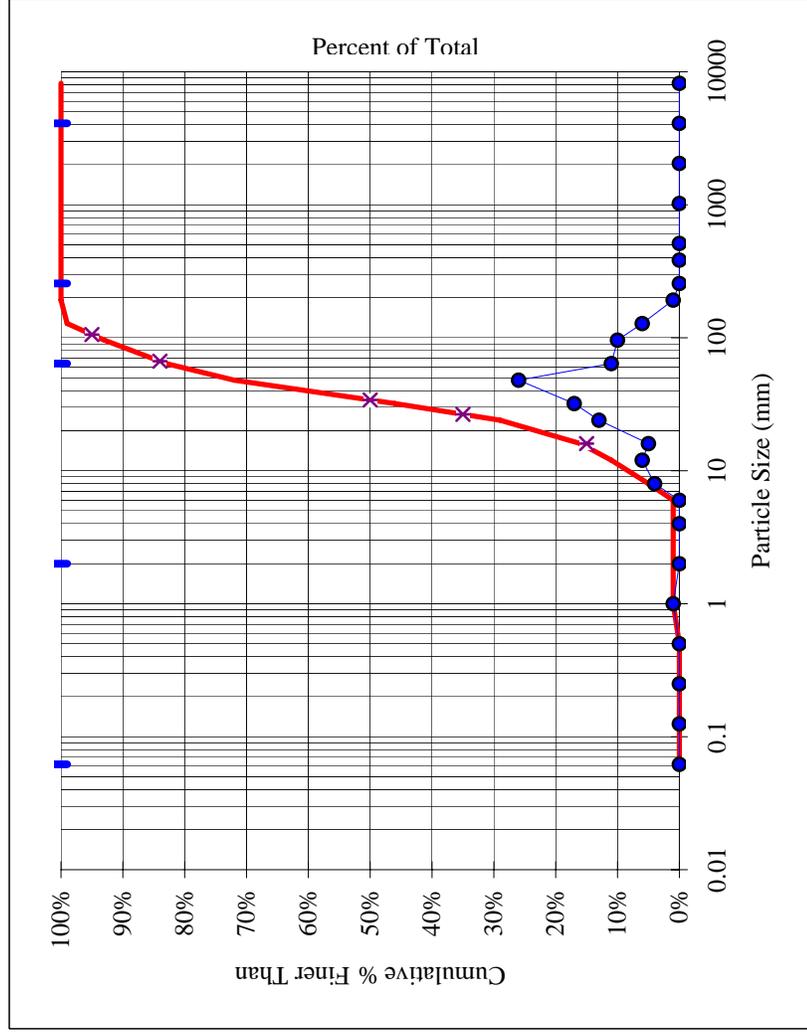
DANIELS RUN - DOWNSTREAM RIFFLE PEBBLE COUNT

STREAM NAME: Daniels Run
USGS ID #:
FWS ID #:
DATE: 4/6/2006
CREW: CE, KF

Particle Size Distribution (mm)	D16	D35	D50	D84	D95
	16.00	26.56	34.06	66.65	105.66

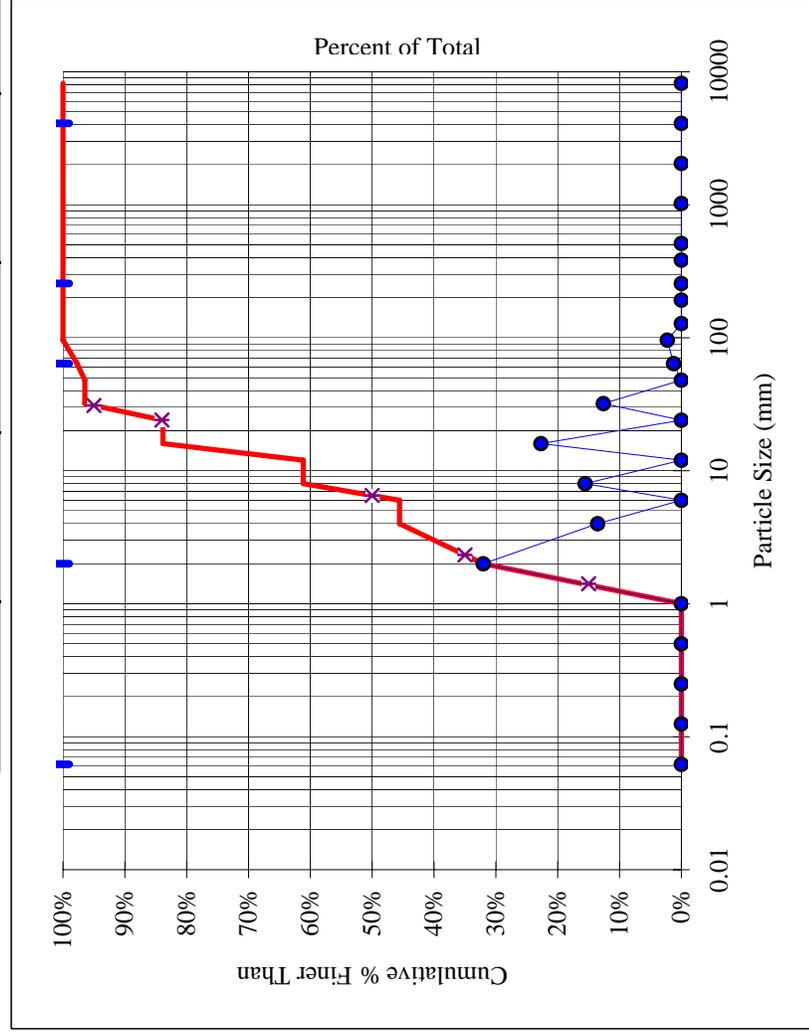
DANIELS RUN - UPSTREAM BAR SAMPLE

STREAM NAME: Daniels Run
USGS ID #:
FWS ID #:
DATE: 4/6/2006
CREW: CE, KF

Particle Size Distribution (mm)	D16	D35	D50	D84	D95
	1.41	2.33	6.51	24.08	30.95

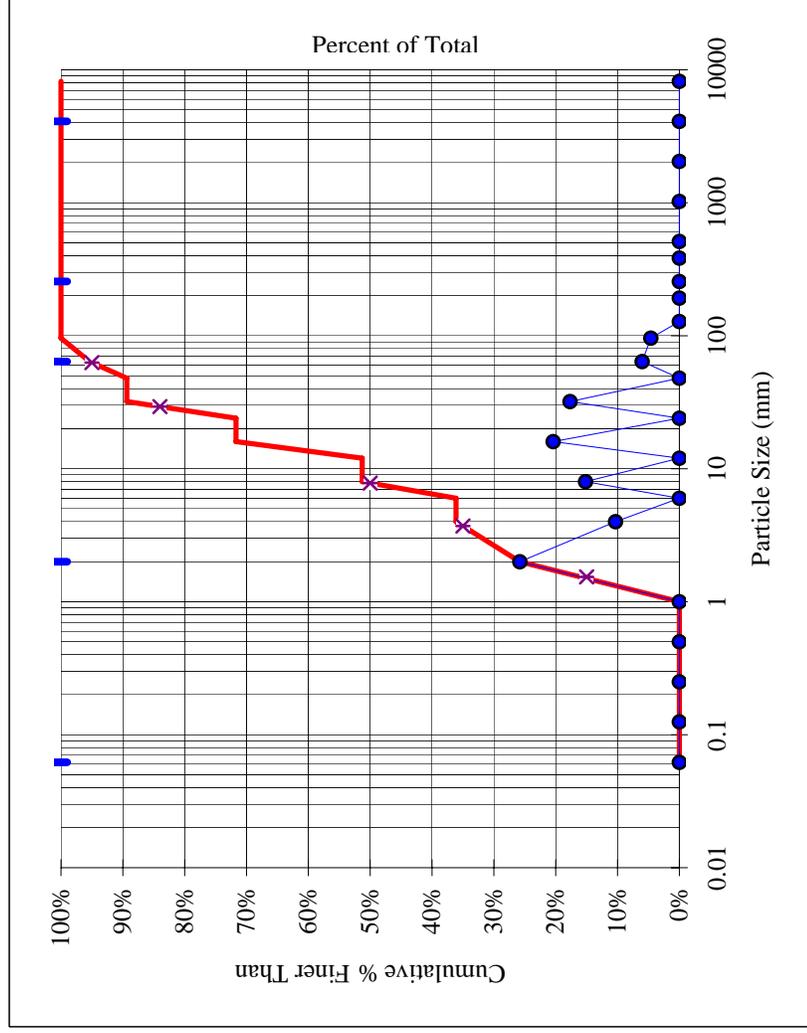
DANIELS RUN - DOWNSTREAM BAR SAMPLE

STREAM NAME: Daniels Run
USGS ID #:
FWS ID #:
DATE: 4/6/2006
CREW: CE, KF

Particle Size Distribution (mm)	D16	D35	D50	D84	D95
	1.54	3.71	7.81	29.32	62.83
