East Branch Ausable River -- Restoration with Onsite Materials Keene Valley, NY -- Tropical Storm Irene Flood Devastated Area

East Branch Ausable River 2012 Restoration: TU & USFWS (Partners and Fisheries Programs)

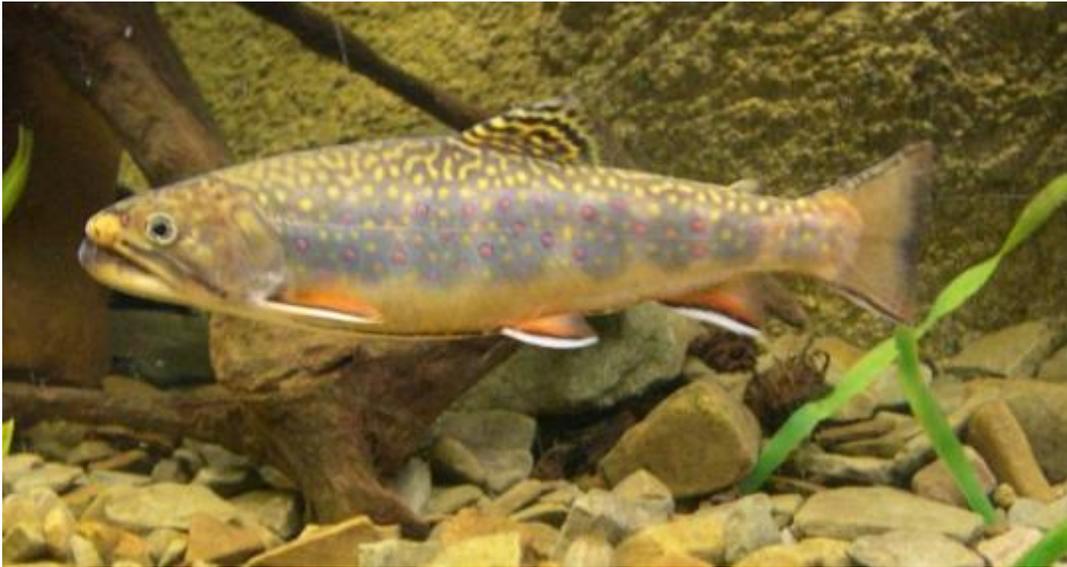
The long absent eastern brook trout returned to the Toe Wood 4 days into construction. Representative picture – not taken at site.
