Pacific Lamprey Passage Evaluations at Hatchery Facilities in Southwest Washington State

Summary Graphic Report: 2022

Joe Skalicky, US Fish and Wildlife Service, Columbia River Fish and Wildlife Conservation Office, January 2022

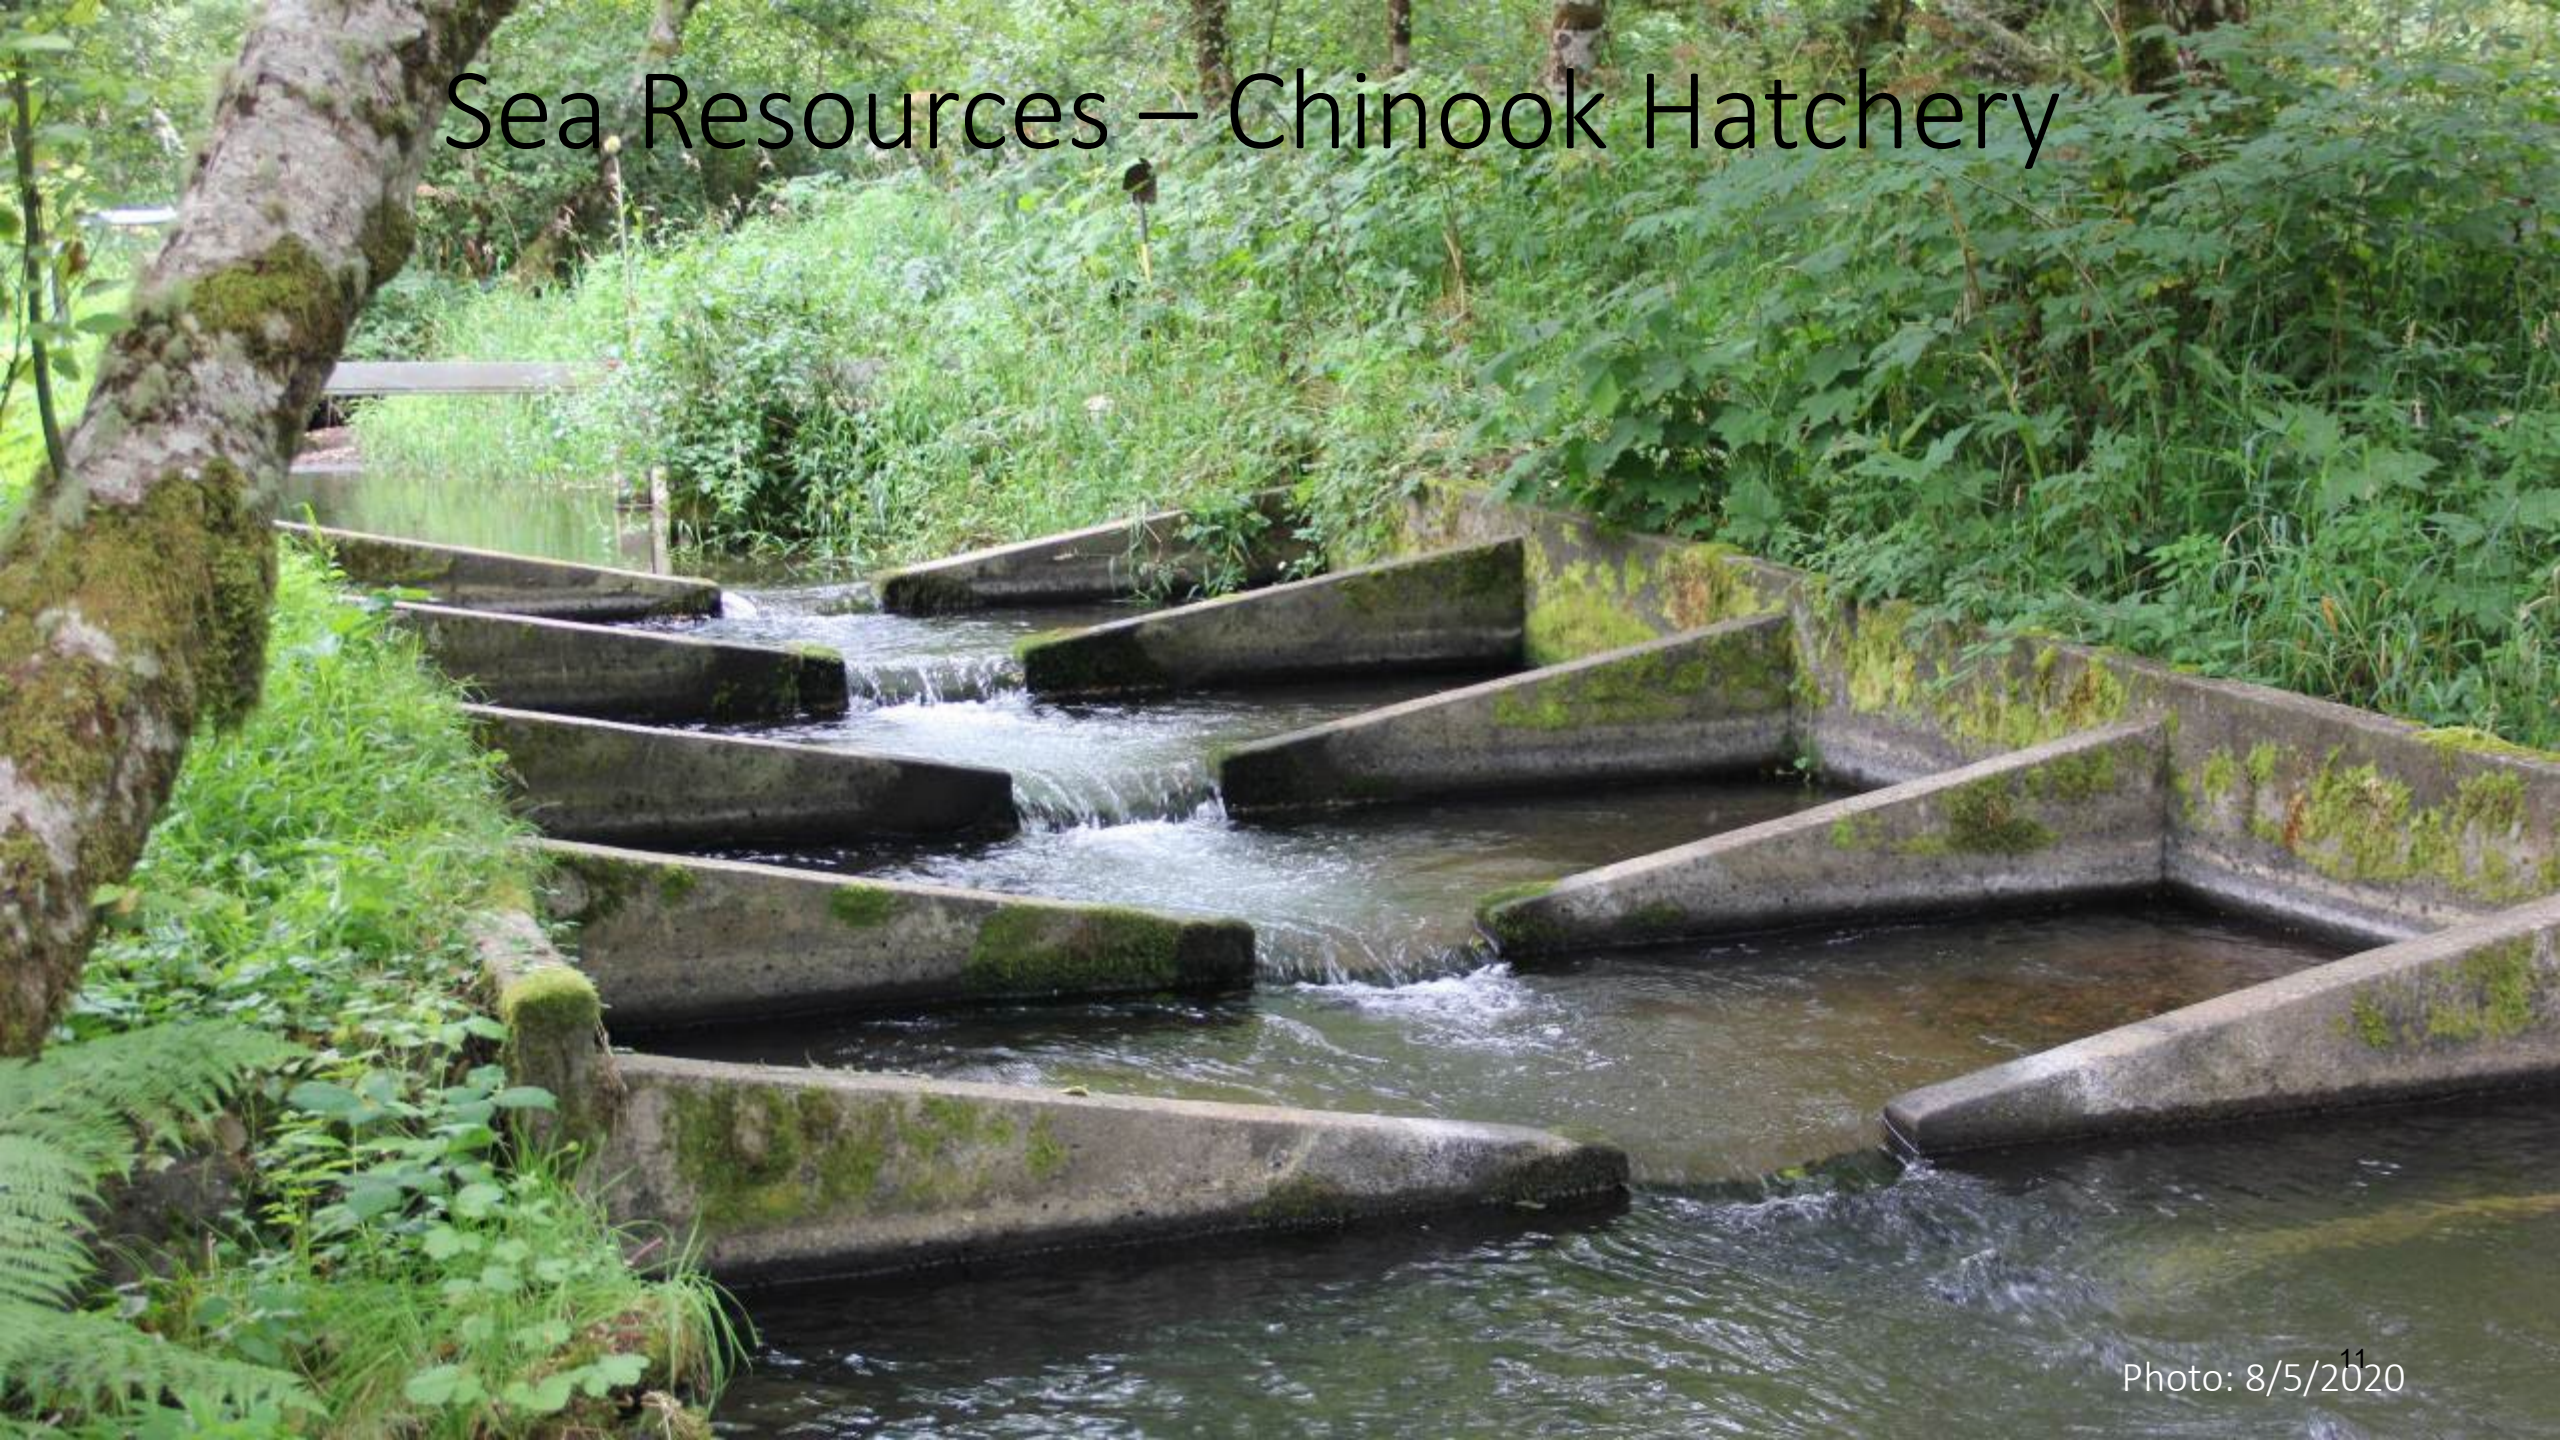
Sea Resources – Chinook Hatchery

Weir and intake
diversion

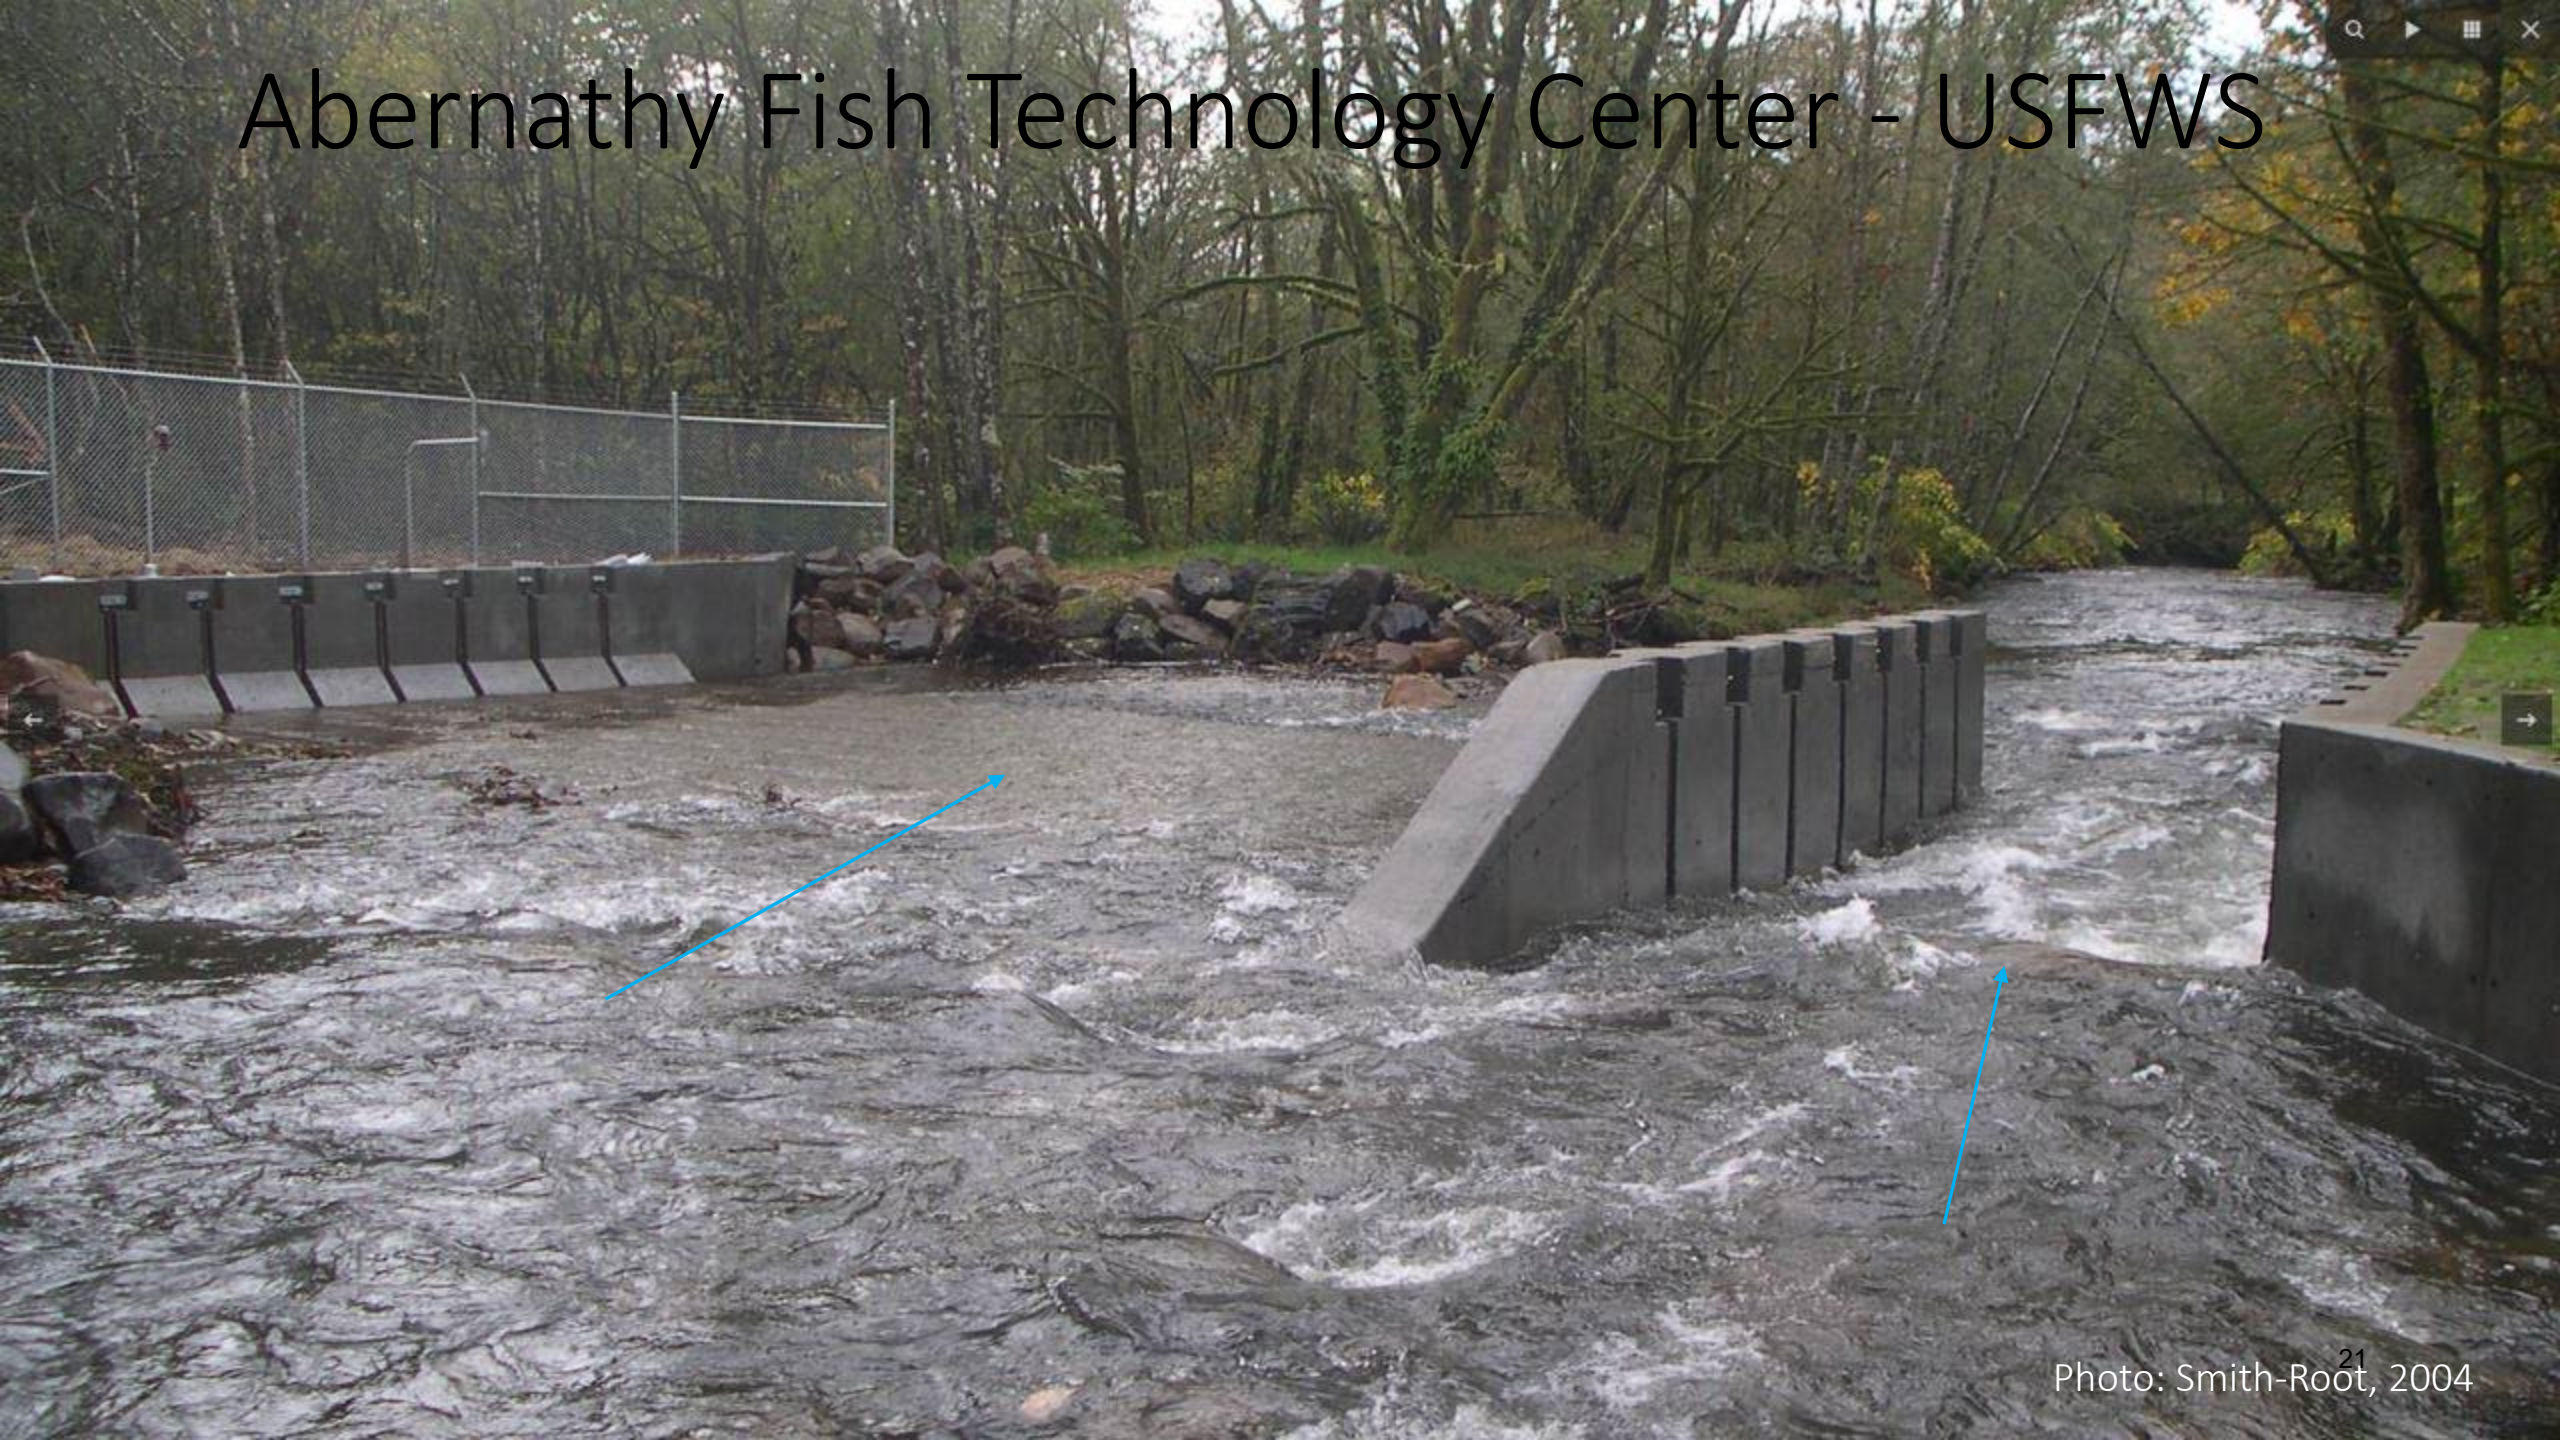
Abernathy Fish Technology Center - USFWS

- Sheet pile dam appears to be failing
 - All 90 angles, no orifices
 - Option to replace with roughened riffle?
- Recommend re-assessing at spring migration flows

- Many smaller-bodied native fishes are likely blocked permanently.
- Larval Pacific and Lampetra species observed above the hatchery in the Elochoman
- Adults observed in fishway in hatchery ladder on Beaver Creek

- Increased predation risk below barriers

- Recommend concrete or aluminum ramps on the sheet pile dam, on both ends.
- Consider adding lamprey-specific orifices, either vertical or horizontal depending on the infrastructure

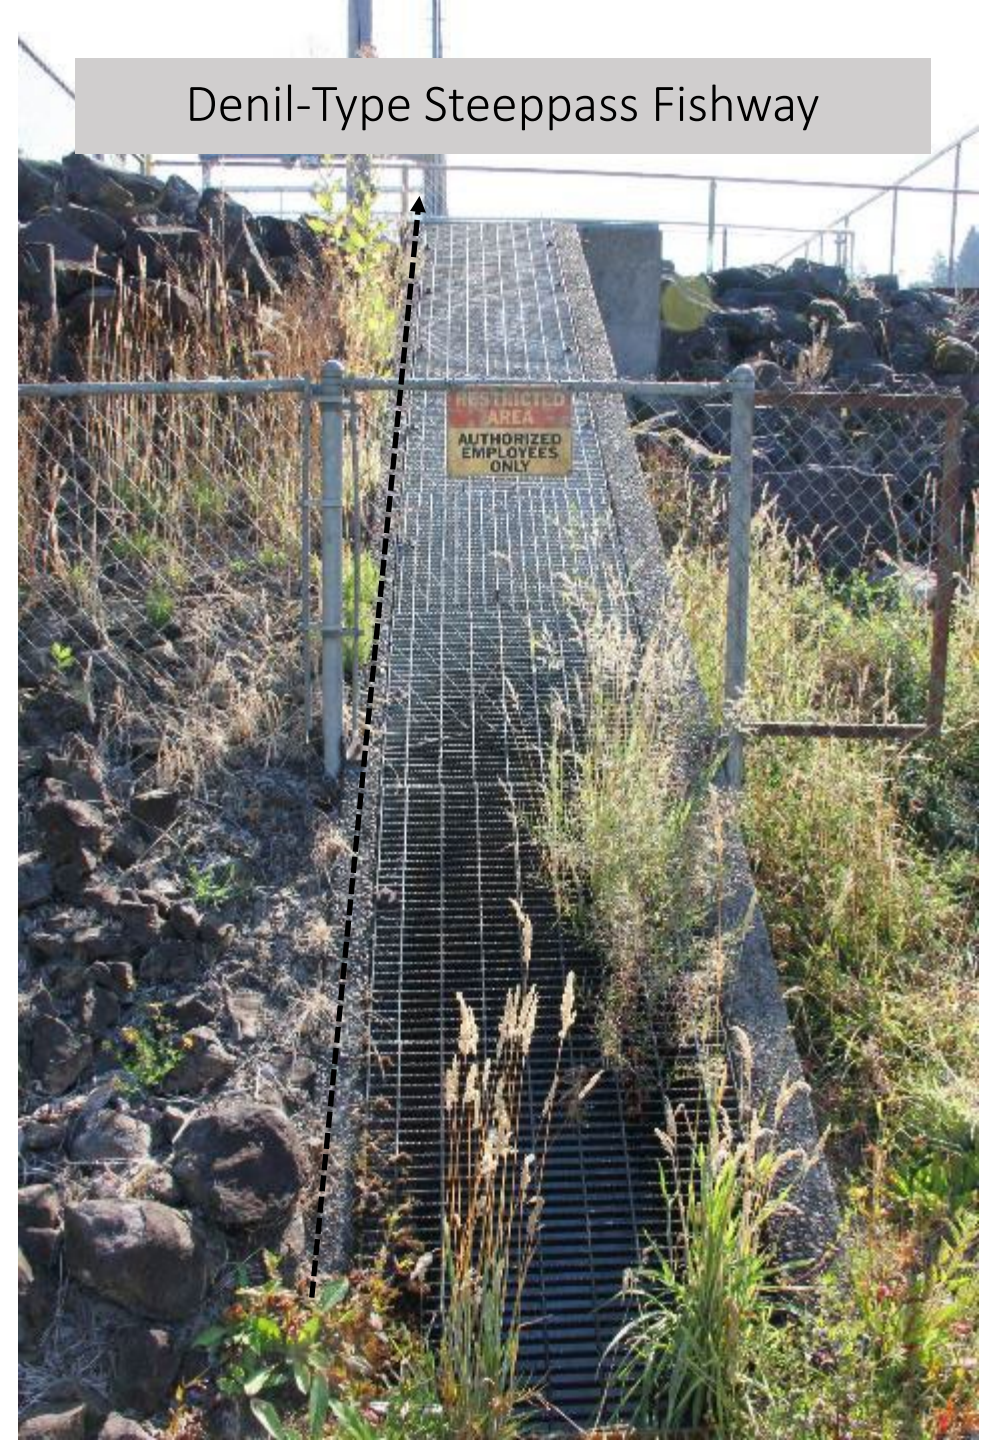
Lewis Hatchery Results:

- No barrier dam exists at the hatchery
 - Most of the ladder is a Denil-Type Steeppass fishway and should preclude any lamprey passage if they choose to attempt it
 - Entrance velocities appear high but were not accessible
 - No actions are recommended at the facility.
 - No observations of adults or larvae by the hatchery by staff

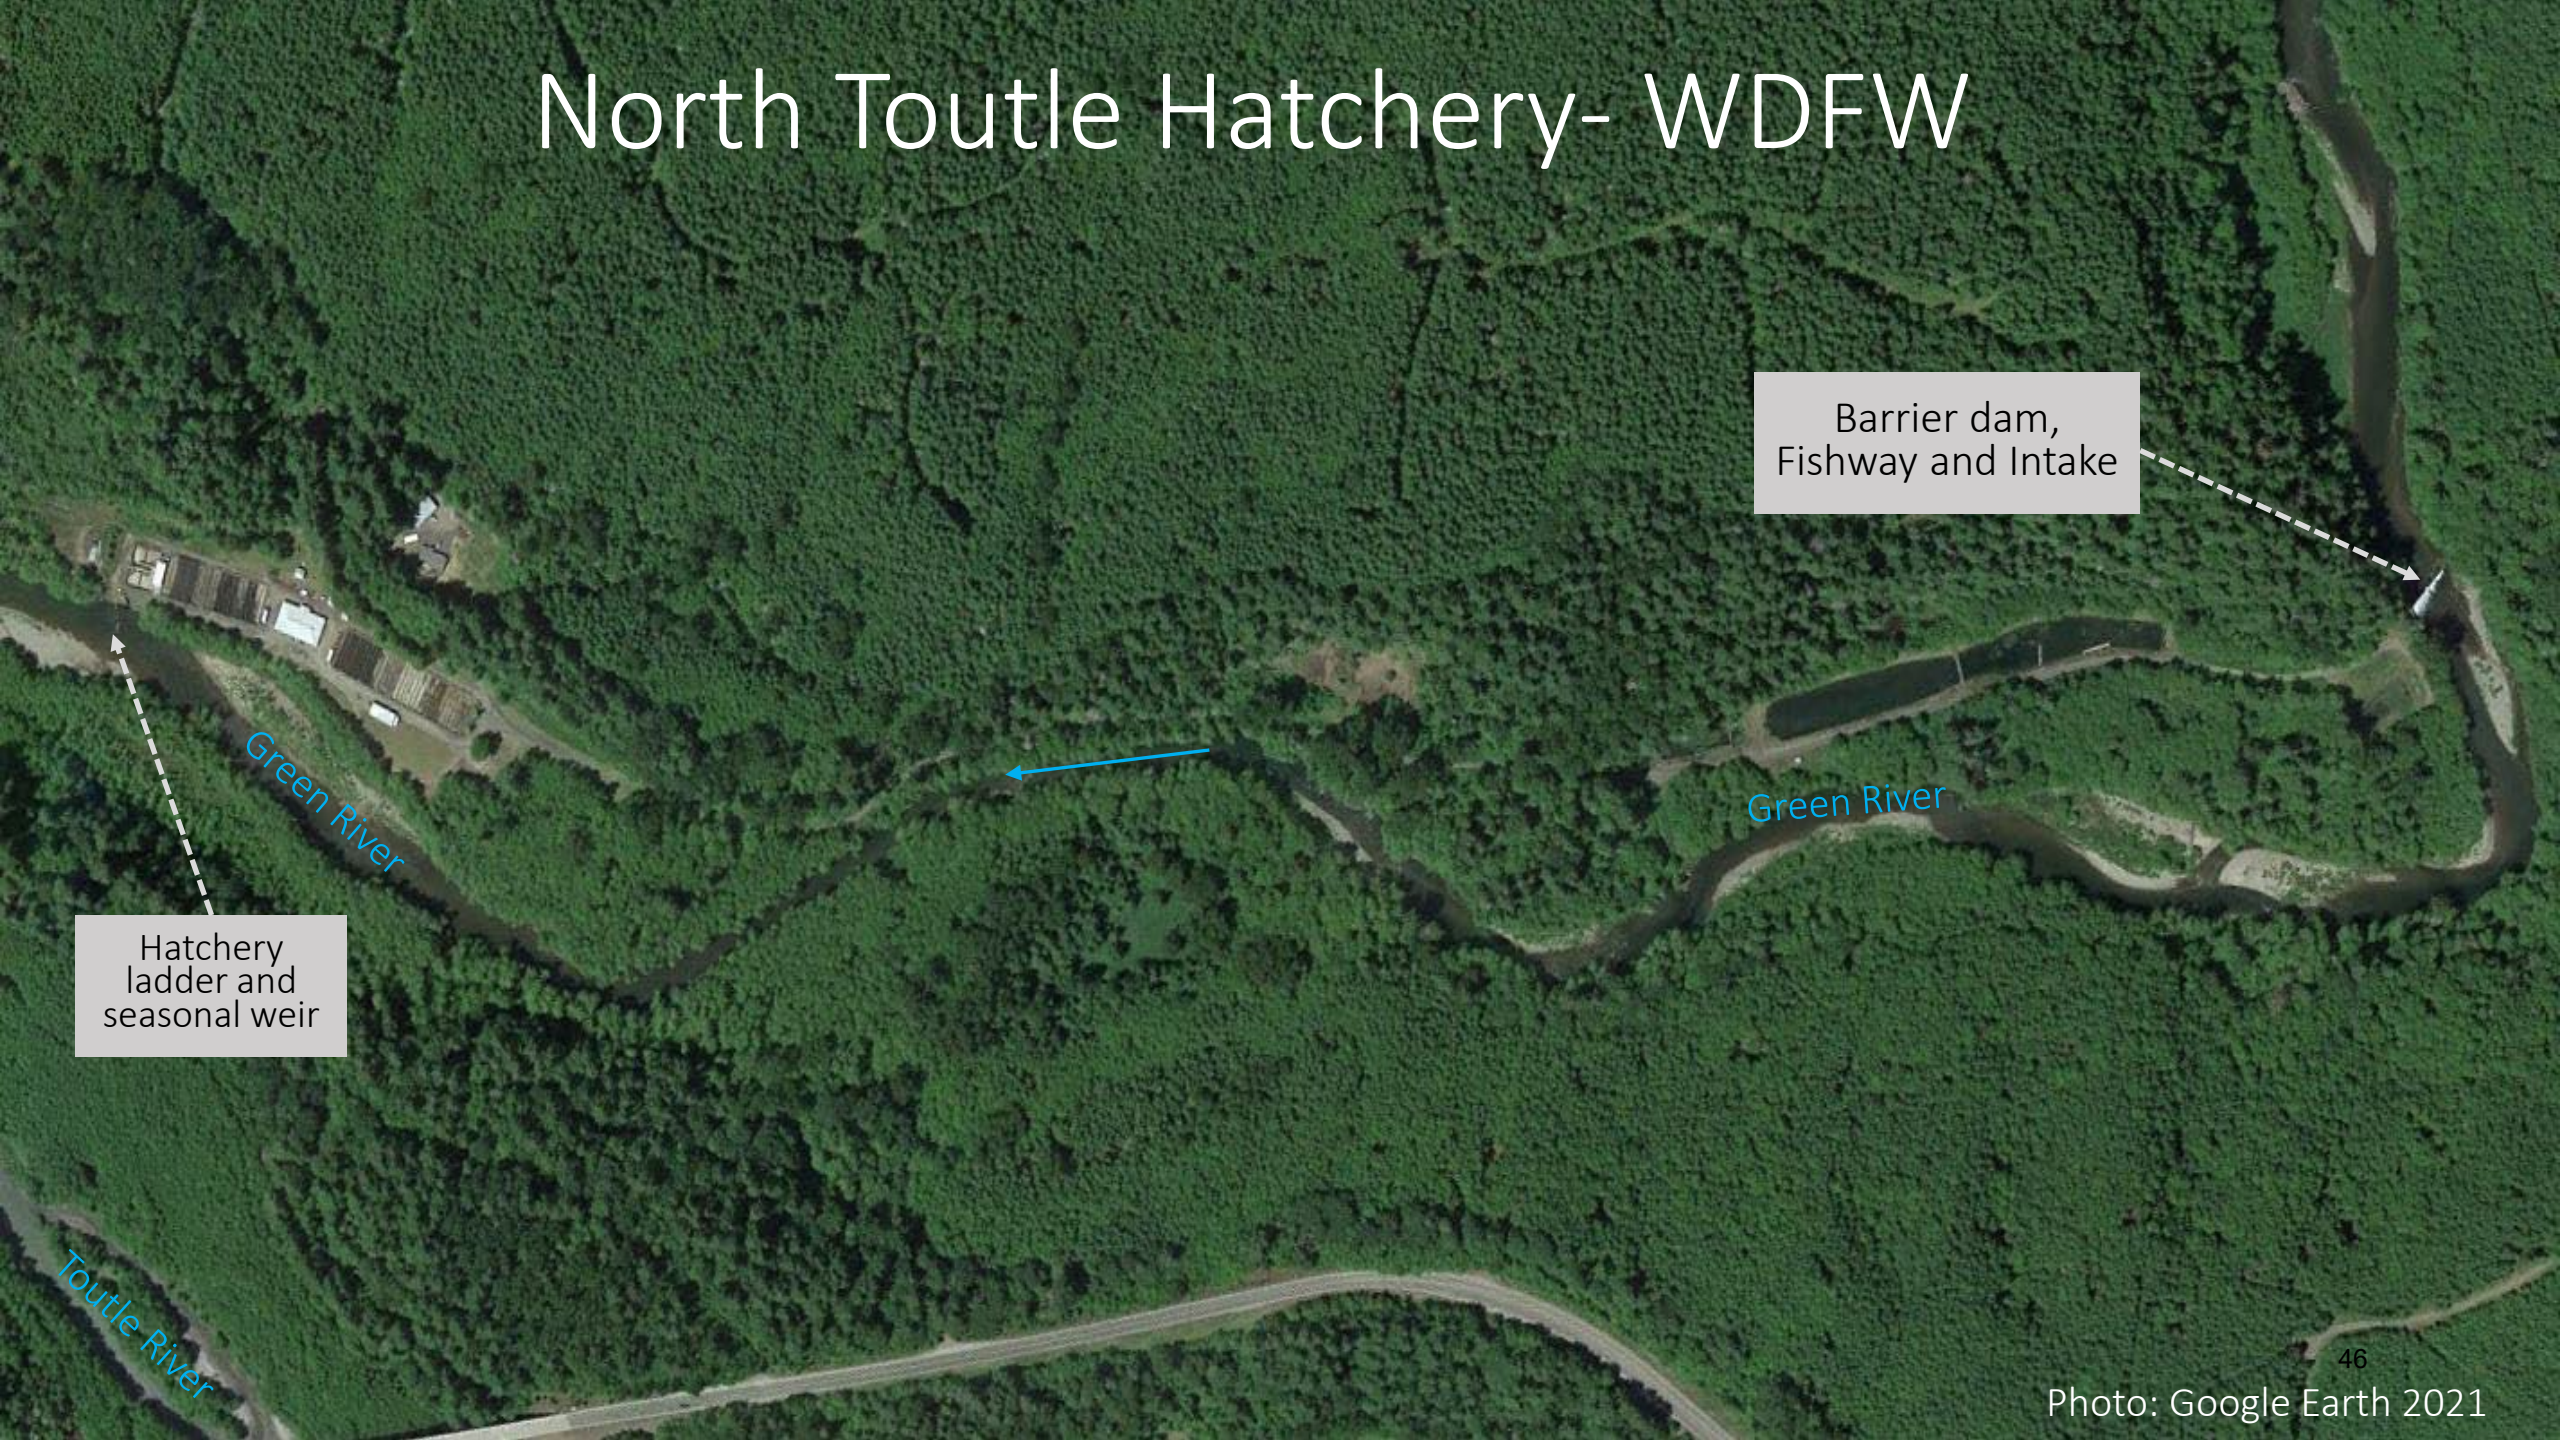
North Toutle Hatchery- WDFW

Barrier dam,
Fishway and Intake

Hatchery
ladder and
seasonal weir

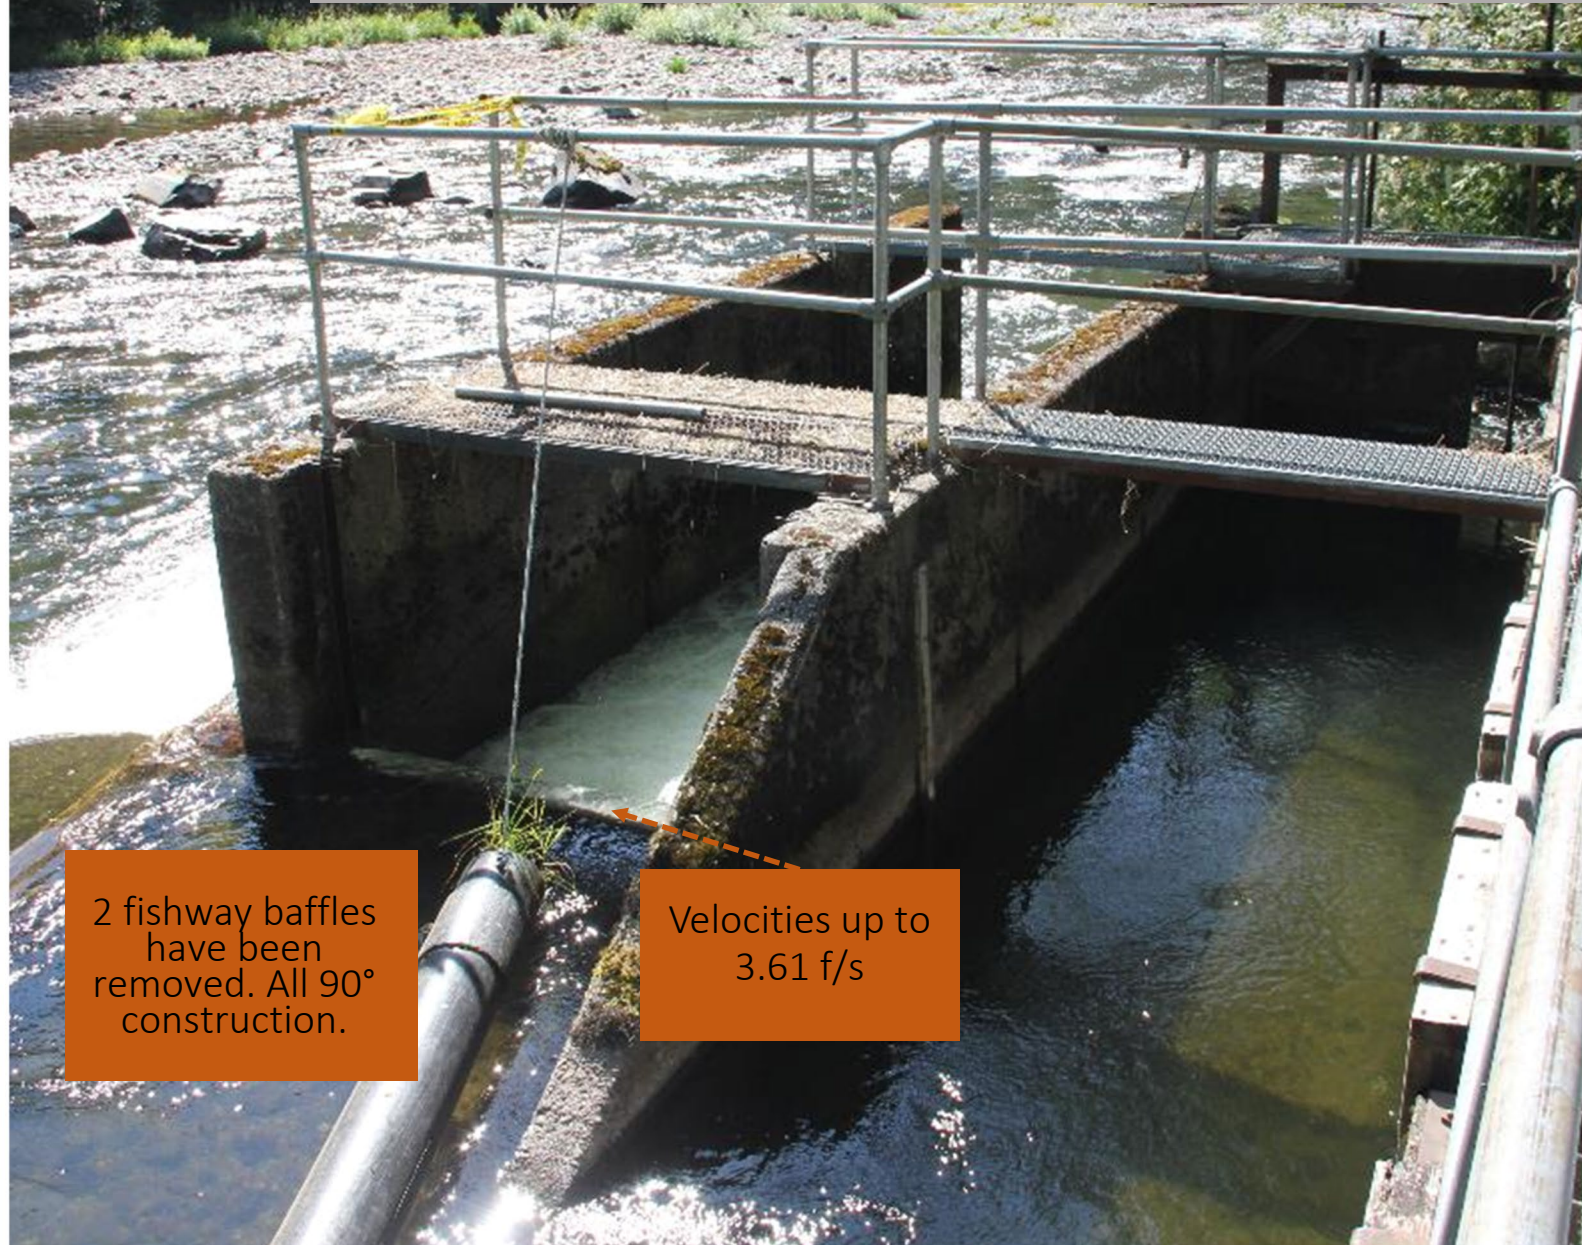
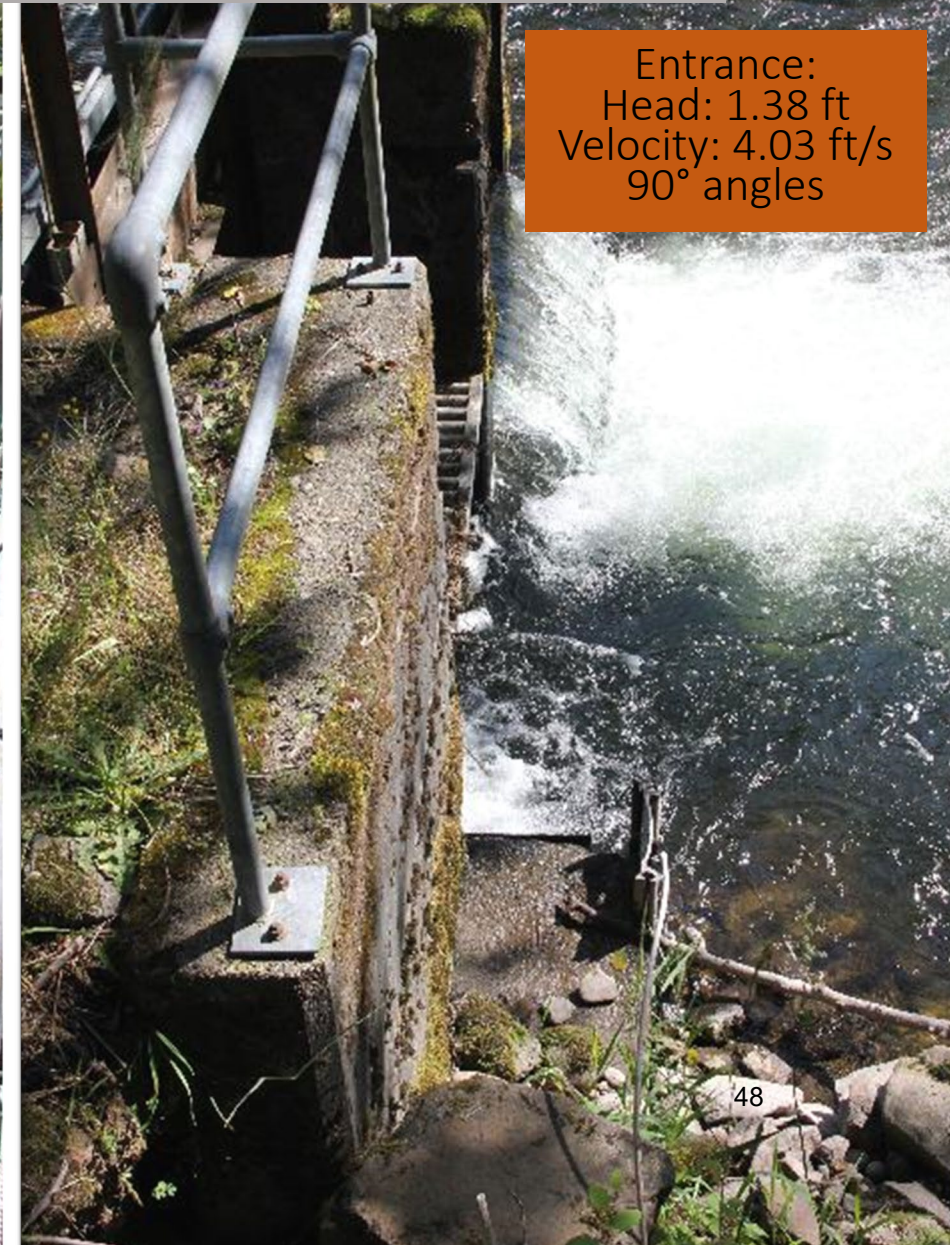
North Toutle - Fishway and Entrance

- Downstream
 - No barrier dam exists at the hatchery
 - Seasonal weir used to convey fish into hatchery (spacing 1.5’)
 - The downstream was fishway dewatered during the visit
- Upstream barrier dam, fishway, and intake
 - Fishway operates all year with volitional salmon passage
 - Entrance velocities exceed lamprey swimming speeds
 - Recommend ramps on the dam and smoothing surfaces
 - Recommend adding attachment surfaces to the entrance and adding lamprey orifices to the pool and weir fishway baffles
 - Thousands of larval pacific lamprey observed in earthen ponds
 - Recommend reassessing during spring migration flows
 - Replacing the dam with a nature-like fishway could be a viable solution
