Pacific Lamprey and Bull Trout Passage Assessment at Warm Springs National Fish Hatchery

2014 Report

> Final June 20, 2014

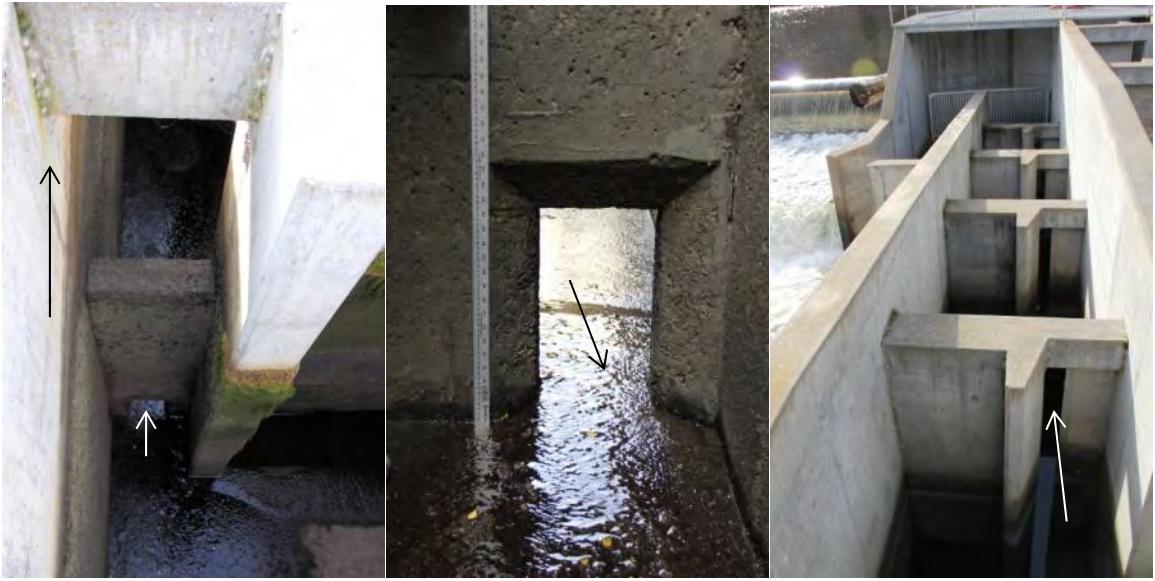
Figure 7. Weir types present at WSNFH. Plates A and B depict the two types of orifices within the orifice weir section of the ladder and Plate C depicts the vertical slot weirs. The arrows depict the direction of streamflow through the ladder and weirs.

The larger top orifice in the orifice weir section of the ladder is approximately 18 inches wide and 6 feet tall, meets the recommended minimum width and height. The top orifice did not have 4 inch rounded corners or edges on the top or sides as recommended for lamprey passage. The bottom of the top orifice was slightly rounded (Figure 17). The bottom orifice measured 9 inches wide and 15.5 inches tall which does not meet recommended width of 12 inches. In the bottom orifice, where lamprey are more likely to be passing, the sides and top of the orifice are slightly rounded (Figure 8 plate B). The bottom is completely open and flush with the fishway floor, allowing lamprey to move along the bottom of the ladder unimpeded. However, on both the top and bottom orifices the roughened aggregate surfaces may limit lamprey ability to maintain suction (Figure 17).

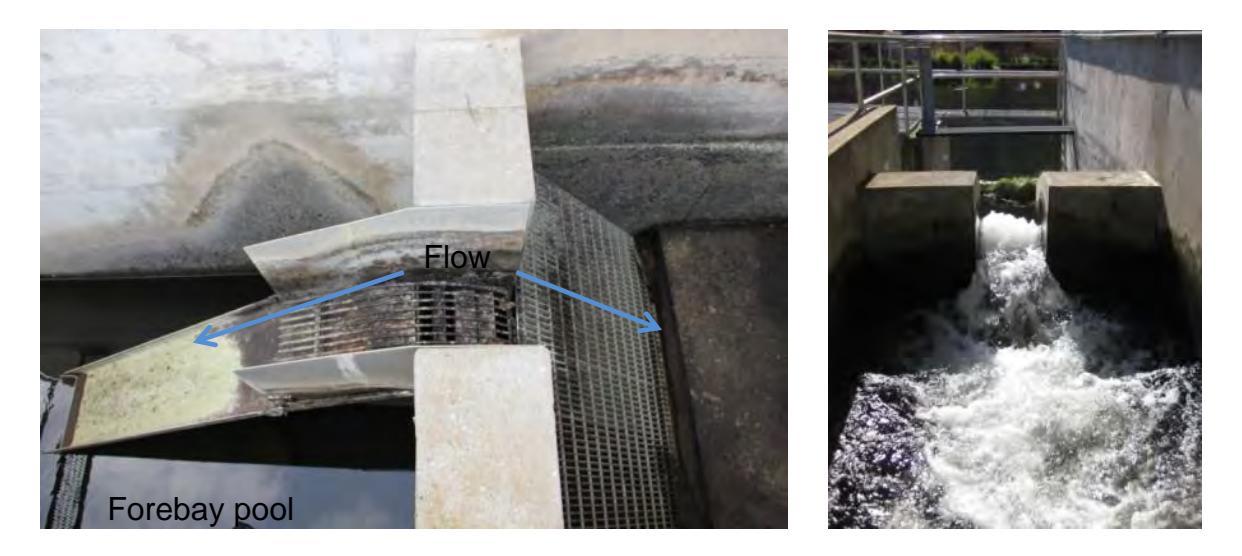
Figure 8. View of the fishway exit dewatered (left) and operational (right) at WSNFH.

The fishway exit pool is longer than the minimum length requirement of 18.6 feet and the exit location is acceptable to minimize risk of non-volitional falling back. Fish ascending the fishway exit must pass through the exit weir before entering the forebay (Figure 8) except for fish small enough to slip through the grates at turning pool B3. The exit weir is at a higher elevation than the forebay. The higher elevation of the exit weir eliminates sediment and debris from entering the transport channel. The distance from the water surface elevation upstream of the exit weir to the bottom of the exit weir notch is approximately 1.42 feet which exceeds the recommended pool drop of 1 foot. It is unknown if this causes any delay in adult salmonids exiting the fishway, but hatchery personnel have not reported adult salmonids being "backed up" near the exit.

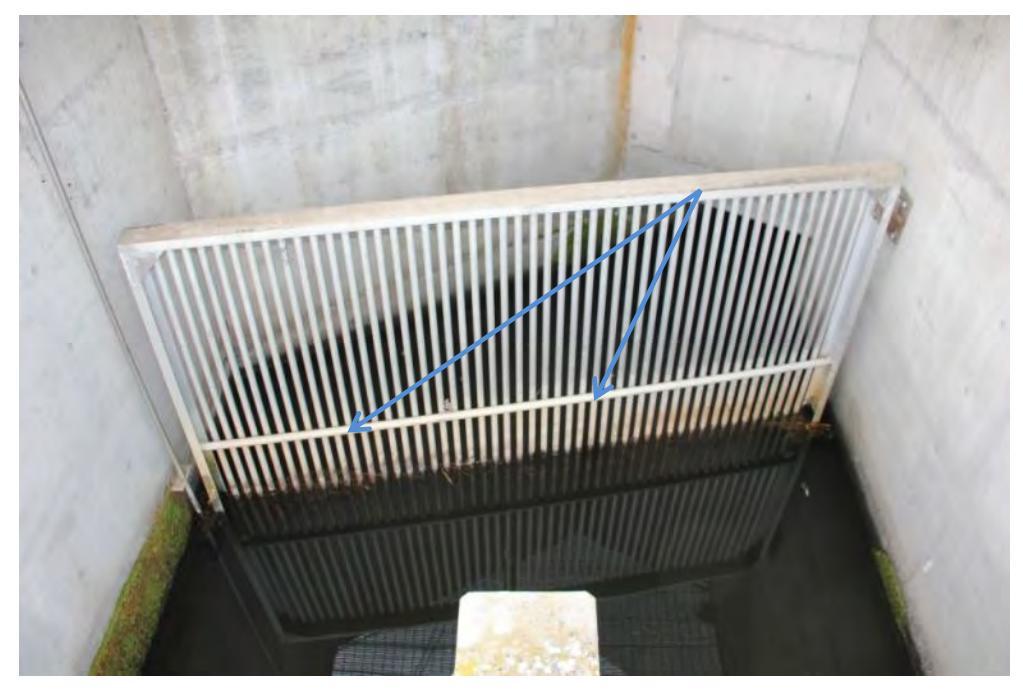
Figure 9. Water input into the fishway at turning pool B1 is conveyed from an Auxiliary Water Supply (AWS) behind the grate and to the right. The input end of the AWS is in the forebay and adjacent to the intake drum screen and is not pictured.

There are two downstream passage routes within the ladder. First, fish that enter the unscreened AWS pipe near the water intake screens will enter the ladder behind the gate of turning pool B1 (Figure 9). The gate is constructed of 1.5 inch grating and has 1.375 inch spacing between grate elements. We were unable to measure water velocity in the pipe exit, but it appeared to be faster than salmonids or lamprey can swim. If fish are flushed out of the pipe, it is possible they could become impinged on the steel gate or become injured from contact with the gate. Future assessments should measure the pipe intake velocities to determine if it is likely unintentional entrainment is occurring.

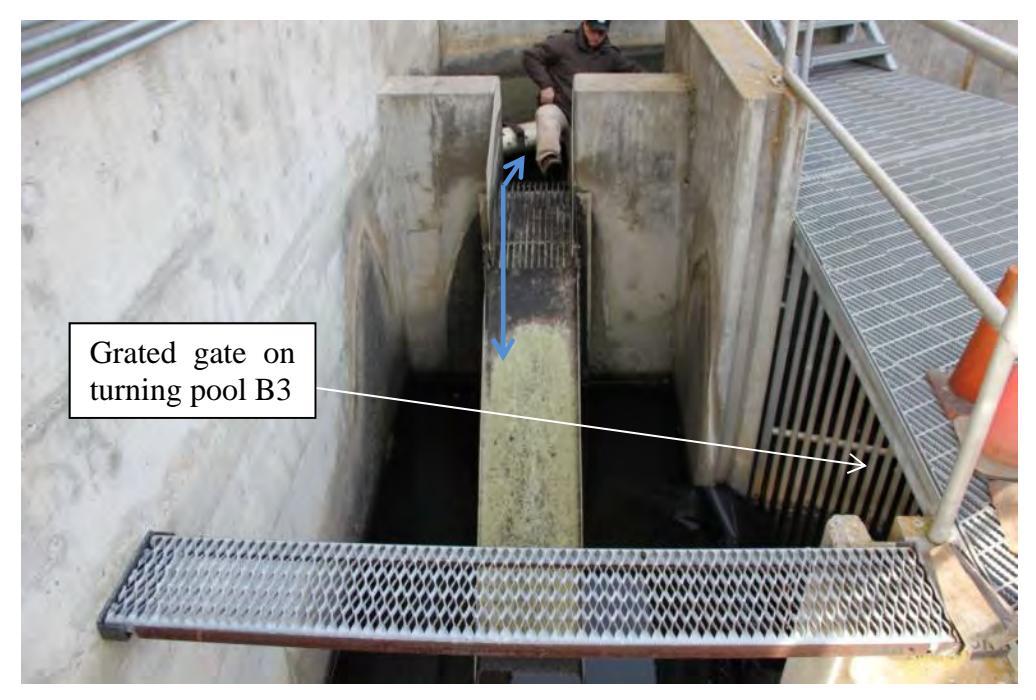
Figure 10. Fishway exit and grated gate at turning pool B3. Water enters the fishway at both of these locations.

passage for lamprey to ascend the fish passage system is to pass through or under the gate at turning pool B3 (Figure 11, Figure 10) which significantly shortens their travel time in the fishway.

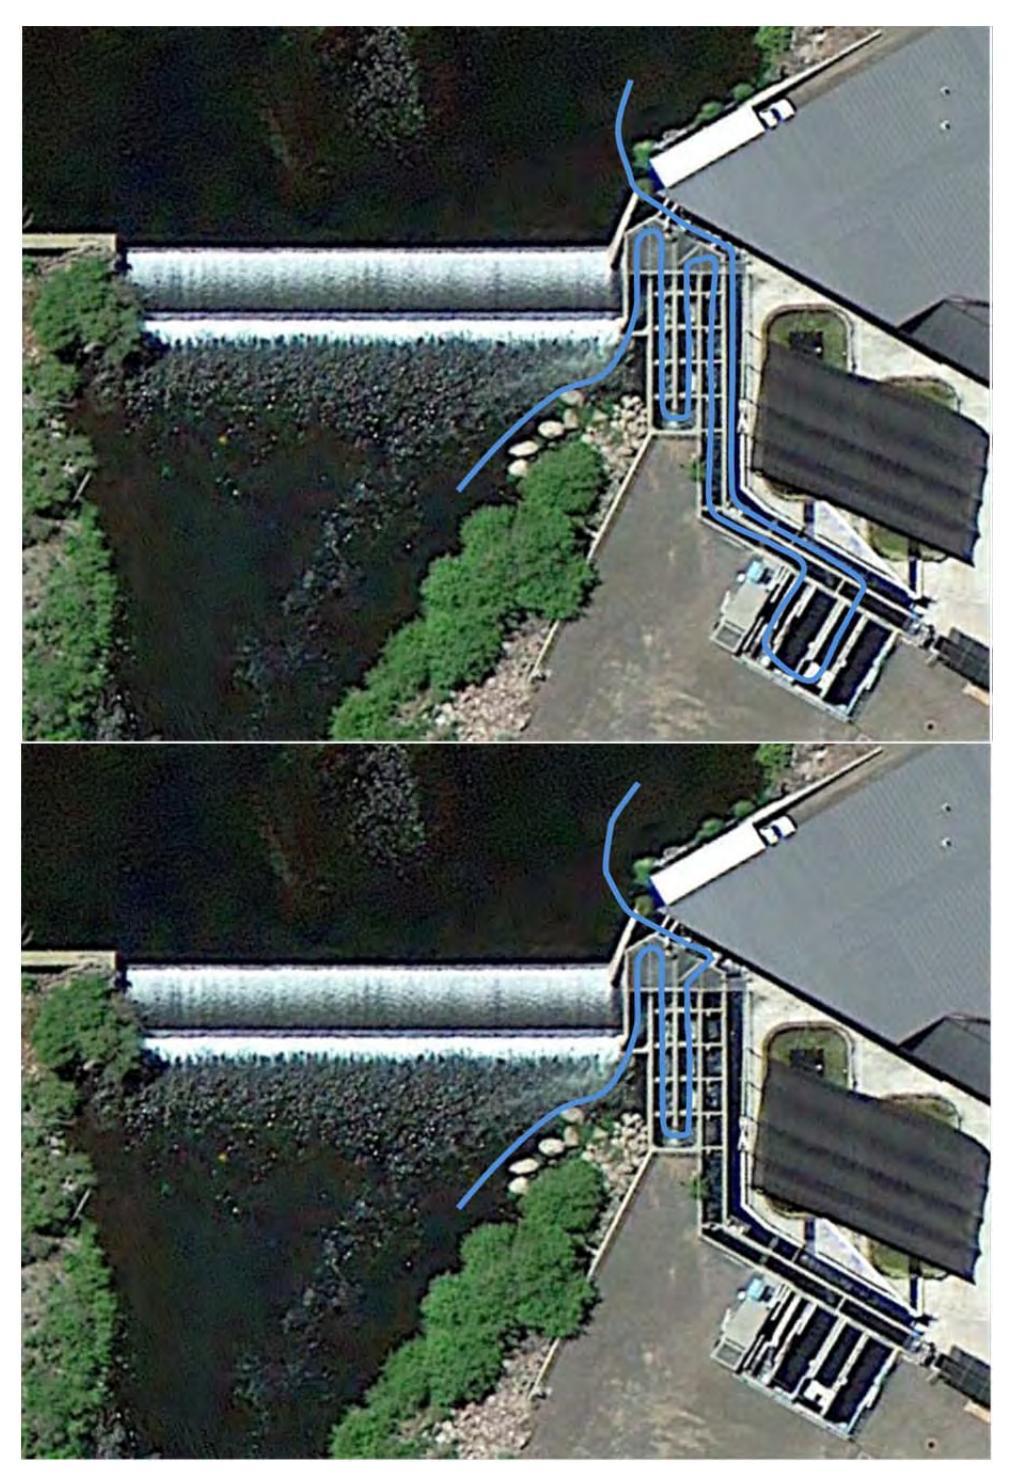
Figure 11. Two potential routes of passage through the WSNFH fishway partially dependent upon fish size and when the grates are open. Annually these grates are opened to all fish from mid-December through February.

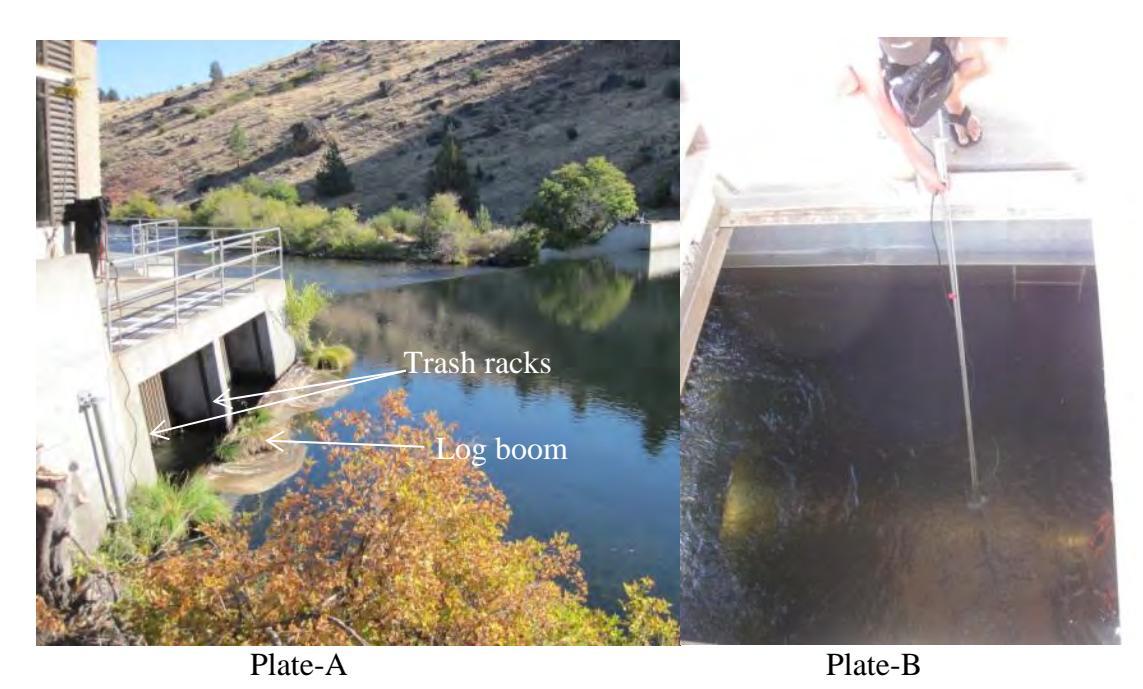
WSNFH water intakes should be properly screened. Behind the log boom and trash racks of the water intake structure (Figure 13, Plate-A), there are two passive screens that provide screened water for the hatchery (Figure 13, Plate-B). The approach velocity, measured perpendicular to the intake screens, should not exceed 0.2 ft/s for passive screens. The sweeping velocity measured parallel to the intake screens, should exceed the approach velocity.

Figure 13. The WSNFH water intake structure (plate A) and one of two water intake screens (plate B).
