TRIP REPORT OF SITE VISITS TO BASIN CREEK, DURANGO, COLORADO  
12 MAY 2014 AND 9-10 JULY 2014

30 JULY 2014

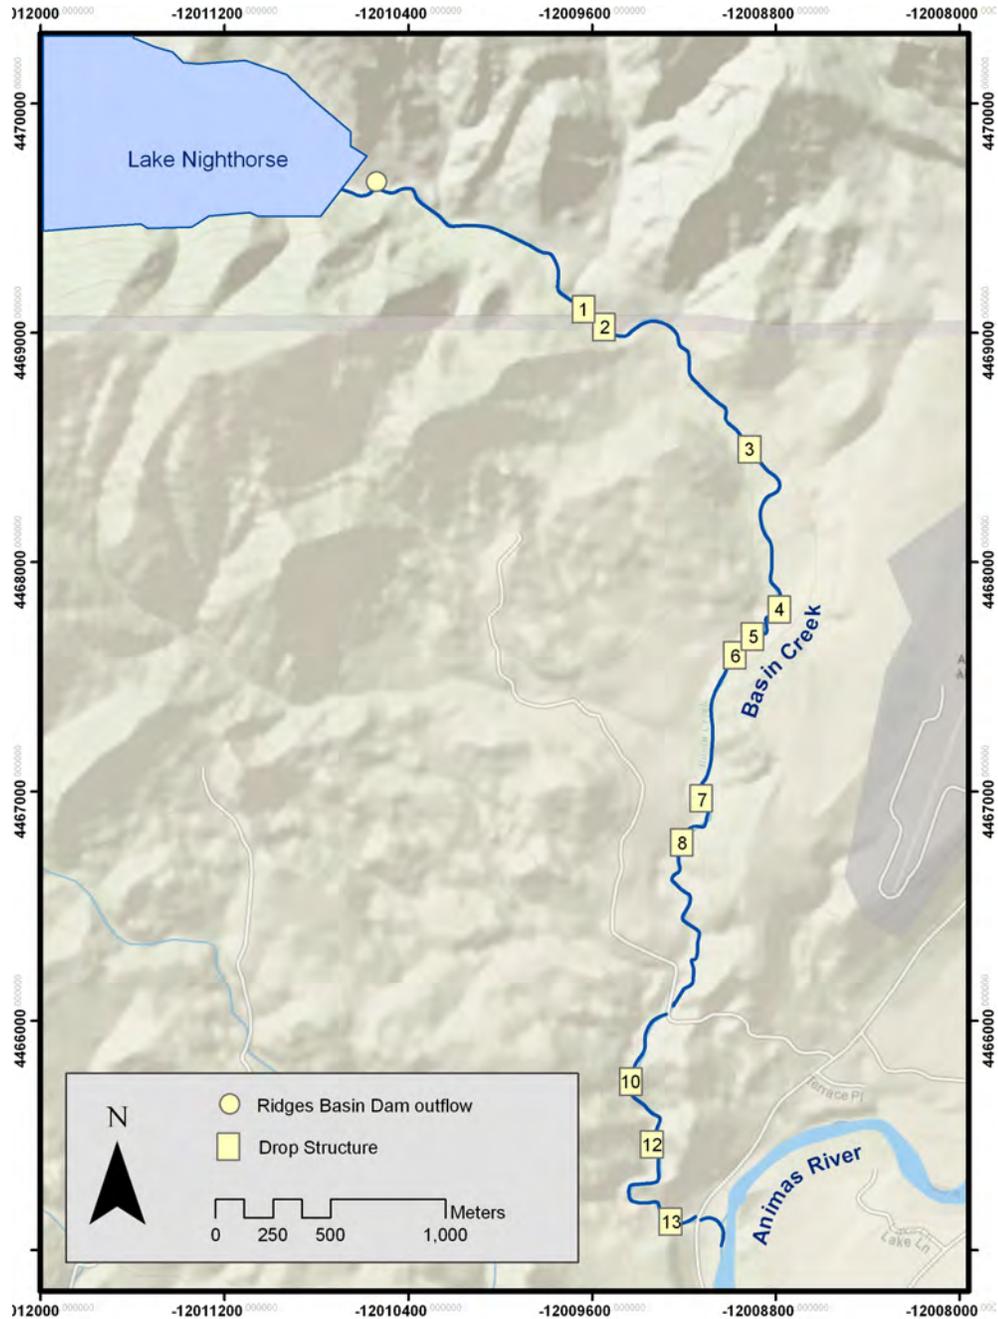
Figure 1. Lake Nighthorse and Basin Creek study area with the locations and numbers of the Drop Structures indicated. (Drop Structures 9 and 11 were not constructed).

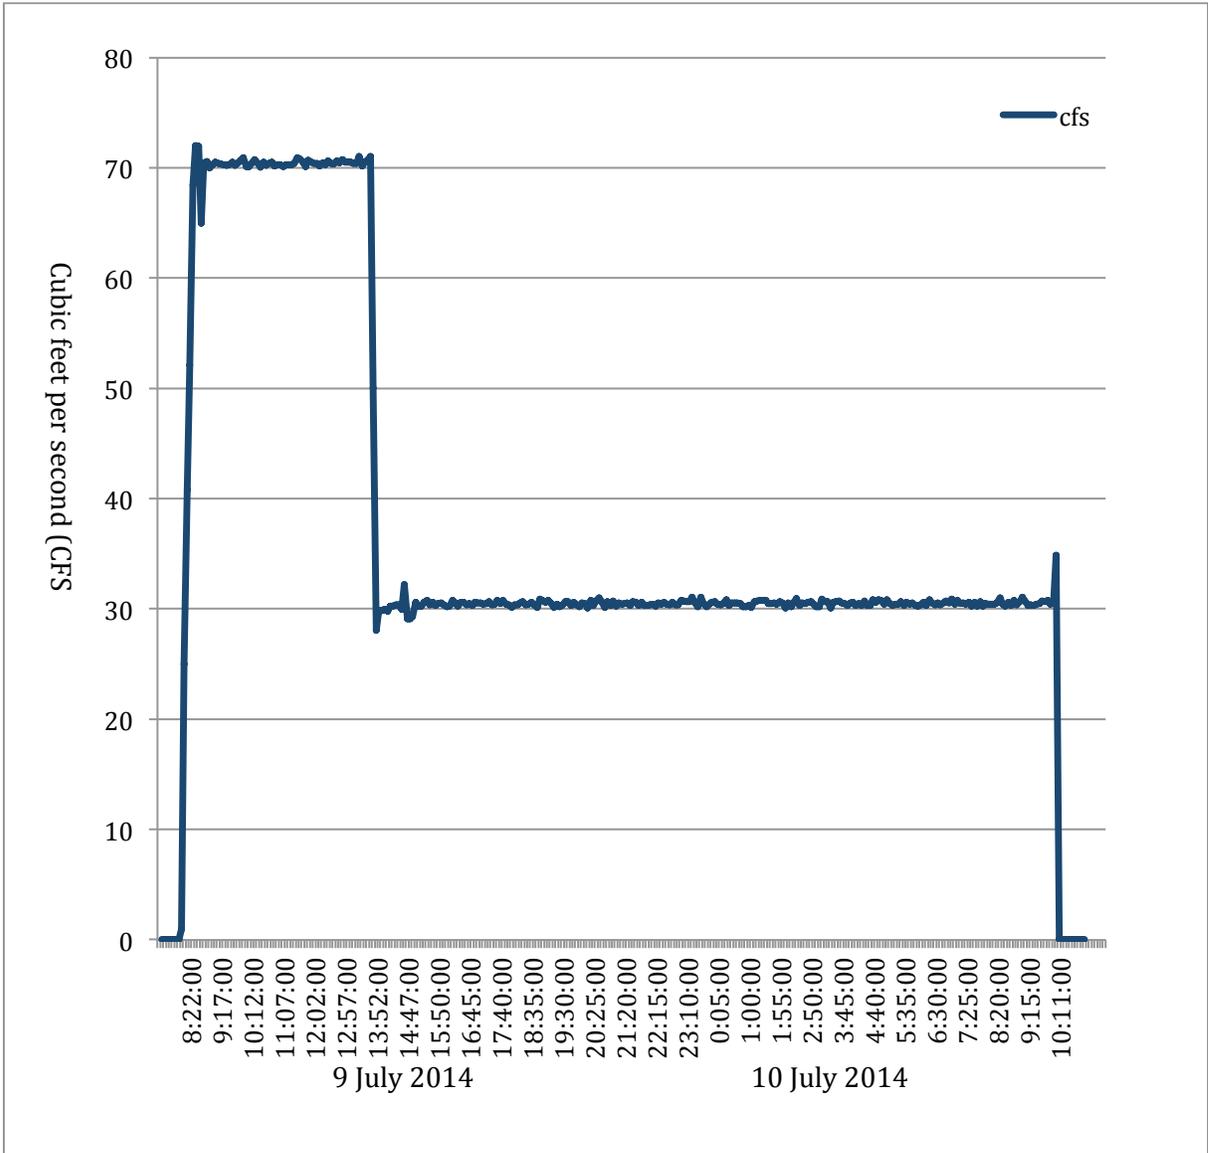
**9-10 July 2014 Site Visit:** During the second visit to Basin Creek and Ridges Basin Dam water was released from the dam for a duration of approximately 26 hours. A release of 70 cubic feet per second (cfs) was initiated on 9 July 2014 at 08:07 hours and lasted for about 5.5 hours (Figure 8). The purpose of the higher initial flow was to flush the channel within Basin Creek and saturate the subsurface soil. The period of release at 70 cfs was extended for a longer duration than initially expected (approximately 1.5 hours) due to the amount of time it took for the water to pass through all the drop structures and saturate the subsurface soils. By 1400 hours on 9 July 2014 discharge from the dam was reduced to 30 cfs which was a typical release from the dam for water delivery purposes. The discharge of 30 cfs was maintained until 10:06 hours on 10 July 2014 (20 hours).

Figure 8. Hydrograph of the 9-10 July 2014 test release at Ridges Basin Dam (provided by Robert Waldman, USBR, Durango).
