**WDFW Fish Passage and Diversion Inventory Database**  
**Site Description Report**

**Site ID:** 1310034

**Project:** FPGRANT

**WDFW Fish Passage and Diversion Inventory Database  
Level A Culvert Assessment Report**

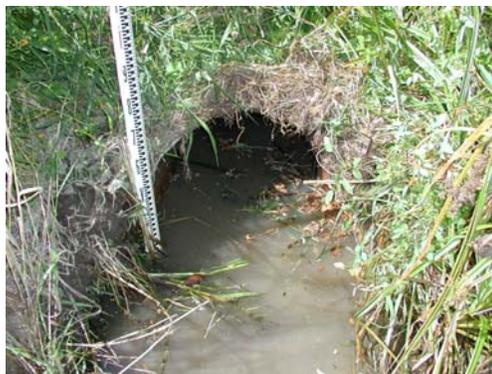
Bed Material Present:      Yes  
Outfall Drop (m):  
Culvert Slope (%):      1.23  
Ave. Bed Width (m):  
Culvert/Stream Width Ratio:

Barrier:    Yes      Passability (%)    0      Repair Status:    UD      Method:    LA  
Problem:    water control structure

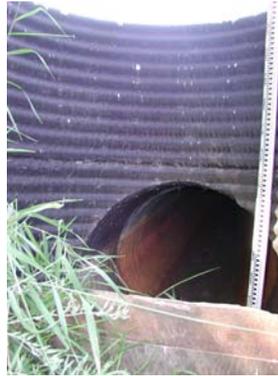
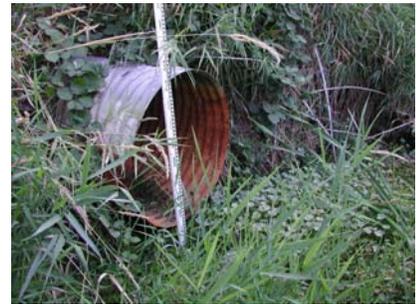
Bed Material Present:	No
Outfall Drop (m):	0.01
Culvert Slope (%):	1.70
Ave. Bed Width (m):	
Culvert/Stream Width Ratio:

Barrier: Yes    Passability (%) 0    Repair Status: UD    Method: LA  
 Problem: other, slope

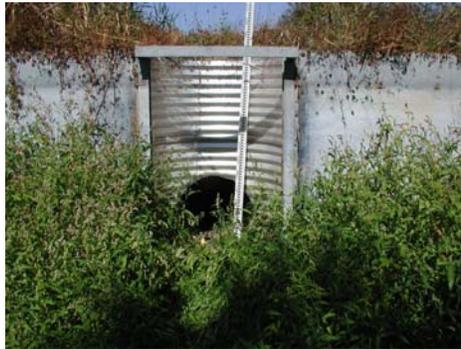
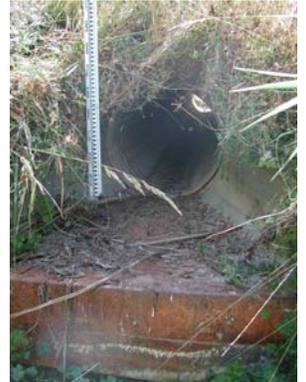
Bed Material Present: No  
Outfall Drop (m): 0.35  
Culvert Slope (%): 0.41  
Ave. Bed Width (m):  
Culvert/Stream Width Ratio:

Barrier: Yes      Passability (%) 33      Repair Status: UD      Method: LA  
Problem: outfall

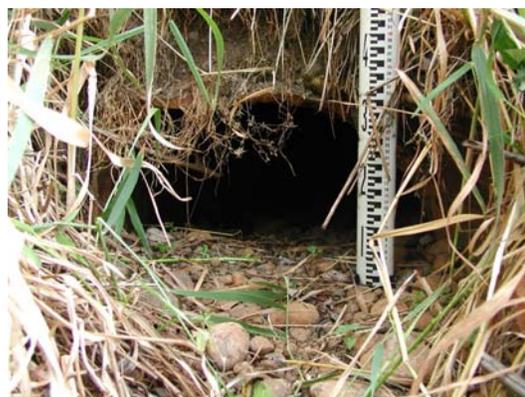
Bed Material Present: No  
 Outfall Drop (m): 0.28  
 Culvert Slope (%):  
 Ave. Bed Width (m):  
 Culvert/Stream Width Ratio:

Barrier: Yes    Passability (%) 67    Repair Status: UD    Method: LA  
 Problem: outfall

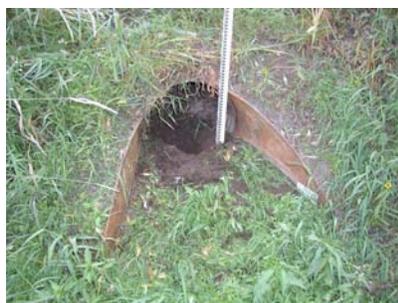
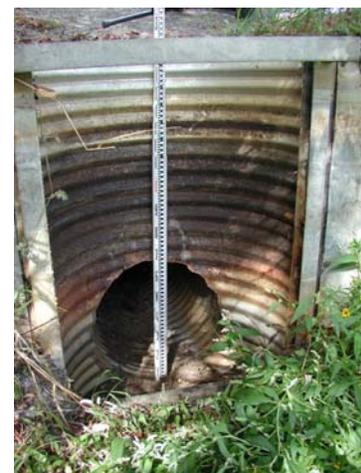
Bed Material Present:	Yes
Outfall Drop (m):	0.00
Culvert Slope (%):	1.55
Ave. Bed Width (m):	
Culvert/Stream Width Ratio:

Barrier: Yes    Passability (%) 33    Repair Status: UD    Method: LA  
 Problem: water control structure

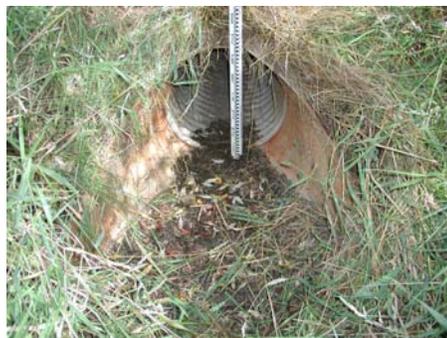
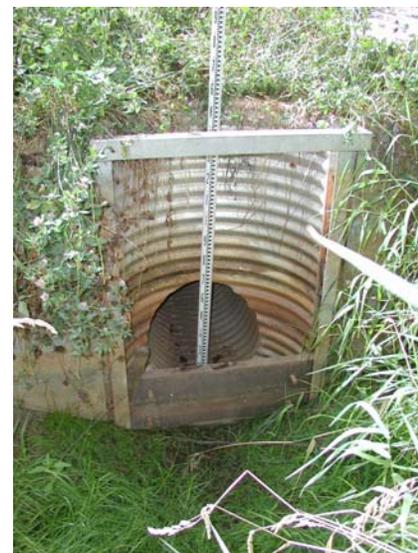
Bed Material Present:	Yes
Outfall Drop (m):	0.00
Culvert Slope (%):	0.00
Ave. Bed Width (m):	
Culvert/Stream Width Ratio:

Barrier: Yes    Passability (%) 0    Repair Status: UD    Method: LA  
 Problem: water control structure

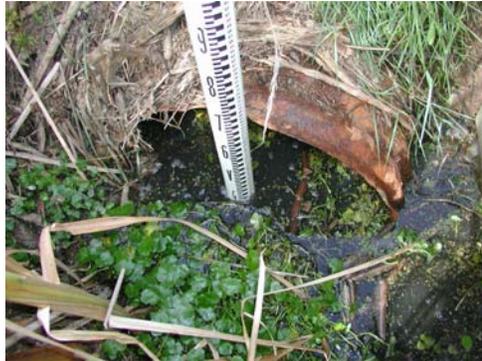
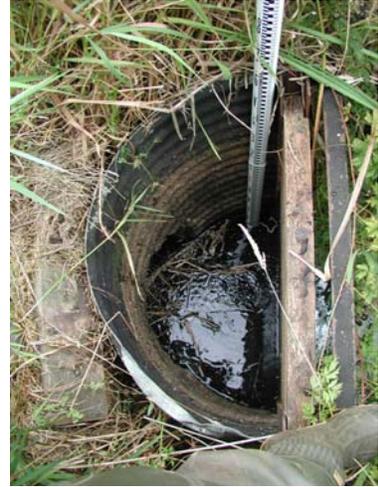
Bed Material Present: Yes  
 Outfall Drop (m): 0.00  
 Culvert Slope (%): 2.42  
 Ave. Bed Width (m):  
 Culvert/Stream Width Ratio:

Barrier: Yes      Passability (%) 0      Repair Status: UD      Method: LA  
 Problem: water control structure

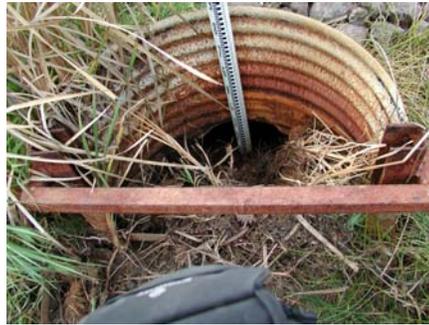
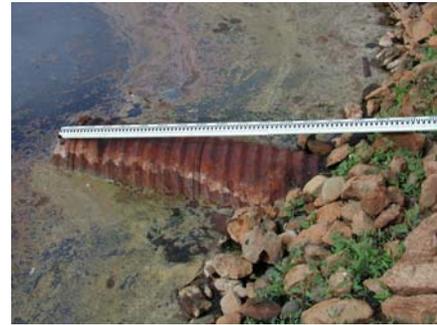
Bed Material Present:	Unk
Outfall Drop (m):	0.00
Culvert Slope (%):	4.26
Ave. Bed Width (m):	
Culvert/Stream Width Ratio:

Barrier: Yes    Passability (%) 0    Repair Status: UD    Method: LA  
 Problem: slope
