# WDFW Fish Passage and Diversion Inventory Database

## Level A Culvert Assessment Report

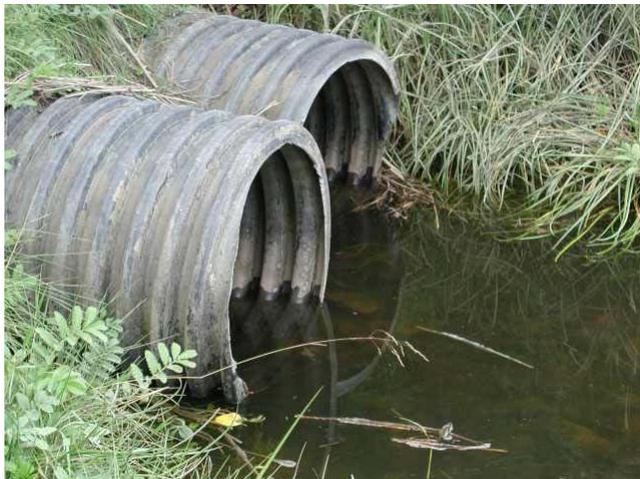
DS end is tidal slough, so no plunge pool or toe accessible. Also tidally influenced upstream of culvert. This is the right bank culvert.

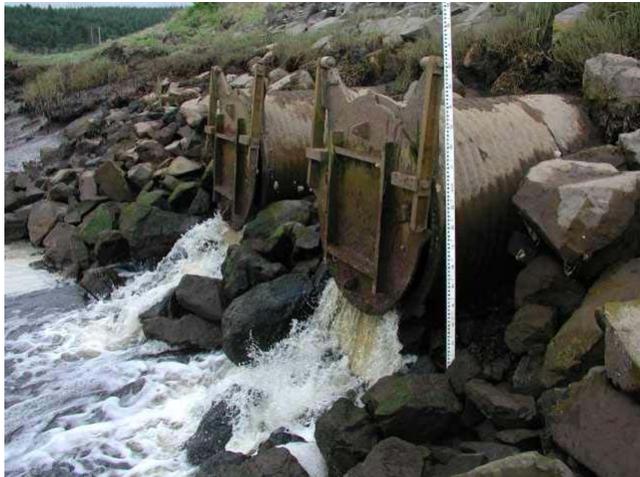
Bed Material Present:	<input type="text" value="No"/>
Outfall Drop (m):	<input type="text" value="0.60"/>
Culvert Slope (%):	<input type="text" value="1.23"/>
Ave. Bed Width (m):	<input type="text" value="2.00"/>
Culvert/Stream Width Ratio:	<input type="text" value="1.30"/>
