FLOODPLAIN HABITAT RESTORATION
2005 MONITORING FINAL REPORT
GREEN RIVER, UTAH

Report Prepared
October 2005

GSA Contract
Tetra Tech Inc. Project No. 0929-004-00

U.S. Fish and Wildlife Service
Upper Colorado River Endangered Fish Recovery Program

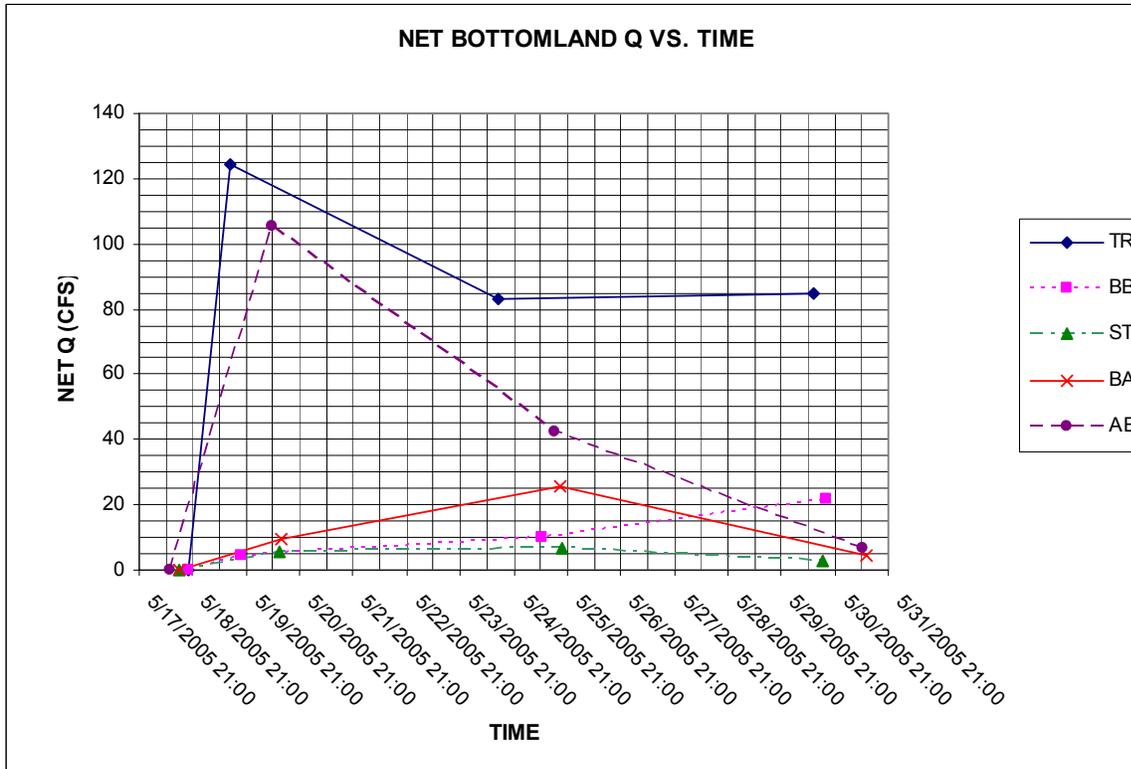
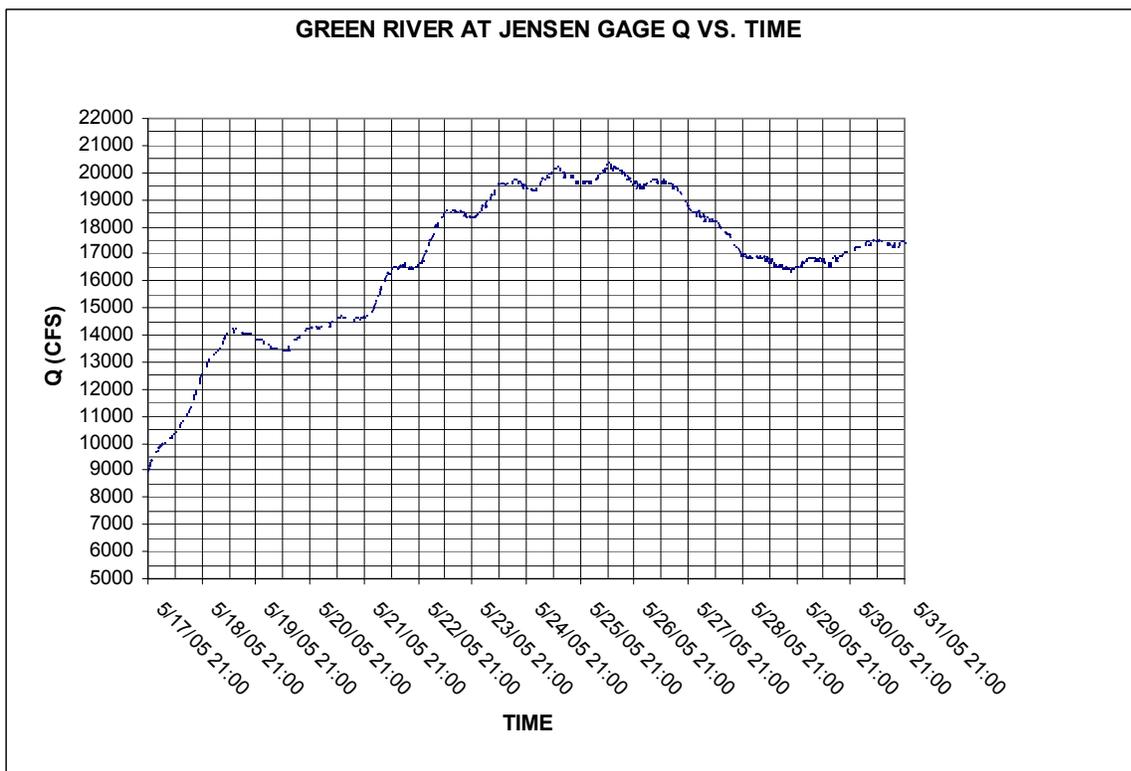
Figure 1. Net Inflow to Bottomland Sites versus Time

Figures 1 and 2 are plots of inflow versus time for all five sites. These plots are placed below the Green River hydrograph to show the relative timing of peak flows on the Green River versus the five monitored sites. Figure 1 depicts net inflow (inflow minus outflow) to each site; Figure 2 depicts total inflow. Based on this plot and other data presented herein it appears that the multiple openings (inlets and outlets) have several advantages over single notch opening in diverting flows from the main stem. First, the relatively high inflows achieved early in test period, at Thunder Ranch and Above Brennan is due to rapid filling through all the inlets plus filling through the outlet. With these high inflows occurring early in the runoff hydrograph, it is possible that a higher percentage of river flow is captured, which in turn, increases the likelihood for entraining drifting larvae if they are present. Second, these sites will achieve a steady flow-through condition as river flows equalize which, in turn increases the potential for capturing drifting larvae by increasing the time and amount of flows being diverted into the bottomland site. Perhaps the most dominant factor observed this year is depth and volume of water in the bottomlands. This impacts the

Figure 1. Net Inflow to Bottomland Sites versus Time.....	20
Figure 2. Total Inflow to Bottomland Sites versus Time	21

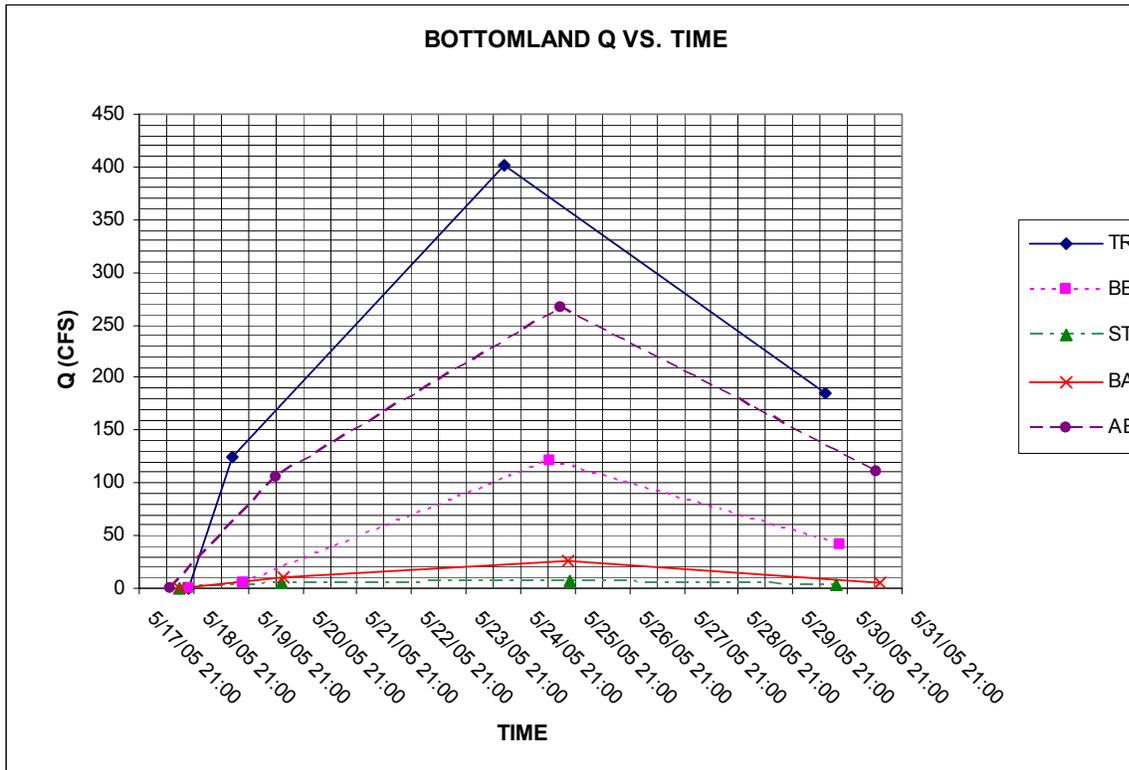
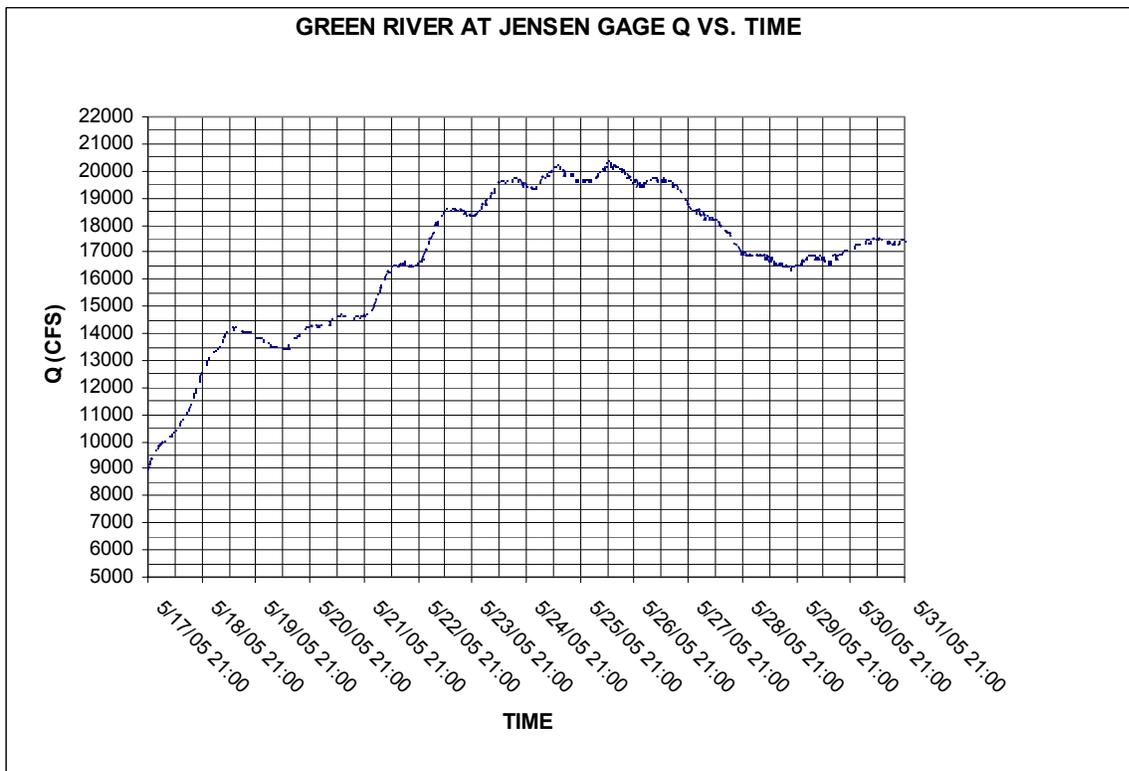
Figure 2. Total Inflow to Bottomland Sites versus Time

hydraulic gradient within the site and ability of the site to capture flows. Figure 2 clearly shows the relative differences in volumes of flow-through for the multiple opening sites versus the single opening sites with ST and BA showing relatively low volumes of inflow in comparison.
