MOSSY CREEK DAM REMOVAL AND RESTORATION, AUGUSTA COUNTY, VIRGINIA: PROJECT SUMMARY AND DESIGN REPORT

By: John B. Hutzell and Richard R. Starr

Stream Habitat Assessment and Restoration Program
U.S. Fish and Wildlife Service
Chesapeake Bay Field Office

CBFO – S12 - 02

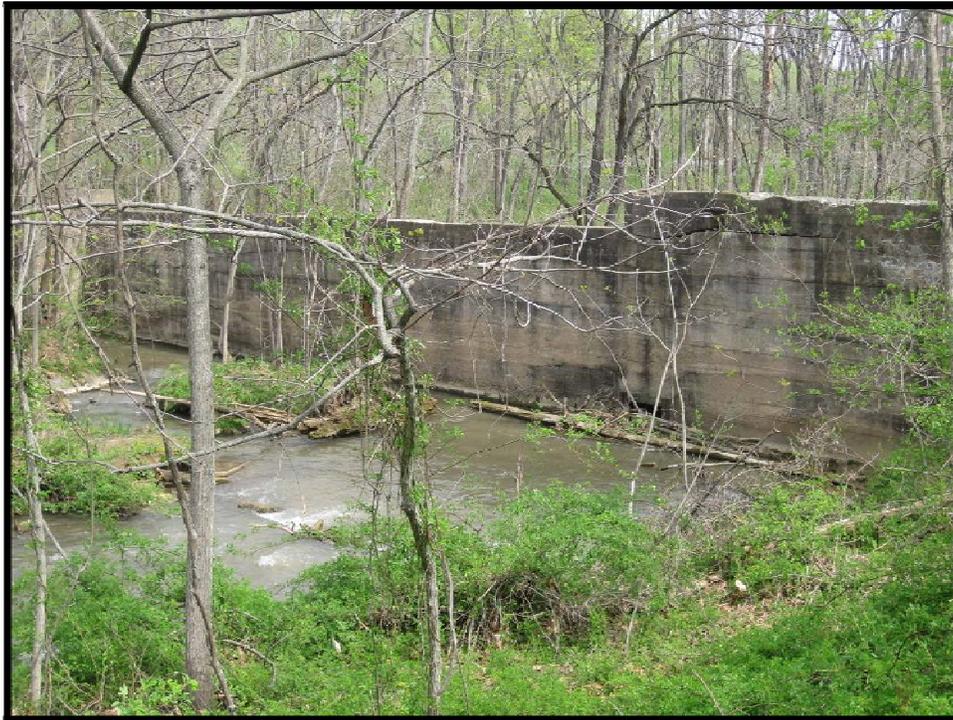
Figure 2. Bypass channel

The Service found that the Mossy creek had bypassed the dam (**Figure 2**) during a high flow event in the past, and has now formed a separate channel that flows around the left side of the dam. A small portion of flow continues to move through the outlet structure of the dam, but the majority of the water is being conveyed through the bypass channel (**Appendix A**).

The bypass channel shows signs of widespread vertical and lateral instability. This instability is indicative of a stream that is still undergoing adjustment, which is typical of a newly formed channel or avulsion. However, this bypass channel is unlikely to stabilize due to its location and lateral constraints. The channel cut through unconsolidated deposition and fill material so the majority of the banks are unstable and highly erodible. The channel is actively incising, as there does not seem to be any stable grade control. The access to available floodplain is also limited due to the steep side slope on the left bank, and the intact dam on the right bank. With these constraints, it is expected that channel incision will continue to move upstream with little hope of stabilization and this reach will continue to be a large source of sediment to Mossy Creek.

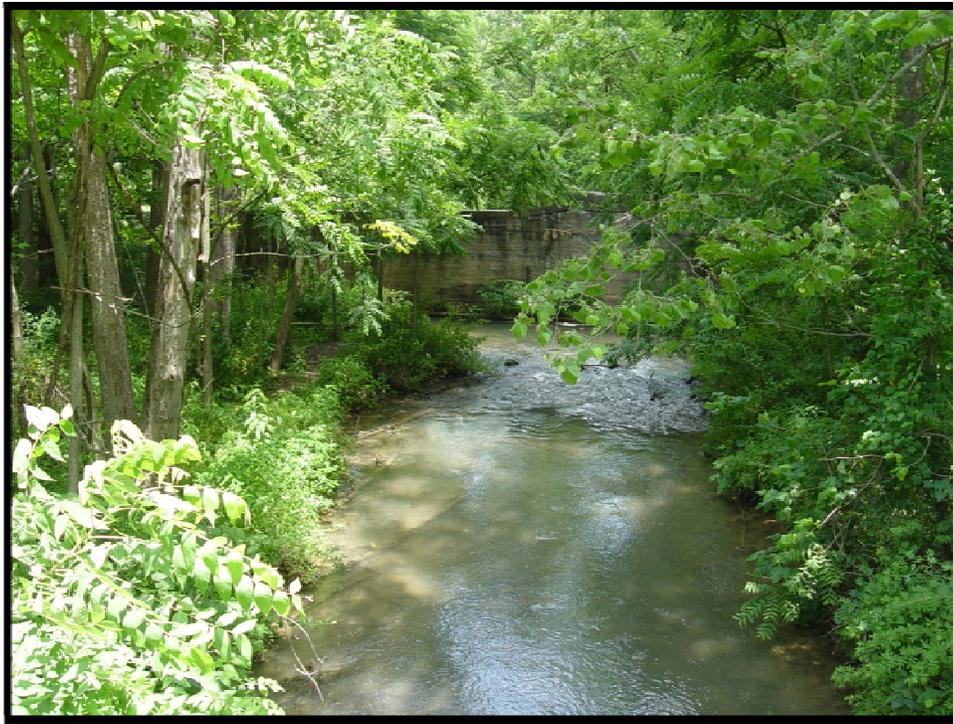
Figure 3. Upstream conditions

The areas directly upstream (**Figure 3**) and downstream (**Figure 4**) of the dam (excluding the bypass channel) show indices of a stable Rosgen C4 channel with well-defined characteristics and minimal instability. The width-to-depth ratio and entrenchment ratio are within acceptable ranges for a Rosgen C channel and particle distributions are consistent with the Rosgen C4 channel type as well. Channel stability could be compromised if the baypass channel continues to erode, however if measures are taken to remove the baypass channel, it is expected that the channel will remain stable. Any further assessment was unnecessary due to the limited complexity of the restoration design and limited extent of the proposed restoration project area.

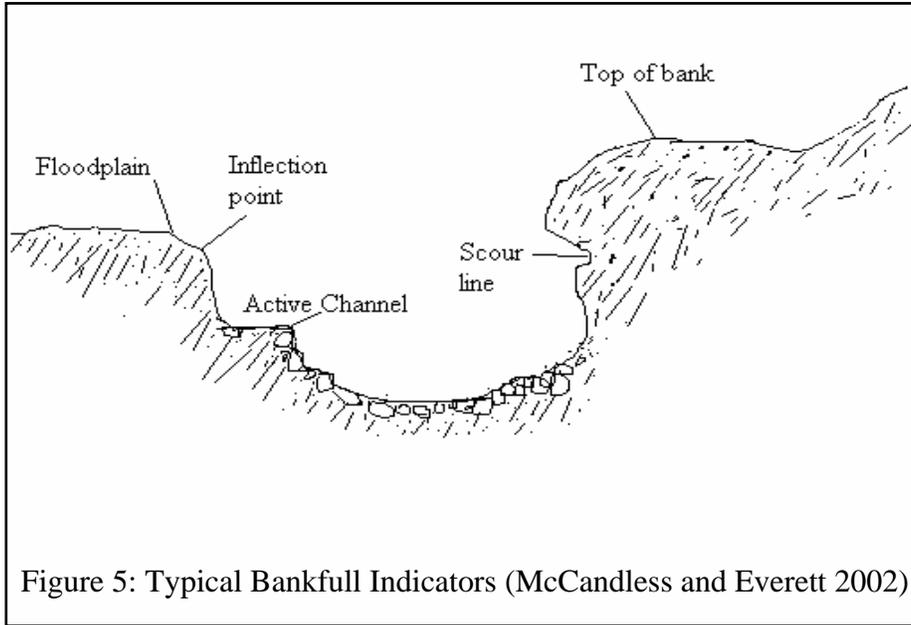
Figure 5: Typical Bankfull Indicators (McCandless and Everett 2002)

During the Mossy Creek assessment, the Service identified bankfull stage using physical indicators of bankfull stage described by McCandless and Everett (2002). **Figure 5** depicts significant geomorphic indicators typically found in the Mid-Atlantic Region. Based on these indicators, the Service identified a consistent geomorphic feature at Mossy Creek. This geomorphic indicator was typically a significant slope break associated with the floodplain that was found throughout the project area. The floodplains were well developed in this area and were typically the highest geomorphic feature adjacent to the stream.

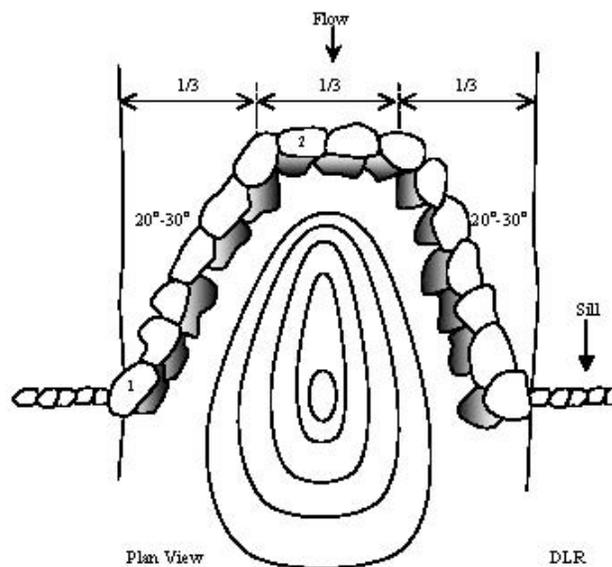
Figure 6. Cross-Vane in Plan View

The Cross-Vane (**Figure 6**) will establish grade control, reduce bank erosion, create a stable width/depth ratio, maintain channel capacity, while maintaining sediment transport capacity, and sediment competence. The Cross-Vane also provides for the proper natural conditions of secondary circulation patterns commensurate with channel pattern, but with high velocity gradients and boundary stress shifted from the near-bank region. The Cross-Vane is also a stream habitat improvement structure due to: 1) an increase in bank cover as a result to a differential raise of the ater surface in the bank region; 2) the creation of holding and refuge cover during both high and low flow periods in the deep pool; 3) the development of feeding lanes in the flow separation zones (the interface between fast and slow water) due to the strong down welling and upwelling forces in the center of the channel; and 4) the creation of spawning habitat in the tail-out or glide portion of the pool. (Rosgen, 2010)

Rock and log structures are instream structures, made of rocks or a combination of rocks and logs, that provide both lateral and vertical channel stability. They were developed by Wildland Hydrology, Inc. (2001) to reduce shear stress along the outer banks of meander curves and halt vertical degradation, but may be used also to steer and redirect the direction of flow through bends.
