United States Department of the Interior
Fish and Wildlife Service
Mid-Columbia Fish and Wildlife Conservation Office

MEMORANDUM

RE: Assessing Fish Passage at Leavenworth National Fish Hatchery using DIDSON Sonar

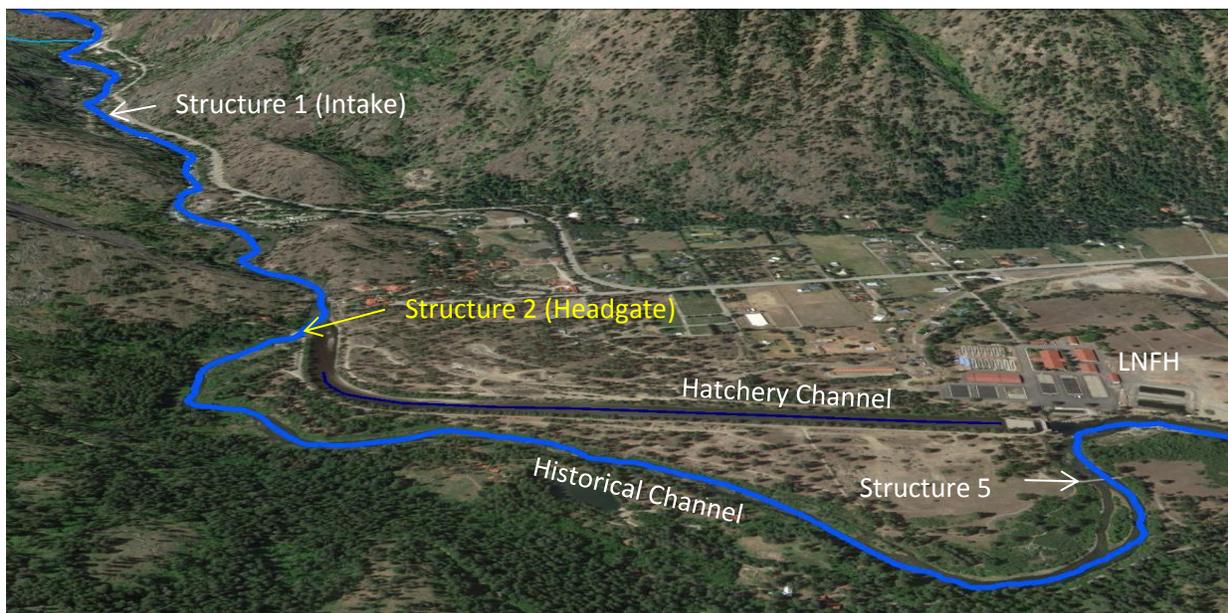
Figure 1 Leavenworth National Fish Hatchery

Leavenworth National Fish Hatchery (LNFH) has operated several water diversion structures since its construction in 1939. One of these structures, Structure 2, is a channel-spanning diversion dam consisting of two, 5ft x 16ft radial gates (Figure 1, 2). Using one or both of the steel radial gates, water can be diverted away from the Historical Channel and into the Hatchery Channel (Figure 3). Structure 2 has been operated in the previous years for multiple reasons, including, seasonal flood control through the Historical Channel, groundwater aquifer recharge and to generate attraction flows for broodstock collection. (Anglin, 2013). However, Structure 2 can impede fish passage under high and low flow conditions (high velocity and inadequate depths, respectively (Anglin, 2013)).

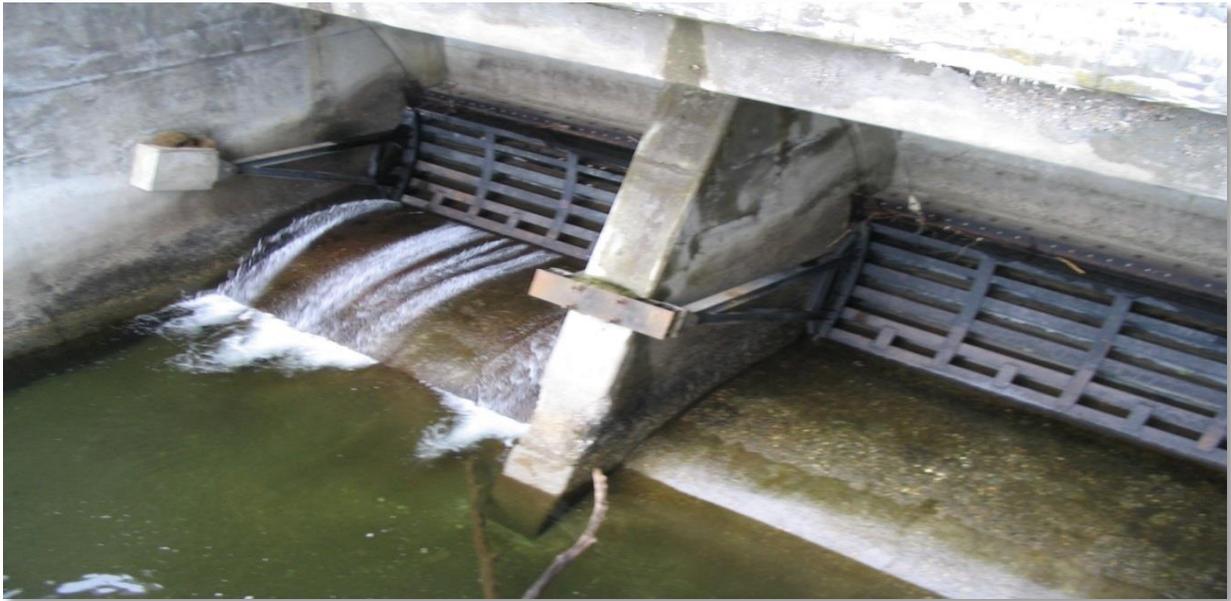
Figure 2. Structure 2 radial gates in a closed position.
