MOORES RUN, BALTIMORE CITY, MARYLAND 2007 ABBREVIATED GEOMORPHIC CONDITION AND CHANNEL STABILITY RESURVEY

By: Sandra L. Davis and Richard R. Starr

Stream Habitat Assessment and Restoration Program
U.S. Fish and Wildlife Service
Chesapeake Bay Field Office

CBFO-S08-02

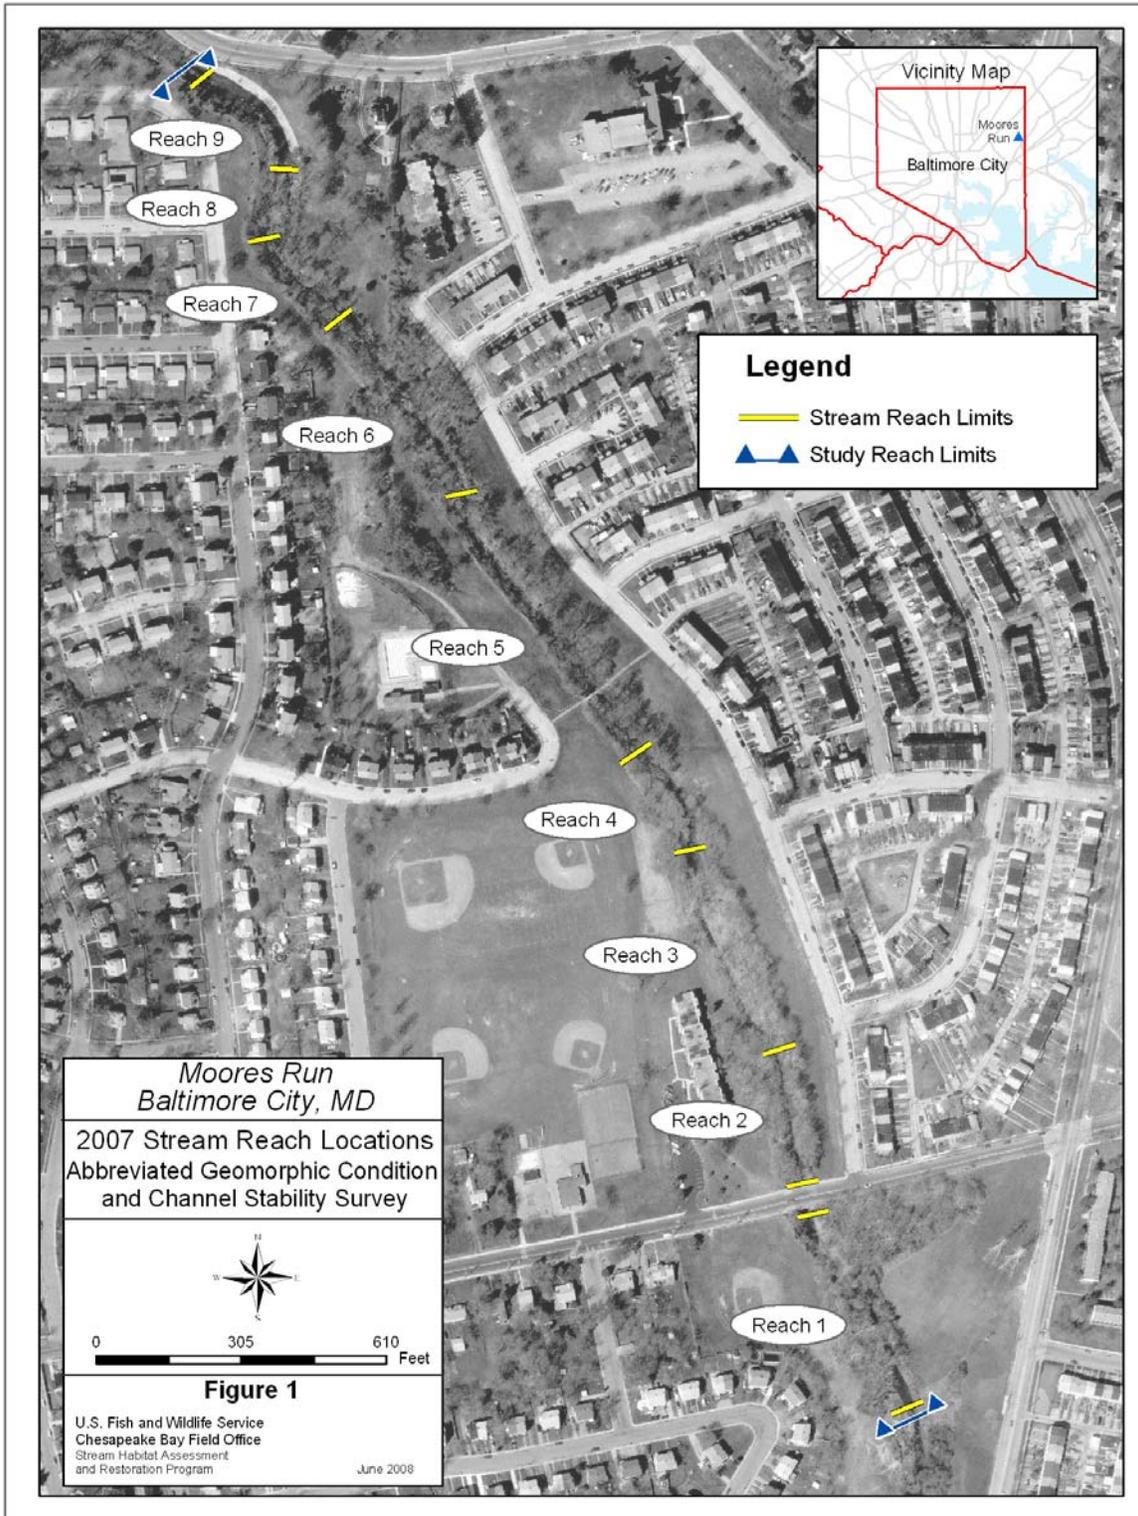
In 2003, the Service divided Moores Run into nine stream reaches based on geomorphic characteristics and stability conditions (Table 1). Since the stream type and stability conditions of the reaches did not significantly change, the 2007 resurvey of Moores Run was conducted on the same nine reaches originally identified (Figure 1).

Figure 1. Moores Run, Baltimore City, MD. 2007 Stream Reach Locations.....	2
Figure 2. Moores Run, Baltimore City, MD. 2007 Cross Section Locations.....	6
Figure 3. Moores Run, Baltimore City, MD. 2007 Reach BEHI Locations.....	15

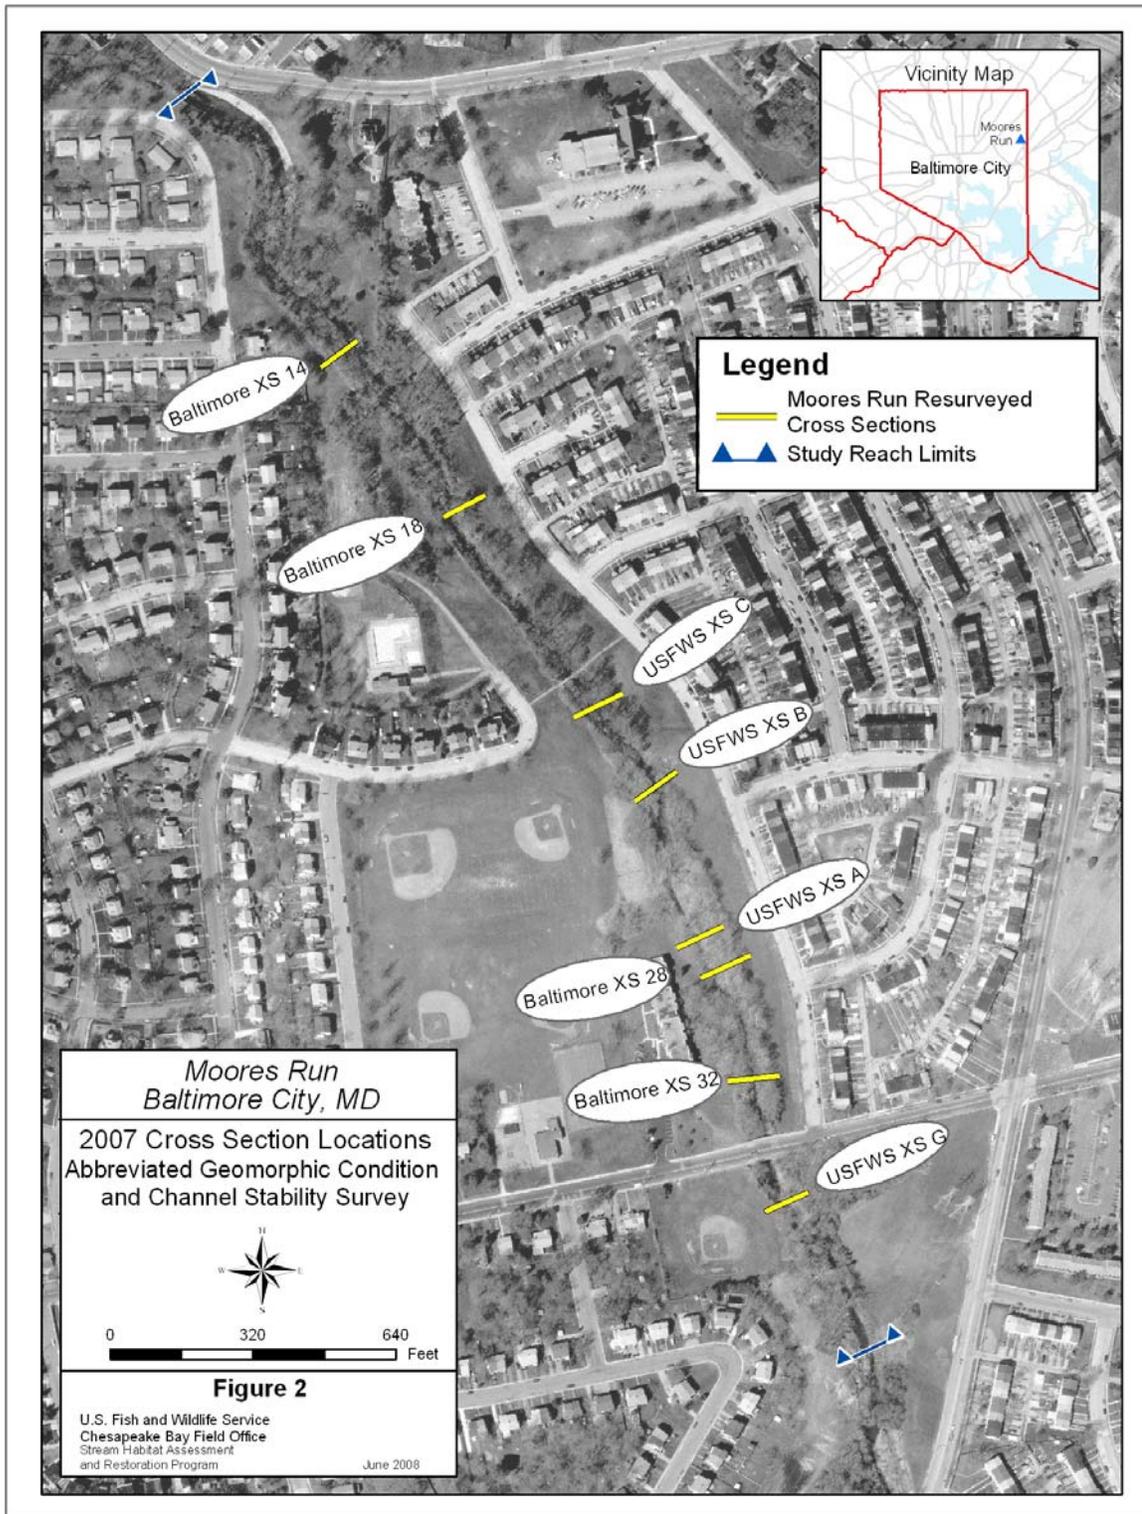
In order to reassess channel stability conditions and to validate erosion rates the Service resurveyed the eight cross sections selected in 2005 (Figure 2). The cross sections selected represented the range of conditions present in Moores Run (Eng *et al.* 2007). The Service did not survey the remaining cross sections established in 2003 by the City of Baltimore and the Service because they represent duplicate bank erosion conditions, less dominant bank

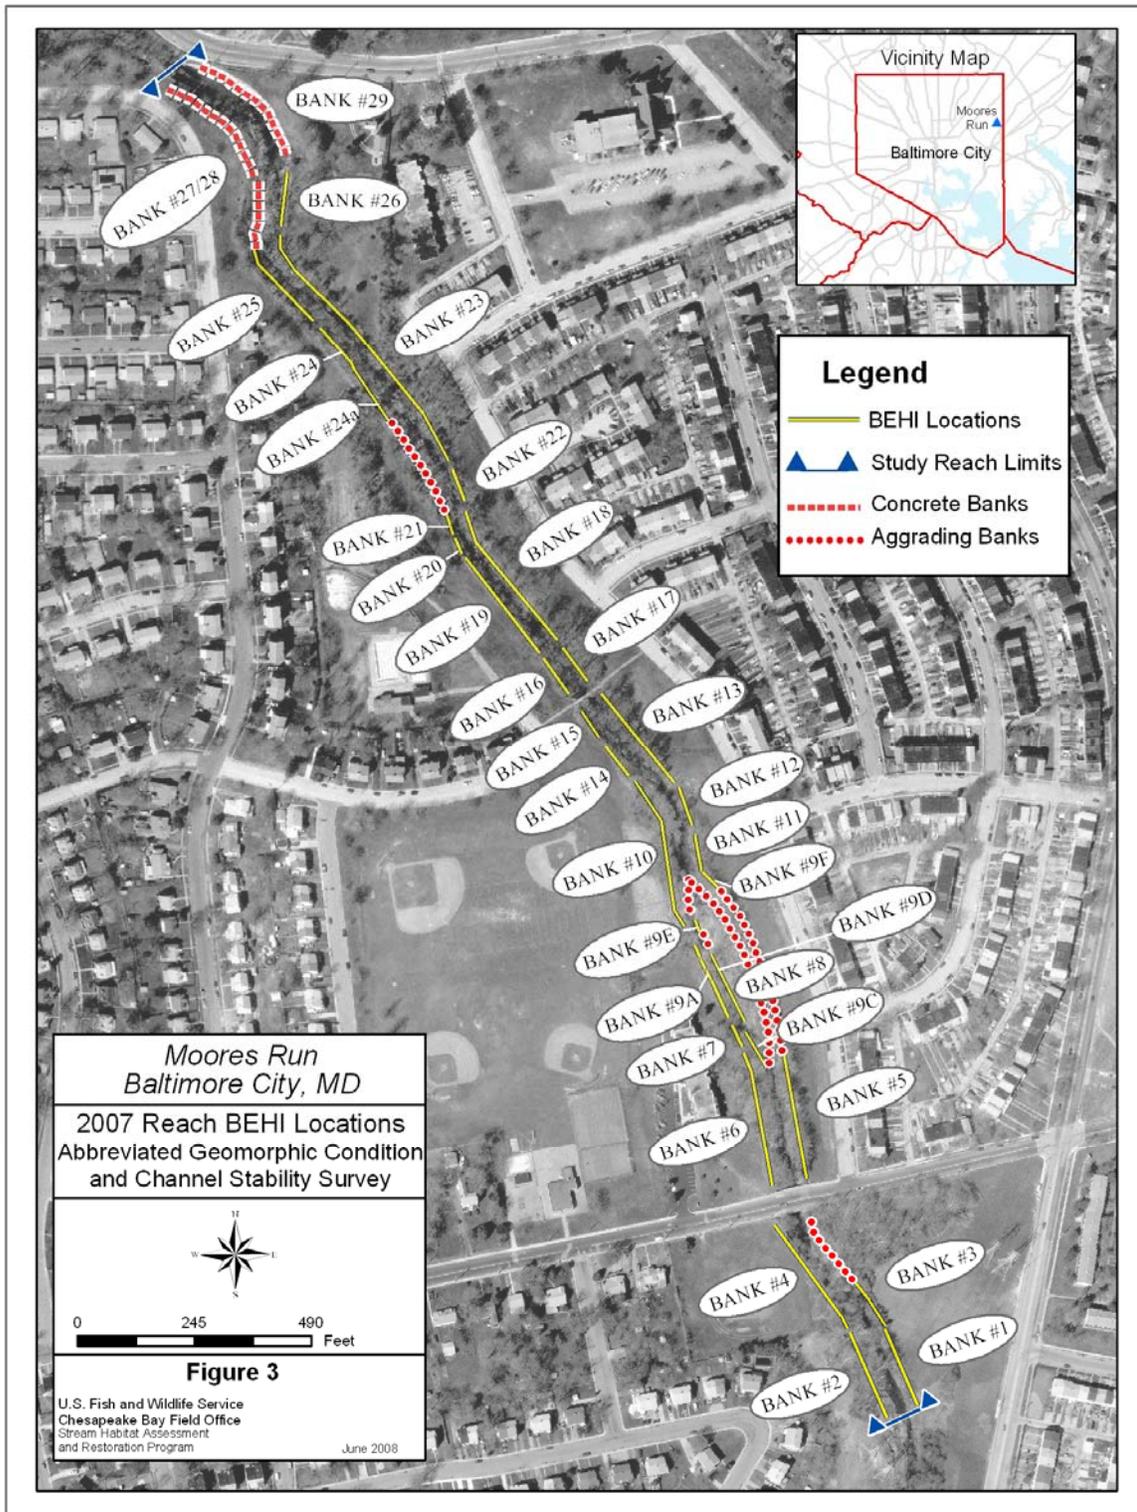
For the 2007 survey, the Service assessed 4,783 feet of stream bank of the total 6,716 feet of bank (Figure 3). The Service did not assess banks in Reach 09 because of an on-going bank stabilization project. A summary of the reach BEHIs and NBS ratings are provided in Table 11. A geomorphic map with detailed 2007 BEHI bank locations is located in Appendix C. BEHI ratings range from low to extreme. The low ratings represent 27 percent of the banks while the moderate rating represents 27 percent of the banks. The high and very high ratings represent 45 percent. The extreme rating represents approximately 1 percent of the banks. NBS ratings range from low to high, with the low rating representing 67 percent of banks and the moderate rating representing 26 percent of banks. The high NBS rating represents the remaining 7 percent of banks.
