CLIFFORD BRANCH DAM REMOVAL AND RESTORATION, FREDERICK COUNTY, MARYLAND: PROJECT SUMMARY AND DESIGN REPORT

Stream Habitat Assessment and Restoration Program
U.S. Fish and Wildlife Service
Chesapeake Bay Field Office

CBFO – S12 - 01

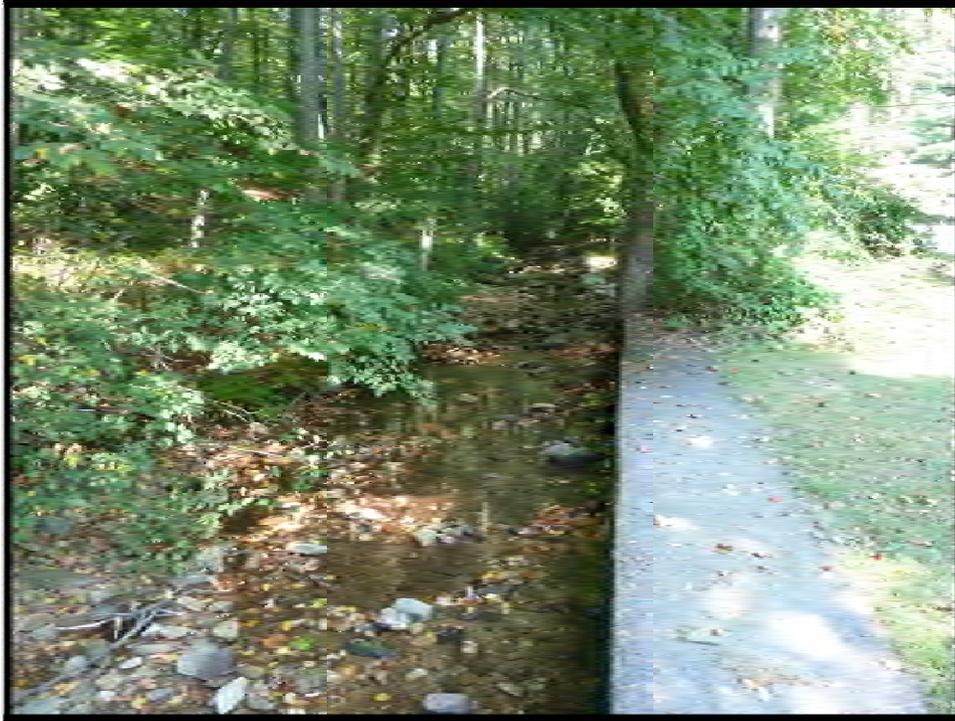
Figure 1. Project area (Looking upstream from dam)

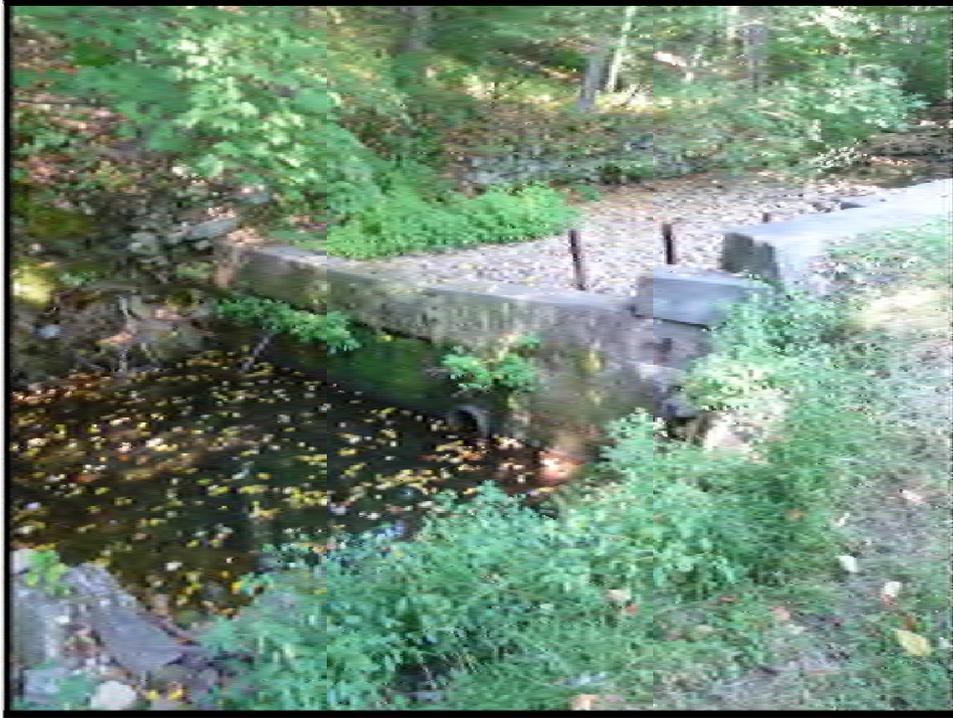
Figure 2. Clifford Branch Dam

The Service found that the dam is a blockage to Brook trout passage on Clifford Branch (**Figure 2**). The dam is approximately 4 feet high and 20 feet wide and allows a small portion of water to flow over its crest into a plunge pool approximately 5 feet deep. Water continues to be redirected through the intake structure, which is piped downstream approximately 200 feet. During periods of low flow, all water moves through this intake and cuts off flowing water to a portion of Clifford Branch. During high flow events, the dam is still a complete fish blockage to Brook trout. Brook trout typically can only jump blockages with heights up to 4 - 5 times their body length if provided with an approach pool of 3 – 4 times their body length. However, blockages over 90cm prove impassable regardless of fish size, or pool depth (Kondratieff and Myrick 2005).

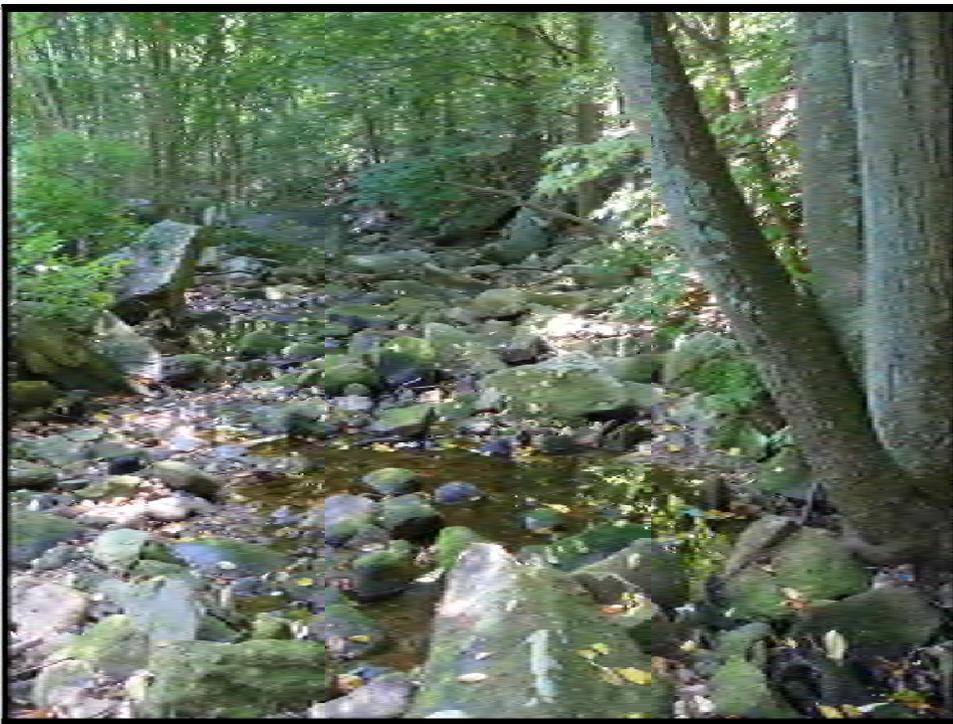
Figure 3. Stable downstream conditions

The areas directly upstream and downstream of the dam show indices of a stable Rosgen B3 channel with well-defined characteristics and only minimal and localized instability (**Figure 3**). The width-to-depth ratio and entrenchment ratio are within acceptable ranges for a Rosgen B channel and particle distributions are consistent with the Rosgen B3 channel type as well. Post dam removal the stream is expected to remain and function as a stable B3 channel due to the fact that the proposed design will mimic the stable channel geometry found upstream and downstream of the project area. Any further assessment was unnecessary due to the limited complexity and extent of the restoration design.

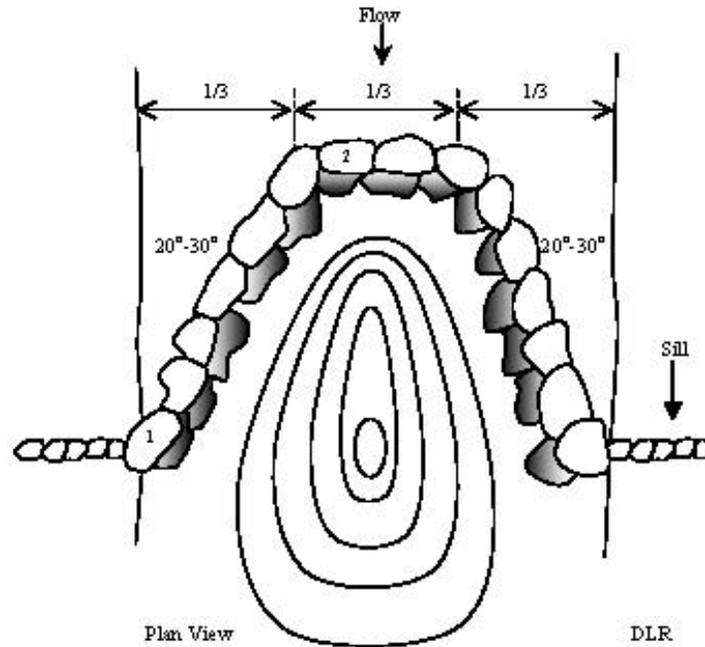
Figure 5. Cross-Vane in Plan View

The Cross-Vane (**Figure 5**) will establish grade control, reduce bank erosion, create a stable width/depth ratio, maintain channel capacity, while maintaining sediment transport capacity, and sediment competence. The Cross-Vane also provides for the proper natural conditions of secondary circulation patterns commensurate with channel pattern, but with high velocity gradients and boundary stress shifted from the near-bank region. The Cross-Vane is also a stream habitat improvement structure due to: 1) an increase in bank cover as a result to a differential raise of the ater surface in the bank region; 2) the creation of holding and refuge cover during both high and low flow periods in the deep pool; 3) the development of feeding lanes in the flow separation zones (the interface between fast and slow water) due to the strong down welling and upwelling forces in the center of the channel; and 4) the creation of spawning habitat in the tail-out or glide portion of the pool. (Rosgen, 2010)

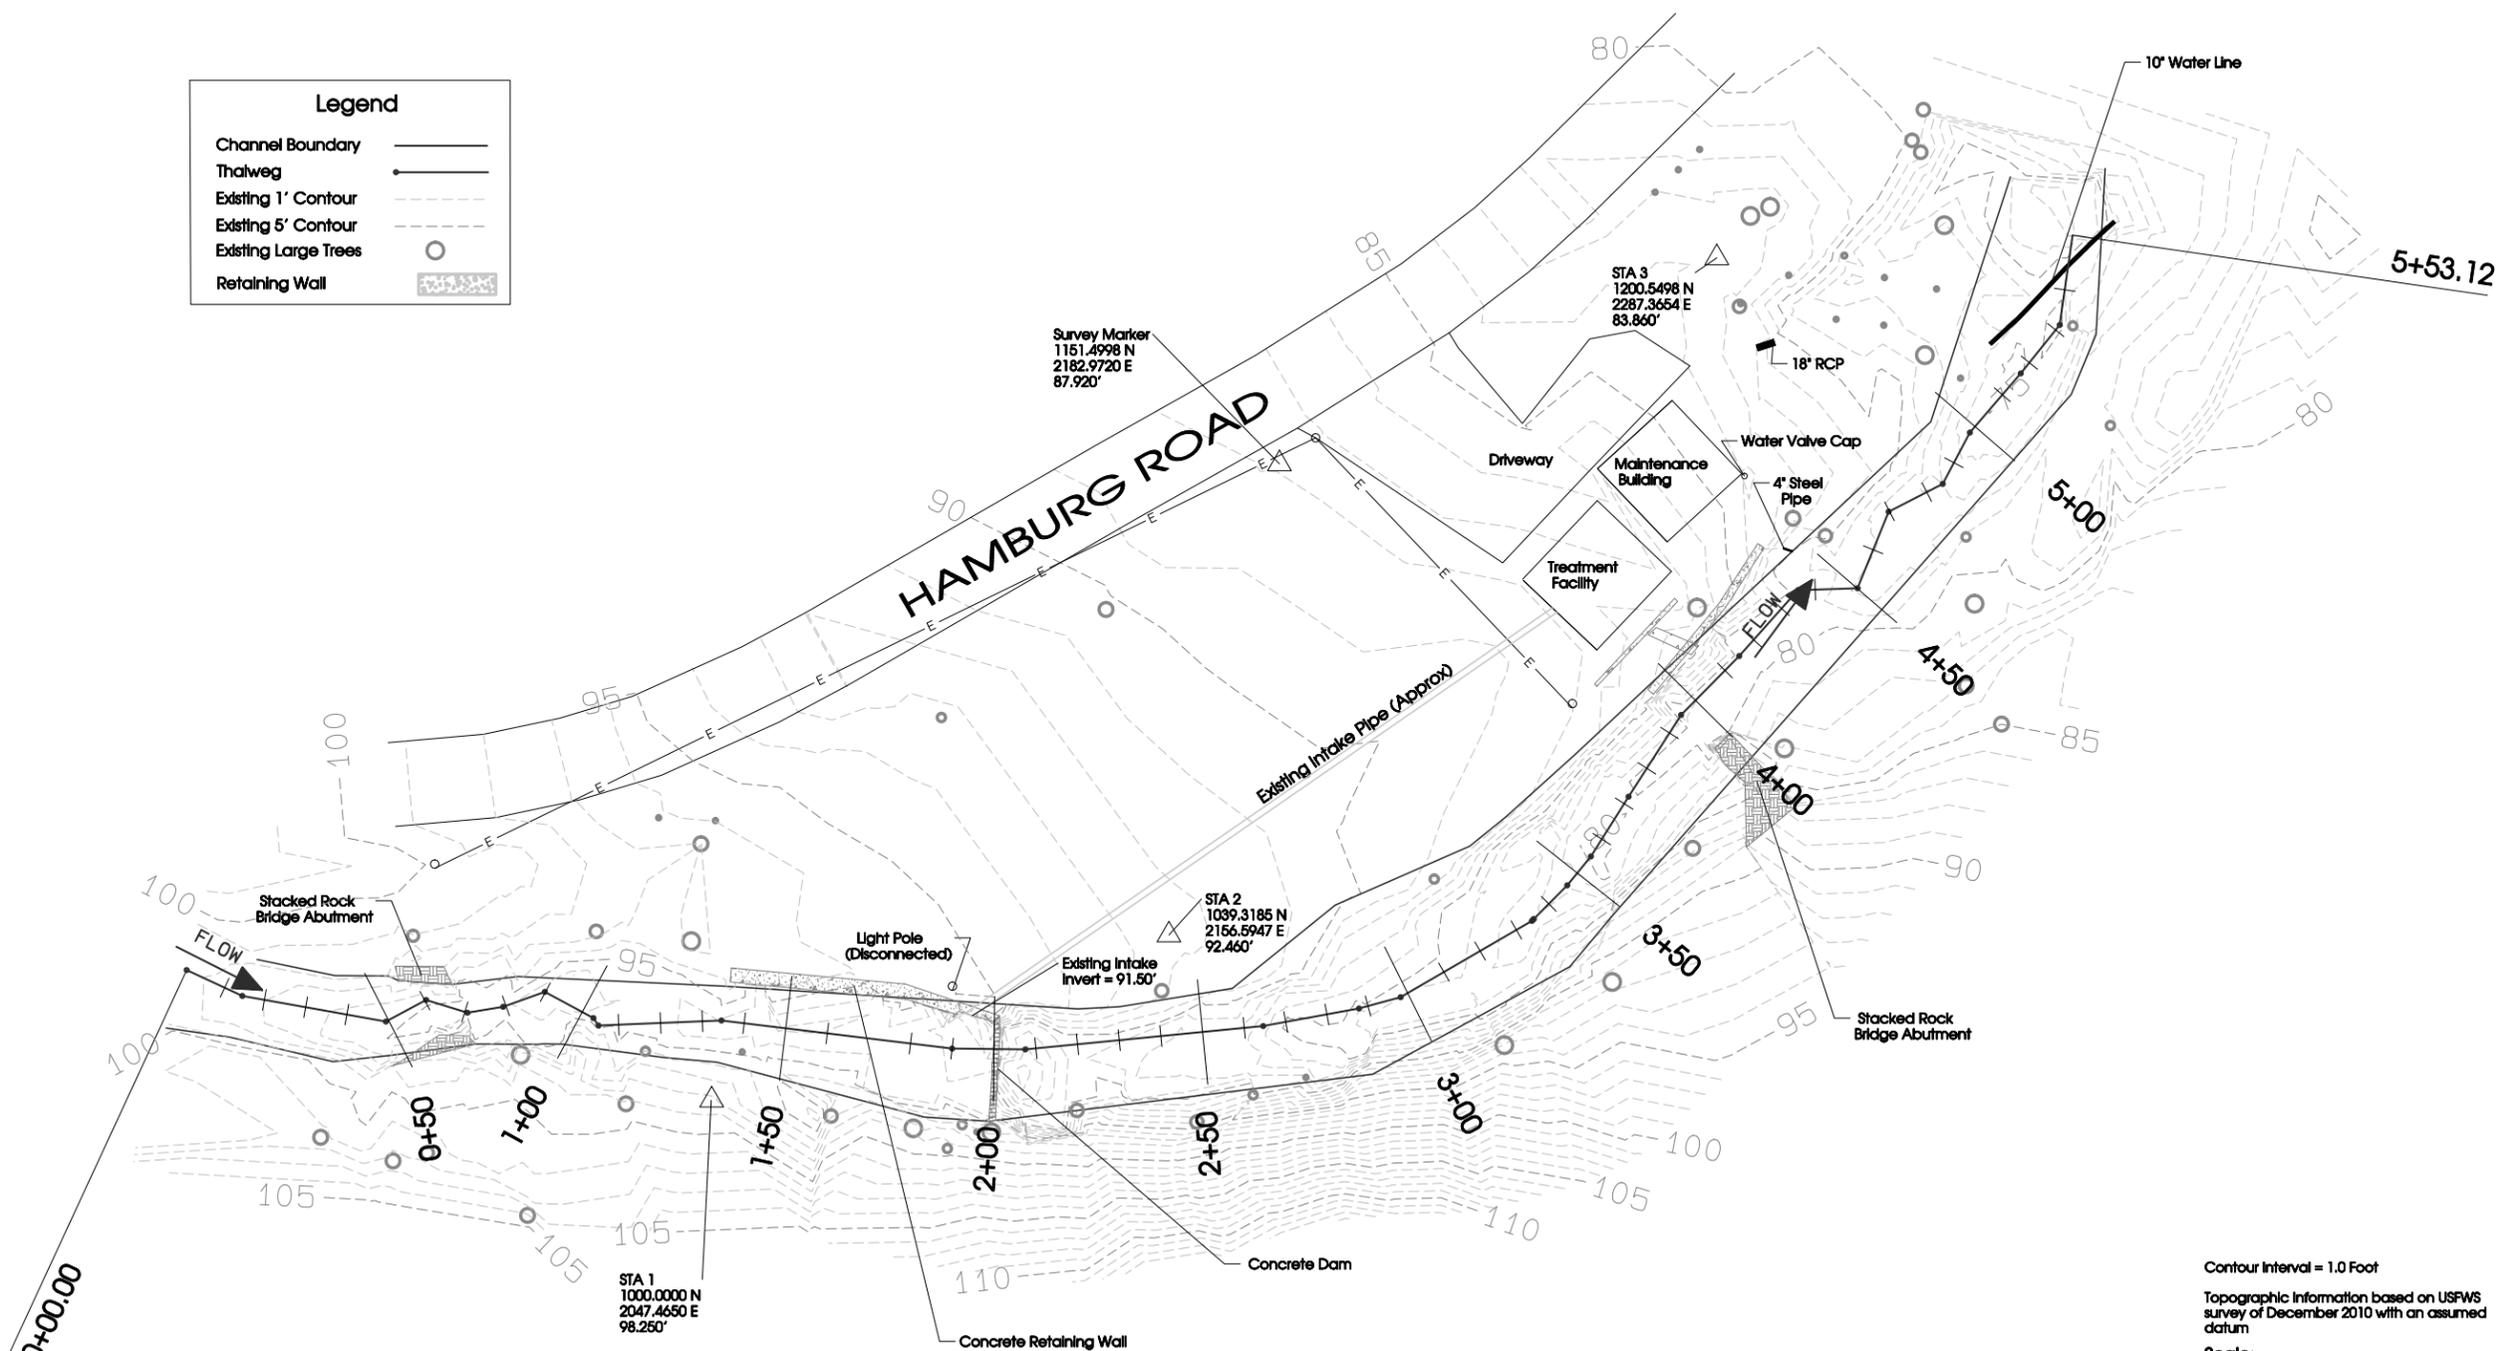
Contour Interval = 1.0 Foot
 Topographic Information based on USFWS survey of December 2010 with an assumed datum
 Scale:

Clifford Branch
 Frederick County, MD
 100% Design
 Existing Conditions

The Service conducted a baseline survey and produced 1-foot ground survey information to accurately map (**Appendix A**) and represent the project area. This Service used this information to assess base line conditions and to develop and illustrate a restoration design plan. Plan form, longitudinal profile, and topographic information is represented.

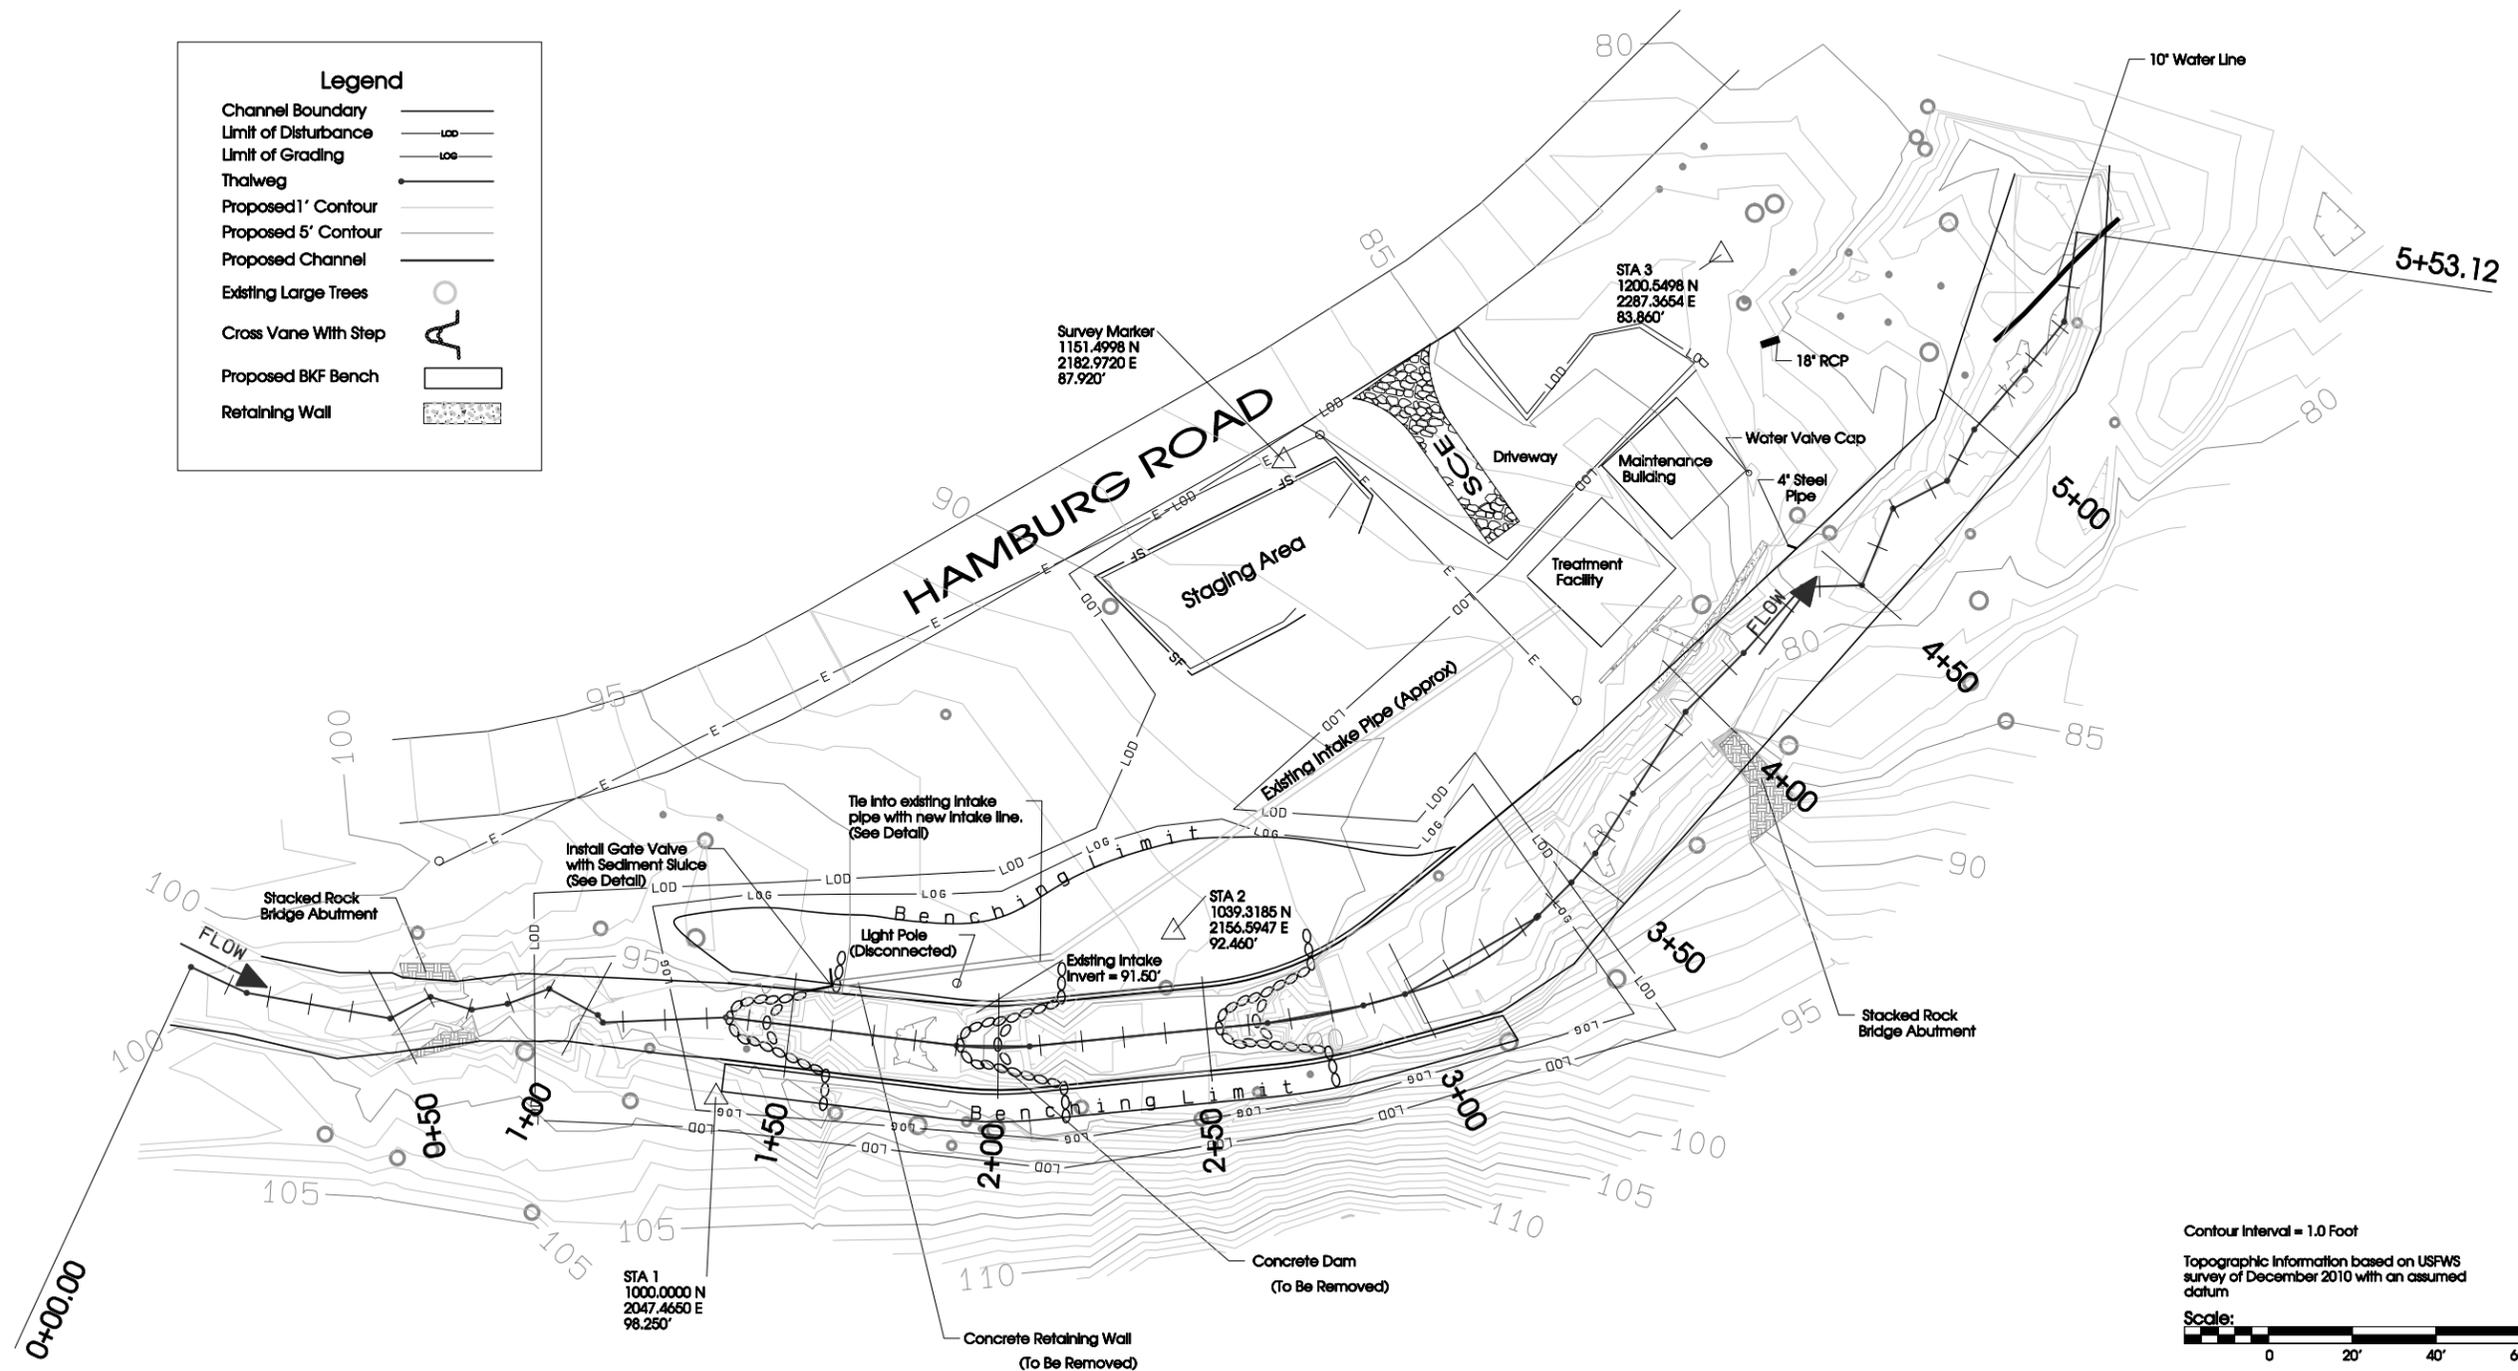
Contour Interval = 1.0 Foot
 Topographic Information based on USFWS survey of December 2010 with an assumed datum
 Scale:

Clifford Branch
 Frederick County, MD
 100% Design
 Proposed Conditions
