Comprehensive Monitoring in Red Hill Branch Subwatershed, Howard County, Maryland

Our Best Chance to Show Restoration Success

*Mid-Atlantic Stream Restoration Conference
November 16, 2011*

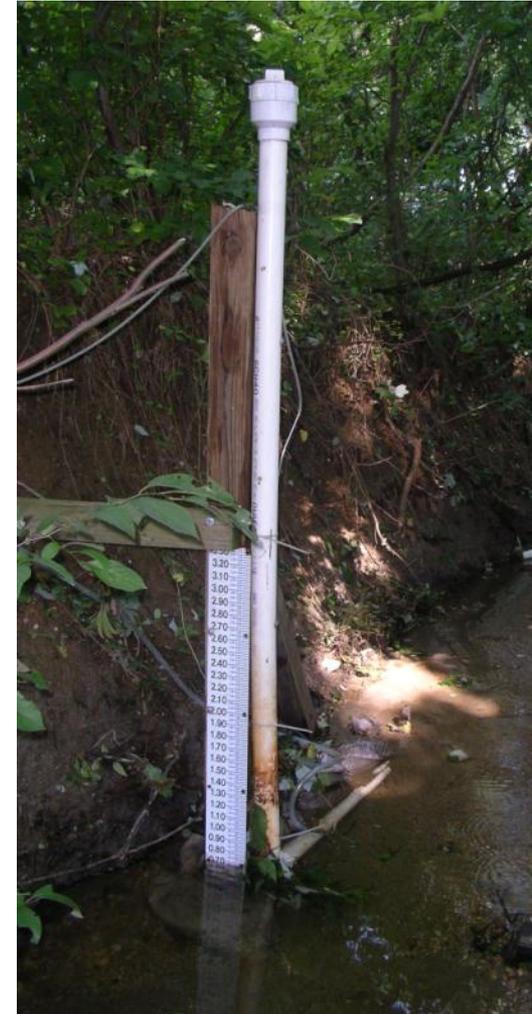
Continuous Discharge Monitoring

- **Continuous flow data have been collected in partnership with Maryland Department of Natural Resources**
- **Flow data are undergoing QC and verification, and are not available at this time**
- **Accurate flow data required for estimation of loads and quantifying load reductions**

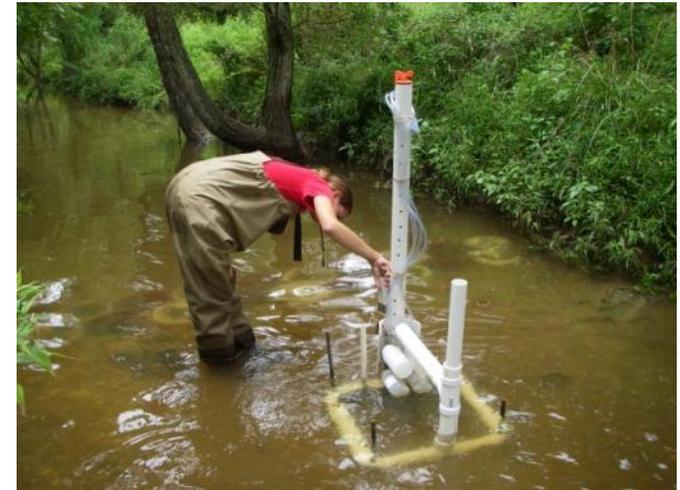
- **Suspended sediment monitored during storm events with siphon sampler**
- **Allows samples to be collected at multiple stages of the rising limb of the hydrograph**
- **Relating to gauge discharge data will enable creation of sediment transport curve**

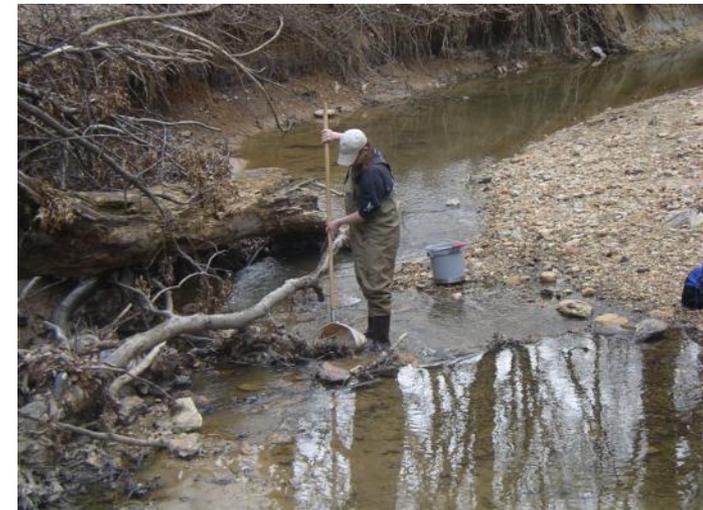
- **Biological conditions stable across the two years**
- **BIO-2 showed additional degradation in 2011**
- **All sites with degraded benthic communities**

SITE	2010 BIBI		2011 BIBI	
BIO-1	1.67	Very Poor	1.67	Very Poor
BIO-2	2.67	Poor	1.67	Very Poor
BIO-3	2.33	Poor	2.33	Poor
BIO-4	1	Very Poor	1.67	Very Poor

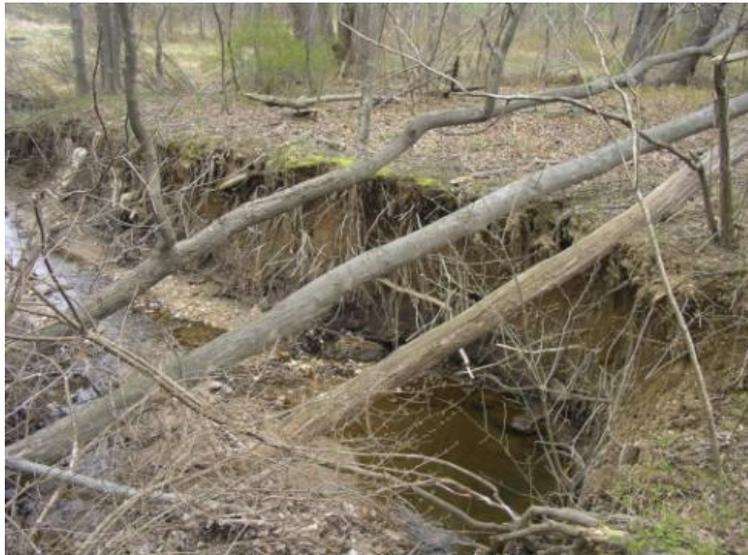
- Physical Habitat Assessment scores consistently indicate degraded conditions across all sites and years

Site	2010 RBP		2011 RBP	
	Score	Category	Score	Category
BIO-1	58.5	Non-Supporting	58.6	Non-Supporting
BIO-2	60	Partially Supporting	59.7	Non-Supporting
BIO-3	60	Partially Supporting	72.4	Partially Supporting
BIO-4	60.5	Partially Supporting	65.8	Partially Supporting

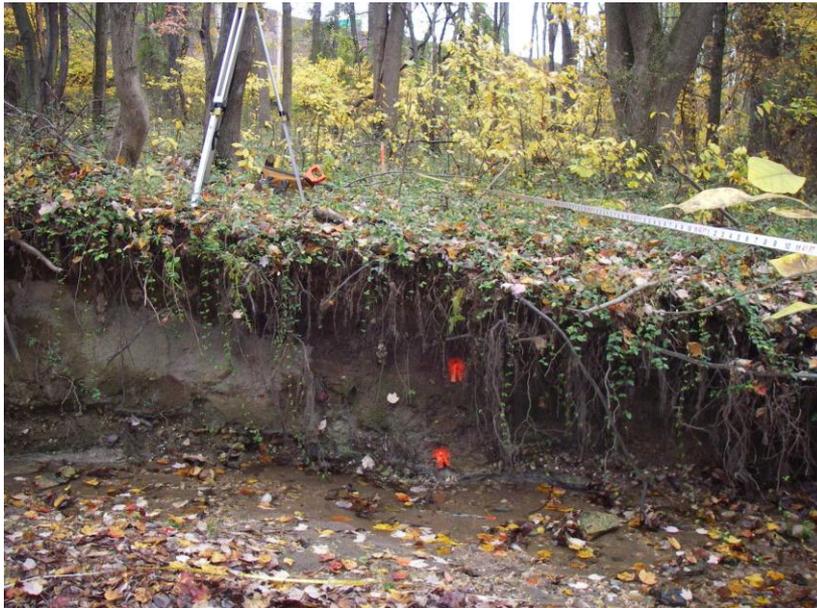
Bank Pins

Bed and Bank Erosion

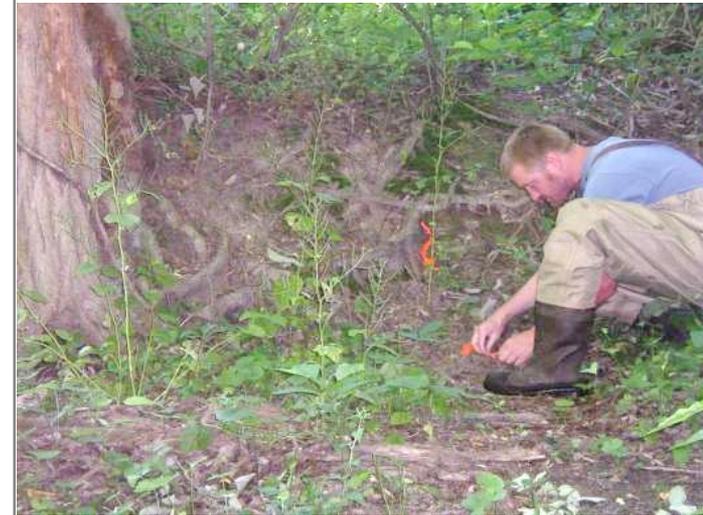
Bramhope Upstream Reach (BH01-GEO) Bank Erosion Rates

Example Bank Pin Data

Bankpin stations listed left to right from downstream to upstream.

1st Letter: R = Right bank facing downstream/ L = Left bank facing downstream;
 2nd Letter: U = Upper/ L = Lower/
 T = Toe;
 3rd Letter: O = Outer/ I = Inner
