United States Department of the Interior  
Fish and Wildlife Service  
Mid-Columbia Fish and Wildlife Conservation Office

**MEMORANDUM**

**RE: Assessing Fish Passage at Leavenworth National Fish Hatchery using DIDSON Sonar**

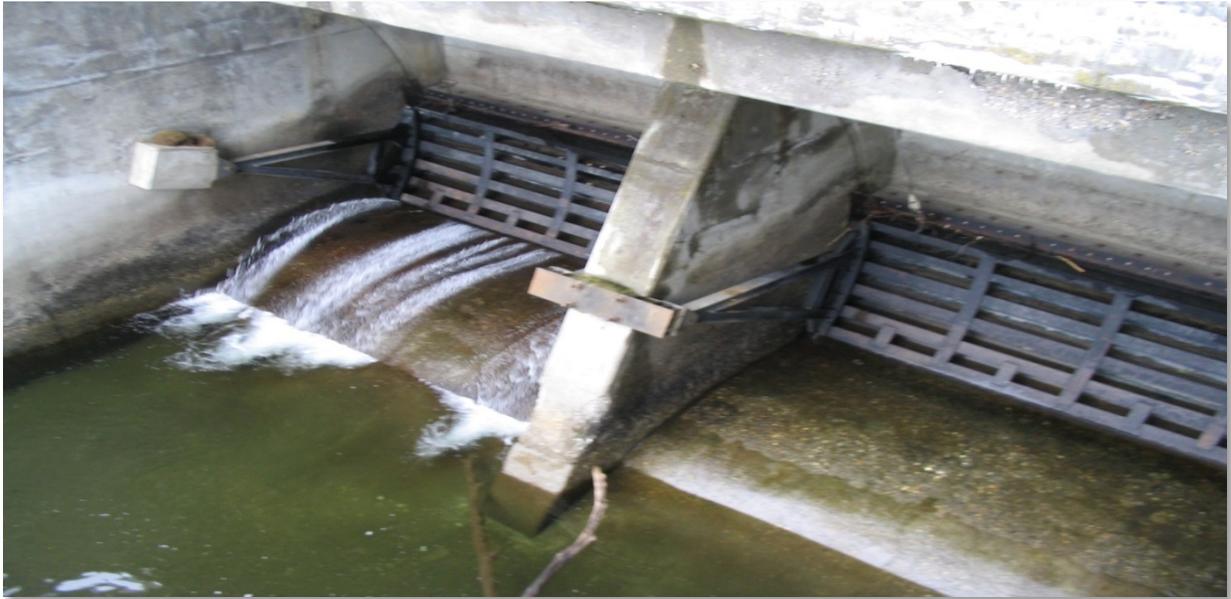
Figure 2. Structure 2 radial gates in a closed position.

Leavenworth National Fish Hatchery (LNFH) has operated several water diversion structures since its construction in 1939. One of these structures, Structure 2, is a channel-spanning diversion dam consisting of two, 5ft x 16ft radial gates (Figure 1, 2). Using one or both of the steel radial gates, water can be diverted away from the Historical Channel and into the Hatchery Channel (Figure 3). Structure 2 has been operated in the previous years for multiple reasons, including, seasonal flood control through the Historical Channel, groundwater aquifer recharge and to generate attraction flows for broodstock collection. (Anglin, 2013). However, Structure 2 can impede fish passage under high and low flow conditions (high velocity and inadequate depths, respectively (Anglin, 2013)).
