## FIGURES

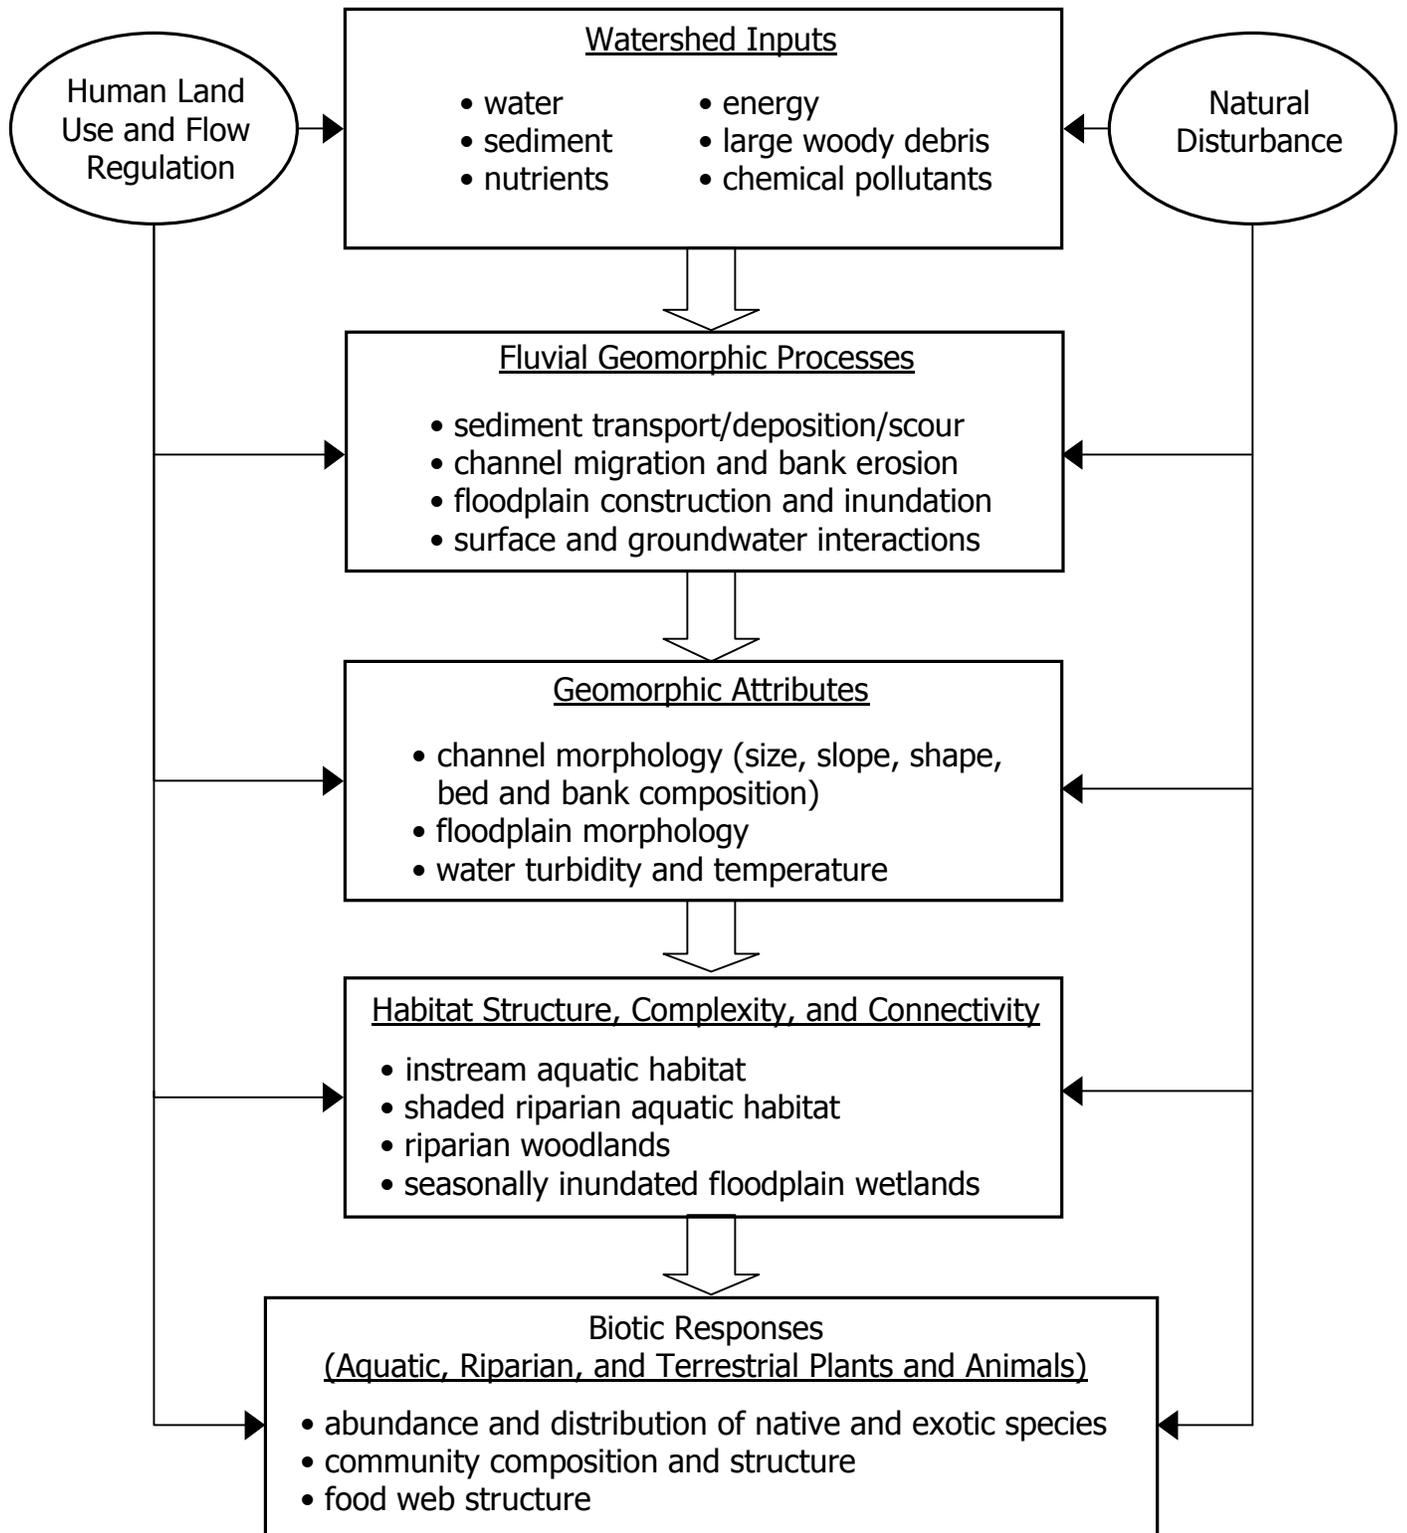
**Figure 2-1. A simplified conceptual model of the physical and ecological linkages in alluvial river-floodplain systems.**

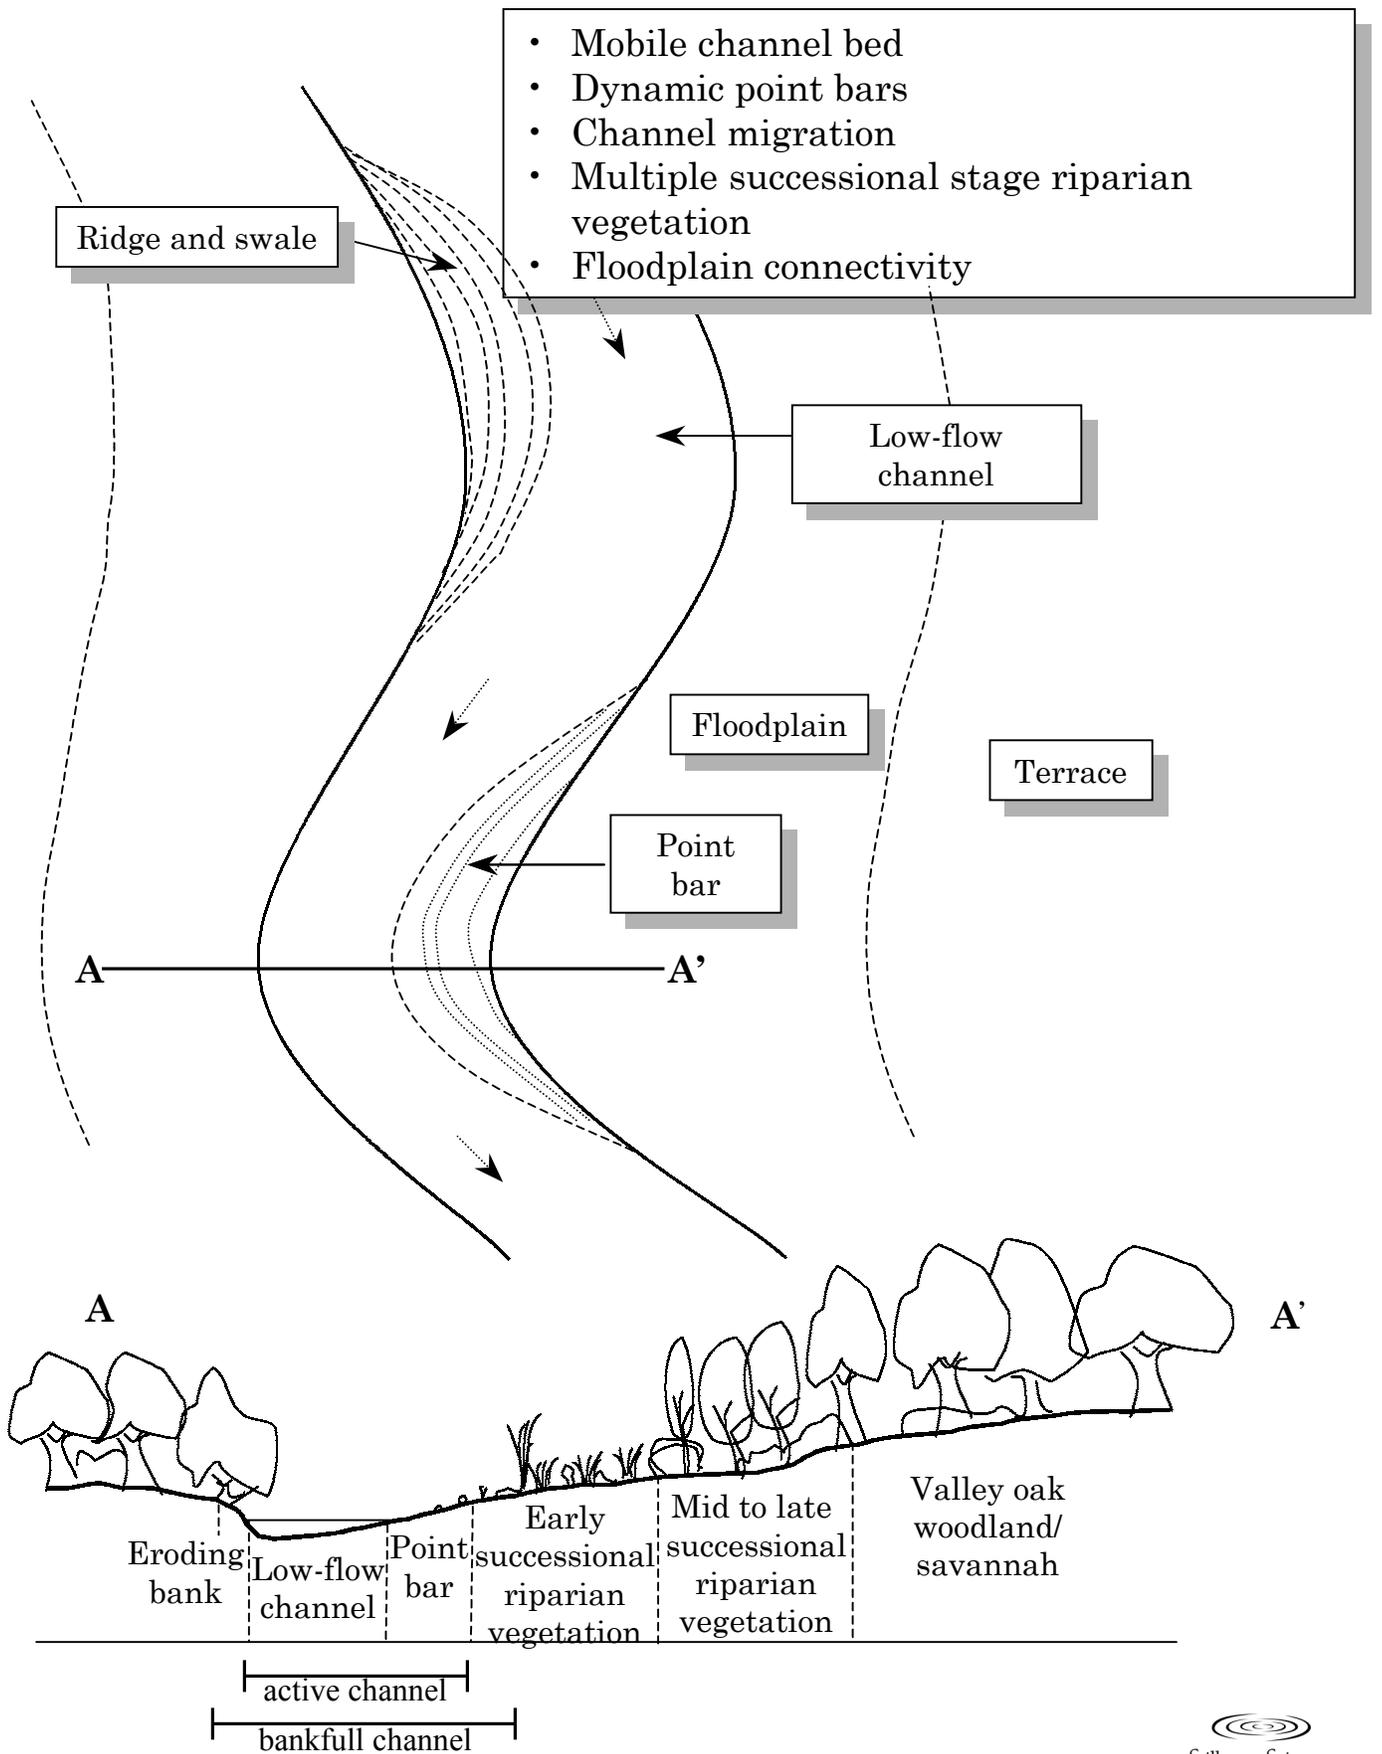
**Figure 2-2. Conceptual diagram of a "healthy" alluvial river system.**

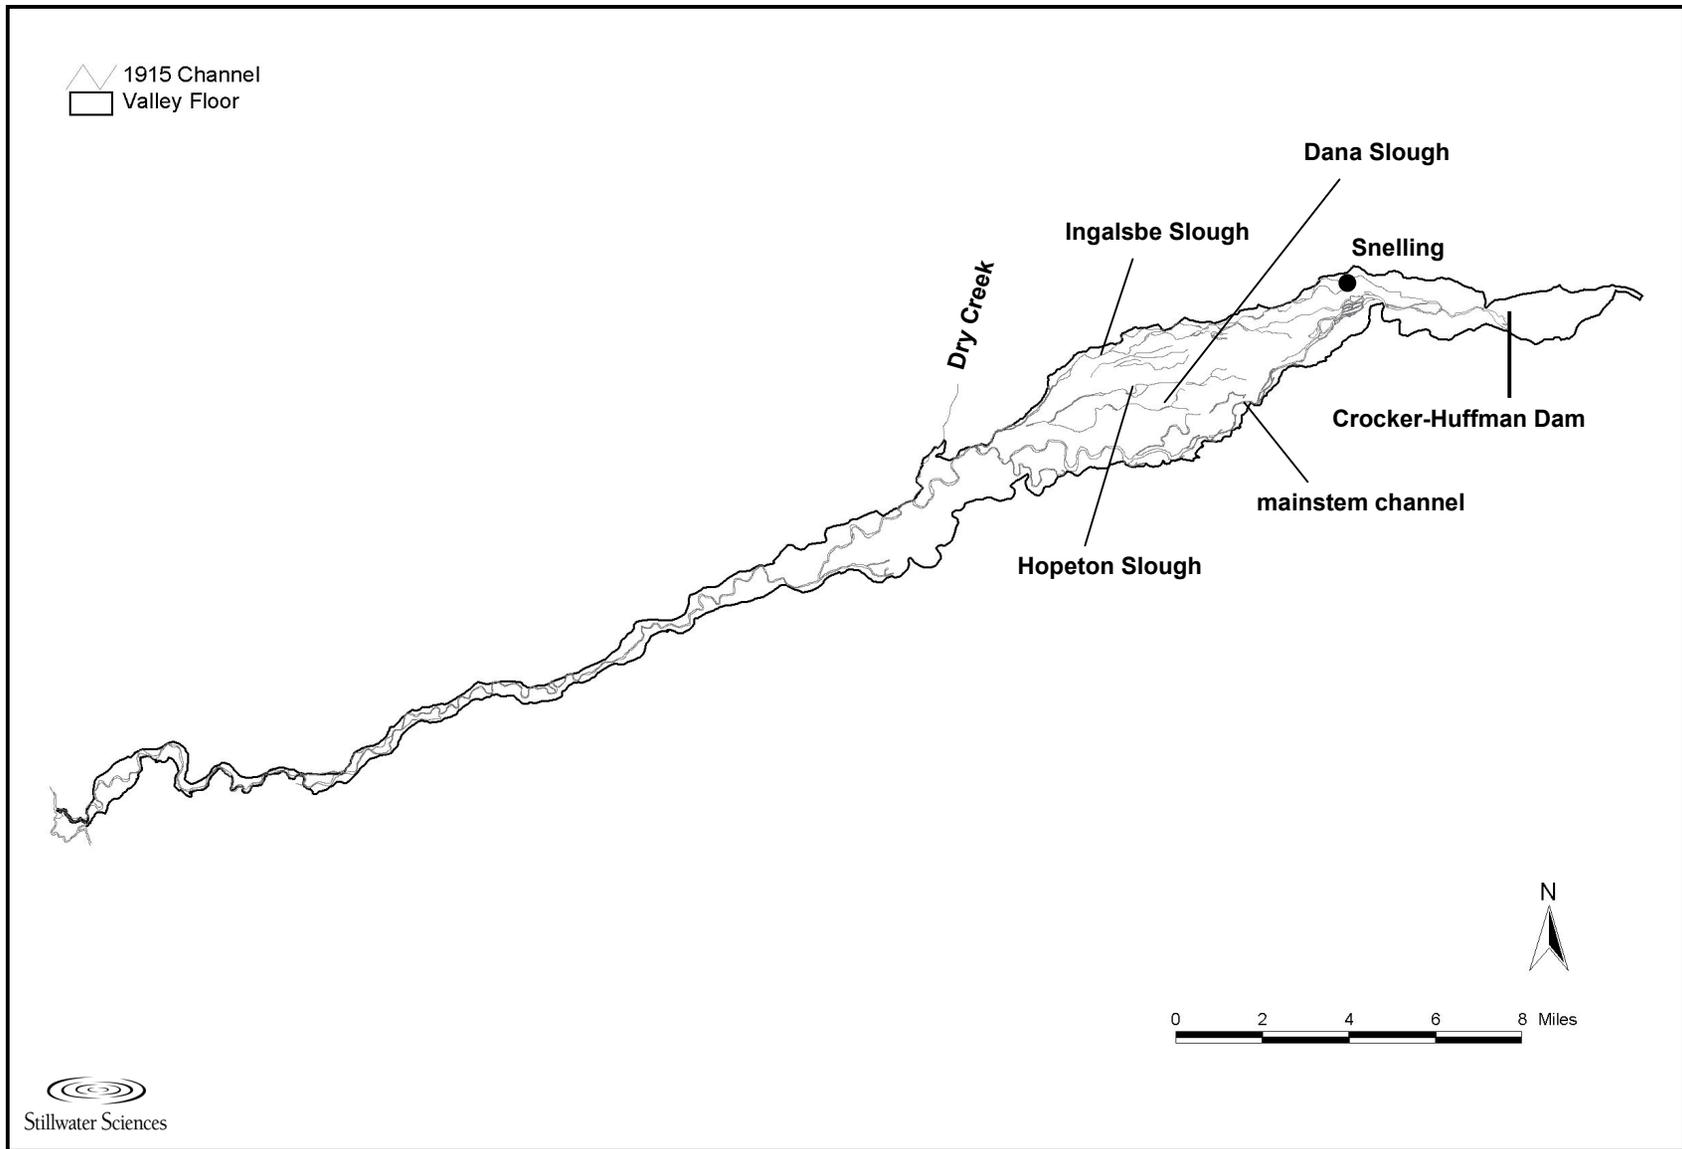
**Figure 3.1-2. Merced River alluvial valley floor boundary and 1915 channel alignment.**

(The alluvial valley floor was identified and digitized using geologic maps and 1:24,000-scale topographic maps. The 1915 channel alignment was digitized from historical 1:31,680-scale topographic maps.)

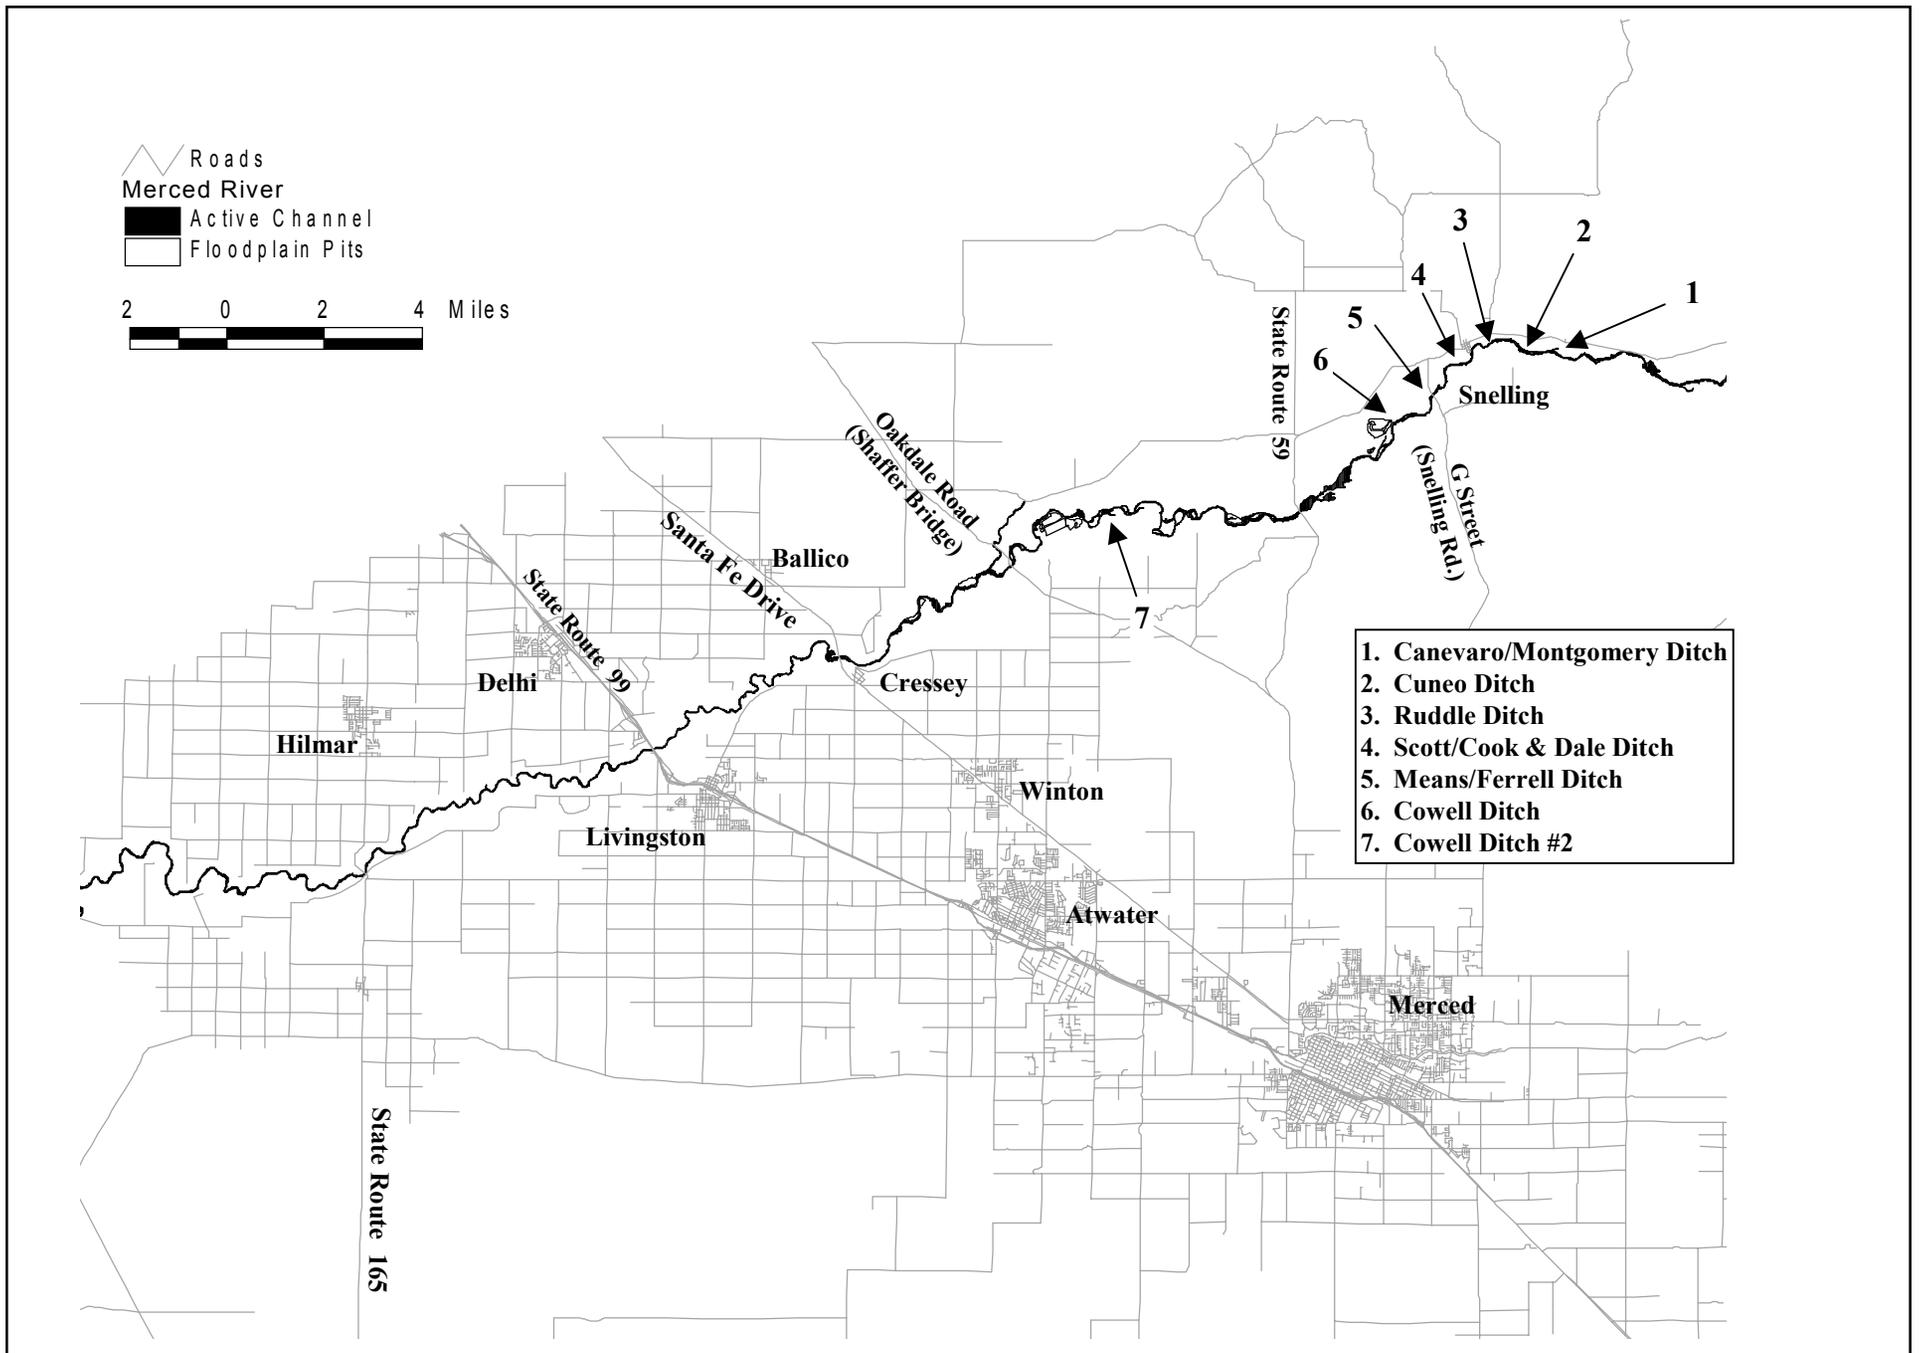
**Figure 3.1-3. Merced River riparian water diversions.**

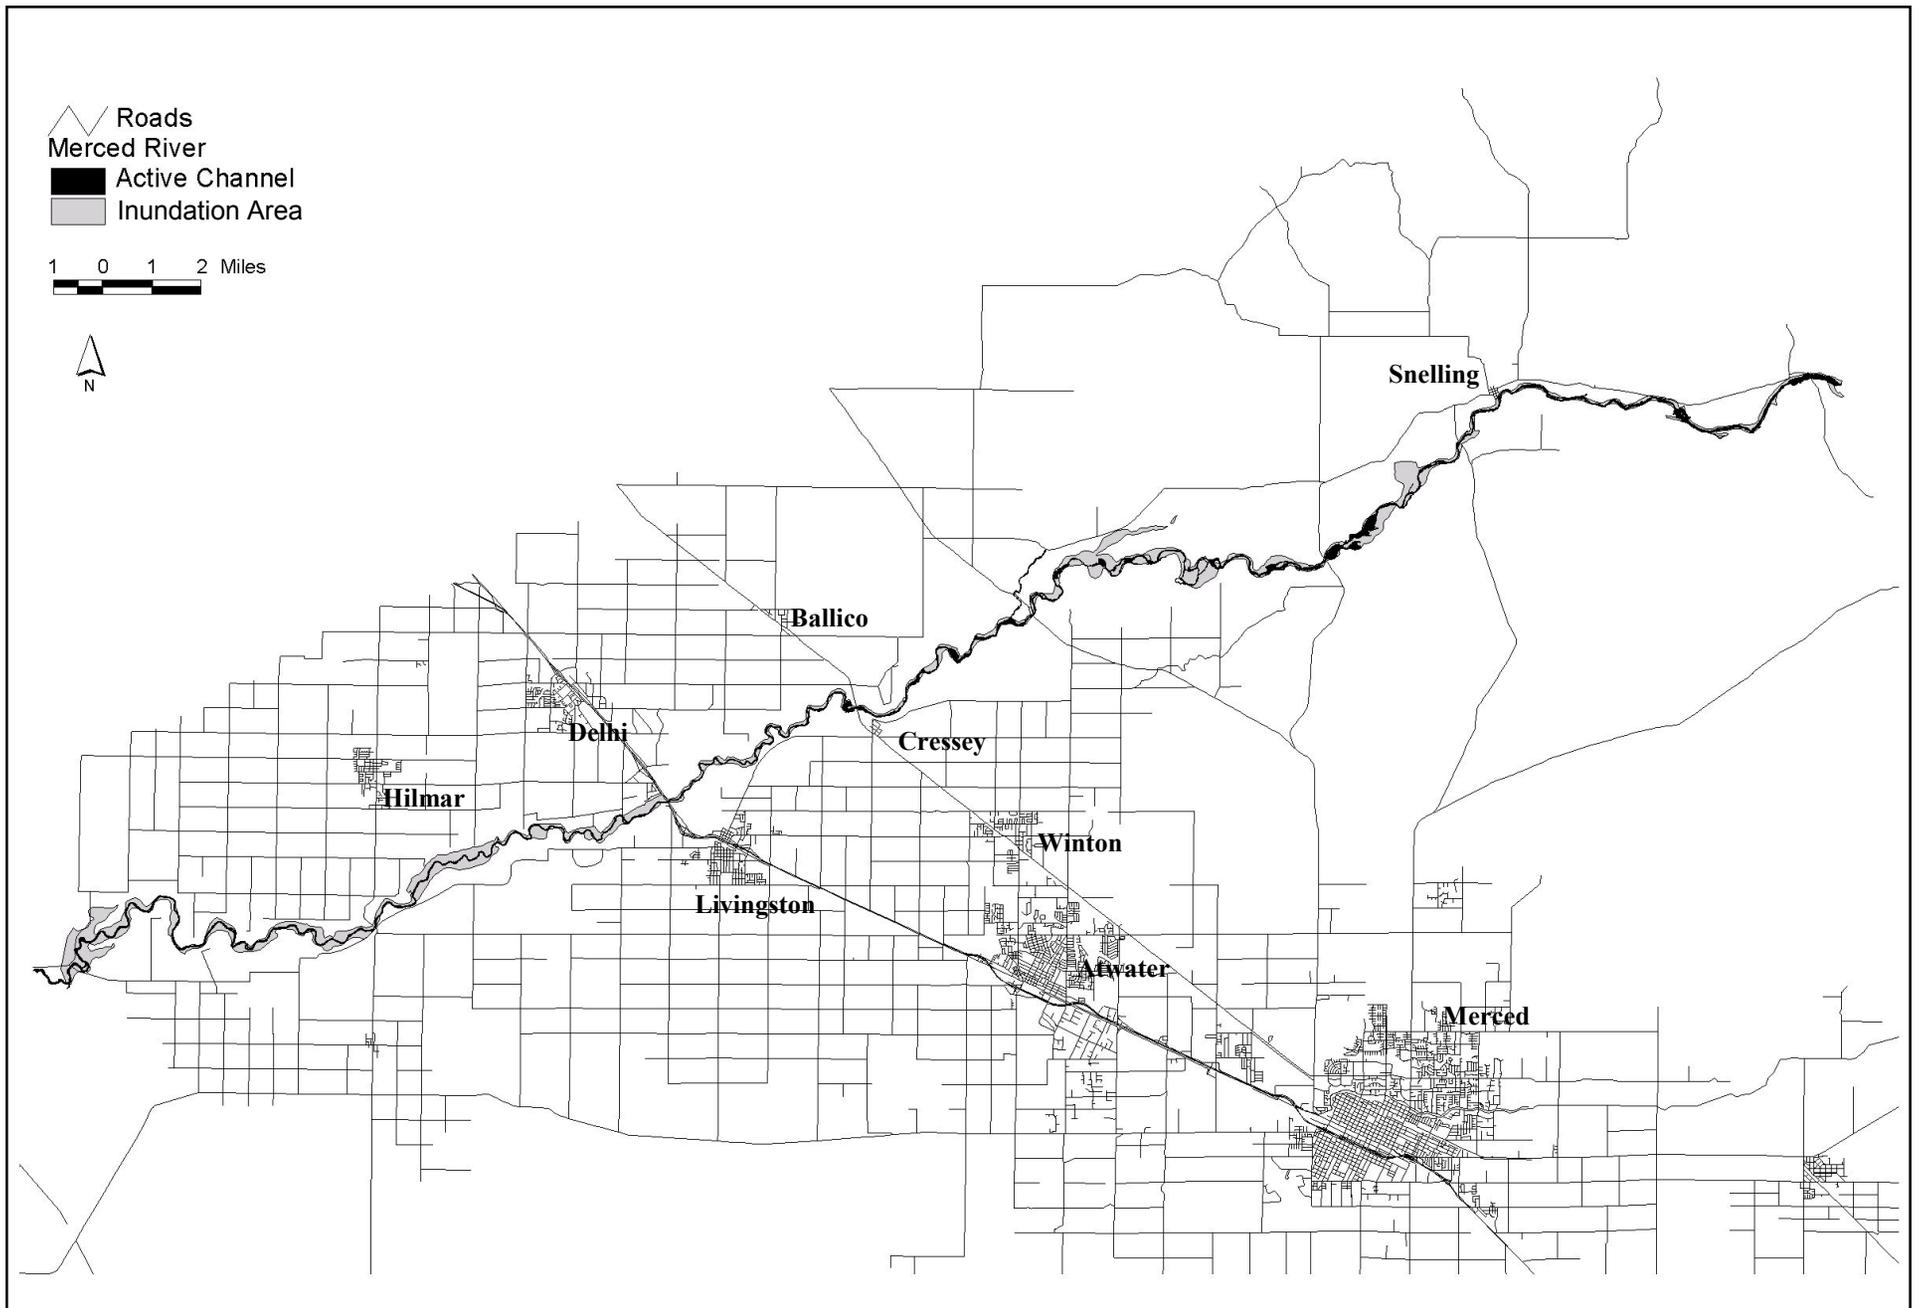
**Figure 3.2-1. Area inundated by January 1997 flood.**

(Source: Corps of Engineers, unpublished data)

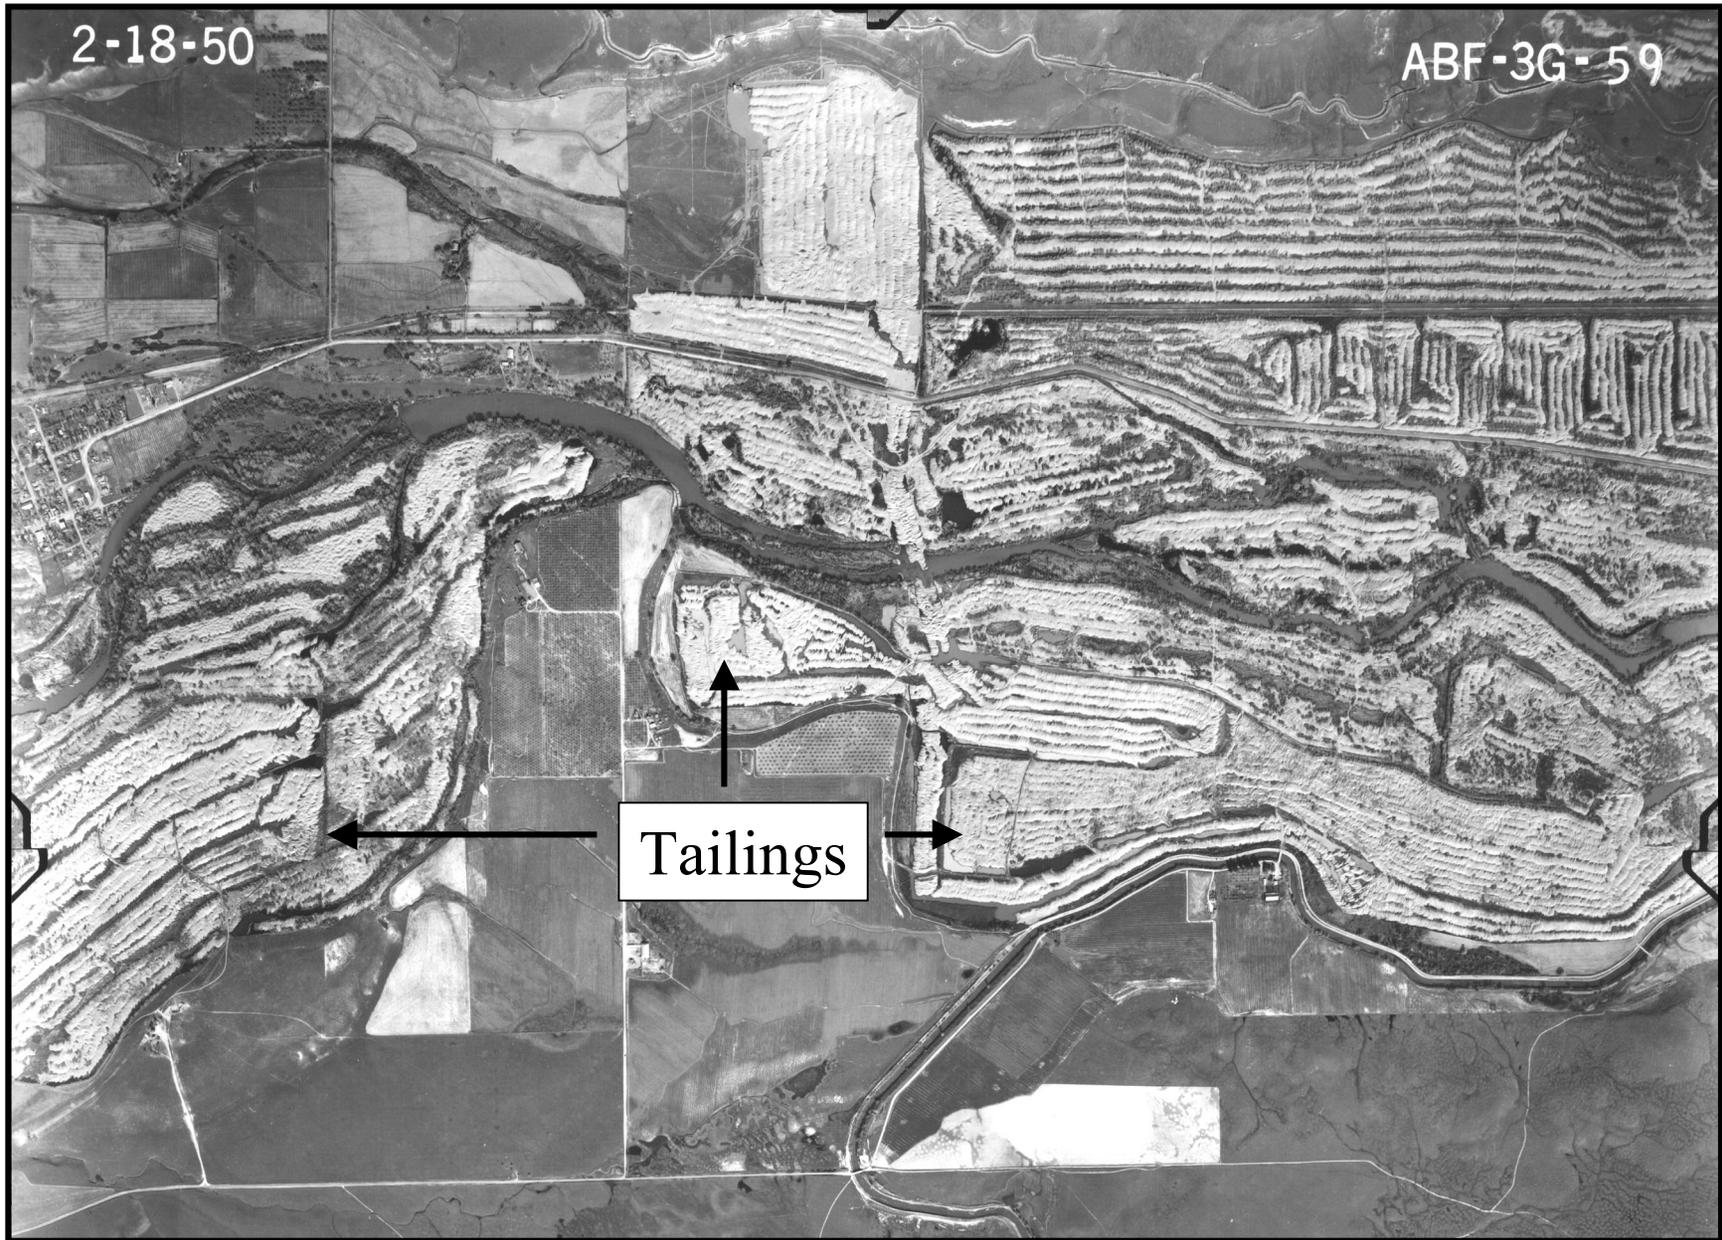
**Figure 3.2-2. Dredger tailings in the Snelling vicinity.**

(photograph: Agricultural Stabilization and Conservation Service 1950)

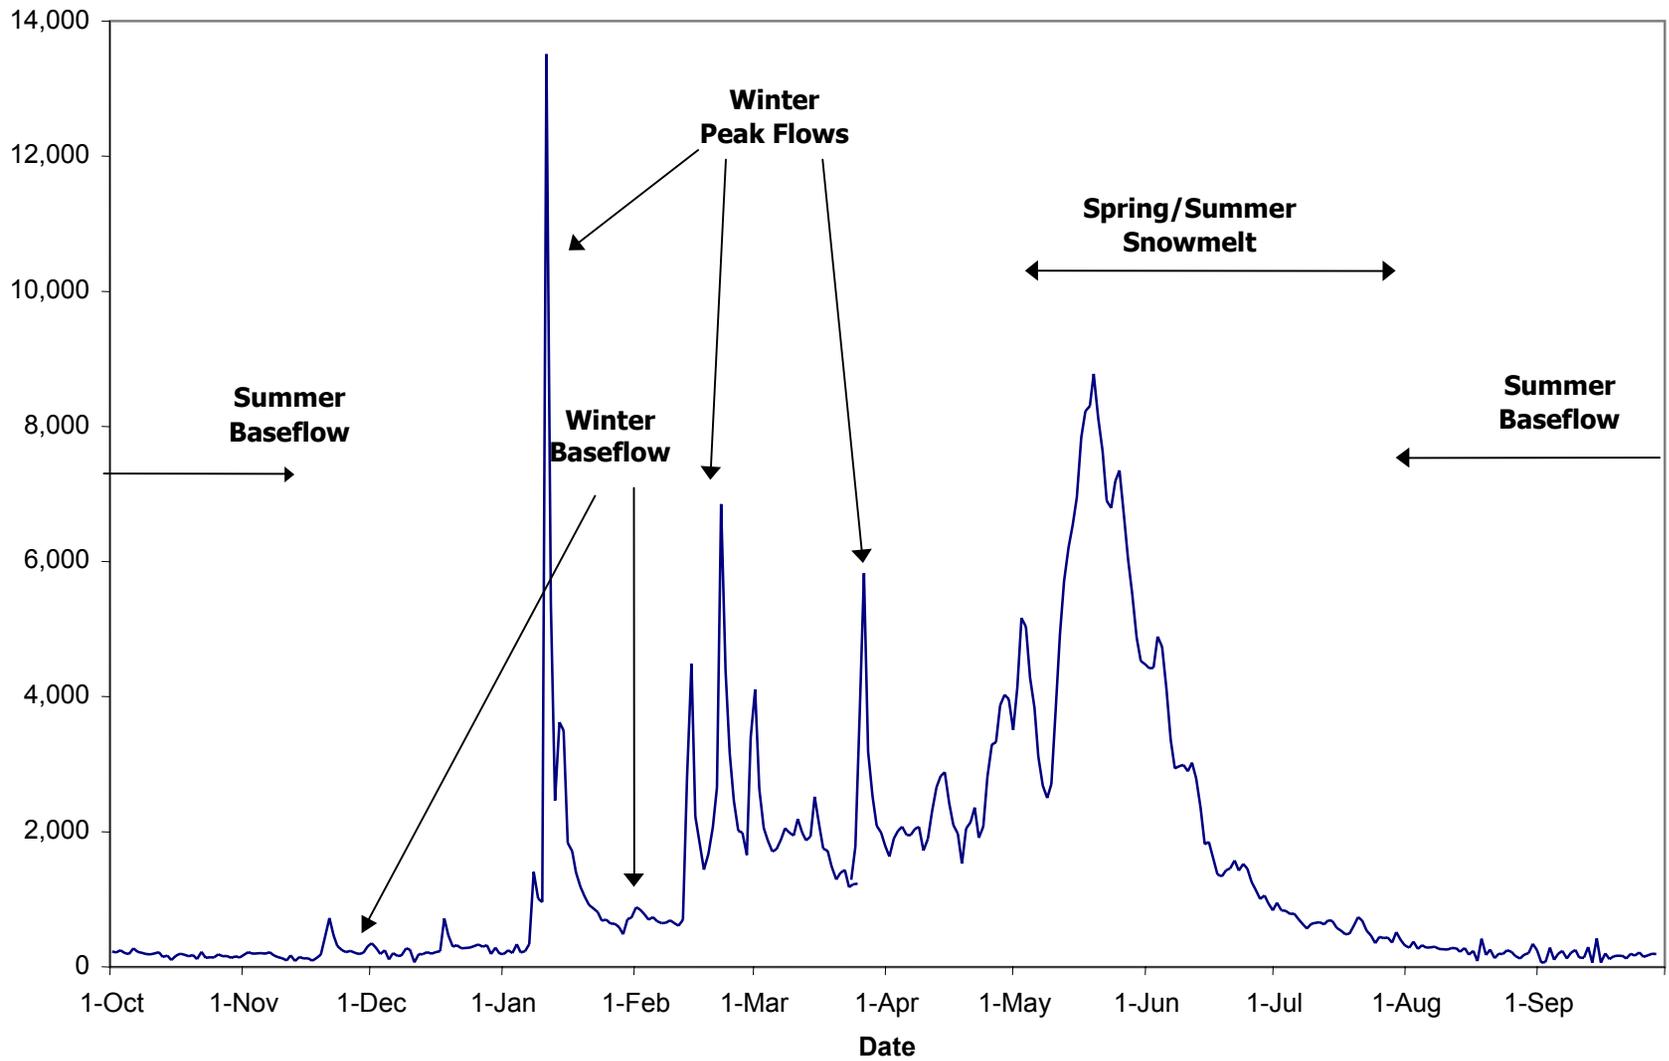
**Figure 4.1-1. Hydrograph components for unregulated flow conditions in the Merced River.**  
 (Hydrograph shown is estimated inflow to Lake McClure for water year 1979, representative of a median water year.)  
 (source: Merced Irrigation District)

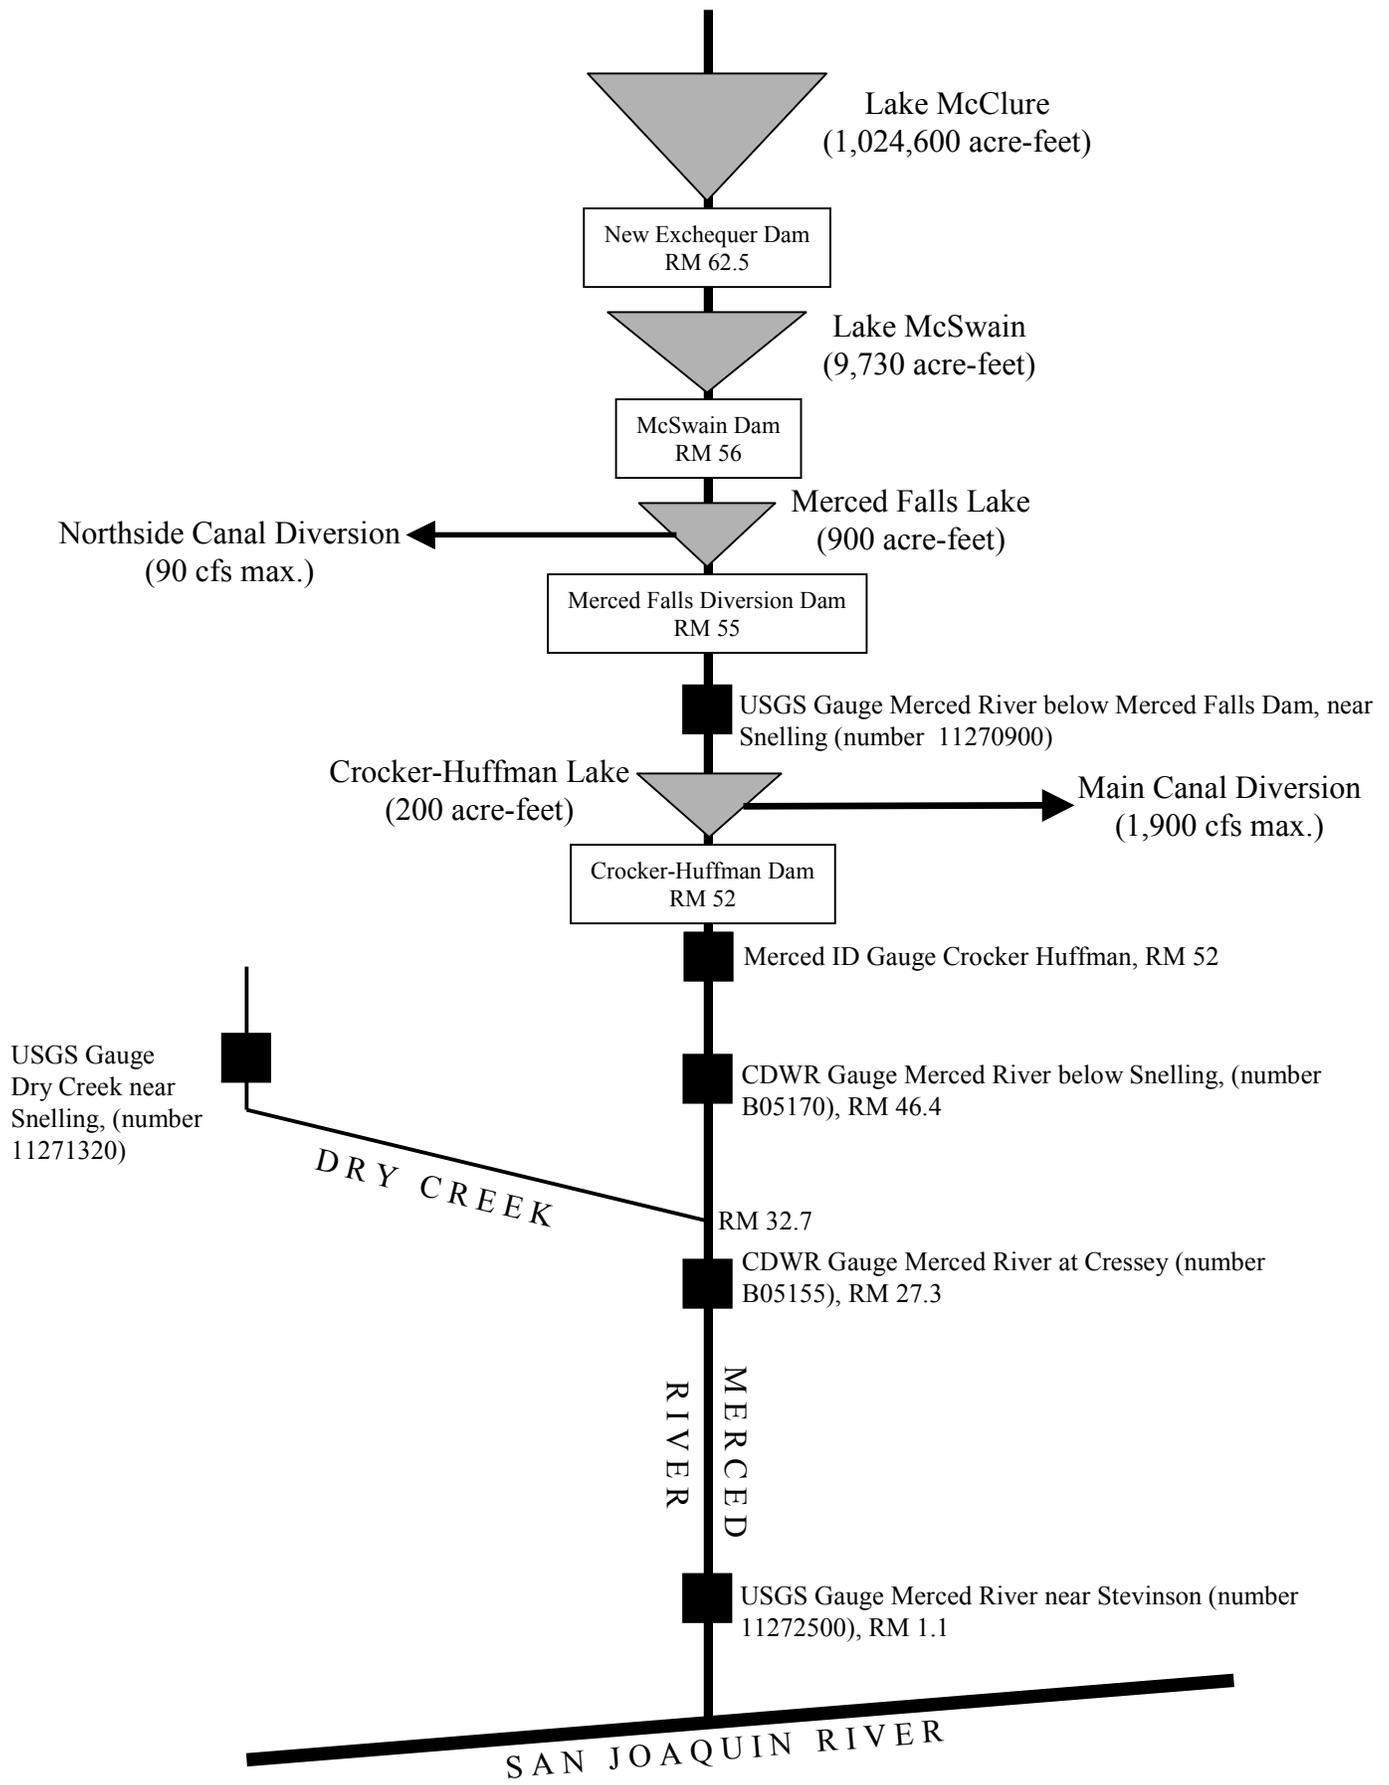
**Figure 4.2-1. Schematic diagram of Merced River dams, reservoirs, diversions and flow gauges.**

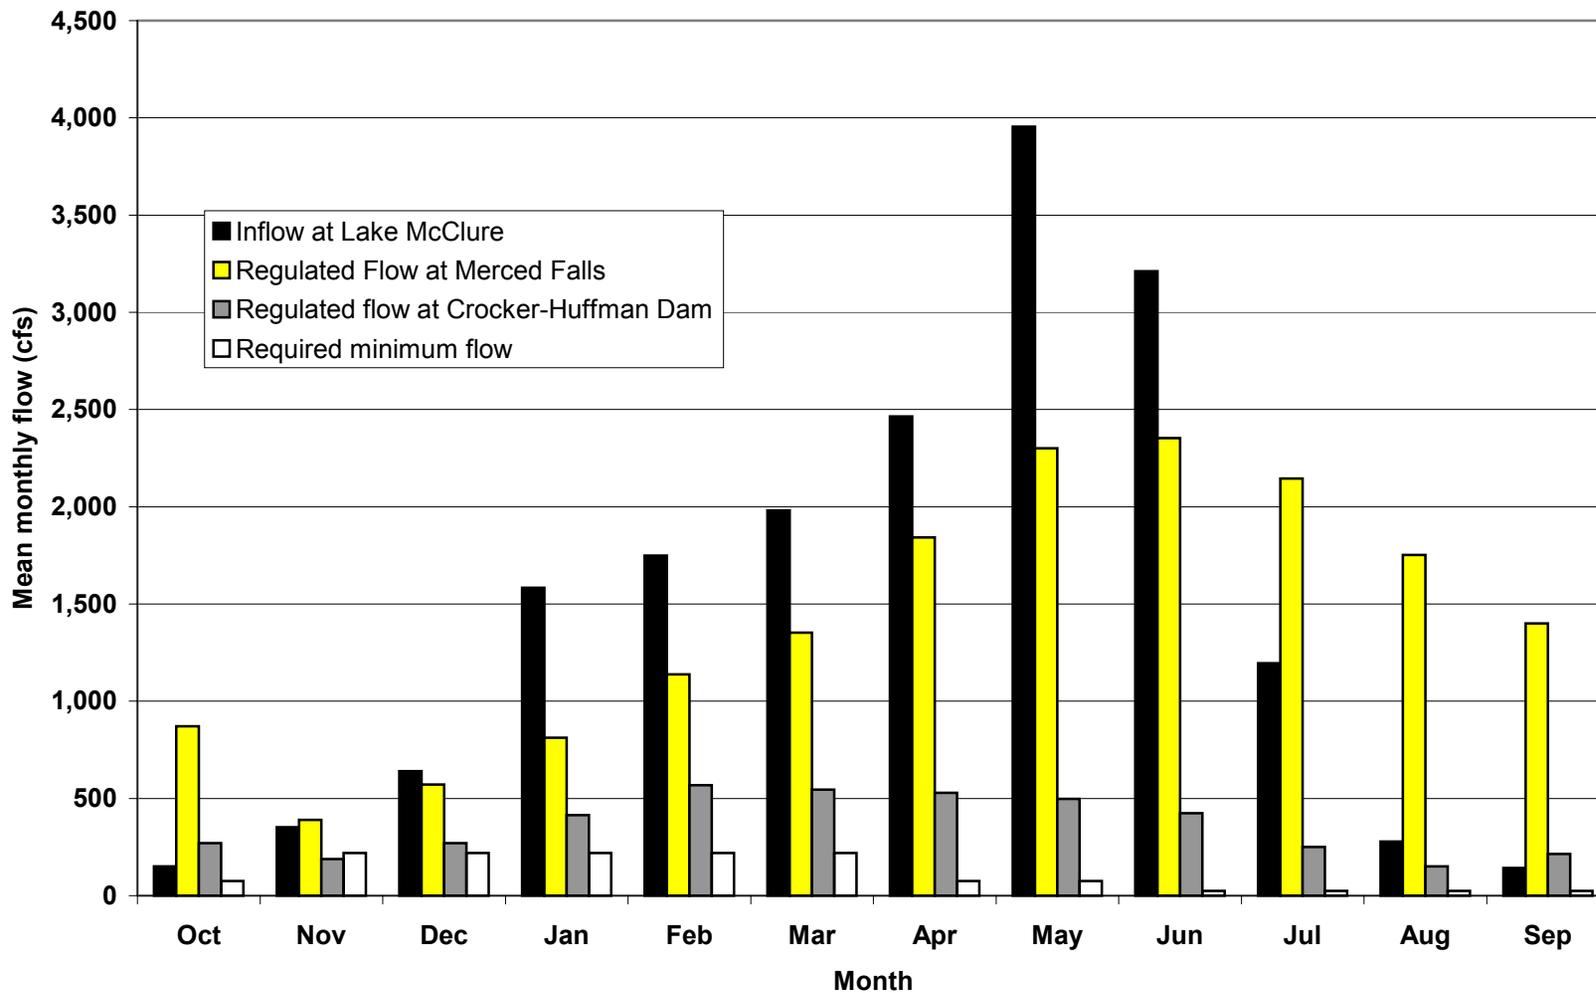
**Figure 4.2-2. Unregulated and regulated monthly average flow in the lower Merced River (1968–1998).**

Note: Minimum flow requirements represent FERC requirements for normal water years between April and October, and higher minimum flows required by the Davis-Grunsky contract from November through March.

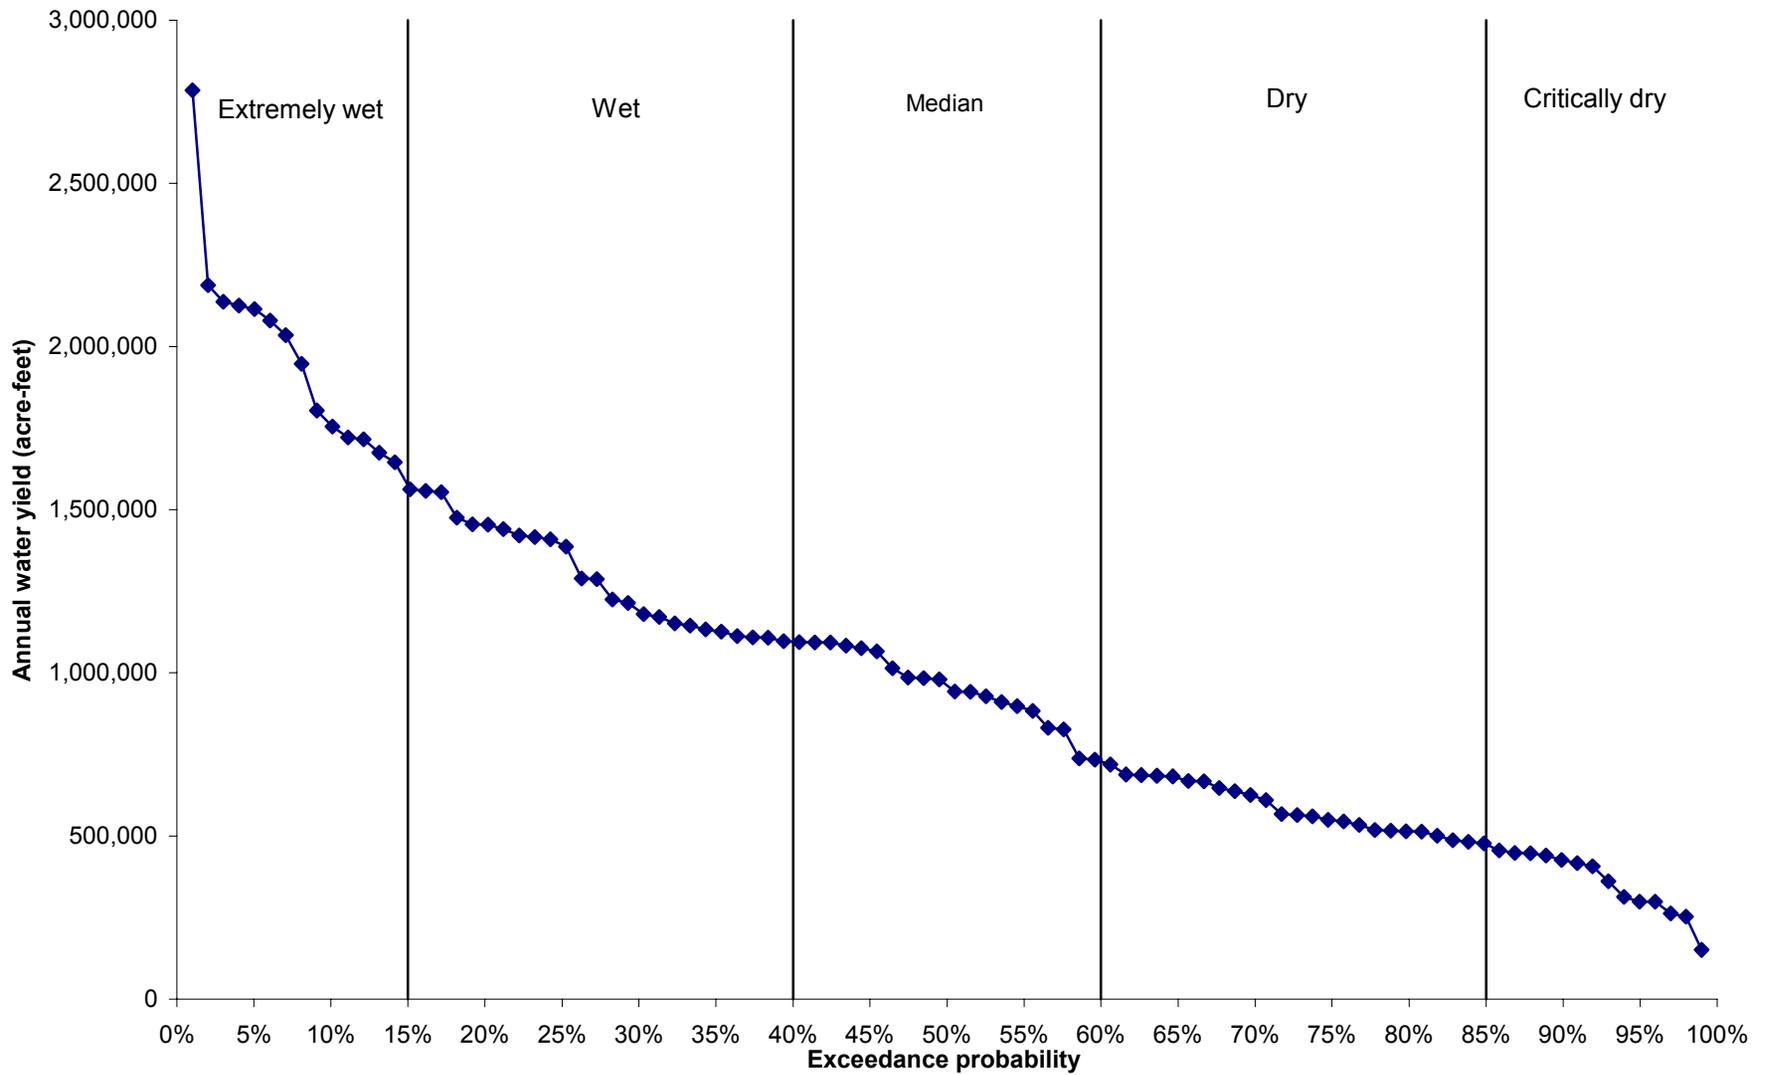
**Figure 4.2-3. Cumulative plot of ranked annual water yields from the Merced River (1902–1998).**

(source: Merced Irrigation District)
