## FIGURES

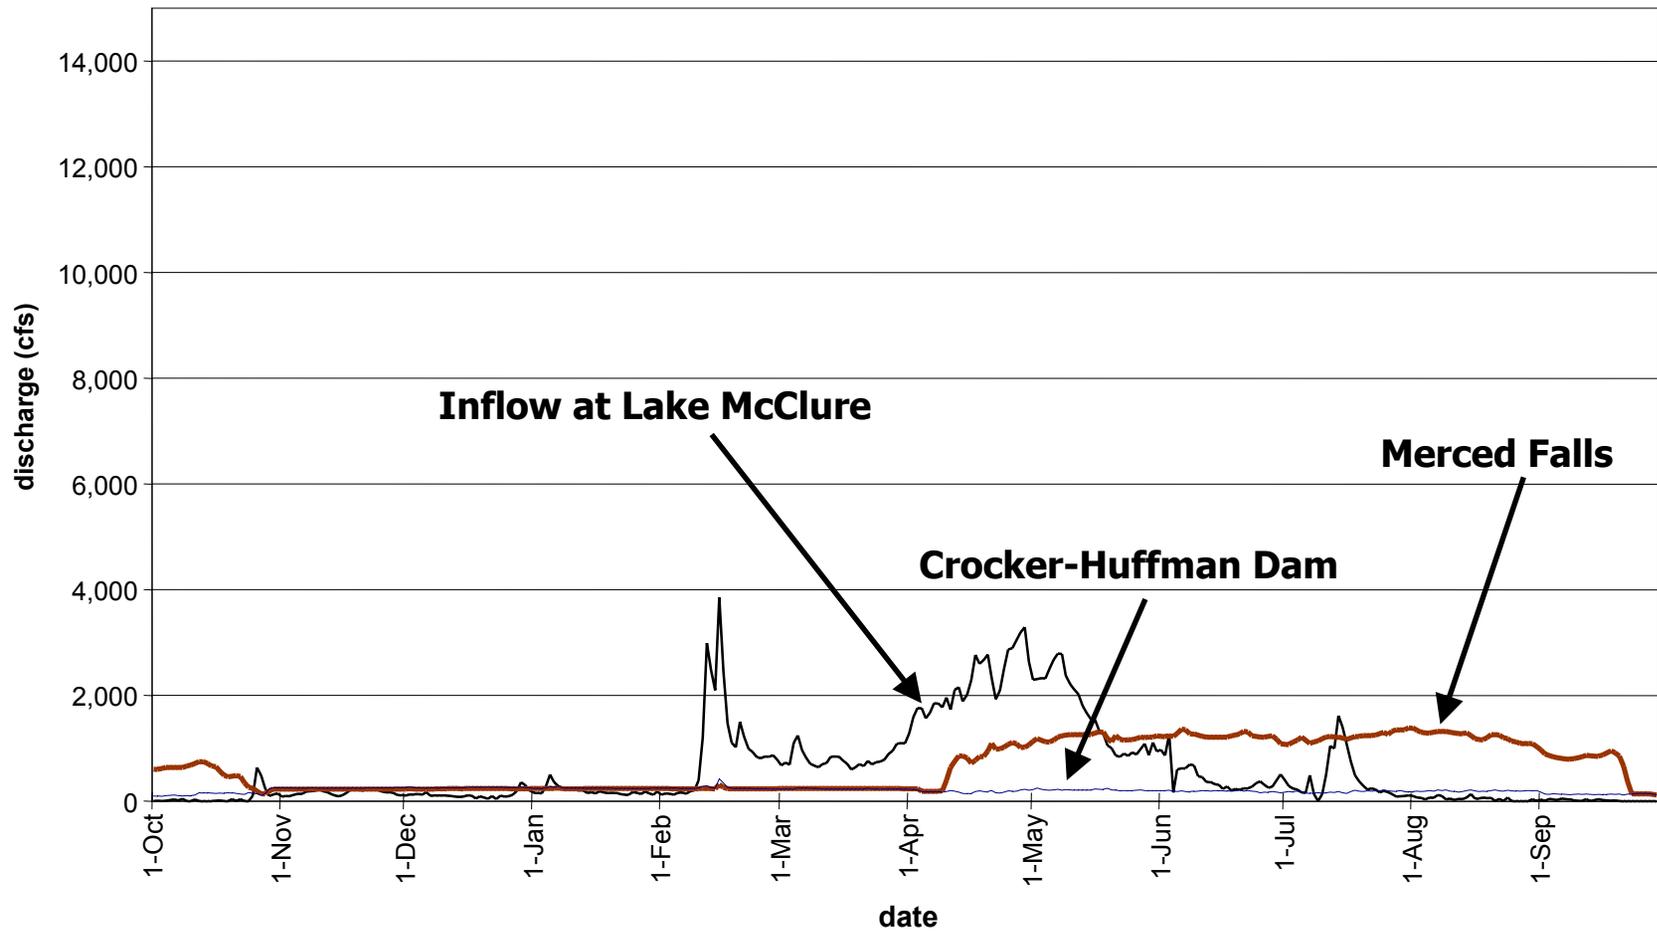
**Figure 4.2-4A. Annual hydrographs of inflow to Lake McClure and flow at Merced Falls and Crocker-Huffman Dam for a critically dry year (water year 1992).**

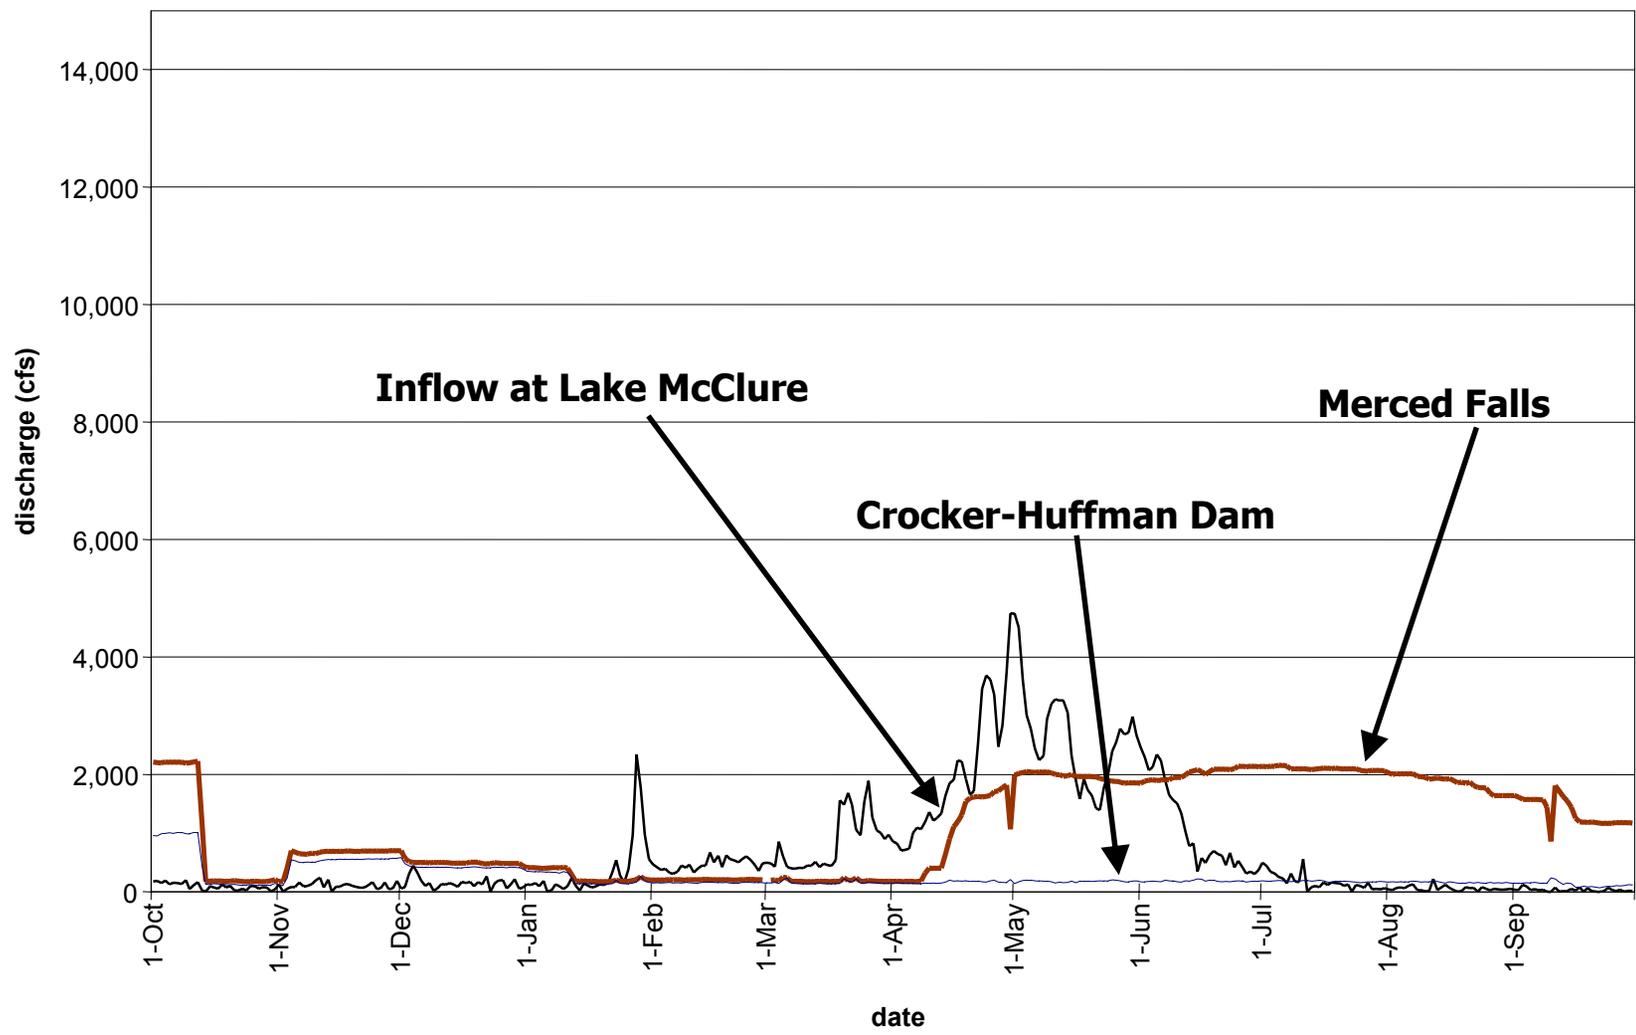
**Figure 4.2-4B. Annual hydrographs of inflow to Lake McClure and flow at Merced Falls and Crocker-Huffman Dam for a dry year (water year 1981).**

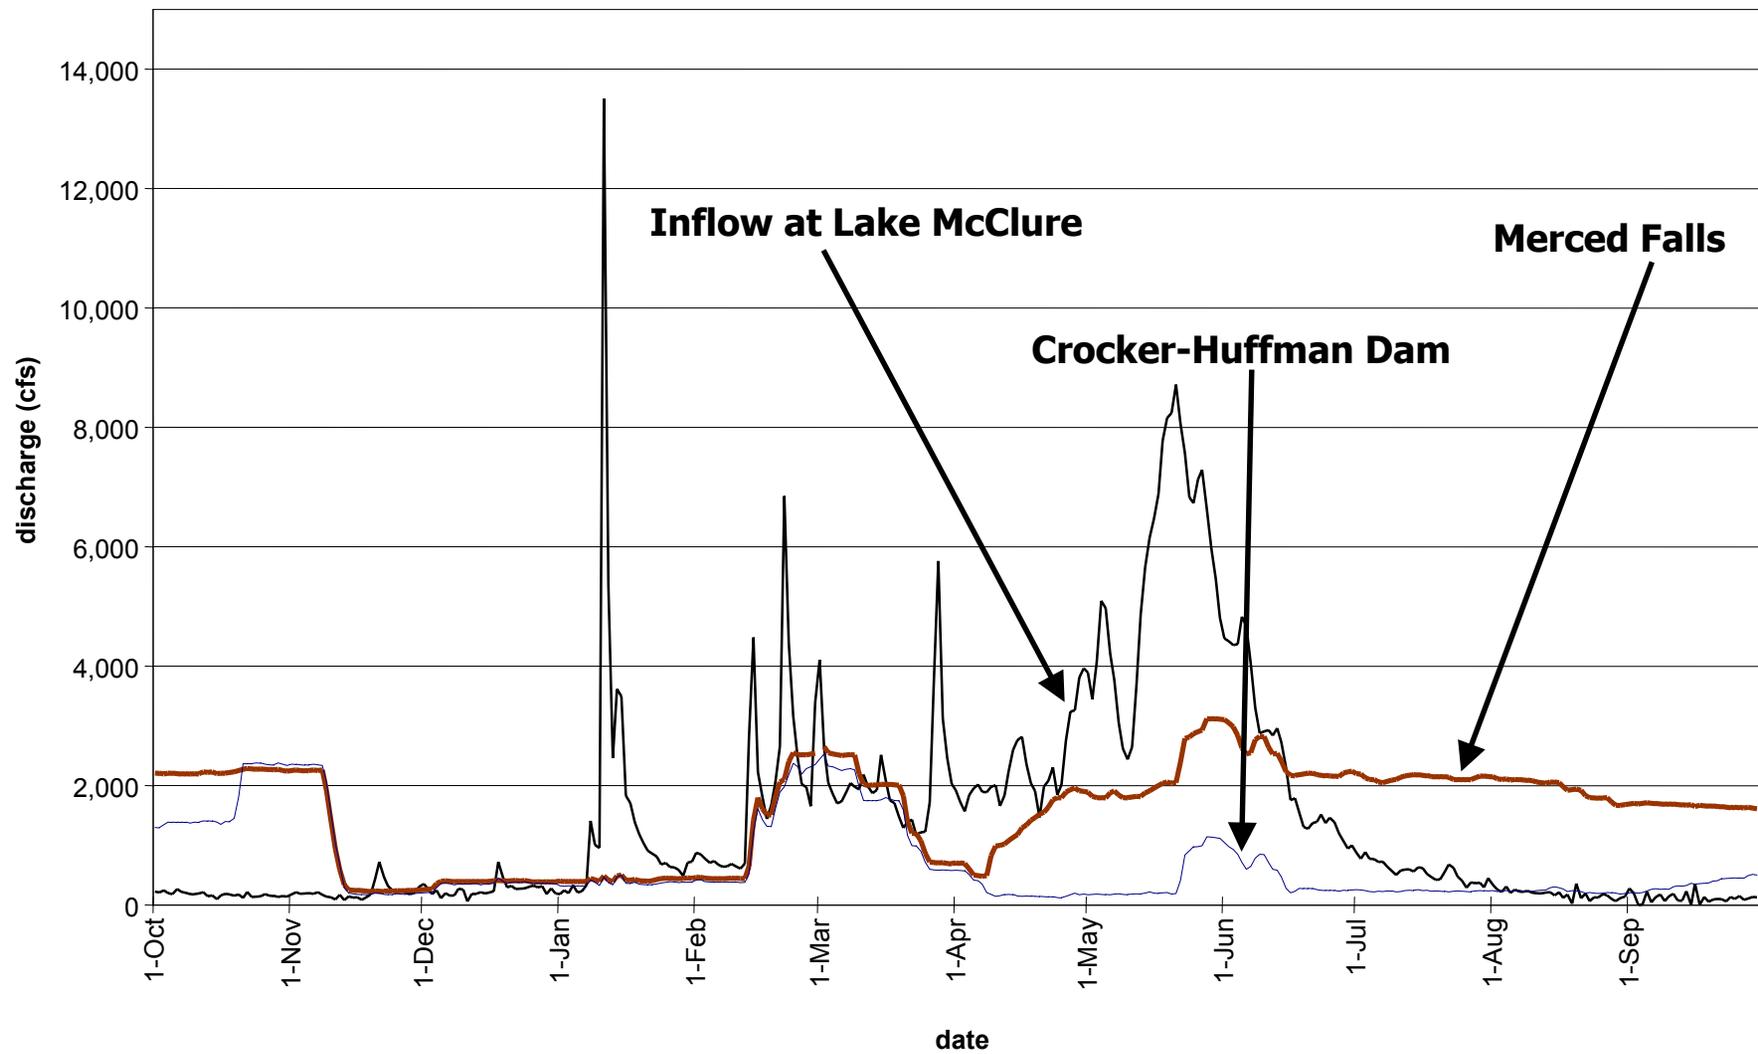
**Figure 4.2-4C. Annual hydrographs of inflow to Lake McClure and flow at Merced Falls and Crocker-Huffman Dam for a median year (water year 1979).**

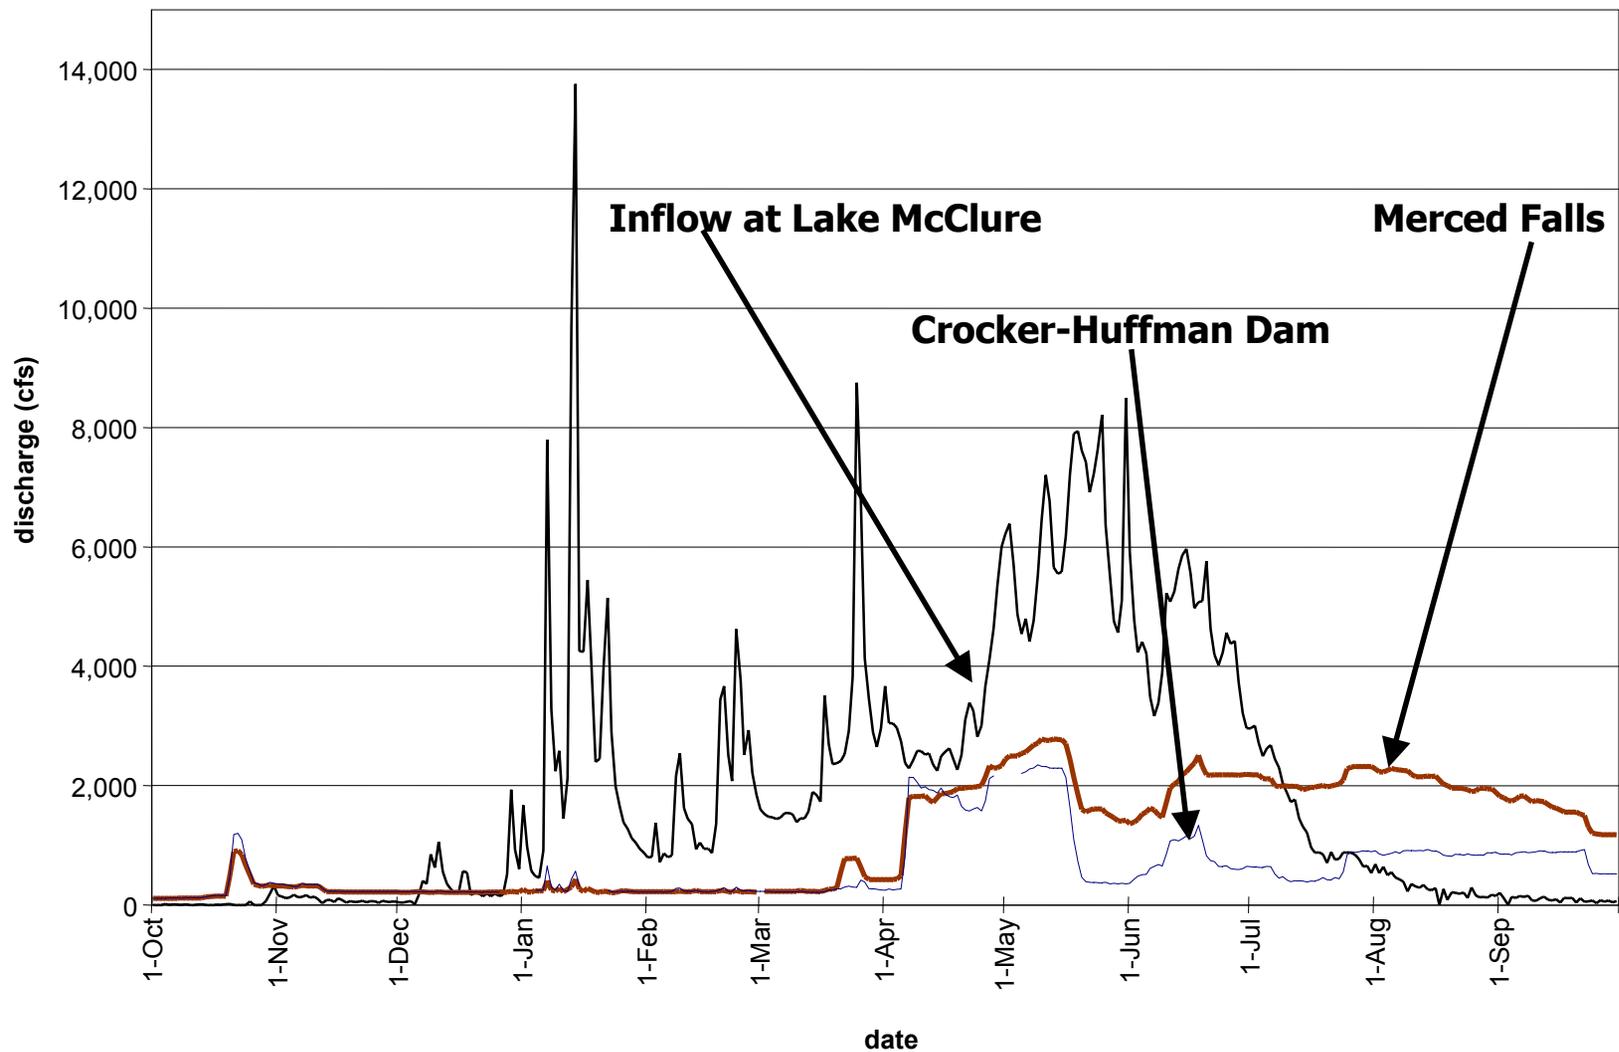
**Figure 4.2-4D. Annual hydrographs of inflow to Lake McClure and flow at Merced Falls and Crocker-Huffman Dam for a wet year (water year 1993).**

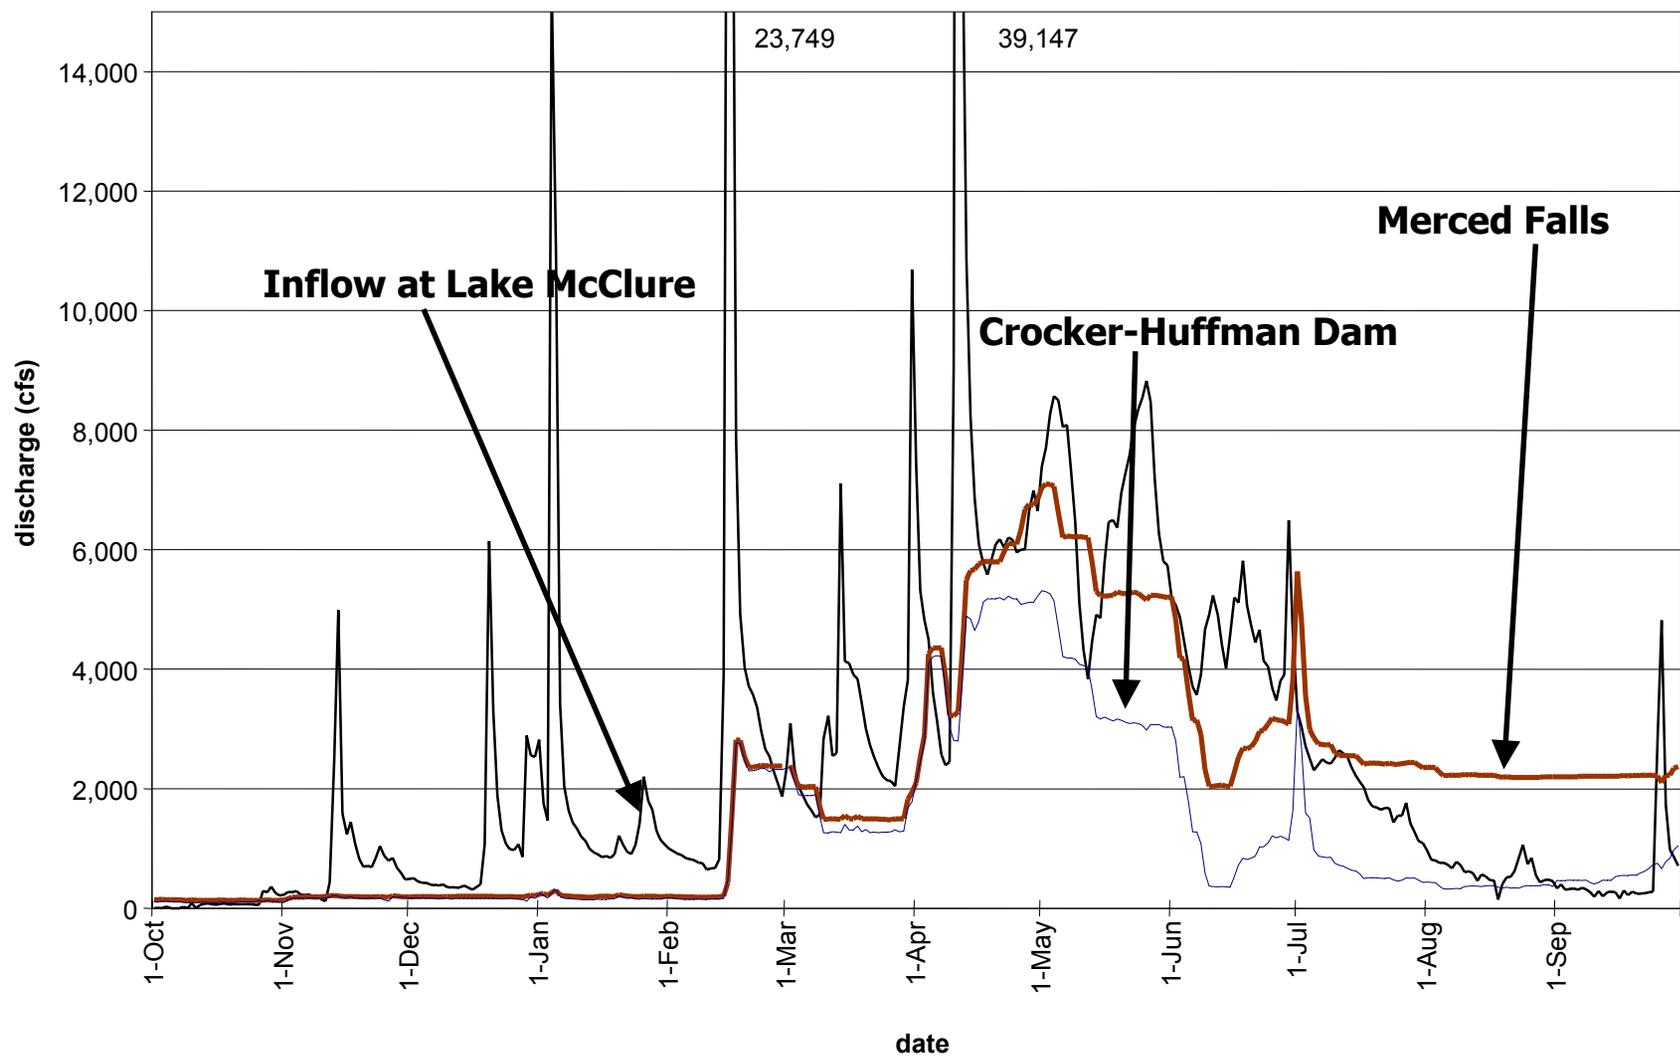
**Figure 4.2-4E. Annual hydrographs of inflow to Lake McClure and flow at Merced Falls and Crocker-Huffman Dam for an extremely wet year (water year 1982).**

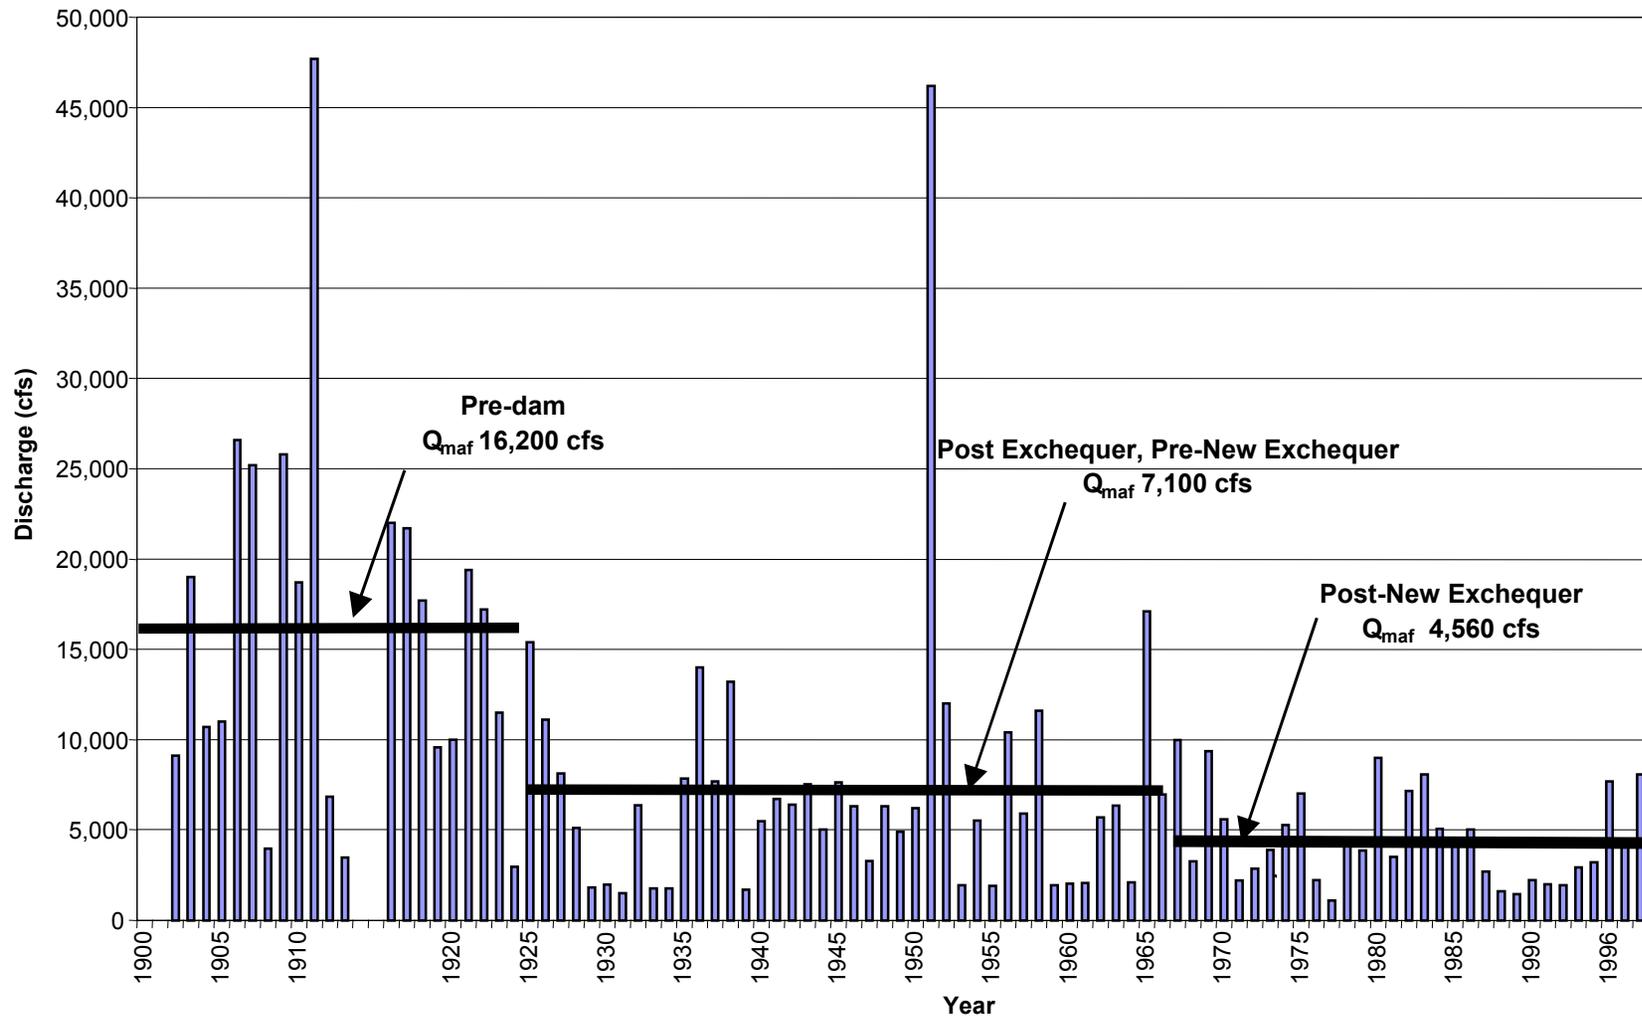
**Figure 4.3-1. Maximum instantaneous flows at the Exchequer (1902–1967) and Merced Falls (1968–1998) gauges.**

(source: USGS gauge numbers 11270000 and 11270900, respectively)

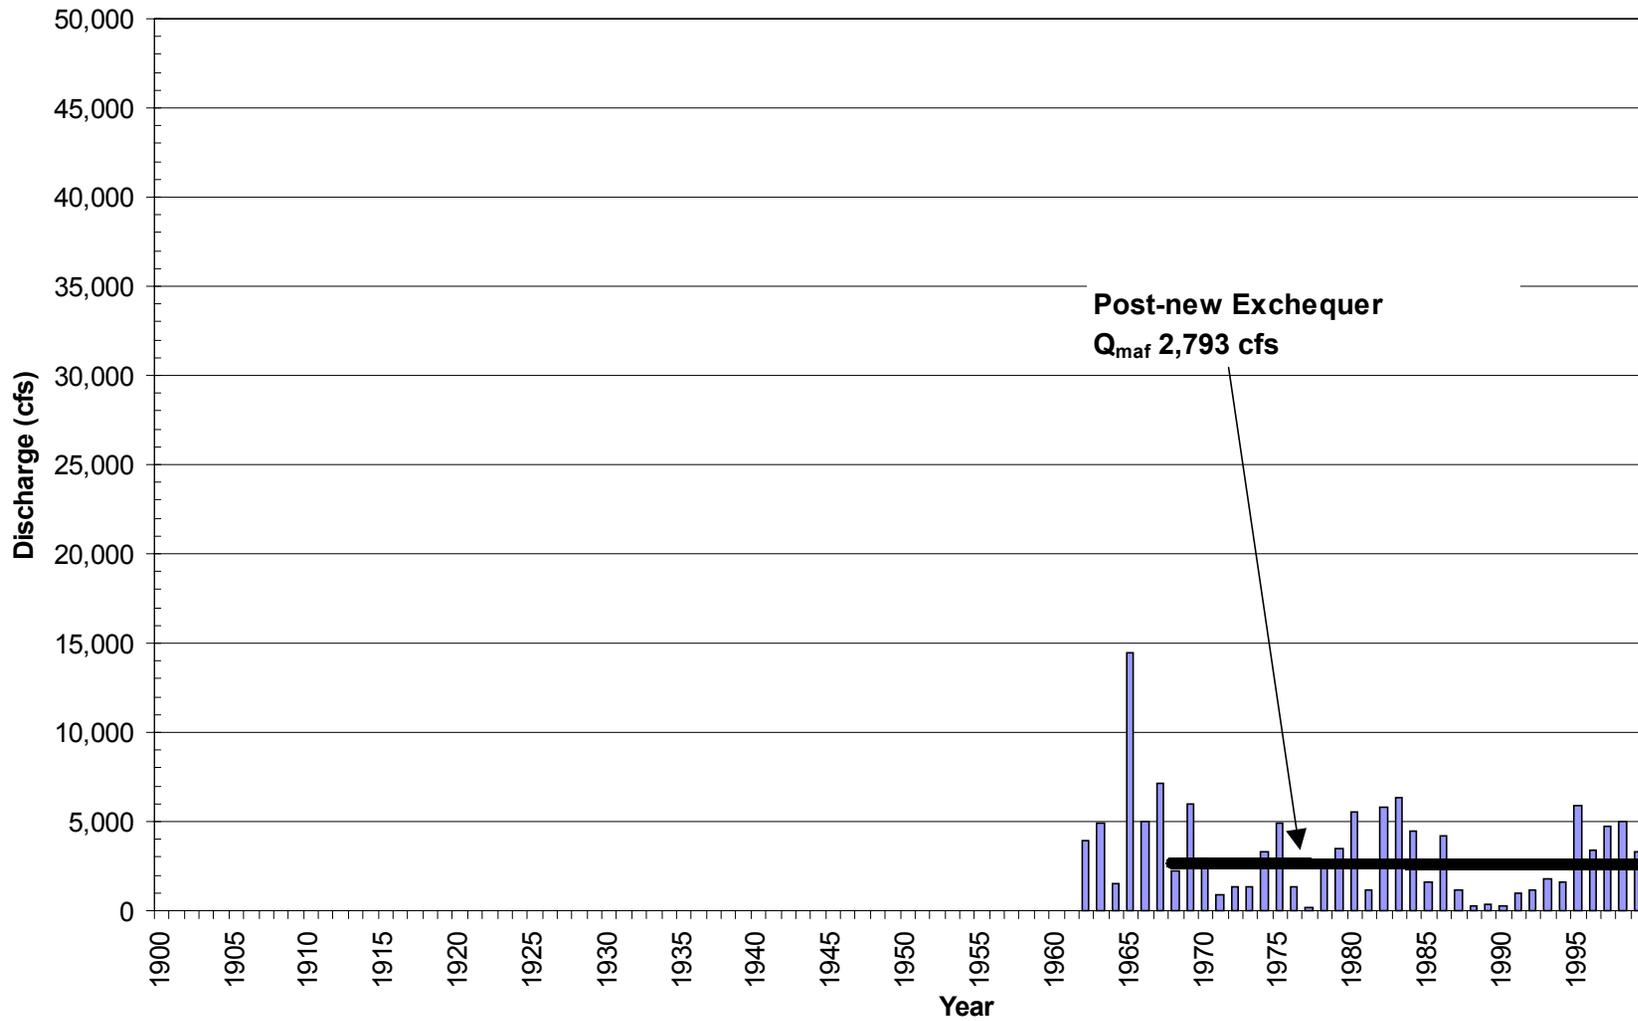
**Figure 4.3-2. Maximum instantaneous flows at the Snelling gauge (1962–1998).**  
 (source: CDWR Gauge Merced River below Snelling, B05170)

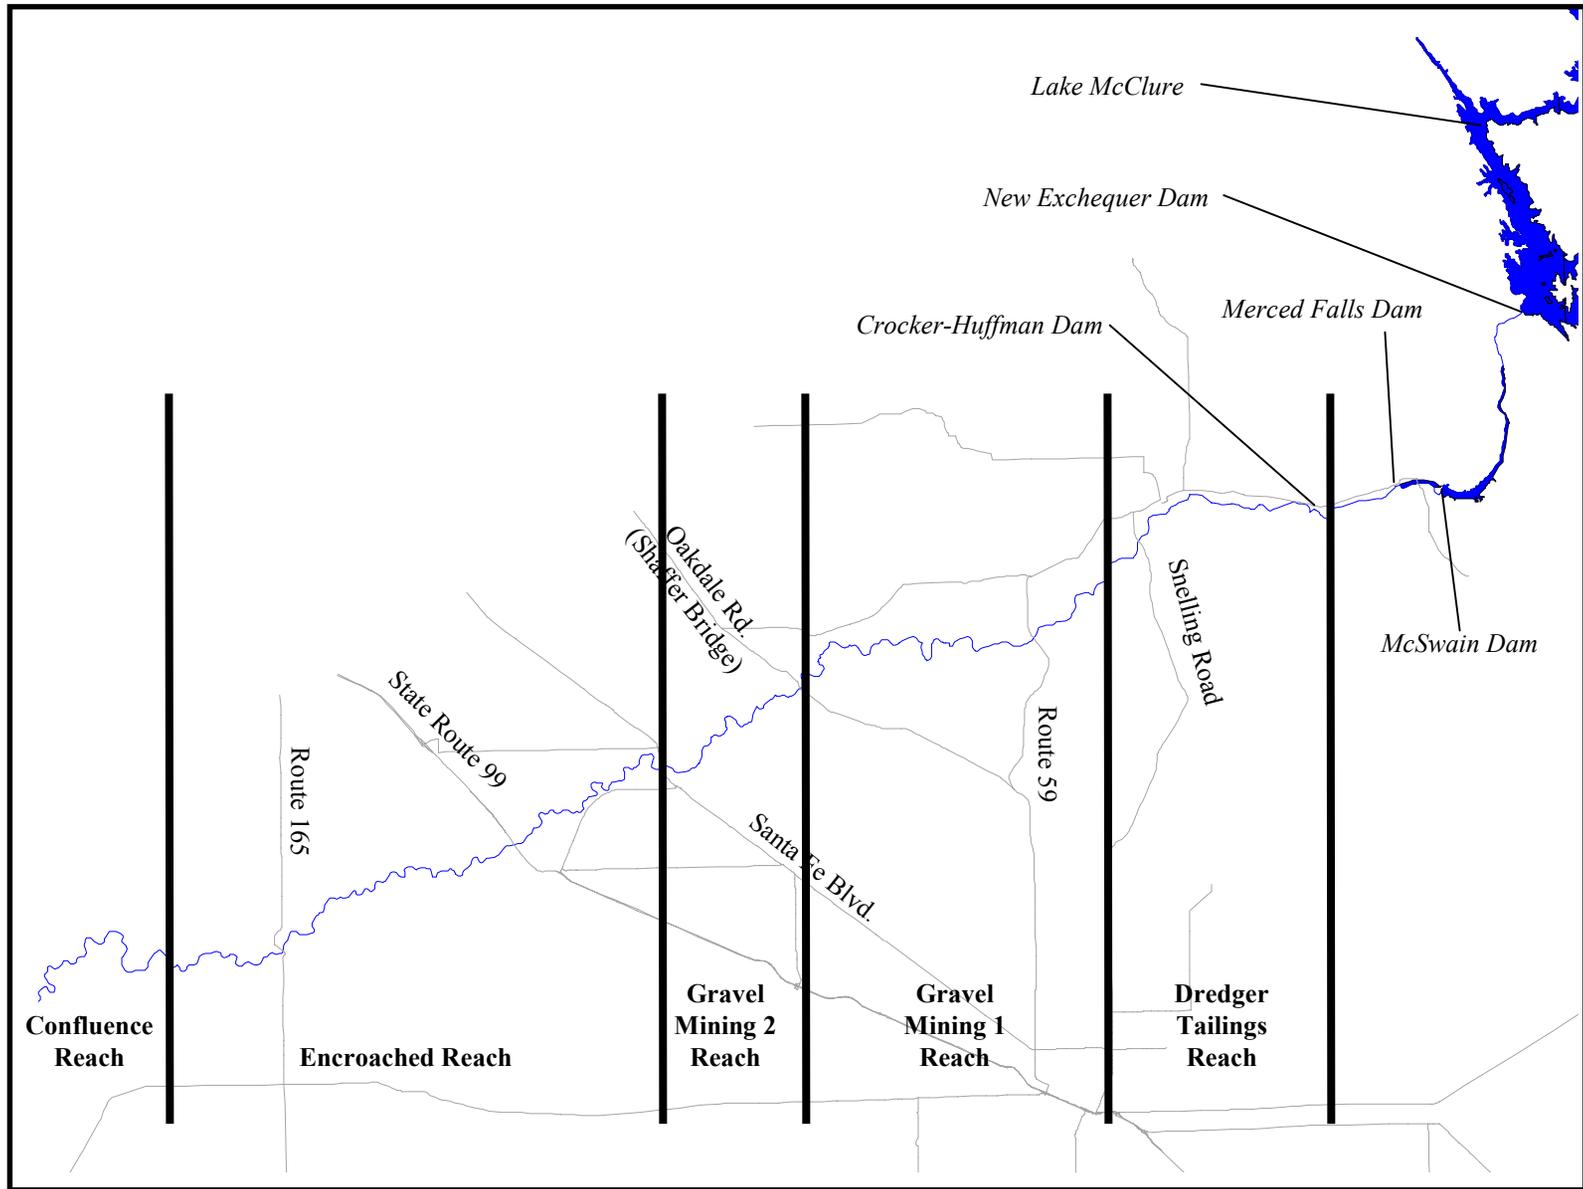
**Figure 5.1-1. Merced River reaches delineation.**

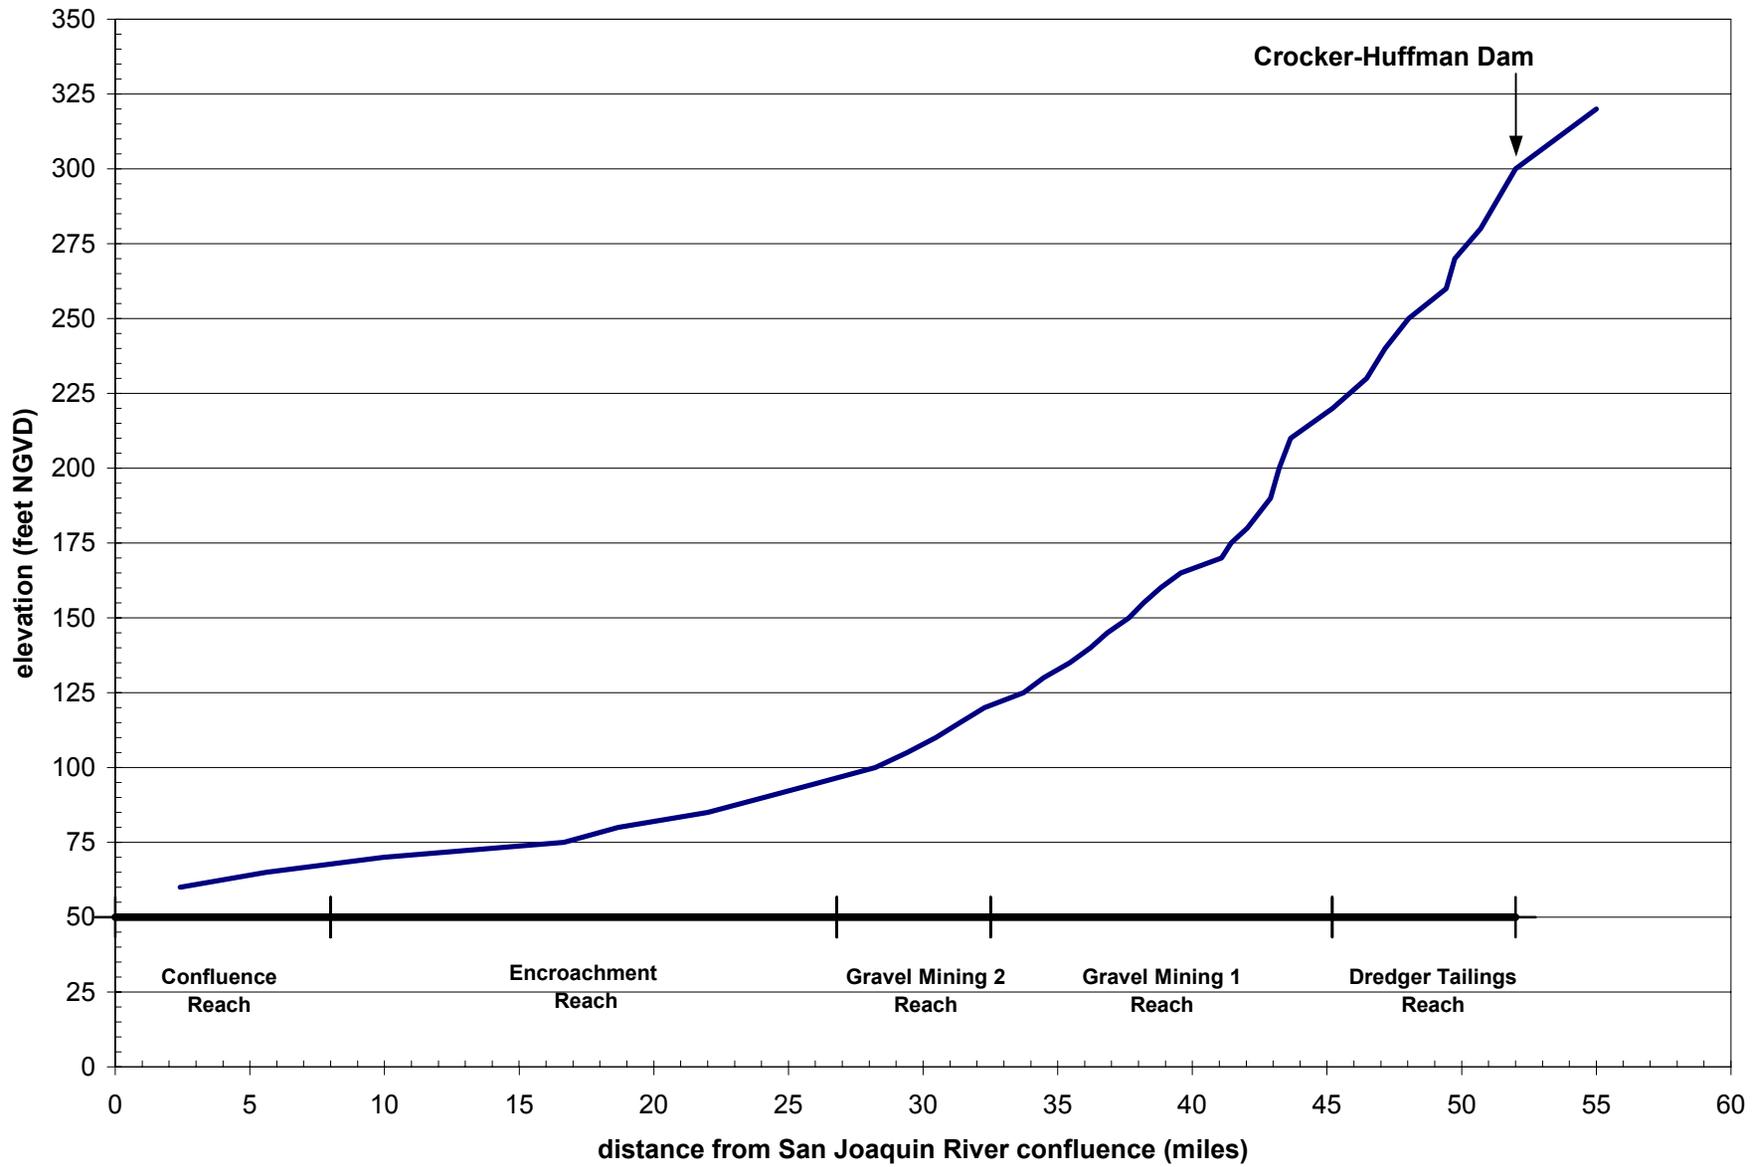
**Figure 5.1-2. Merced River longitudinal profile.**  
 (from U. S. Geological Survey 1:24,000-scale topographic maps)

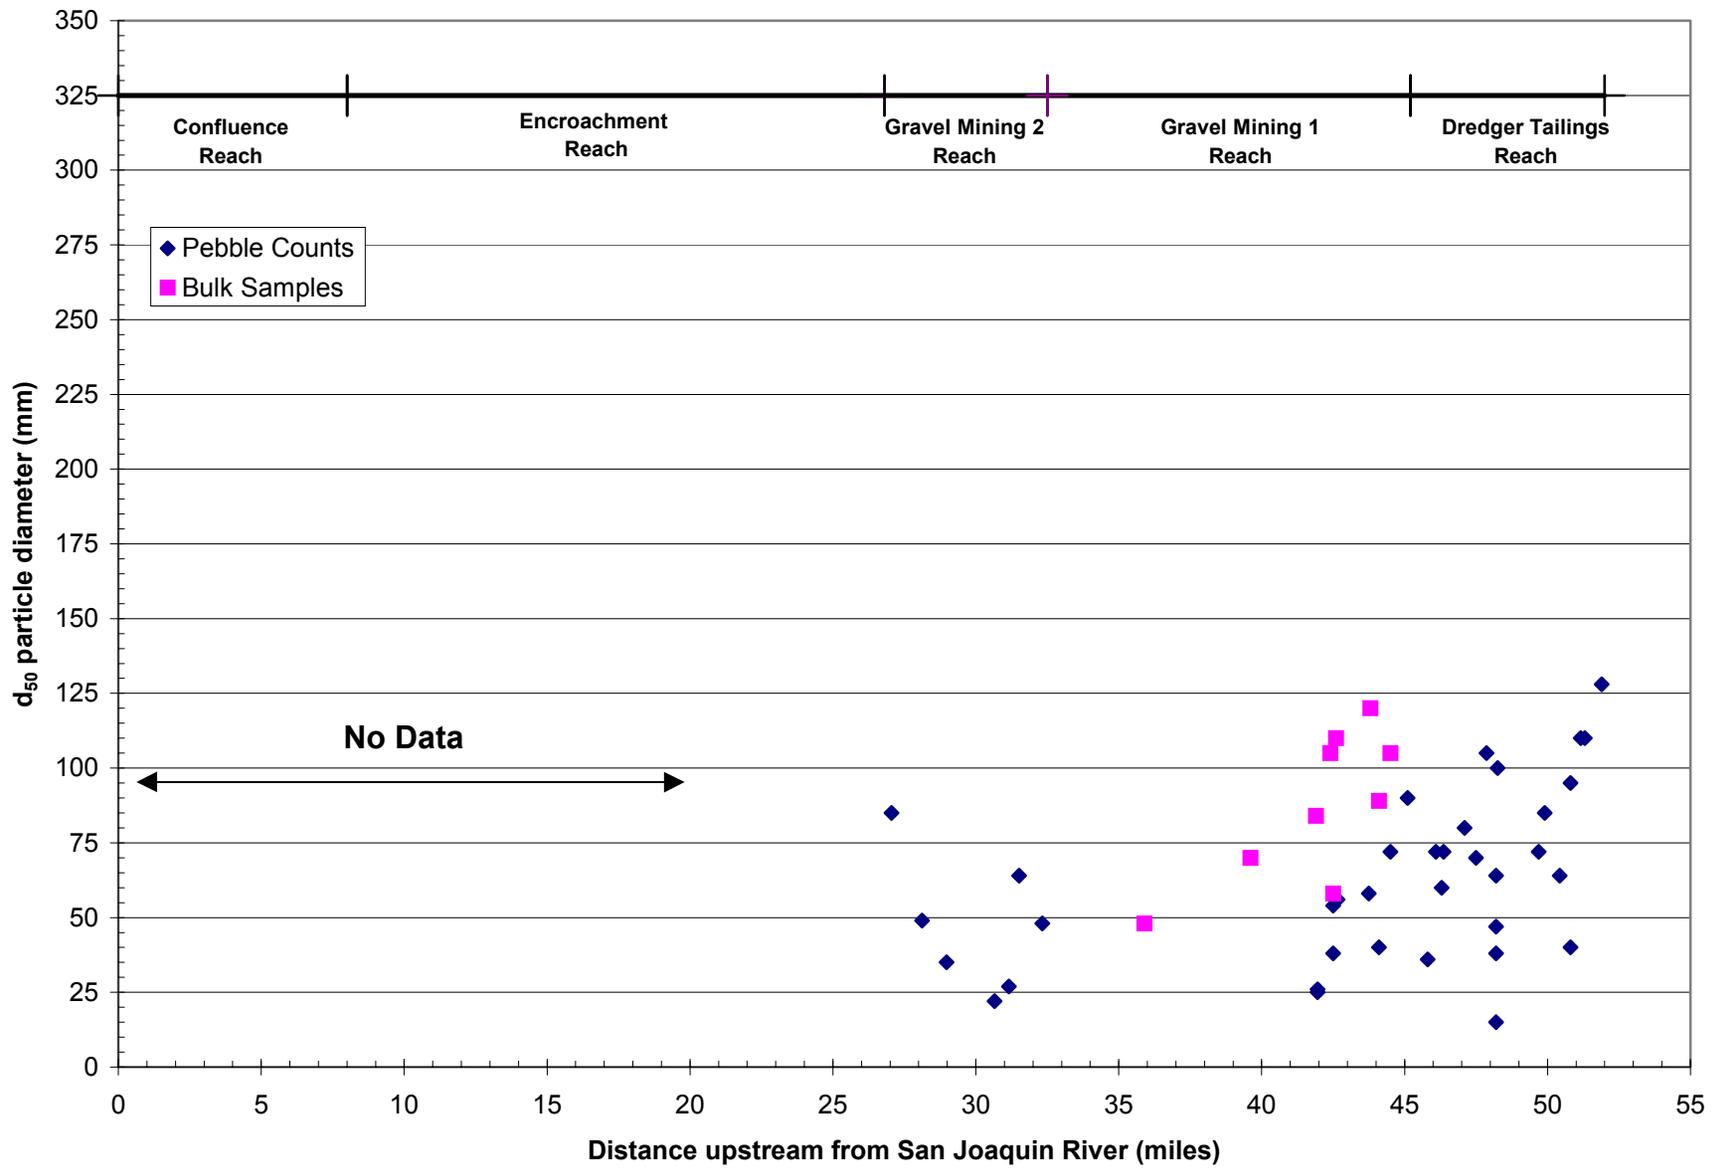
**Figure 5.1-3. Merced River surface particle size -  $D_{50}$ .**  
 (sources: CDWR 1994b, Vick 1995)

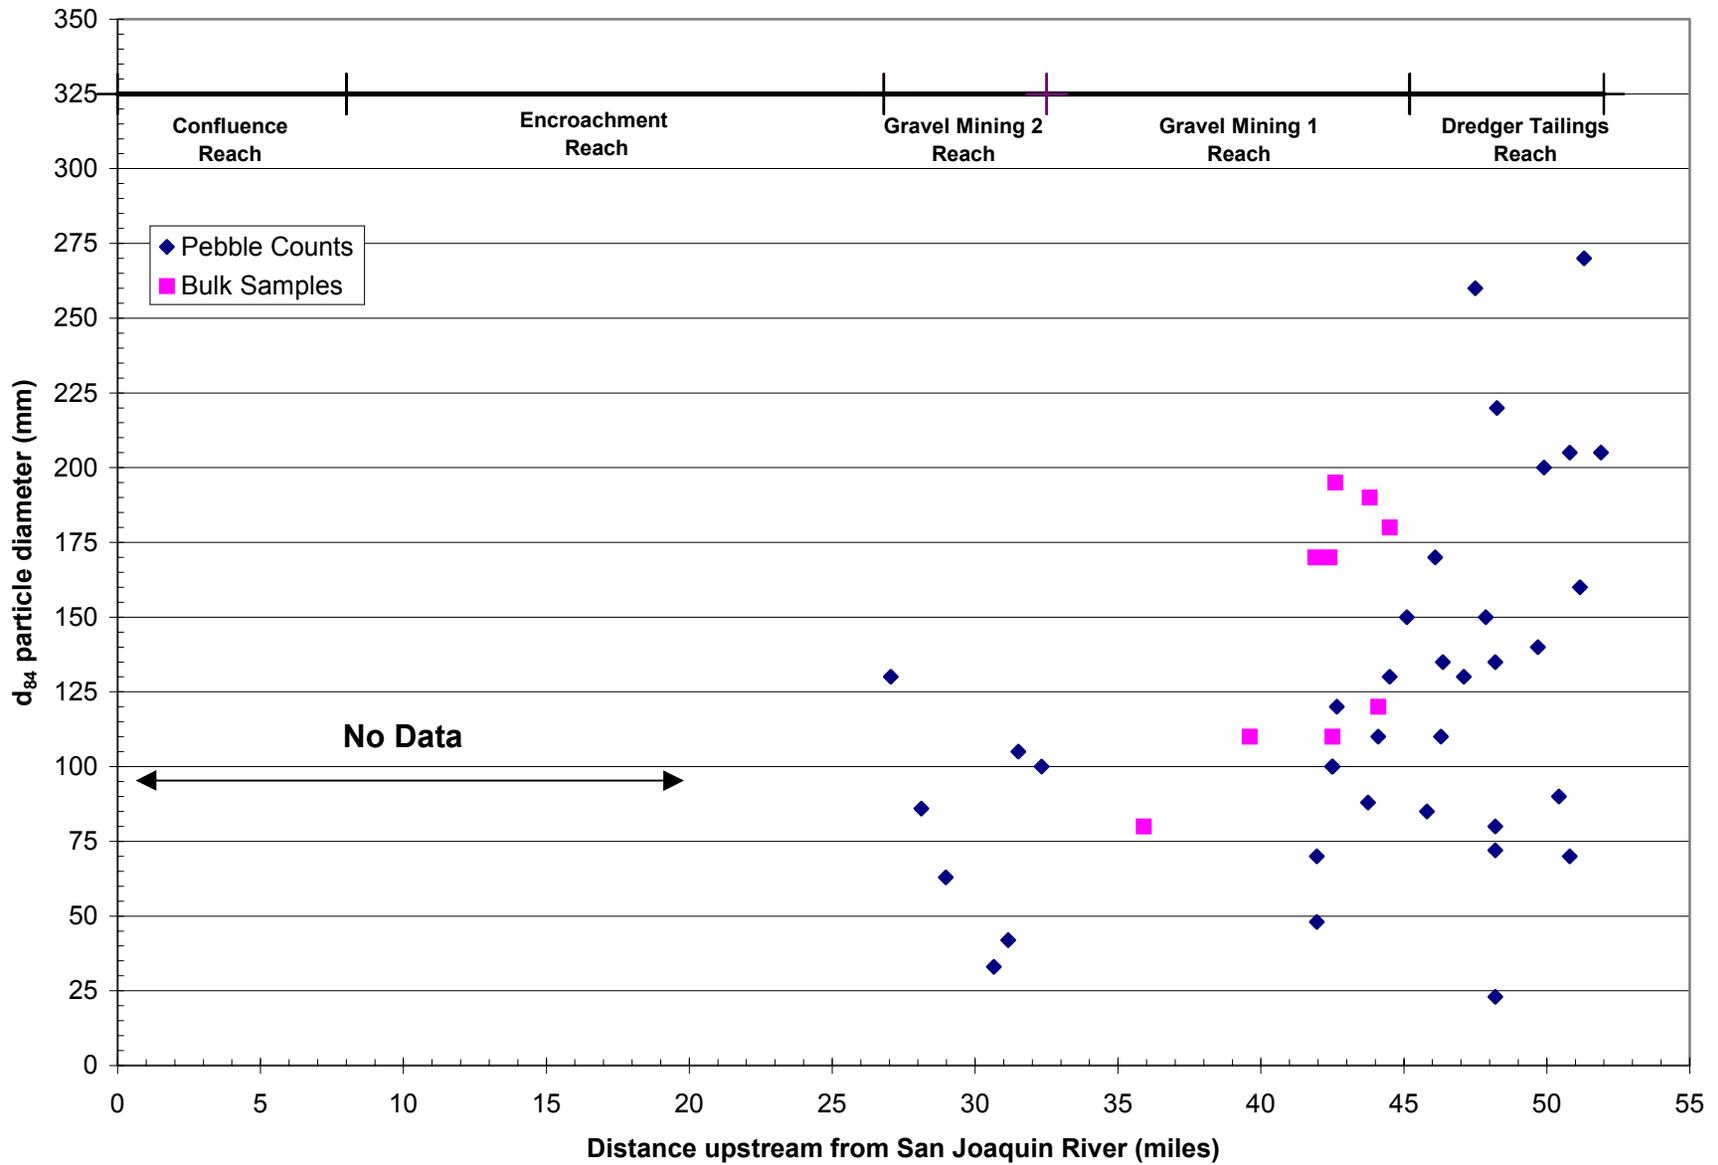
**Figure 5.1-4. Merced River surface particle size -  $D_{84}$ .**  
 (sources: CDWR 1994b, Vick 1995)

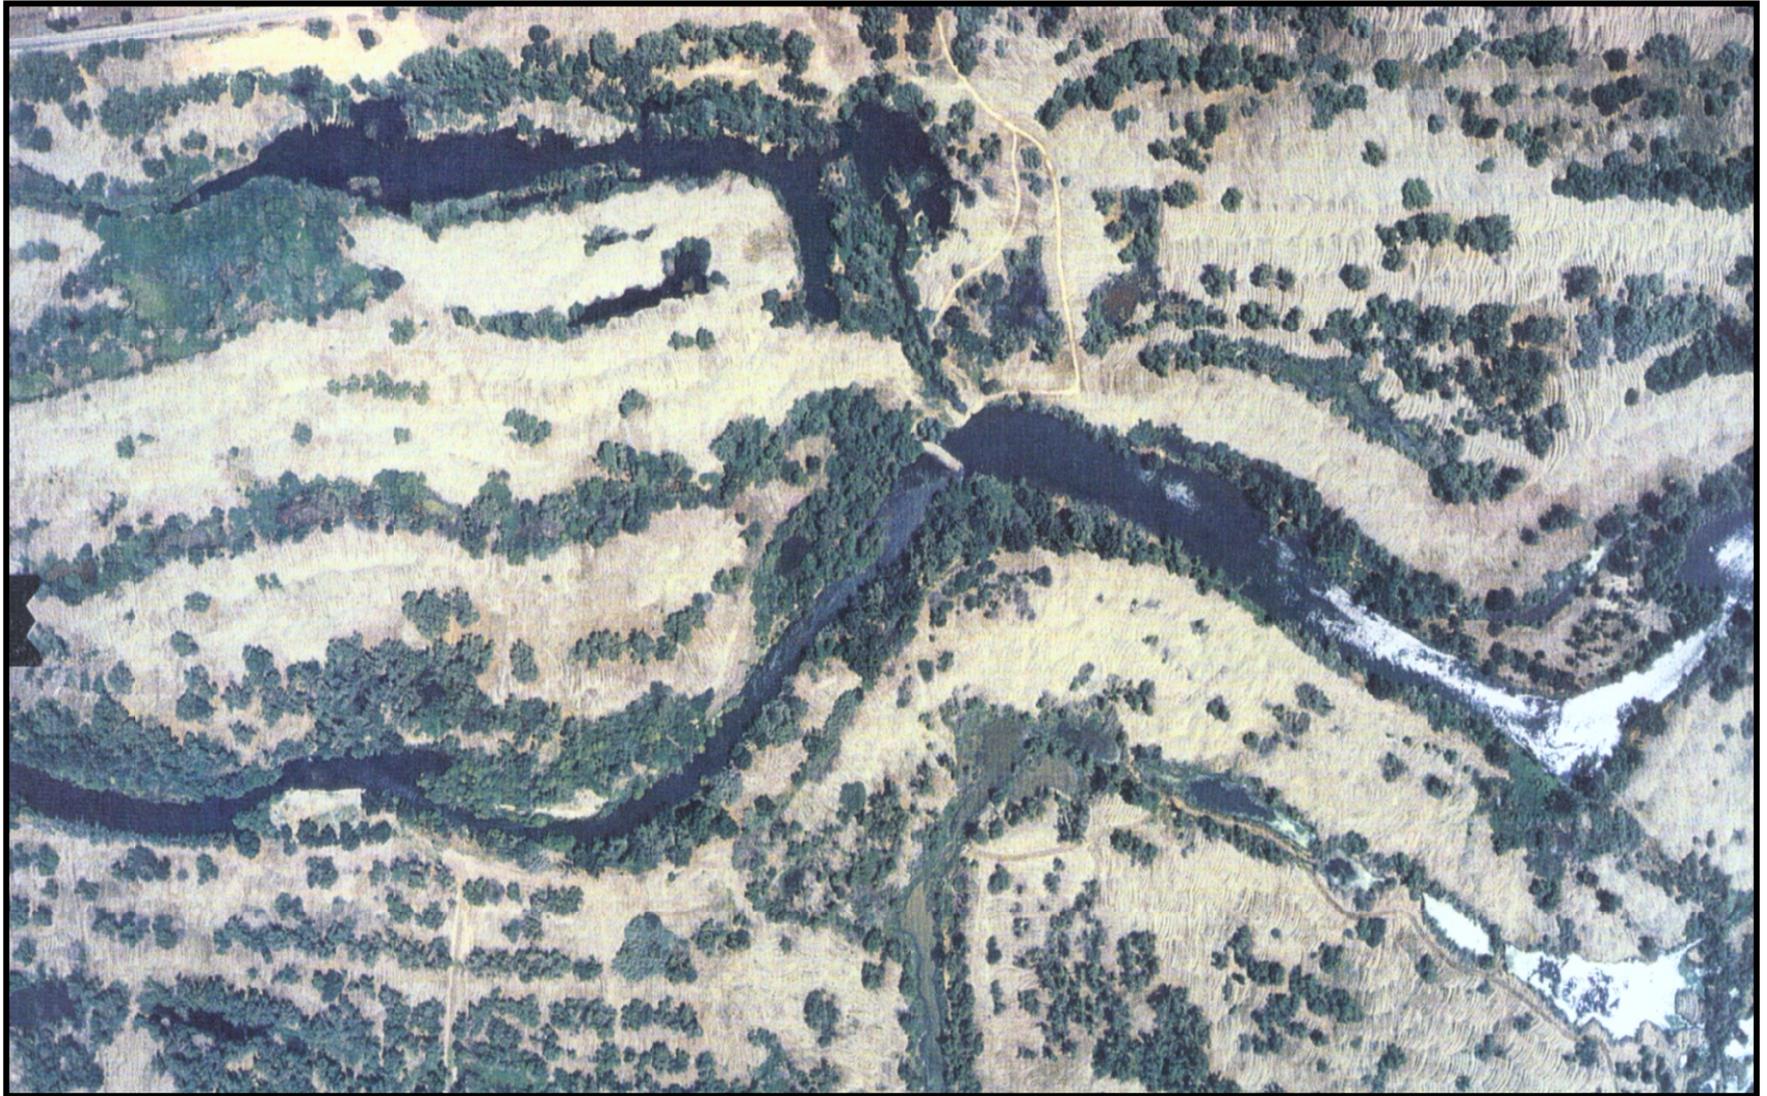
**Figure 5.1-5. Aerial photograph showing conditions in the Merced River Dredger Tailings Reach.**

(photo: U.S. Bureau of Reclamation 1993)
