## FIGURES

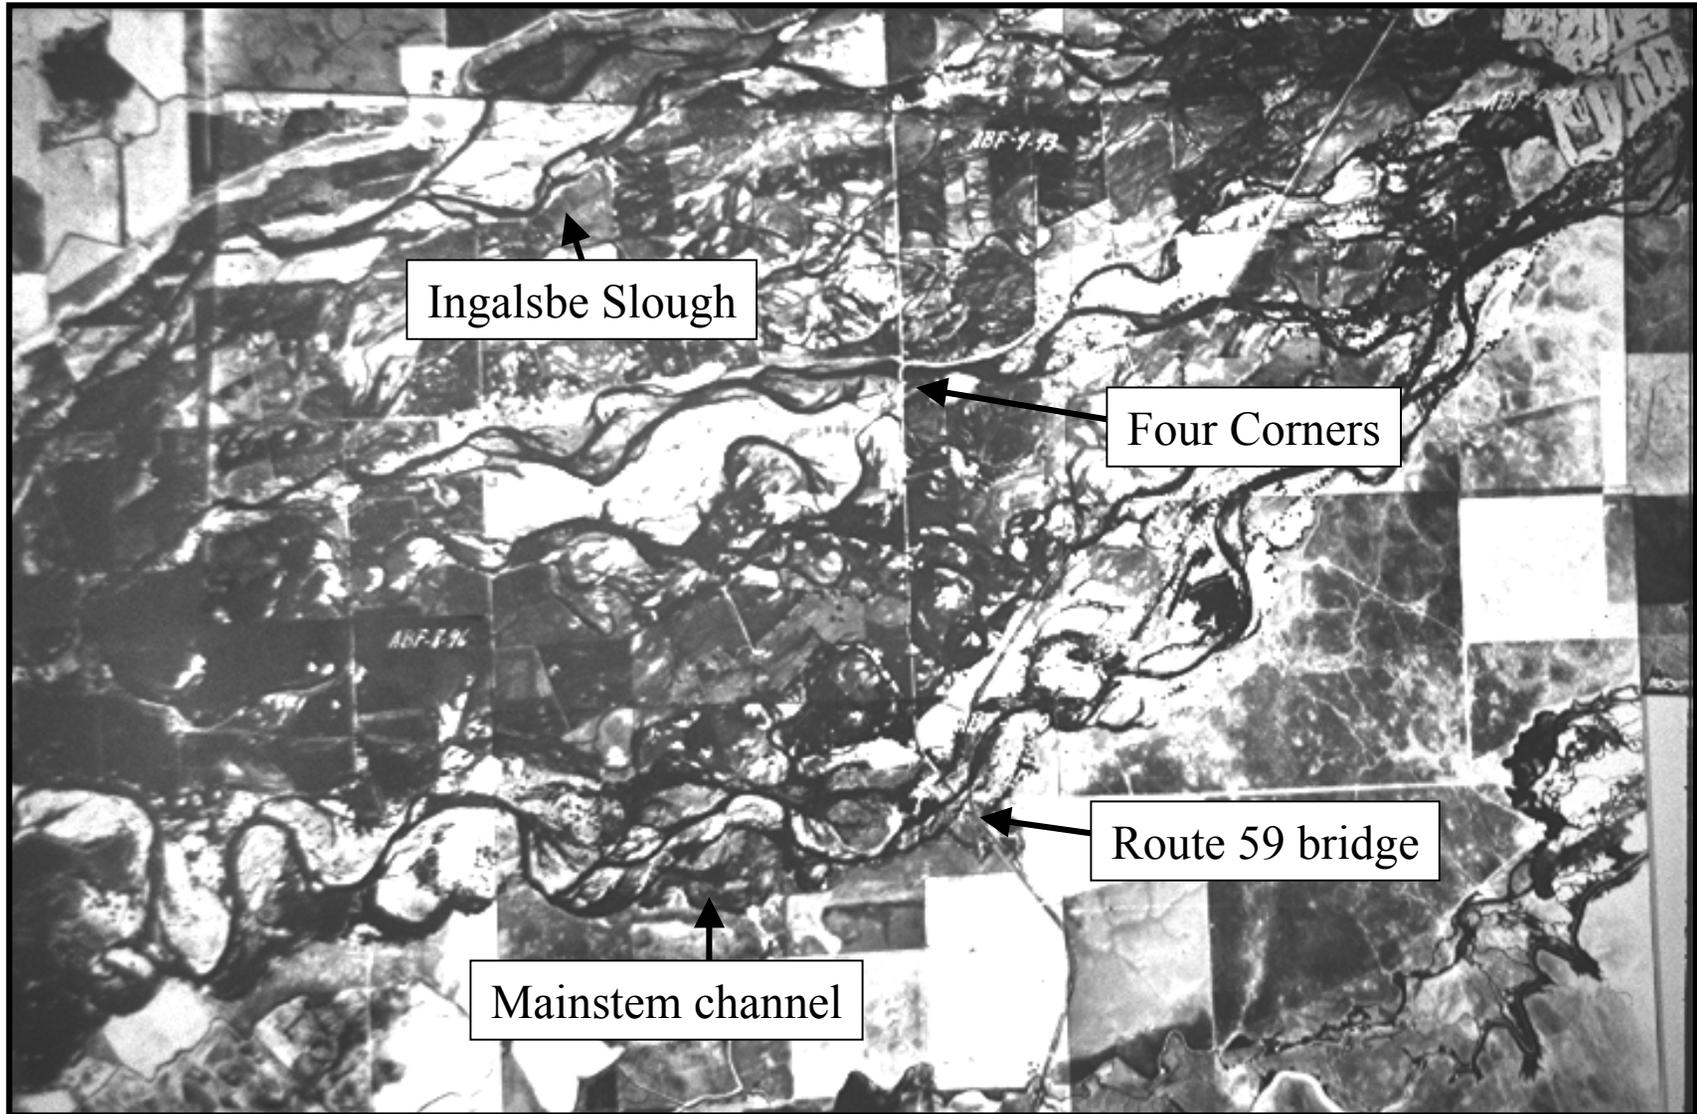
**Figure 5.1-6. Merced River multiple-channel system as shown in 1937 aerial photographs.**  
(photo: Agricultural Stabilization and Conservation Service 1937)

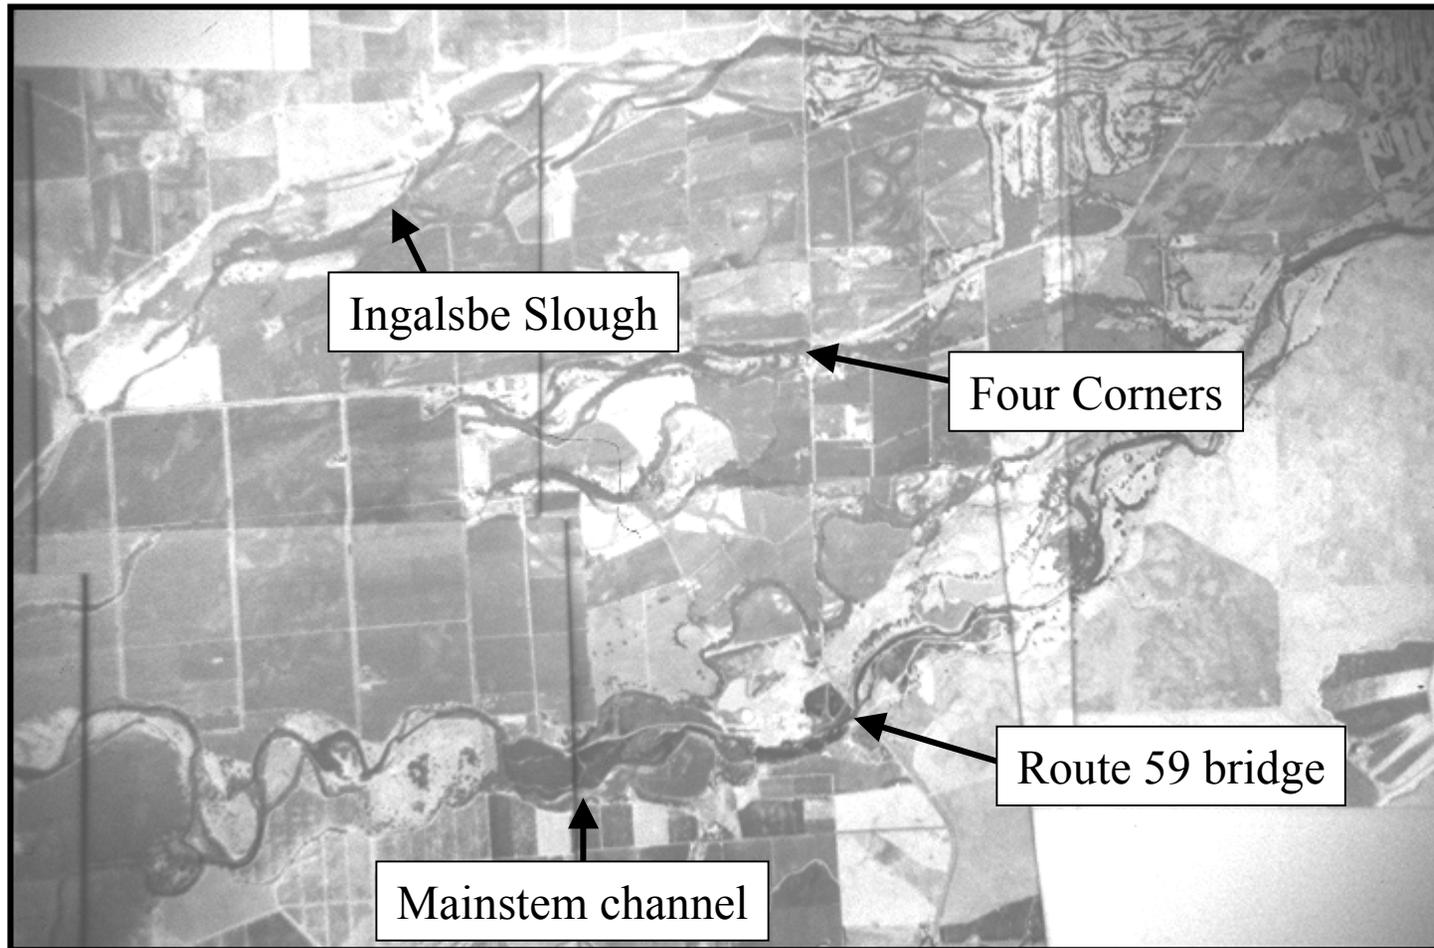
**Figure 5.1-7. Merced River remnant slough system as shown in 1979 aerial photographs.**  
(photo: Agricultural Stabilization and Conservation Service 1979)

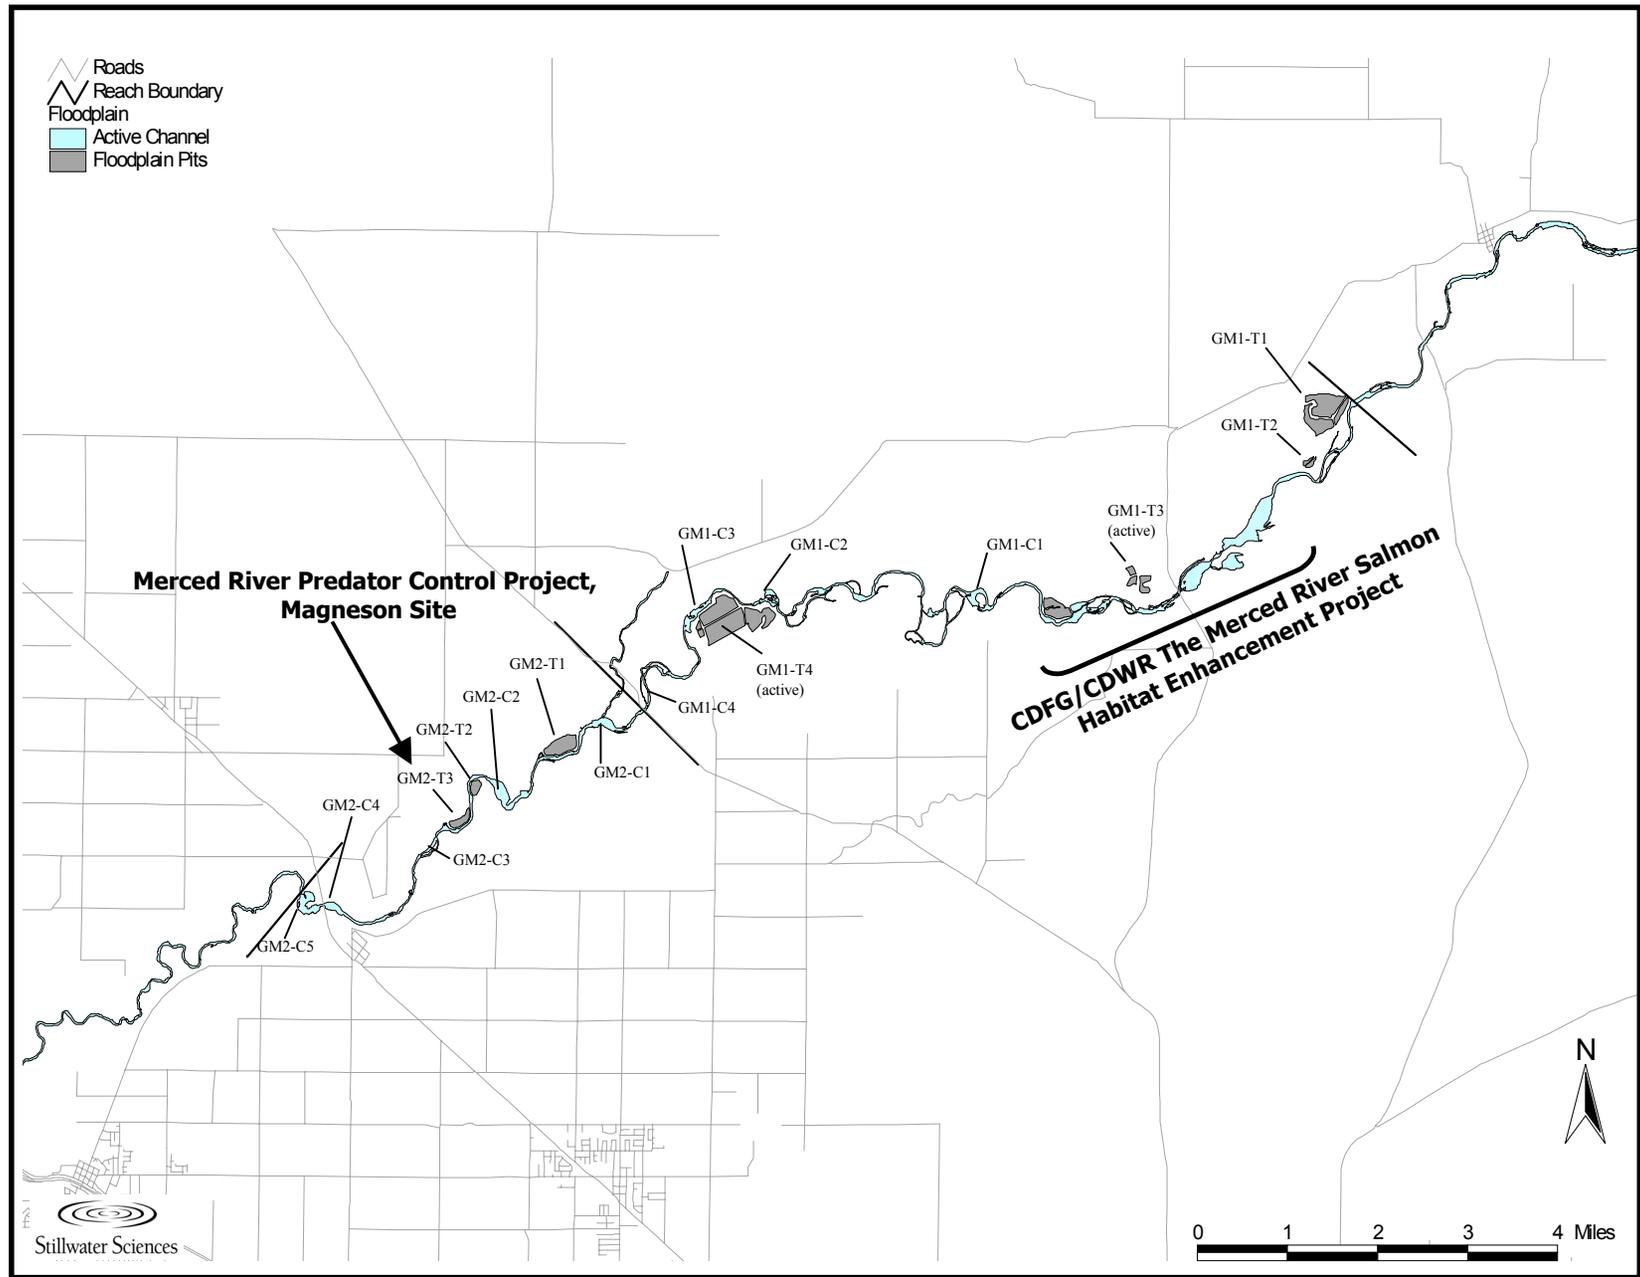
**Figure 5.1-8. Terrace and in-channel aggregate mines in the Gravel Mining 1 and Gravel Mining 2 reaches.**

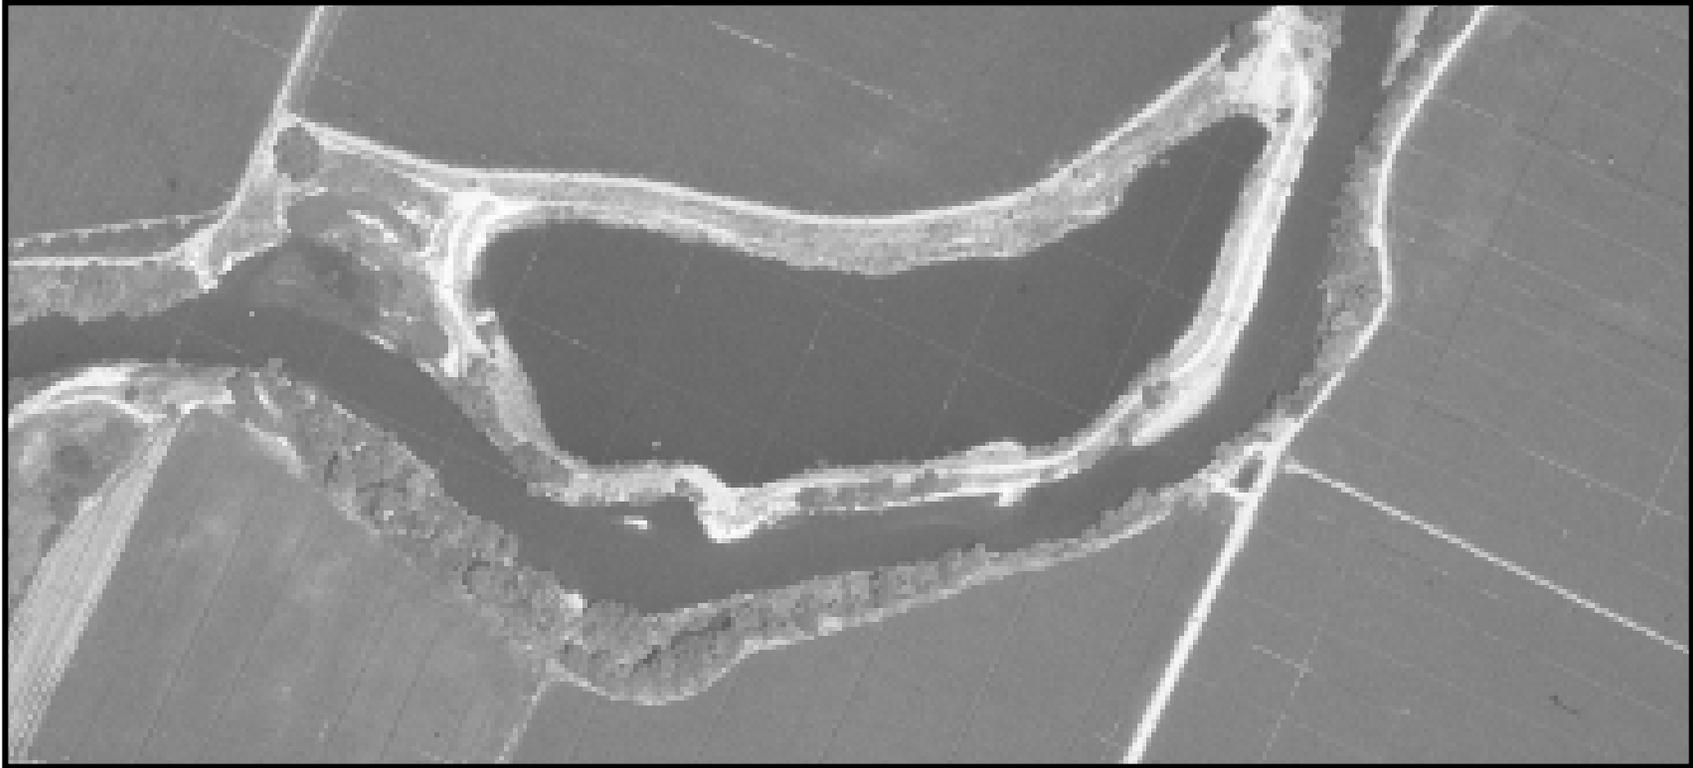
**Figure 5.1-9. Merced River Predator Control Project, Magneson Site.**

(photo: Merced County Planning and Community Development Department 1998)

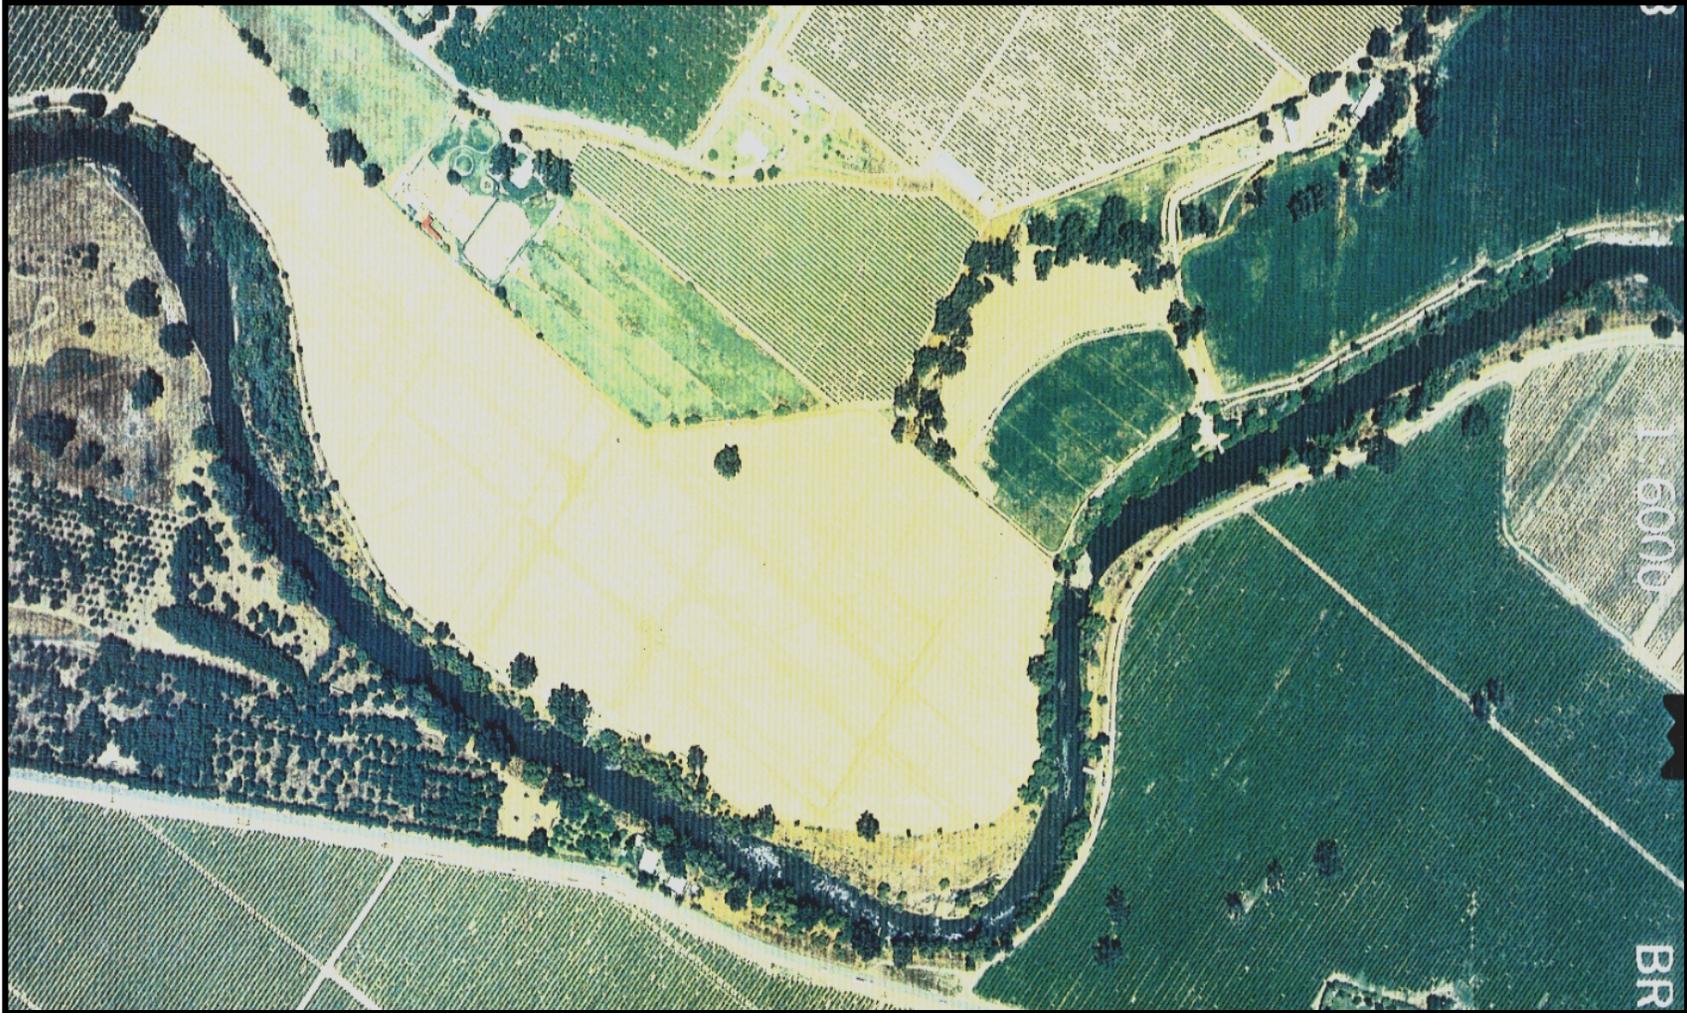
**Figure 5.1-10. Aerial photograph showing conditions in the Encroachment Reach.**  
(photo: U. S. Bureau of Reclamation 1993)

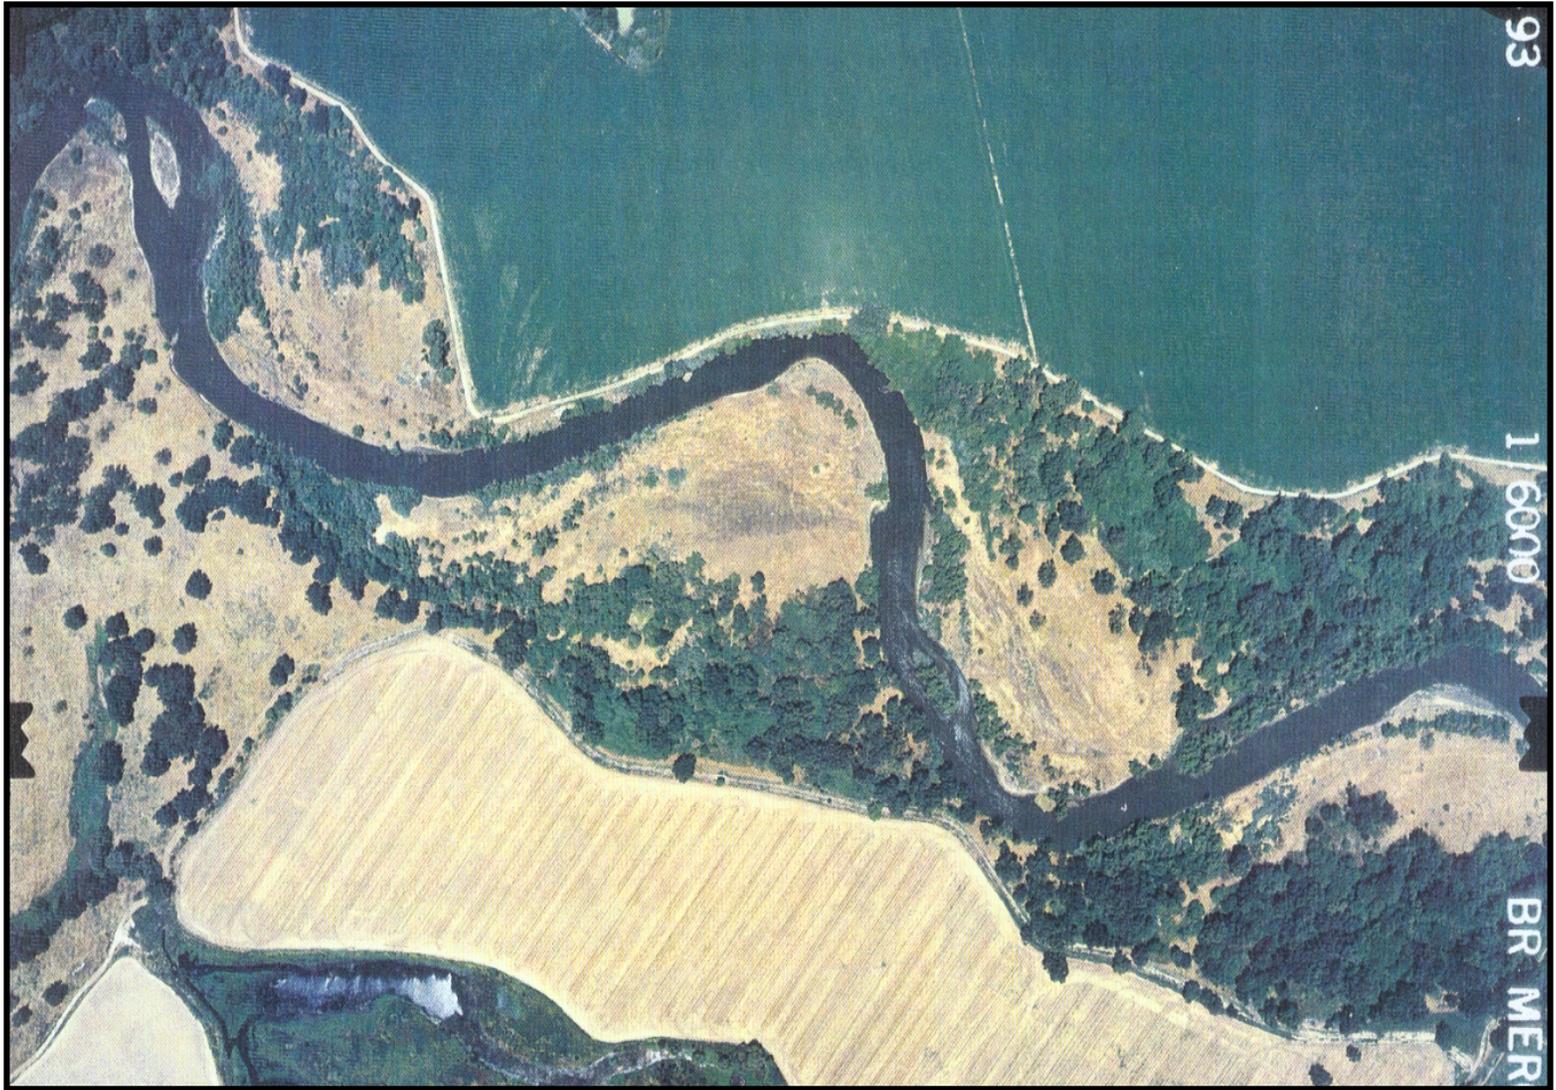
**Figure 5.1-11. Aerial photograph showing conditions in the Confluence Reach.**  
(photo: U. S. Bureau of Reclamation 1993)

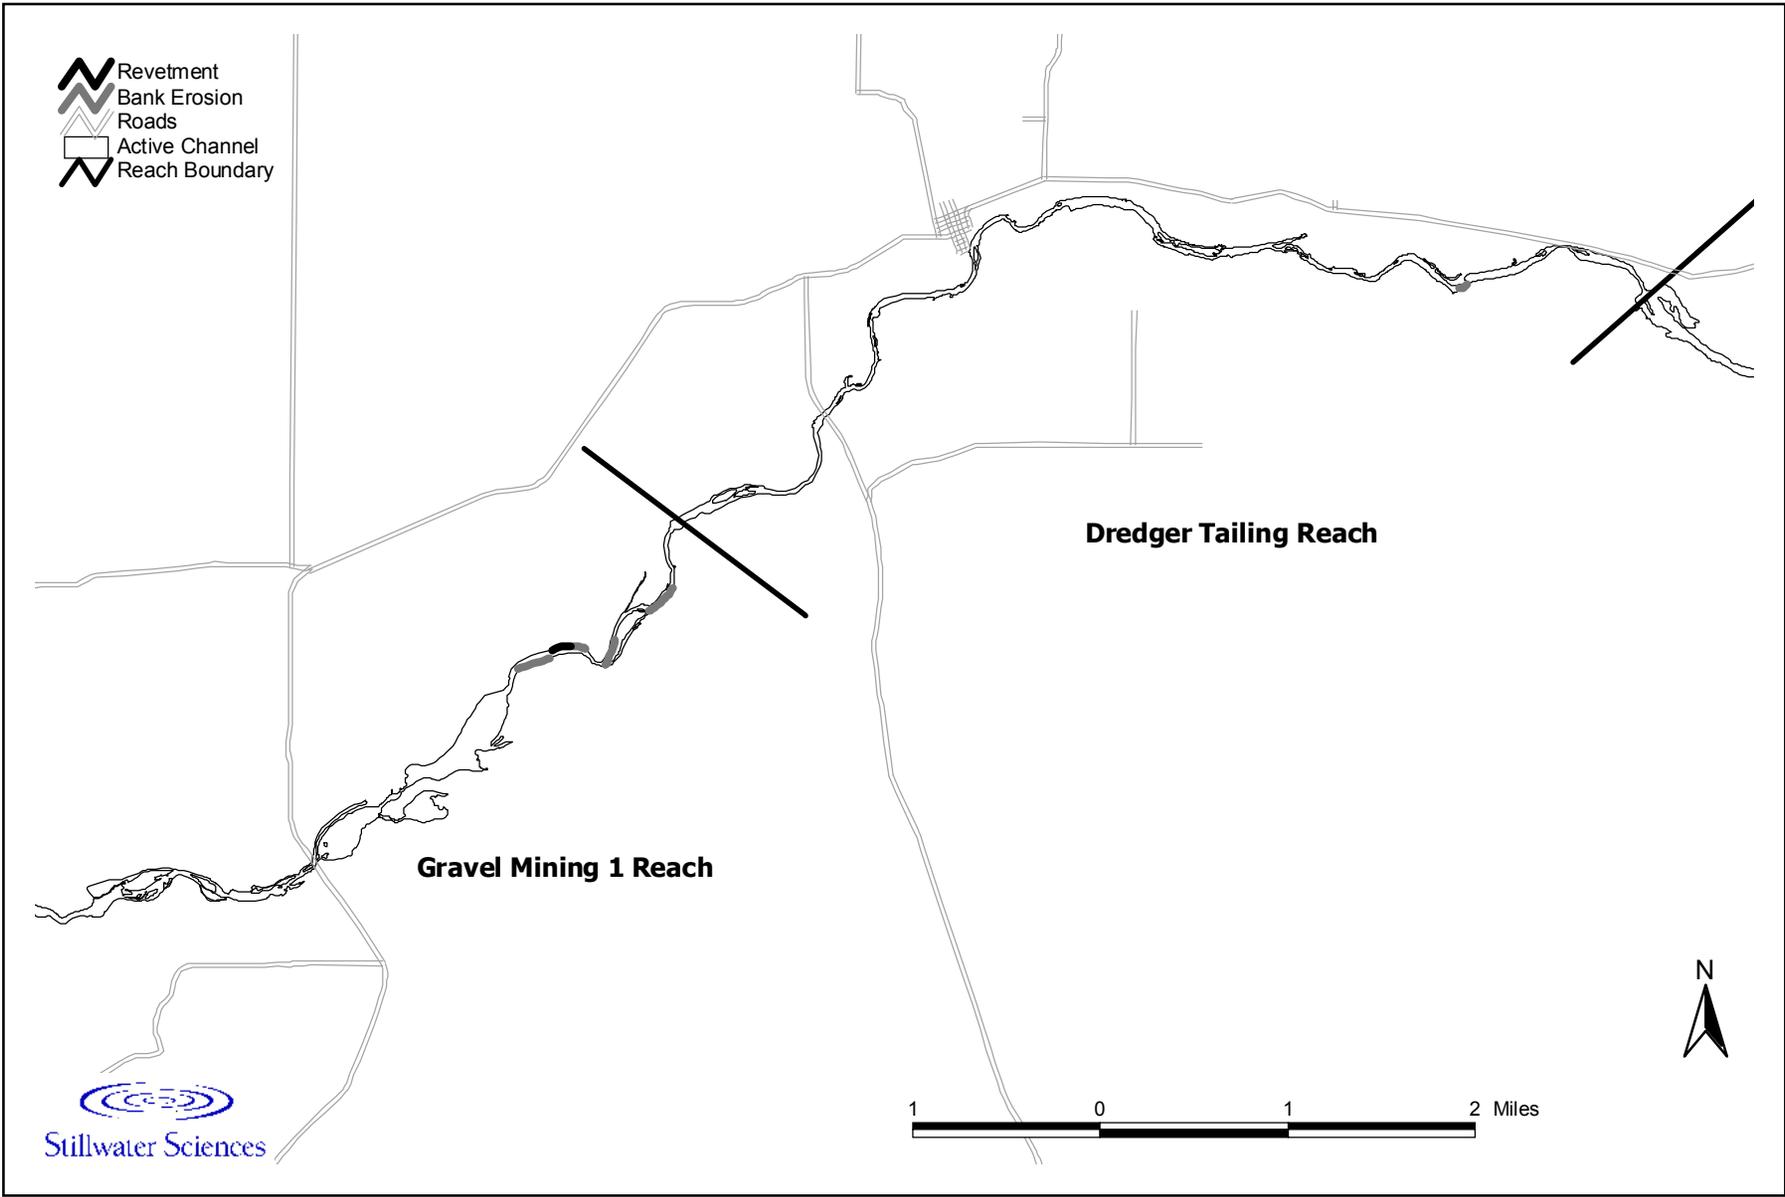
Figure 5.2-1A. Bank erosion and revetment in the Merced River.

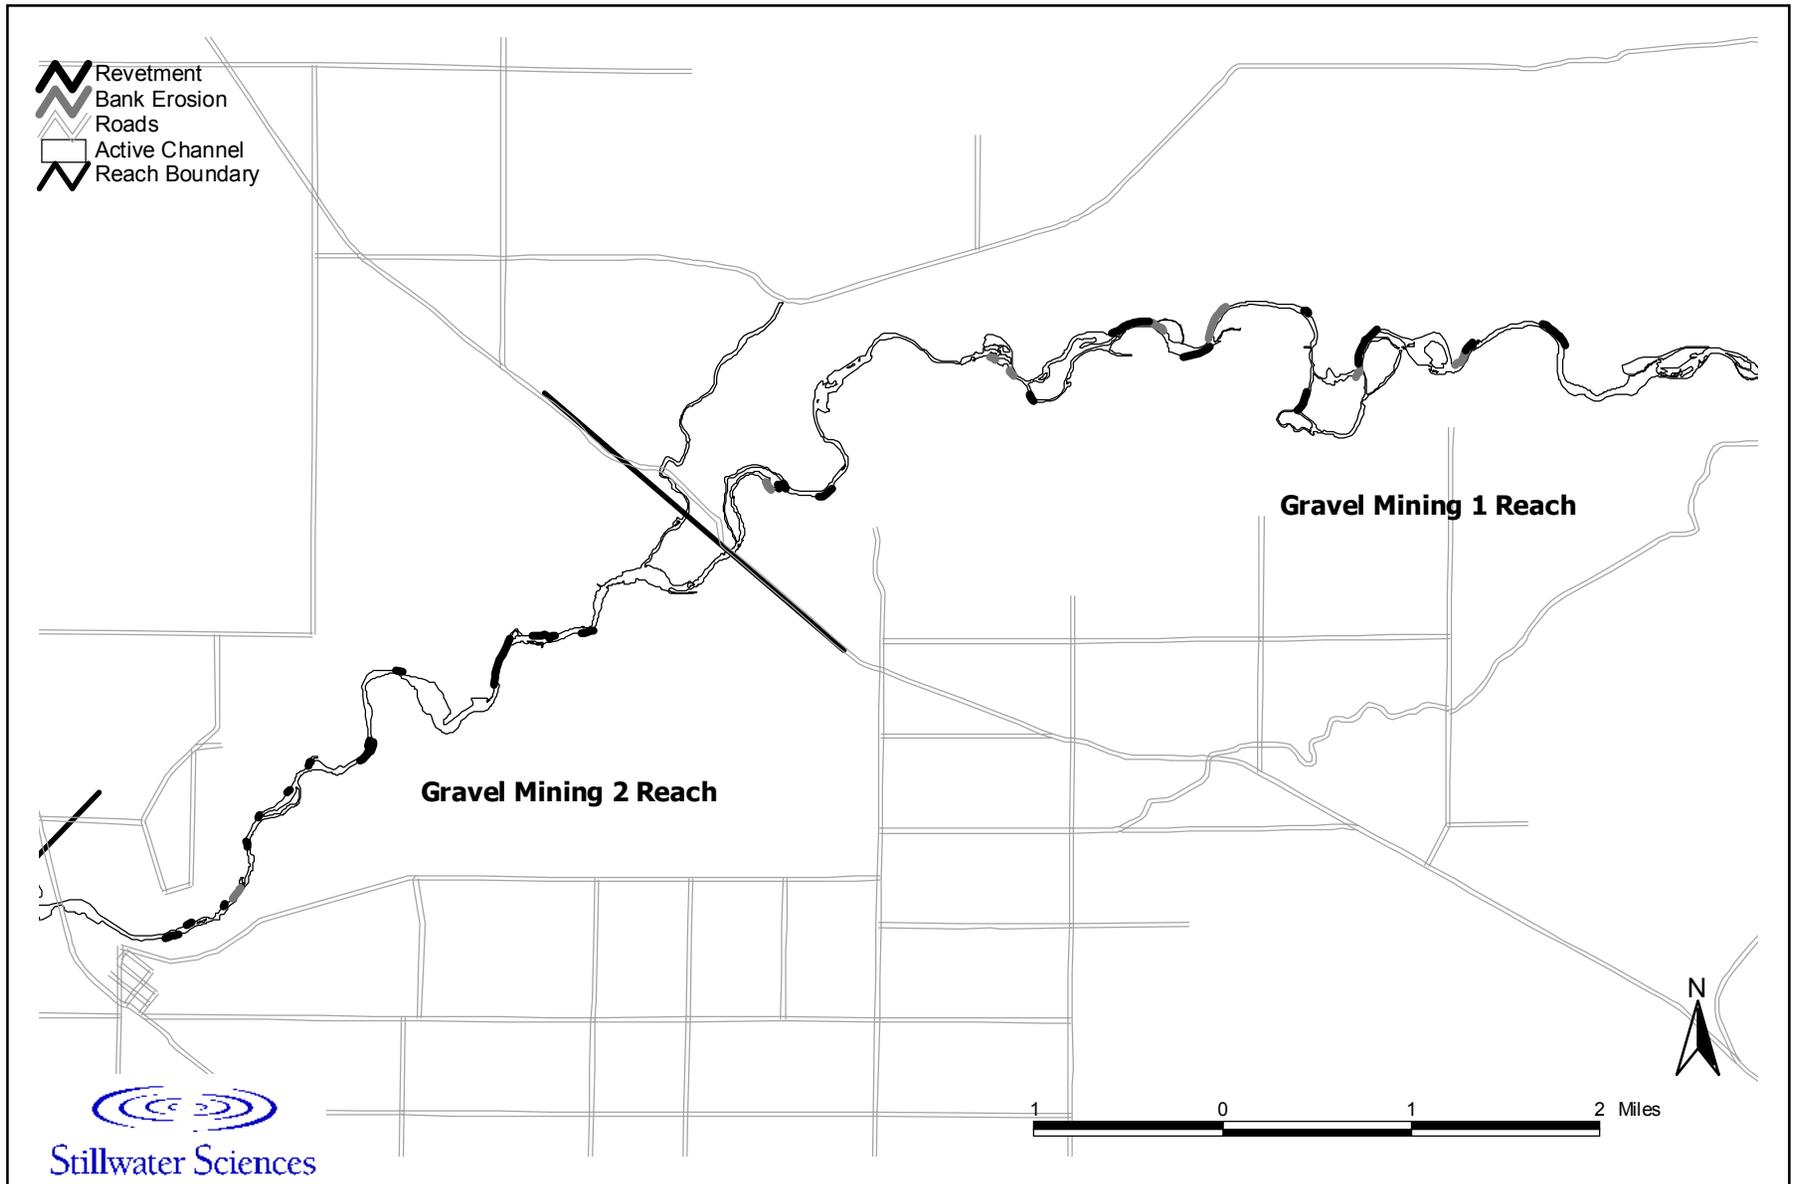
**Figure 5.2-1B. Bank erosion and revetment in the Merced River.**

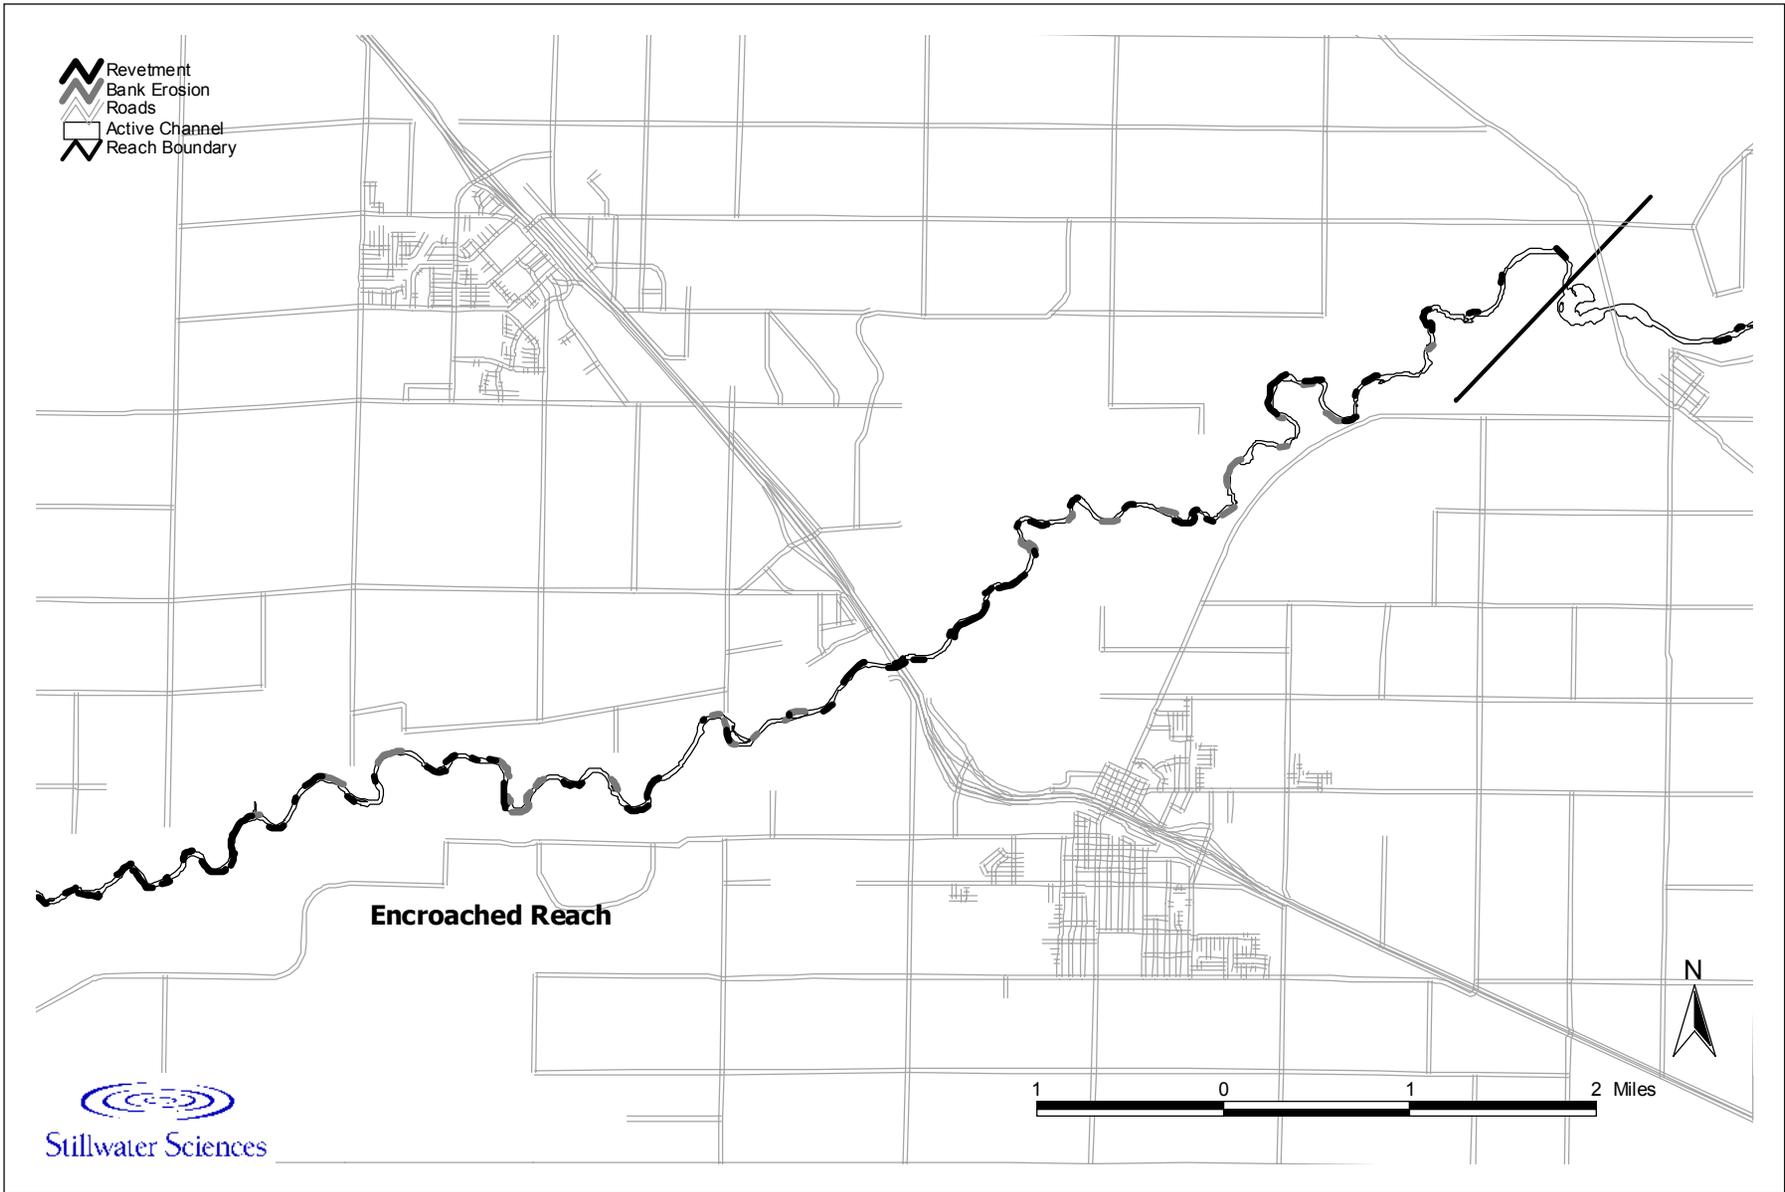
Figure 5.2-1C. Bank erosion and revetment in the Merced River

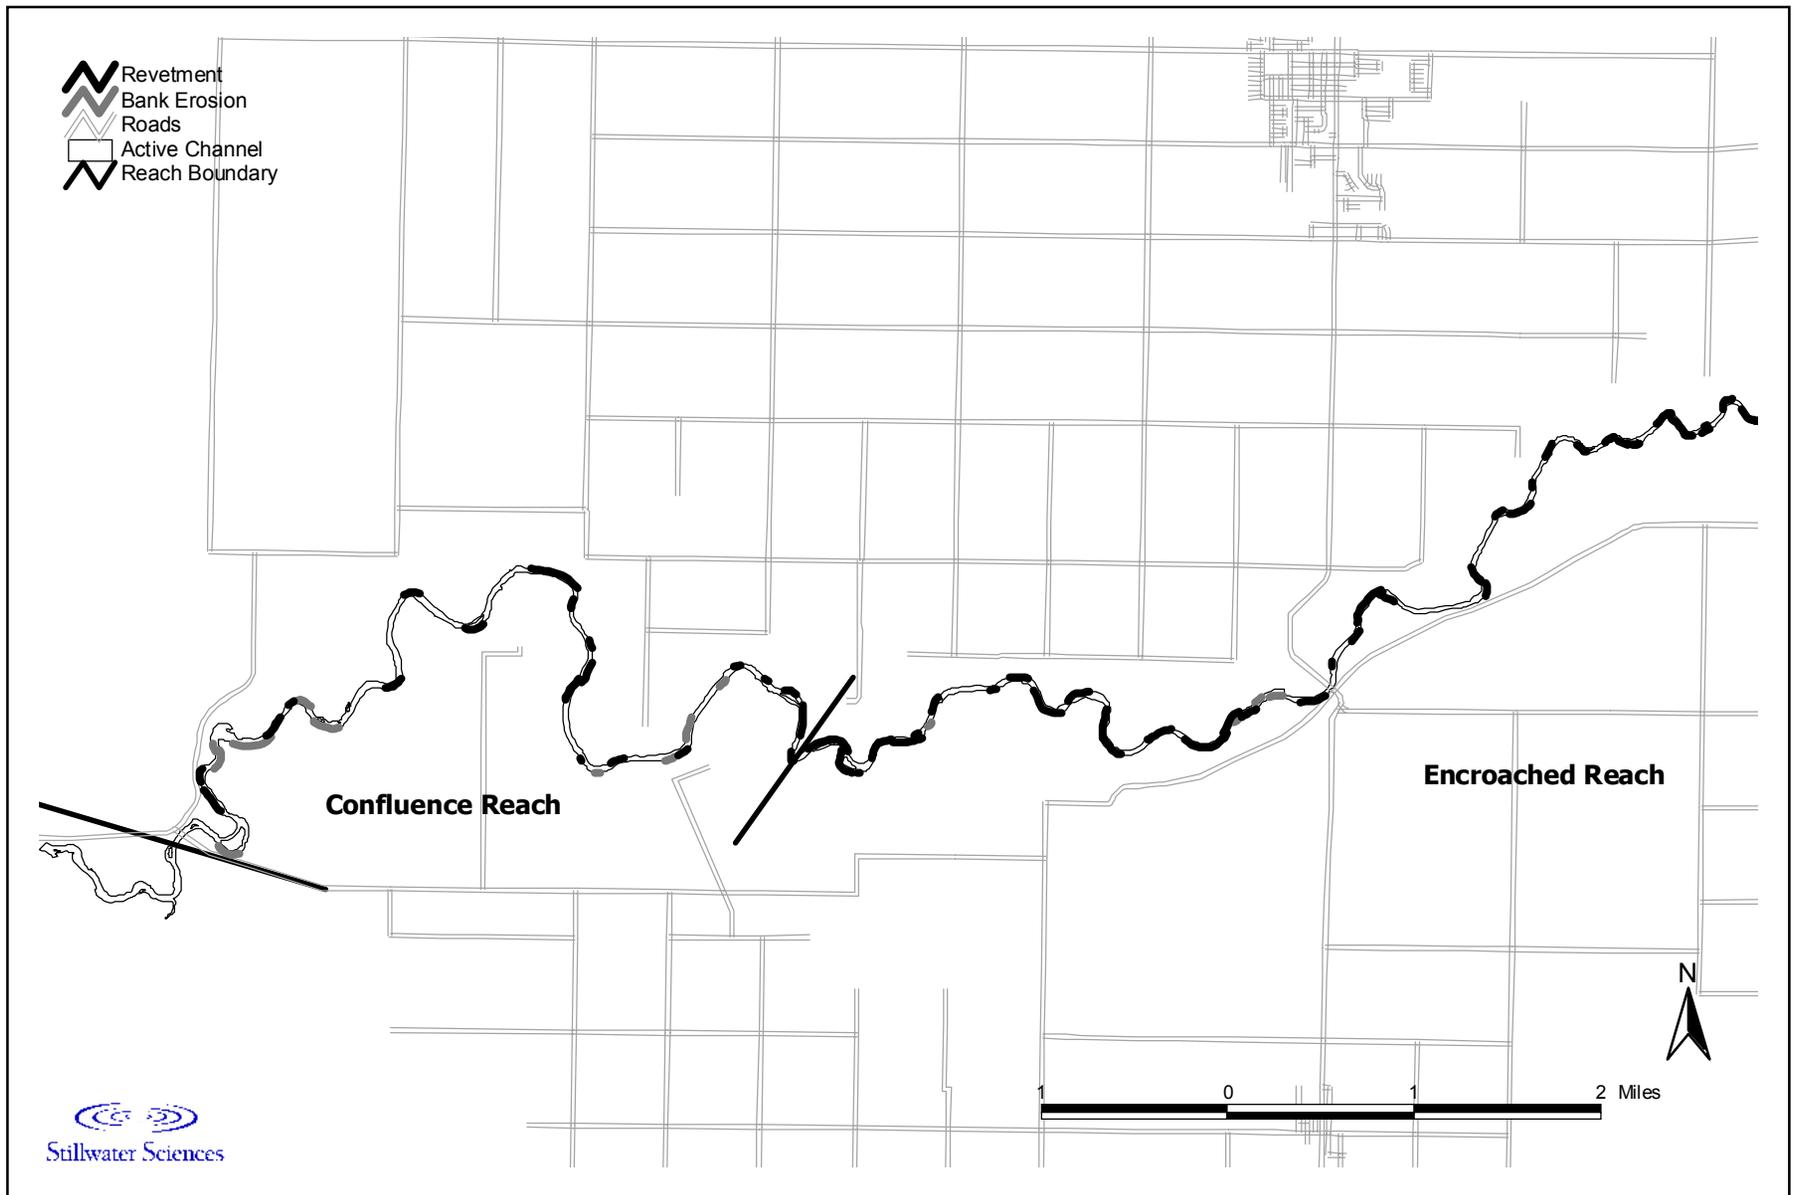
**Figure 5.2-1D. Bank Erosion and revetment in the Merced River.**

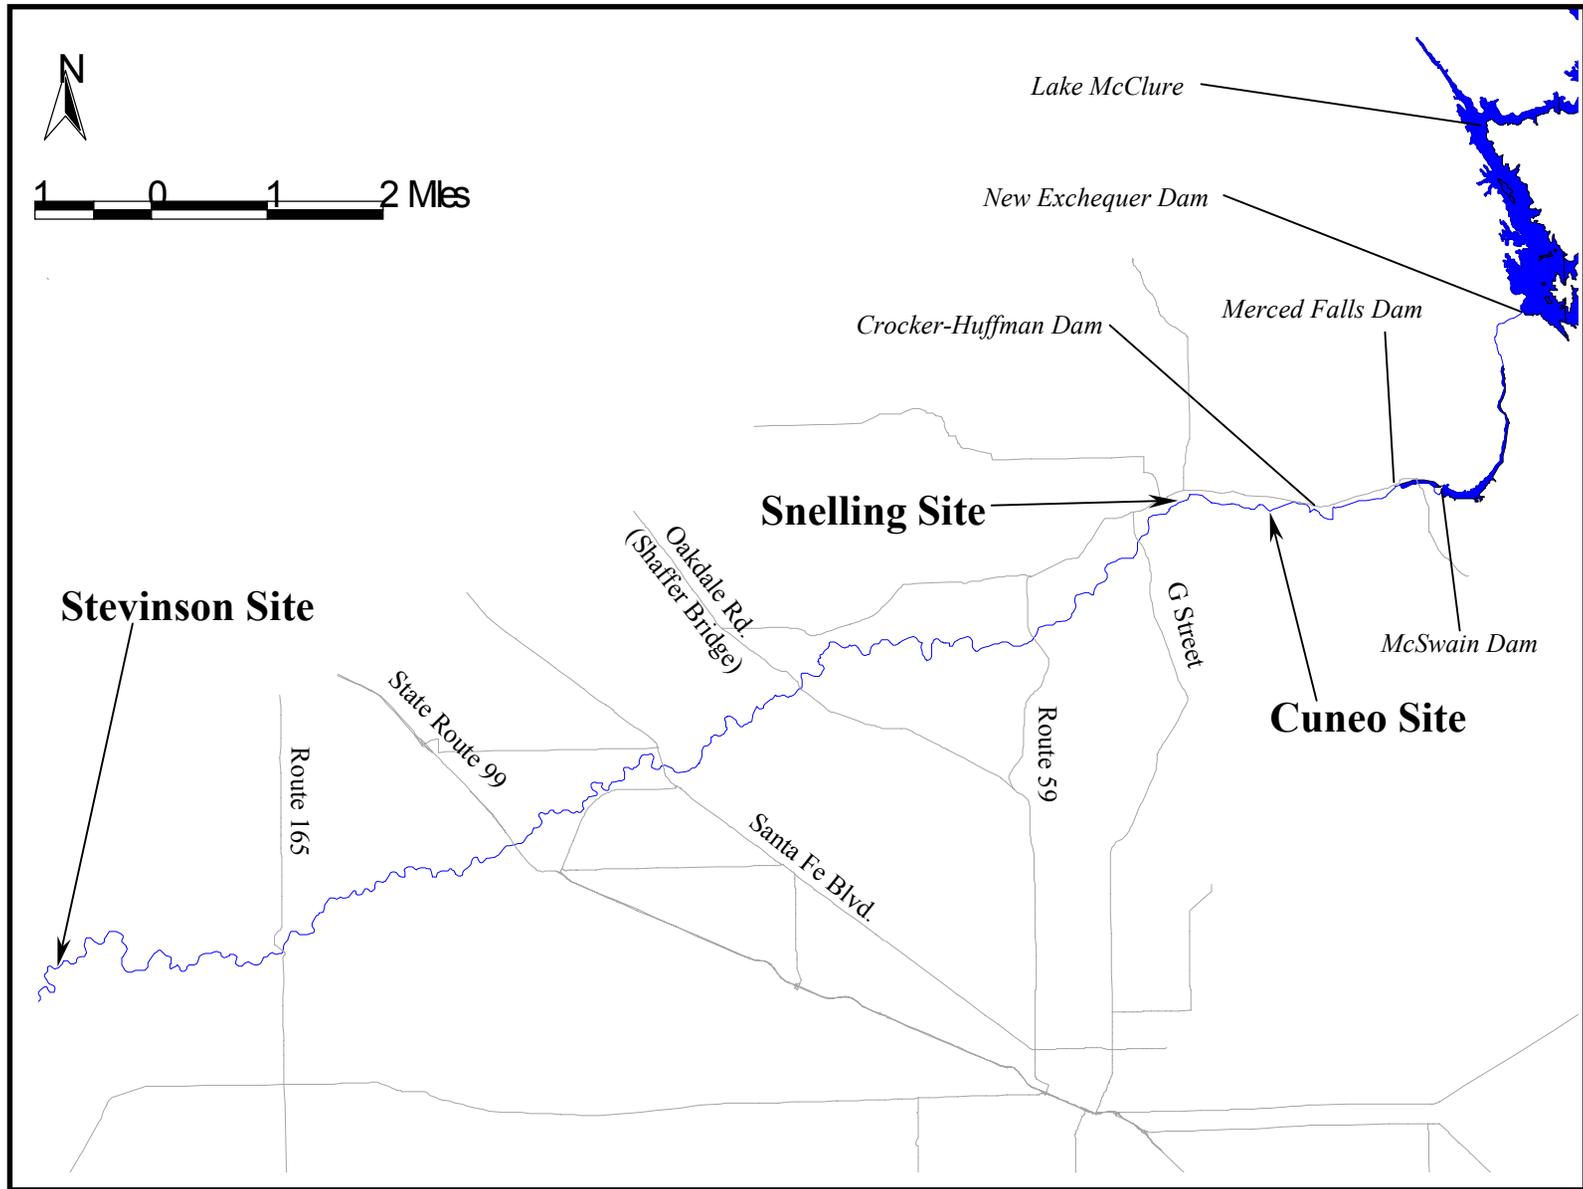
**Figure 5.3-1. Location of Phase II study sites on the Merced River.**

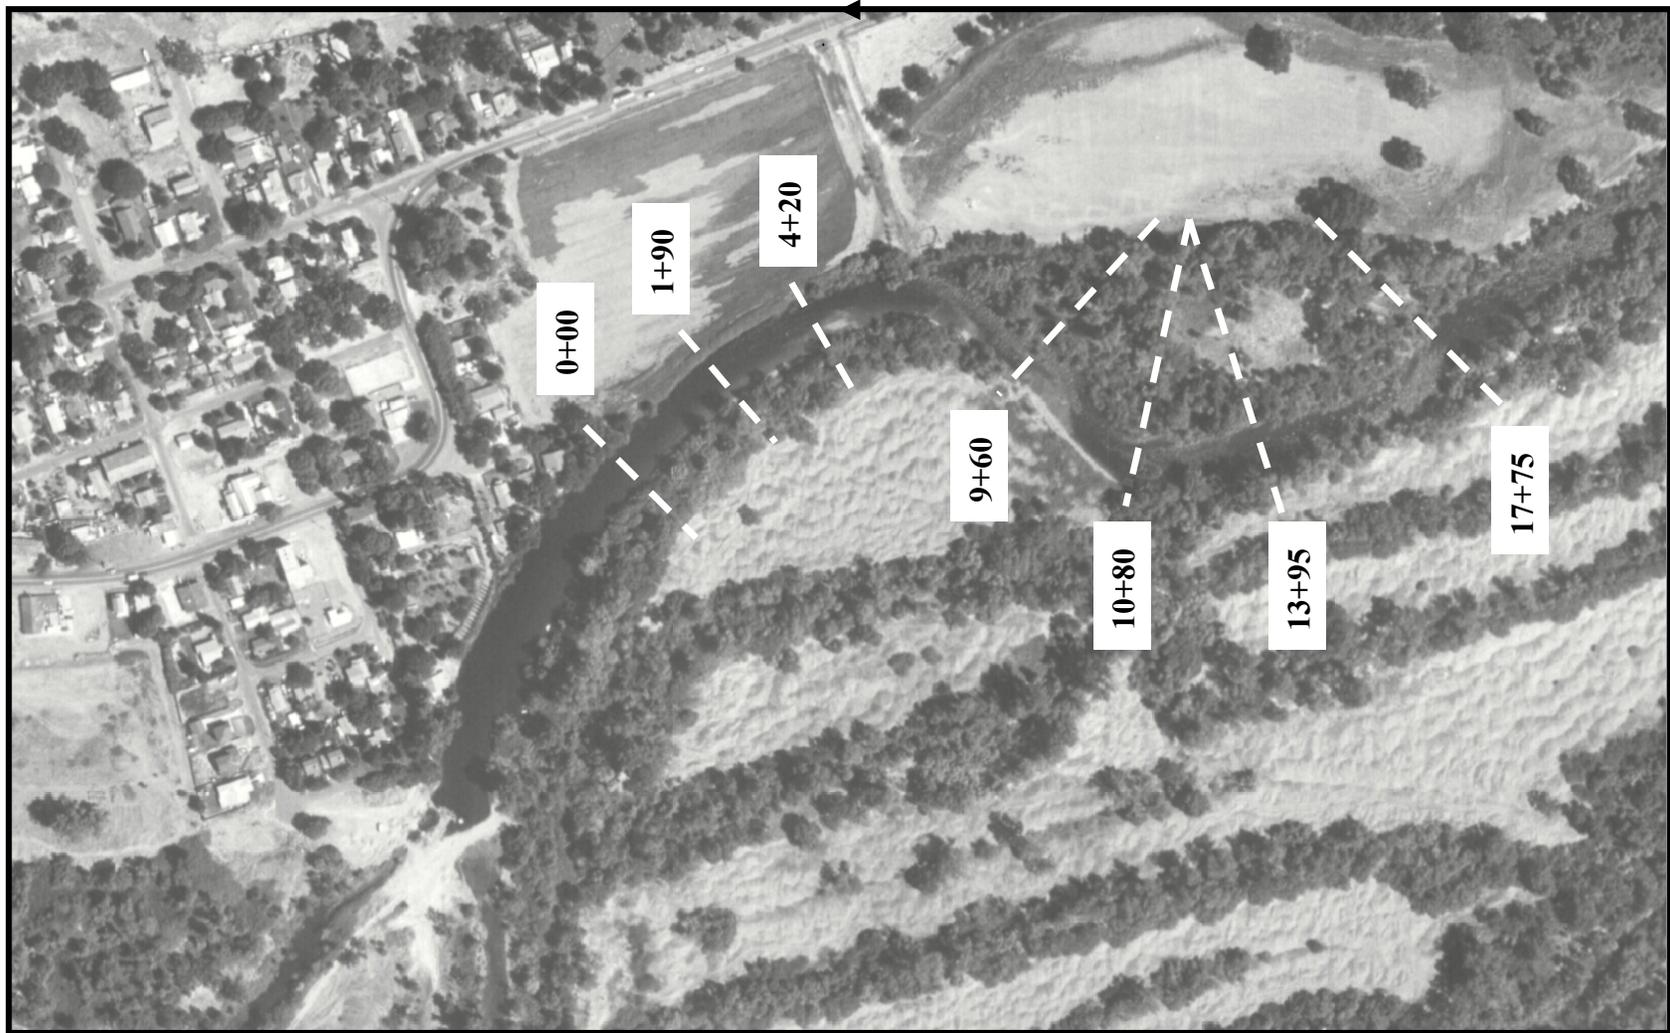
**Figure 5.3-2. Cross section survey locations at the Snelling Site.**  
(photo: Merced County Planning and Community Development Department 1998)
