## FIGURES

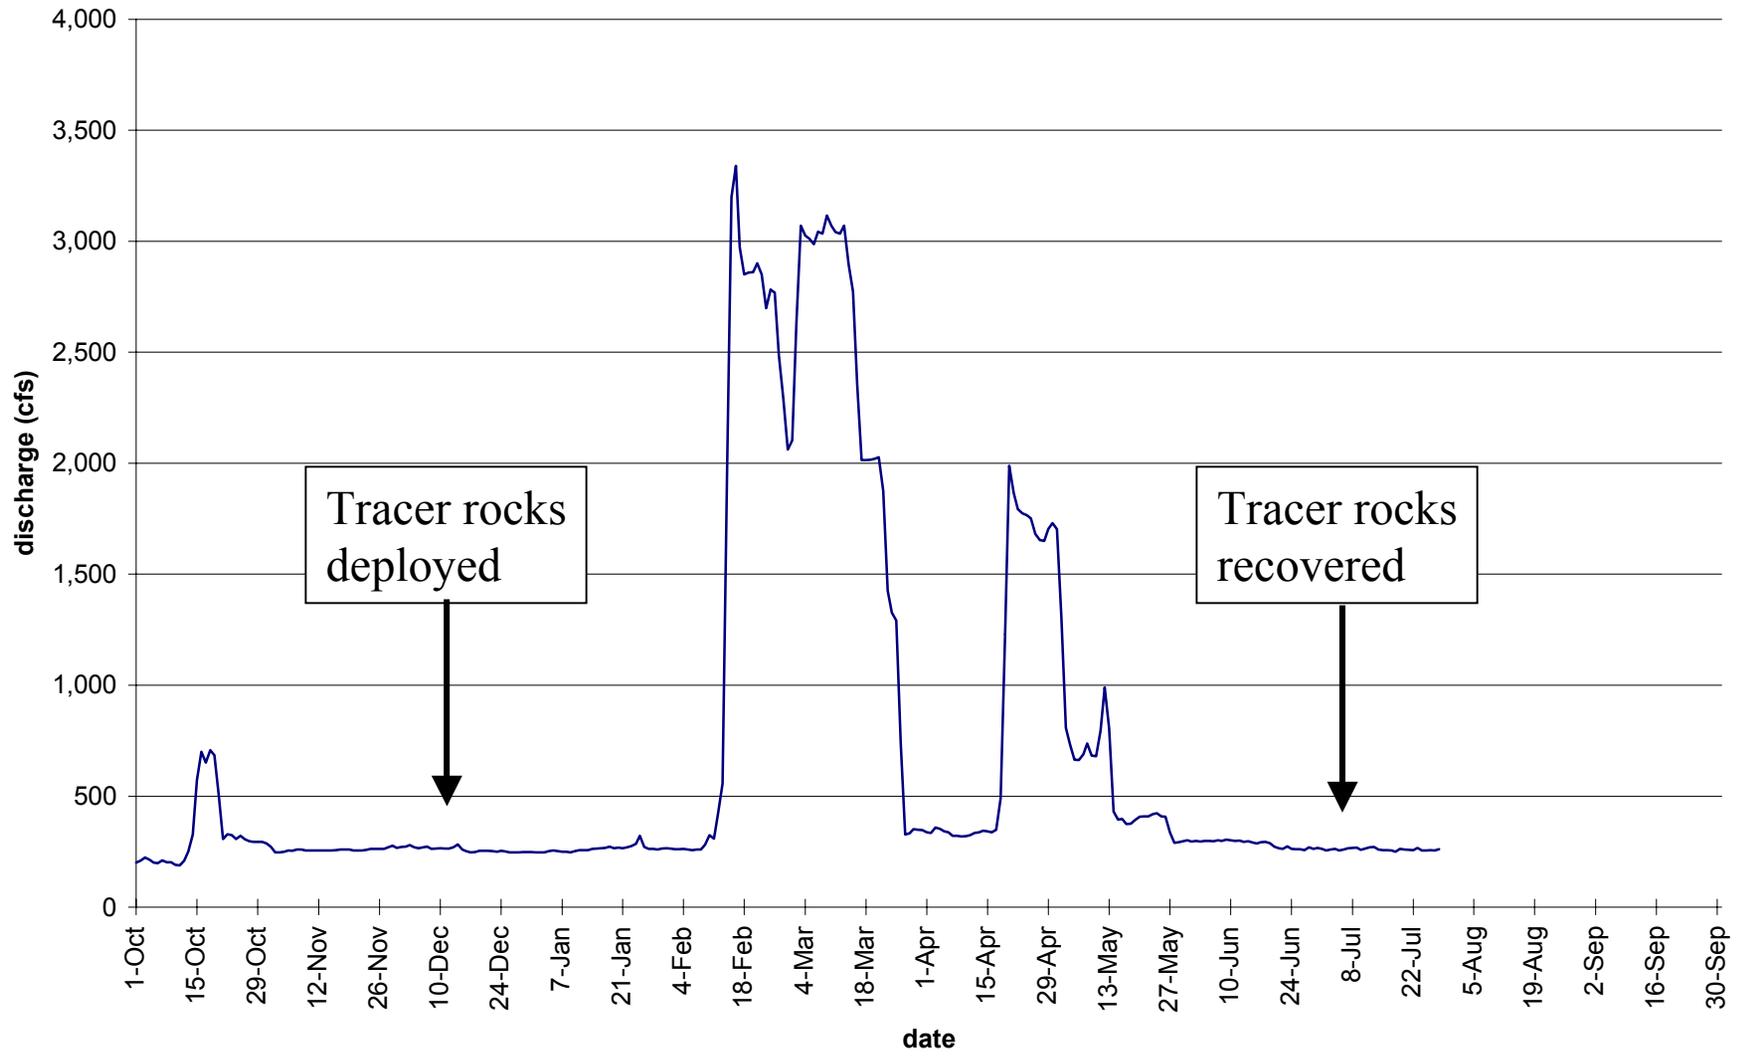
**Figure 5.3-3. Flows at the Snelling Site between tracer rock deployment and recovery.**  
 (source: Merced Irrigation District Crocker-Huffman gauge)

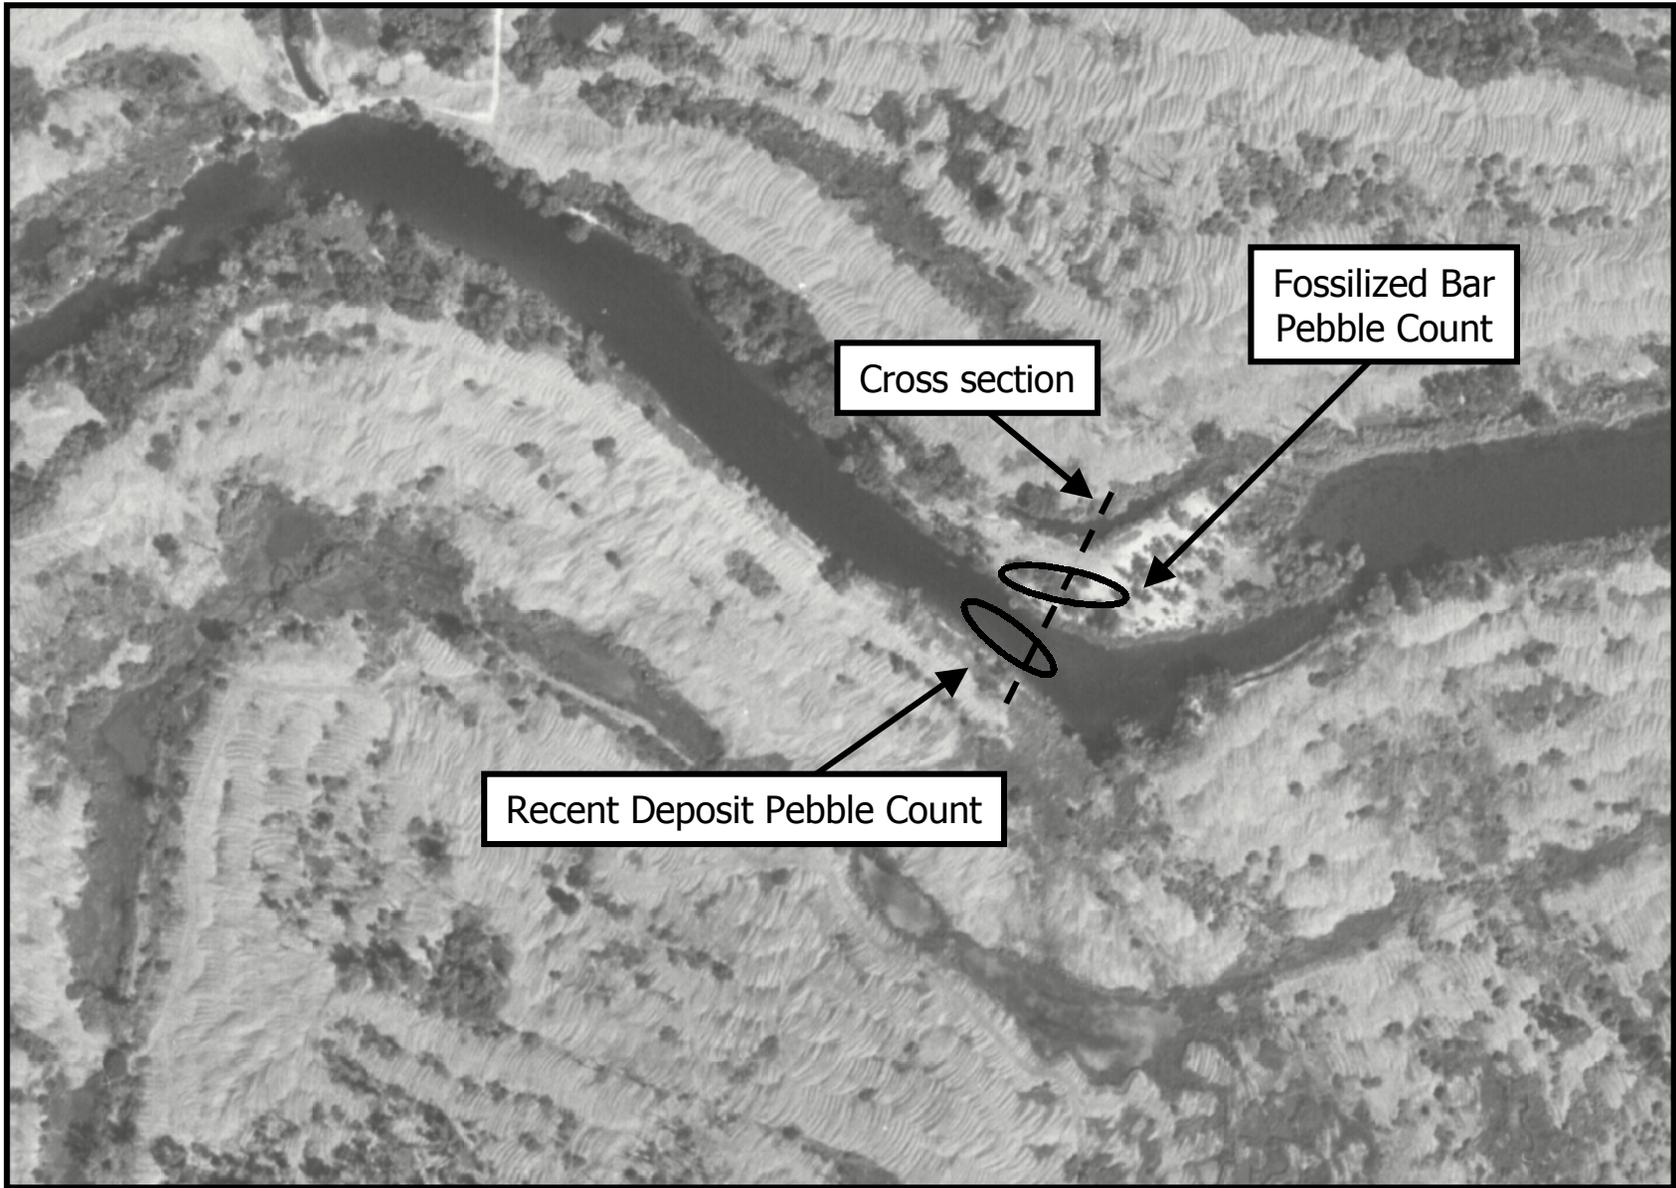
**Figure 5.3-4. Cross section and pebble count locations at the Cuneo Site.**  
(photo: Merced County Planning and Community Development Department 1998)

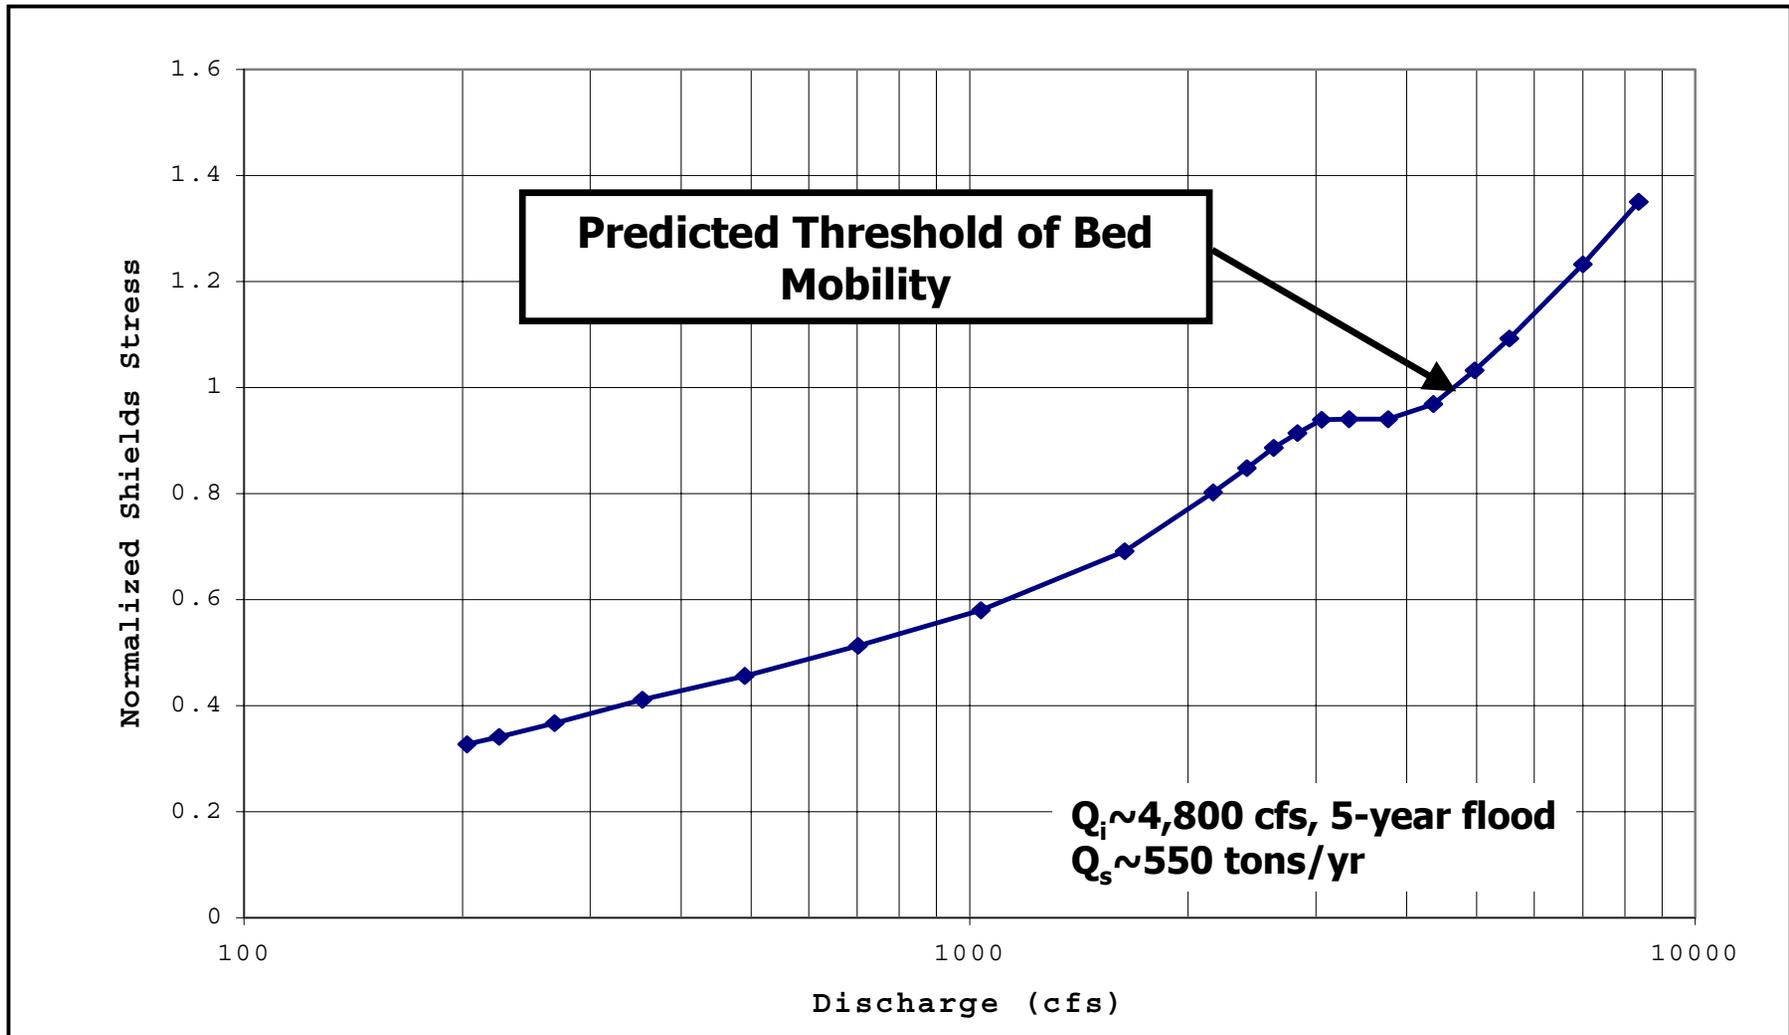
**Figure 5.3-5. Normalized Shields stress versus discharge for the Snelling Site.**

(The channel bed is predicted to be in motion when the normalized Shields stress is  $\geq 1$ .)

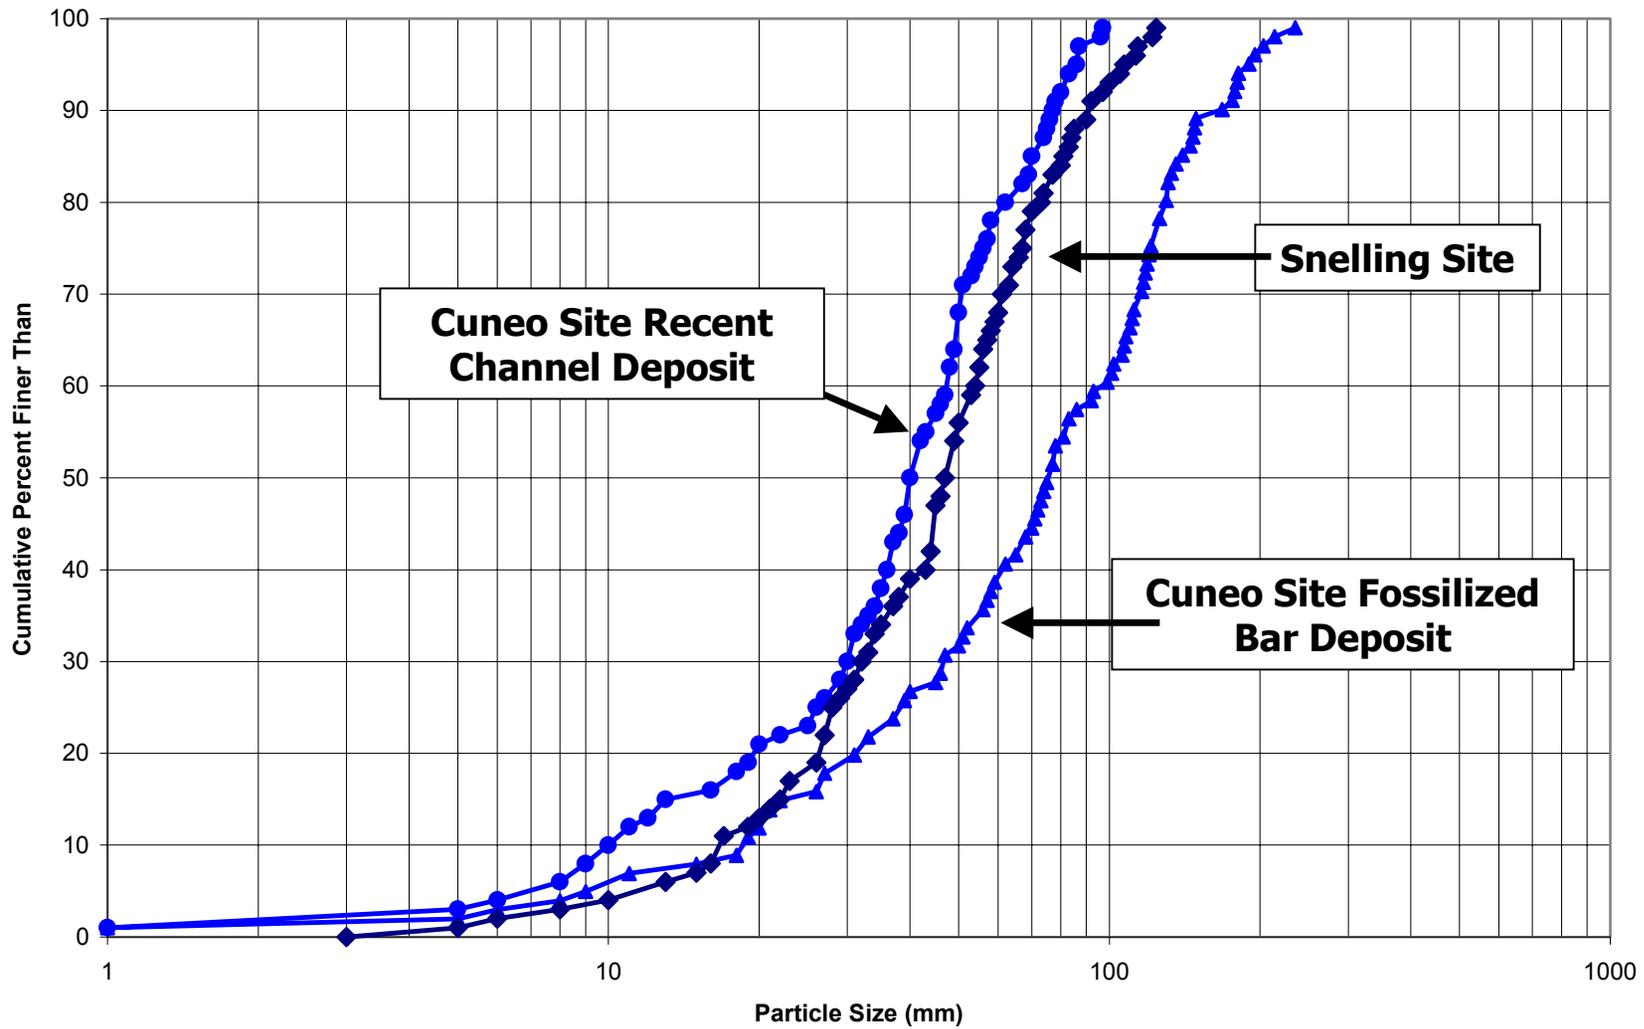
**Figure 5.3-6. Cumulative particles size distribution for the fossilized bar and recent channel deposits at the Cuneo Site.**

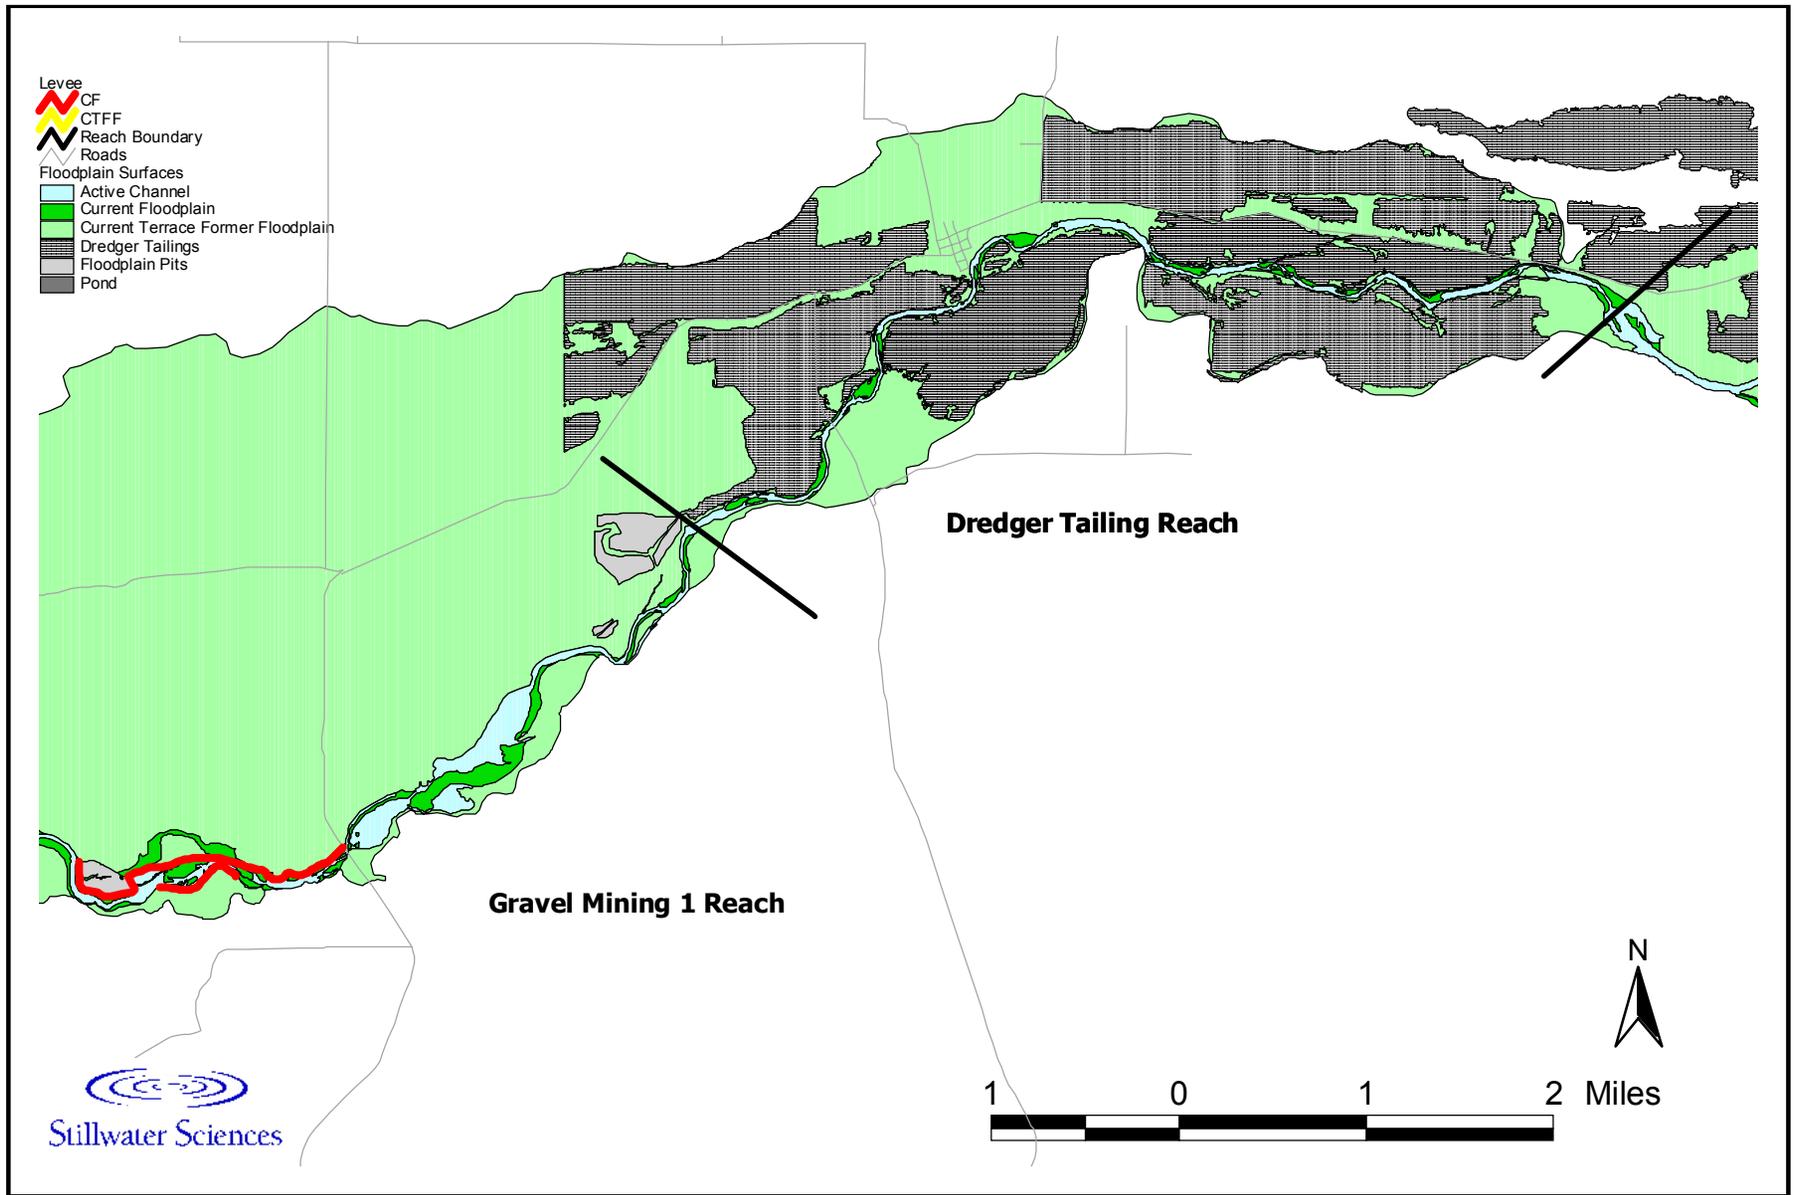
**Figure 5.5-1A. Merced River current and historic floodplain and levees**

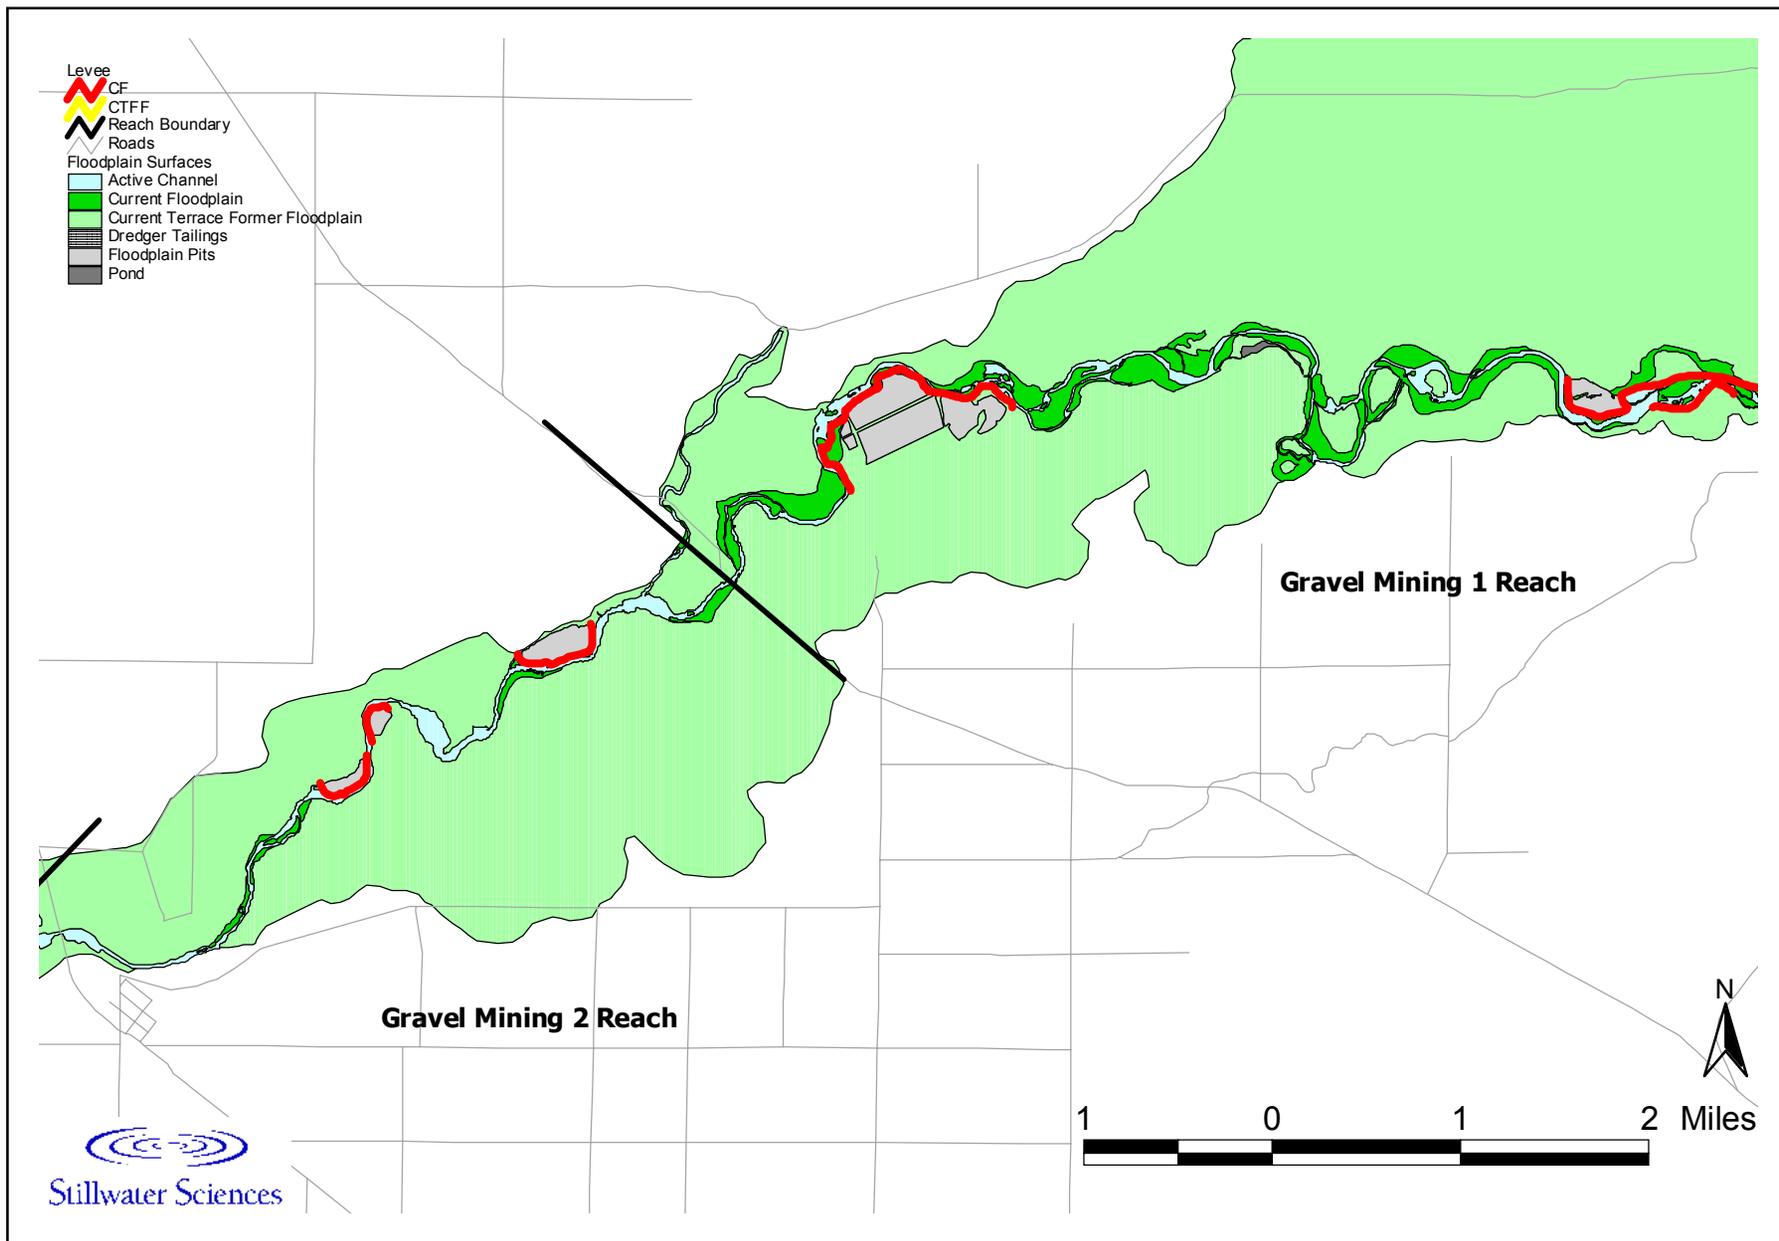
**Figure 5.5-1B. Merced River current and historic floodplain and levees.**

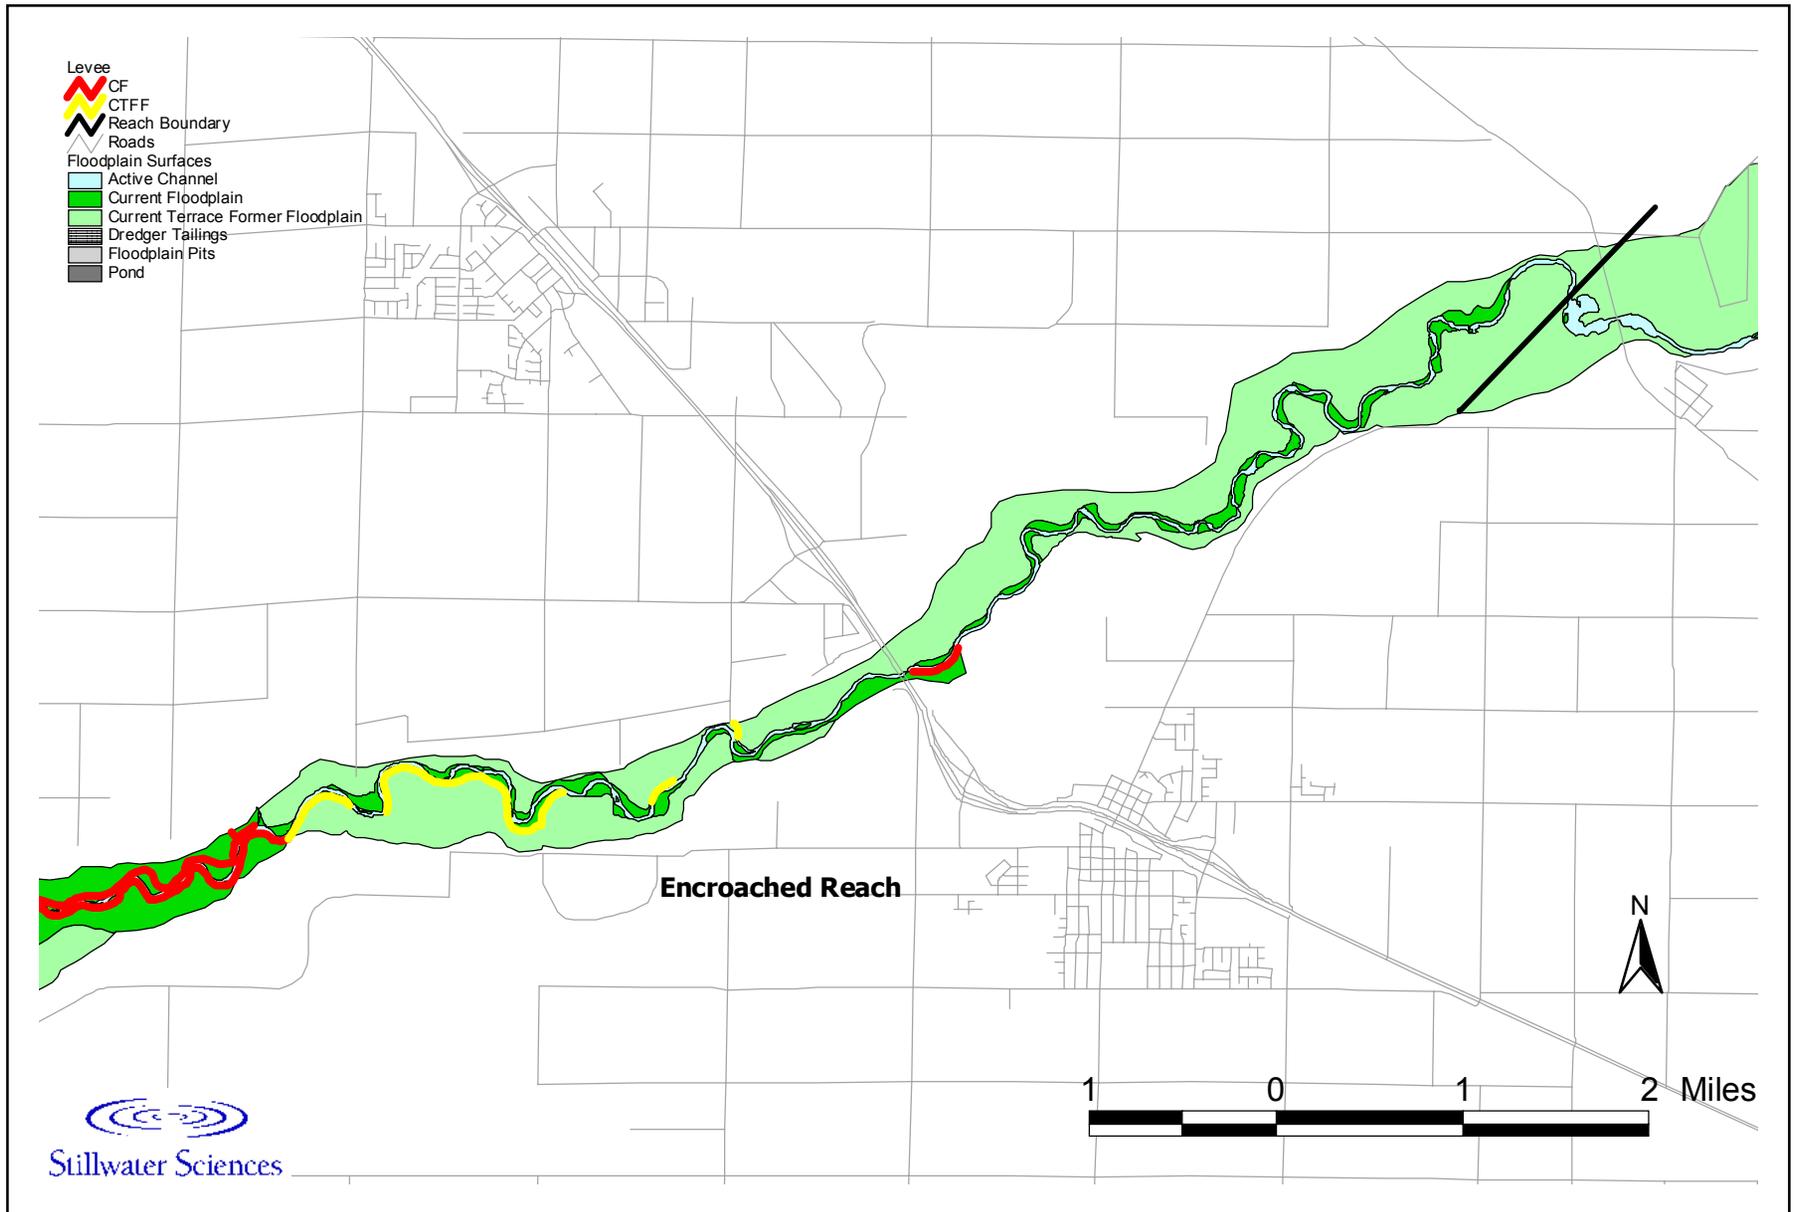
**Figure 5.5-1C. Merced River current and historic floodplain and levees.**

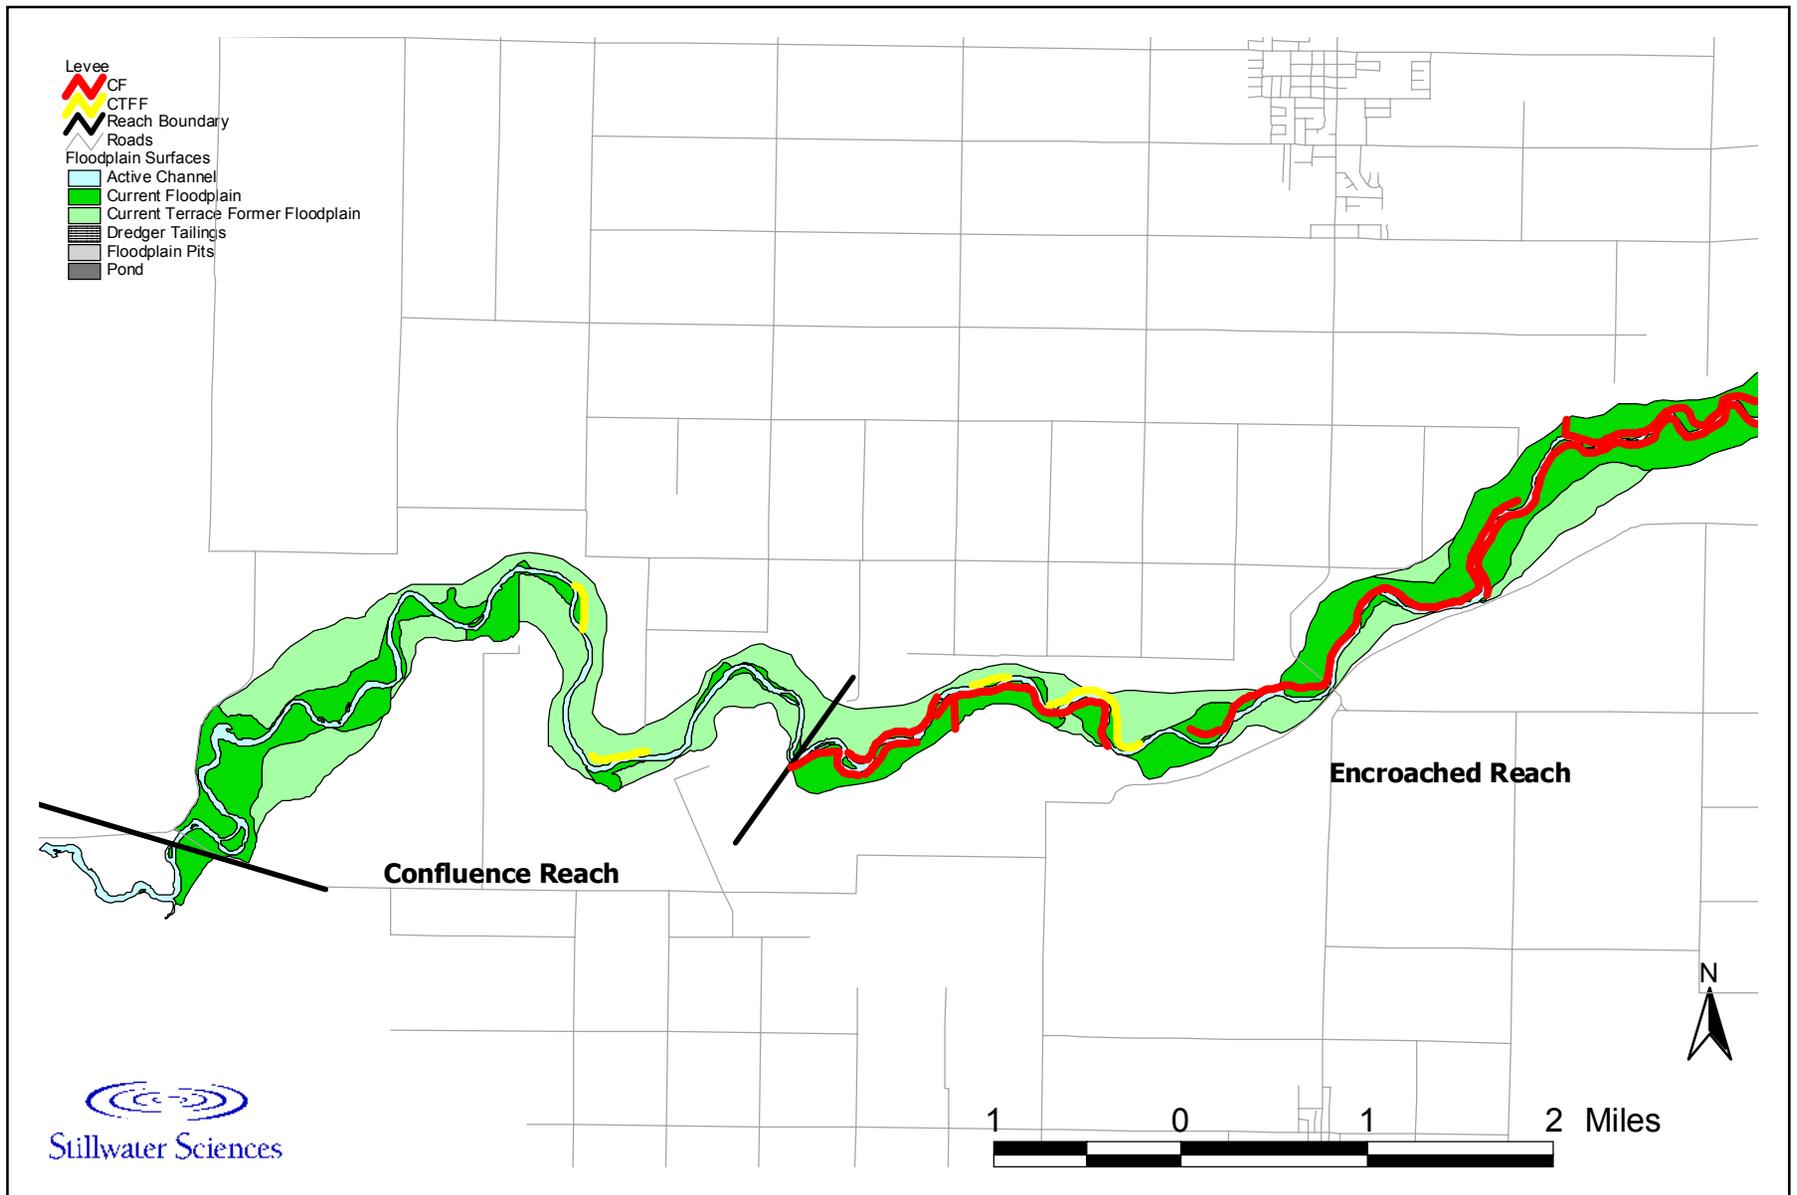
**Figure 5.5-1D. Merced River current historic floodplain and levees.**

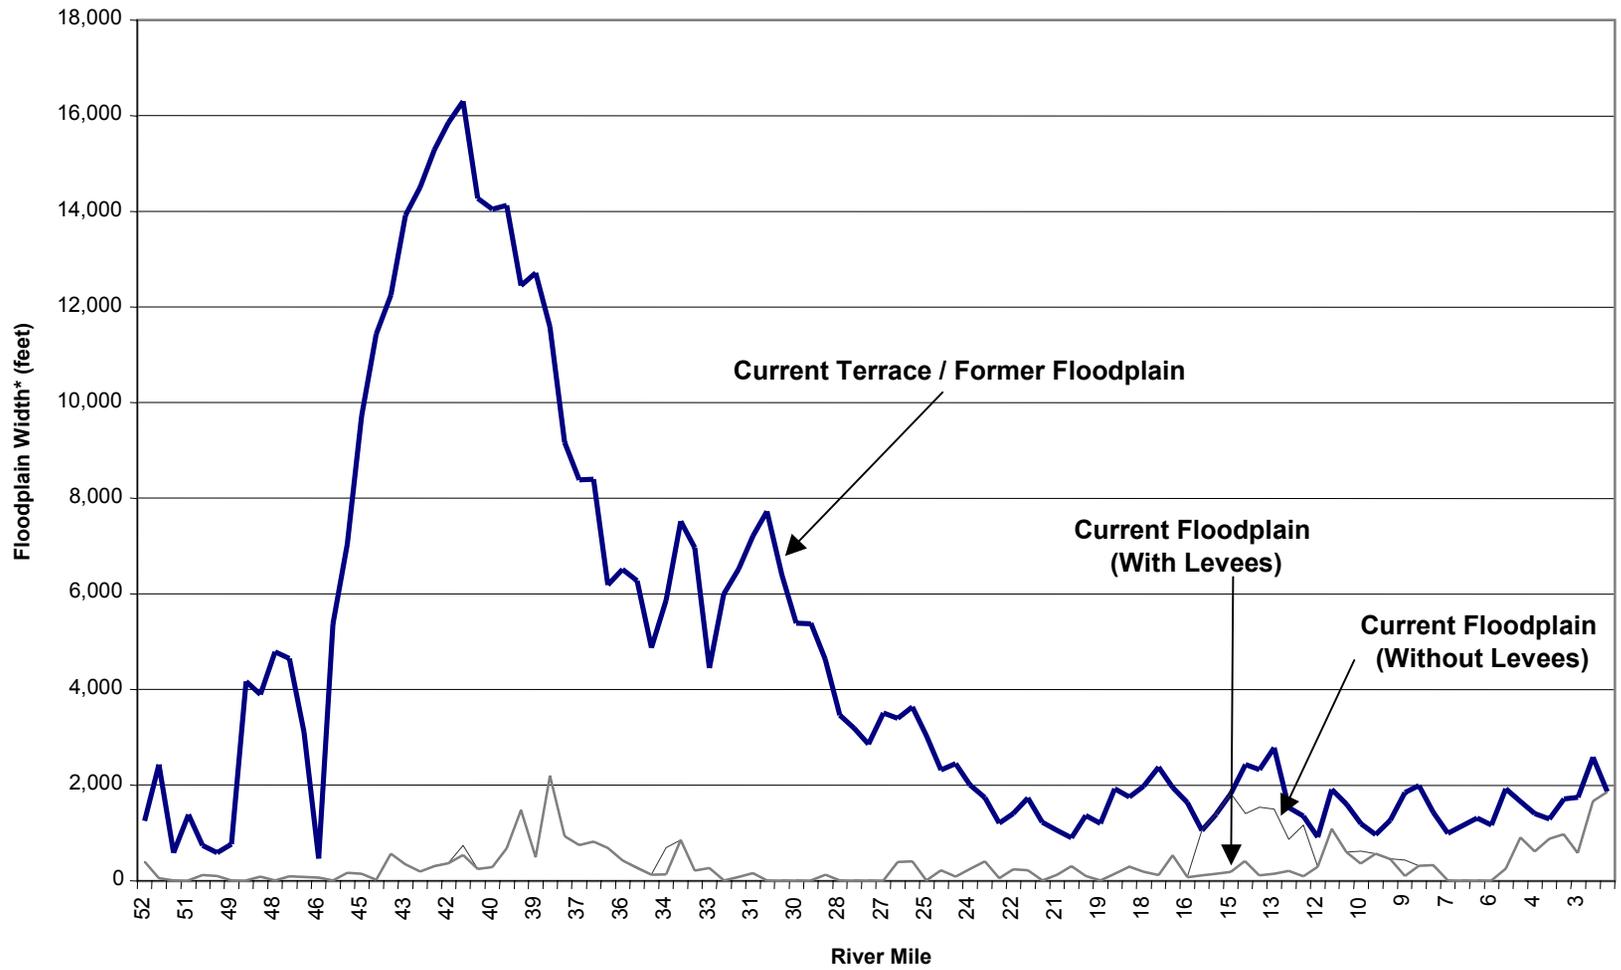
**Figure 5.5-2. Historic and current floodplain width (with and without levees) in the Merced River corridor.**

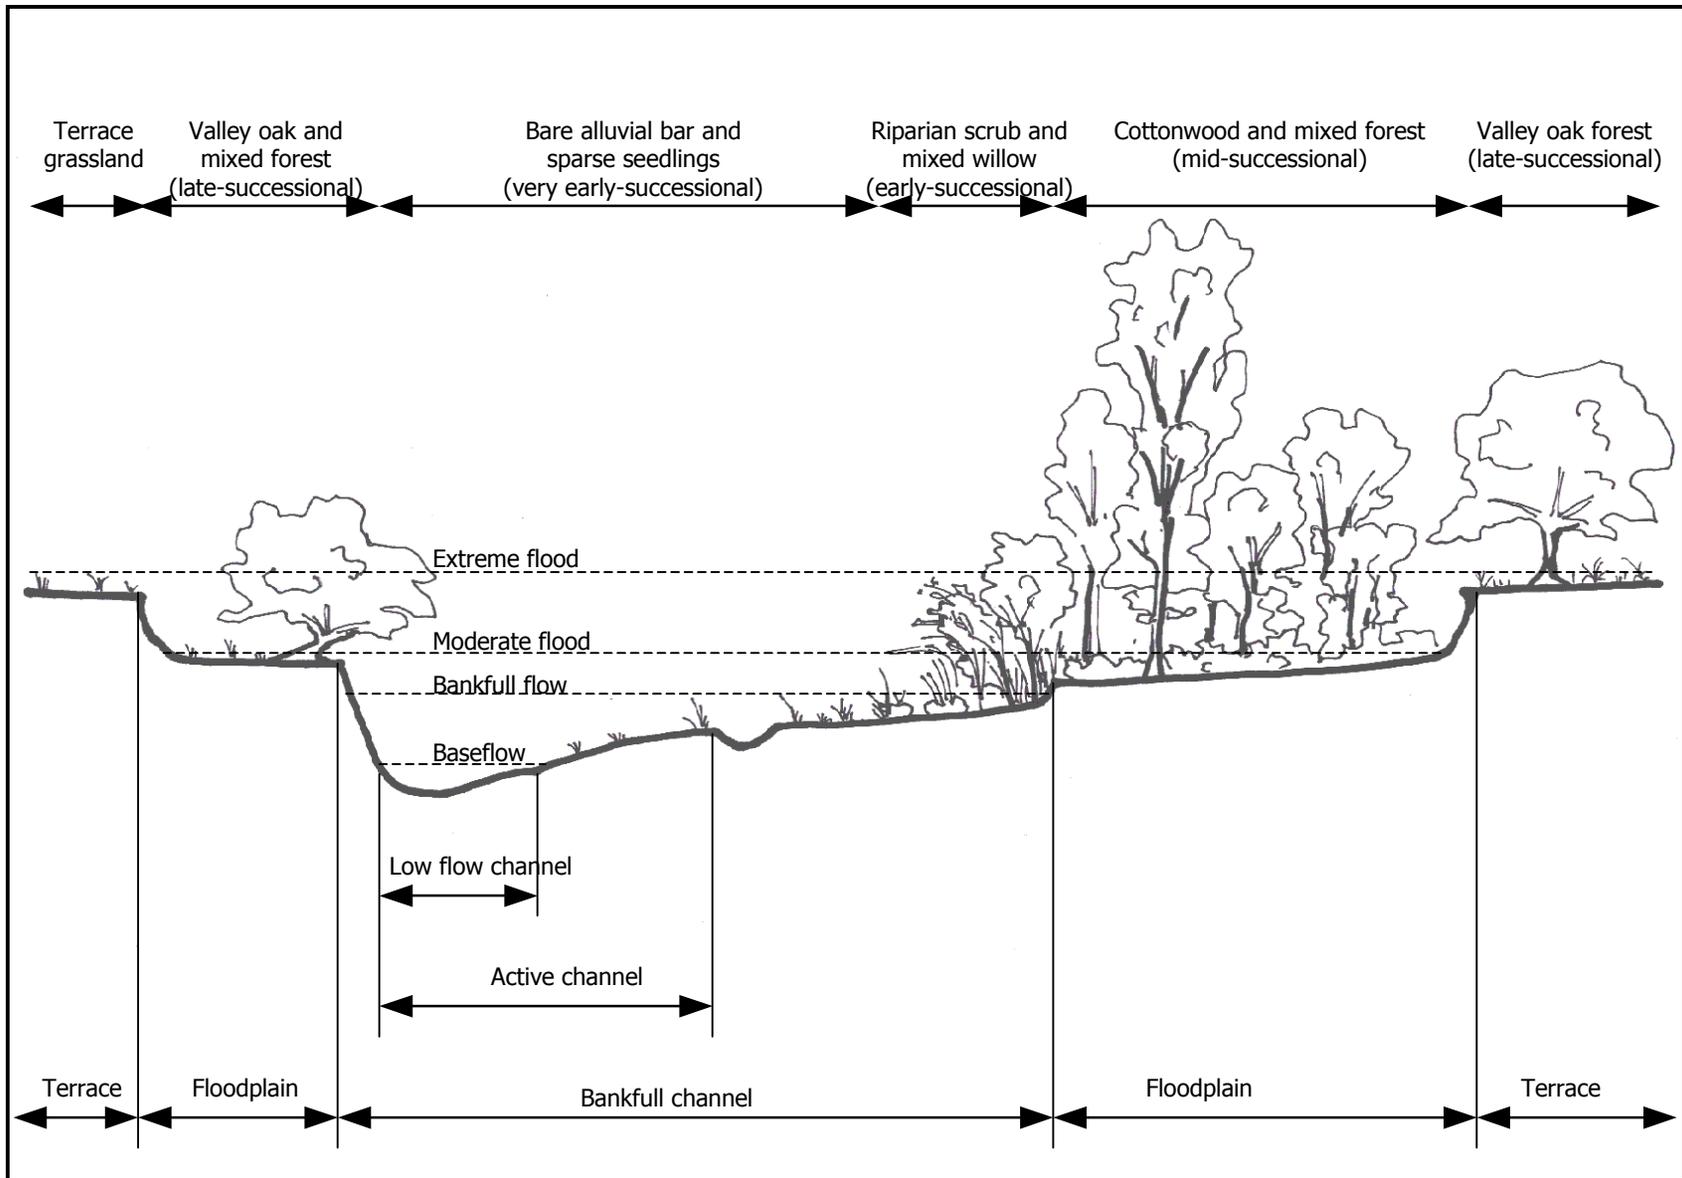
**Figure 5.6-1. Schematic cross section of the "healthy" alluvial river.**

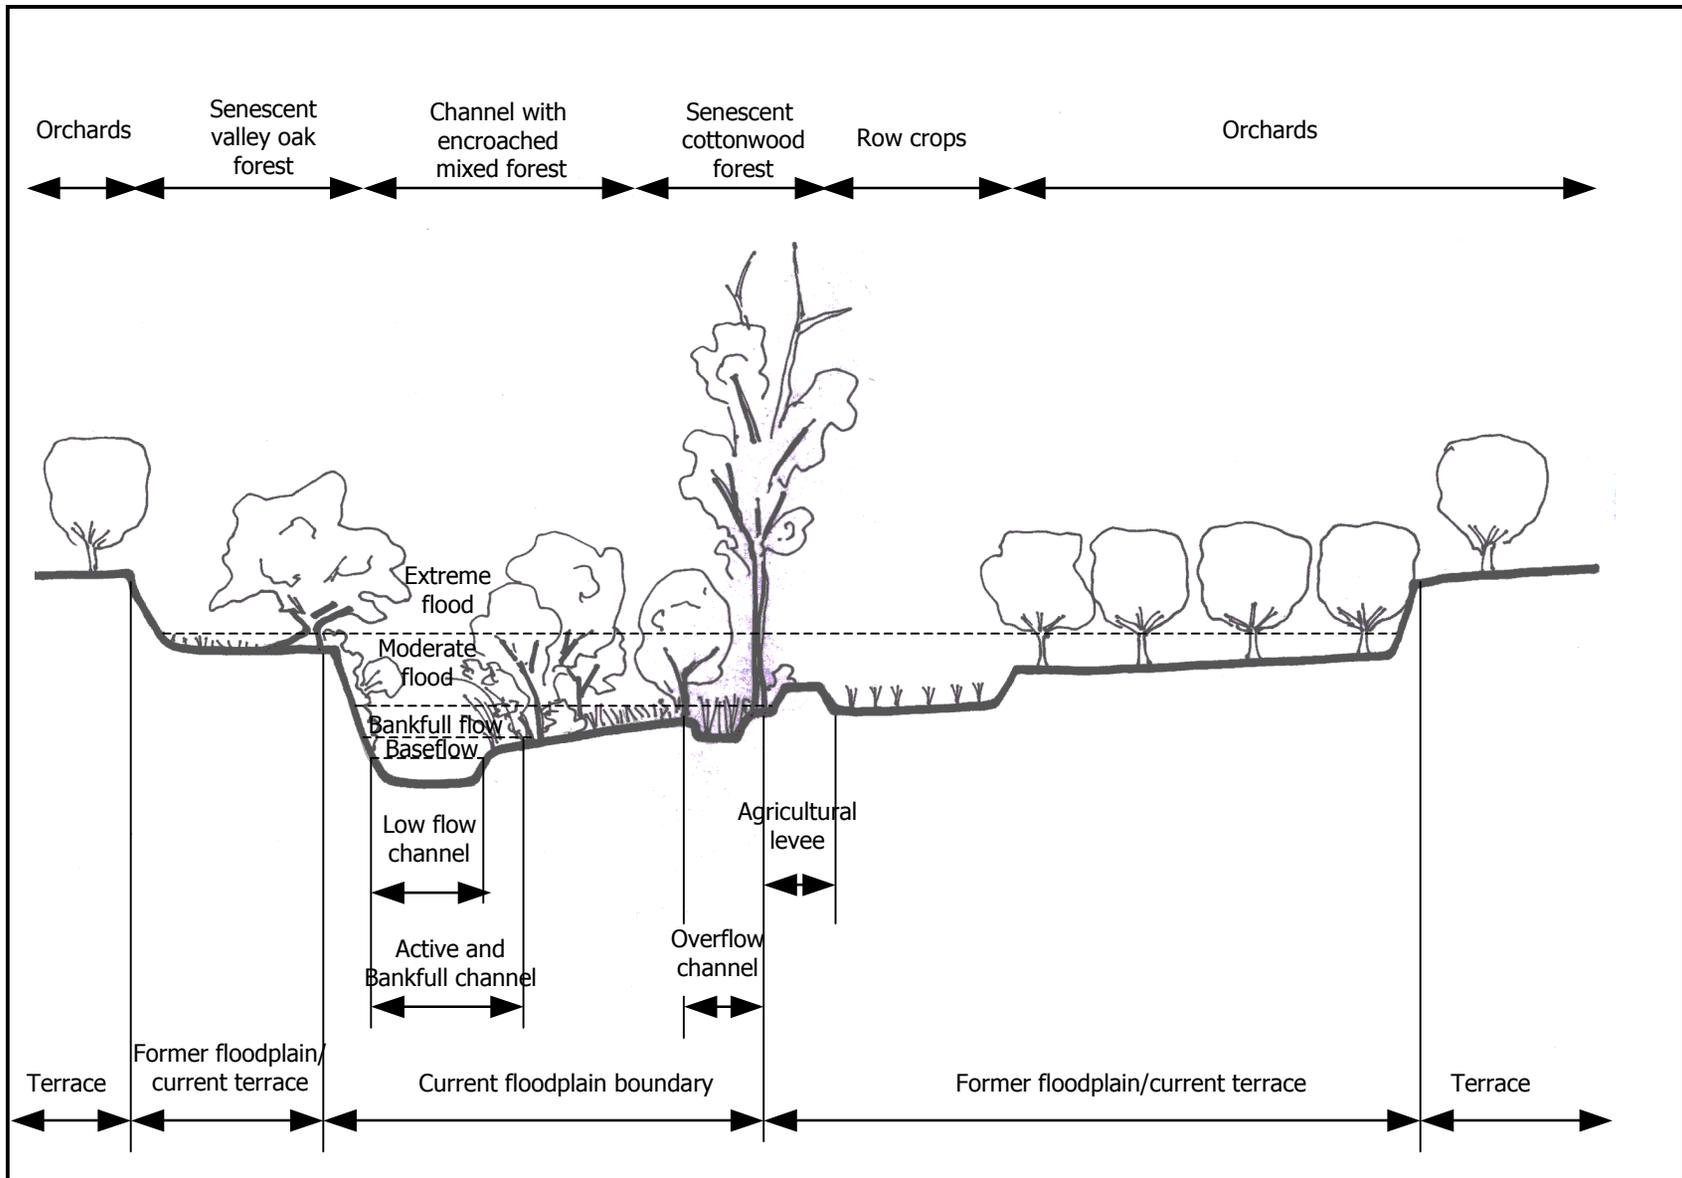
**Figure 5.6-2. Schematic cross section of a river channel with encroached riparian vegetation.**
