## FIGURES

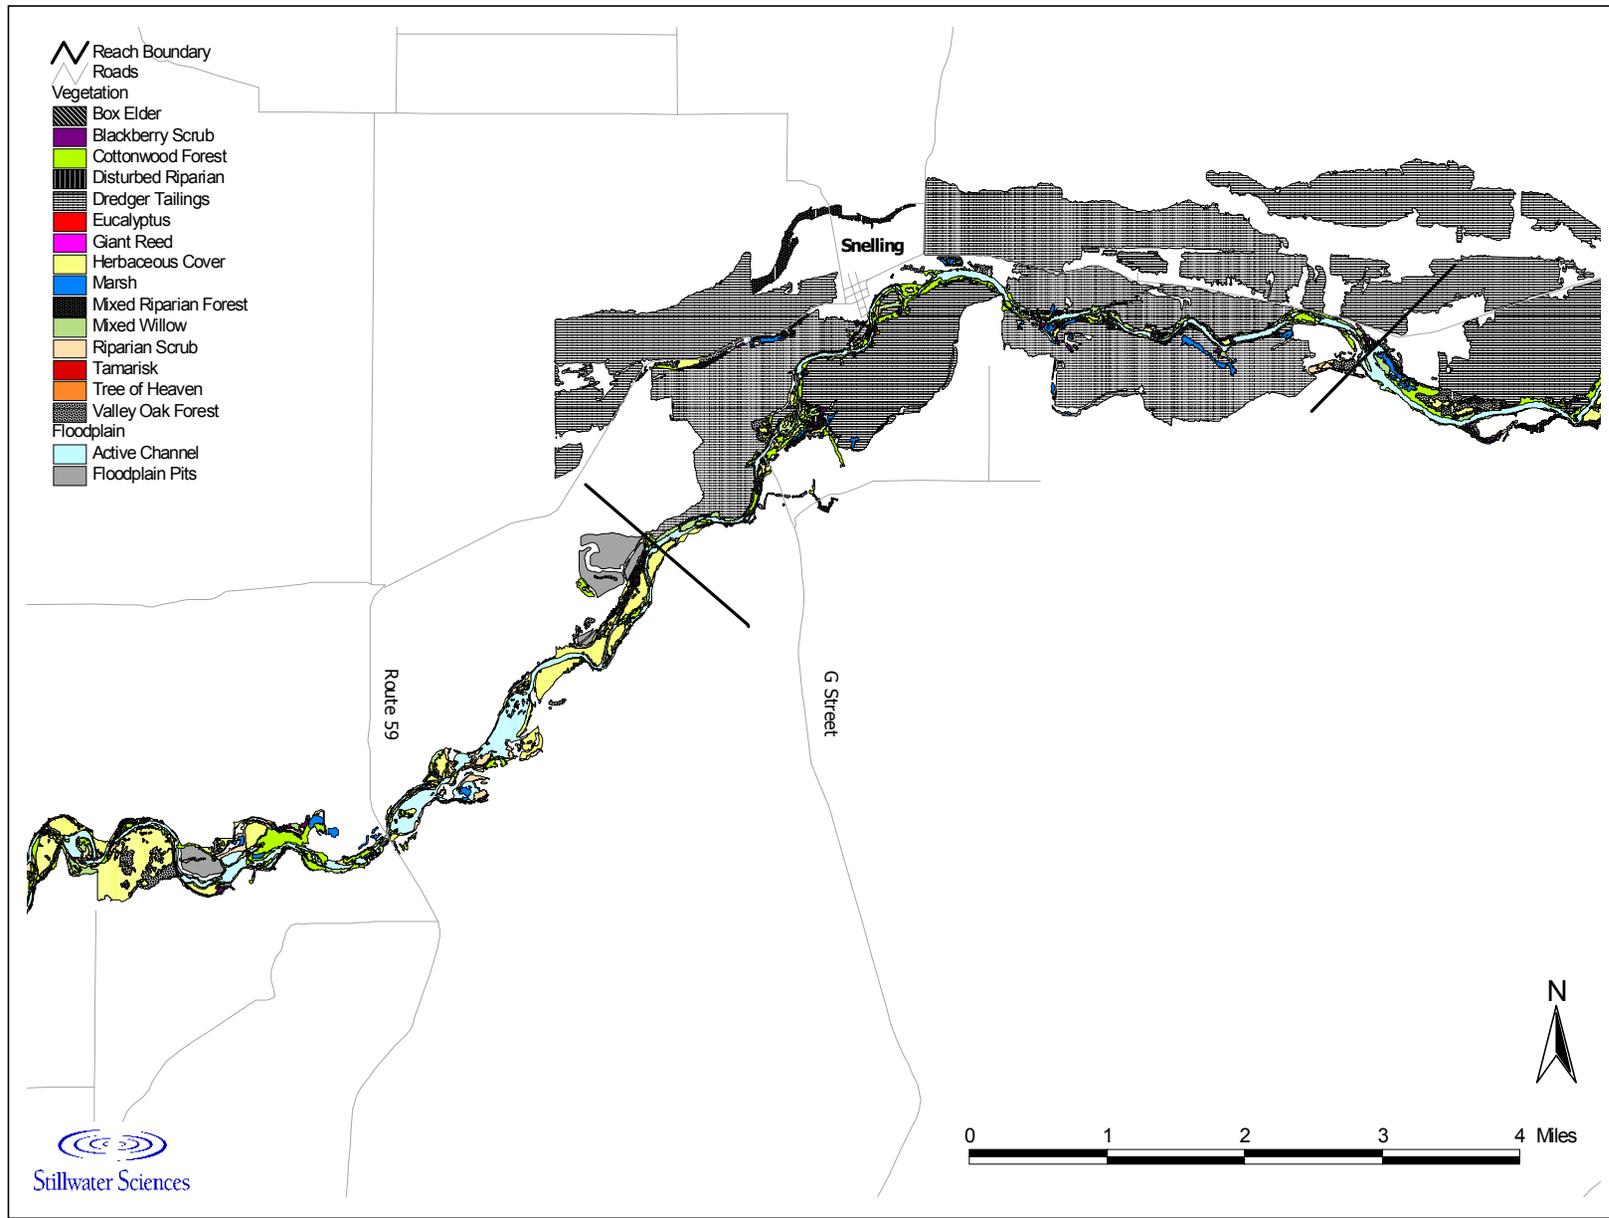
Figure 6.1-1A. Merced River vegetation distribution.

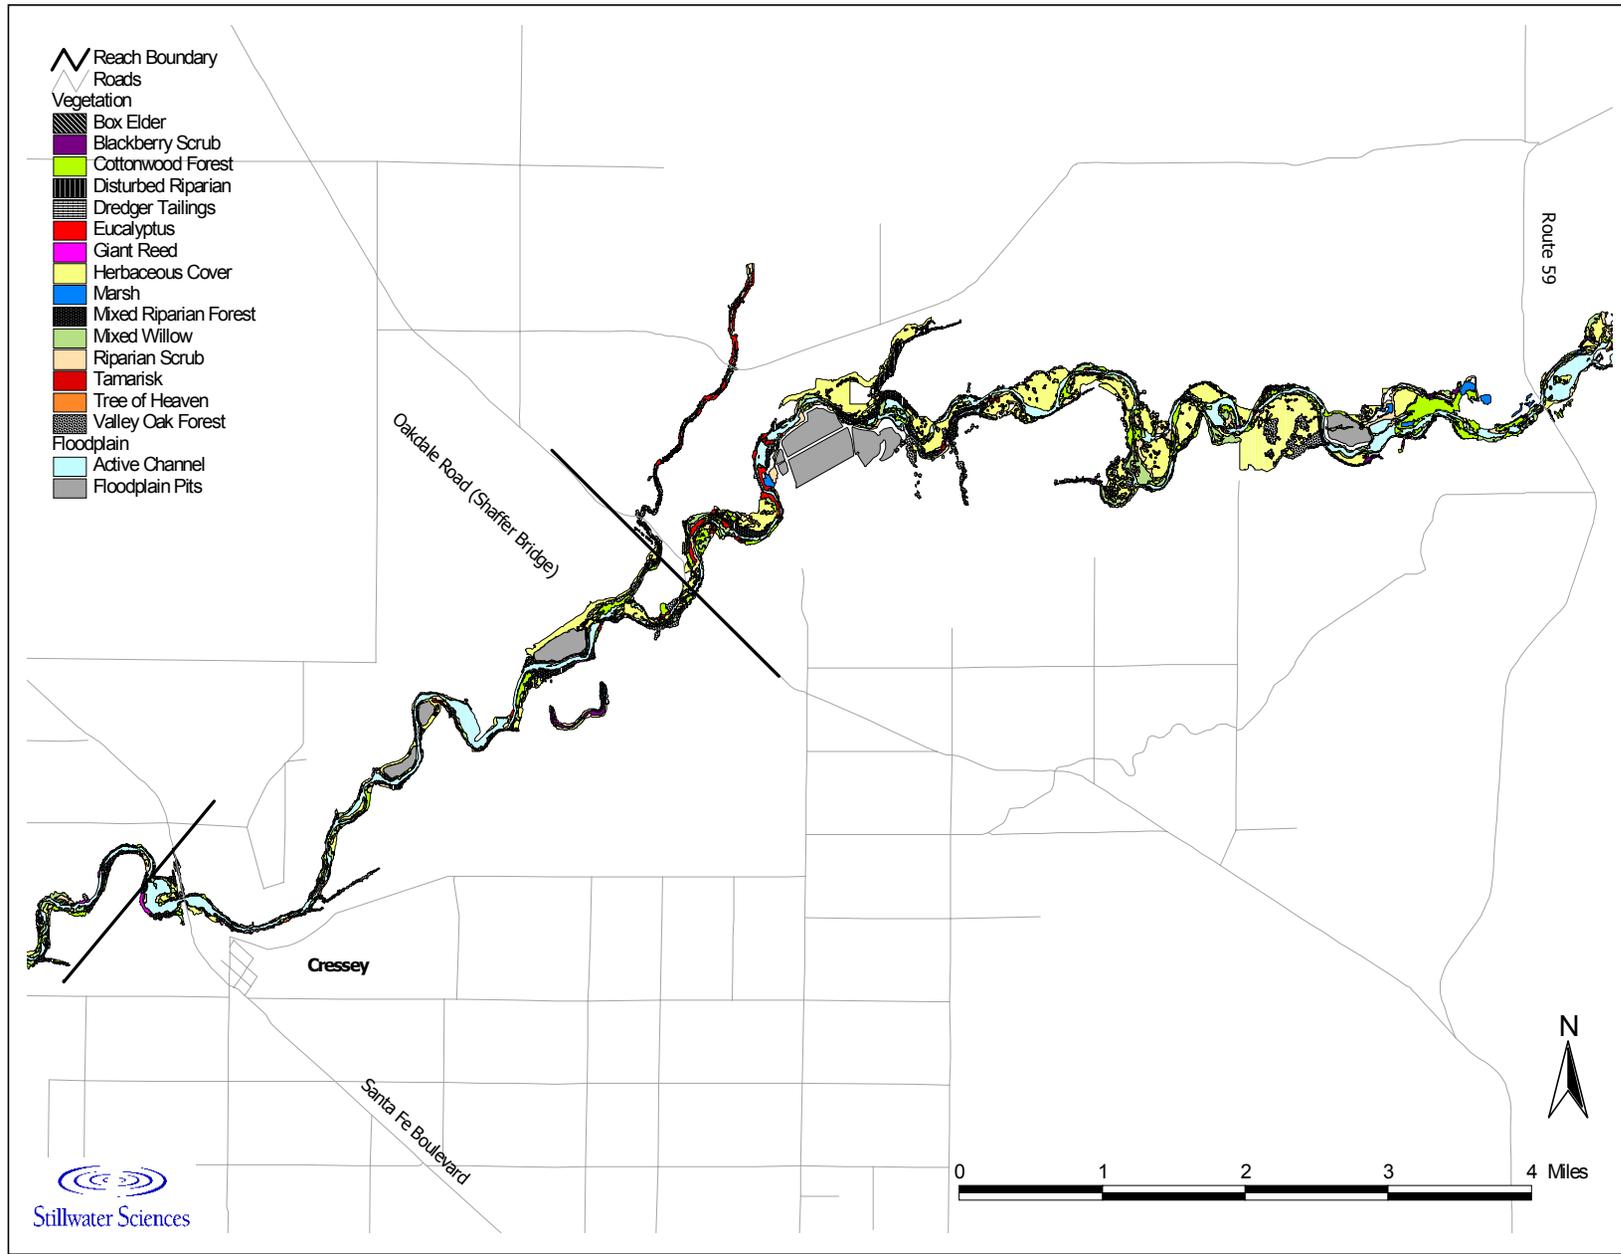
Figure 6.1-1B. Merced River vegetation distribution.

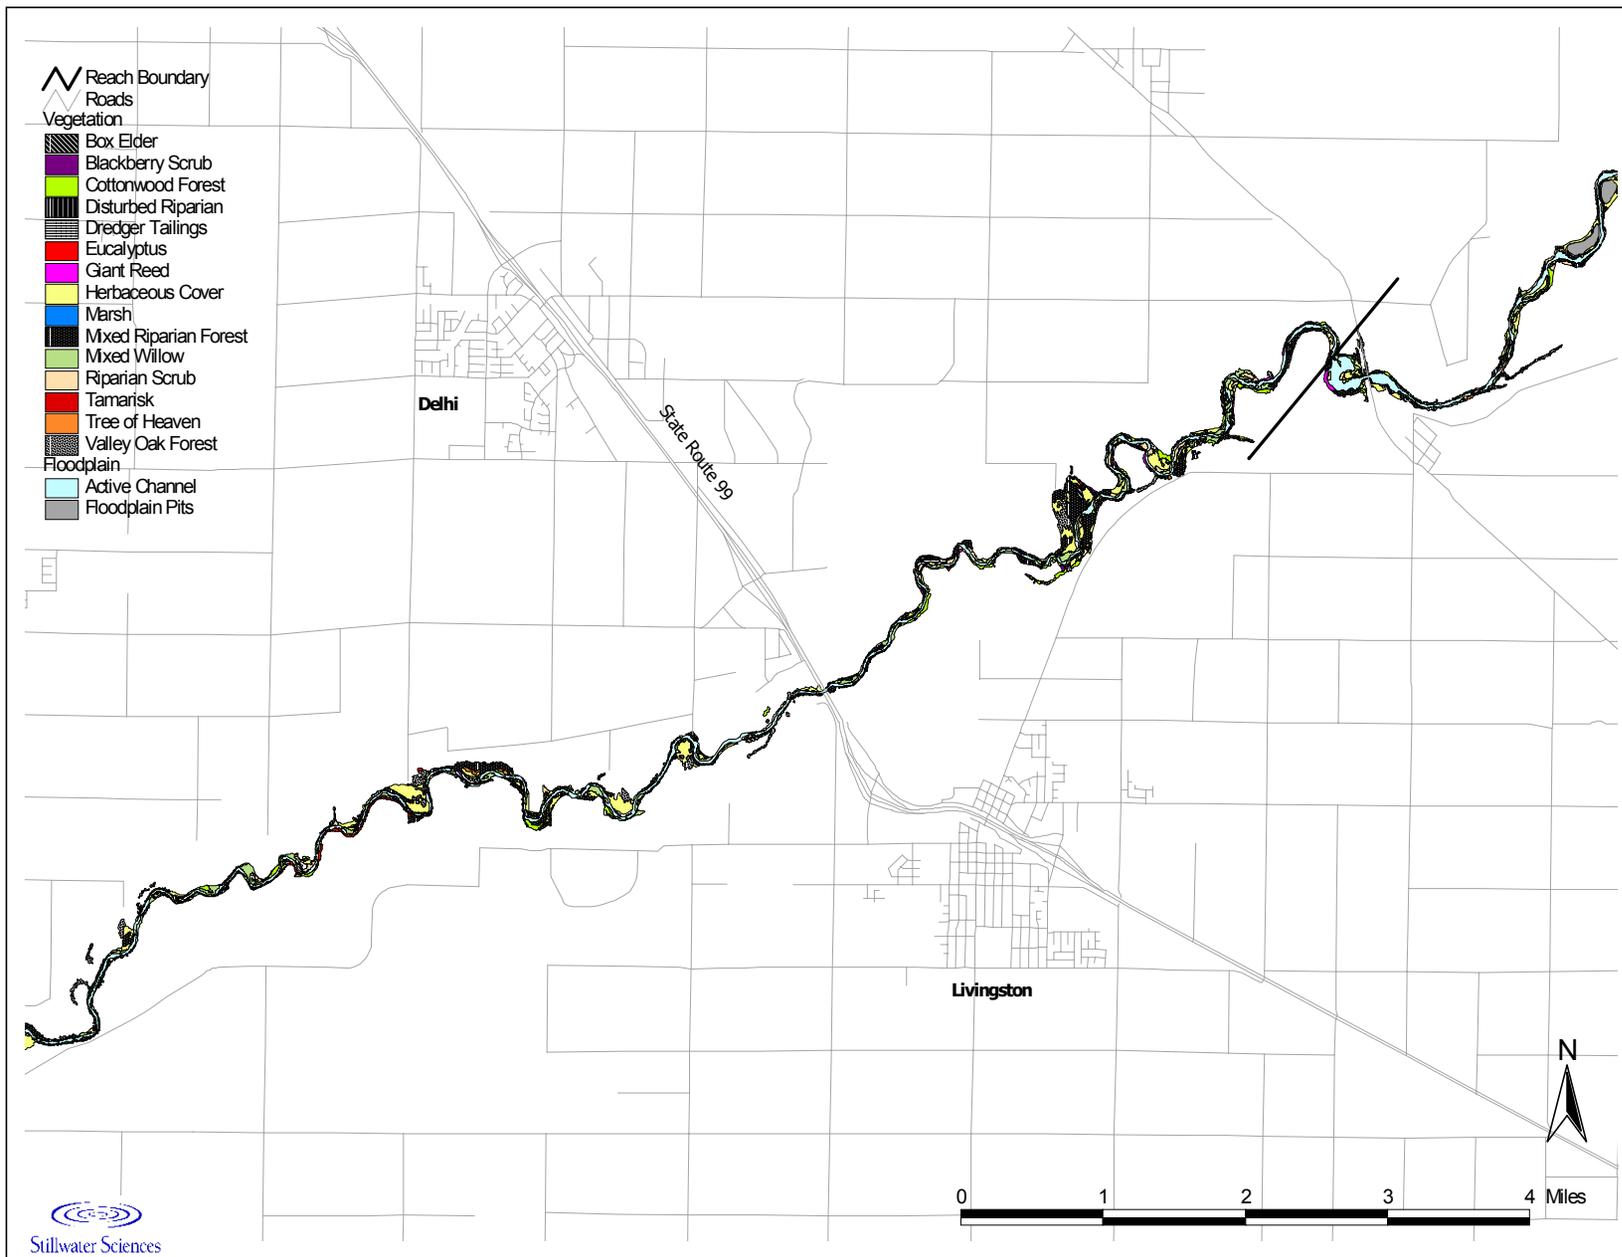
Figure 6.1-1C. Merced River vegetation distribution.

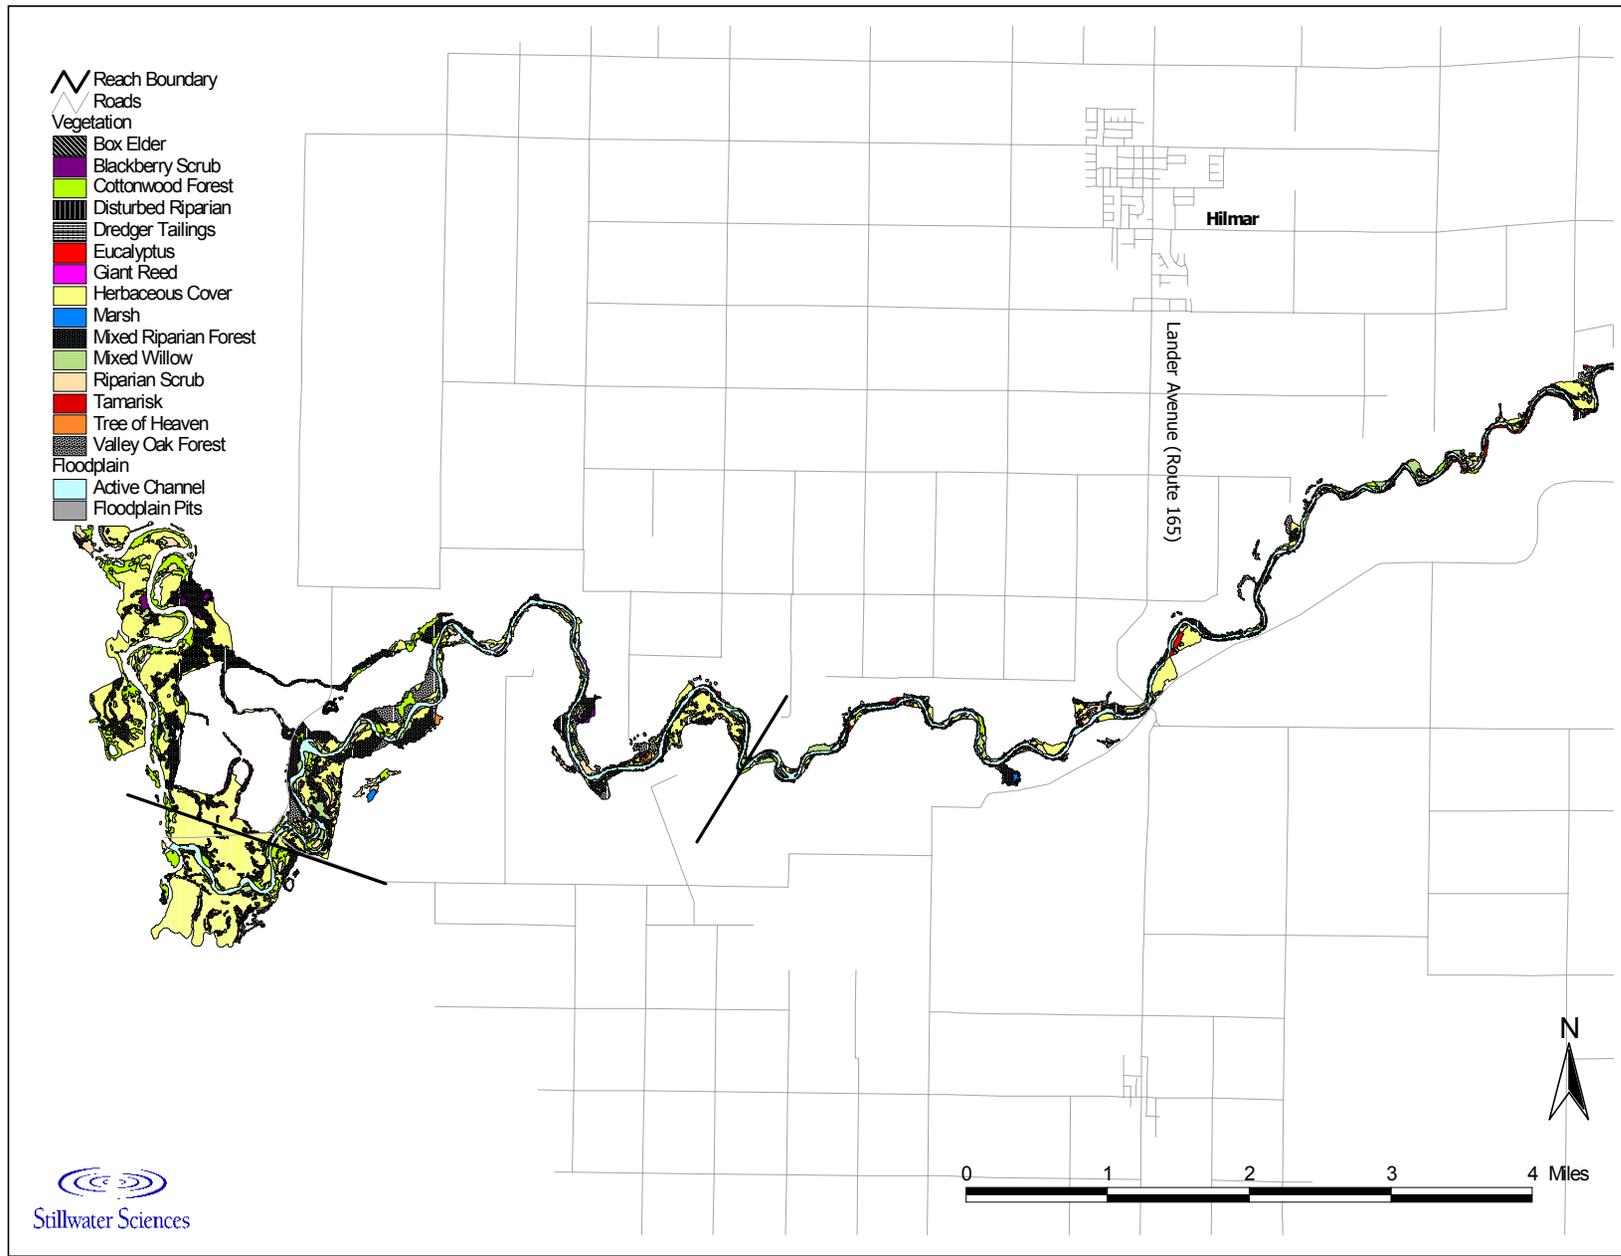
Figure 6.1-1D. Merced River vegetation distribution

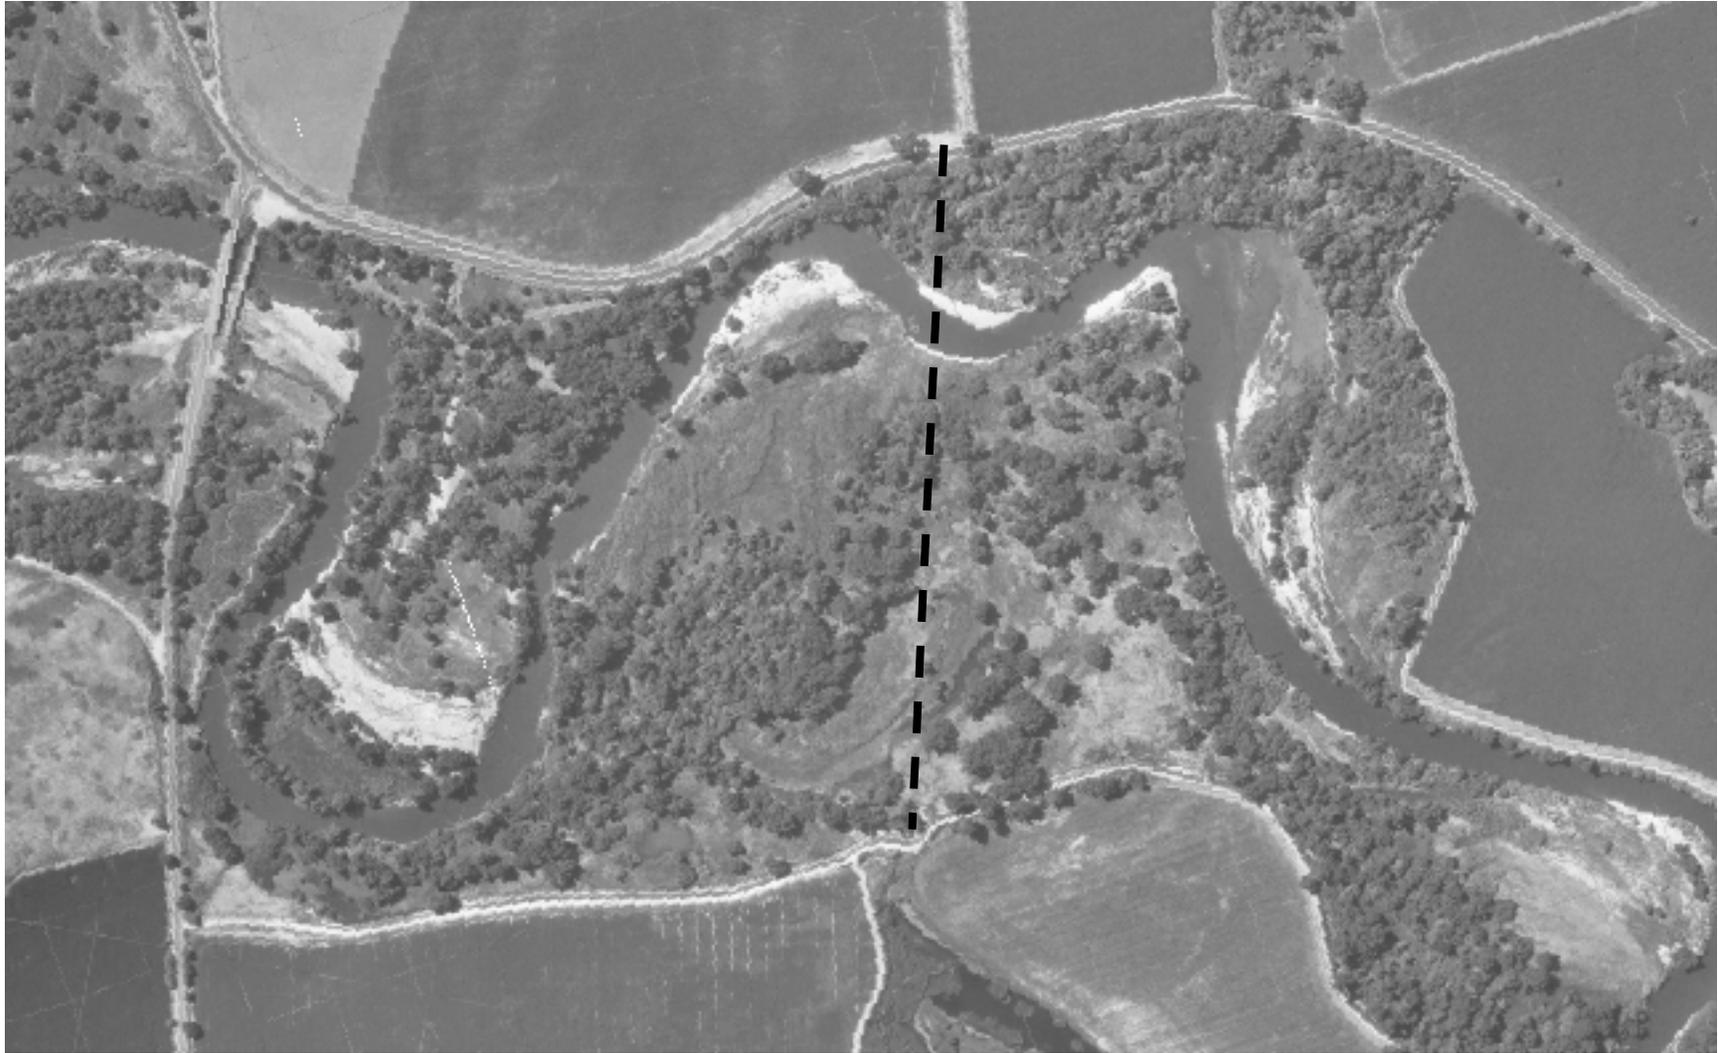
**Figure 6.2-1. Aerial photograph of the Stevinson Site showing vegetation transect location.**  
(photo: Merced County Planning and Community Development Department 1998)

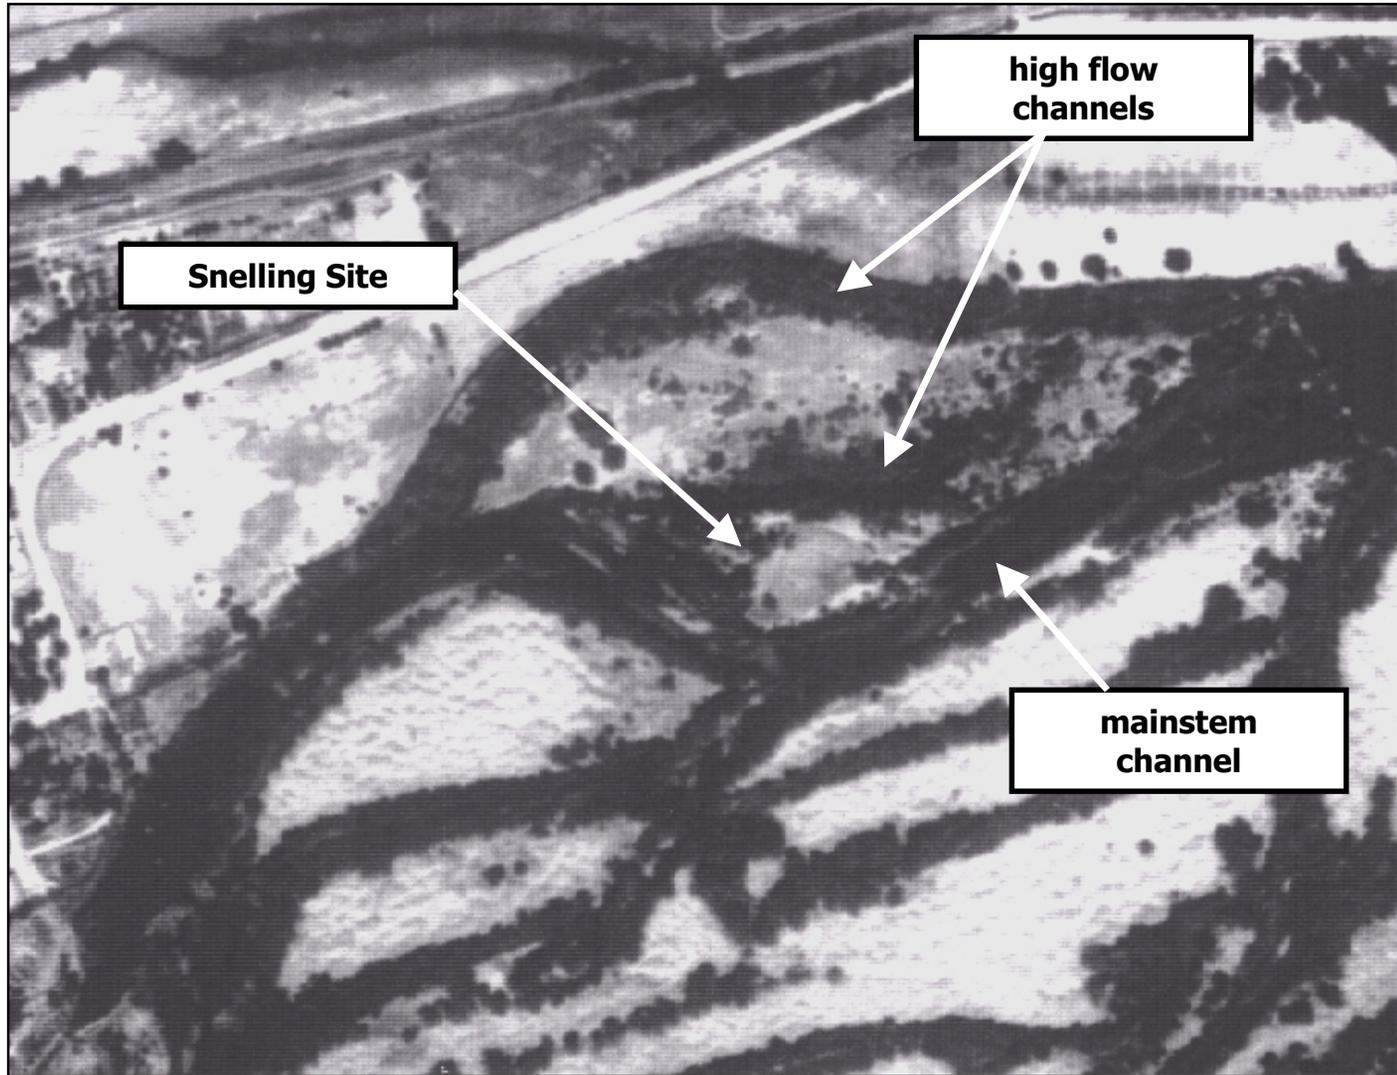
**Figure 6.3-1. Aerial photograph of the Snelling Site - 1937.**  
(photo: Agricultural Stabilization and Conservation Service 1937)

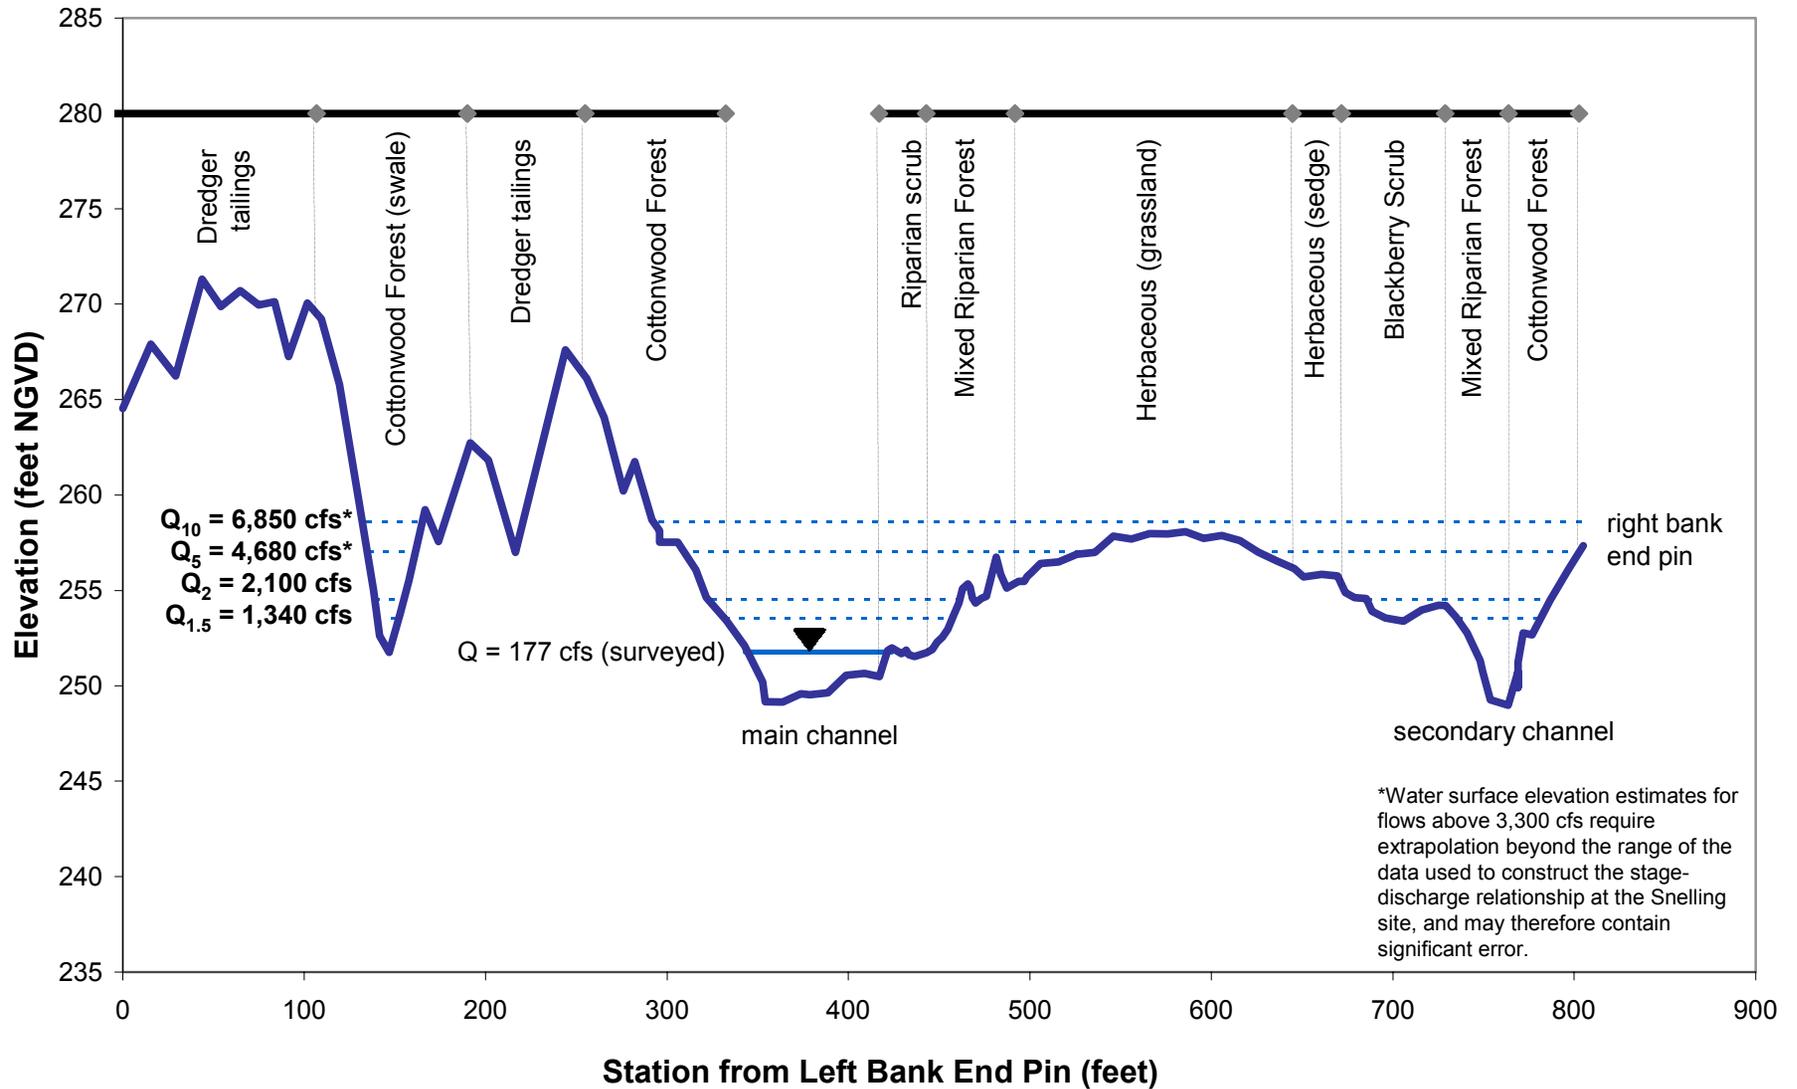
**Figure 6.3-2. Snelling Site vegetation cover and topographic cross section 13+95.**

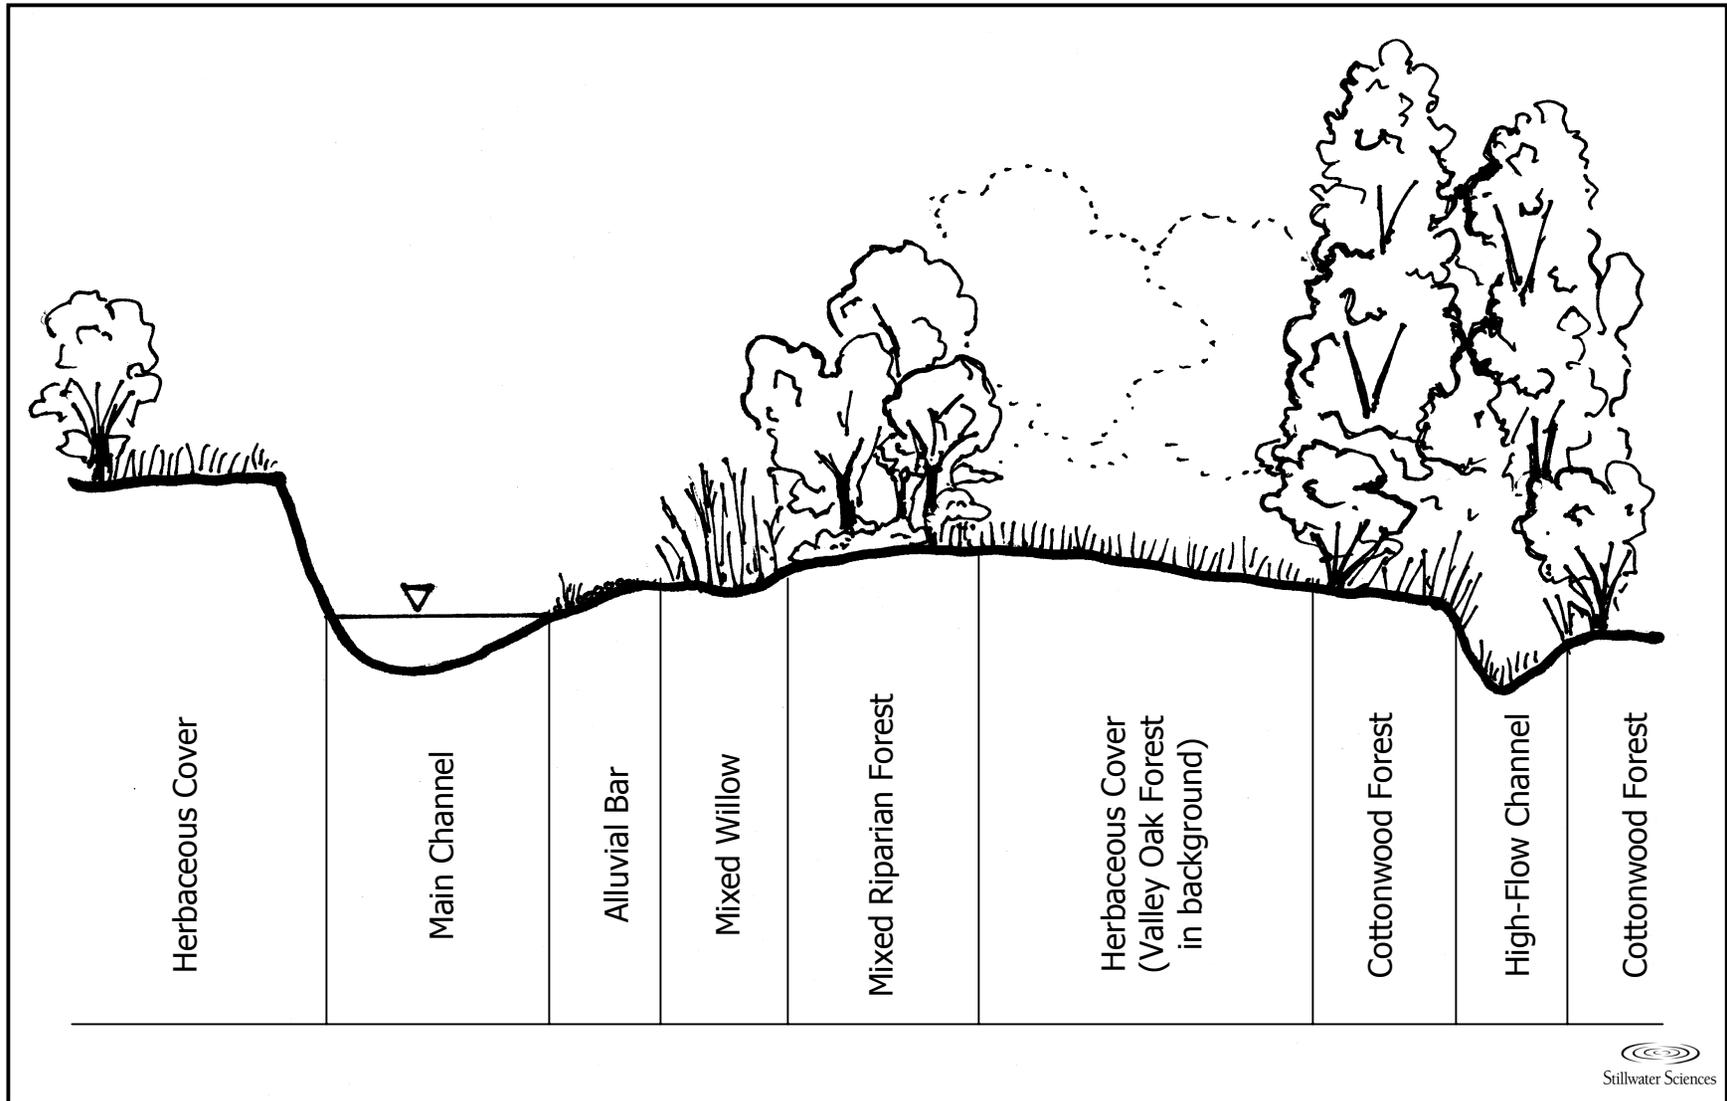
**Figure 6.4-1. Generalized vegetation toposequence for least disturbed sites on the Merced River.**

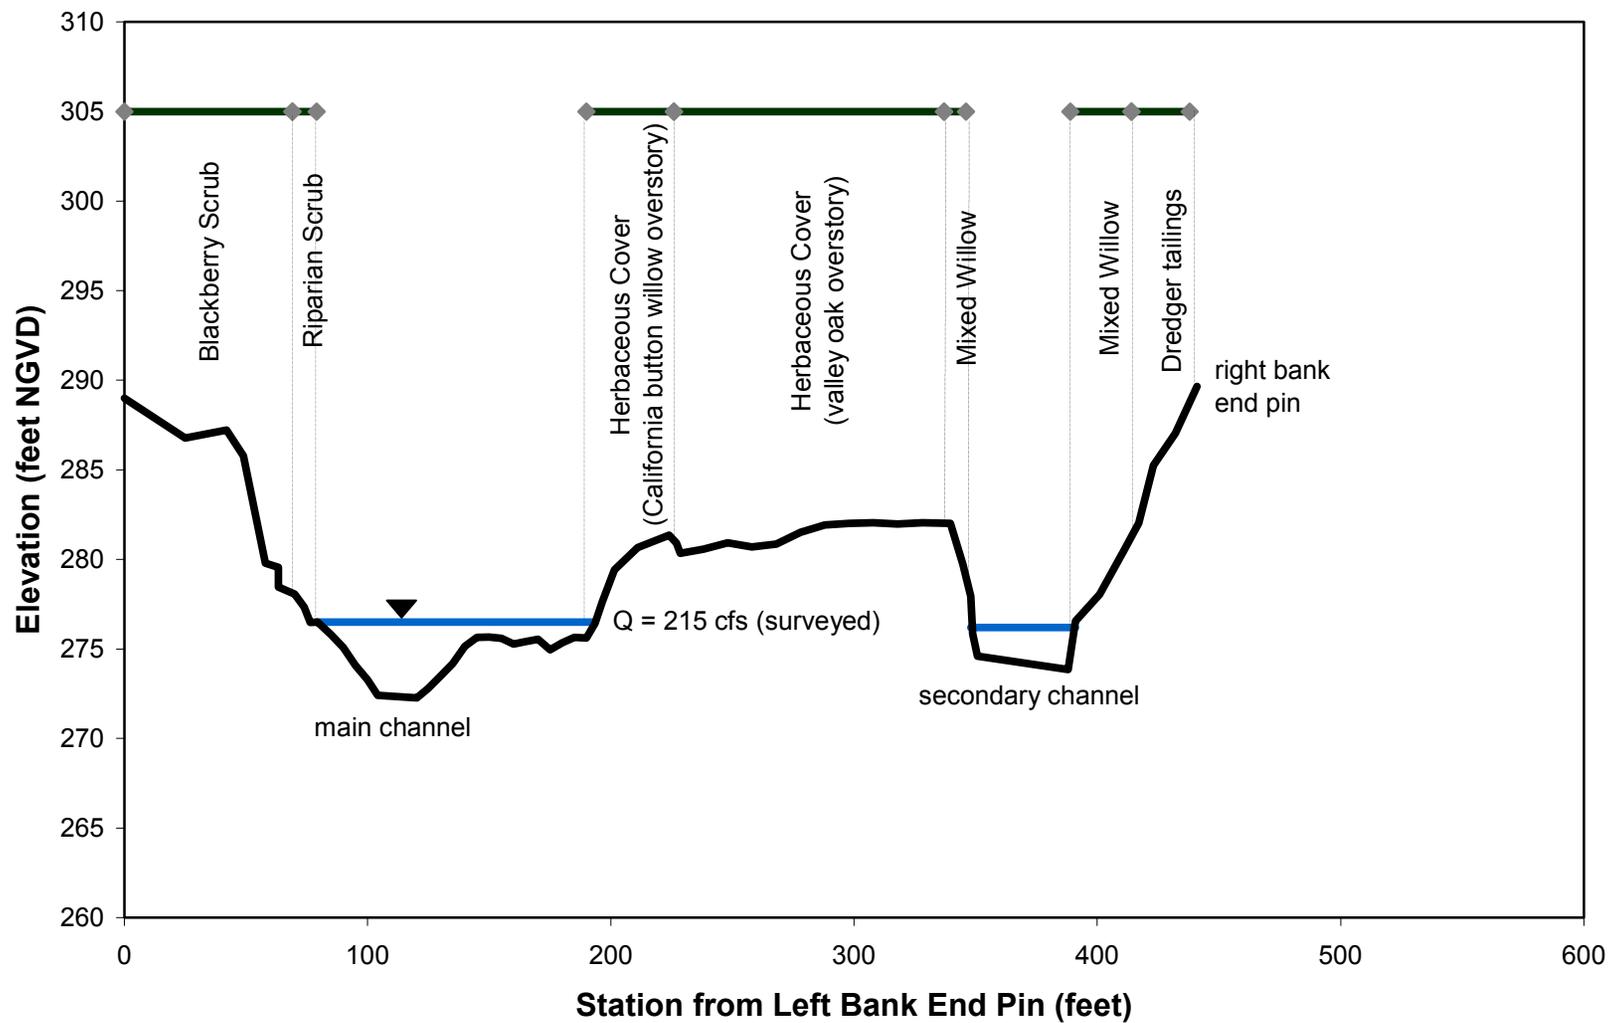
**Figure 6.4-2. Cuneo Site vegetation cover and topographic cross section.**

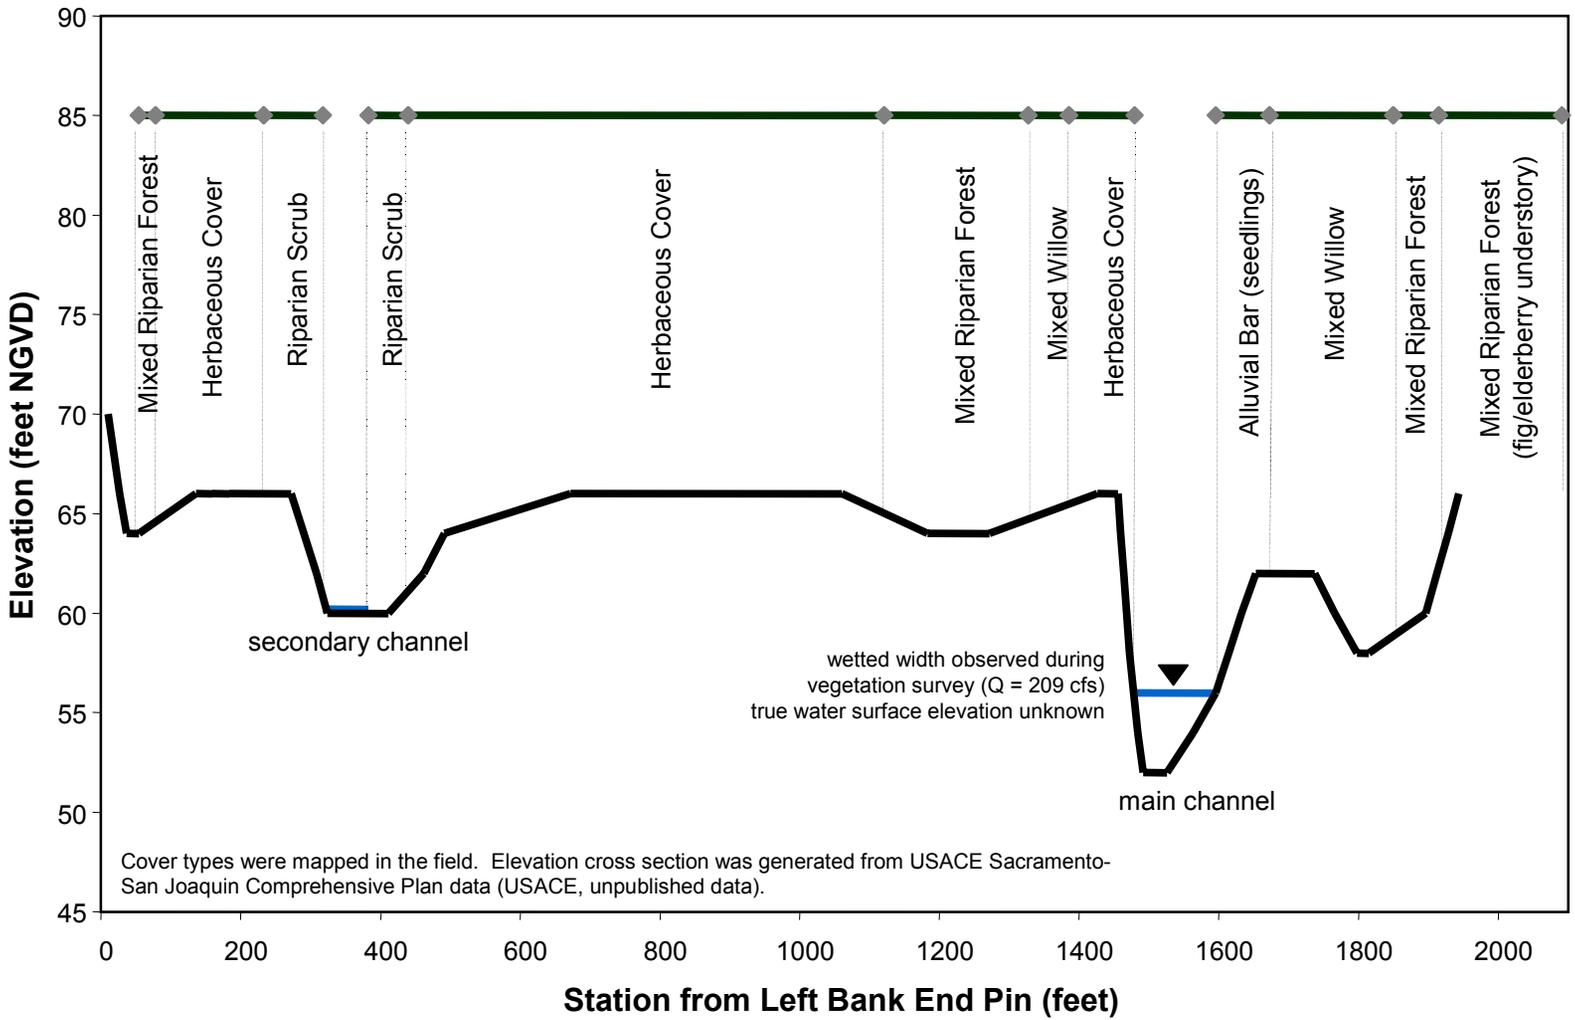
**Figure 6.4-3. Stevenson Site vegetation cover and topographic cross section.**

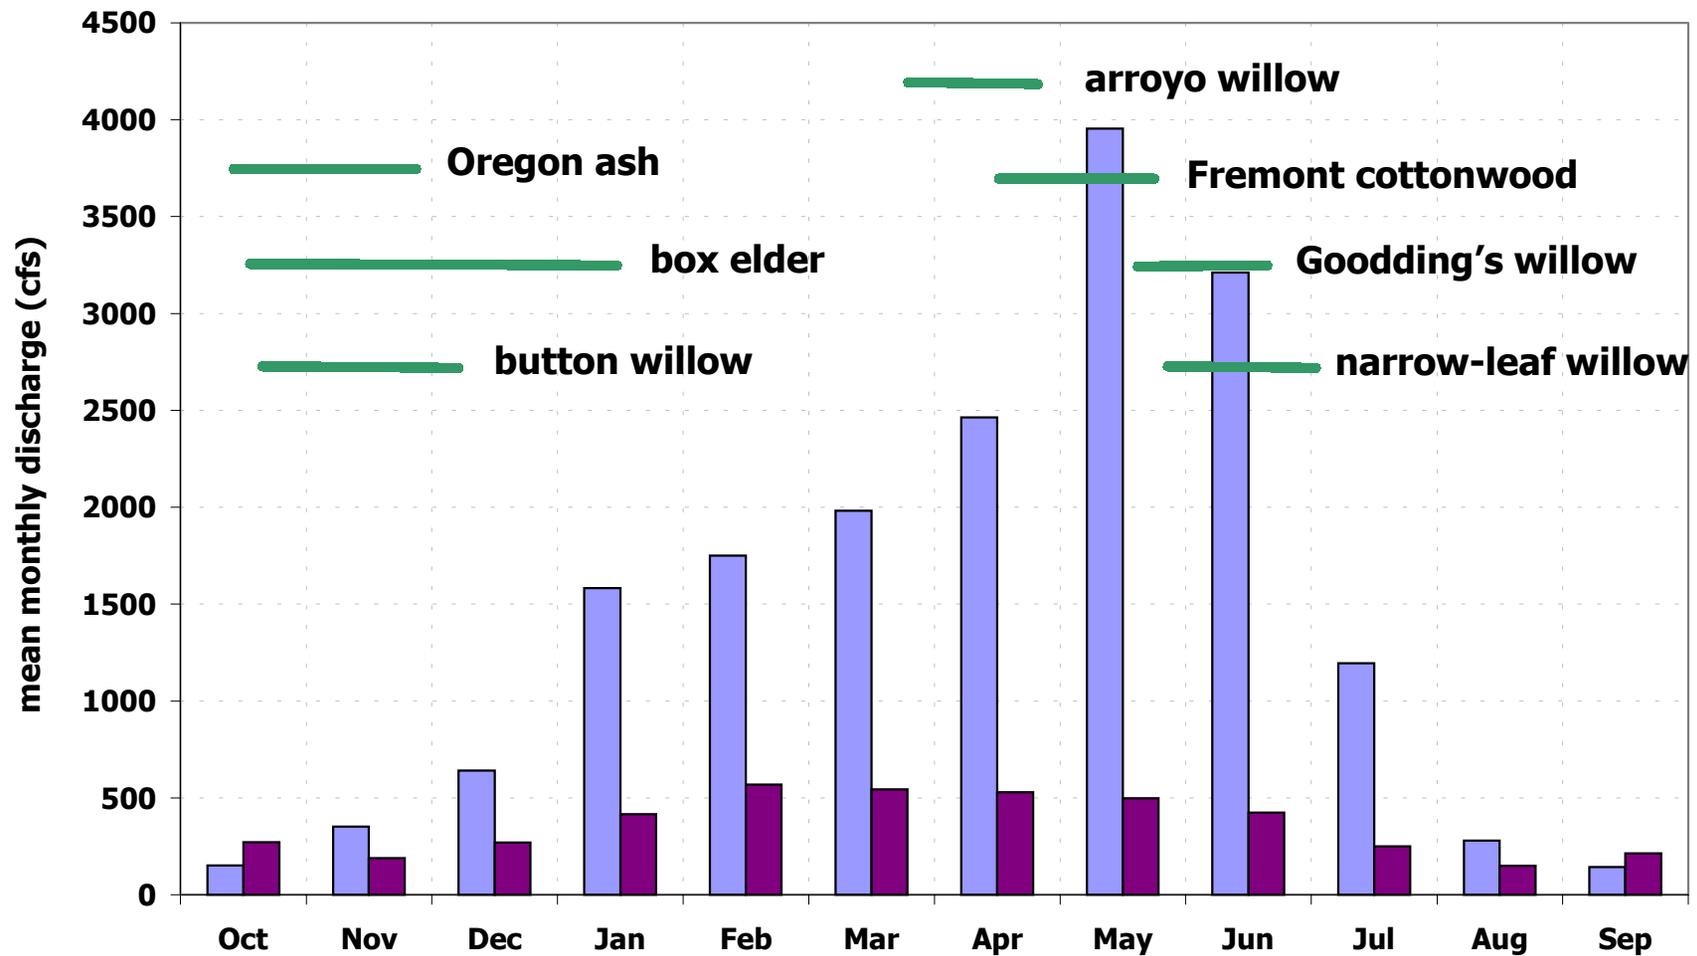
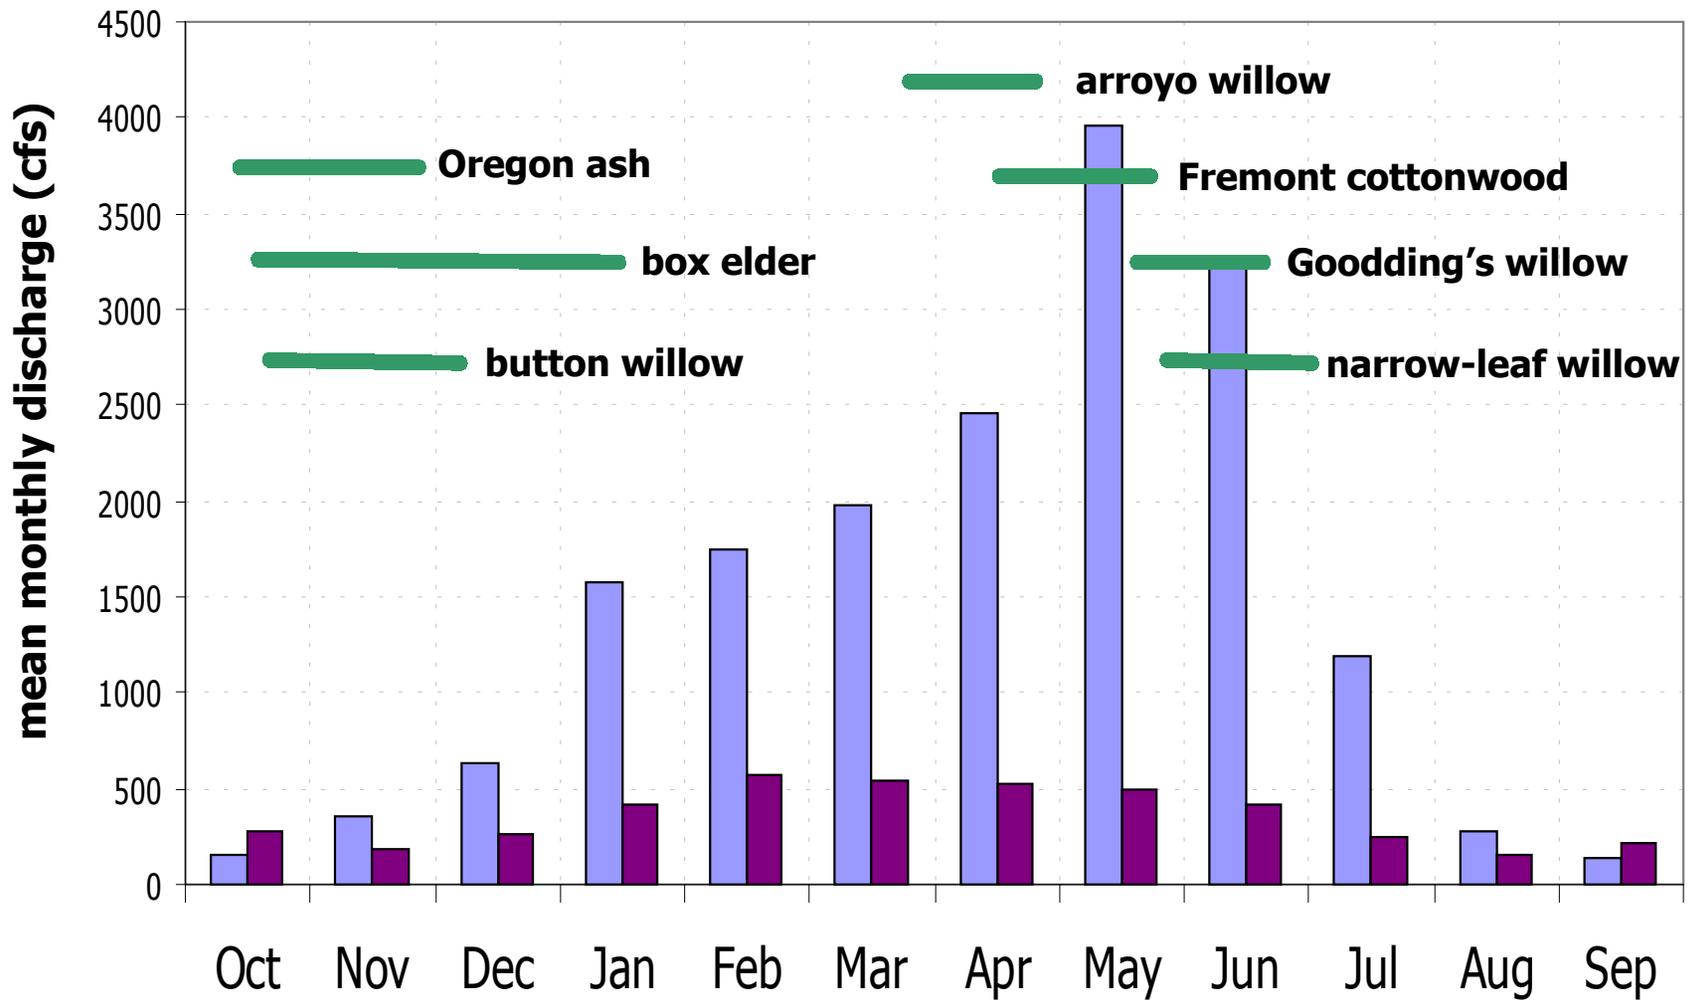
**Figure 6.5-1. Riparian tree seed release periods compared to Merced River unimpaired and regulated mean monthly flow, 1968-1998.** Unregulated flow (lighter bars) is estimated by CDWR (1994a). Regulated flow (dark bars) is measured at Crocker-Huffman Dam (Merced ID), downstream of all major dams and diversions. Seed release data are approximate and are taken from CALFED (2000).
