## FIGURES

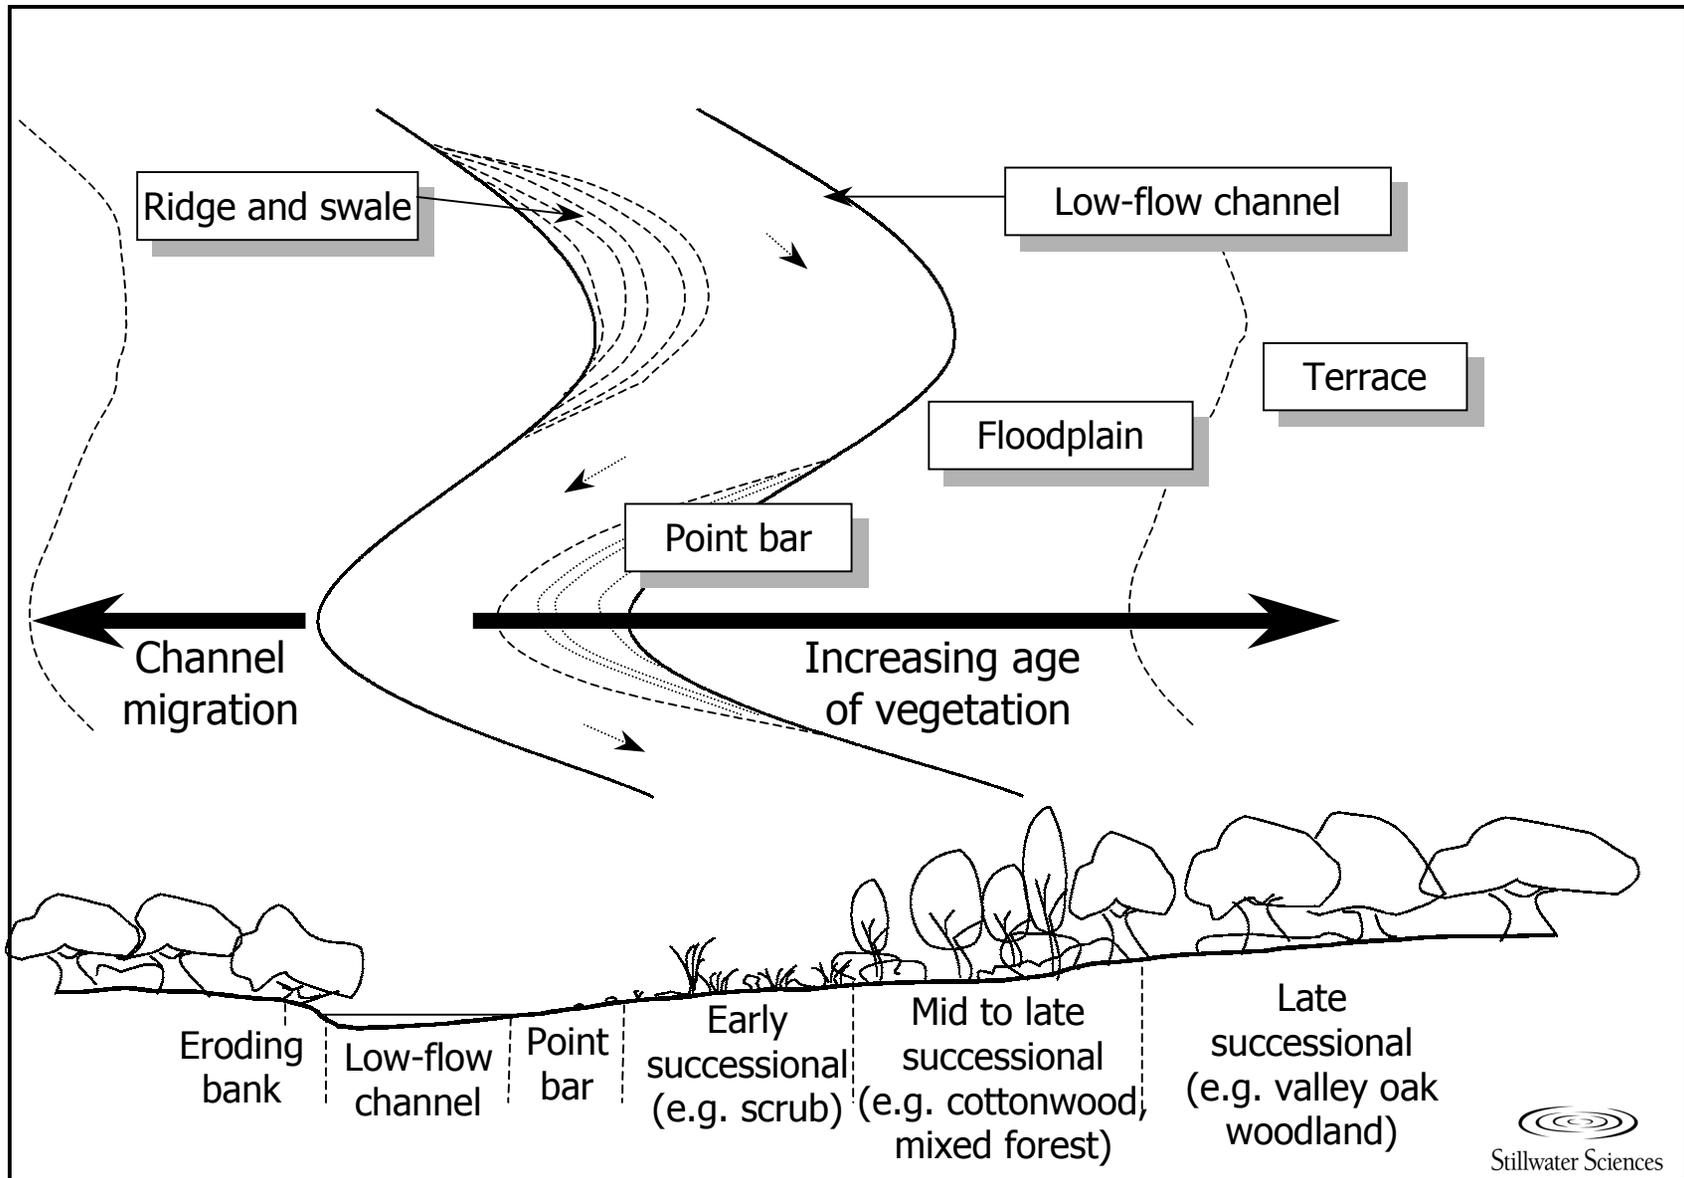
**Figure 6.5-2. Schematic diagram of riparian succession.**

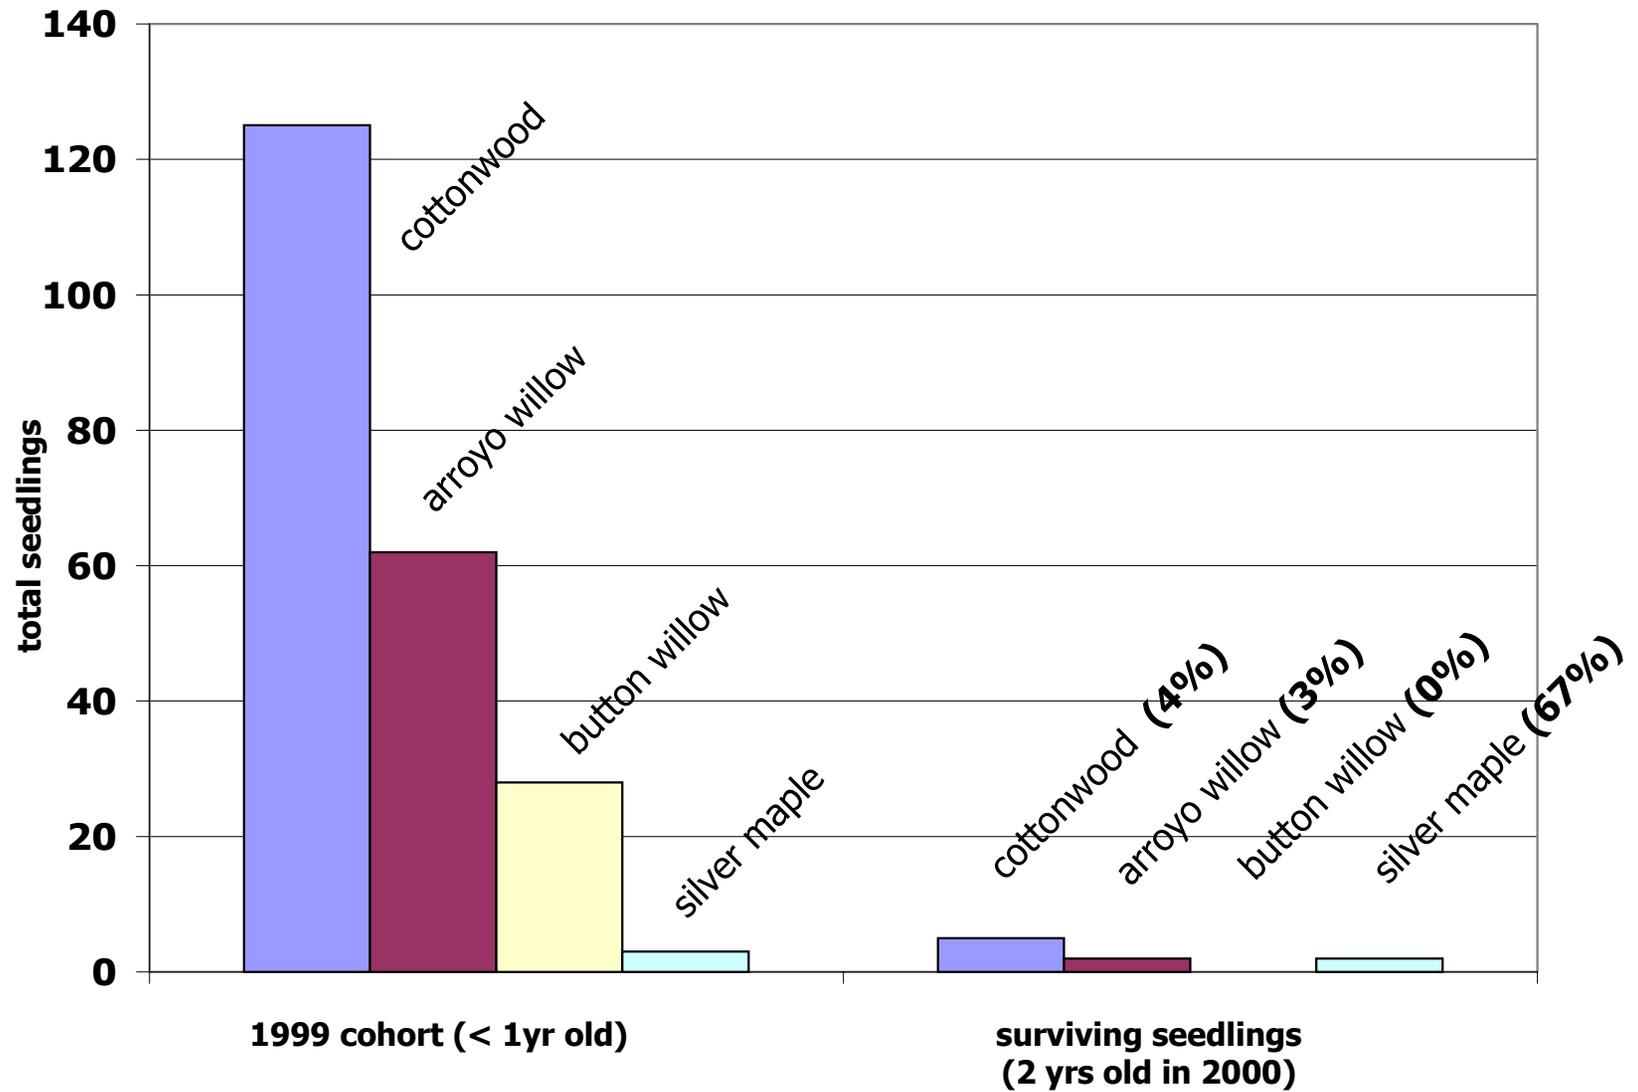
**Figure 6.5-3. Seedling survival between October 1999 and June 2000, Snelling cross section 13+95.**  
 Percent survival for each species is in parentheses.

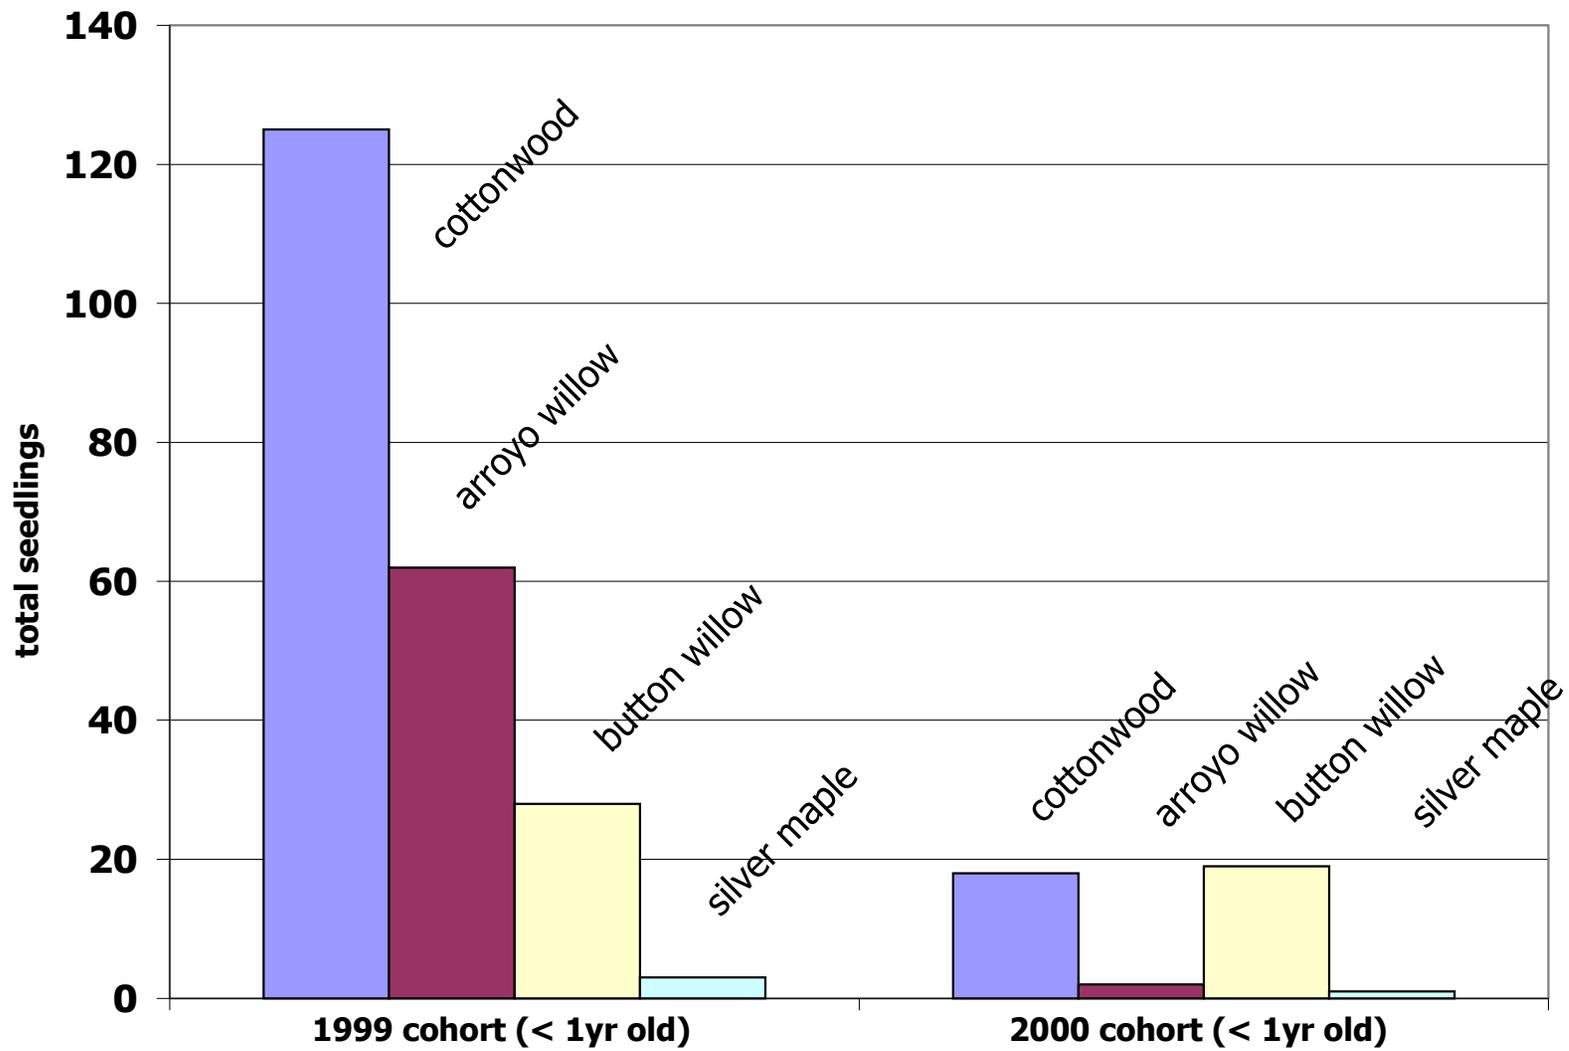
**Figure 6.5-4. Annual variability in recruitment between the 1999 and 2000 cohorts at Snelling cross section 13+95.**

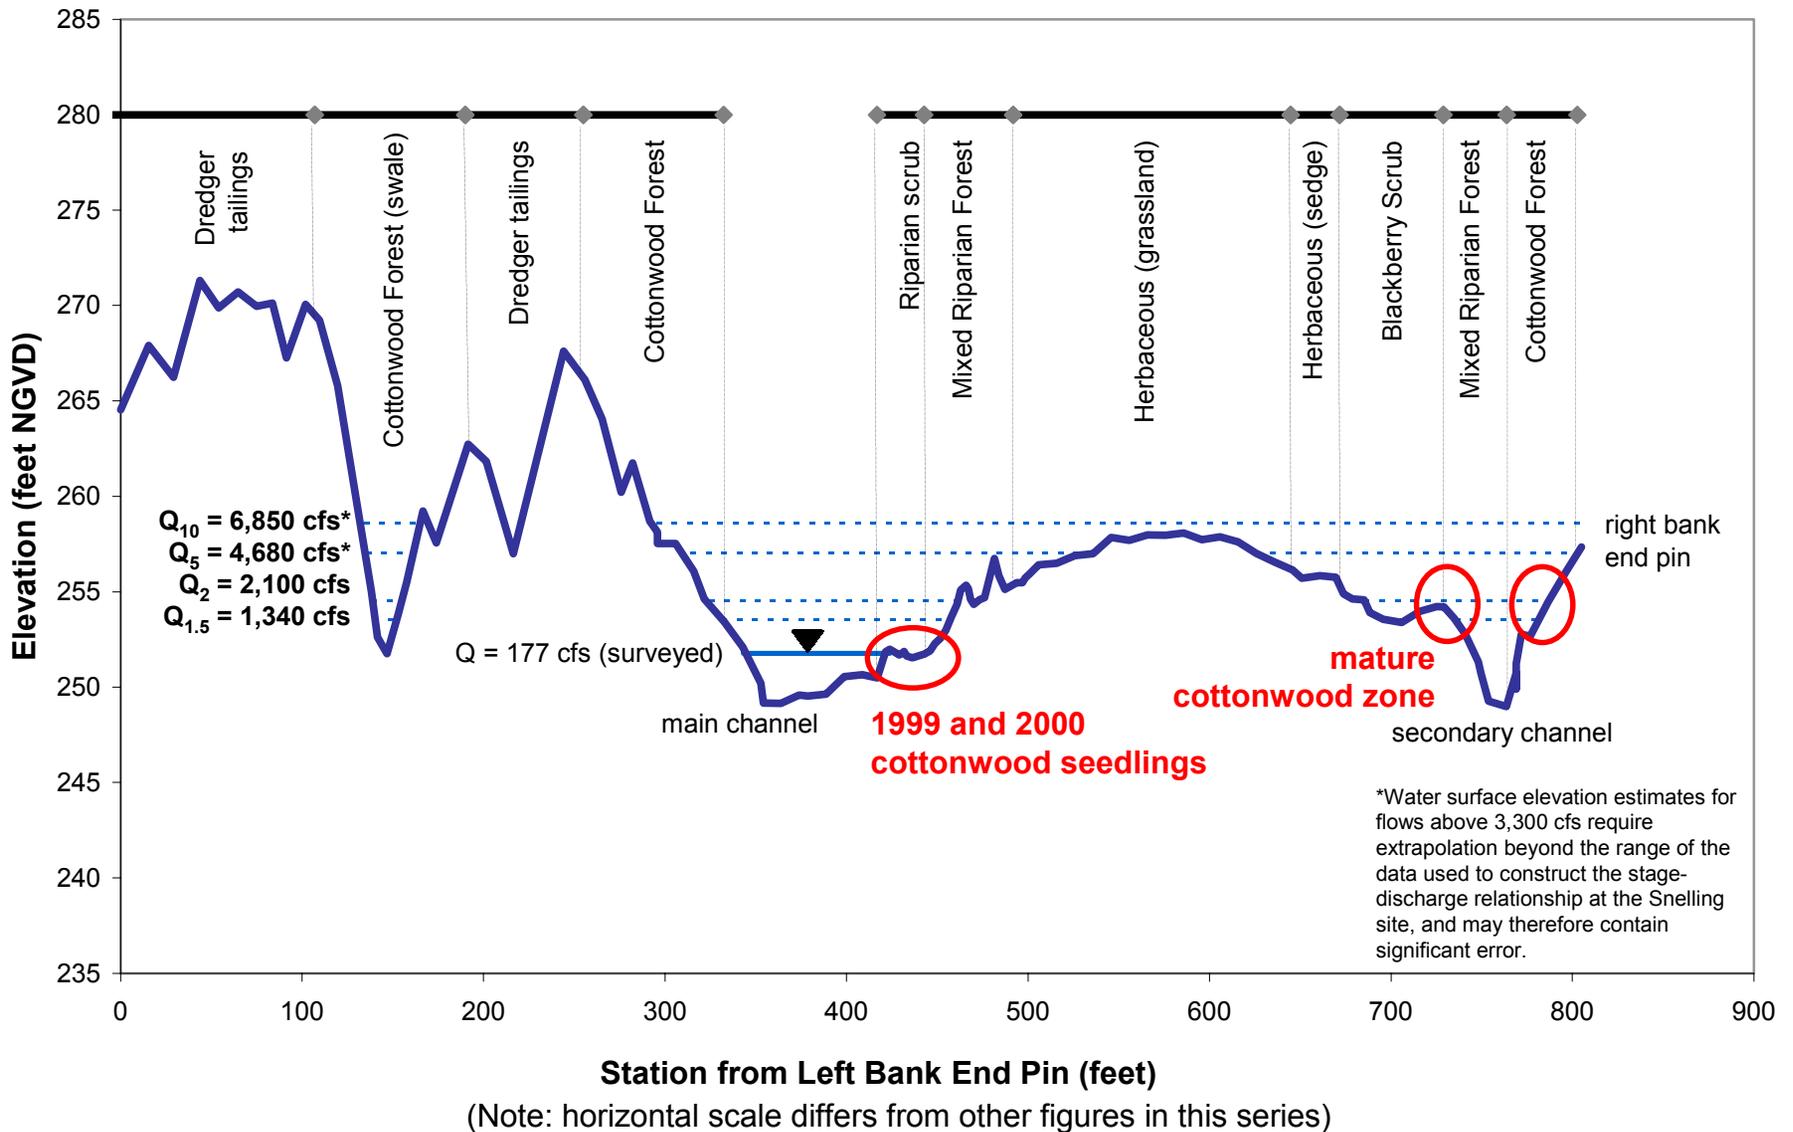
**Figure 6.5-5. Snelling cross section 13+95, showing elevation and inundation frequency of current cottonwood germination zone and root crown elevation of mature cottonwoods.** Current seedlings germinate within the bankfull channel. Mature trees are inundated at flows corresponding to the post-dam 1.5 to 5-year recurrence intervals.

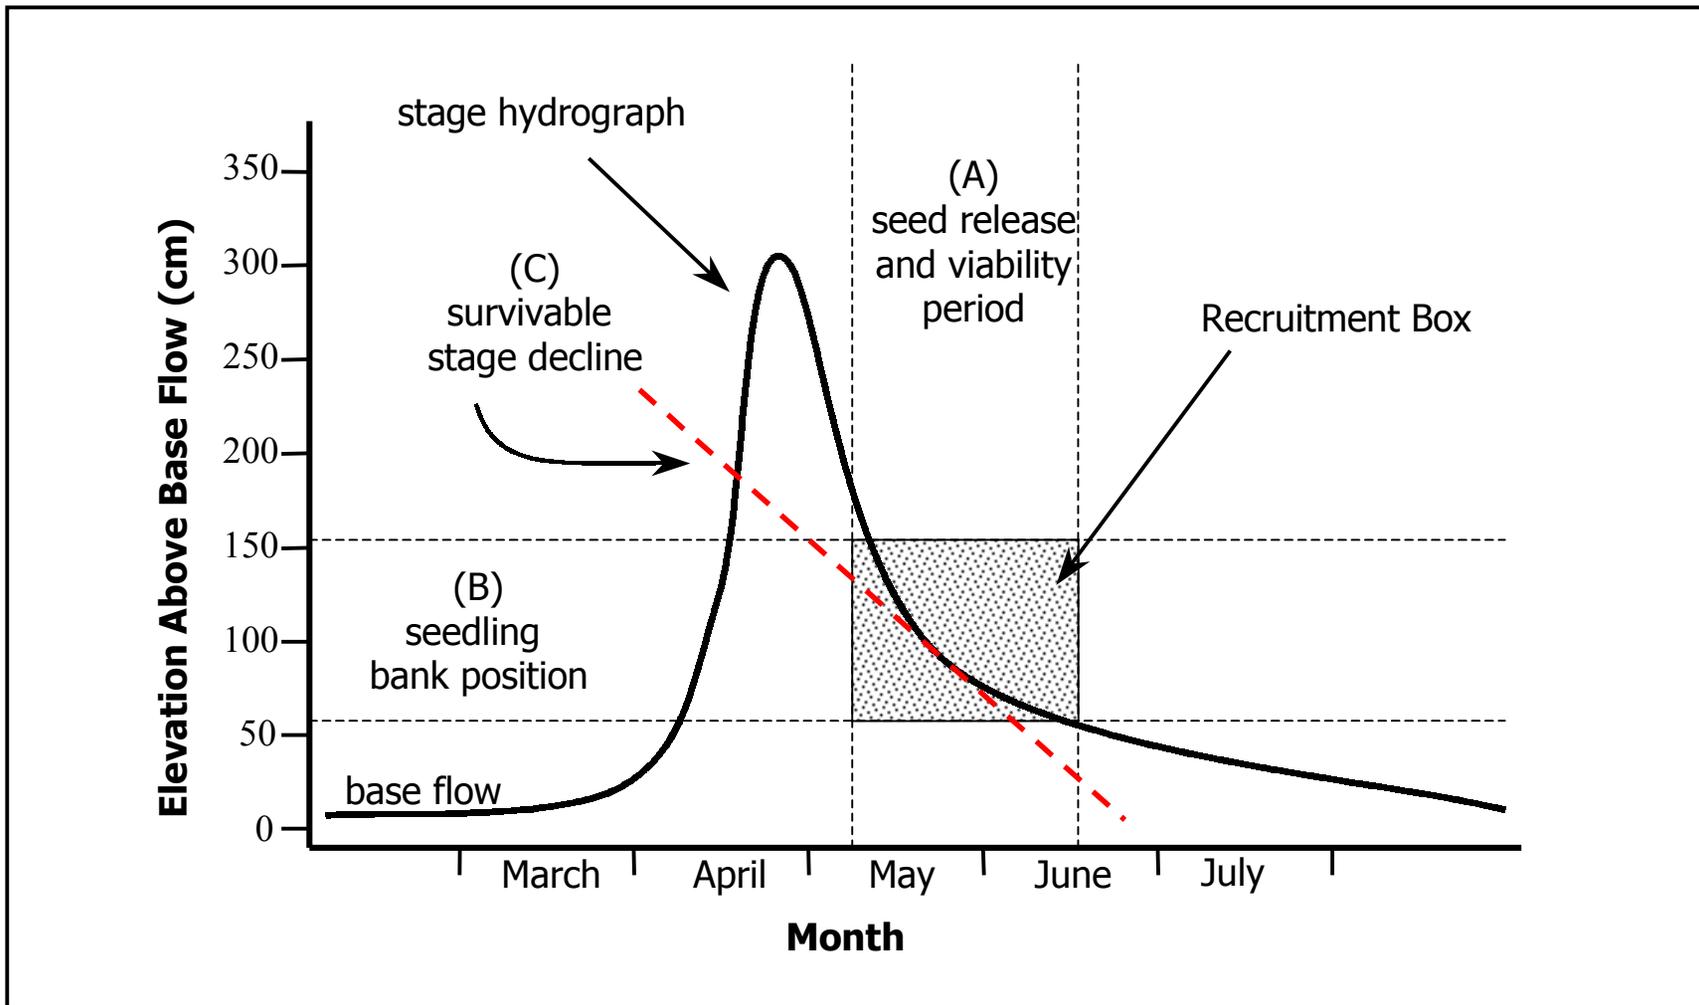
**Figure 6.5-6. The 'Recruitment Box' concept** (adapted from Mahoney and Rood, 1998). The recruitment box is a space defined in elevation and time in which seedlings of riparian plant species are likely to become successfully established based on stream flow conditions. The graph represents the relationship between the stream hydrograph and the timing of (A) the seed release and viability period for a particular riparian plant species; (B) the range of bank elevations (or stream stages) at which successful seedling recruitment is likely to occur for that species; and (C) the survivable rate of stream stage decline determined by the seedling's ability to maintain functional contact with the receding water table through root elongation.

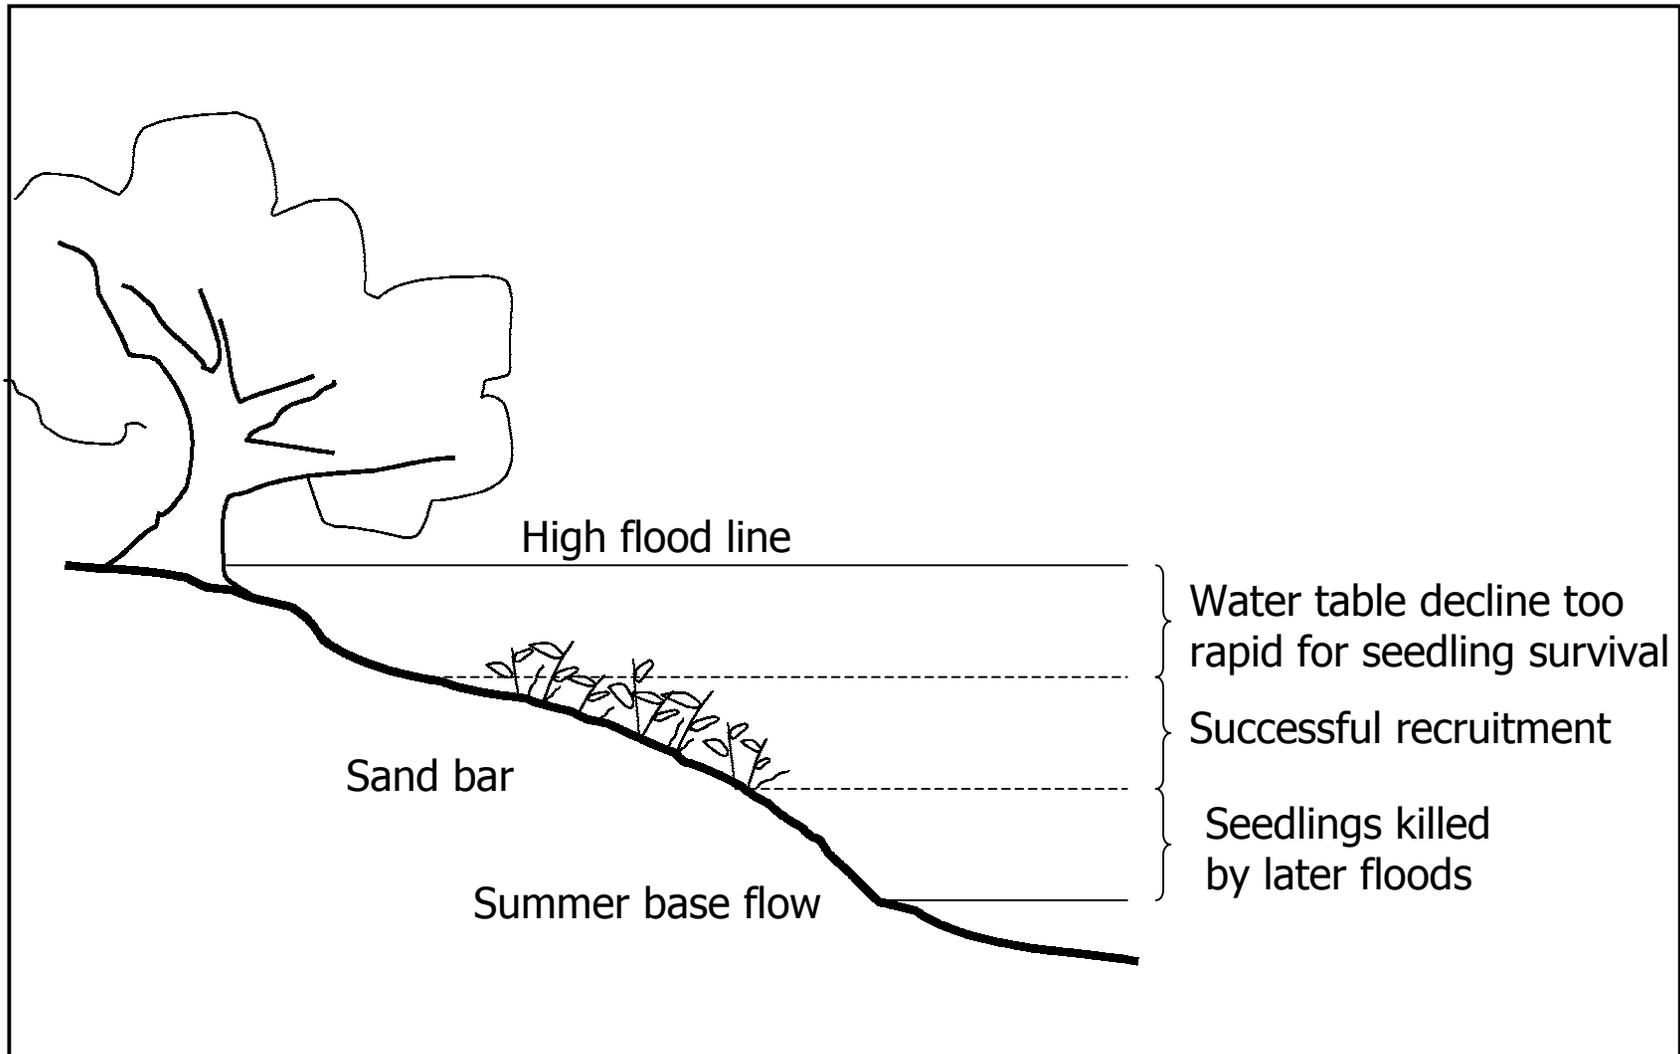
**Figure 6.5-7. Cottonwood and willow recruitment patterns.**

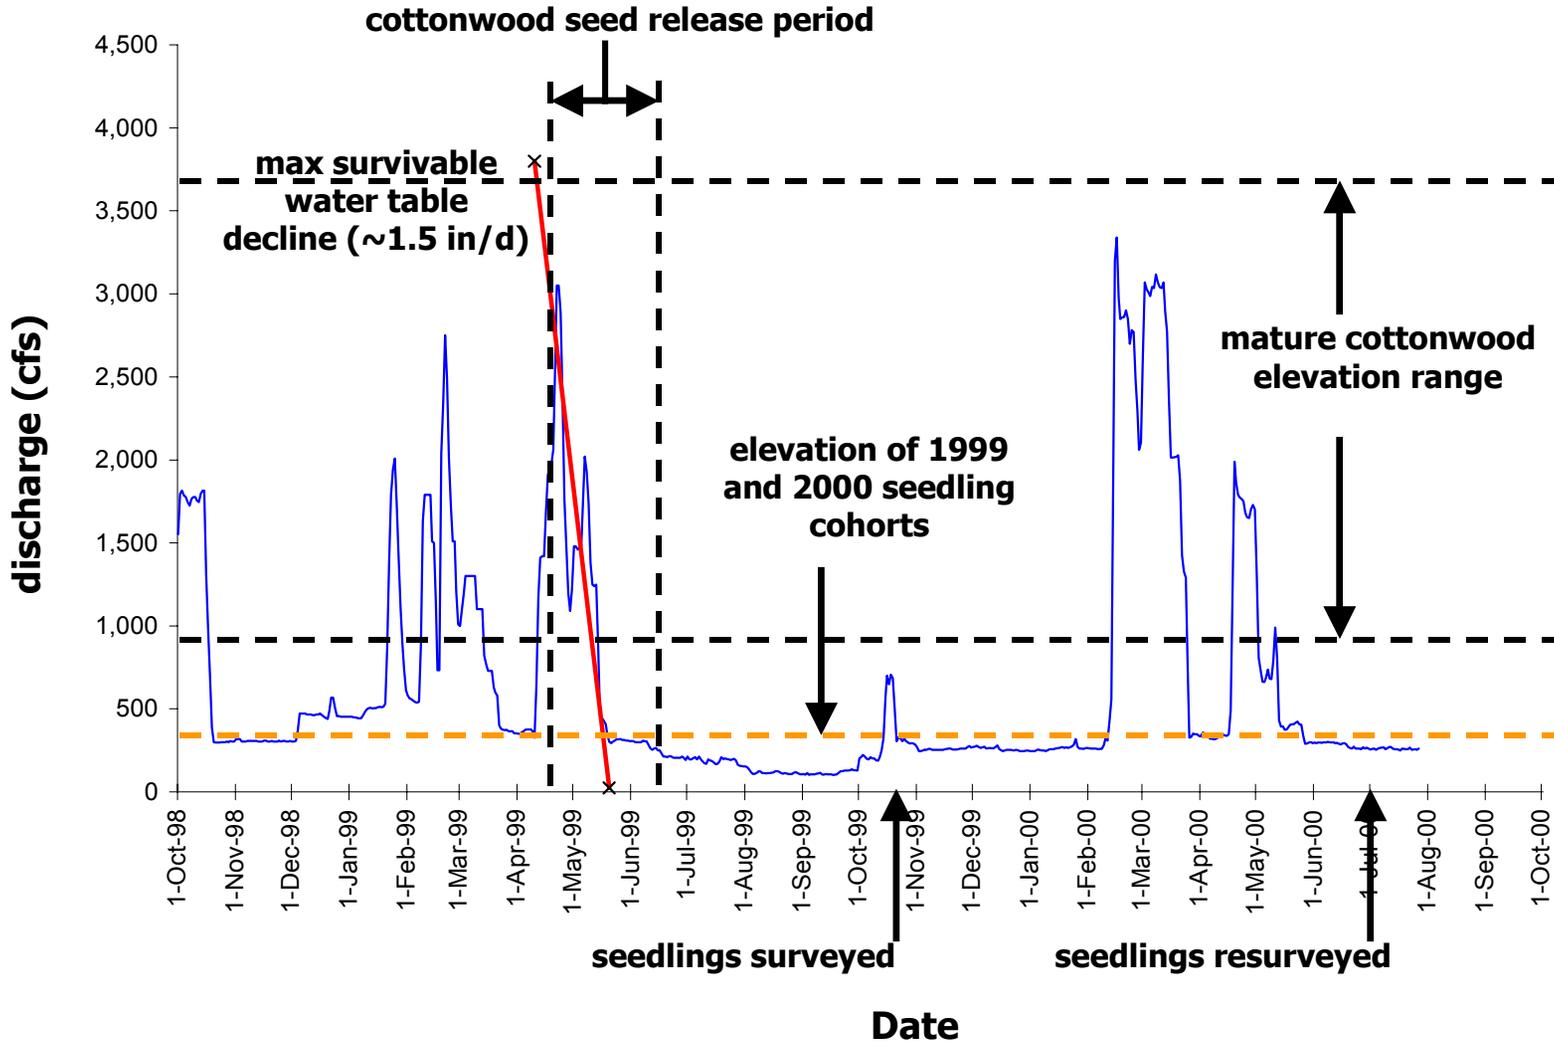
**Figure 6.5-8. 'Recruitment Box' Analysis of Snelling Site.**

Flow data are from the Merced ID Merced River at Crocker-Huffman gauge.
