Overall, the building quality and condition are fair to poor.

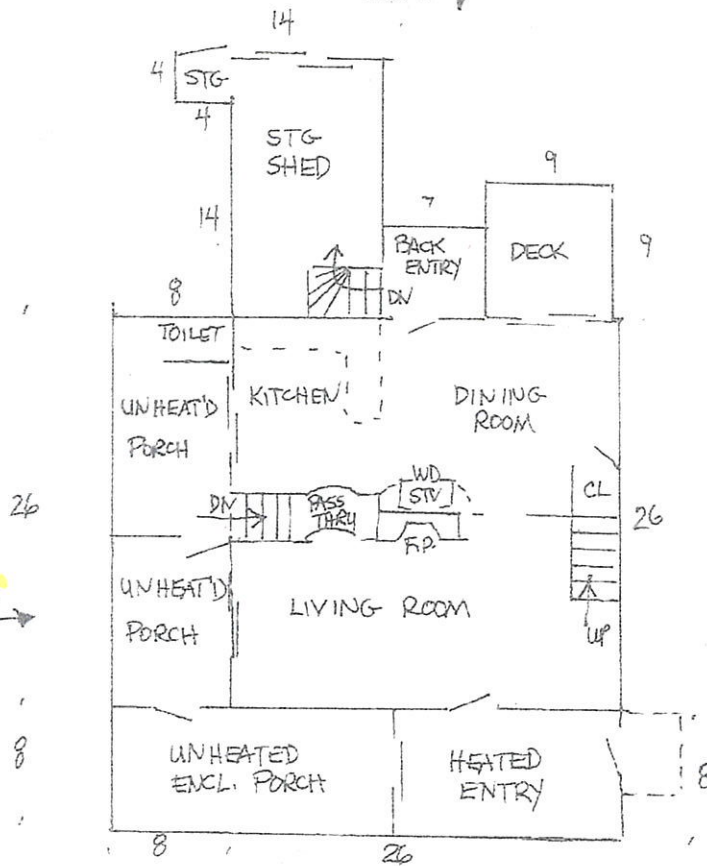
$$\begin{array}{r} 26 \times 26 = 676 \\ 8 \times 15 = 120 \\ 7 \times 6 = 42 \\ \hline 838 \end{array}$$
