# Ni-les'tun Tidal Wetlands Restoration Project: Planning, Implementation, and Lessons Learned

*Biological Technical Publication*  
*BTP-R1015-2017*

The tidal wetlands restoration project at the Ni-les'tun Unit of the Bandon Marsh National Wildlife Refuge was the result of more than a decade of planning, partnerships, land acquisition, scientific study, and engineering. Funding sources included the U.S. Fish and Wildlife Service (USFWS or Service), Federal Highway Administration, M/V *New Carissa* oil spill natural resource trustees, Oregon Watershed Enhancement Board, Ducks Unlimited, National Oceanic and Atmospheric Administration, National Fish and Wildlife Foundation, and Cape Arago Audubon Society.

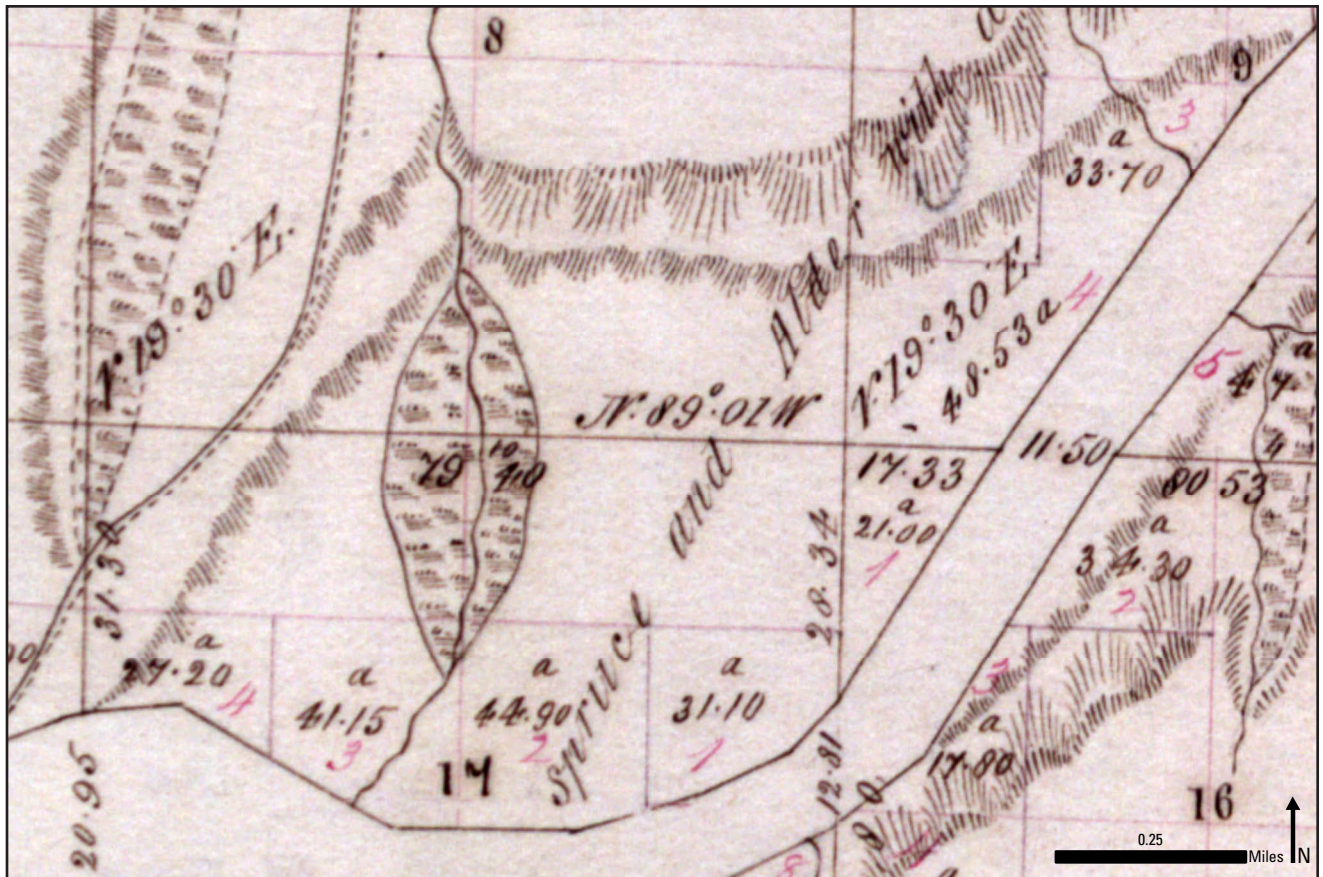
Figure 2. Detail of 1857 General Land Office map showing pre-agricultural conversion features

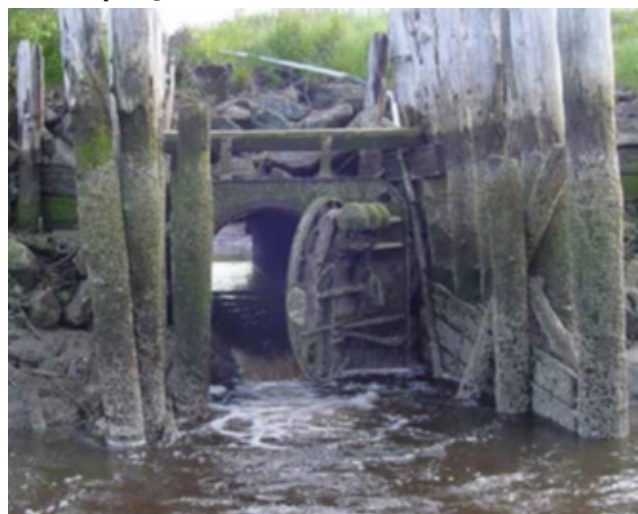
**Figure 11. Fahys Creek tide gate during mid-ebb tide in late spring, 2010**

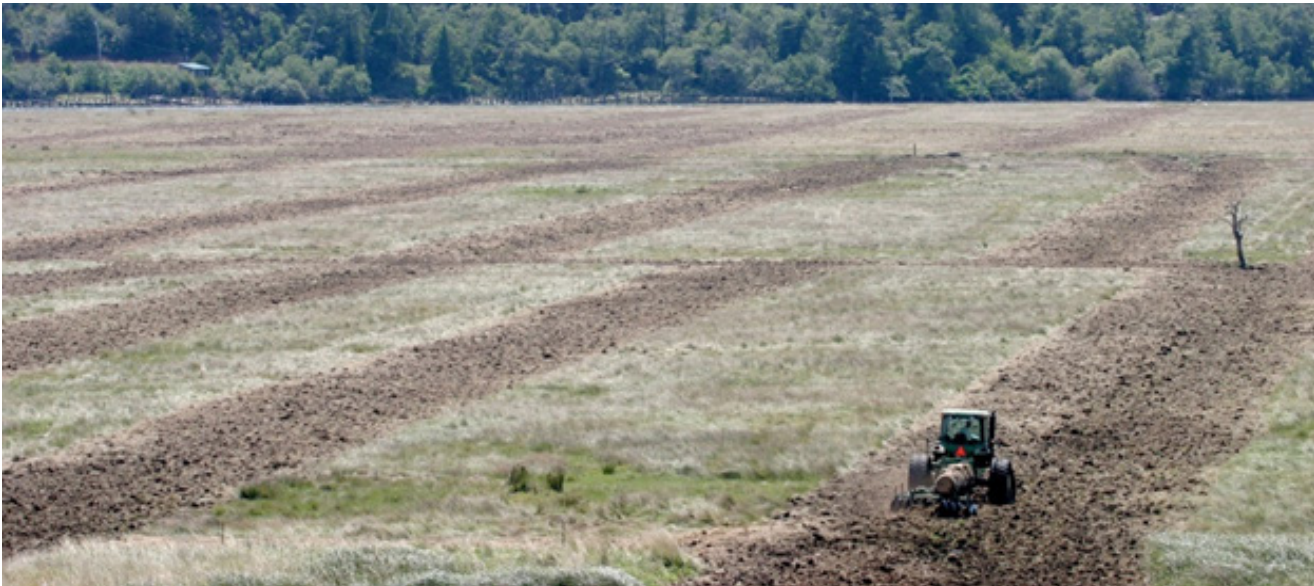
**Figure 14. Mowing and discing treatment of the restoration site**

Treatment of the many small ditches throughout the site involved mowing vegetation, ripping the soil surface and vegetation mat with a ripper on a bulldozer, and discing the top 8 to 12 inches with pulled disc mounted on a tracked farm tractor. The intent was for the broken soil to be pushed into and disrupt the small ditches, but this did not occur to a sufficient degree. Subsequently, small berms were bulldozed across the ditches to further disrupt their function.

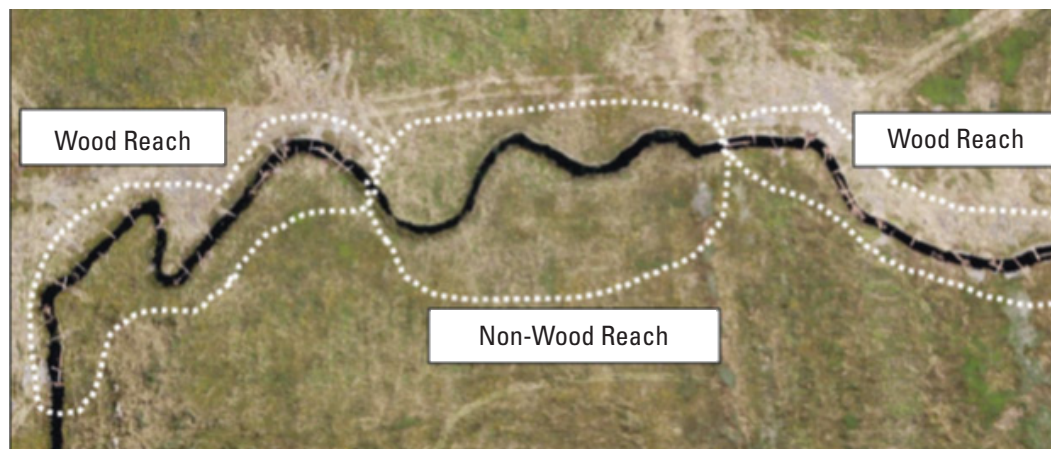
**Figure 16. Aerial view of an excavated channel showing the alternating reaches with and without LWD installed**

Fish use of a LWD reach was compared to adjacent reaches without LWD to evaluate the habitat value of the LWD.

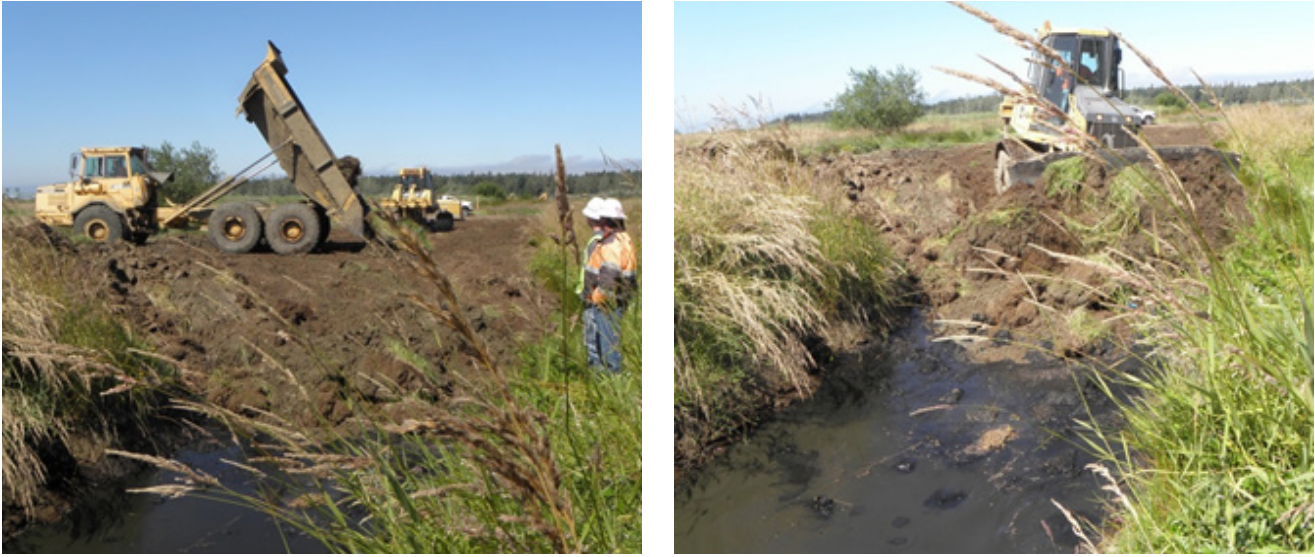
### Figure 20. Large ditch filling

Large ditches were filled continuously from the top of the drainage downward with adjacent spoils, or fill trucked in from channel excavation (*left*). Fill was pushed in with the bulldozer (*right*) for greater compaction, and to permit the water in the ditch to flow unimpeded toward the outlet.

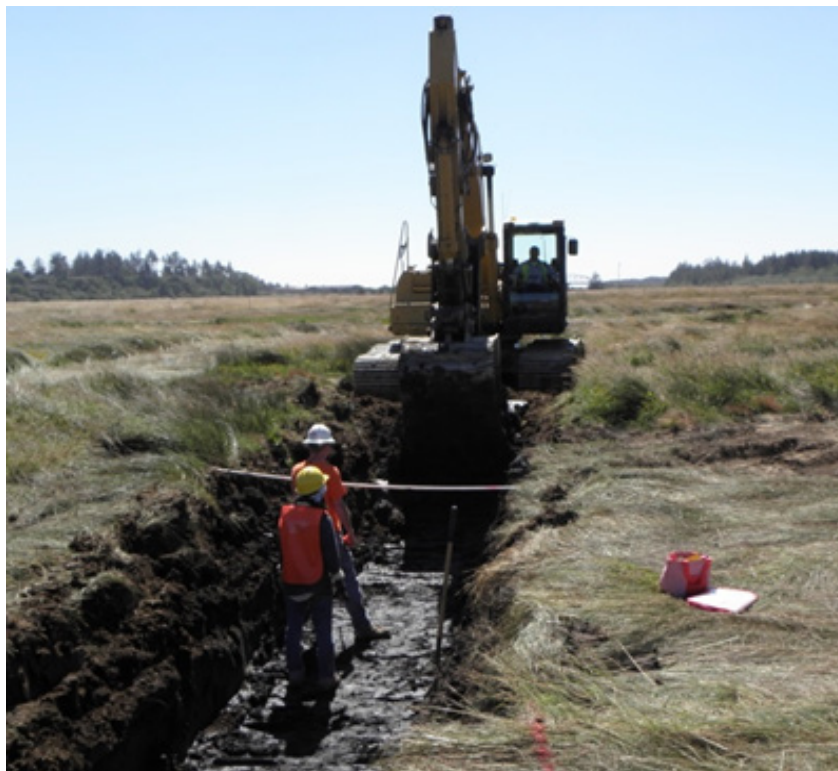
### Figure 21. Excavation of a fourth order channel

The excavator followed a path flagged by the project engineer. The spoils were loaded directly into a truck and transported to fill locations. A contractor worker (*white hat*) monitored the channel width and depth, and an archaeology monitor (*yellow hat*) kept watch for exposed cultural artifacts.

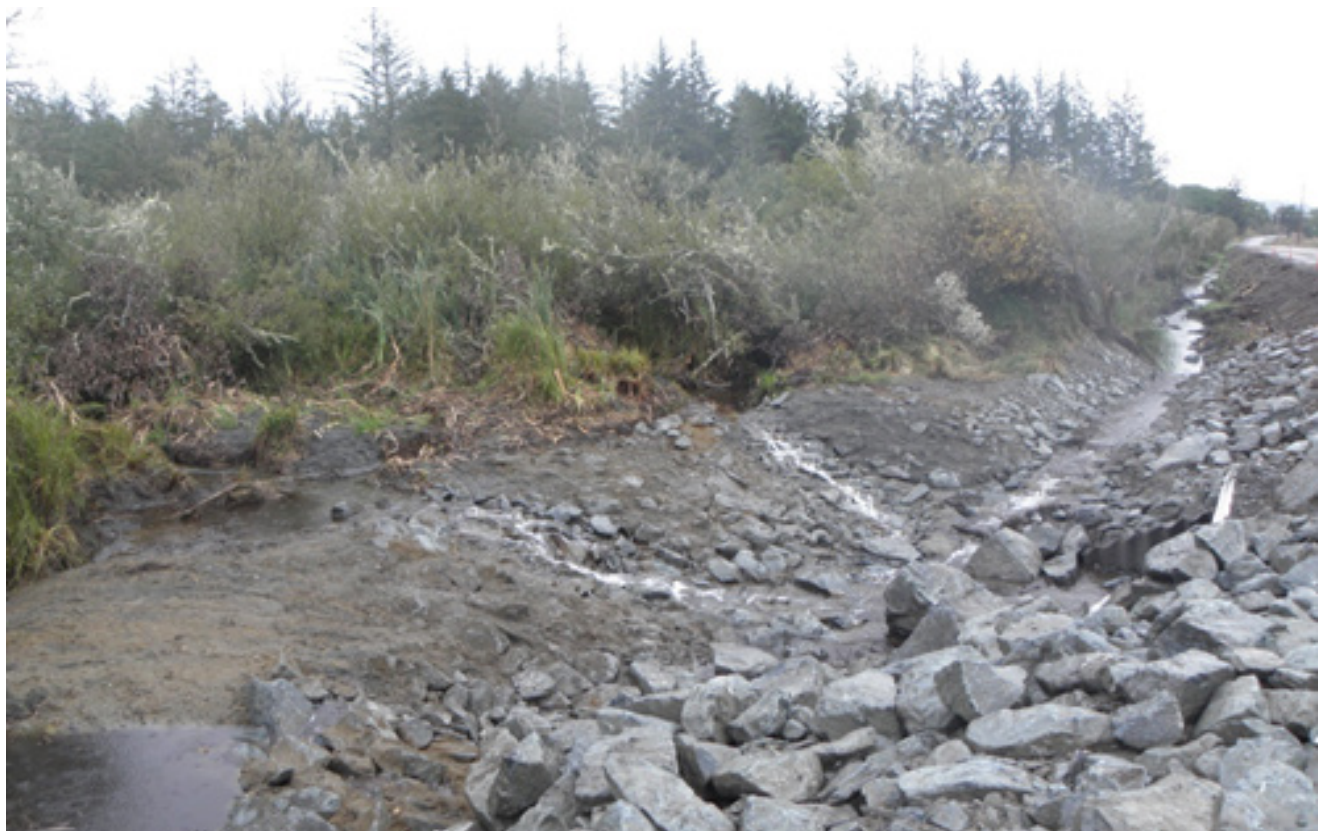
**Figure 23. Ground view of the Fahys Creek transition structure, looking east**

Note the culvert entrance on the far right center of the picture, and multiple streams flowing down the structure.

that included channels for the various streams (Figures 22 and 23). At monthly high tides, water levels are at or near the top rim of the structures, and at seasonal high stream flows migrating salmon can easily pass over the structures.

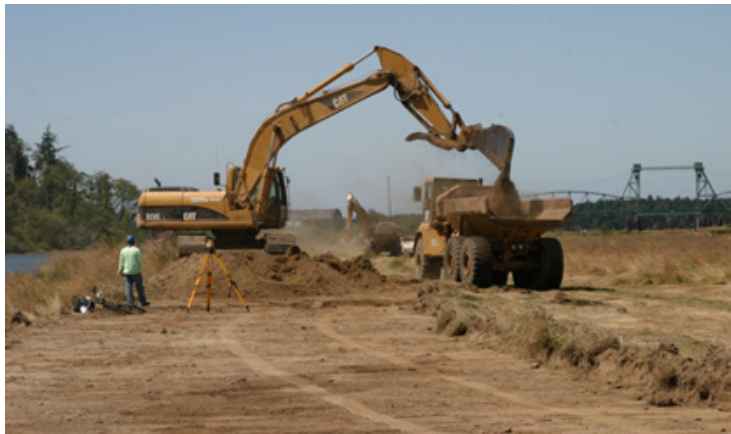
**Figure 24. The second stage of dike removal, bringing the dike to the design elevation**

After all tidal channel construction was finished in the summer of 2011, the process of allowing the tides back on the marsh by lowering stretches of the river dike, and ultimately removing the three tide gates began. This process was timed to coincide with a period of lower high (neap) tides that occurred in August, which would allow the dikes to be taken down to design elevations without being overtopped by the tides, thus preventing premature flooding of the site that would affect heavy equipment operation. The total amount of time needed to lower the dikes was longer than the lower high tide window, so dike removal occurred in two stages (lifts). The first stage removed material along the entire length to be lowered to within six inches above the predicted high tides of the following two weeks (or design elevation, if higher), and also substantially narrowed the dike to minimize the volume of material remaining for the second stage. The second

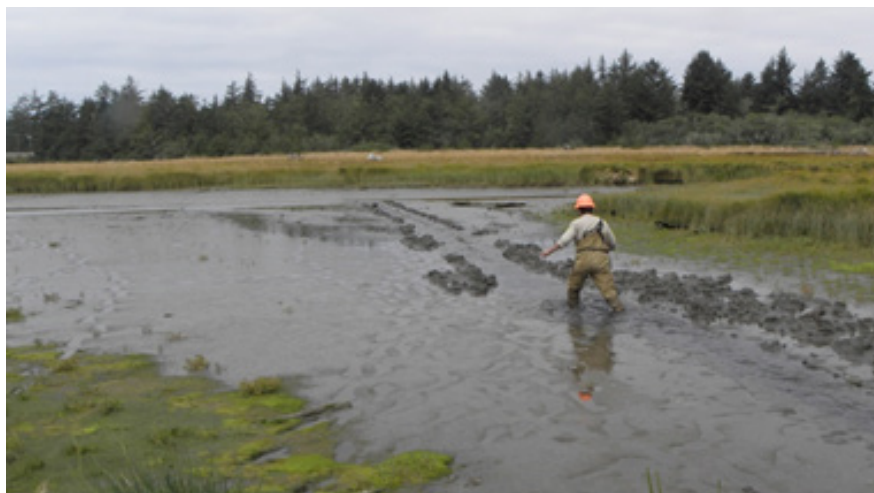
### Figure 28. The hand dug "pilot" channel to direct flow through the sedimented historic Fahys Creek lower channel

The pilot channel was intended to focus the erosive forces of the outflow and begin the process of channel adjustment to the restored flow rates.

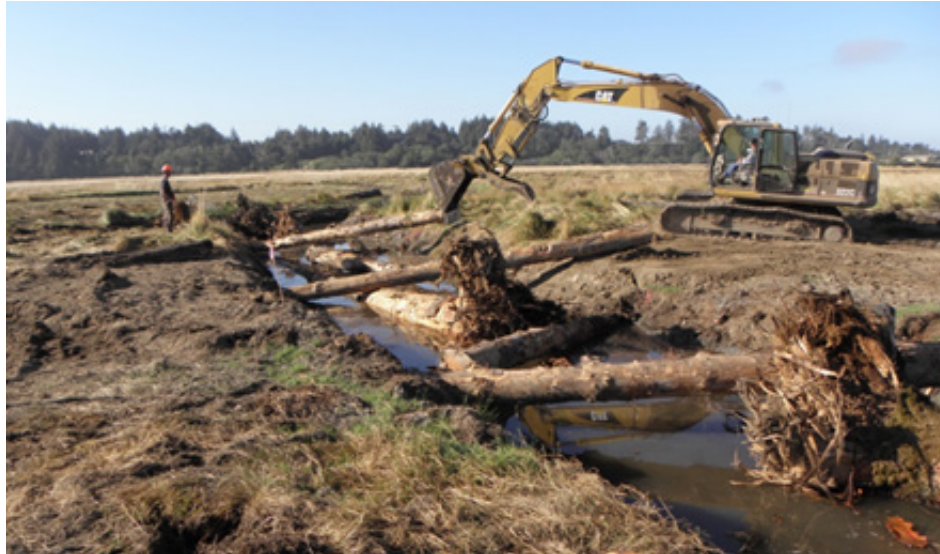
**Figure 29. Installation of LWD using an excavator to push logs into the banks**

In this case, a large log laid down the center of the channel is being held in place with two pin logs. In other cases, the root mass log was pushed into the bank.

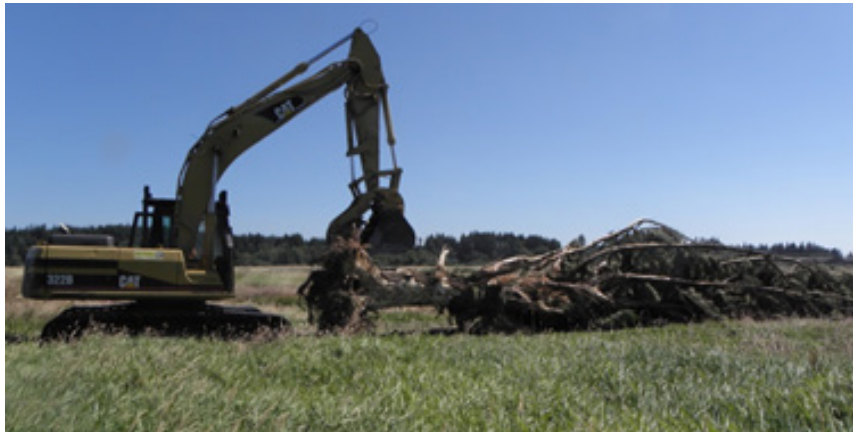
**Figure 33. Dragging a spruce tree from where it had been growing on the old dike to be deposited in the Fahys Creek channel as LWD**

The branches, root mass, and large size would serve to anchor it in the channel.

metal and plastic trash. One salvageable tide gate was turned over to the Coquille Watershed Association for recycling. Organic debris, such as LWD off-cuts, felled trees, or unburied wood was left on the marsh table as habitat elements. One large spruce tree that had been growing on a portion of the dike that was removed was dragged with branches and roots intact (Figure 33) to the mid-channel of Fahys Creek, where a LWD cluster had been planned, but could not be embedded due to sandy soils.

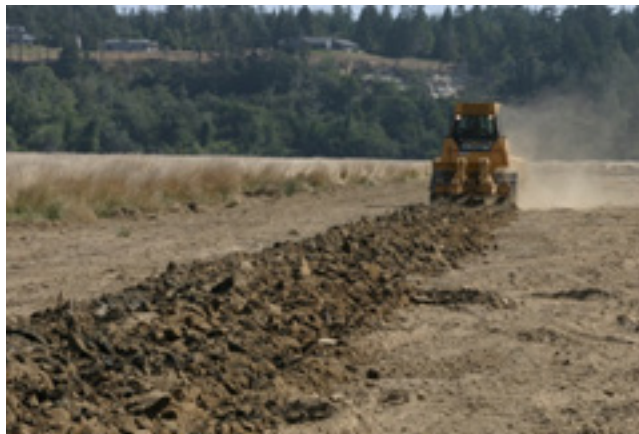
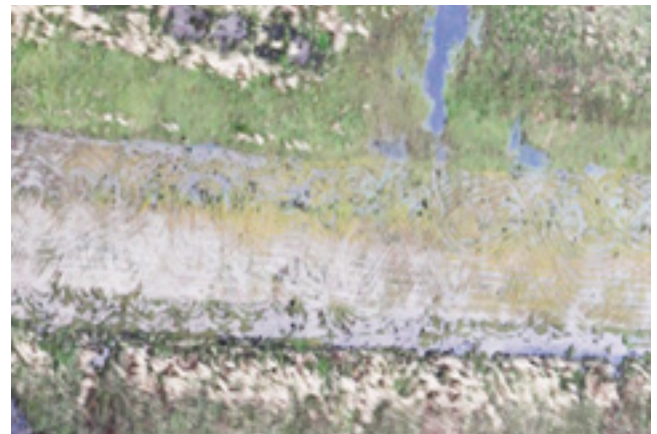
**Figure 34. KR bulldozer ripping the farm road (left) and an aerial view of a portion of the decommissioned farm road showing the tracks left by the bulldozer ripping teeth, and the start of natural revegetation (right)**

The roadbed remained elevated above the surrounding marsh in some areas.

The construction specifications required the contractor to repair haul roads with excessive (as determined by the engineer) rutting, and decommission farm roads by ripping and grading to marsh table elevations. In most cases haul road ruts were repaired by the excavators side-casting their buckets to smooth out the ruts. In a few cases, spoils were used as fill material to level deep ruts. The main central north-south farm road had been built up over the years with compacted gravel and sand, and was elevated above the surrounding surface for most of its length, and so could not be easily graded down without disposing of significant spoils. The decision was made to cut the highest portions down by spreading material out with a bulldozer, and to then rip the roadbed to about a foot deep to loosen the substrate enough to support plants (Figure 34).

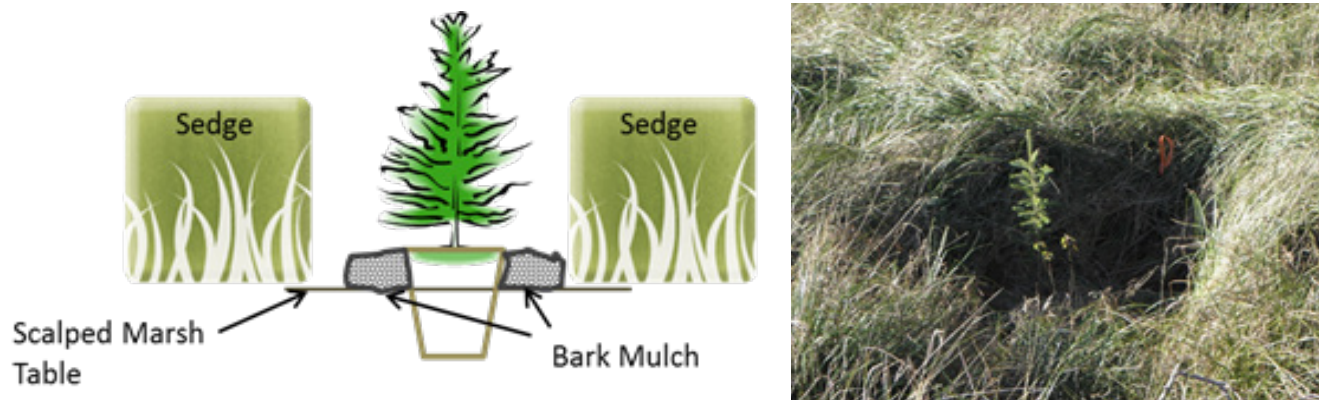
**Figure 37. Sitka spruce planting technique**

*Left:* Diagram showing how spruce roots planted in wet soils dominated by slough sedge were elevated about three inches above the surrounding marsh table and mulched with coarse bark to provide aerated soil for the roots. *Right:* The photograph shows the result of the grubbing to reduce sedge competition with the trees.

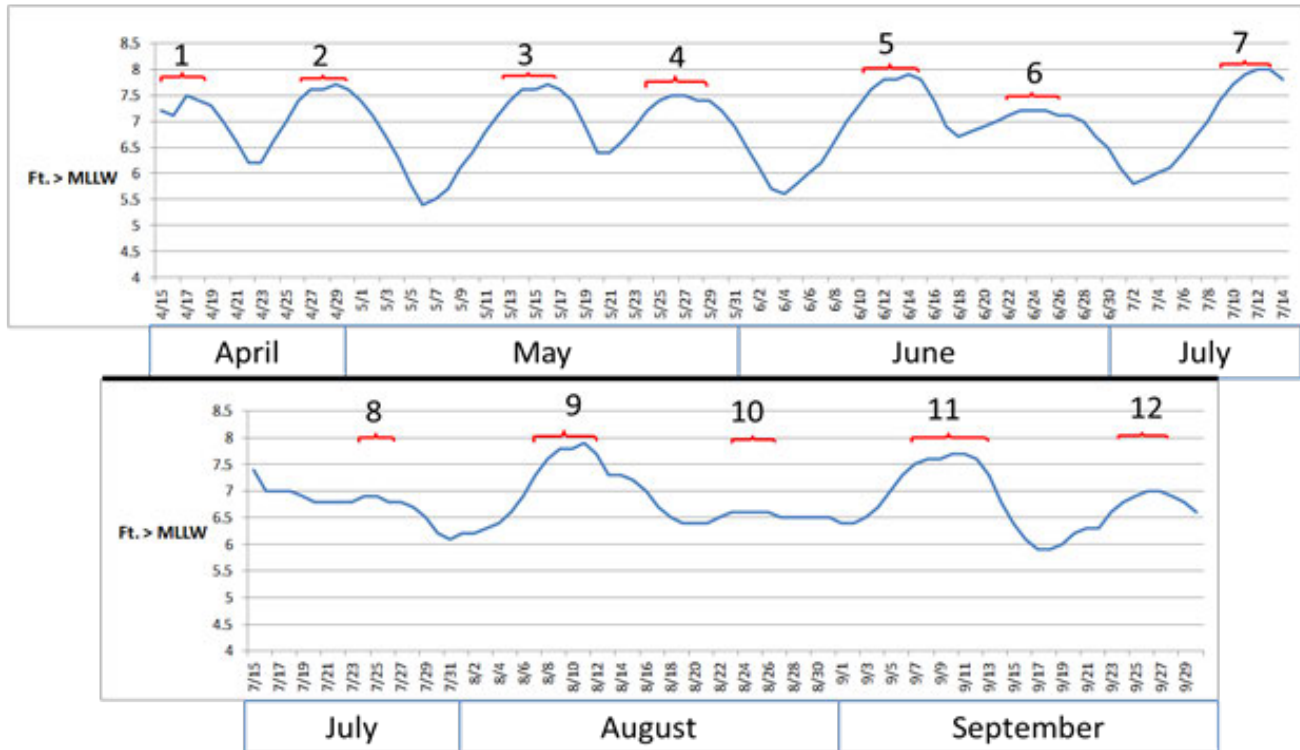
**Figure 42. The correlation between predicted daily higher high tides (blue line) and salt marsh mosquito egg hatches (numbers and brackets) in 2014**

Larvae resulting from hatches two through 12 were treated with *Bti* larvicide. Lower tides resulted in fewer breeding pools flooded, and correspondingly less *Bti* applied. Small numbers of larvae appeared after the late September high tides and were spot treated, but the hatching season essentially ended at hatch number 12.

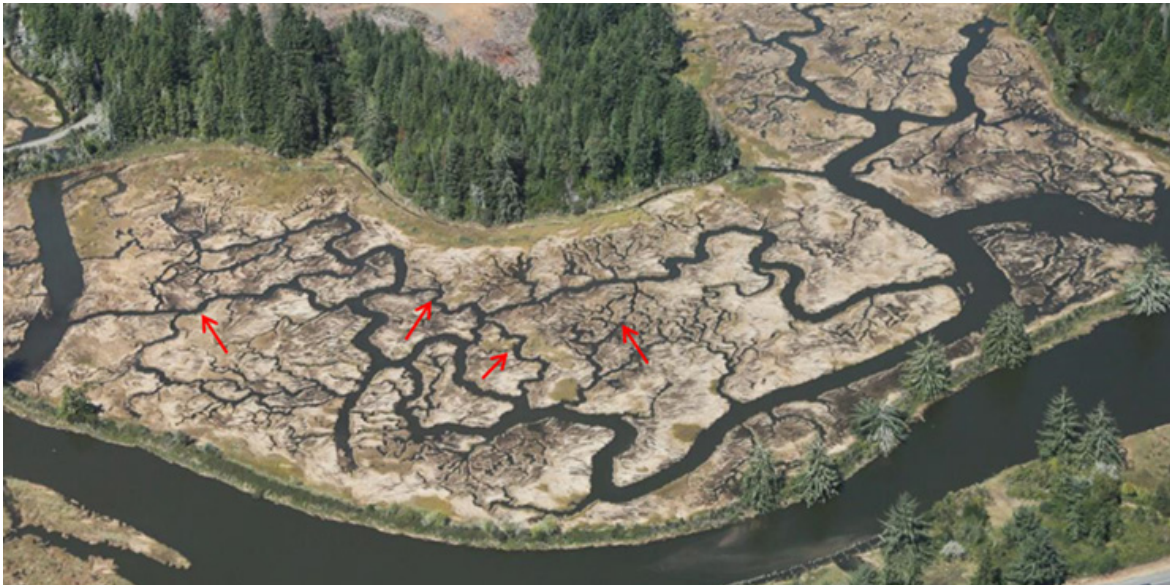
**Figure 46. Aerial photograph of a tidal marsh in Coos Bay that has been partially diked, but with most of the natural channel system remaining, illustrating the typical preponderance of low order channels**

Examples of naturally developed channels that provide alternate pathways (short circuits) between sub-watersheds for tidal flow are indicated by the arrows.

The natural development of new lower order unexcavated channels was very limited. Erosive forces strong enough to form headcuts occurred in only a handful of places where marsh table topography focused water draining from large areas during ebb tides. Besides the relatively low energy of the slow moving water over most of the table, the dense roots and stems of living and dead vegetation covering most of the site add to the resistance to soil erosion. It is difficult to predict how long it would have taken to develop the extensive system of small channels necessary to maximize tidal exchange efficiency, but based on the slow start, it would certainly have taken several decades, and perhaps it would never have reached the channel density seen in naturally developed tidal marshes (Figure 46). The new lower order channels dug in 2014 and after have rendered such speculation moot.

Ultimately, the construction of low order channels to solve the mosquito problem resulted in largely restoring the function of the small ditches that had been disrupted. In some cases, this did result in “short circuiting” tidal flow in the larger channels by creating channels connecting small sub-watersheds, but with little apparent consequence since flow in the large channels is still dominant, and such connections can readily be observed in natural tide marshes (Figure 46).

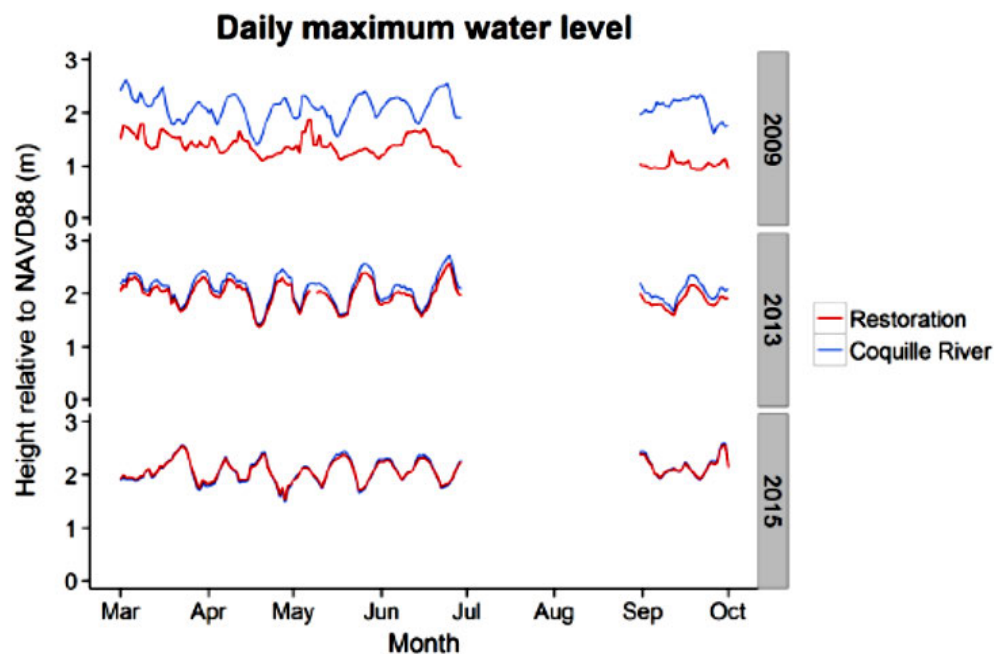
**Figure 47. Pre-restoration (2009) and post-restoration daily maximum tide heights for the Ni-les'tun restoration site (red), compared to the adjacent Coquille River (blue)**

Note the poor synchrony before restoration; nearly matching curves in 2013 indicating some dampening of the highest tides in the marsh by restricted flow capacity of the main channel; and by 2015 the channel had adjusted to permit unrestricted tidal exchange with the river.

the site closely approximated those of the adjacent river (Brophy et al. 2014). By 2015 (Figure 47) the channel enlarged enough so that the high tide water levels in the marsh matched those in the adjacent river. Large channel enlargement in all three sub-basins has continued since then, and that plus the extensive additional lower order channels excavated in 2014 and after have undoubtedly increased the tidal prism.

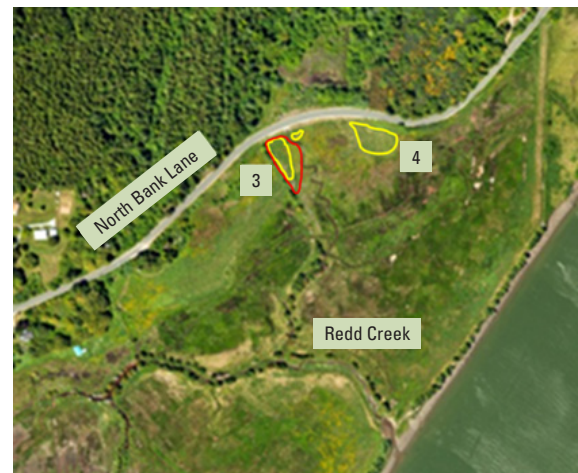
**Figure 50. The fate of woody plantings**

The shaded parts of areas 1 and 2 show where willows died due to salinity exposure. Trees planted in areas 2 and 3 close to the respective streams suffered extensive beaver cutting. Some crabapple and twinberry in area 1 suffered from deer browse. The 2011 willow planting along North Bank Lane shown in the left image continued to thrive except at the extreme west end where beavers have cut them. The red polygons outline where willow whips were planted in March 2013. The yellow polygons outline where Sitka spruce, Pacific crabapple, and twinberry were planted in December 2013.

Due to the demands associated with the mosquito crisis, intentions to better maintain and monitor these plantings were not realized, and survival rates suffered. No systematic count of woody plant survival was conducted, but the areas were monitored informally. Survival of the woody plantings was variable depending on species and planting area. Hooker's willows have some tolerance for salinity, but clearly many of the plantings were exposed to too much salt and mortality was nearly 100% in the lower parts of Area 1 and 2 (Figure 50), but survival of willows planted in slightly higher elevations was well over 75%, and for

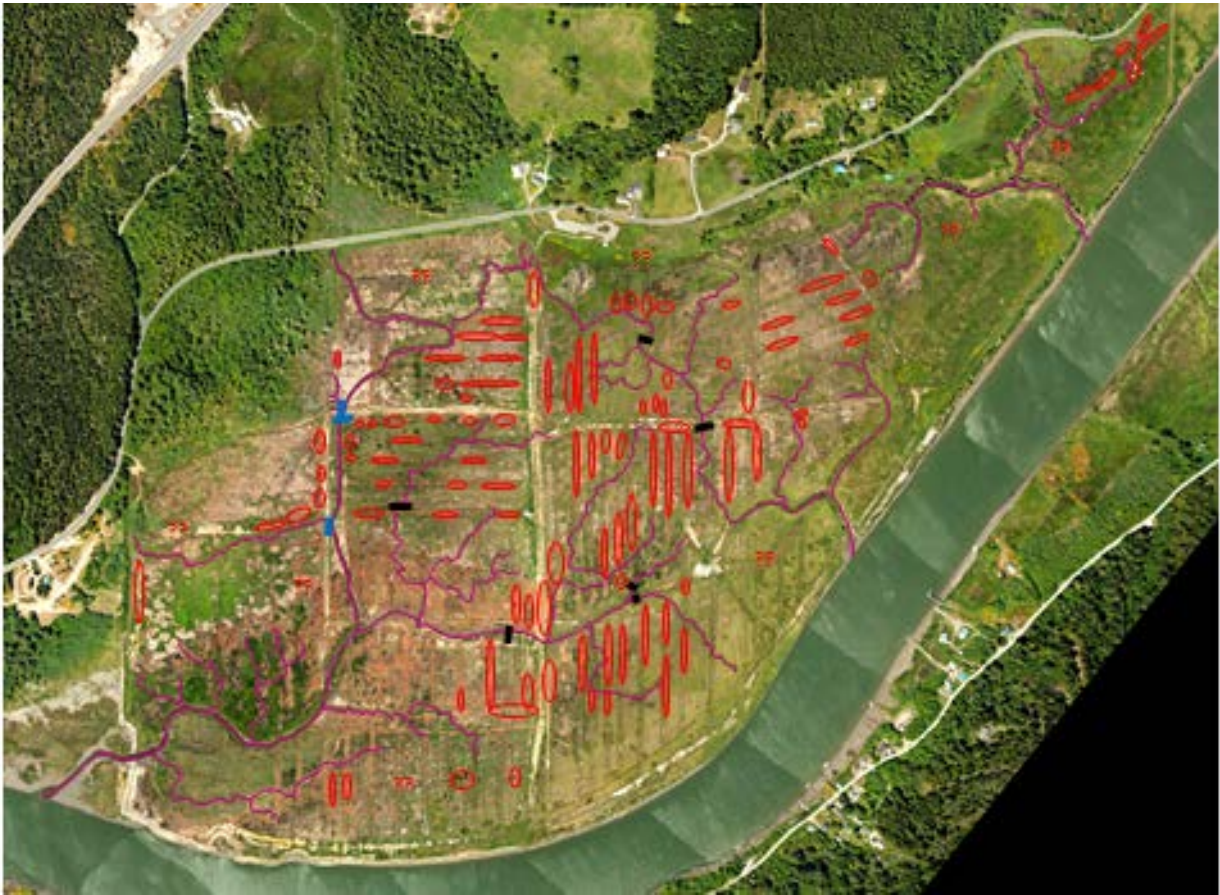
Figure 1. Aerial photograph of the Ni-les'tun Unit with constructed tidal channels indicated in purple. The red ovals surround concentrations of mosquito breeding pools based on 2013 surveys. Black and blue bars indicate footbridges installed to facilitate access.

The primary target of mosquito management is an approximately 300 acre portion of the Ni-les'tun Unit of the Refuge that was restored from diked pasture to tidal marsh in 2011 (Figure 1). Mosquito breeding pools were unintentionally created along old drainage ditches and other depressions that remained after the restoration, and are filled with water during semi-monthly high tides. In 2013, Service staff and cooperators determined that a population of salt marsh mosquito (*Aedes dorsalis*) has successfully exploited this new habitat to the degree that active management is necessary, and this species is the focus of the larvae monitoring and treatment program. Adult monitoring via CDC traps in 2014 took place around the perimeter of the marsh, and also extended to areas well beyond the Refuge boundaries to document movement away from the breeding sites.

*Field methods:* Based on 2013 surveys, known breeding pools were mapped on a recent aerial photograph of the Ni-les'tun Unit (Figure 1), and the entire area was divided into blocks, labeled A through F. In each block, a sampling path was laid out such that every pool could be sampled as the path was walked. These paths, or transects, were marked in the field with orange pin flags, each of which was numbered, located with GPS coordinates, and mapped. (Figure 3) The intention was for members of the monitoring team to walk each of these transects at weekly intervals while recording on field data sheets the larvae dip counts, locations (by transect flag number), and development stage of larvae encountered. Color coded pin flags were placed in or near pools with dip counts above the threshold to direct the larvicide applicators, who would replace the flags with another color that indicated where treatment had been done. This system allowed the applicators to walk directly to pools needing treatment, keep track of where treatment had occurred, and direct post-treatment efficacy monitors to treated pools. However, after several weeks of monitoring, it became apparent that mosquito hatches were highly synchronized with predicted tides, and that when larvae were discovered in certain pools it was likely that they were also present in similar concentrations over larger areas.

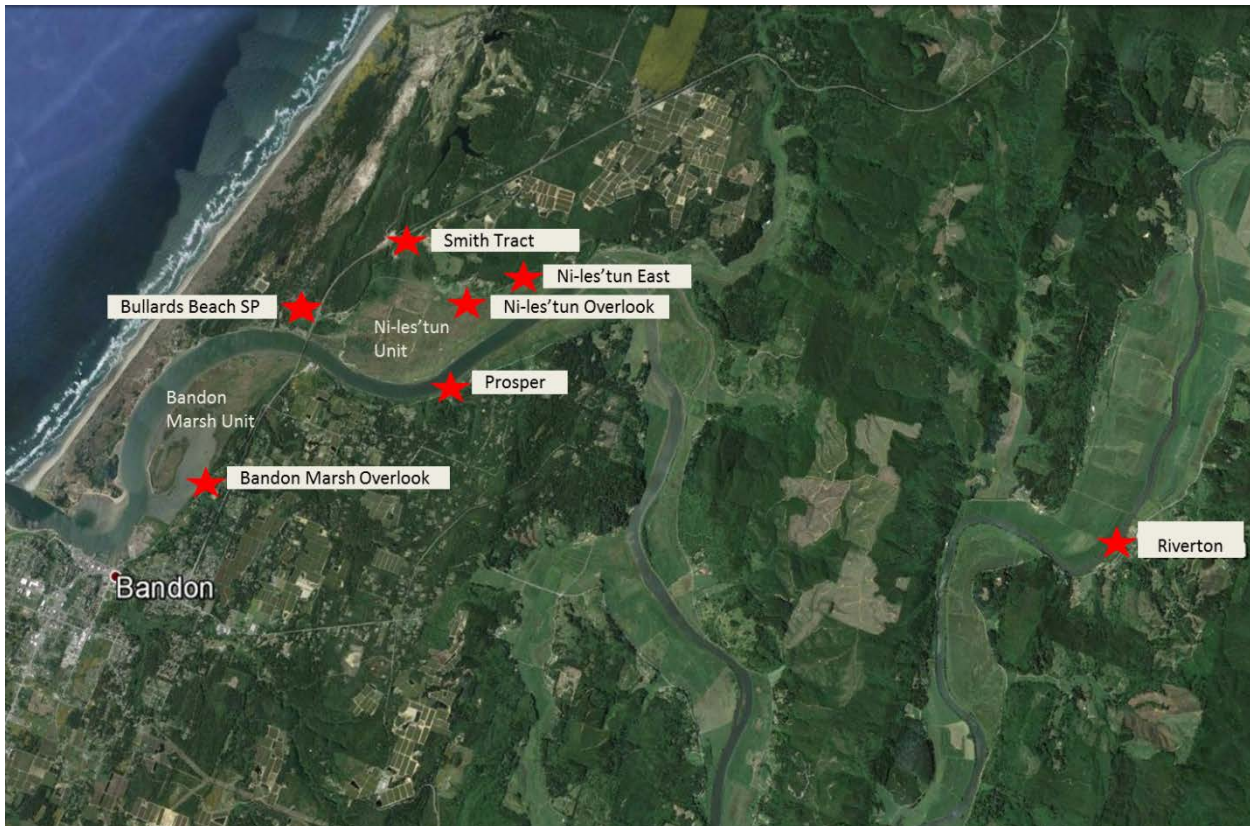
Figure 3. Locations of adult monitoring traps.

All adult monitoring was conducted by CCPH and VDCI staff. Seven sites in and around the Refuge (Figure 3) were selected for placement of CDC traps one night per week beginning late April through
