**Sequence of Work & Narrative**  
**Lyons Dam Removal & Toewood Bench Construction at Lyons, MI**  
**for the**  
**Village of Lyons & the Ionia County Conservation District**

## Grand River Dam Removal and Toewood Bench Construction Above the Dam

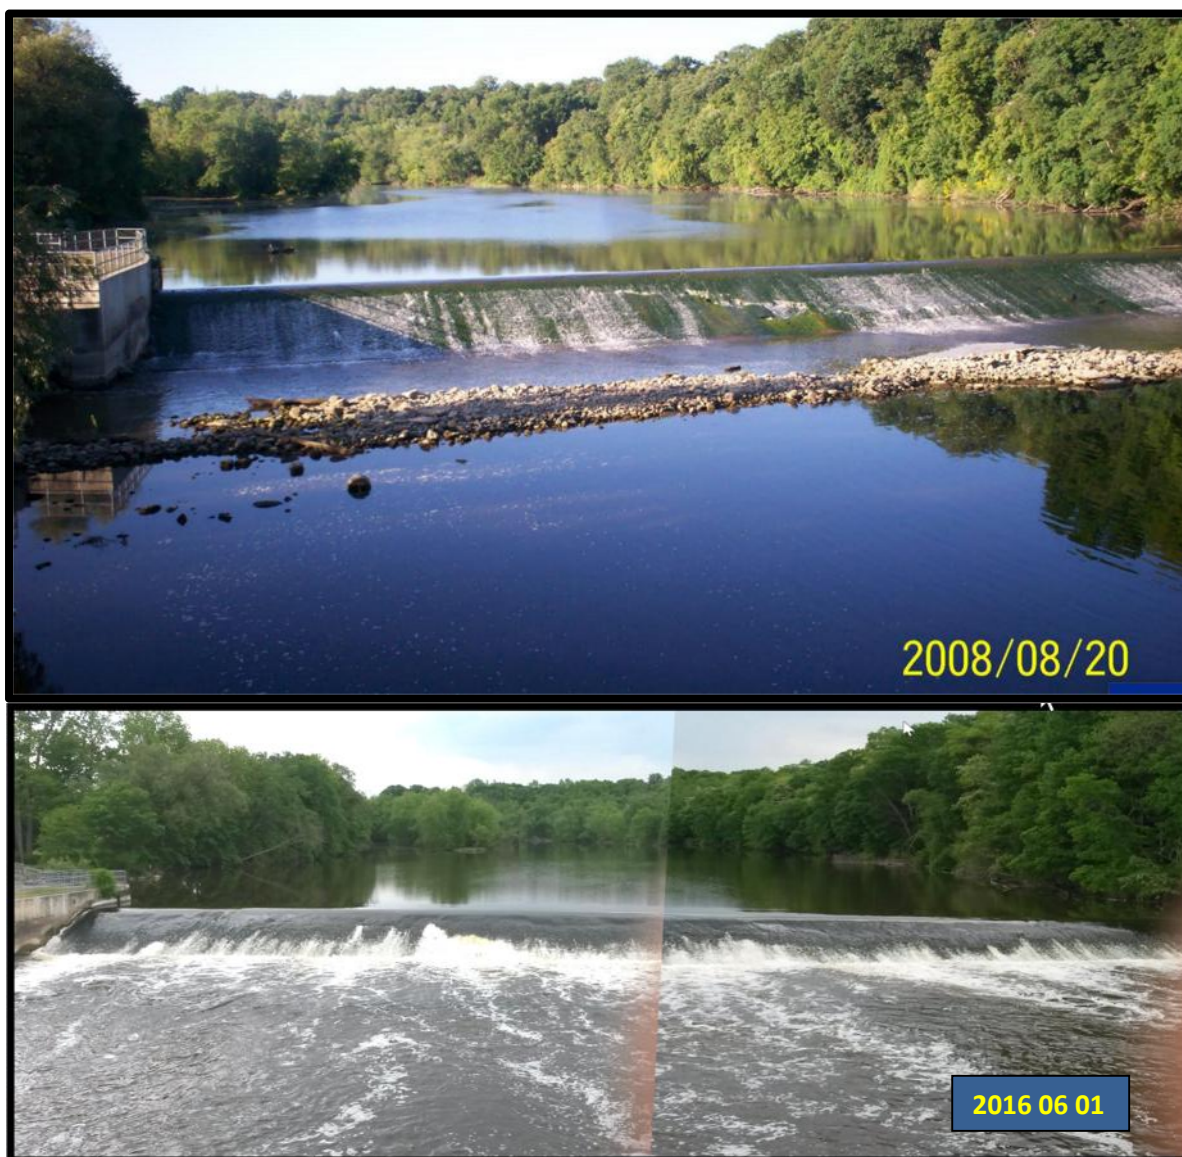
**Figure 1.** Face of Lyons Dam about 8 years apart.

**Figure 1** shows the dam face in 2008 and 2016. While the surface of the dam is now more pitted and some splayed off holes on the face of the dam have enlarged, the end run of water around the west end and subsequent bank erosion there has forced a speed up in the awarding of bids. This sequence is funded with federal funds from the US Fish and Wildlife Service, and it is anticipated these funds will be available for spending at the completion of the Emergency Work at the West End which is funded by state funds that are currently available for spending.
