EVALUATION OF HOGBACK FISH WEIR: DESIGNED TO REDUCE ENTRAINMENT OF ENDANGERED FISH IN CANALS

Mark McKinstry

US Bureau of Reclamation, Salt Lake City, UT

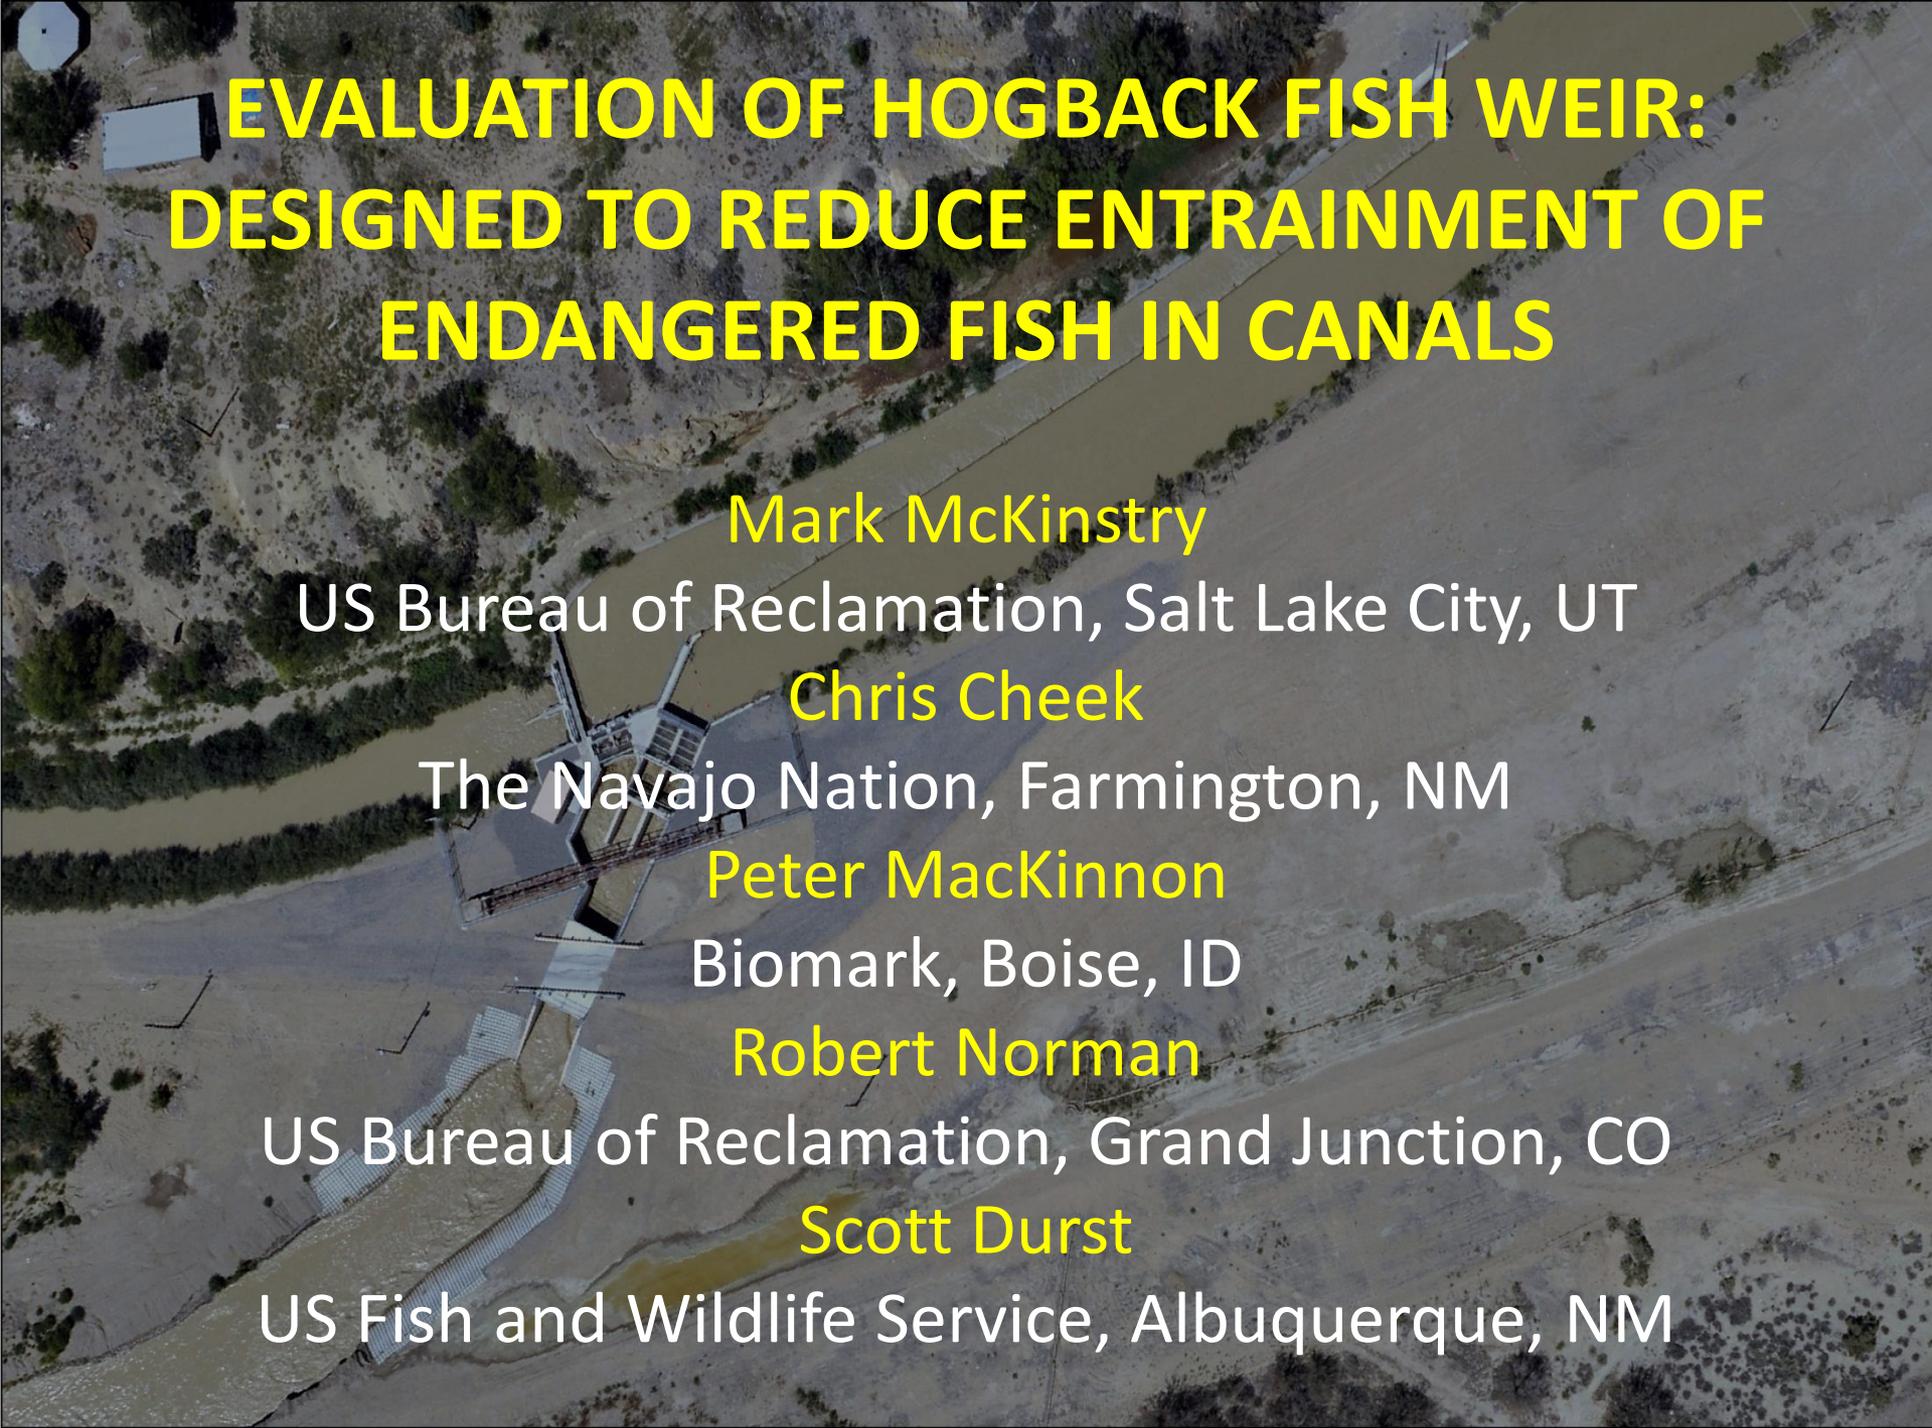
An aerial photograph of a fish weir structure in a canal. The weir is a large, rectangular concrete structure with a central gate and several smaller structures on either side. The canal is filled with water, and the surrounding area is a mix of sandy soil and sparse vegetation. The text is overlaid on the image in yellow and white.

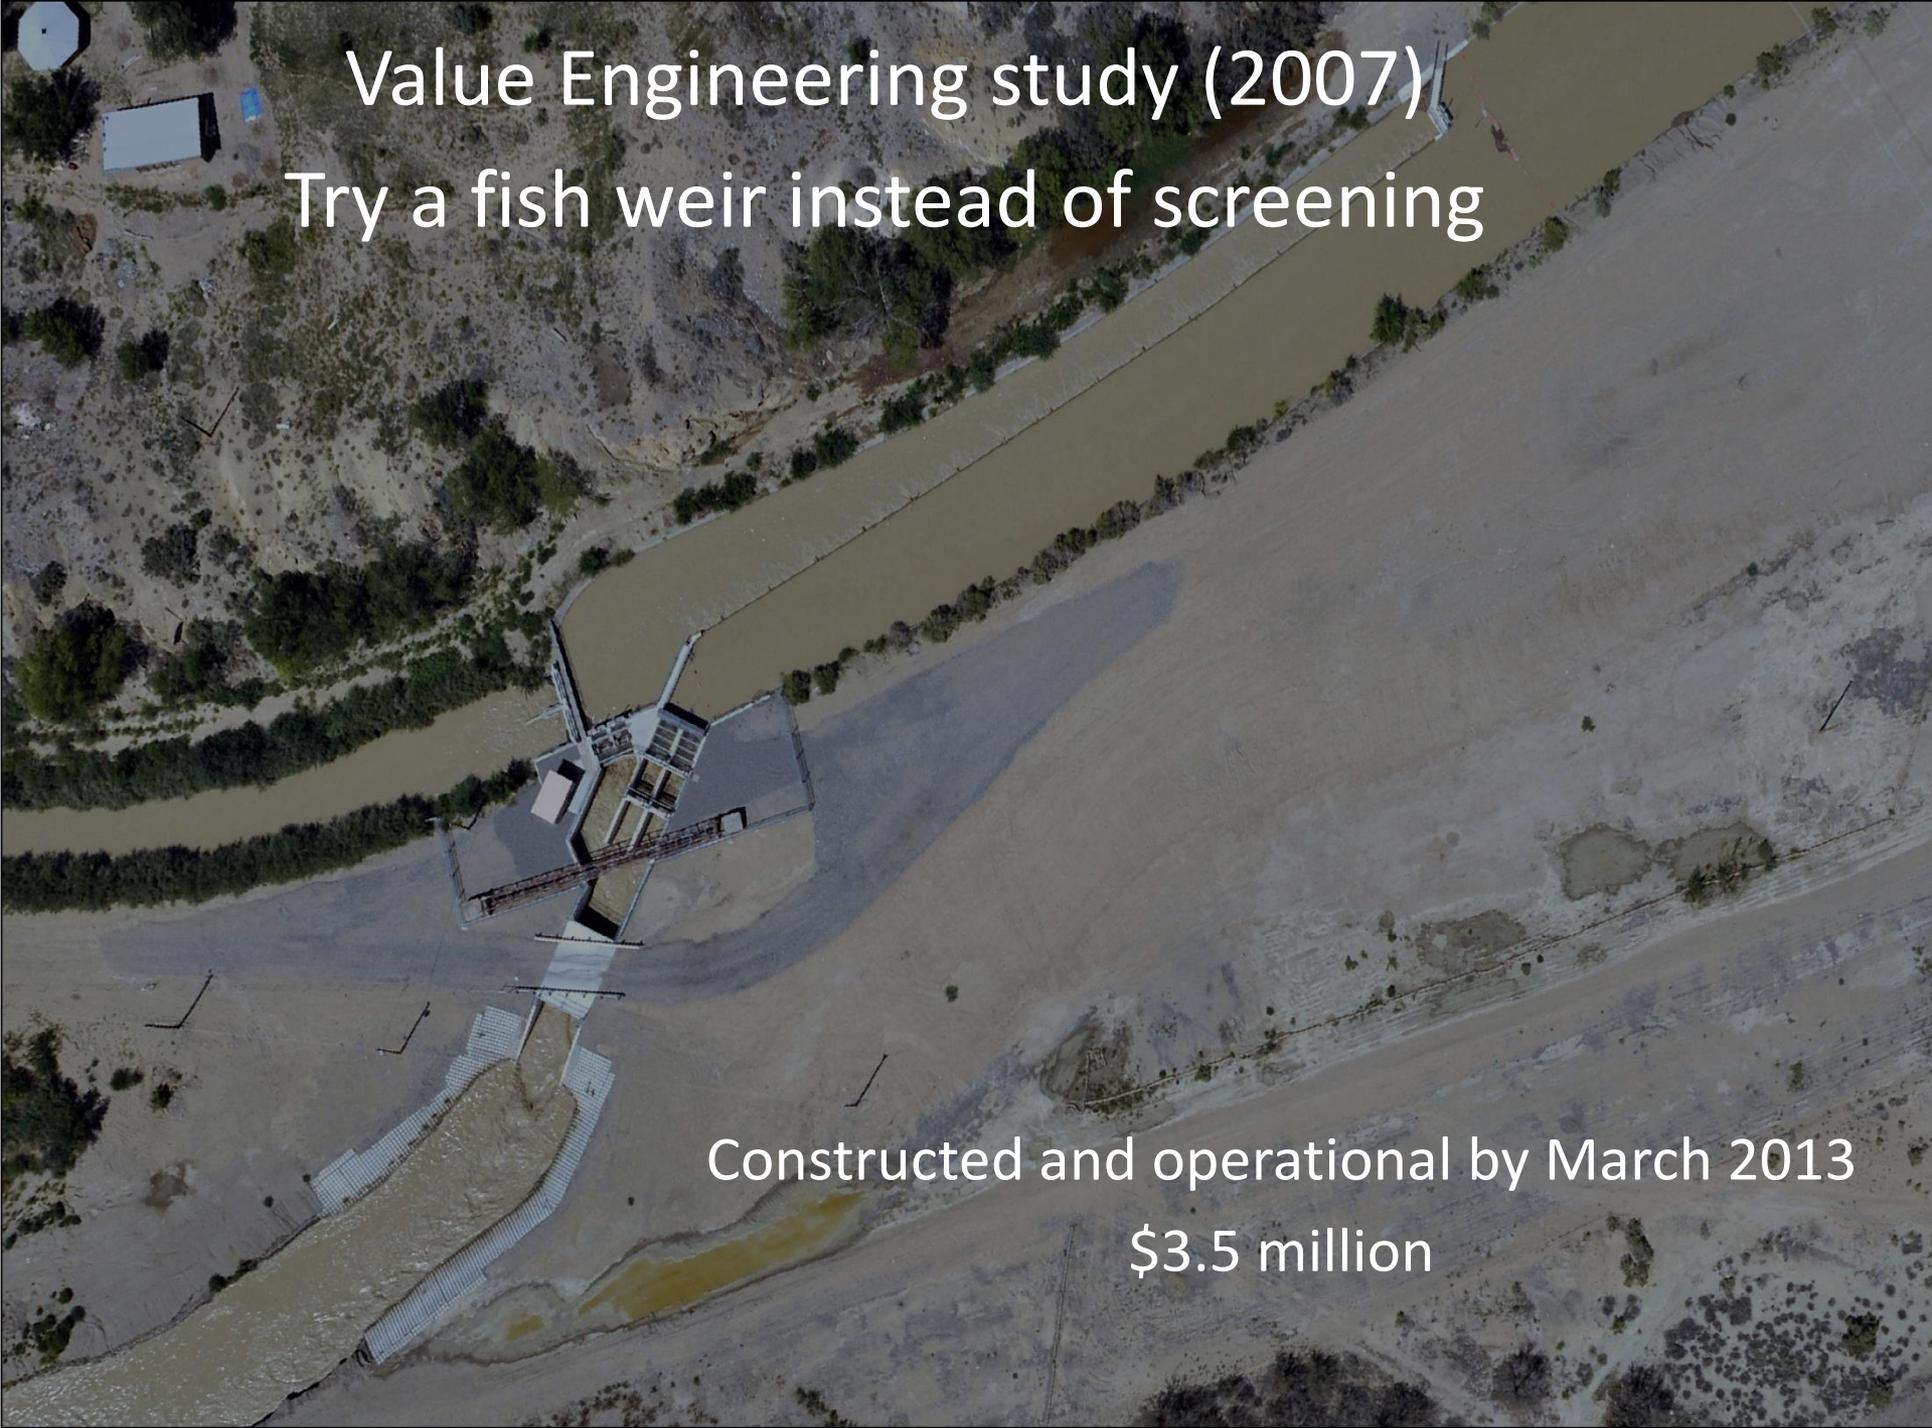
An aerial photograph of a river with a fish weir structure. The river is brown and flows from the top left towards the bottom left. The weir structure is a complex of concrete and metal components, including a central gate and side channels. The surrounding area is dry and sandy with some sparse vegetation. The text is overlaid on the top left of the image.

Value Engineering study (2007)
Try a fish weir instead of screening

Constructed and operational by March 2013
\$3.5 million

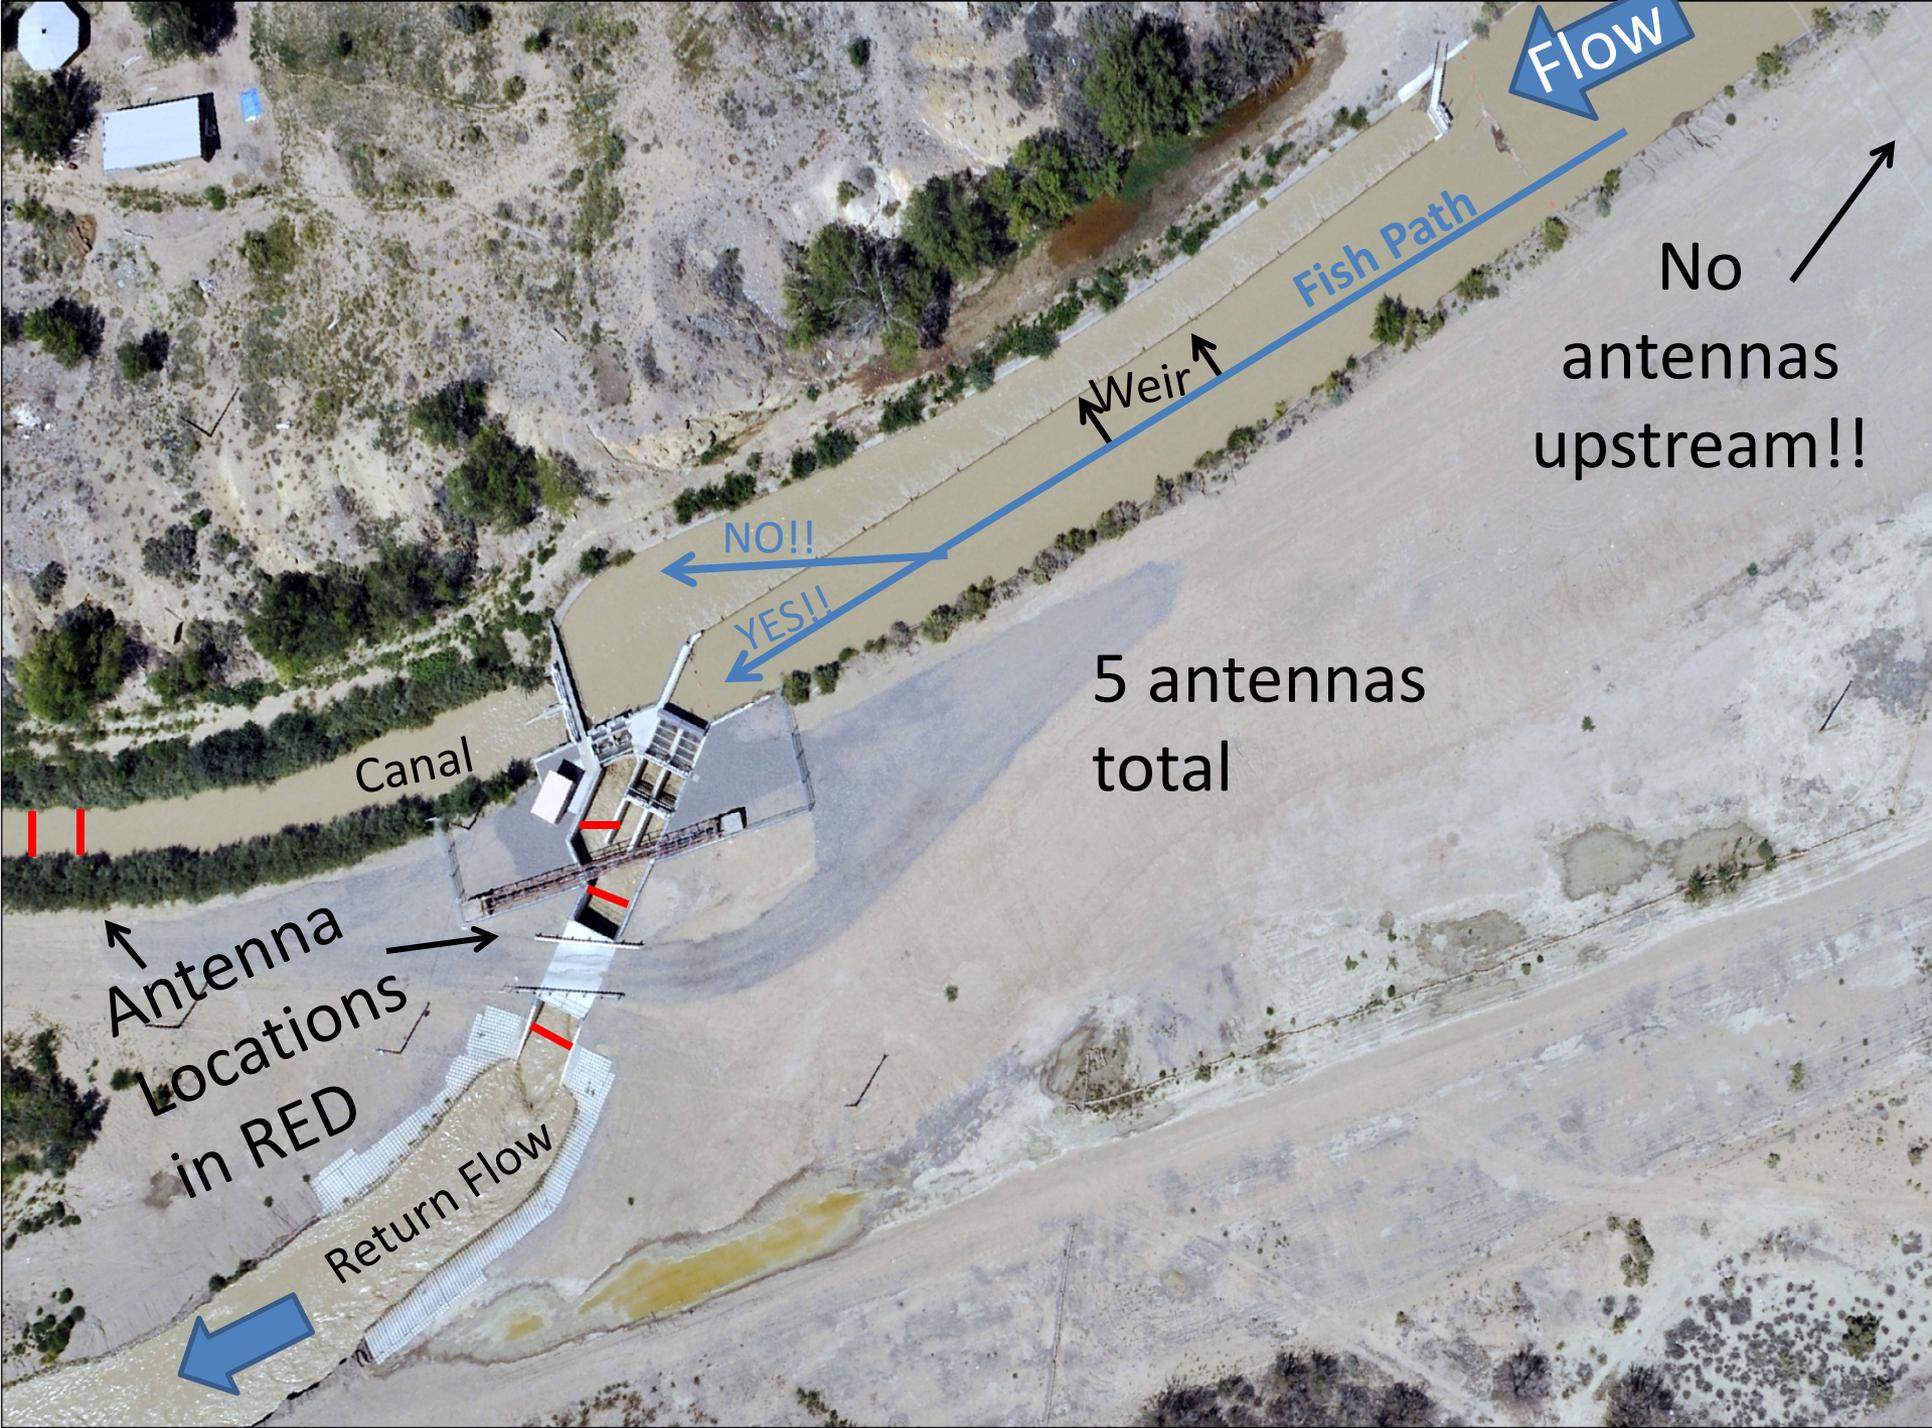
Antenna Locations in RED

FLOW

No antennas upstream!!

Fish Path

Weir

5 antennas total

Canal

Return Flow

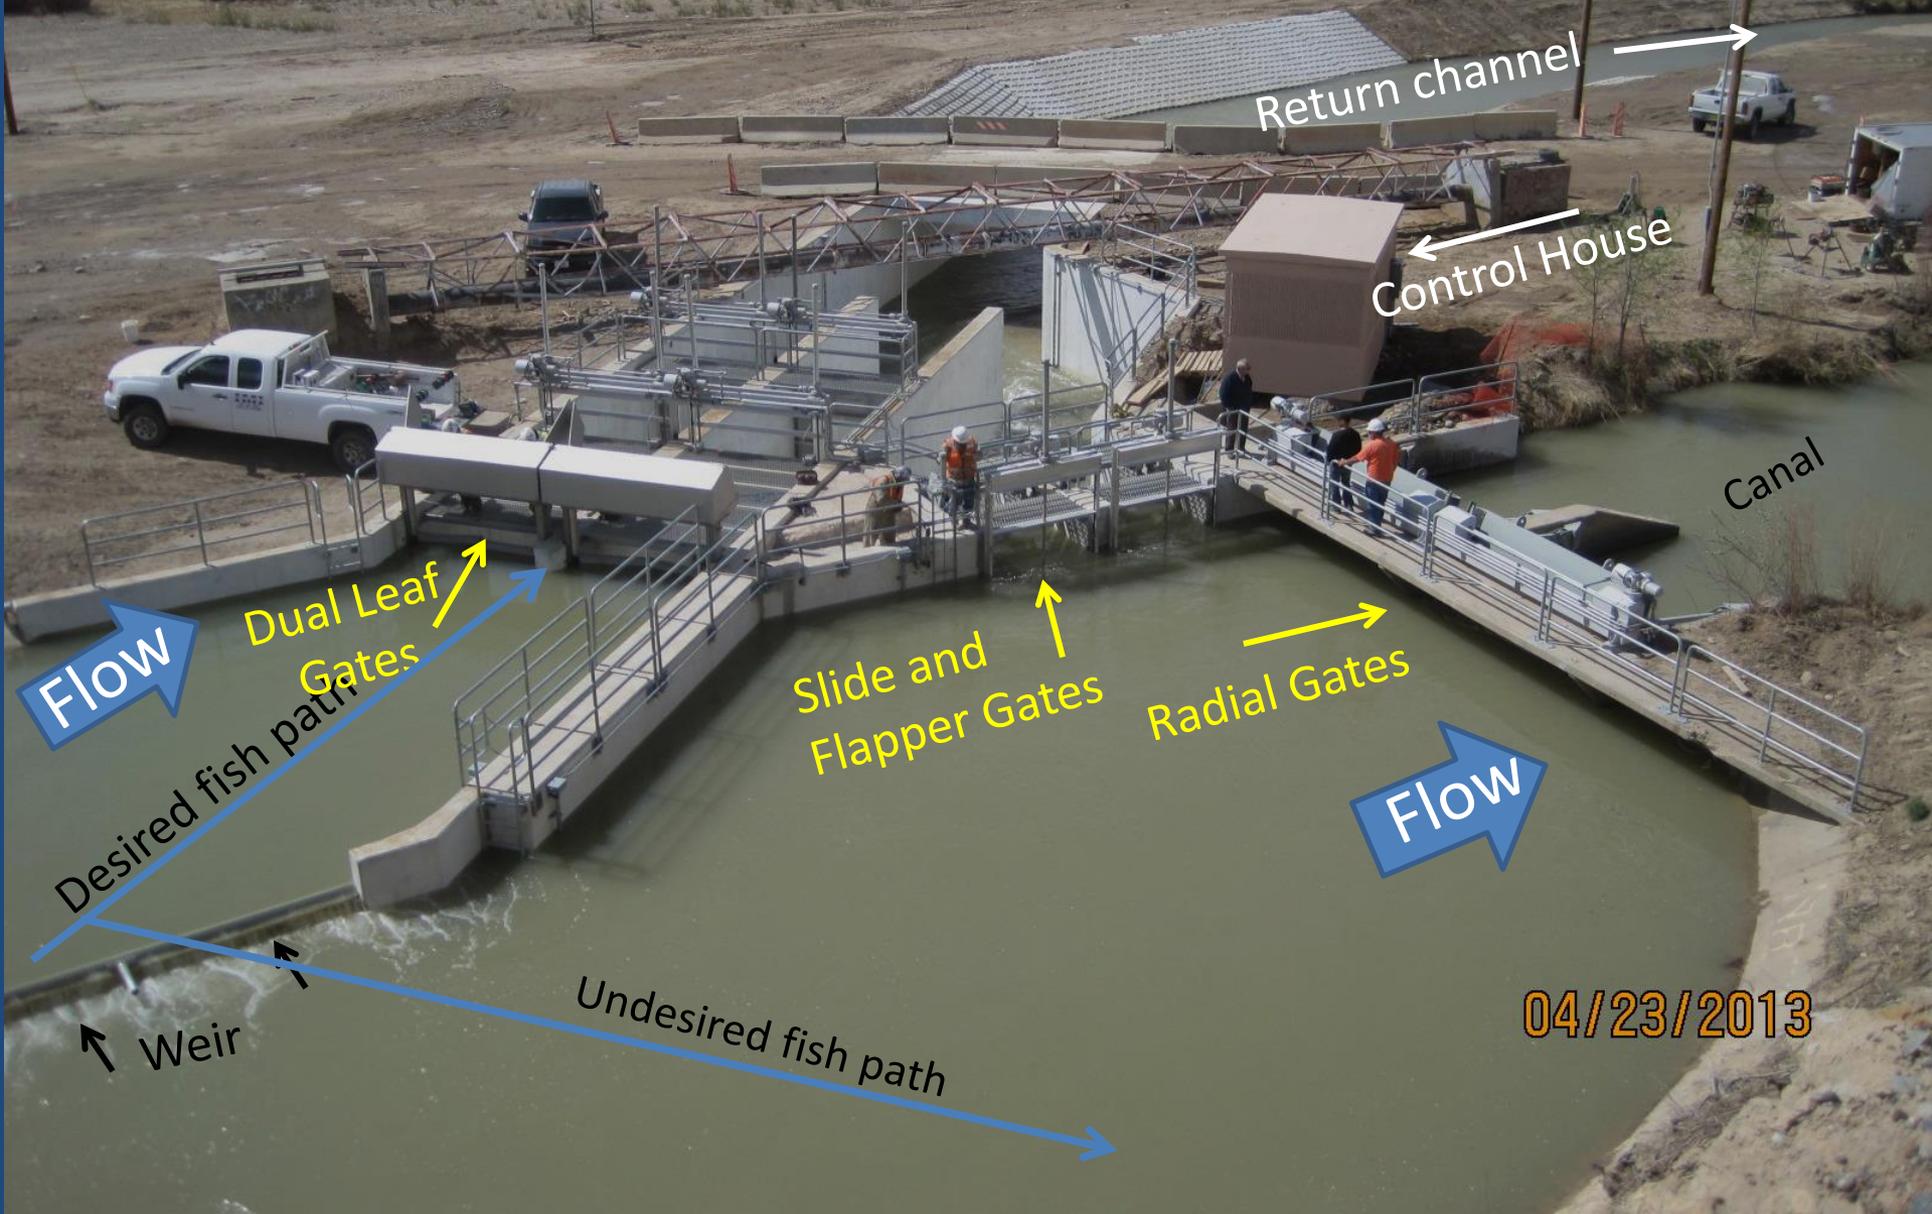
Hogback Weir Facility

Return channel

Control House

Canal

Dual Leaf Gates

Slide and Flapper Gates

Radial Gates

Desired fish path

Undesired fish path

Weir

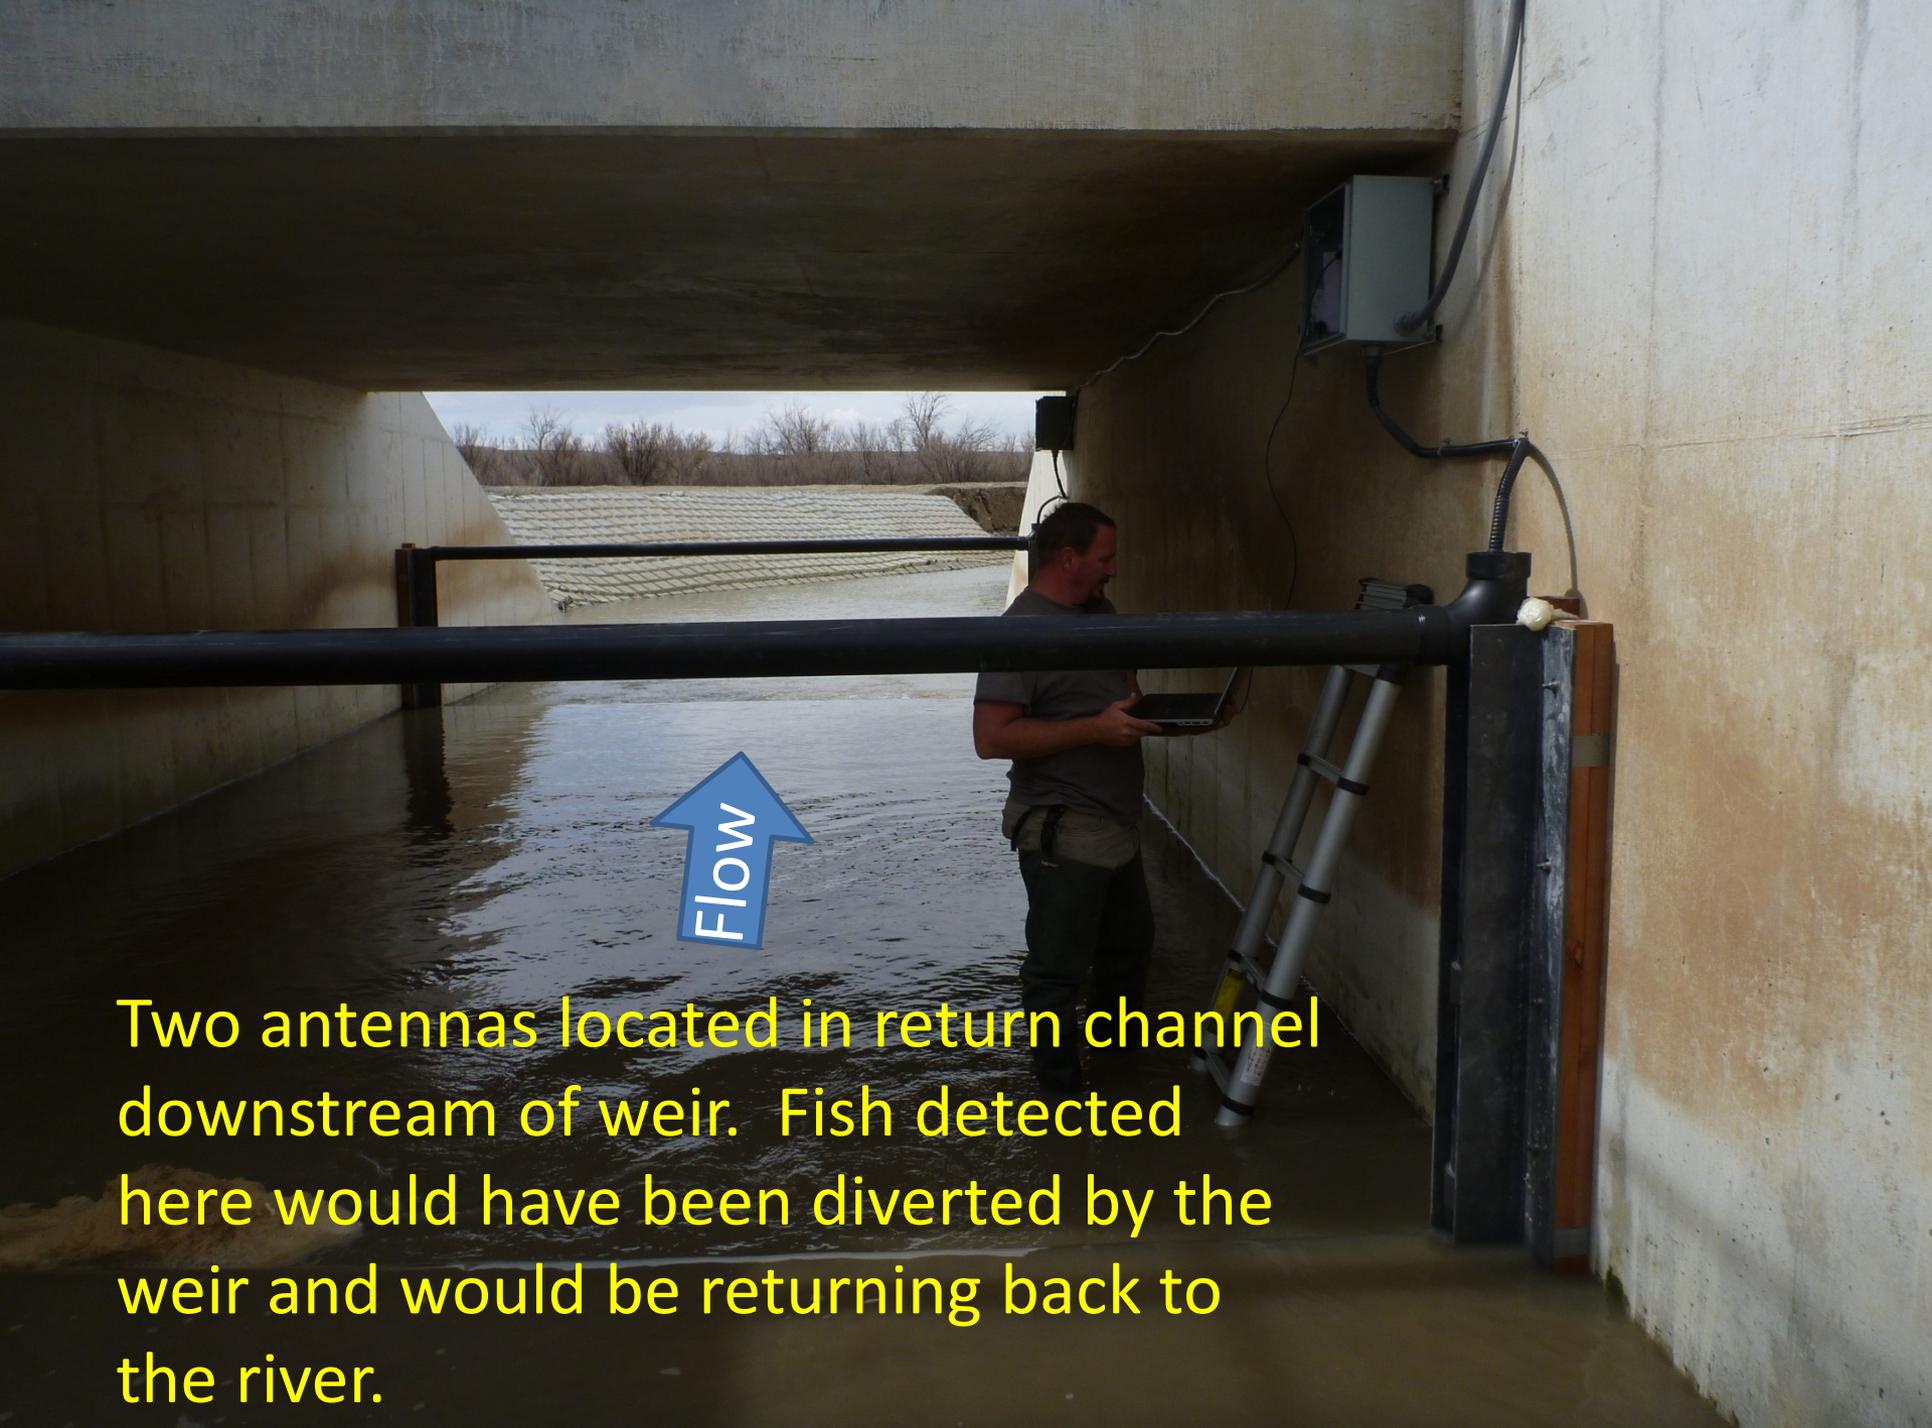
Two antennas located in return channel downstream of weir. Fish detected here would have been diverted by the weir and would be returning back to the river.

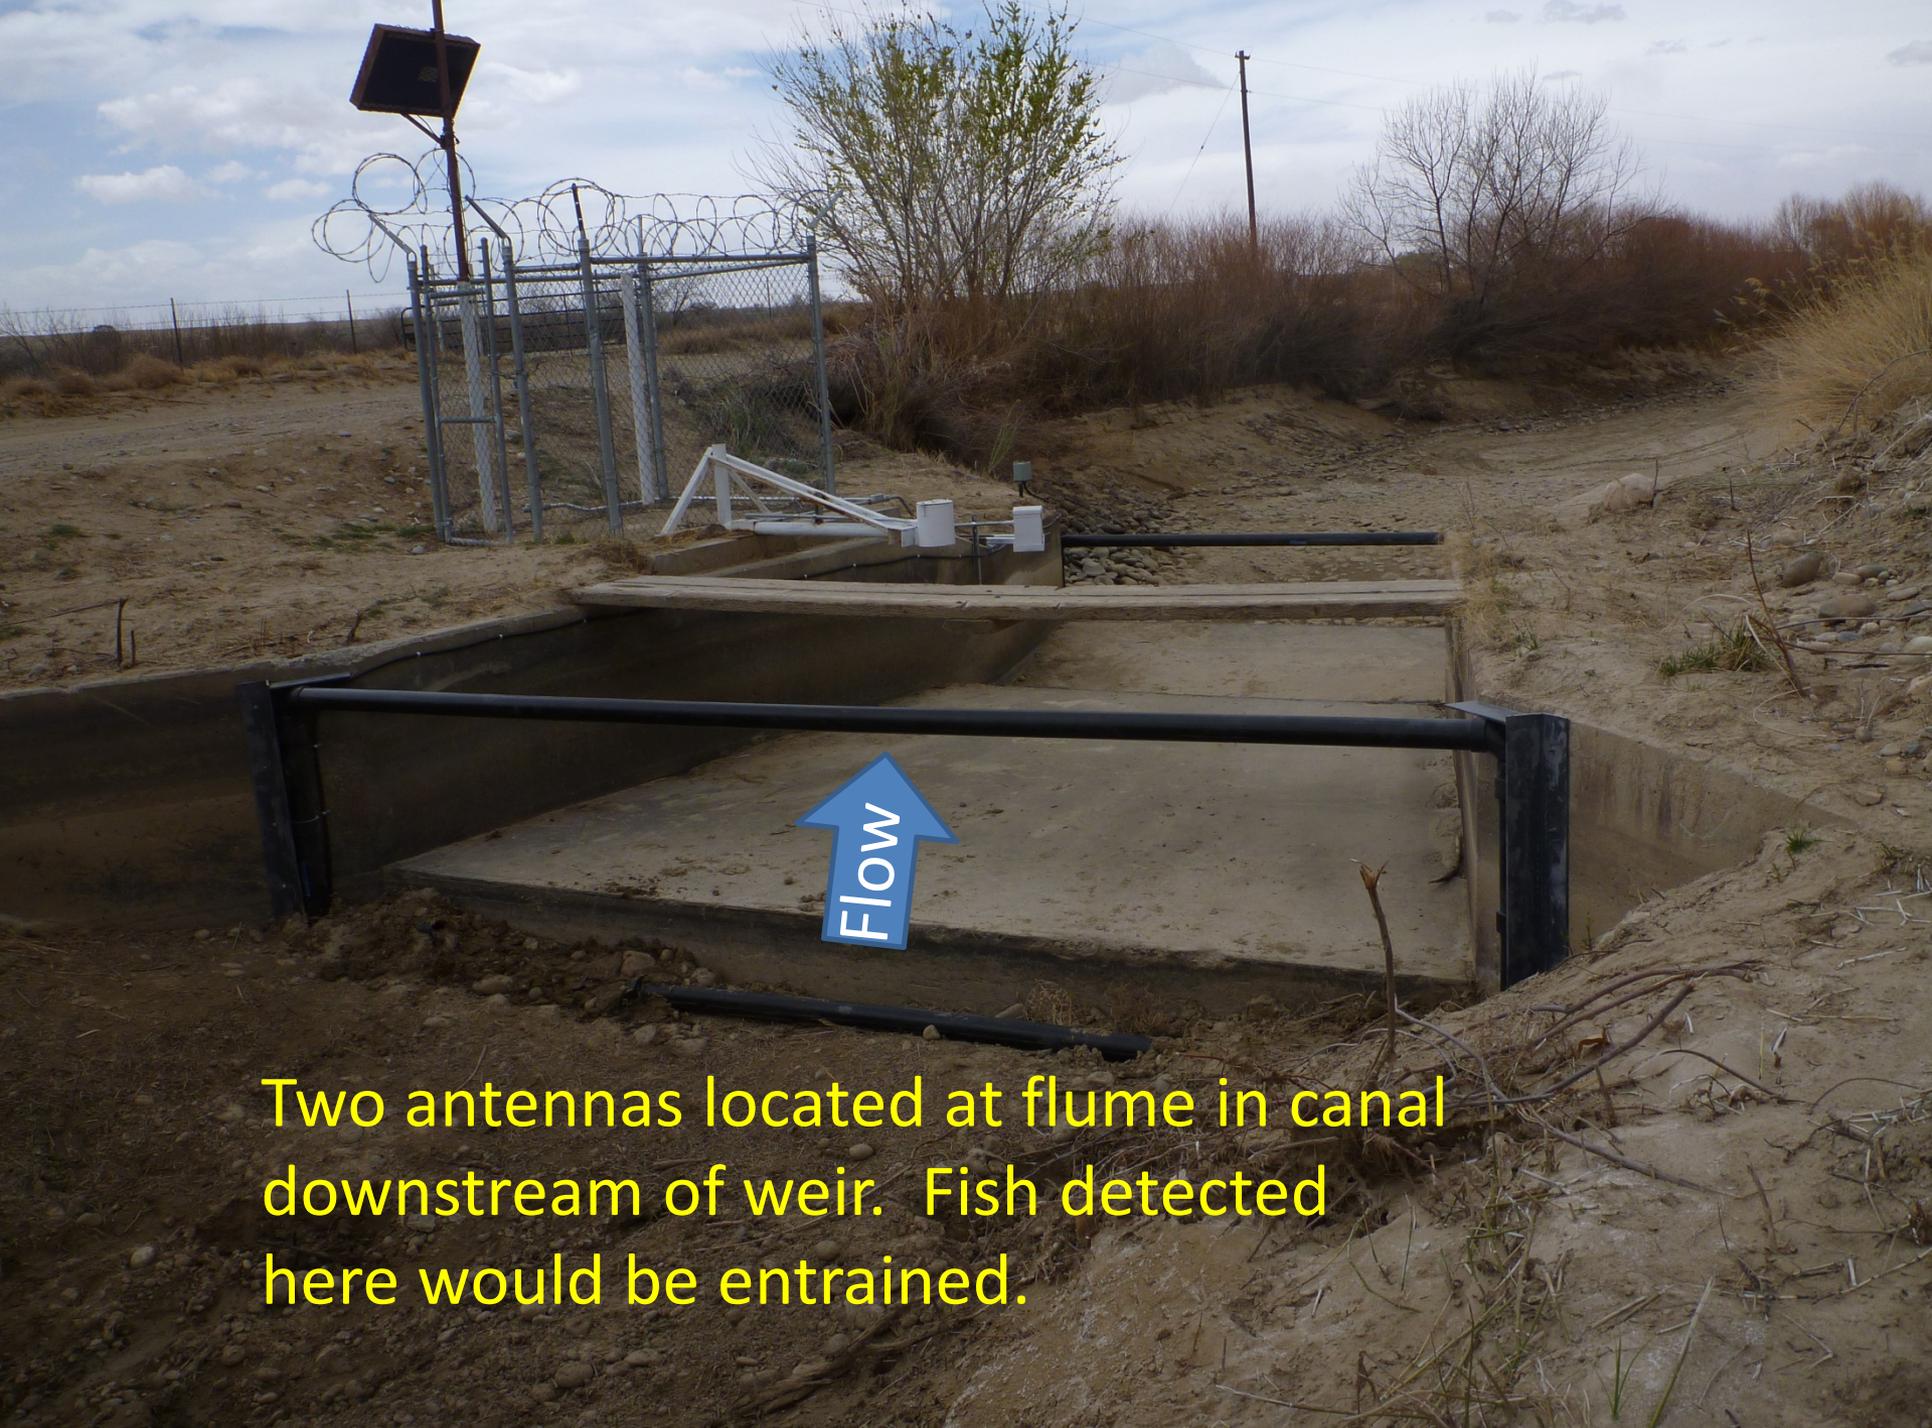
Two antennas located at flume in canal downstream of weir. Fish detected here would be entrained.

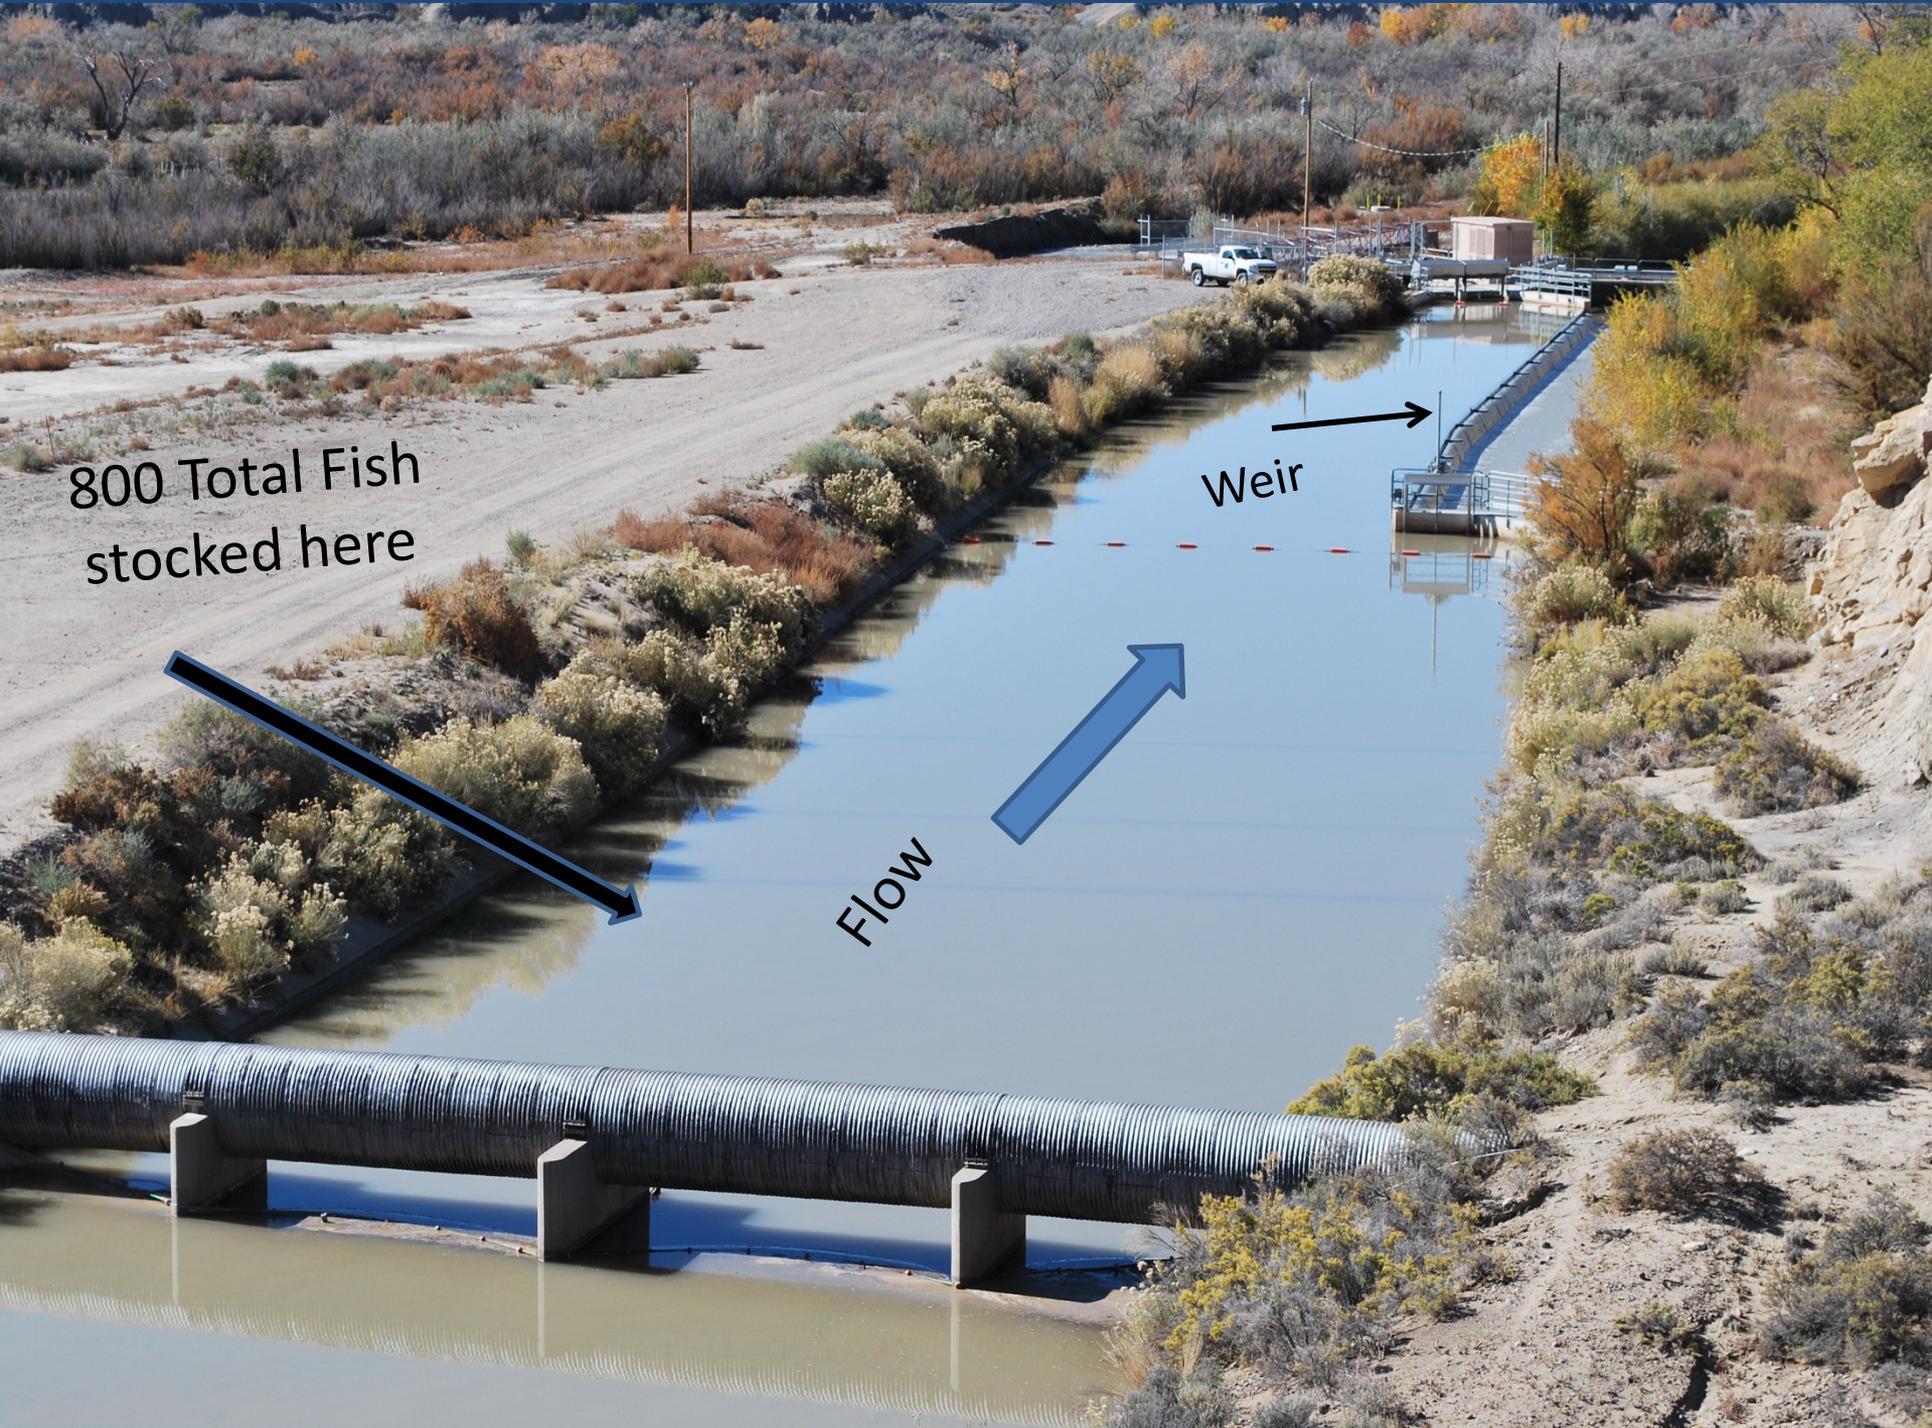
Intake to Hogback Canal

800 Total Fish stocked here

Weir

FLOW

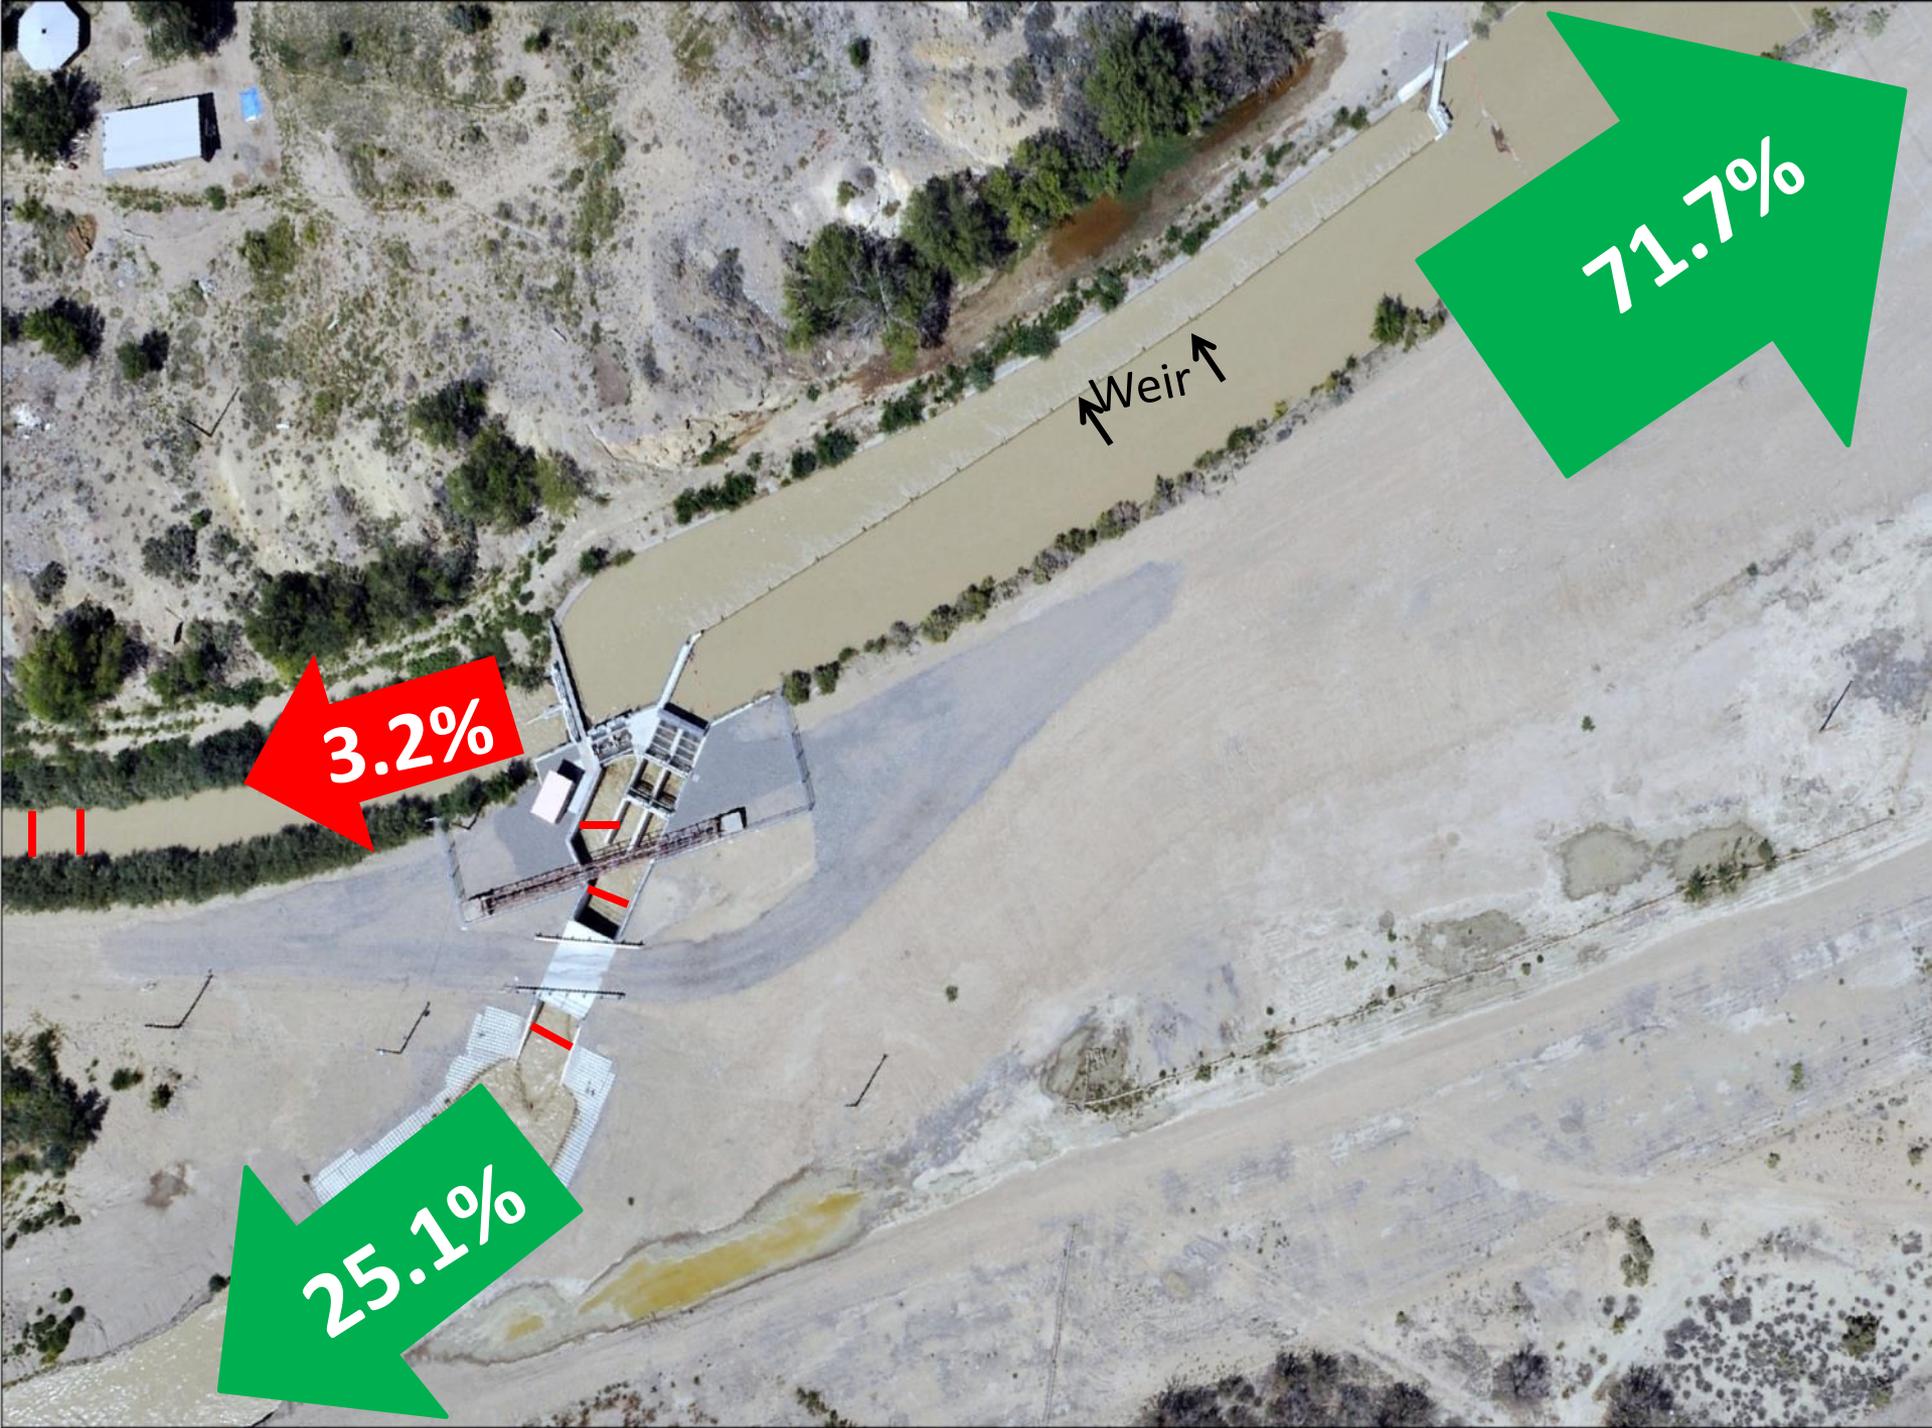
3.2%

25.1%

71.7%

Weir

Total
Number Stocked	803
1- Fish Bypassed during test	143
2-Fish Entrained during test	18
3- Undetected (upstream?)	408 50.8% (408/803)
% bypassed 1+2	88.8% (143/161)
% bypassed of total exiting facility 1+2+3	25.1% (143/569)
% entrained 1+2	11.2% (18/161)
% entrained of total exiting facility 1+2+3	3.2% (18/569)
Post Test Fish Remaining in Intake Canal (not entrained or bypassed)	234 29.1% (234/803)
