EVALUATION OF HOGBACK FISH WEIR: DESIGNED TO REDUCE ENTRAINMENT OF ENDANGERED FISH IN CANALS

Mark McKinstry

US Bureau of Reclamation, Salt Lake City, UT

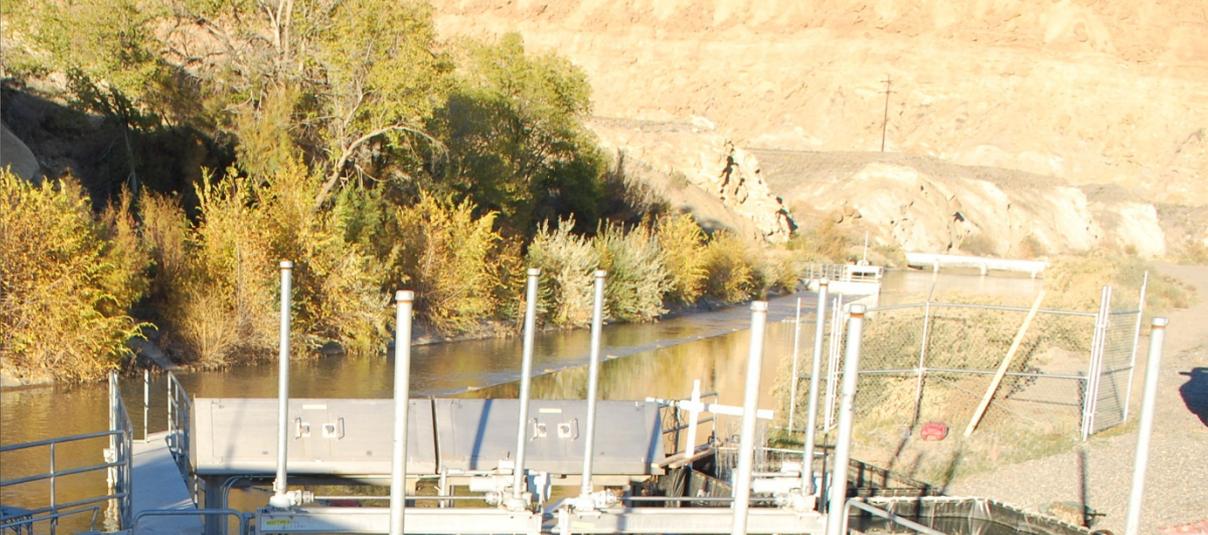
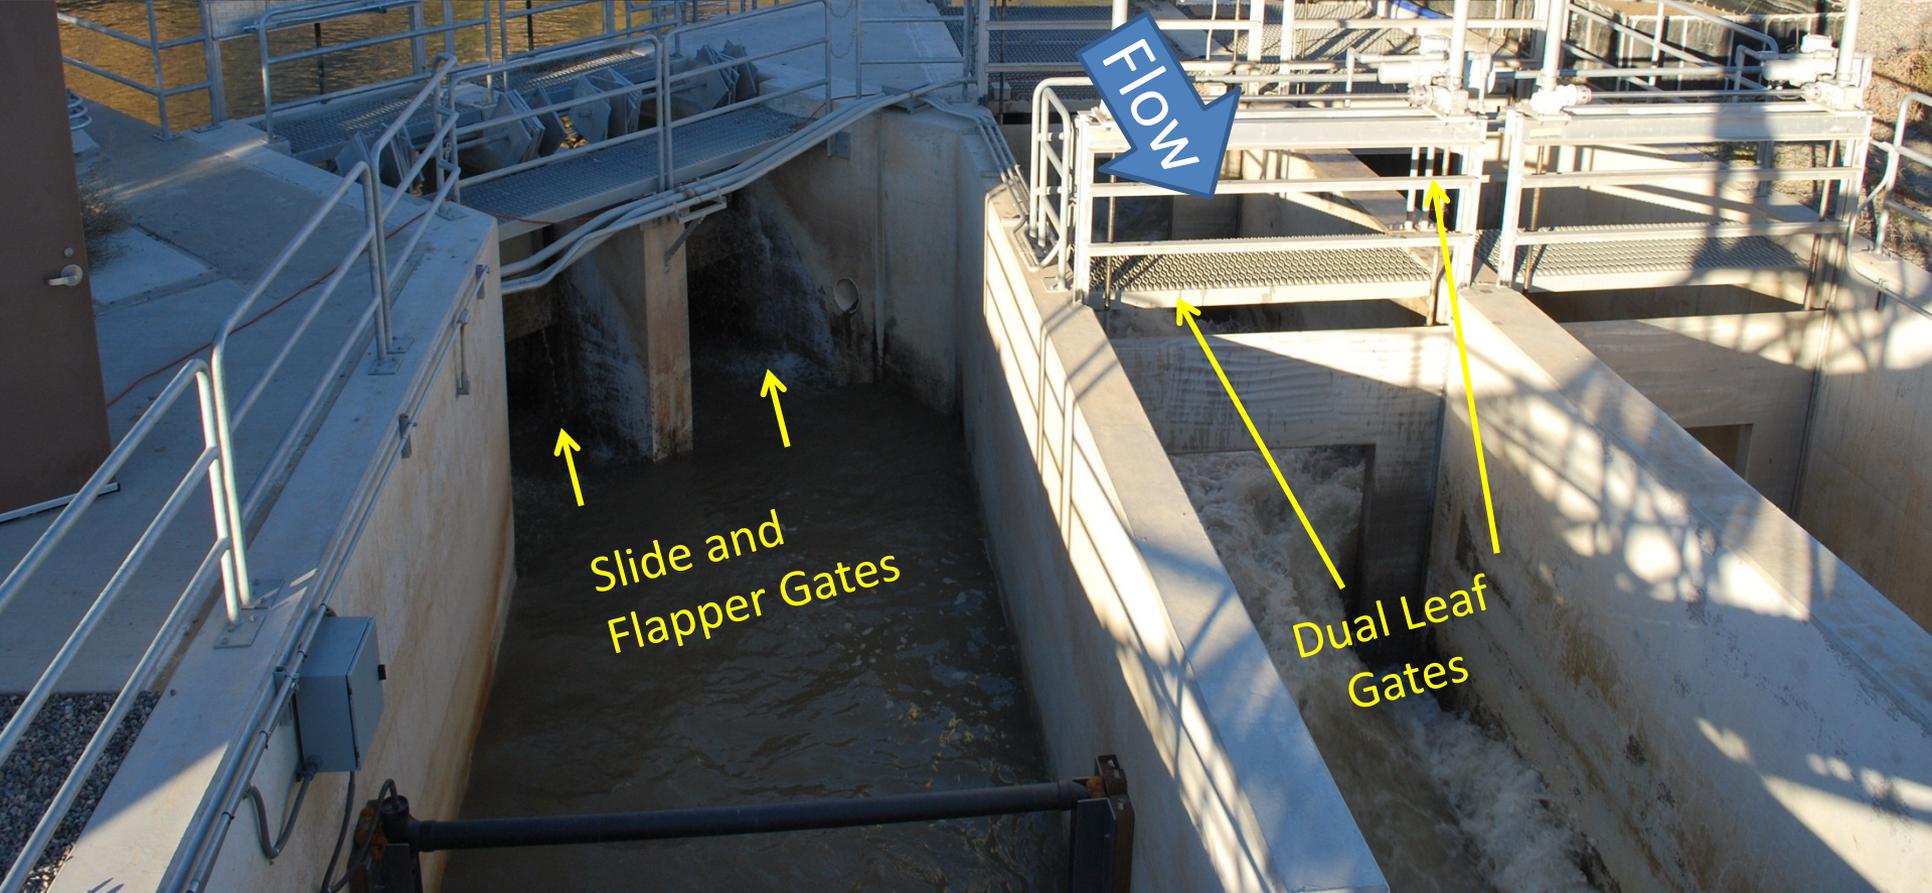
Dual Leaf Gates

FLOW

Slide and
Flapper Gates

Dual Leaf
Gates

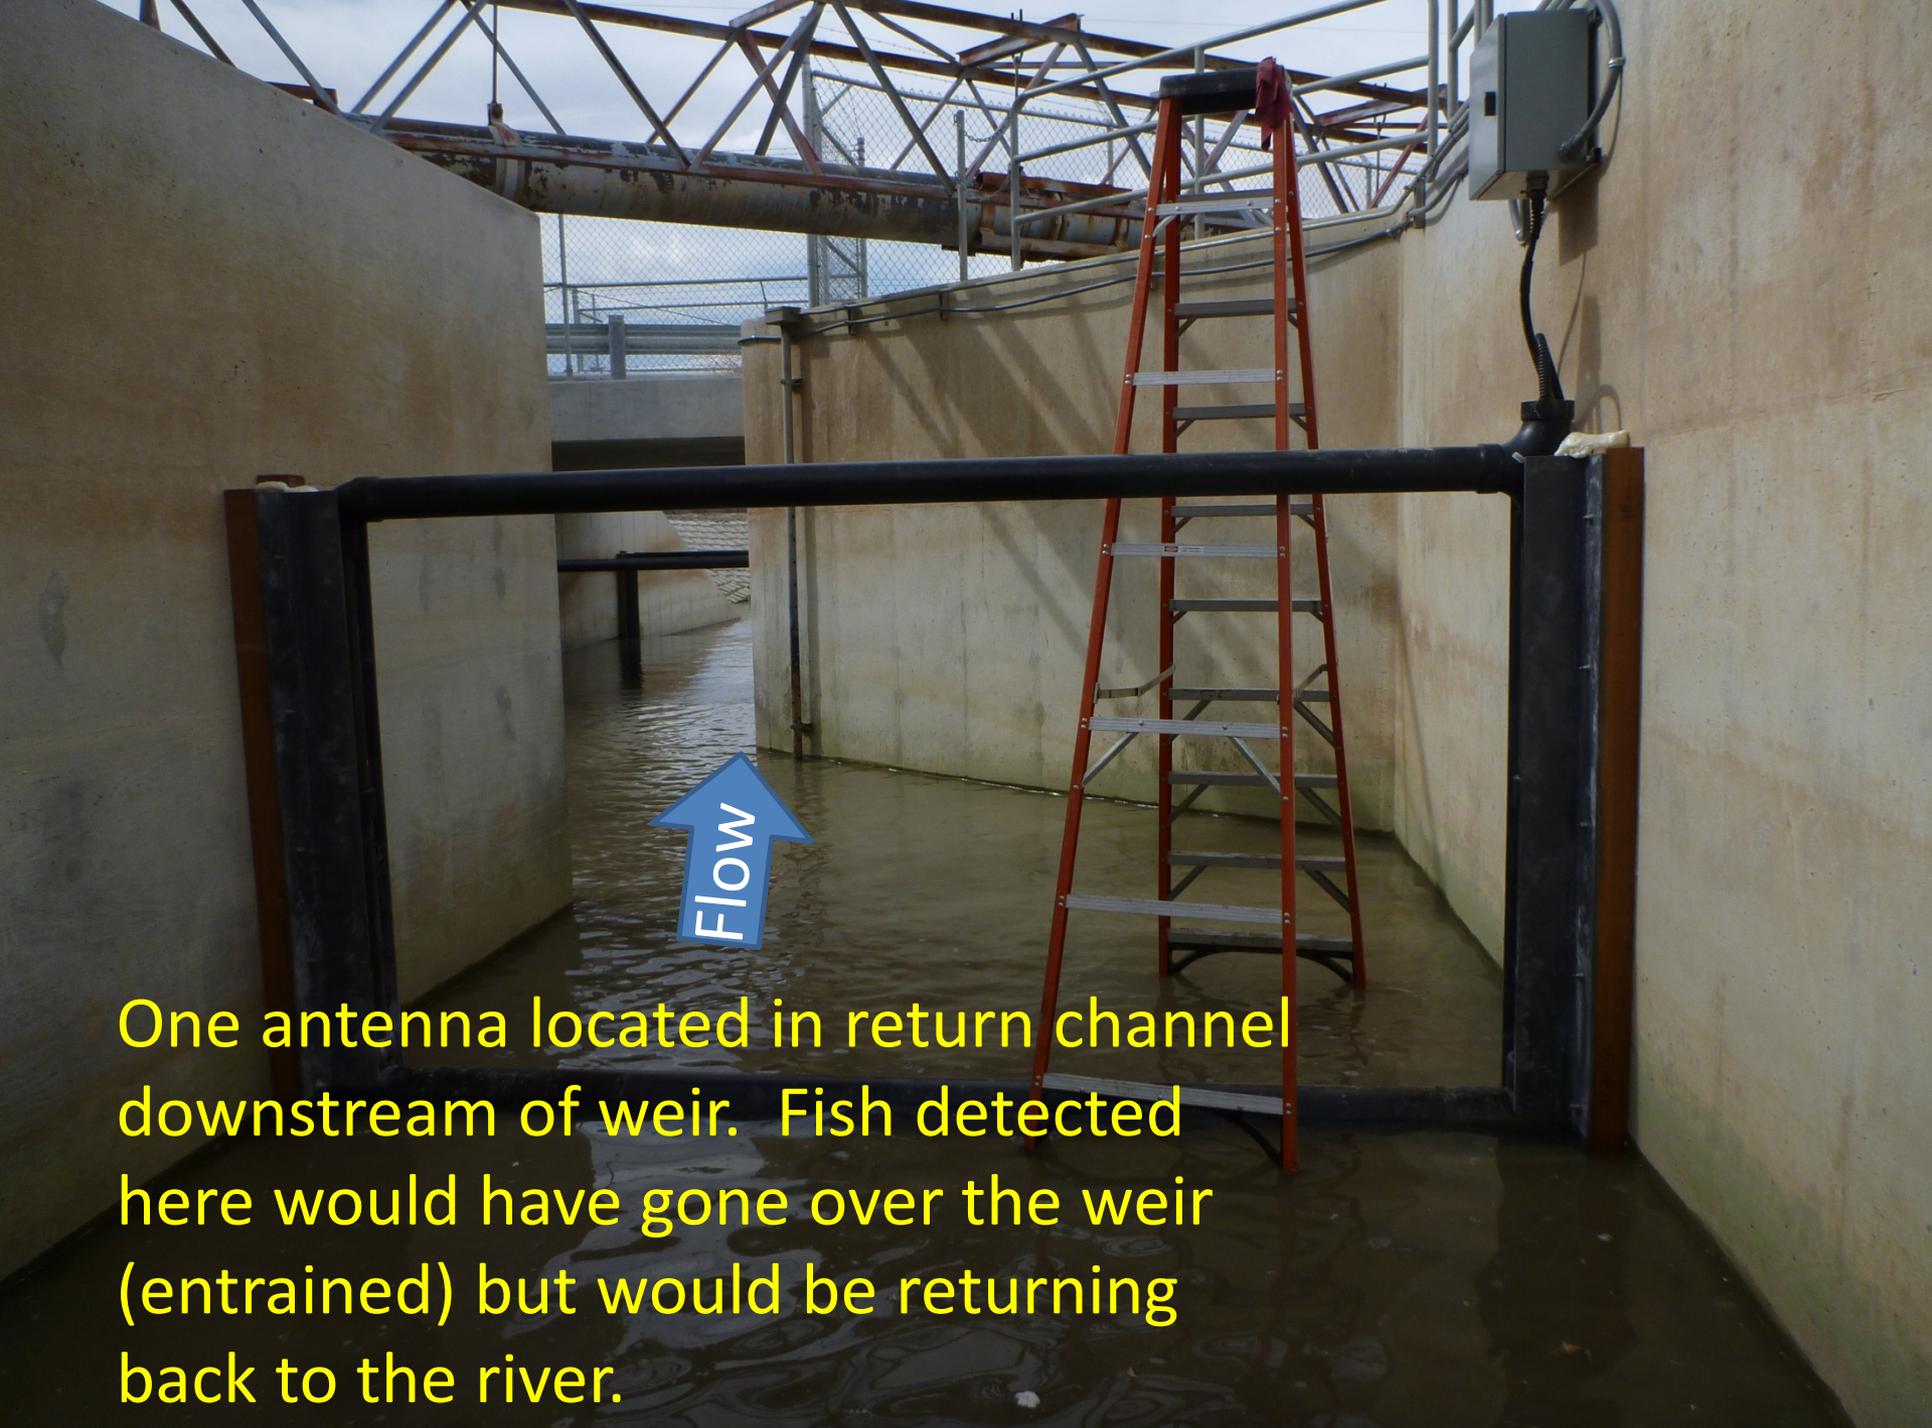
One antenna located in return channel downstream of weir. Fish detected here would have gone over the weir (entrained) but would be returning back to the river.
