FINAL REPORT

Feasibility Evaluation of Restoration Options to Improve Habitat for Young Colorado Pikeminnow on the San Juan River

May 2006

Melissa Stamp, Jill Grams, Michael Golden, and Darren Olsen, BIO-WEST, Inc.;
Tyler Allred, Allred Restoration, Inc.

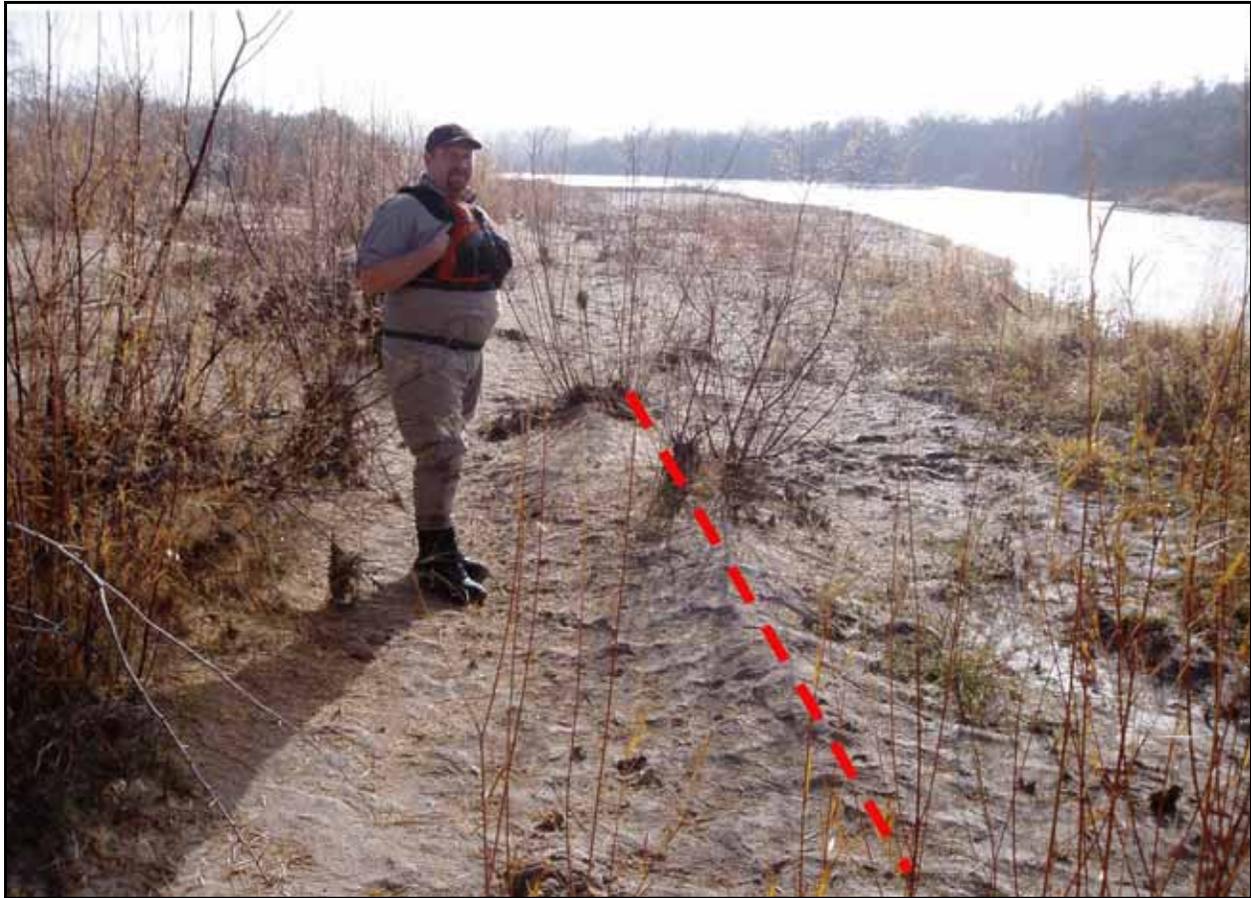
Figure 4.1.1. Elevated “levee” surface (indicated by red dashed line) created by tamarisk capturing sediment at RM 172 bar. Photo taken November, 2004.

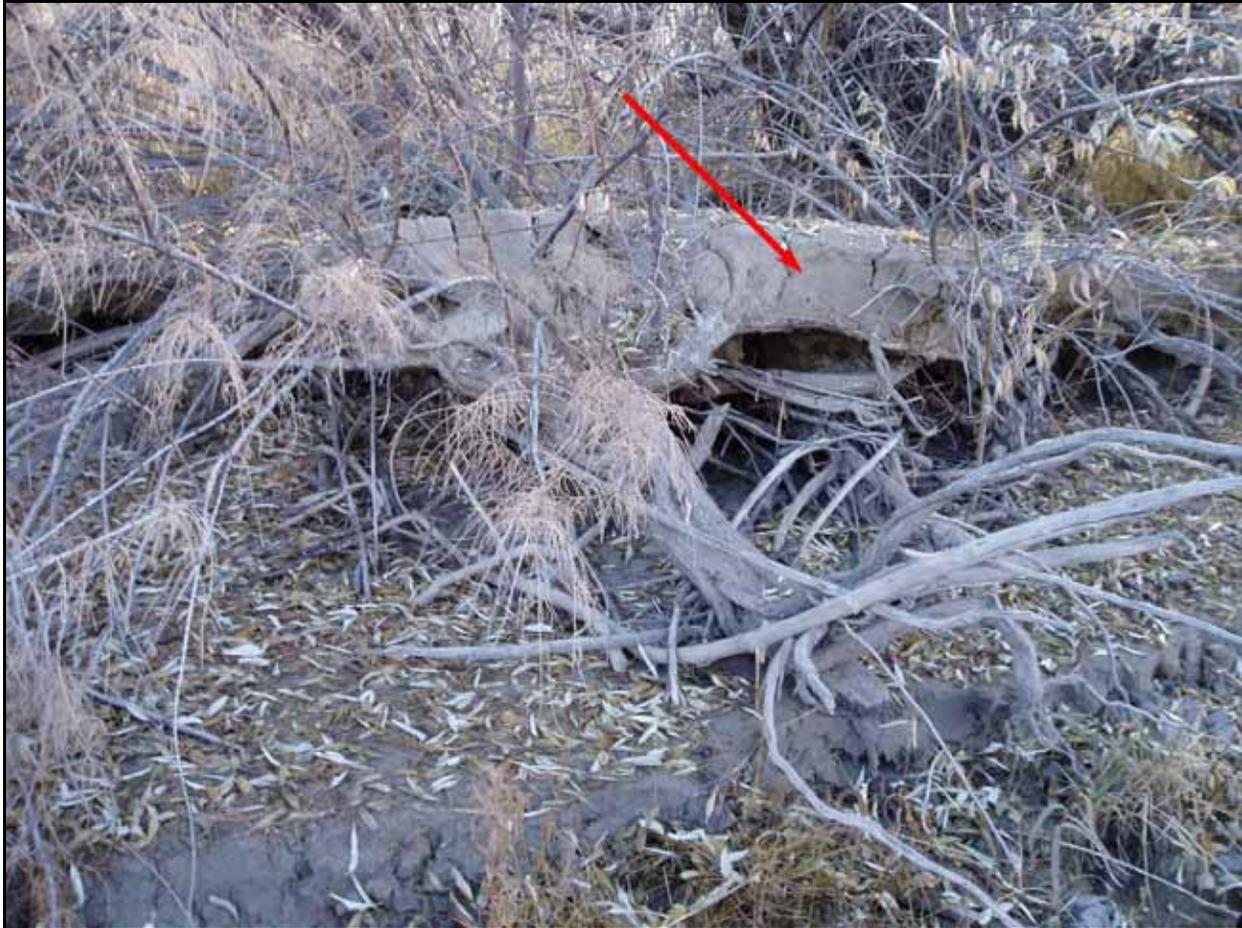
Figure 4.1.2. Photo of tamarisk growing on streambank near RM 171. Note how the extensive root and stem network protects deposited sediment from erosion. Photo taken November, 2004.

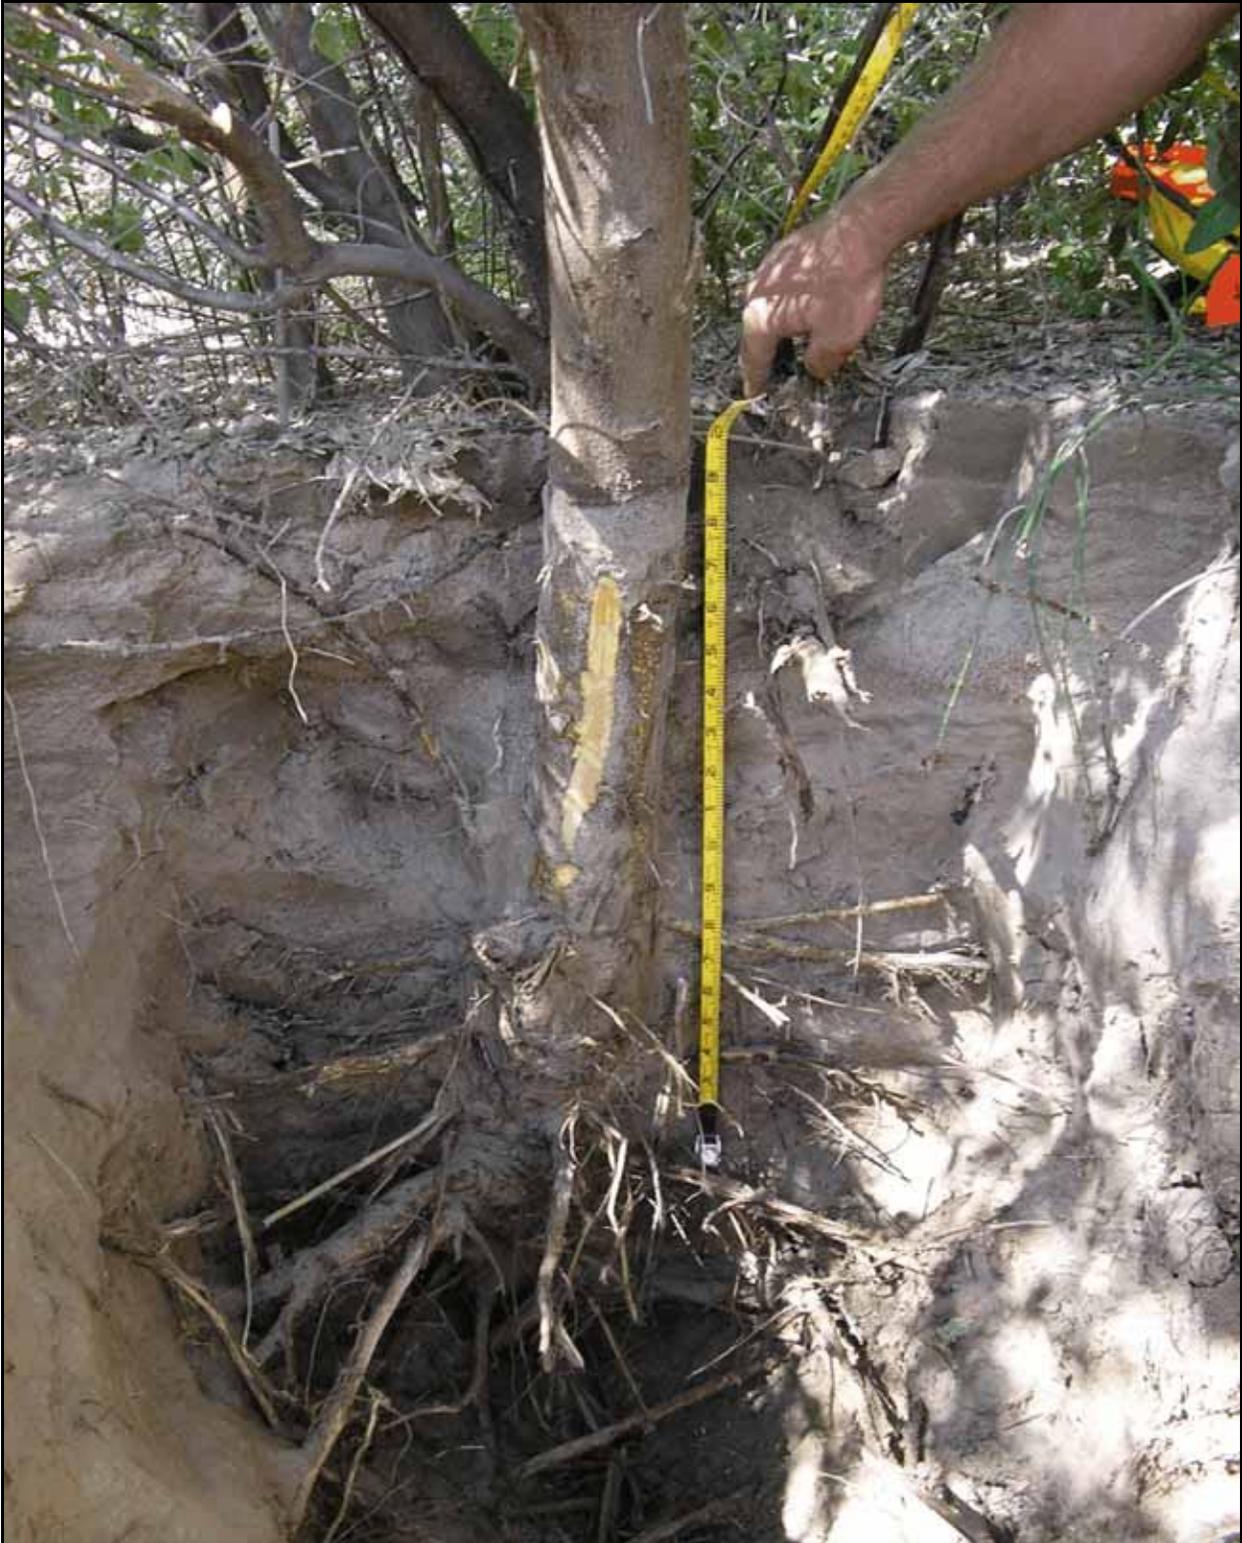
Figure 4.1.4. Excavated Russian olive growing on RM 172 island. Photo taken 8/17/05.

about 60 feet downstream from the sampled tamarisk on the RM 172 island. The Russian olive was 6 years old, with a diameter of 2.75 inches, and its root crown was buried by 2.1 feet of sand (Figure 4.1.4). These results indicate that accretion rates can be spatially and temporally variable, even within the same island. Two young tamarisk saplings growing along the right bank of the secondary channel at RM 176.2 were also excavated and sampled in August 2005. The stems were sanded so that the tree rings could be counted, and both saplings were found to be 2 years old. Since initial establishment, the saplings have been buried by 0.65' and 1.1' of medium-grained sand, respectively (Figure 4.1.5).

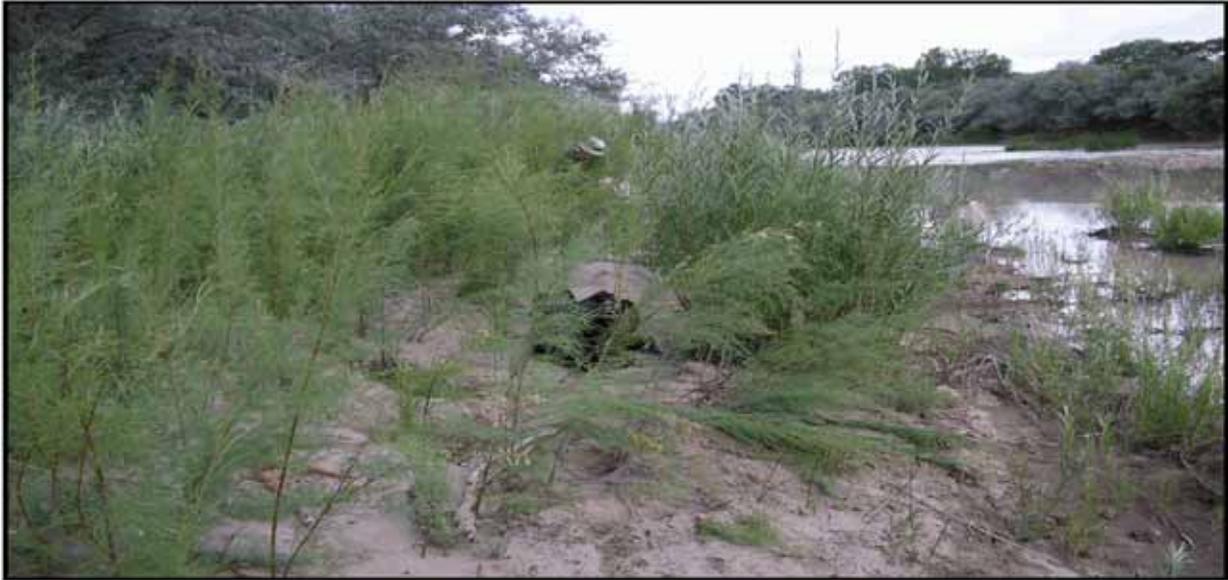
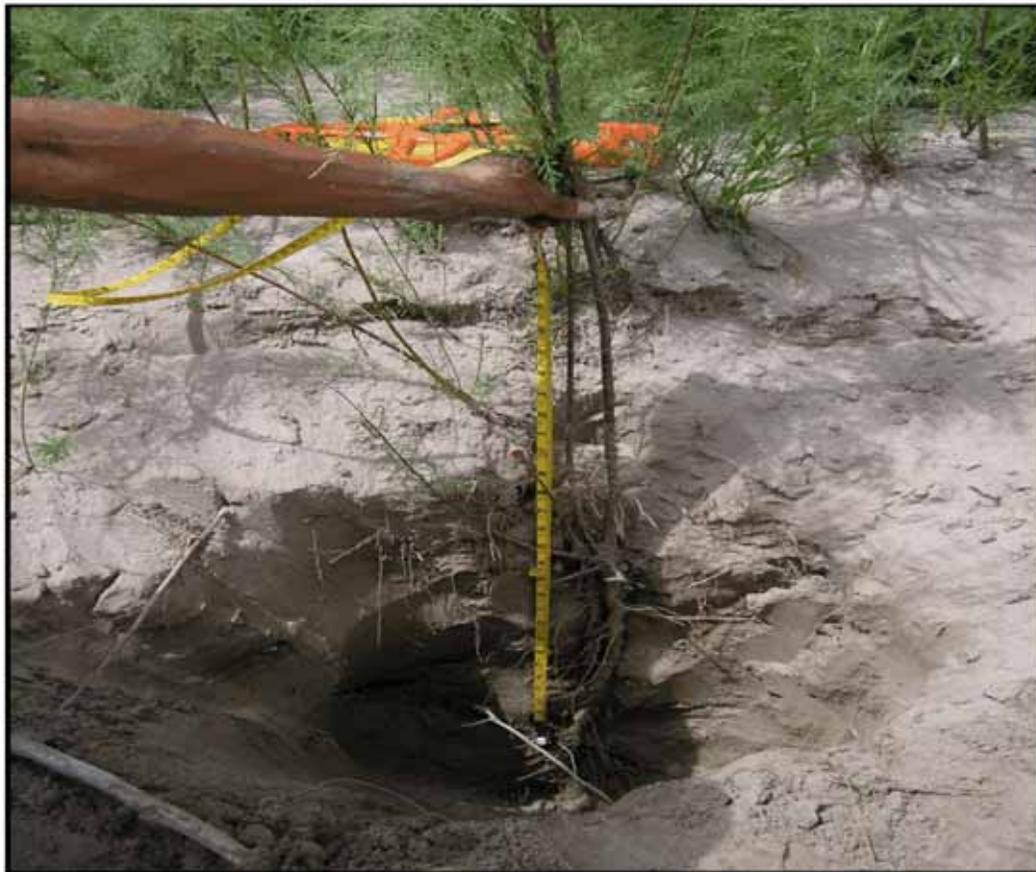
Figure 4.1.5. Photos of vegetation growing along bank of secondary channel near RM 176. Top: view of young tamarisk and willows growing on bank; Bottom: close-up of excavated tamarisk sapling. Photos taken 8/16/05.

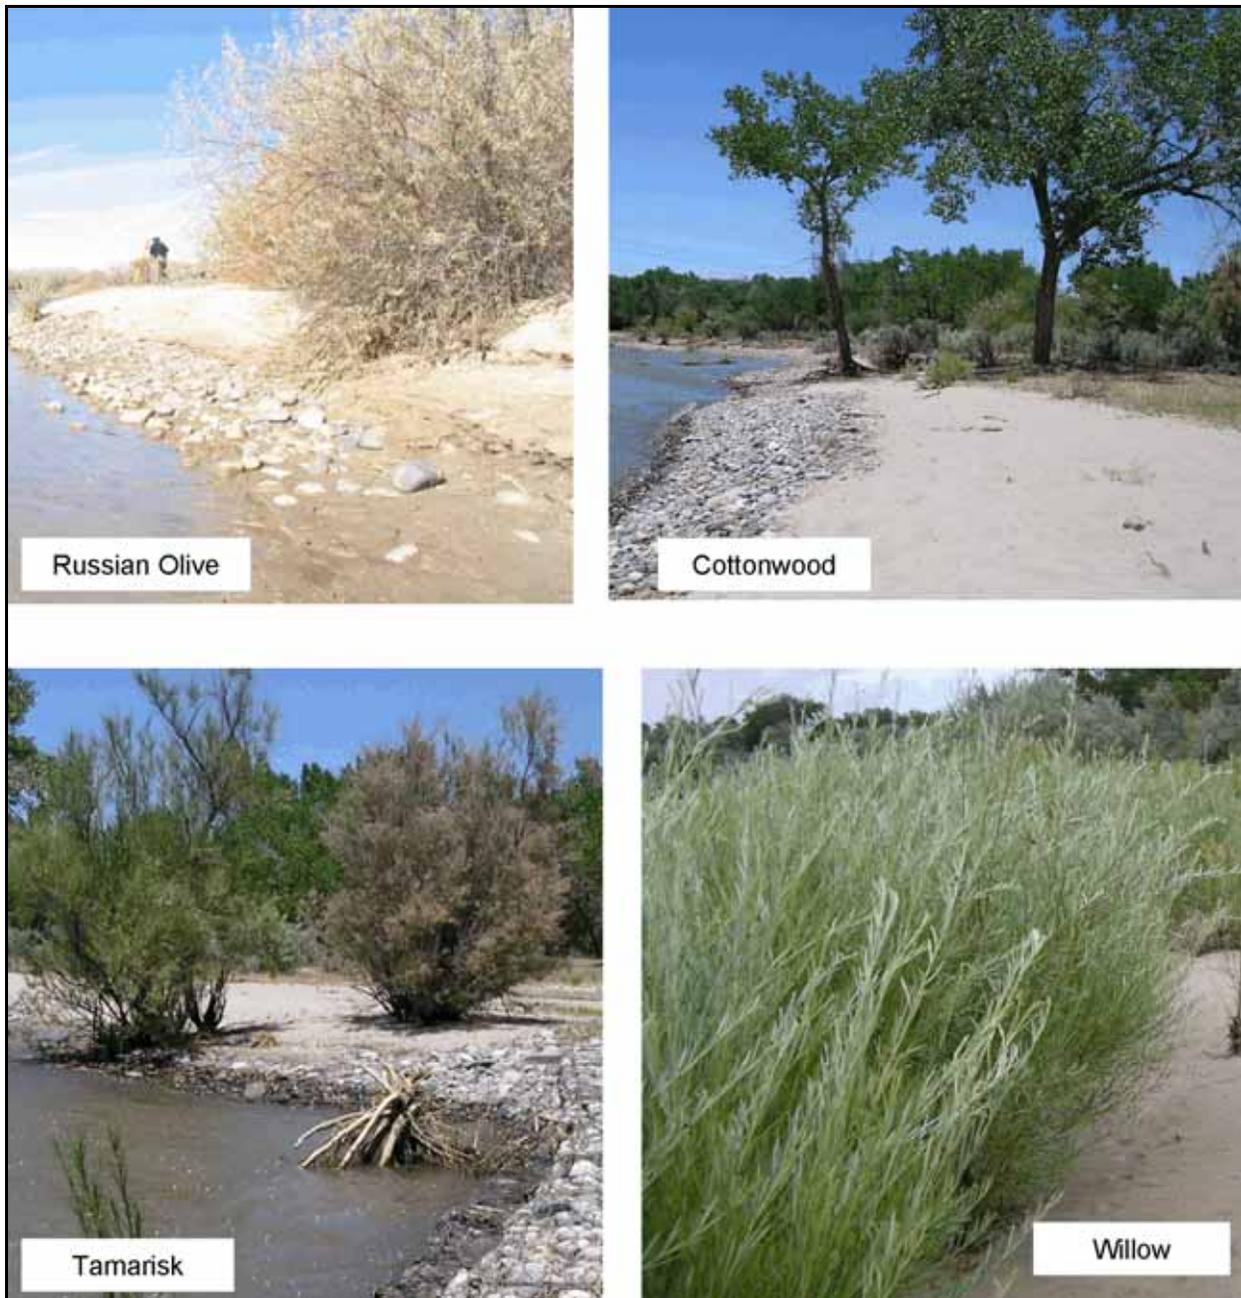
Figure 4.4.1. Comparison photos of plant structure for four major riparian plant types within the Study Area. Note low stem and near-ground branch density of cottonwood relative to other plant types. Note that the tamarisk photo is of a mature plant; young tamarisk stands are more similar to willow (see Figure 4.1.5).

Additional inferences about Russian olive and cottonwood can be made based on differences in plant structure. Like tamarisk and willow, Russian olive tends to grow from multiple stems, and forms a dense "thicket" of branches, stems, and leaves near the ground (Figure 4.4.1). In contrast, mature cottonwoods on the San Juan River typically have only one or two main stems, and branching occurs higher above the ground to form a broad high canopy (Figure 4.4.1). In

addition, mature cottonwood trees tend to be less densely spaced than Russian olive, tamarisk, or sandbar willow. Because of these plant structure differences, a cottonwood forest would likely have a lower hydraulic roughness than the other three plant types. A young cottonwood stand, however, grows more densely and would have hydraulic properties more similar to willow, Russian olive, or tamarisk stands.

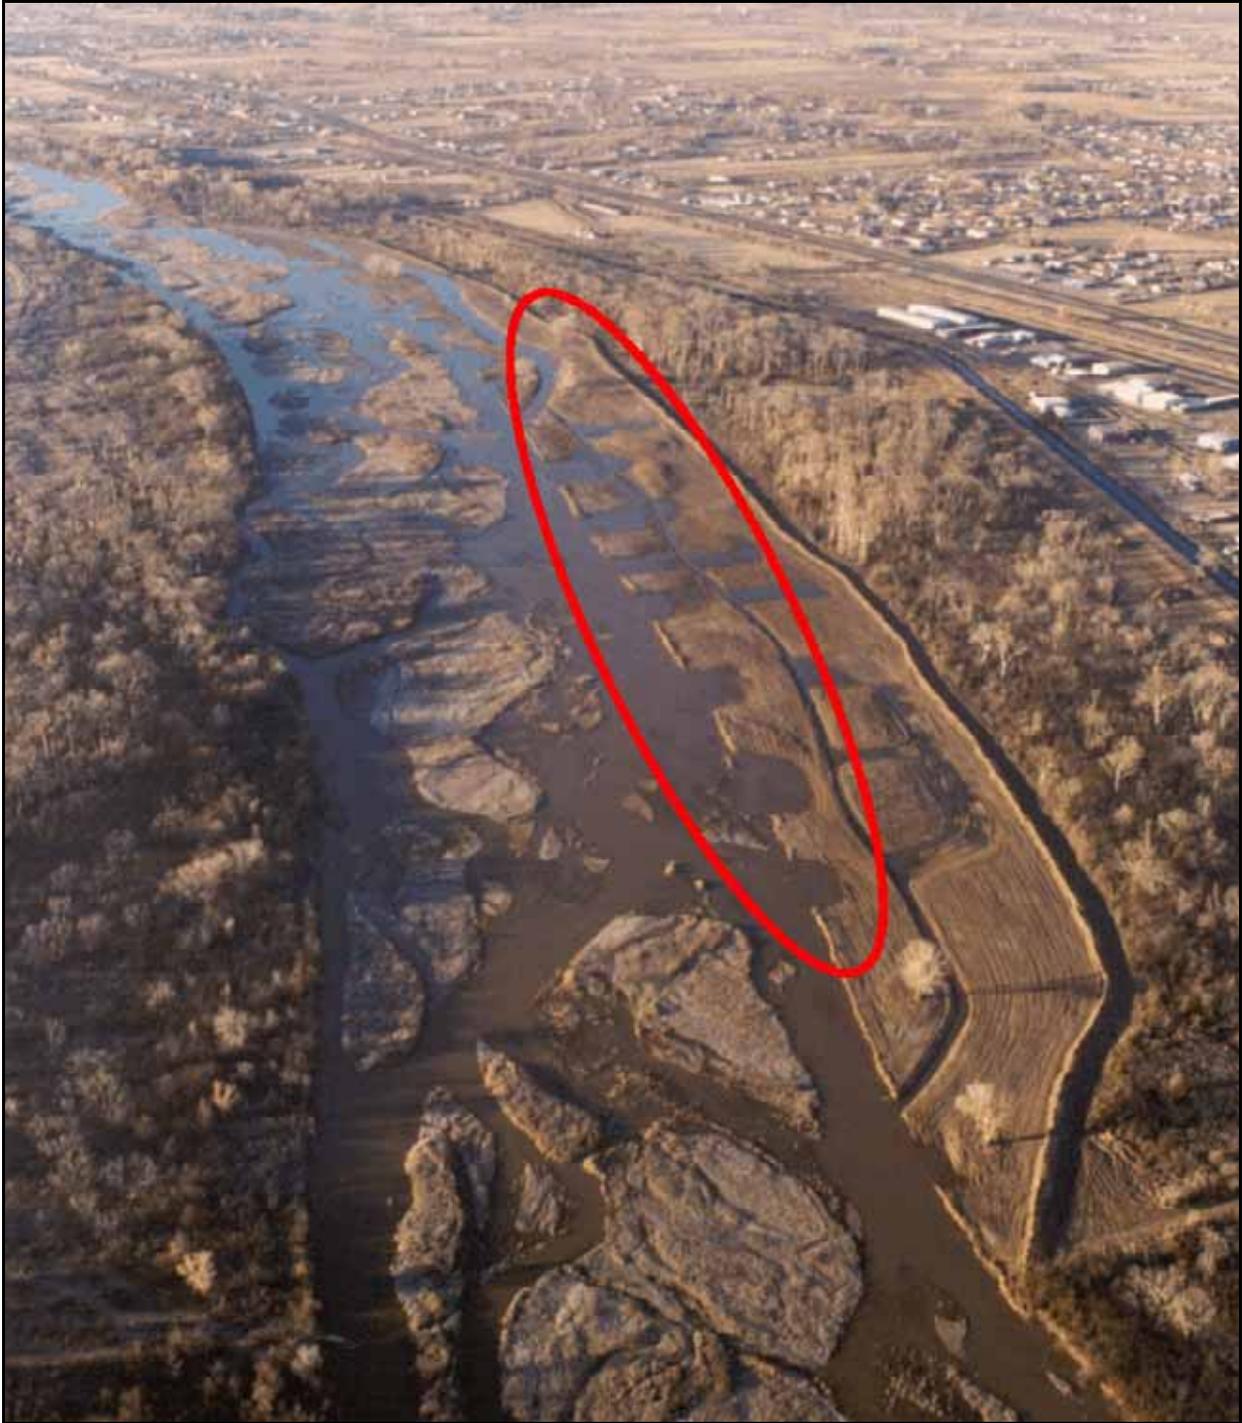
Figure 5.3.1. Photo of constructed bank indentations (area within red circle) installed as part of the Los Lunas Habitat Restoration Project on the Rio Grande.

This restoration activity involves digging out a series of indentations, or “scallop” into the river bank to create a shoreline with a “crenulated” appearance (Figure 5.3.1). The irregular bankline would create eddies or slackwater areas that would serve as low-velocity habitats similar to backwaters. Individual bank indentations could be varied in size, shape, position, elevation, and alignment to provide a variety of habitats (Figure 5.3.2).

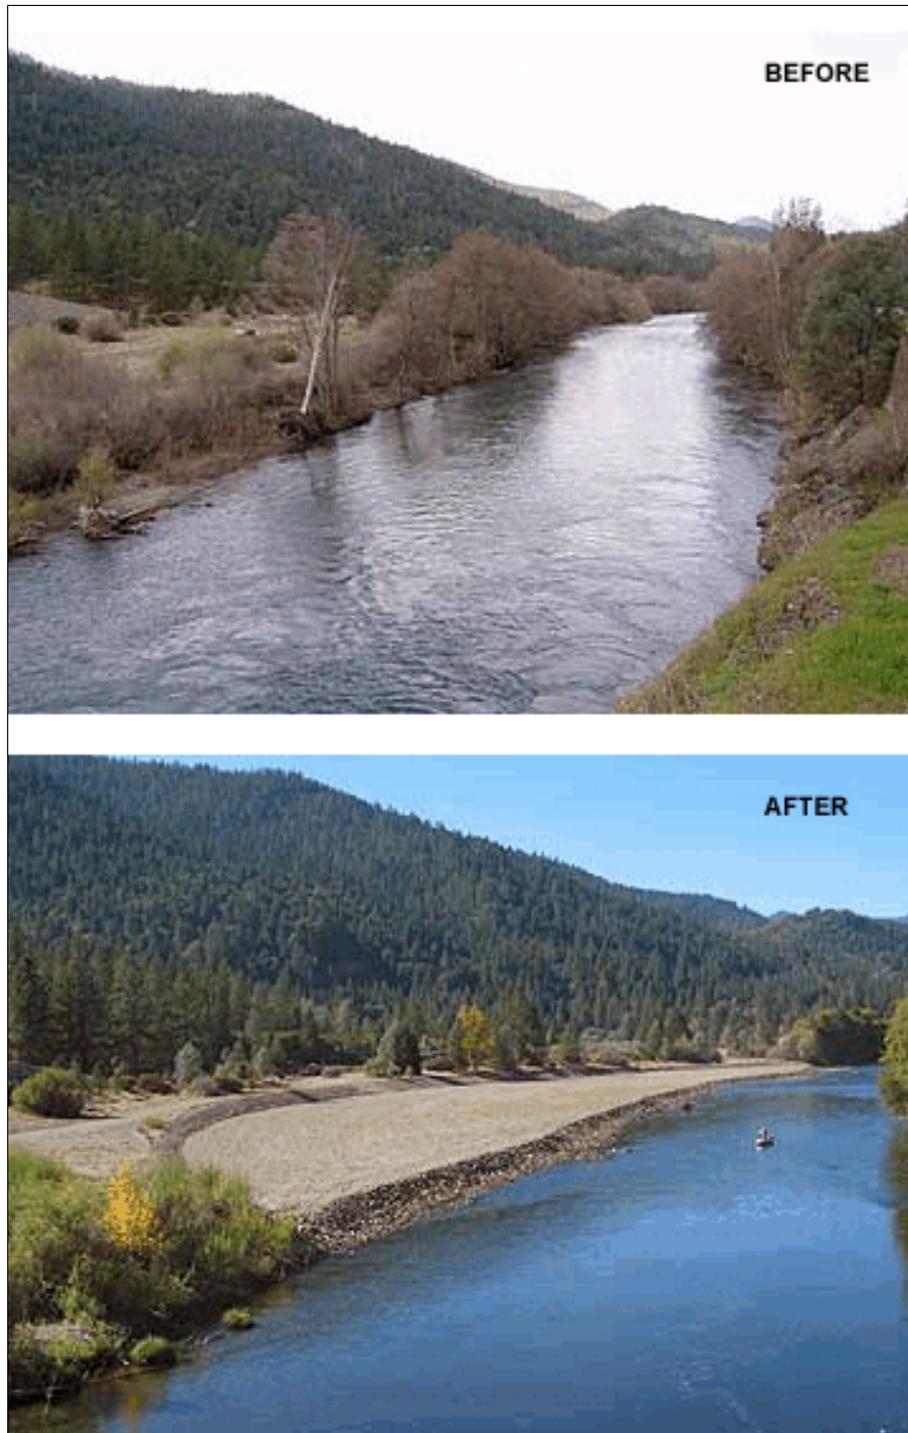
Figure 5.5.1. Photos of the Hocker Flat channel rehabilitation site on the Trinity River before and after implementation of floodplain lowering/bank destabilization. Photos obtained from <http://www.tcrd.net/almanac/current/article04.htm>.

On the Rio Grande, floodplain lowering was recently implemented by the BOR as part of the Albuquerque Overbank Project at a cost of \$5,000/acre. For this project, about 2.4 acres of floodplain was lowered by about 2 feet, for a total removal of approximately 6,100 cubic meters of material (Muldavin et al. 2004). The site was graded to create small channels and diverse, uneven floodplain topography to increase microhabitat diversity. To date, the project has resulted in localized channel widening/bank erosion and highly successful cottonwood establishment relative to portions of the floodplain that were not lowered (Muldavin et al. 2004). As with the other destabilization techniques described in this section, additional studies and pilot projects would be needed to better assess the effectiveness of floodplain lowering as a technique to increase backwater habitats on the San Juan River. Implementing a combination of bank destabilization, floodplain lowering, and island destabilization throughout a reach may be the most effective way to initiate active channel reworking and other dynamic processes. Figure 5.5.1 shows before and after photos of a recently completed floodplain lowering/destabilization project completed in the Hocker Flat area of the Trinity River near Junction City, California.

The Hocker Flat Rehabilitation project, located near Junction City, California, was constructed in 2005 as a pilot project of the Trinity River Restoration Program. The project involved the following: selective removal of fossilized berms (berms that have been anchored by extensive woody vegetation root systems and consolidated sand deposits); revegetation and provision of conditions for regrowth/sustenance of native riparian vegetation; and creation of alternate point bars and complex fish habitat similar in form to the conditions that existed prior to the construction of the Trinity River Diversion. Specific activities included lowering of the floodplain by approximately 4 feet and removing more than 93,000 cubic yards of material within a 17-acre project area along a 1.1 mile segment of the Trinity River. Total project cost was approximately \$915,000. Excavation accounted for about two thirds of the total cost (\$629,000), with clearing/grubbing and revegetation expenditures each totaling approximately \$65,000. The remaining costs were associated with mobilization and preparation (\$38,000), surveying (\$25,000), erosion control and dust abatement (\$69,000), and final site preparation (\$22,000) (J. Reiss 2006, pers. comm.). To date, the project appears to have been successful in restoring some alluvial processes and channel dynamics. Shortly after construction was completed, winter flood flows resulted in the creation of high-flow channels, caused sediment deposition and scour, and deposition of large woody debris on floodplain surfaces. More information about the Hocker Flat project can be found online at:

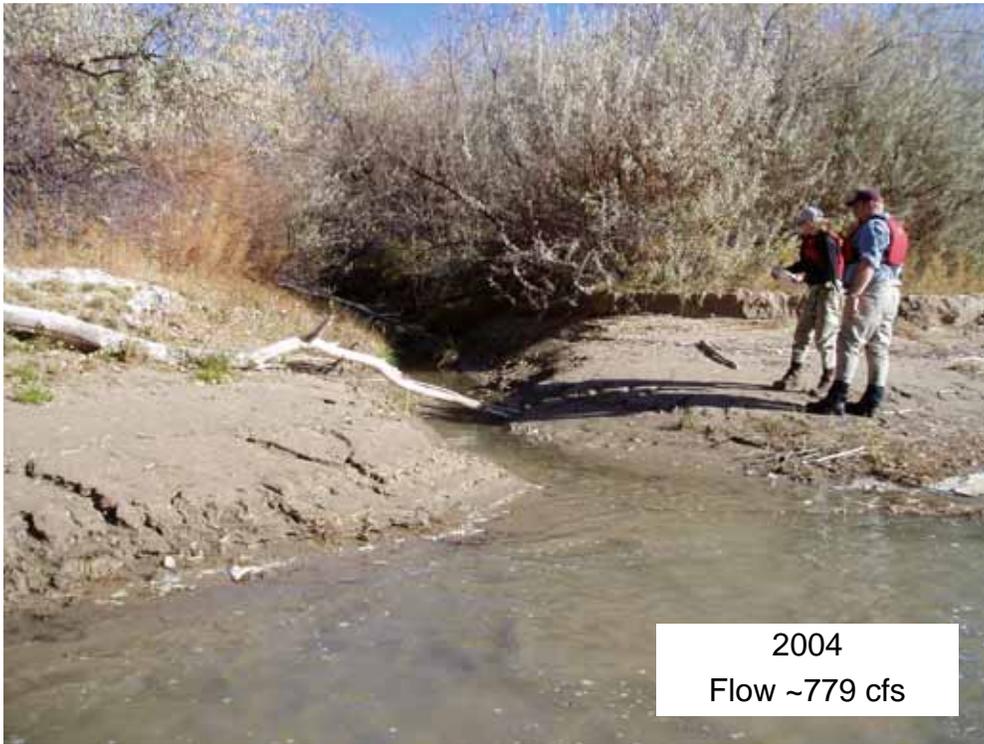
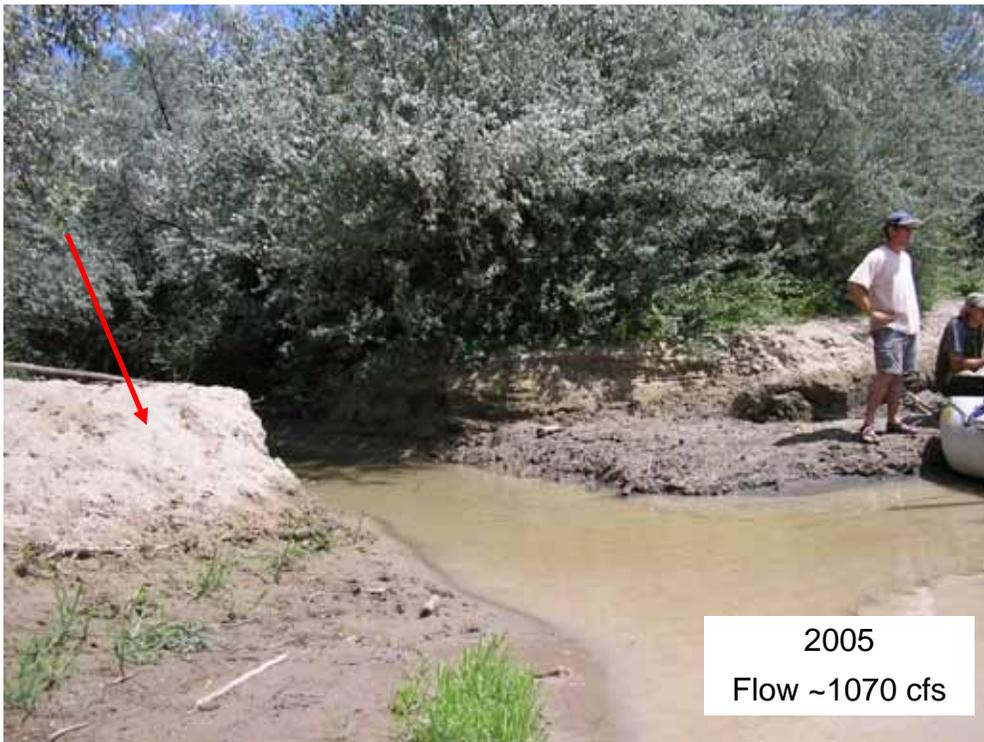
Figure A1. Mouth of irrigation return channel at RM 163.3 before and after the spring 2005 flood. Note fresh sand deposit indicated by red arrow.

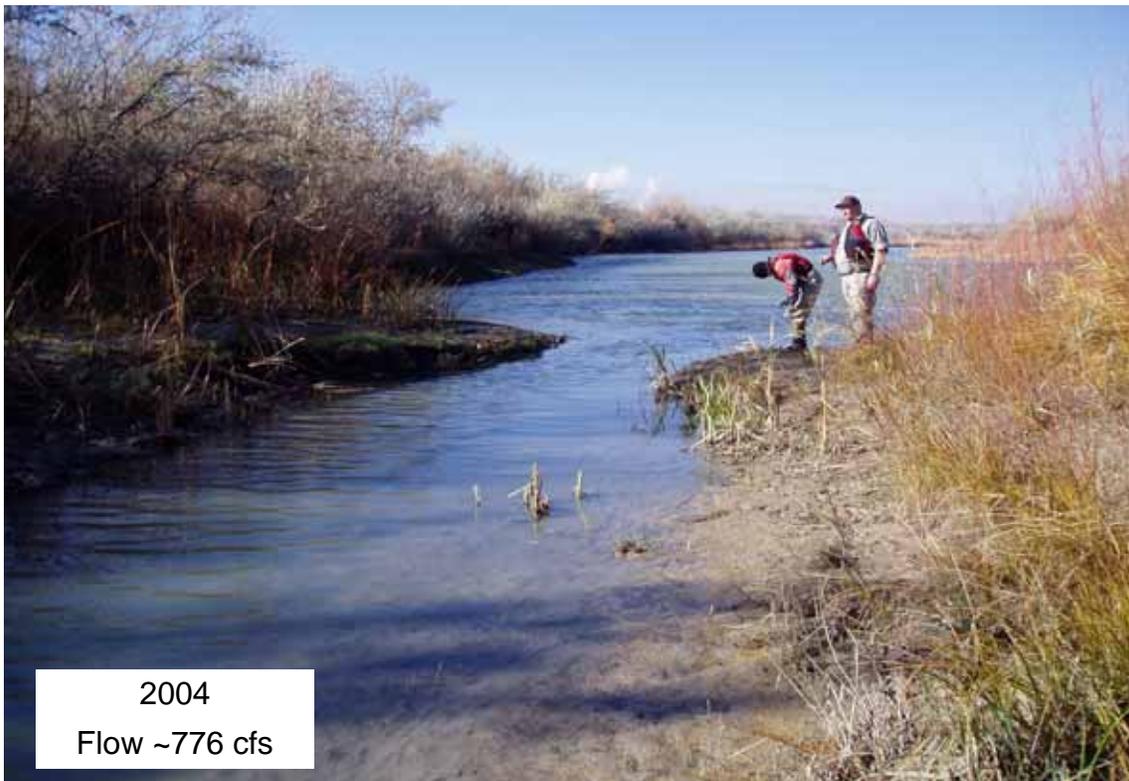
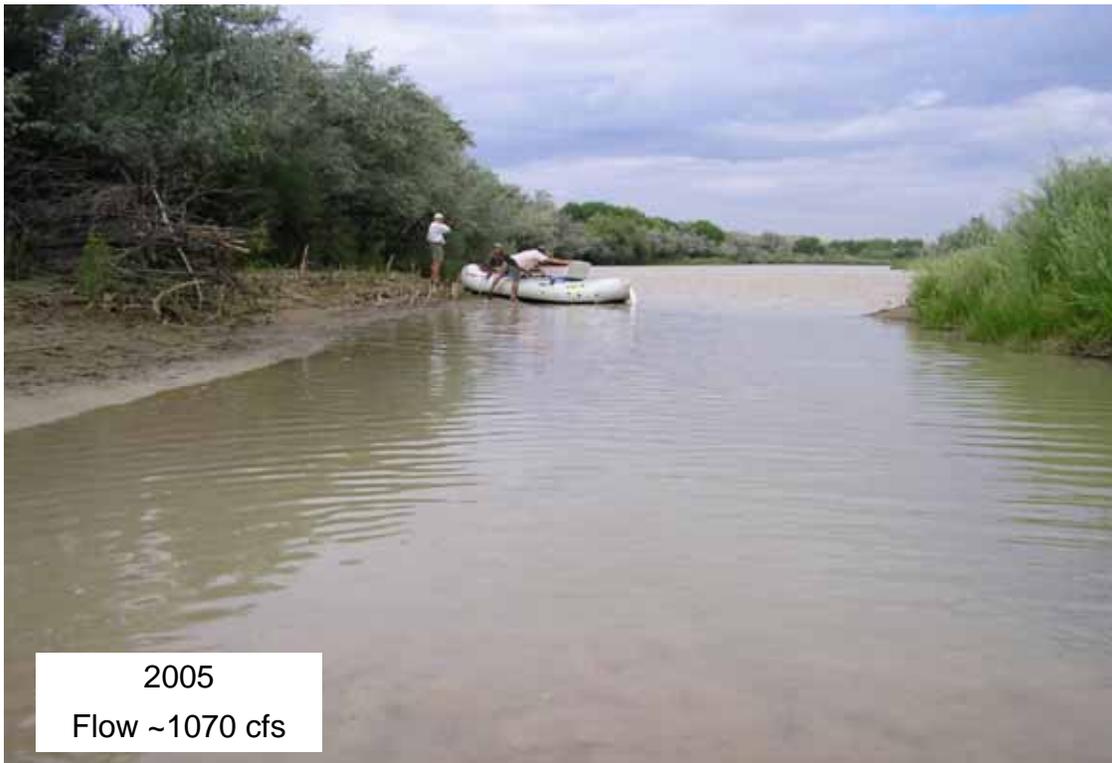
Figure A2. Backwater at exit to secondary channel at RM 170.9 in 2004 versus 2005.

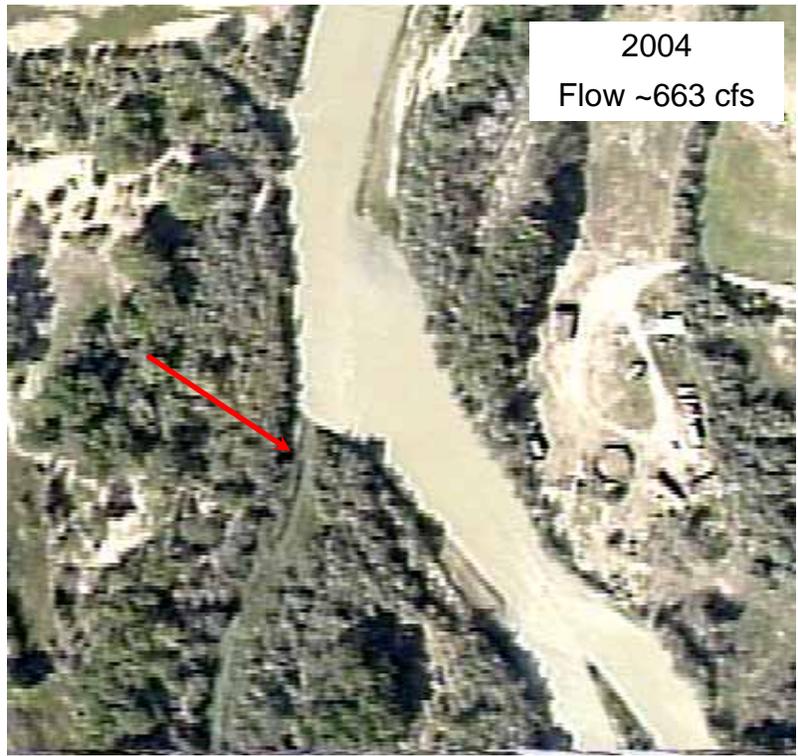
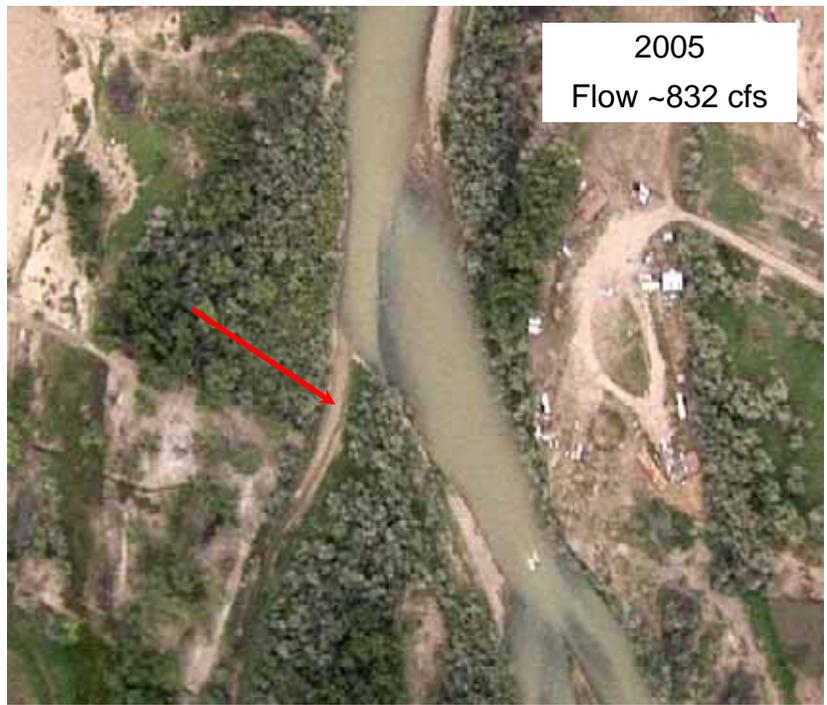
Figure A3. Comparison of 2004 and 2005 aerial videography images of RM 170.9 side channel mouth.

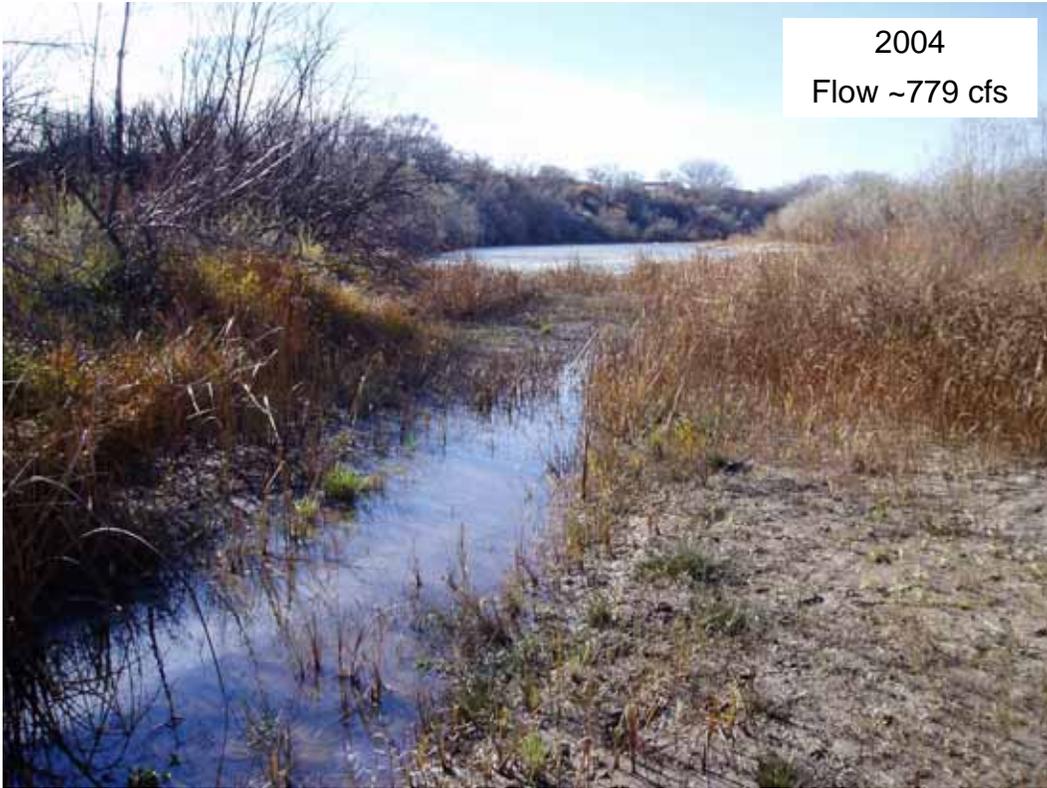
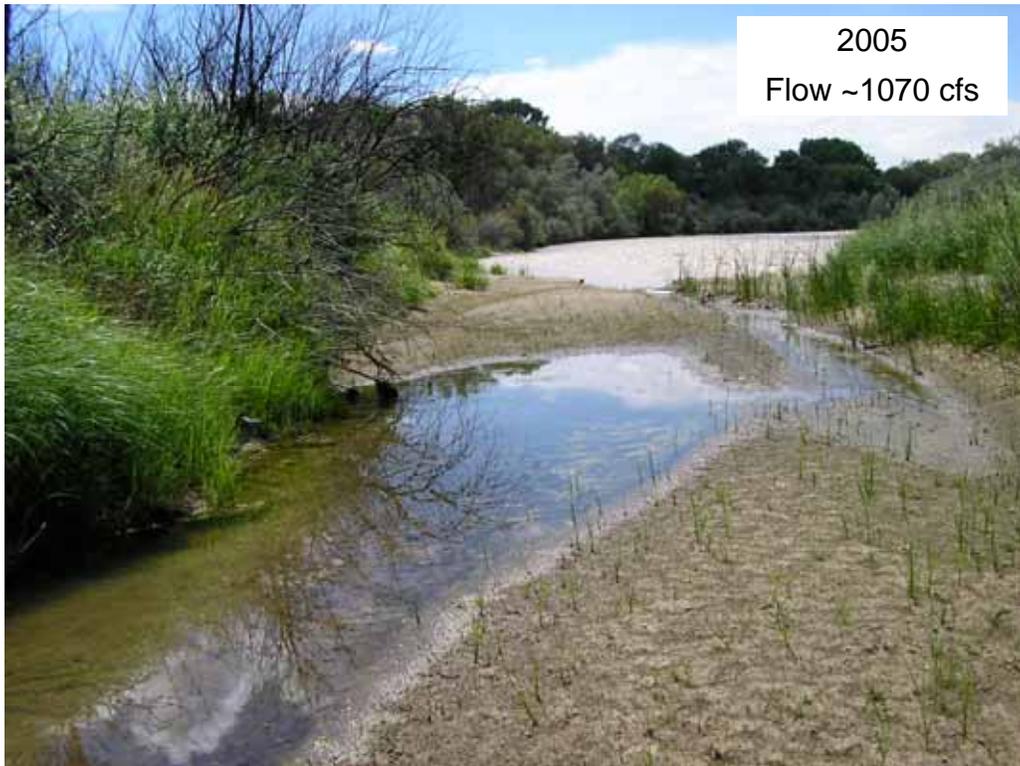
Figure A4. Comparison of RM 162.7 side channel mouth in 2004 versus 2005.

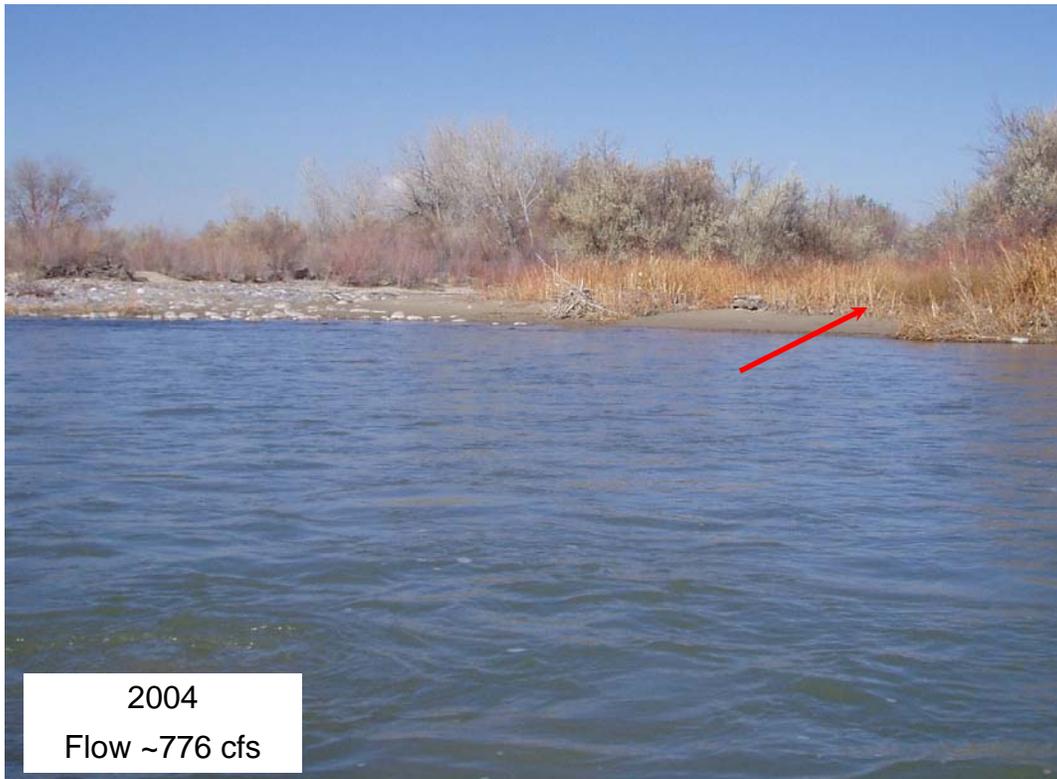
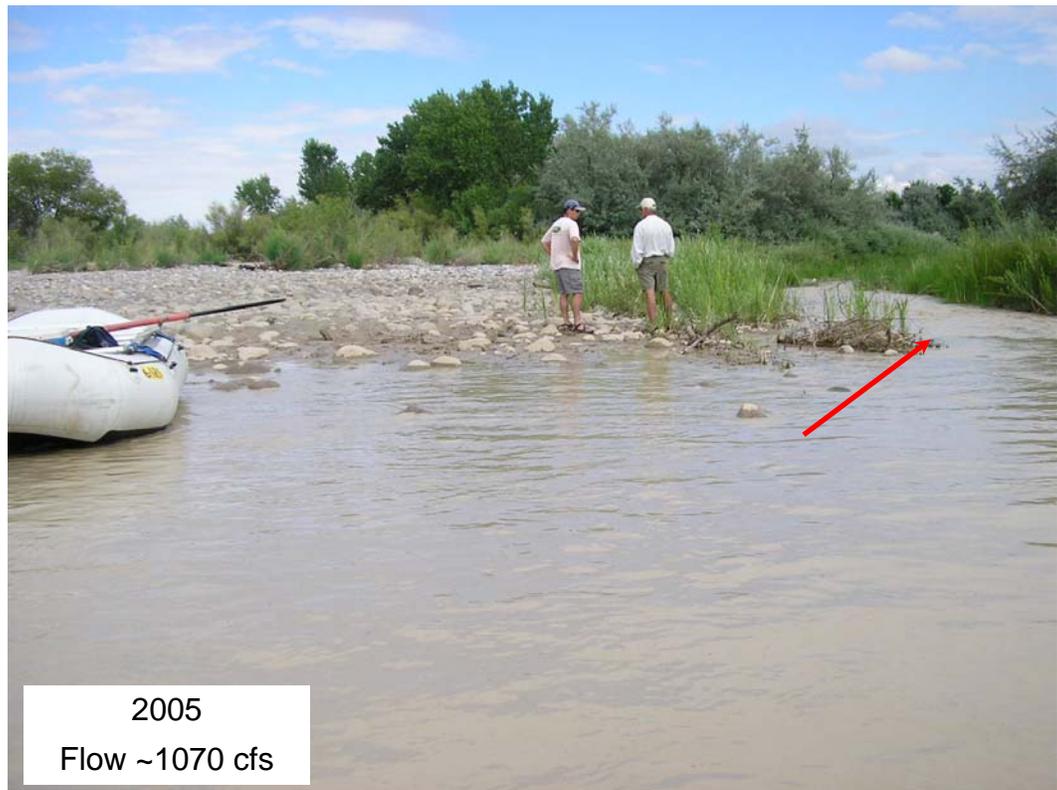
Figure A5. Entrance to secondary channel at RM 170.4 in 2004 versus 2005. Note re-activation of previously vegetated channel entrance following the 2005 spring flood.

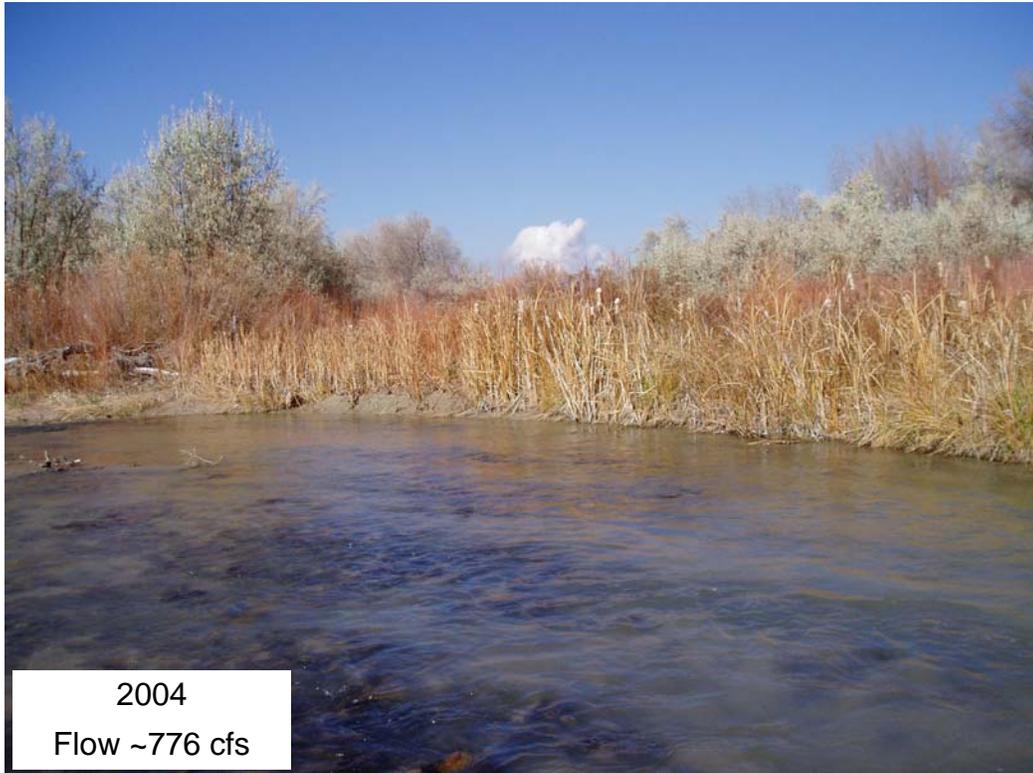
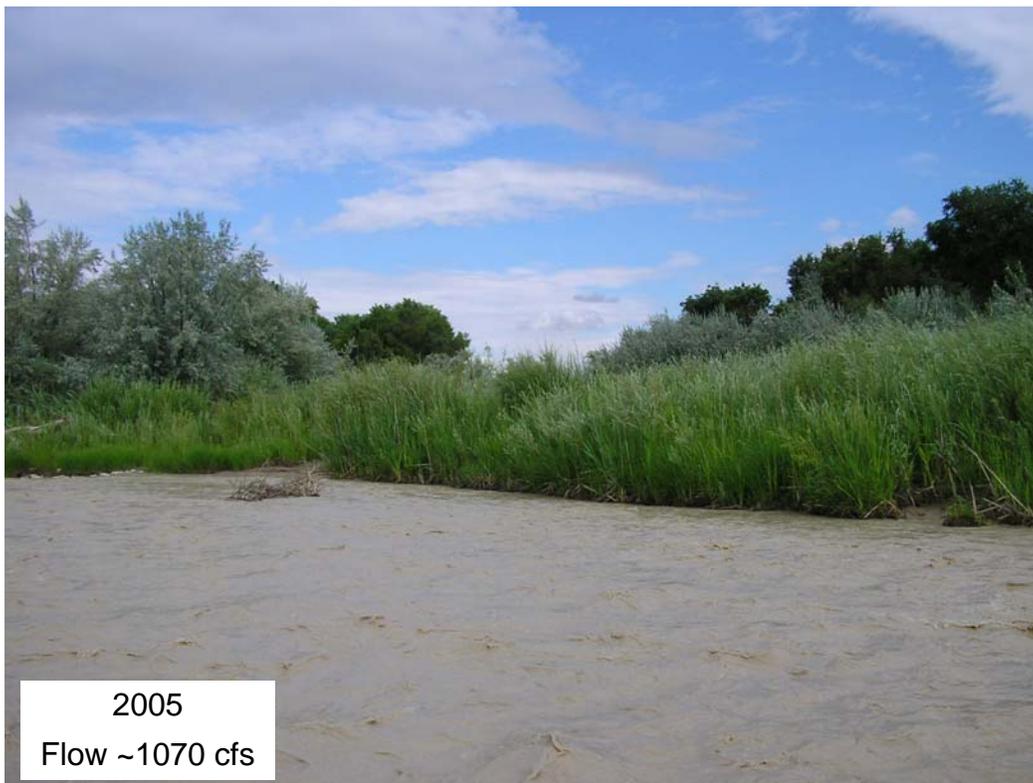
Figure A6. Entrance to inactive channel at RM 170.1 in 2004 versus 2005. Note persistence of vegetation following the 2005 spring flood.

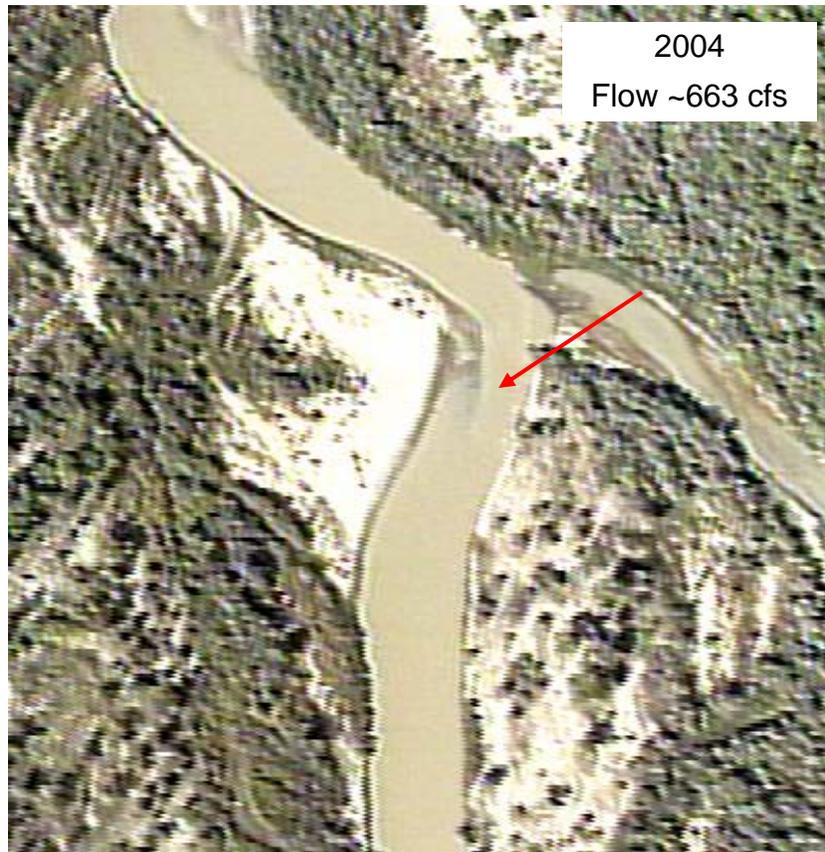
Figure A7. Comparison of 2004 and 2005 aerial videography images of cobble bar at RM 160.7. Note associated channel narrowing at location indicated by arrows.
