FINAL REPORT

Feasibility Evaluation of Restoration Options to Improve Habitat for Young Colorado Pikeminnow on the San Juan River

May 2006

Melissa Stamp, Jill Grams, Michael Golden, and Darren Olsen, BIO-WEST, Inc.;
Tyler Allred, Allred Restoration, Inc.

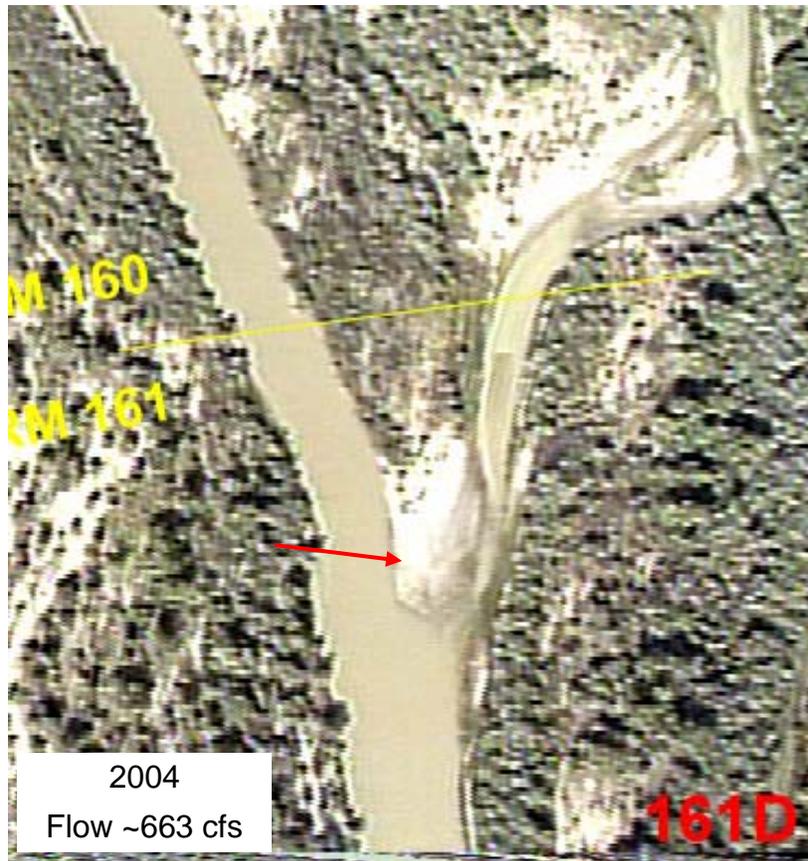
Figure A8. Comparison of 2004 and 2005 aerial videography images of entrance to secondary channel at RM 161.1. Note fresh cobble deposit in area indicated by arrows.

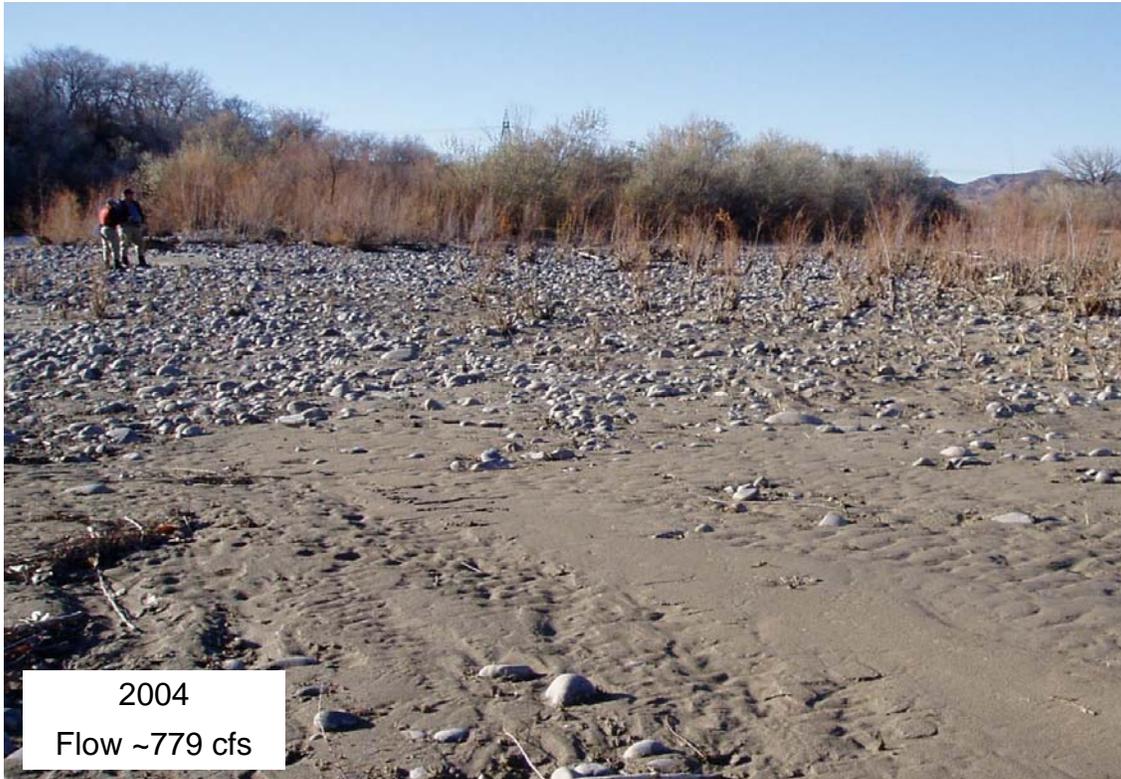
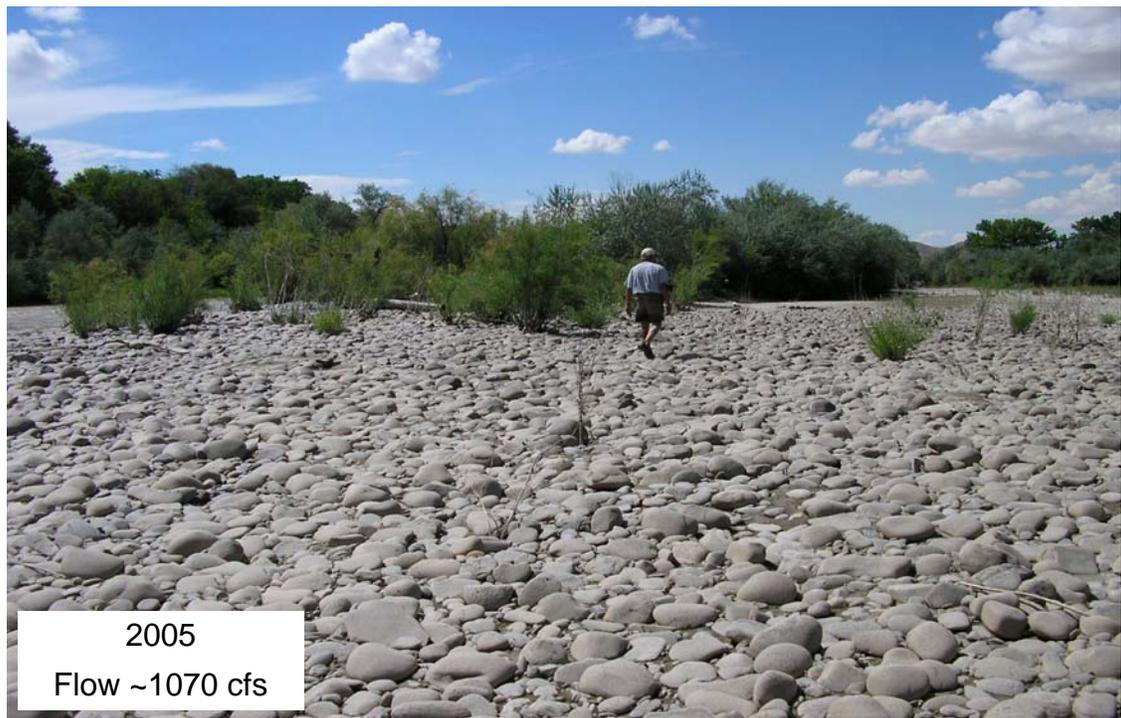
Figure A9. Entrance to secondary channel at RM 162.5 in 2004 versus 2005. Note fresh cobble and loss of some young tamarisk.
