ASBESTOS BULK SAMPLING LOG

NAF MIDWAY

THE SZARAS COMPANIES

SAMPLE ID NO	SAMPLE LOCATION / DESCRIPTION	ANALYTICAL RESULTS	FRIABLE	CONDITION	AMOUNT										
<table border="1" style="width: 100%; border-collapse: collapse;"> <tr> <td style="width: 30%;">BUILDING NUMBER 619</td> <td style="width: 35%;">BUILDING NAME Pacific Cable House</td> <td colspan="3">BUILDING DESCRIPTION 1 Story</td> </tr> <tr> <td>TSC PROJECT NUMBER 865</td> <td>TSC INSPECTOR J. Kain and B. Kain</td> <td colspan="3">TSC LABORATORY ID No. 120293C</td> </tr> </table>						BUILDING NUMBER 619	BUILDING NAME Pacific Cable House	BUILDING DESCRIPTION 1 Story			TSC PROJECT NUMBER 865	TSC INSPECTOR J. Kain and B. Kain	TSC LABORATORY ID No. 120293C		
BUILDING NUMBER 619	BUILDING NAME Pacific Cable House	BUILDING DESCRIPTION 1 Story													
TSC PROJECT NUMBER 865	TSC INSPECTOR J. Kain and B. Kain	TSC LABORATORY ID No. 120293C													
INTERIOR:															
A1123-26	Basement north end Brown sheet vinyl	Tile - None detected Mastic - 10% Chrysotile	Yes	Fair	110 sq. ft.										
A1123-27	Kitchen south end Red stamped pattern 12" x 12" floor tile	Tile - 2% Chrysotile Mastic - 1-2% Chrysotile	No	Fair	300 sq. ft.

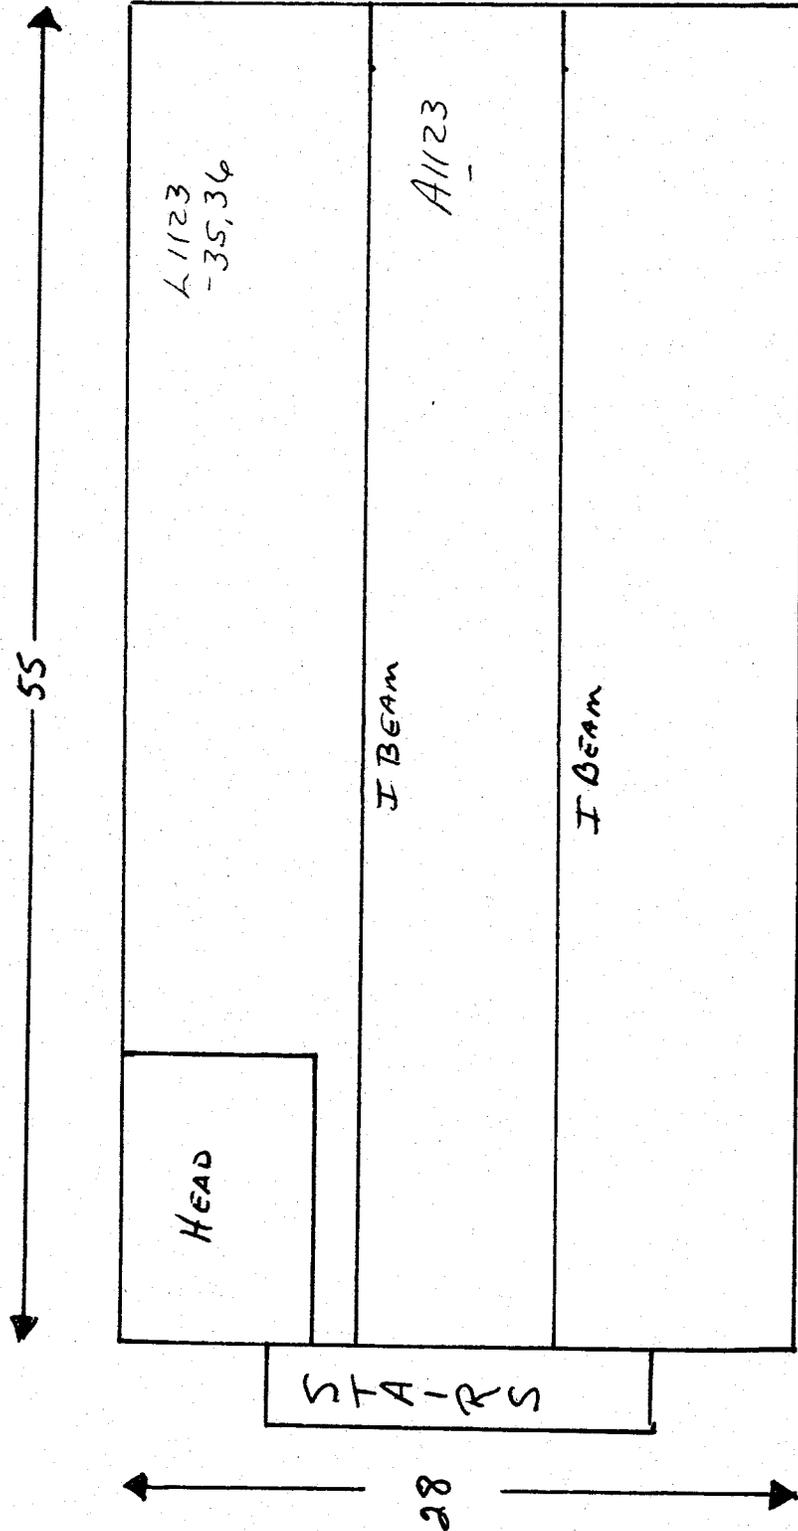
PG. 1 OF 2
 BID # 619
 CABLE HOUSE

(FIRST FLOOR)
 (FROM BLUEPRINT)

SAMPLE ID NO	SAMPLE LOCATION / DESCRIPTION	ANALYTICAL RESULTS (PPM)	CONDITION	AMOUNT								
<table border="1" style="width: 100%; border-collapse: collapse;"> <tr> <td style="width: 30%;">BUILDING NUMBER 619</td> <td style="width: 35%;">BUILDING NAME Pacific Cable House</td> <td colspan="2">BUILDING DESCRIPTION 2 Story</td> </tr> <tr> <td>TSC PROJECT NUMBER 865</td> <td>TSC INSPECTOR J. Kain and B. Kain</td> <td colspan="2">TSC LABORATORY ID No. 120293A</td> </tr> </table>					BUILDING NUMBER 619	BUILDING NAME Pacific Cable House	BUILDING DESCRIPTION 2 Story		TSC PROJECT NUMBER 865	TSC INSPECTOR J. Kain and B. Kain	TSC LABORATORY ID No. 120293A	
BUILDING NUMBER 619	BUILDING NAME Pacific Cable House	BUILDING DESCRIPTION 2 Story										
TSC PROJECT NUMBER 865	TSC INSPECTOR J. Kain and B. Kain	TSC LABORATORY ID No. 120293A										
BASEMENT EXTERIOR NORTH END:												
L1123-33	White paint on wall	12,656.2	Poor	5,000 sq. ft.								
L1123-34	Blue paint on trim on window	149,382.0	Poor	1,500 sq. ft.								
EXTERIOR:												
L1123-40	Southeast side Green paint on door	13,879.3	Poor	1,500 sq. ft.								
L1123-41	Veranda east side Red deck paint	4,971.9	Poor	1,500 sq. ft.								
INTERIOR:												
L1123-35	Northwest wall north end White paint	3,152.1	Poor	8,200 sq. ft.								
L1123-36	Northwest side north end White paint on ceiling	2,784.6	Poor	3,100 sq. ft.								
L1123-37	Shower wall 1st floor Green paint	176.7	Poor	175 sq. ft.								
L1123-38	Hallway wall south end White paint	130,000.0	Poor	8,200 sq. ft.								
L1123-39	Kitchen south end White paint on ceiling	30,521.9	Poor	3,100 sq. ft.

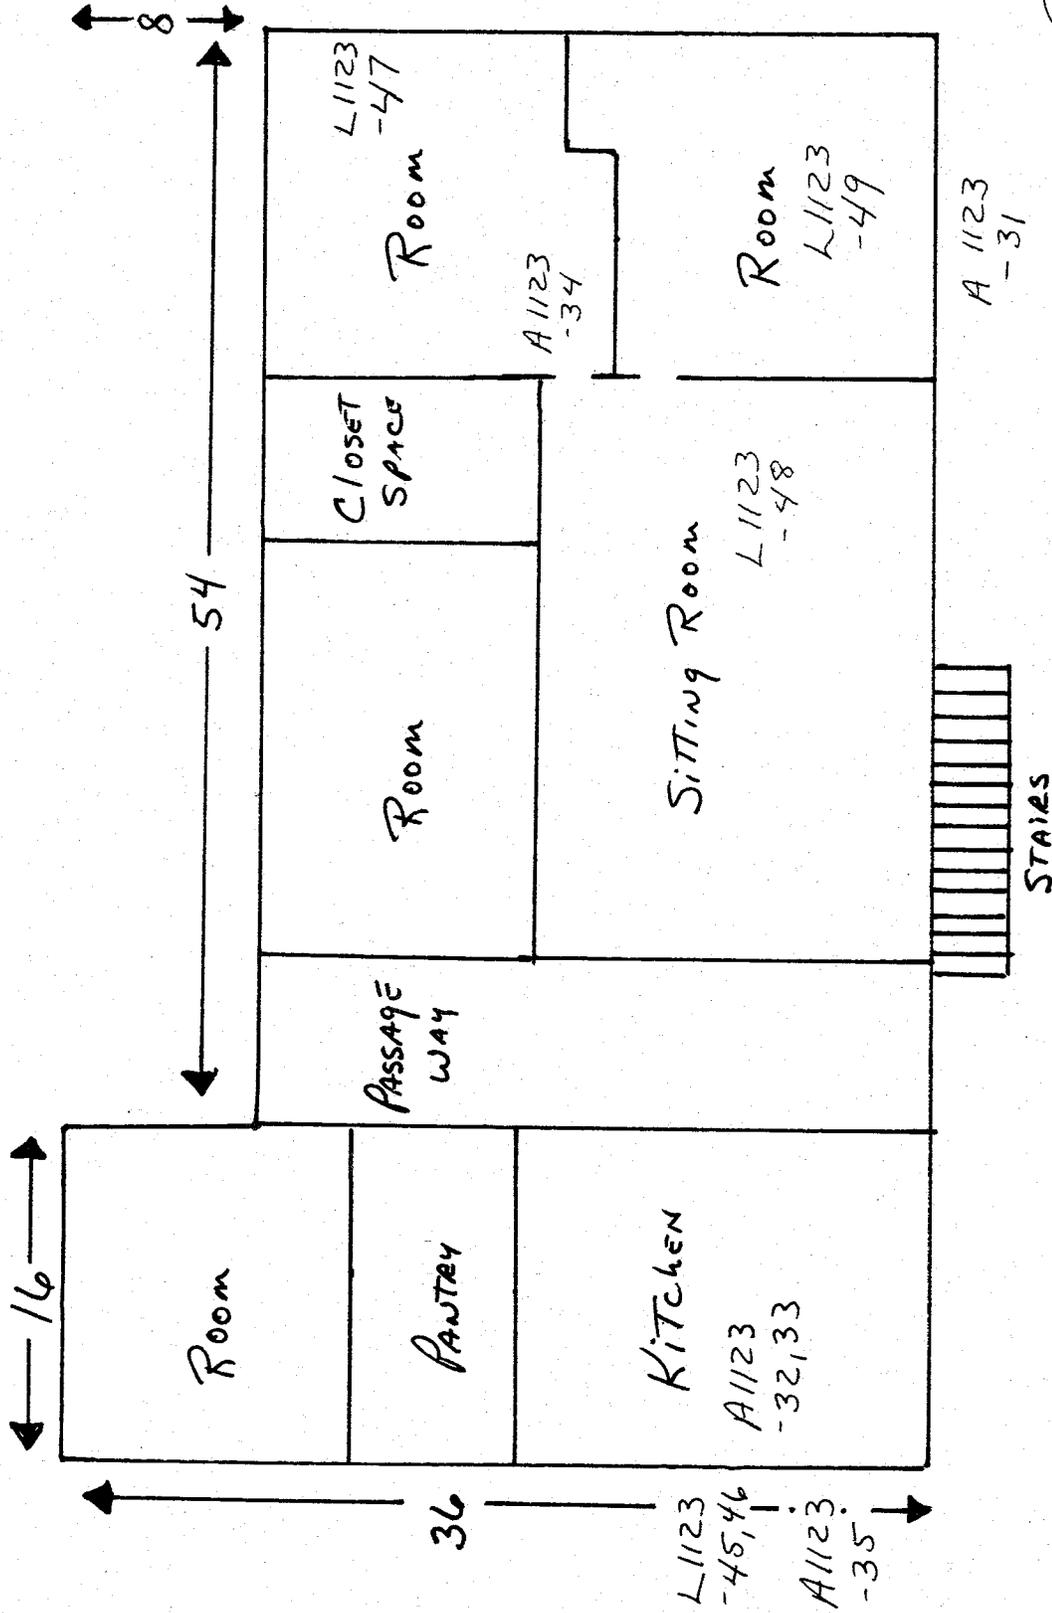
Bld # 628
 Cable House
 PG. 1 OF 2

(First Floor)
 (From Blue Print)

SAMPLE ID NO	SAMPLE LOCATION / DESCRIPTION	ANALYTICAL RESULTS	FRIABLE	CONDITION	AMOUNT
BUILDING NUMBER 628		BUILDING NAME Pacific Cable House		BUILDING DESCRIPTION 2 Story	
TSC PROJECT NUMBER 865		TSC INSPECTOR J. Kain and B. Kain		TSC LABORATORY ID No. 120293D	
A1123-31	Exterior south side Pink stucco coating	None detected	No	Poor	5,000 sq. ft.
A1123-35	Roof core and multi color shingles	None detected	No	Fair	3,400 sq. ft.
No sample collected	Basement Black with white 9" x 9" floor tile Same as sample A1123-18, building 643	Tile - 10% Chrysotile Mastic - 12% Chrysotile	No	Fair	7,000 sq. ft.
INTERIOR 1ST FLOOR:					
A1123-32	Kitchen Red w/white streaks 9" x 9" floor tile	Tile - 6% Chrysotile Mastic - 6% Chrysotile	No	Fair	7,000 sq. ft. mixed with below
A1123-33	Kitchen Gray w/white streaks 9" x 9" floor tile	Tile - 5% Chrysotile Mastic - 3% Chrysotile	No	Fair	Mixed with A1123-32
A1123-34	Northwest side Concrete	None detected	No	Poor	7,000 sq. ft.

SAMPLE ID NO	SAMPLE LOCATION / DESCRIPTION	ANALYTICAL RESULTS (PPM)	CONDITION	AMOUNT						
<table border="1" style="width: 100%; border-collapse: collapse; margin-bottom: 10px;"> <tr> <td style="width: 30%;">BUILDING NUMBER 628</td> <td style="width: 35%;">BUILDING NAME Pacific Cable House</td> <td style="width: 35%;">BUILDING DESCRIPTION 2 Story</td> </tr> <tr> <td>TSC PROJECT NUMBER 865</td> <td>TSC INSPECTOR J. Kain and B. Kain</td> <td>TSC LABORATORY ID No. 120293B</td> </tr> </table>					BUILDING NUMBER 628	BUILDING NAME Pacific Cable House	BUILDING DESCRIPTION 2 Story	TSC PROJECT NUMBER 865	TSC INSPECTOR J. Kain and B. Kain	TSC LABORATORY ID No. 120293B
BUILDING NUMBER 628	BUILDING NAME Pacific Cable House	BUILDING DESCRIPTION 2 Story								
TSC PROJECT NUMBER 865	TSC INSPECTOR J. Kain and B. Kain	TSC LABORATORY ID No. 120293B								
INTERIOR:										
L1123-42	Basement southwest White paint on wall	17,555.5	Poor	17,000 sq. ft. mixed with L1123-42, 47, 48 & 49						
L1123-43	Basement southwest side White paint on ceiling	3,028.4	Poor	6,200 sq. ft.						
L1123-44	Northeast side Green paint on wall	2,101.3	Poor	Mixed with L1123-42						
L1123-47	Northwest side Green paint on wall	131,781.9	Poor	Mixed with L1123-42						
L1123-48	Sitting room Beige paint on wall	178,324.5	Poor	Mixed with L1123-42						
L1123-49	Northeast side Blue/green paint on wall	12,634.4	Poor	Mixed with L1123-42						
EXTERIOR 1ST FLOOR:										
L1123-45	Southeast side Pink paint on wall	88,239.2	Poor	5,000 sq. ft.						
L1123-46	Southeast side Brown paint on trim	3,567.4	Poor	1,500 sq. ft.

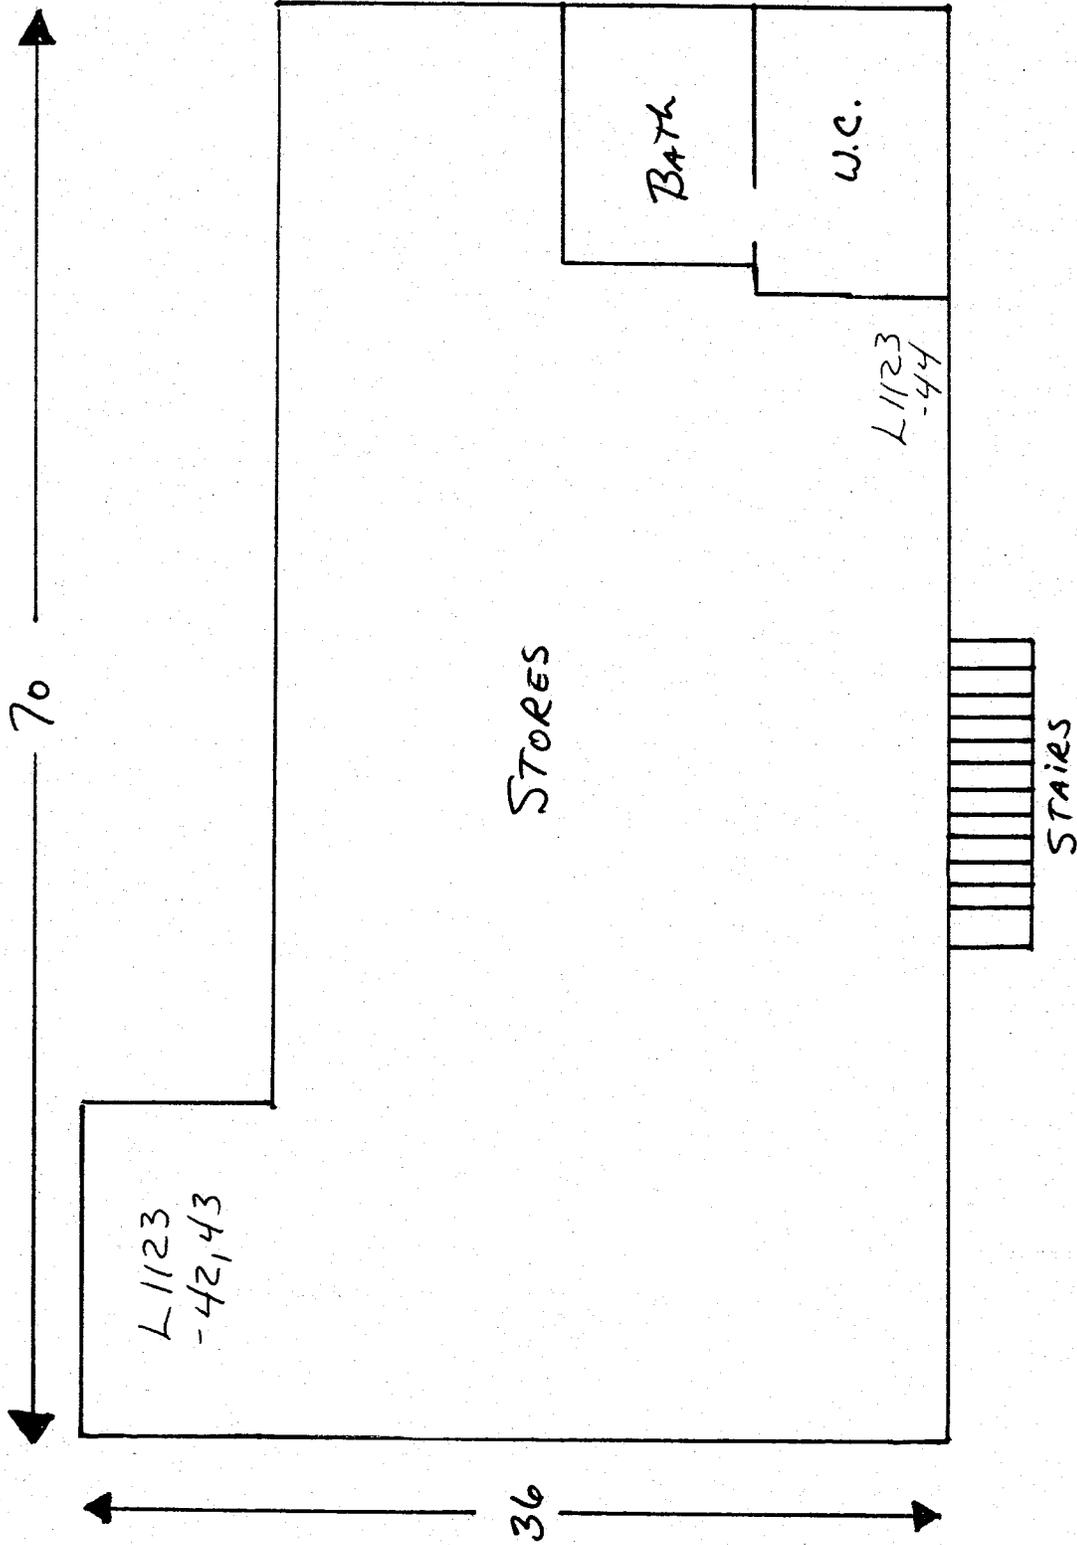
Bld # 628
Cable House
Pg. 2 of 2

(BASEMENT)
(FROM BLUE PRINT)

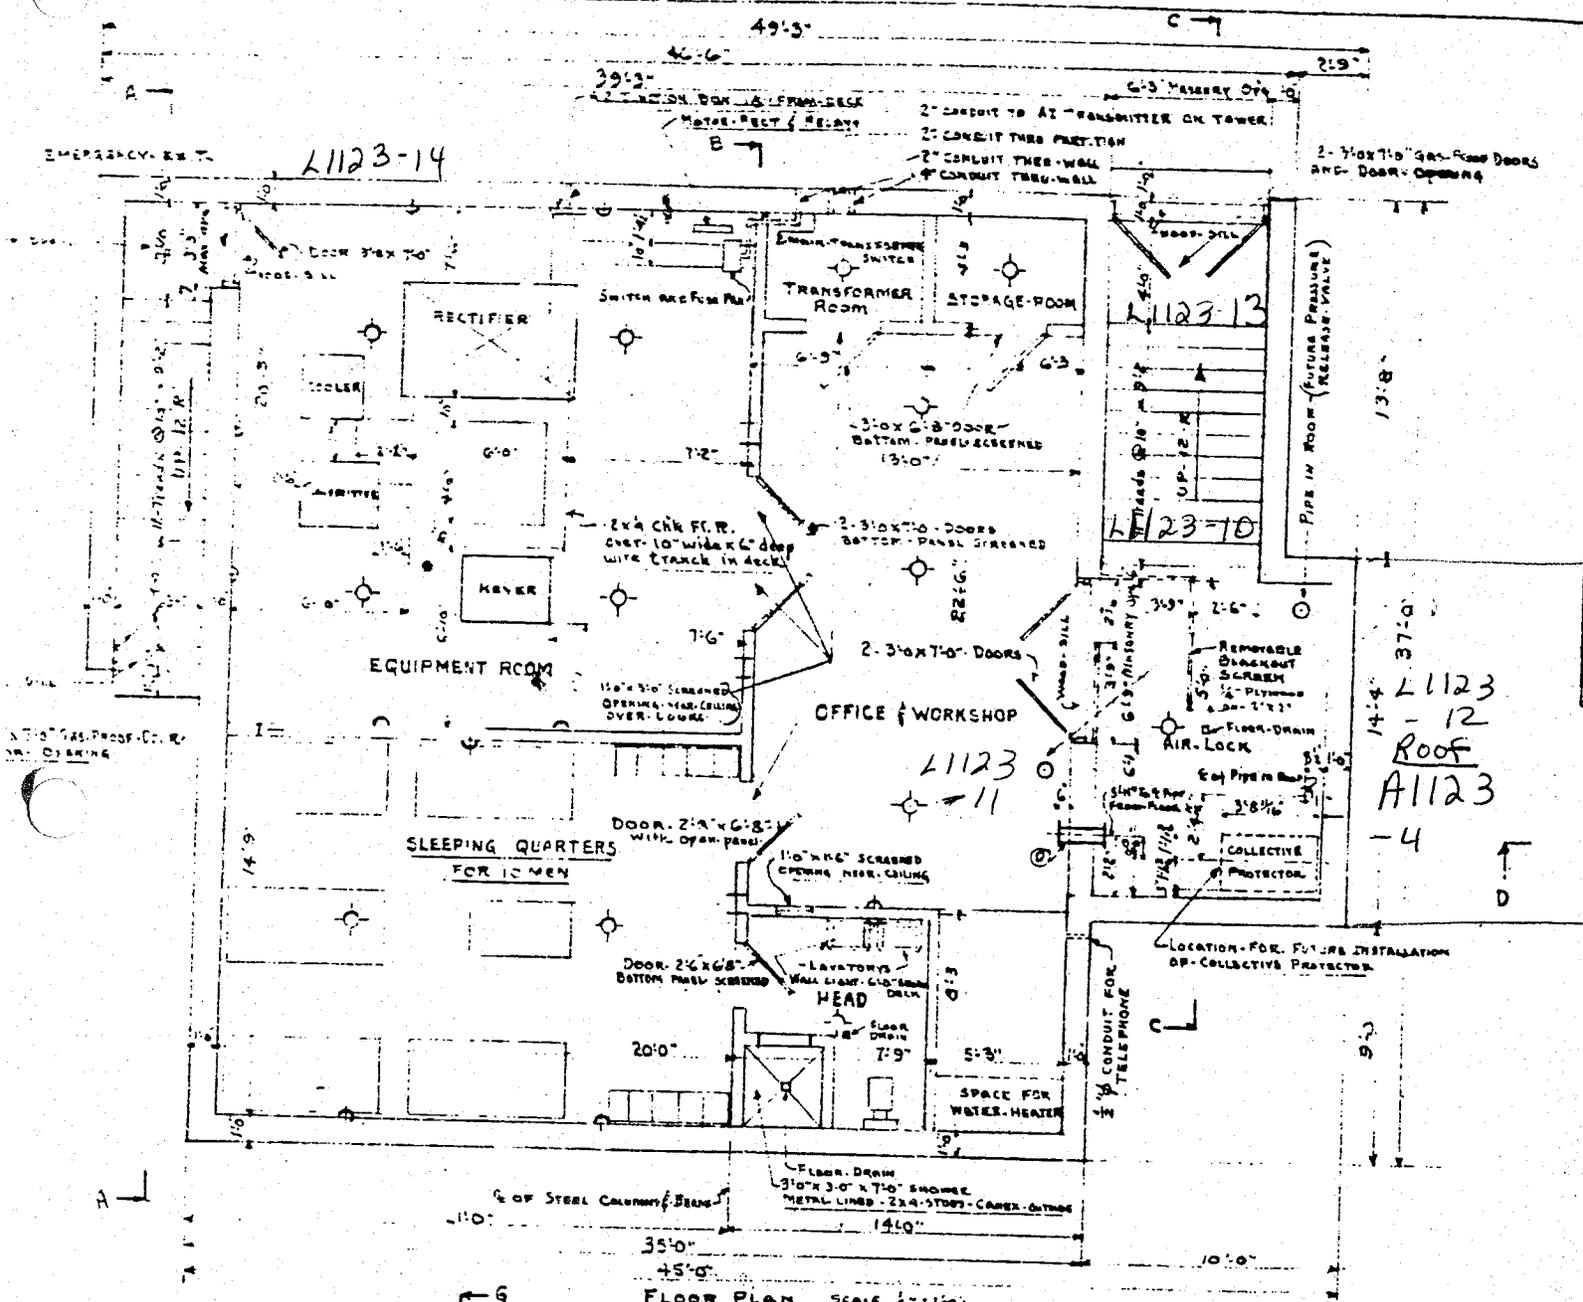
FLOOR PLAN SCALE 1/4" = 1'-0"

BLDG.# 631

Radial Bld

BUILDING NUMBER 631	BUILDING NAME Radar Building	BUILDING DESCRIPTION 1 Story		
TSC PROJECT NUMBER 865	TSC INSPECTOR J. Kain and B. Kain	TSC LABORATORY ID No. 120293A		
SAMPLE ID NO	SAMPLE LOCATION / DESCRIPTION	ANALYTICAL RESULTS (PPM)	CONDITION	AMOUNT
	INTERIOR:			
L1123-10	Stairwell Off-white paint on wall	39,931.3	Poor	1,000 sq. ft.
L1123-11	Office/workshop Green paint on wall	11,114.4	Poor	3,000 sq. ft.
L1123-12	Fallout shelter (add on to building) Beige paint on wall	1,813.8	Poor	350 sq. ft.
L1123-13	Door entrance west side Green paint on door	4,823.7	Poor	150 sq. ft.
	EXTERIOR:			
L1123-14	West side Off-white on wall	80,043.1	Poor	1,400 sq. ft.
	Note: Minimum penetration into building. Ceiling concrete debris on floor.

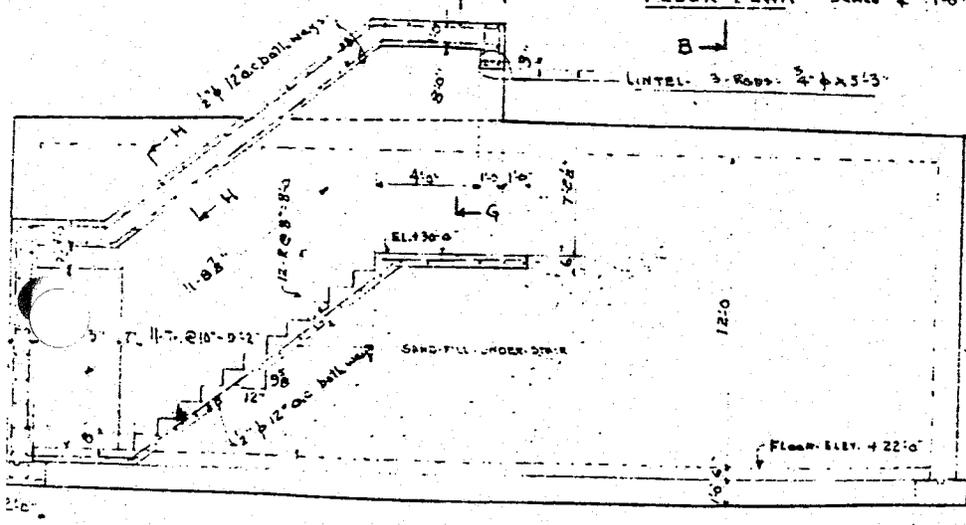
ELECTRICAL NOTES

- PROVIDE FOR FAN AT EXHAUST VENT IN ROOF
- = OVERHEAD-LIGHT
- = CONVENIENCE OUTLET
- = WALL-LIGHT- GO FROM DECK. (IN HEAD. ONLY)

FOR FURTHER DETAILS ON CONSTRUCTION AND LAYOUT OF OPERATING ROOM, REFER TO INSTRUCTION BOOK SCR-271 RADIO SET & DRAWINGS

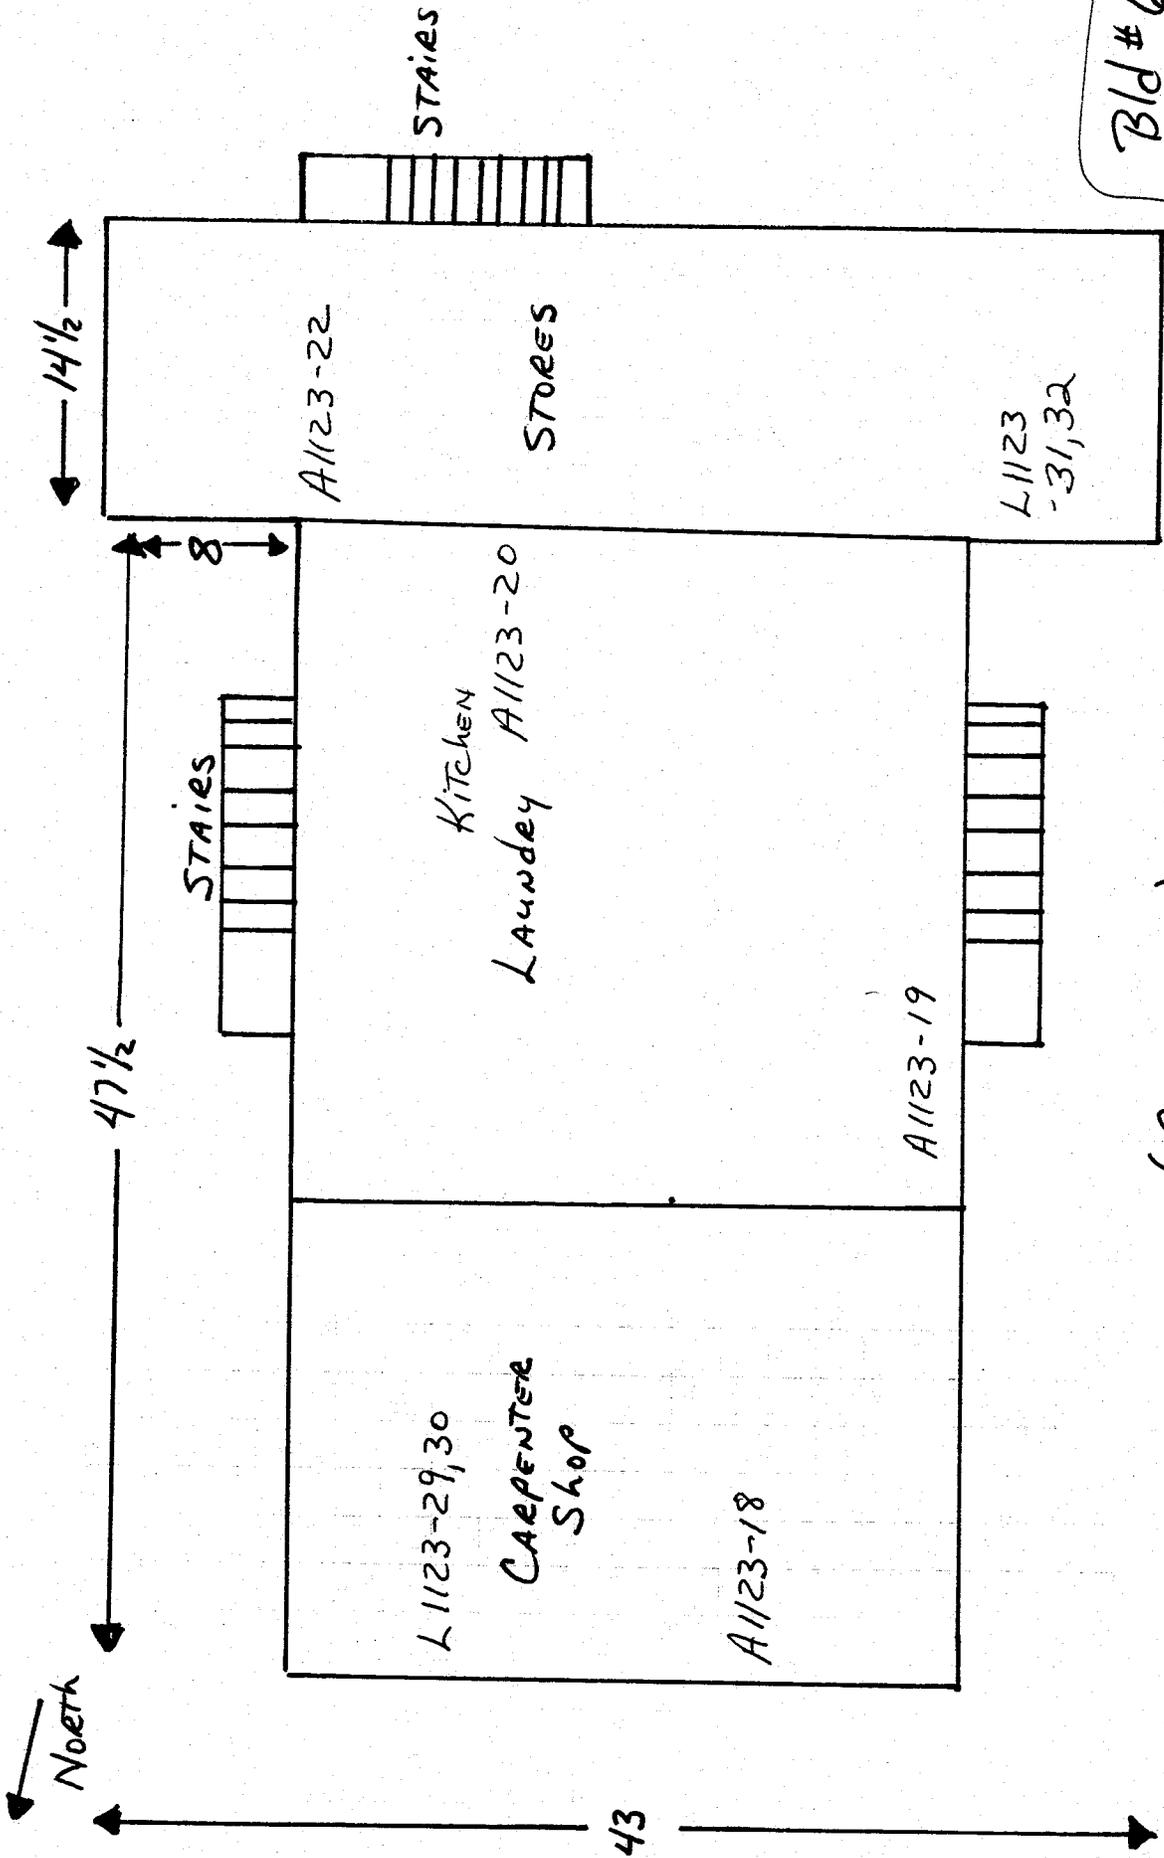
Bld # 643
 Cable House
 Pg. 1 OF 2

(Basement)
 (From Blue Print)

SAMPLE ID NO	SAMPLE LOCATION / DESCRIPTION	ANALYTICAL RESULTS	FRIABLE	CONDITION	AMOUNT
BUILDING NUMBER 643		BUILDING NAME Cable House		BUILDING DESCRIPTION 2 Story	
TSC PROJECT NUMBER 865		TSC INSPECTOR J. Kain and B. Kain		TSC LABORATORY ID No. 120293C	
INTERIOR:					
A1123-18	Basement, Carpenter Shop Black with white streaks 9" x 9" floor tile	Tile - 10% Chrysotile Mastic - 12% Chrysotile	No	Fair	Tile for samples A1123-18, A1123-19, A1123-20, A1123-22, A1123-24, A1123-23 are mixed. Total 7,800 sq. ft.
A1123-19	Basement, Laundry Red with white streaks 9" x 9" floor tile	Tile - 10% Chrysotile Mastic - 4% Chrysotile	No	Fair	
A1123-20	Kitchen Green with white streaks 12" x 12" floor tile	Tile - 3% Chrysotile Mastic - 8% Chrysotile	No	Fair	
No sample collected	Kitchen, underneath A1123-20 Red with white streaks 9" x 9" floor tile - same as sample A1123-19	Tile - 10% Chrysotile Mastic - 4% Chrysotile	No	Fair

A1123-22	Southwest end Beige with gray streaks 12" x 12" floor tile	Tile - 10% Chrysotile Mastic - 15% Chrysotile	No	Good	
A1123-21	Southwest end, 1st floor, porch Green with white 9" x 9" floor tile	8% Chrysotile	No	Good	100 sq. ft.
A1123-24	Southeast end Red with white and orange streaks 9" x 9" floor tile	Tile - None detected Mastic - 20% Chrysotile	No	Good	See note above for mixed floor tiles.
A1123-23	North end, kitchen White with gray streaks 9" x 9" floor tile	1% Chrysotile	No	Good	
No sample collected	Green with white streaks 9" x 9" floor tile - same as sample A1123-7, building 623	Tile - 15% Chrysotile Mastic - 8% Chrysotile	No	Good	
EXTERIOR:					
A1123-25	Roof, south side Roof core	None detected	No	Fair	3,400 sq. ft.

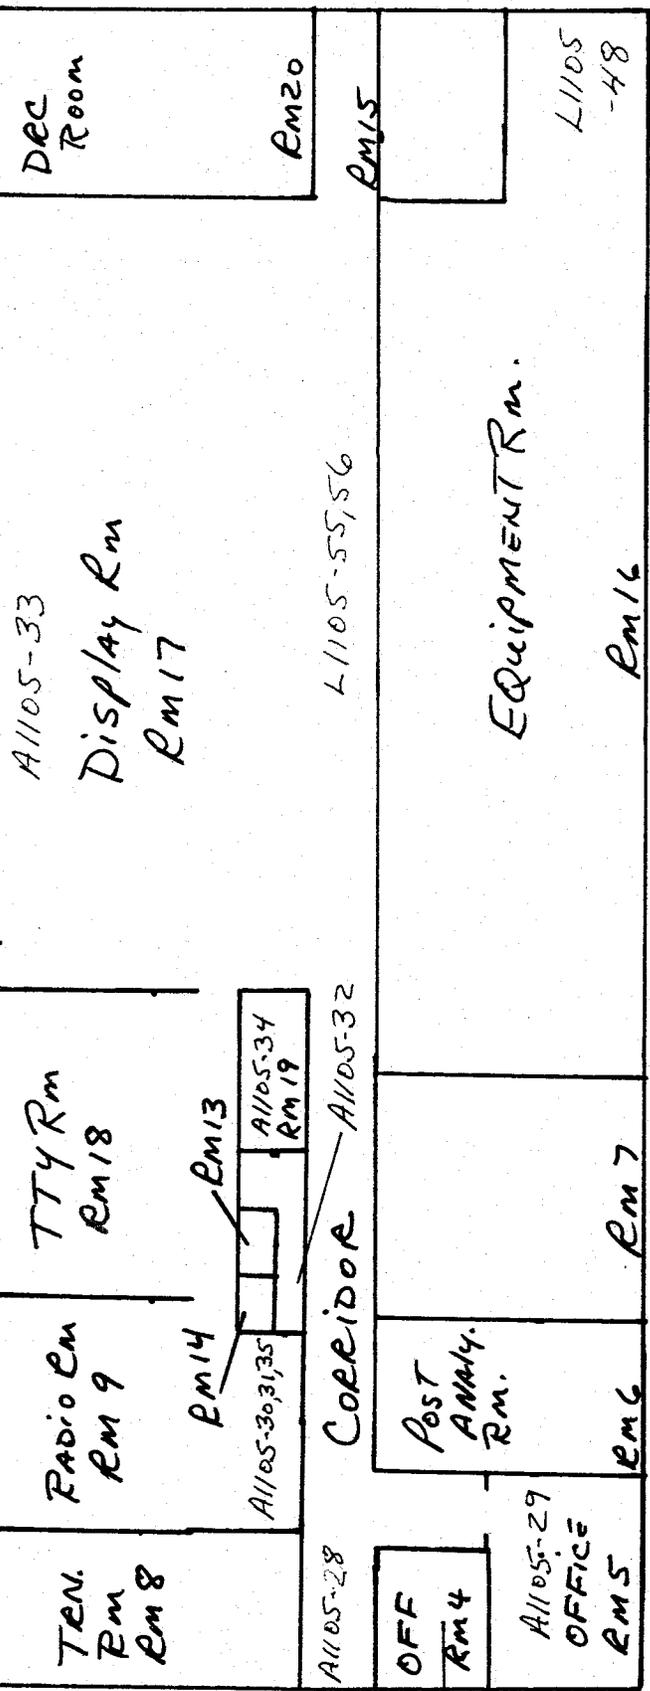
Bld # 970

A/C Em RM21 L1105-51,54

SubSTA RM23 L1105-52,53

Roof A1105-26,27

L1105-47

SAMPLE ID NO	SAMPLE LOCATION / DESCRIPTION	ANALYTICAL RESULTS	FRIABLE	CONDITION	AMOUNT
BUILDING NUMBER 970		BUILDING NAME NAVOcean ProFac		BUILDING DESCRIPTION 1 Story	
TSC PROJECT NUMBER 865		TSC INSPECTOR J. Kain and B. Kain		TSC LABORATORY ID No. 111693I	
A1105-26	Roof northwest end Multi-layer roof core	1. 50% Chrysotile 2. 2% Chrysotile	No	Good	12,500 sq. ft.
A1105-27	Roof north side Light gray tar on roof vents	30% Chrysotile	No	Good	100 sq. ft.
A1105-28	Interior west end by entrance door Light beige with darker brown 9" x 9" floor tile	Tile - <1% Chrysotile Mastic - 7% Chrysotile	No	Fair	12,000 sq. ft.
A1105-29	Interior Room 5 Soutwest office Drywall	None detected	Yes	Fair	6,000 sq. ft.
A1105-32	Interior kitchen Beige with brown 12" x 12" floor tile	Tile - <1% Chrysotile Mastic - None detected	No	Fair	144 sq. ft.
A1105-30	Interior Room 9 1' x 1' wall tile with holes	None detected	Yes	Fair	Mixed with sample A1105-31

SAMPLE ID NO	SAMPLE LOCATION / DESCRIPTION	ANALYTICAL RESULTS (PPM)	CONDITION	AMOUNT
BUILDING NUMBER 970		BUILDING NAME NAVOcean ProFac		BUILDING DESCRIPTION 1 Story
TSC PROJECT NUMBER 865		TSC INSPECTOR J. Kain and B. Kain		TSC LABORATORY ID No. 111693C
L1105-47	Interior southwest office, room 4 Off-white paint on wall	16,875.0	Fair	11,000 sq. ft.
L1105-48	Interior east side, room 16 Green paint on wall	26,026.1	Fair	200 sq. ft.
L1105-49	Exterior north wall Off-white paint on block wall	811.3	Fair	6,000 sq. ft.
L1105-50	Exterior north door, room 23 Blue paint on door	225.8	Fair	400 sq. ft.
L1105-51	Interior north side air conditioning room 21 Red deck paint	3,258.3	Good	350 sq. ft.
L1105-52	Interior north side electrical room 23 Gray deck paint	5,154.3	Poor	300 sq. ft.
L1105-53	Interior north side transformer room 23 Light gray paint on transformer	1,449.5	Good	500 sq. ft.
L1105-54	Interior north side air condition room 21 White paint on tank	5,198.2	Poor	250 sq. ft.

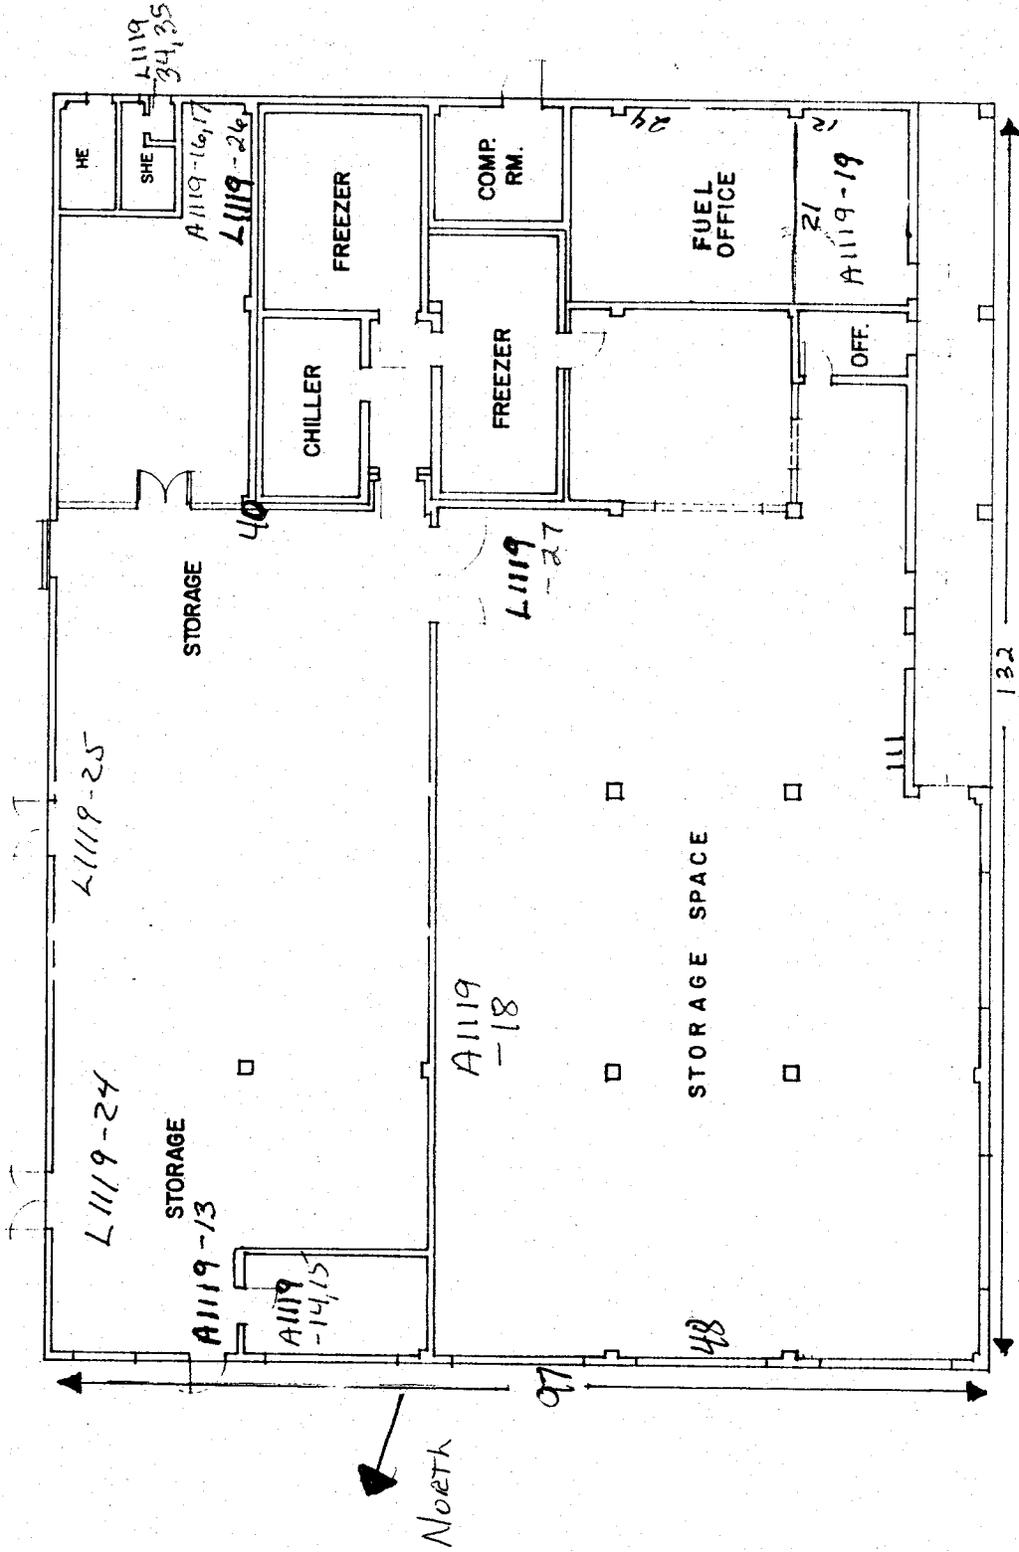
FLOOR PLAN

PICUNIQ MANAGEMENT CORPORATION
 NAVAL AIR FACILITY - MIDWAY ISLAND
GENERAL STORAGE / FUEL OFFICE
BLDG. 2403

SAMPLE ID NO	SAMPLE LOCATION / DESCRIPTION	ANALYTICAL RESULTS	FRIABLE	CONDITION	AMOUNT										
<table border="1" style="width: 100%; border-collapse: collapse; margin-bottom: 10px;"> <tr> <td style="width: 30%;">BUILDING NUMBER 2403</td> <td style="width: 35%;">BUILDING NAME General Storage/Fuel Office</td> <td colspan="3">BUILDING DESCRIPTION 1 Story</td> </tr> <tr> <td>TSC PROJECT NUMBER 865</td> <td>TSC INSPECTOR J. Kain and B. Kain</td> <td colspan="3">TSC LABORATORY ID No. 113093J</td> </tr> </table>						BUILDING NUMBER 2403	BUILDING NAME General Storage/Fuel Office	BUILDING DESCRIPTION 1 Story			TSC PROJECT NUMBER 865	TSC INSPECTOR J. Kain and B. Kain	TSC LABORATORY ID No. 113093J		
BUILDING NUMBER 2403	BUILDING NAME General Storage/Fuel Office	BUILDING DESCRIPTION 1 Story													
TSC PROJECT NUMBER 865	TSC INSPECTOR J. Kain and B. Kain	TSC LABORATORY ID No. 113093J													
INTERIOR:															
A1119-13	Northeast side Black with white and green streaks 9" x 9" floor tile	15% Chrysotile	No	Poor	150 sq. ft.										
A1119-14	Storage north end Black with white streaks 9" x 9" floor tile	Tile - 8% Chrysotile Mastic - 10% Chrysotile	No	Poor	260 sq. ft. mixed with A1119-15										
A1119-15	Storage north end Beige with brown and white streaks 9" x 9" floor tile	Tile - 1-2% Chrysotile Mastic - 8% Chrysotile	No	Poor	Mixed with A1119-14										
A1119-16	Southeast side Pipe lagging	37% Chrysotile	Yes	Fair	300 lin. ft. mixed with A1119-17										
A1119-17	Southeast side Pipe elbow insulation	26% Chrysotile	Yes	Fair	Mixed with A1119-16										
A1119-18	Northwest side Beige with brown streaks 9" x 9" floor tile	Tile - 10% Chrysotile Mastic - 5% Chrysotile	No	Poor	5,850 sq. ft.										
A1119-19	Fuel office Off-white with brown streaks 12" x 12" floor tile	Tile - 7% Chrysotile Mastic - 12%	No	Fair	260 sq. ft.

SAMPLE ID NO	SAMPLE LOCATION / DESCRIPTION	ANALYTICAL RESULTS (PPM)	CONDITION	AMOUNT
BUILDING NUMBER 2403		BUILDING NAME General Storage/Fuel Office		BUILDING DESCRIPTION 1 Story
TSC PROJECT NUMBER 865		TSC INSPECTOR J. Kain and B. Kain		TSC LABORATORY ID NO. 113093G
INTERIOR:				
L1119-24	Storage northeast side Green paint on wall	469.5	Fair	12,000 sq. ft. mixed with L1119-25, 26 & 27
L1119-25	Storage northeast side Blue paint on trim	4,238.6	Fair	Mixed with L1119-24, 26 & 27
L1119-26	Storage south east side Yellow paint on wall	224,704.3	Fair	Mixed with L1119-24, 25 & 27
L1119-27	Storage southwest side Pink with green paint on wall	2,953.5	Fair	Mixed with L1119-24, 25 & 26
L1119-35	Women's restroom White paint on ceiling	2,707.5	Poor	13,000 sq. ft.
No sample collected	Electrical room Gray paint on voltage box Same as sample L1117-65, building 350	281,887.7	Fair	250 sq. ft.
EXTERIOR:				
L1119-34	Women's Restroom door south side Beige, blue and green paint on door jamb	66,675.0	Fair	225 sq. ft.

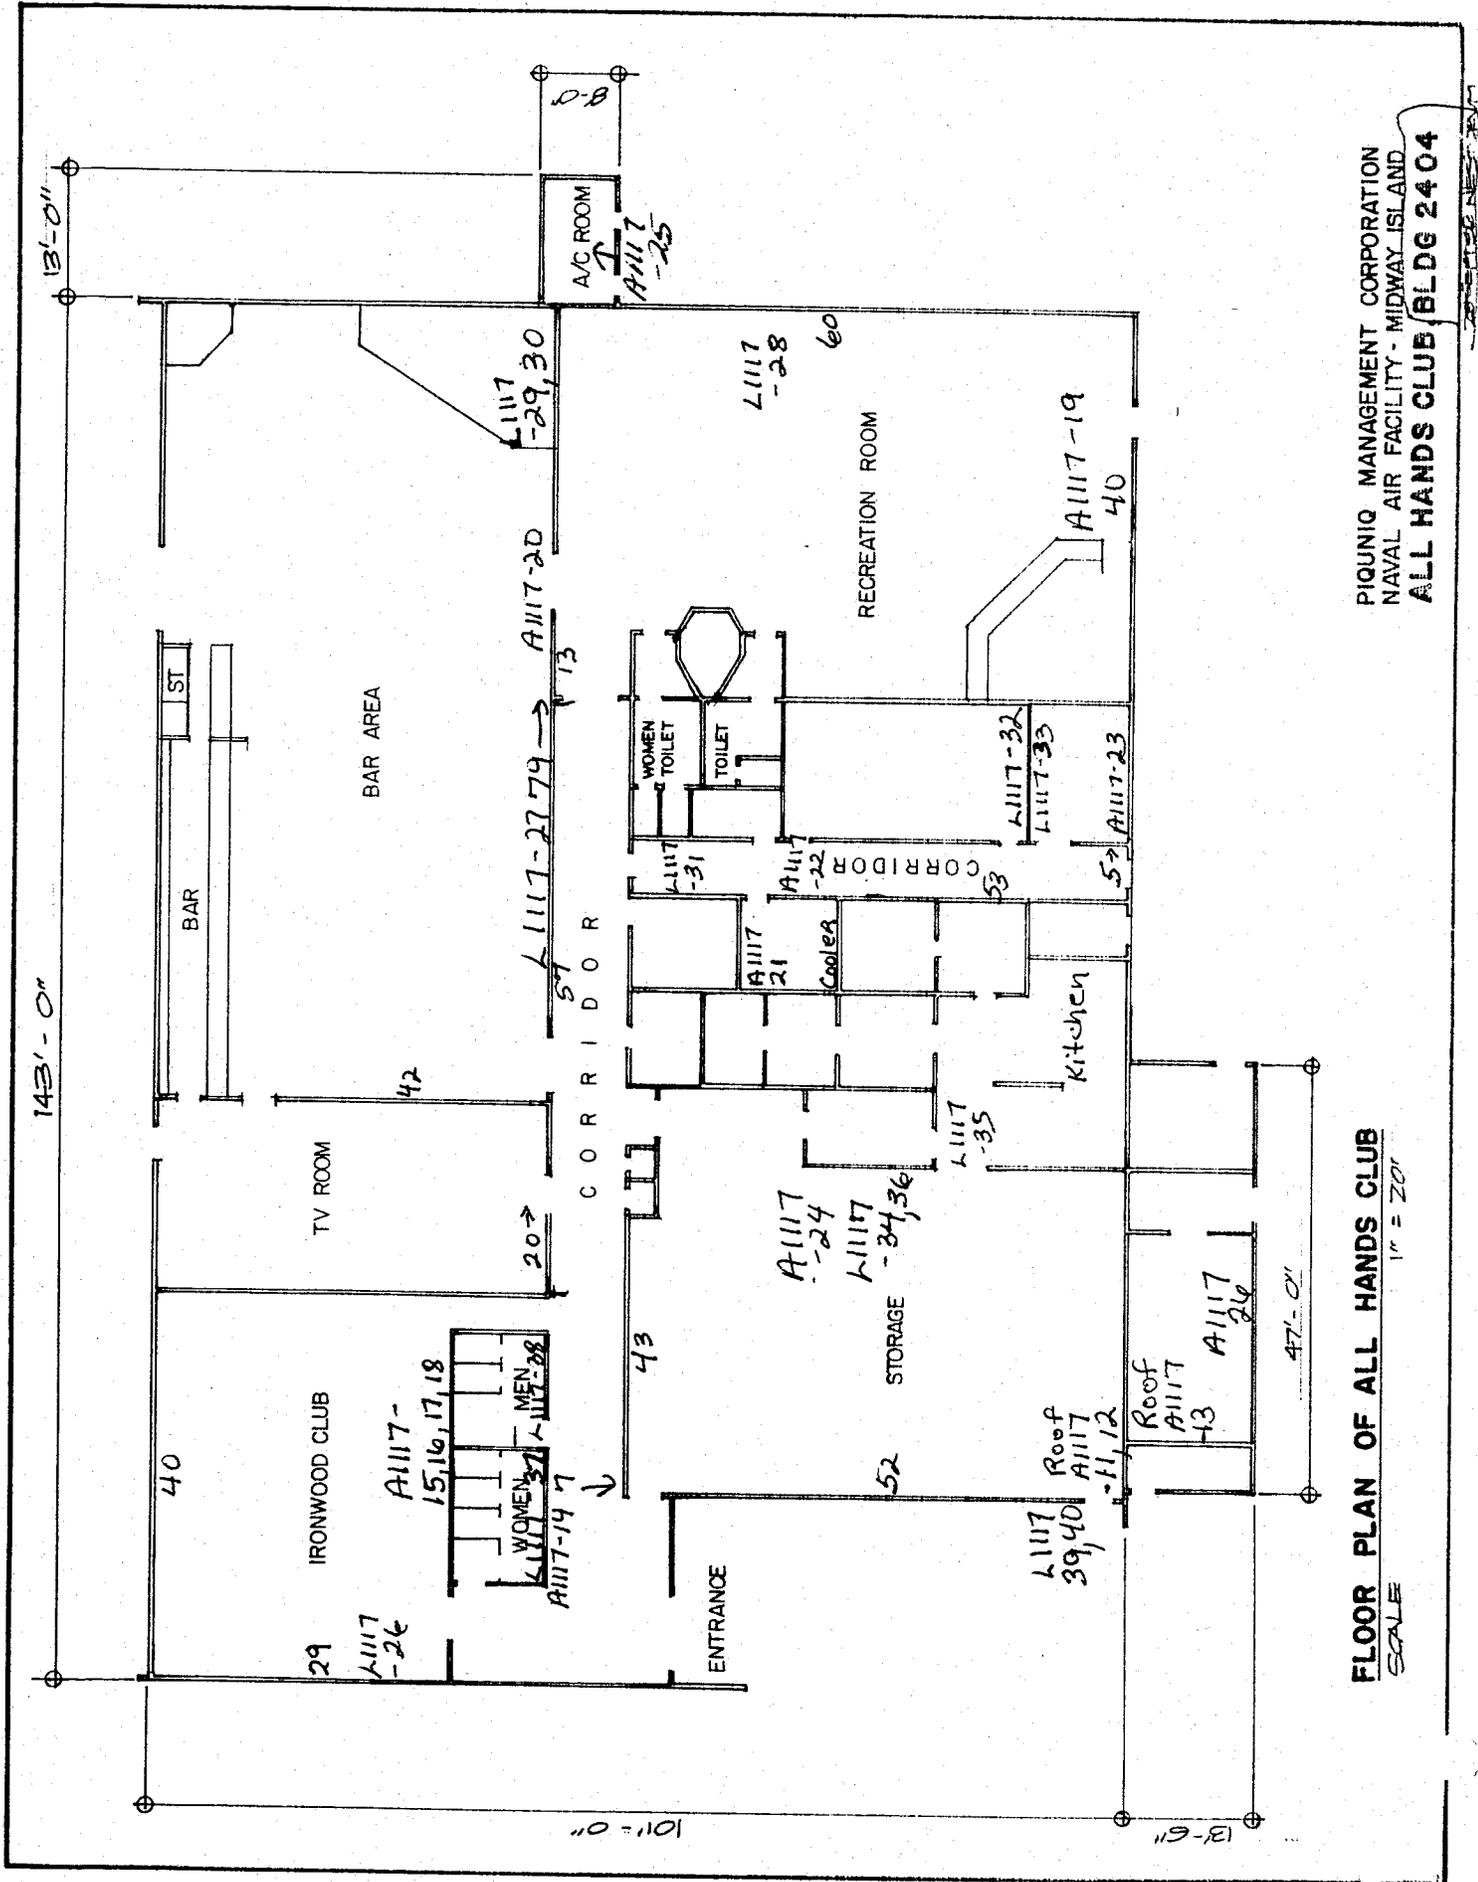
FLOOR PLAN OF ALL HANDS CLUB
 SCALE 1" = 20'

PIQUINQ MANAGEMENT CORPORATION
 NAVAL AIR FACILITY - MIDWAY ISLAND
ALL HANDS CLUB BLDG 2404

SAMPLE ID NO	SAMPLE LOCATION / DESCRIPTION	ANALYTICAL RESULTS	FRIABLE	CONDITION	AMOUNT
BUILDING NUMBER 2404		BUILDING NAME All Hands Club		BUILDING DESCRIPTION 1 Story	
TSC PROJECT NUMBER 865		TSC INSPECTOR J. Kain and B. Kain		TSC LABORATORY ID No. 113093D	
ROOF:					
A1117-11	Upper section west side Roof core; rock roof	None detected	No	Good	15,000 sq. ft.
A1117-12	Upper section west side Tar seal on vent	15% Chrysotile	No	Good	1,500 sq. ft.
A1117-13	Upper section west side White rolled roof shingle	None detected	No	Poor	500 sq. ft.
INTERIOR:					
A1117-14	North end by entrance door Beige with brown and white flecks 12" x 12" floor tile	Tile - None detected Mastic - 8% Chrysotile	No	Fair	450 sq. ft.
	2nd layer of sample A1117-14 Green floor tile		No	Unknown	Unknown
A1117-15	Ironwood Club south side Gray with orange and white streaks 9" x 9" floor tile	None detected	No	Fair	1,200 sq. ft. mixed with A1117-16 & 18

SAMPLE ID NO	SAMPLE LOCATION / DESCRIPTION	ANALYTICAL RESULTS	FRIABLE	CONDITION	AMOUNT
BUILDING NUMBER 2404		BUILDING NAME All Hands Club		BUILDING DESCRIPTION 1 Story	
TSC PROJECT NUMBER 865		TSC INSPECTOR J. Kain and B. Kain		TSC LABORATORY ID No. 113093D	
A1117-20	Bar area west side Gold with brown and yellow flecks (2 layers)(black and white underneath) 12" x 12" floor tile	Tile - None detected Mastic - 5% Chrysotile	No	Good	3,400 sq. ft.
A1117-21	Cooler Black tar on ceiling	None detected	No	Fair	160 sq. ft.
A1117-22	Corridor Green with white and green 9" x 9" floor tile	Tile - None detected Mastic - 2% Chrysotile	No	Fair	300 sq. ft.
A1117-23	Accounting room Light brown with brown and gold flecks 9" x 9" floor tile	Tile - 1-2% Chrysotile Mastic - 3% Chrysotile	No	Fair	140 sq. ft.
A1117-24	Storage room west side Off-white with beige flecks 12" x 12" floor tile	Tile - <1% Chrysotile Mastic - 12% Chrysotile	No	Fair	2,300 sq. ft.

SAMPLE ID NO	SAMPLE LOCATION / DESCRIPTION	ANALYTICAL RESULTS (PPM)	CONDITION	AMOUNT
INTERIOR:				
L1117-26	Ironwood Club north side behind air handler Green paint on wall behind panelling	4,333.5	Fair	1,800 sq. ft.
L1117-27	Bar area west wall Orange paint	41,844.2	Good	500 sq. ft.
L1117-28	Recreation area Off-white paint on wall	4,436.8	Good	2,600 sq. ft.
L1117-29	Bar area south wall Gold paint over stage area	30,957.4	Good	100 sq. ft.
L1117-30	Bar and stage area Gold paint on ceiling tile above suspended tile	1,830.6	Good	3,400 sq. ft.
L1117-31	Corridor Gold paint on wall	2,874.5	Fair	1,400 sq. ft.
L1117-32	Liquor room Mauve paint on wall	1,875.8	Fair	3,700 sq. ft.
L1117-33	Accounting office Beige paint on door	2,505.9	Poor	75 sq. ft.
L1117-34	Storage room Gold paint on ceiling tiles	1,346.7	Fair	2,300 sq. ft.
L1117-35	Kitchen off storage room Gold paint on ceiling	2,732.8	Poor	500 sq. ft.
L1117-36	Storage room east wall Yellow paint	3,354.0	Fair	2,500 sq. ft.

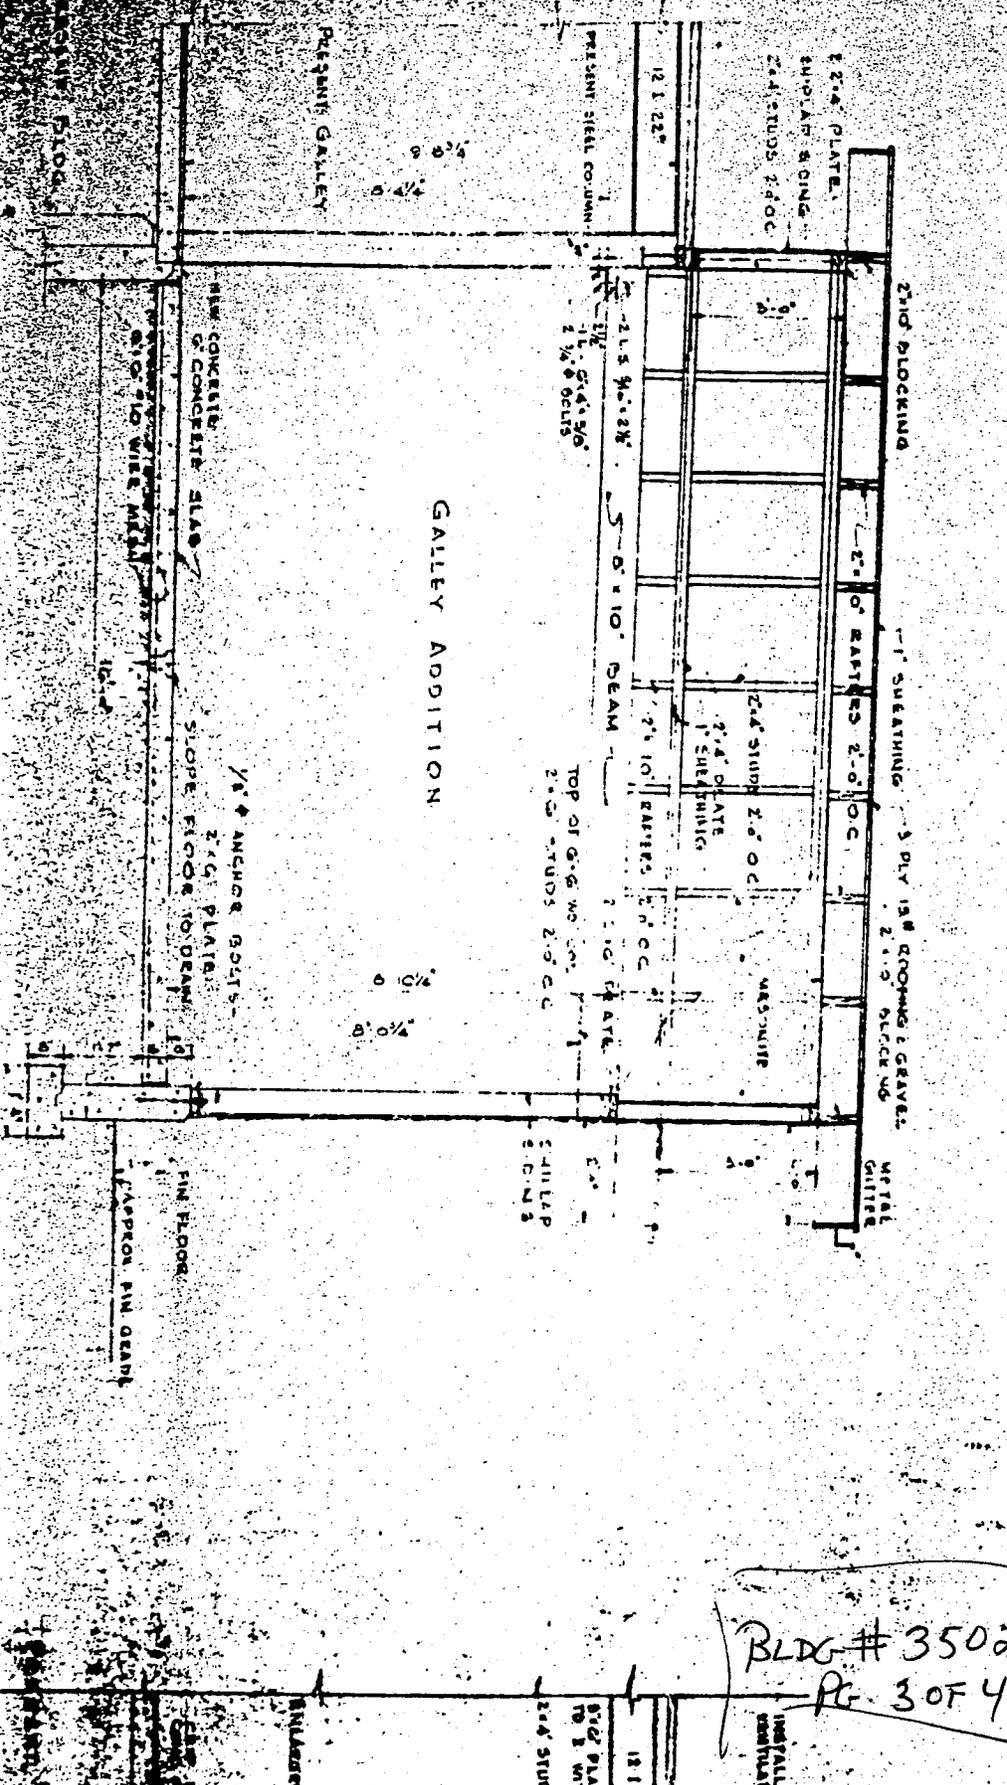
SECTION A-A

GALLEY ADDITION

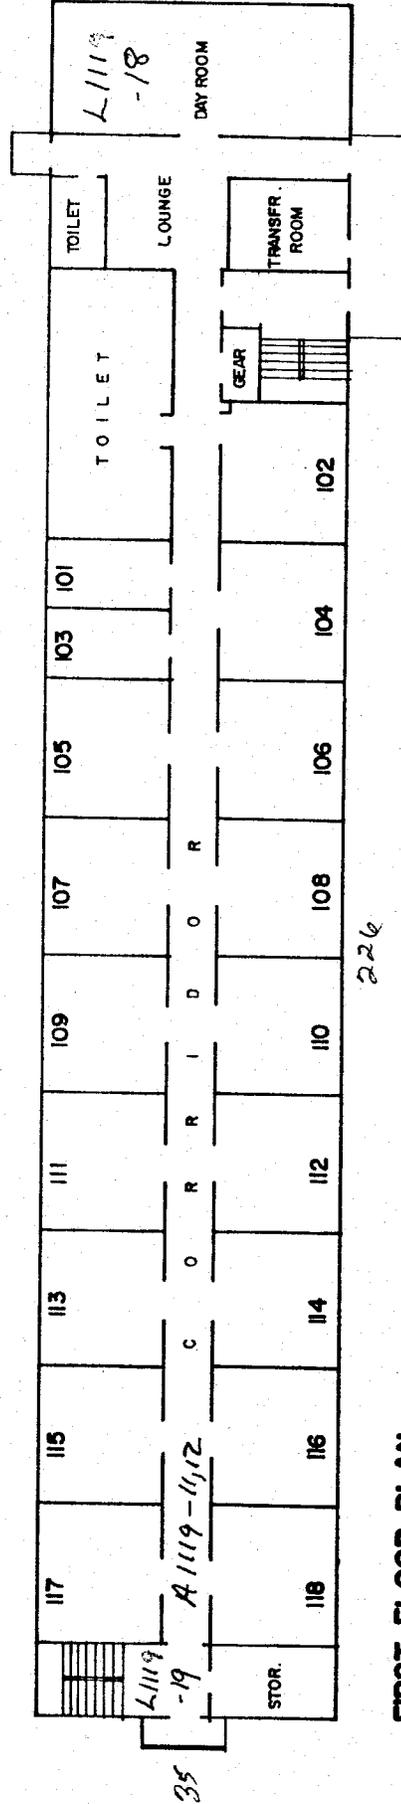
FIRST FLOOR PLAN

PIQUINQ MANAGEMENT CORPORATION
 NAVAL AIR FACILITY - MIDWAY ISLAND
B.E.Q. CHARLIE, BLDG. NO. 3503
