ASBESTOS BULK SAMPLING LOG

NAF MIDWAY

THE SZARAS COMPANIES

SAMPLE ID NO	SAMPLE LOCATION / DESCRIPTION	ANALYTICAL RESULTS	FRIABLE	CONDITION	AMOUNT										
<table border="1" style="width: 100%; border-collapse: collapse;"> <tr> <td style="width: 30%;">BUILDING NUMBER 619</td> <td style="width: 35%;">BUILDING NAME Pacific Cable House</td> <td colspan="3">BUILDING DESCRIPTION 1 Story</td> </tr> <tr> <td>TSC PROJECT NUMBER 865</td> <td>TSC INSPECTOR J. Kain and B. Kain</td> <td colspan="3">TSC LABORATORY ID No. 120293C</td> </tr> </table>						BUILDING NUMBER 619	BUILDING NAME Pacific Cable House	BUILDING DESCRIPTION 1 Story			TSC PROJECT NUMBER 865	TSC INSPECTOR J. Kain and B. Kain	TSC LABORATORY ID No. 120293C		
BUILDING NUMBER 619	BUILDING NAME Pacific Cable House	BUILDING DESCRIPTION 1 Story													
TSC PROJECT NUMBER 865	TSC INSPECTOR J. Kain and B. Kain	TSC LABORATORY ID No. 120293C													
INTERIOR:															
A1123-26	Basement north end Brown sheet vinyl	Tile - None detected Mastic - 10% Chrysotile	Yes	Fair	110 sq. ft.										
A1123-27	Kitchen south end Red stamped pattern 12" x 12" floor tile	Tile - 2% Chrysotile Mastic - 1-2% Chrysotile	No	Fair	300 sq. ft.

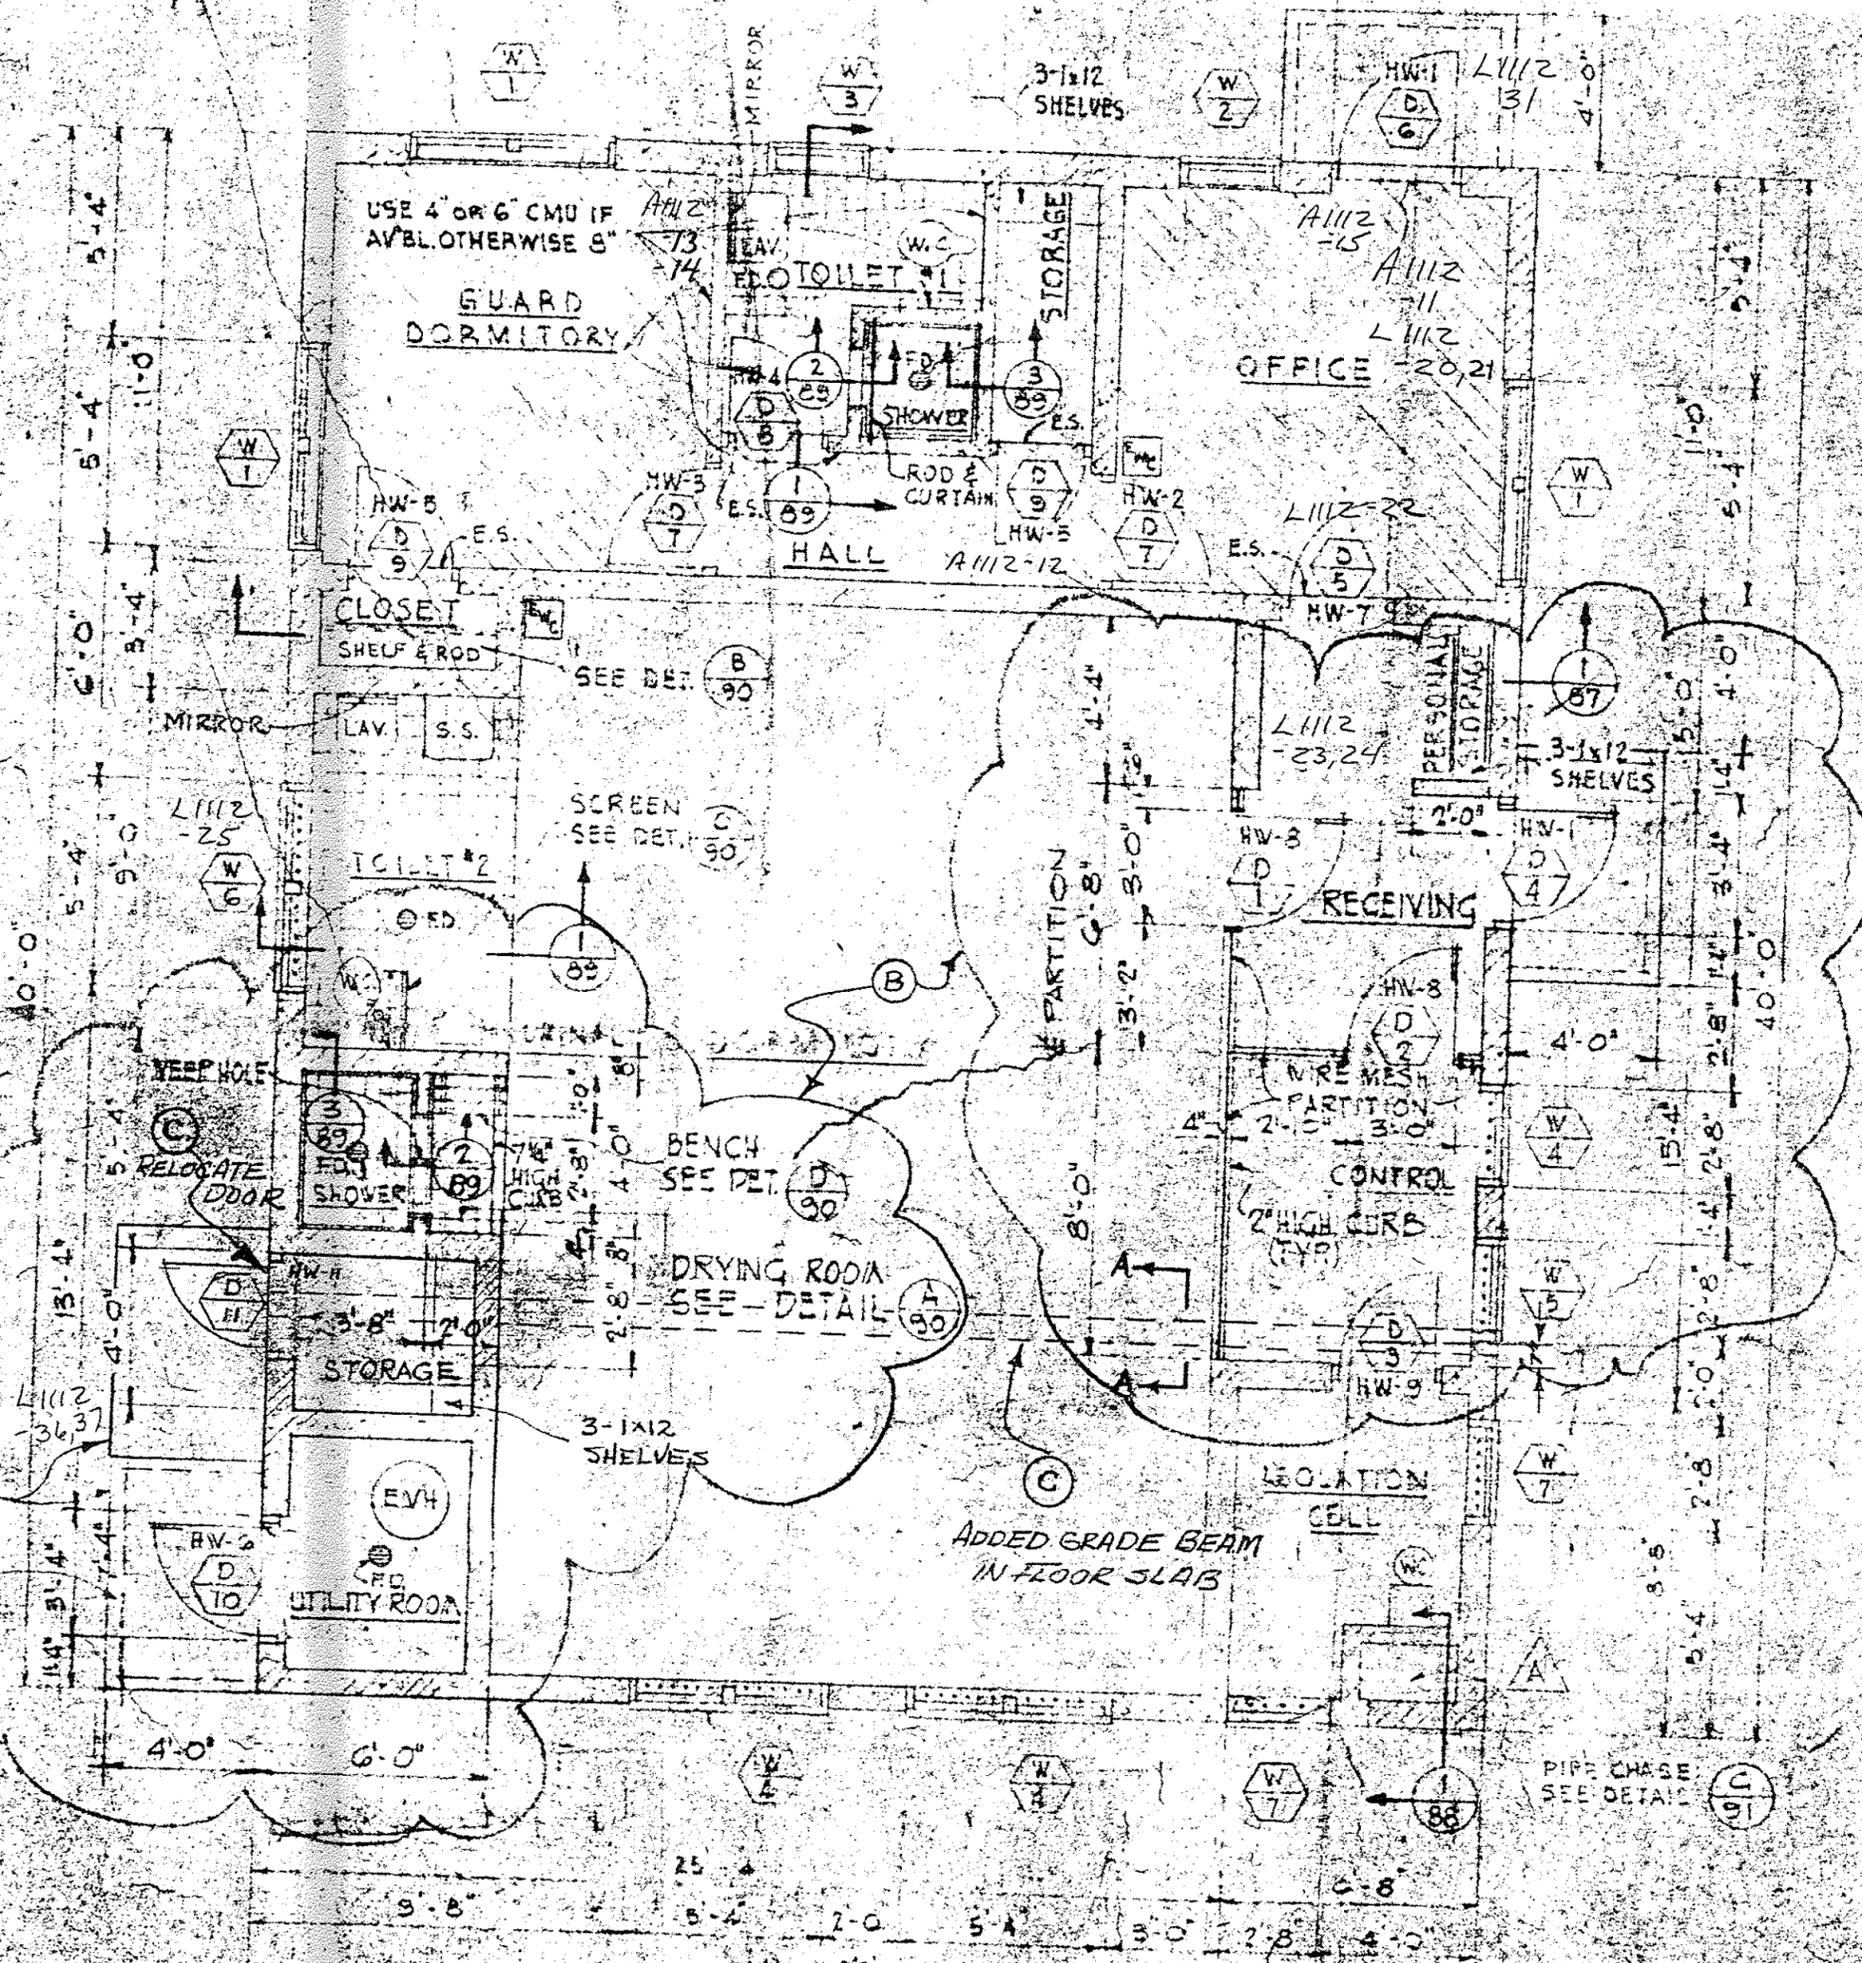
BUDG # 3513
BLDG 3513

4'-0" x 6'-0" CONC. SLAB 4" THICK WITH 6x6-8/8 WWF (TYPICAL AT ALL EXTERIOR DOORS)
THICKEN SLAB TO 6" ALL AROUND (TYP)

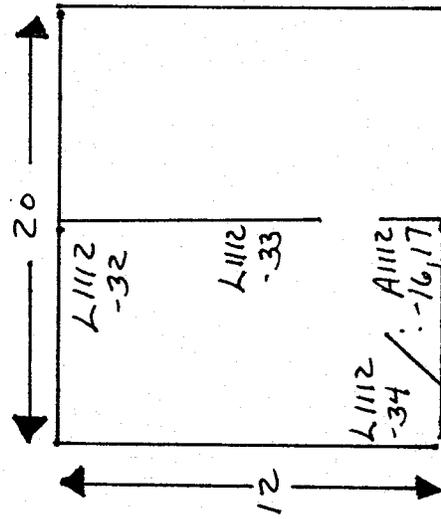
Bld # 3514
Security Police
OFFICE

L1112
35

SAMPLE ID NO	SAMPLE LOCATION / DESCRIPTION	ANALYTICAL RESULTS (PPM)	CONDITION	AMOUNT								
<table border="1" style="width: 100%; border-collapse: collapse;"> <tr> <td style="width: 30%;">BUILDING NUMBER 3514</td> <td style="width: 35%;">BUILDING NAME Security Police Office</td> <td colspan="2">BUILDING DESCRIPTION 1 Story</td> </tr> <tr> <td>TSC PROJECT NUMBER 865</td> <td>TSC INSPECTOR J. Kain and B. Kain</td> <td colspan="2">TSC LABORATORY ID No. 112393A</td> </tr> </table>					BUILDING NUMBER 3514	BUILDING NAME Security Police Office	BUILDING DESCRIPTION 1 Story		TSC PROJECT NUMBER 865	TSC INSPECTOR J. Kain and B. Kain	TSC LABORATORY ID No. 112393A	
BUILDING NUMBER 3514	BUILDING NAME Security Police Office	BUILDING DESCRIPTION 1 Story										
TSC PROJECT NUMBER 865	TSC INSPECTOR J. Kain and B. Kain	TSC LABORATORY ID No. 112393A										
	INTERIOR:											
L1112-32	South wall Beige paint	20,025.0	Fair	700 sq. ft.								
L1112-33	West wall Blue paint	485.7	Fair	150 sq. ft.								
L1112-34	North wall Black paint on baseboard	312.5	Good	30 sq. ft.								
	EXTERIOR:											
No sample collected	Brown paint on door Same as sample L1112-22, building 3513	414.5	Fair	150 sq. ft.								
L1112-35	North wall Beige paint	1,238.5	Fair	600 sq. ft.

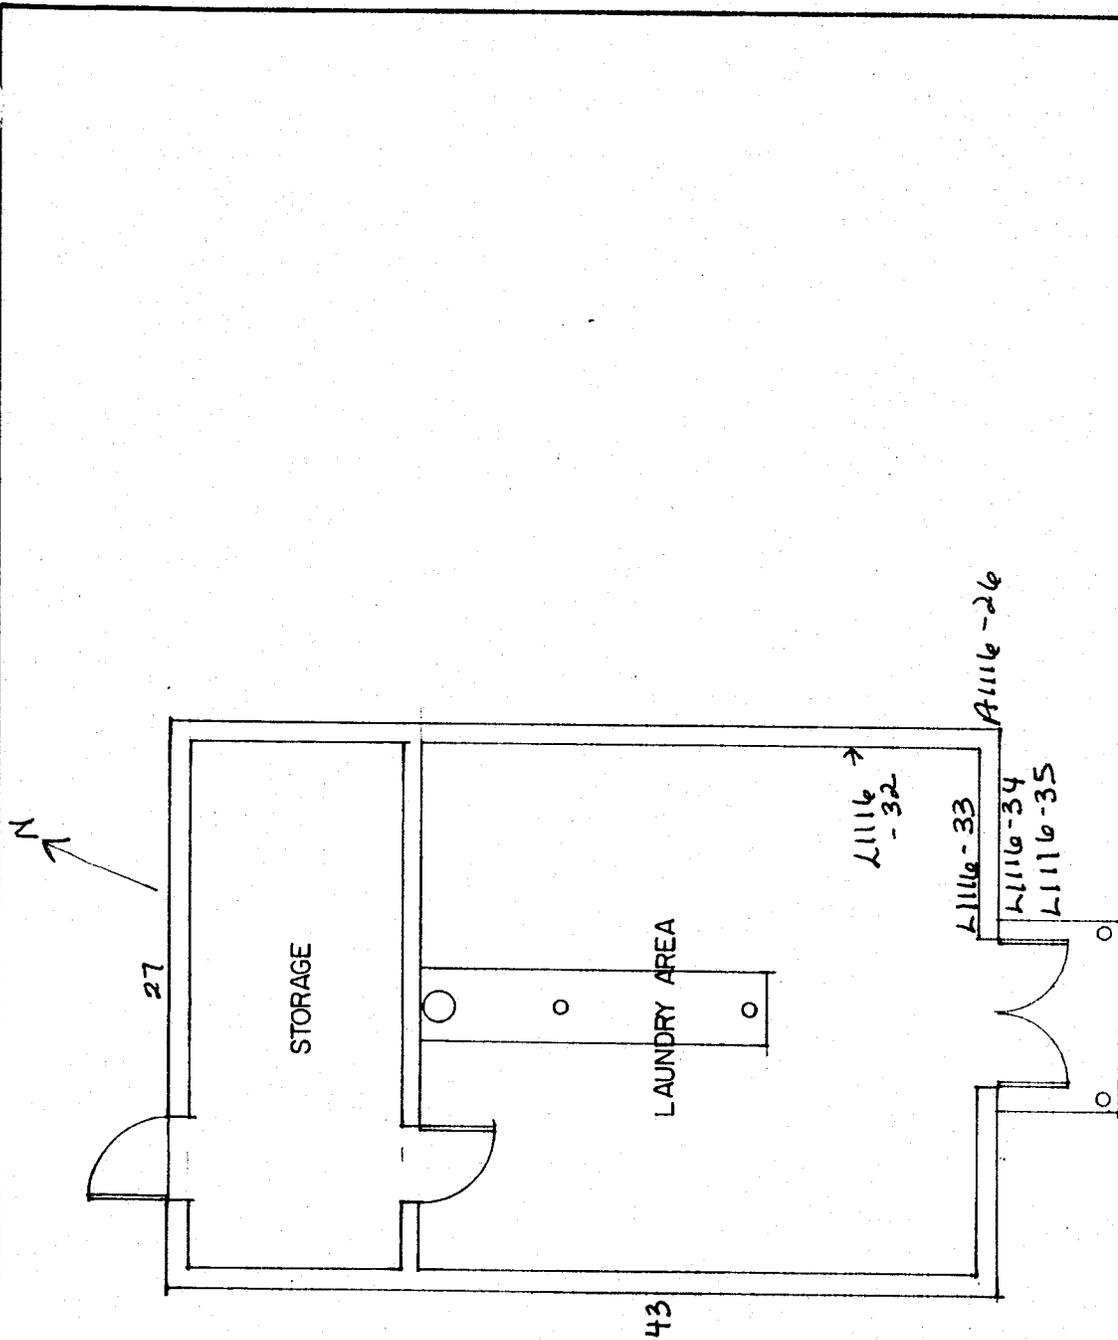
FLOOR PLAN

LAUNDRY DETACHED, BLDG. 3515

SAMPLE ID NO	SAMPLE LOCATION / DESCRIPTION	ANALYTICAL RESULTS (PPM)	CONDITION	AMOUNT								
<table border="1" style="width: 100%; border-collapse: collapse;"> <tr> <td style="width: 30%;">BUILDING NUMBER 3515</td> <td style="width: 35%;">BUILDING NAME Laundry Room</td> <td colspan="2">BUILDING DESCRIPTION 1 Story</td> </tr> <tr> <td>TSC PROJECT NUMBER 865</td> <td>TSC INSPECTOR J. Kain and B. Kain</td> <td colspan="2">TSC LABORATORY ID No. 113093B</td> </tr> </table>					BUILDING NUMBER 3515	BUILDING NAME Laundry Room	BUILDING DESCRIPTION 1 Story		TSC PROJECT NUMBER 865	TSC INSPECTOR J. Kain and B. Kain	TSC LABORATORY ID No. 113093B	
BUILDING NUMBER 3515	BUILDING NAME Laundry Room	BUILDING DESCRIPTION 1 Story										
TSC PROJECT NUMBER 865	TSC INSPECTOR J. Kain and B. Kain	TSC LABORATORY ID No. 113093B										
INTERIOR:												
L1116-32	East wall Pale yellow paint	2,045.4	Fair	1,700 sq. ft.								
L1116-33	Door frame south side Blue paint	3,010.7	Fair	450 sq. ft.								
EXTERIOR:												
L1116-34	South side Off-white paint on wall	440.5	Good	1,700 sq. ft.								
L1116-35	South side Red paint on floor	209.5	Poor	25 sq. ft.								
No sample collected	Brown paint on door Same as sample L1116-37, building 3529	161.8	Fair	600 sq. ft.

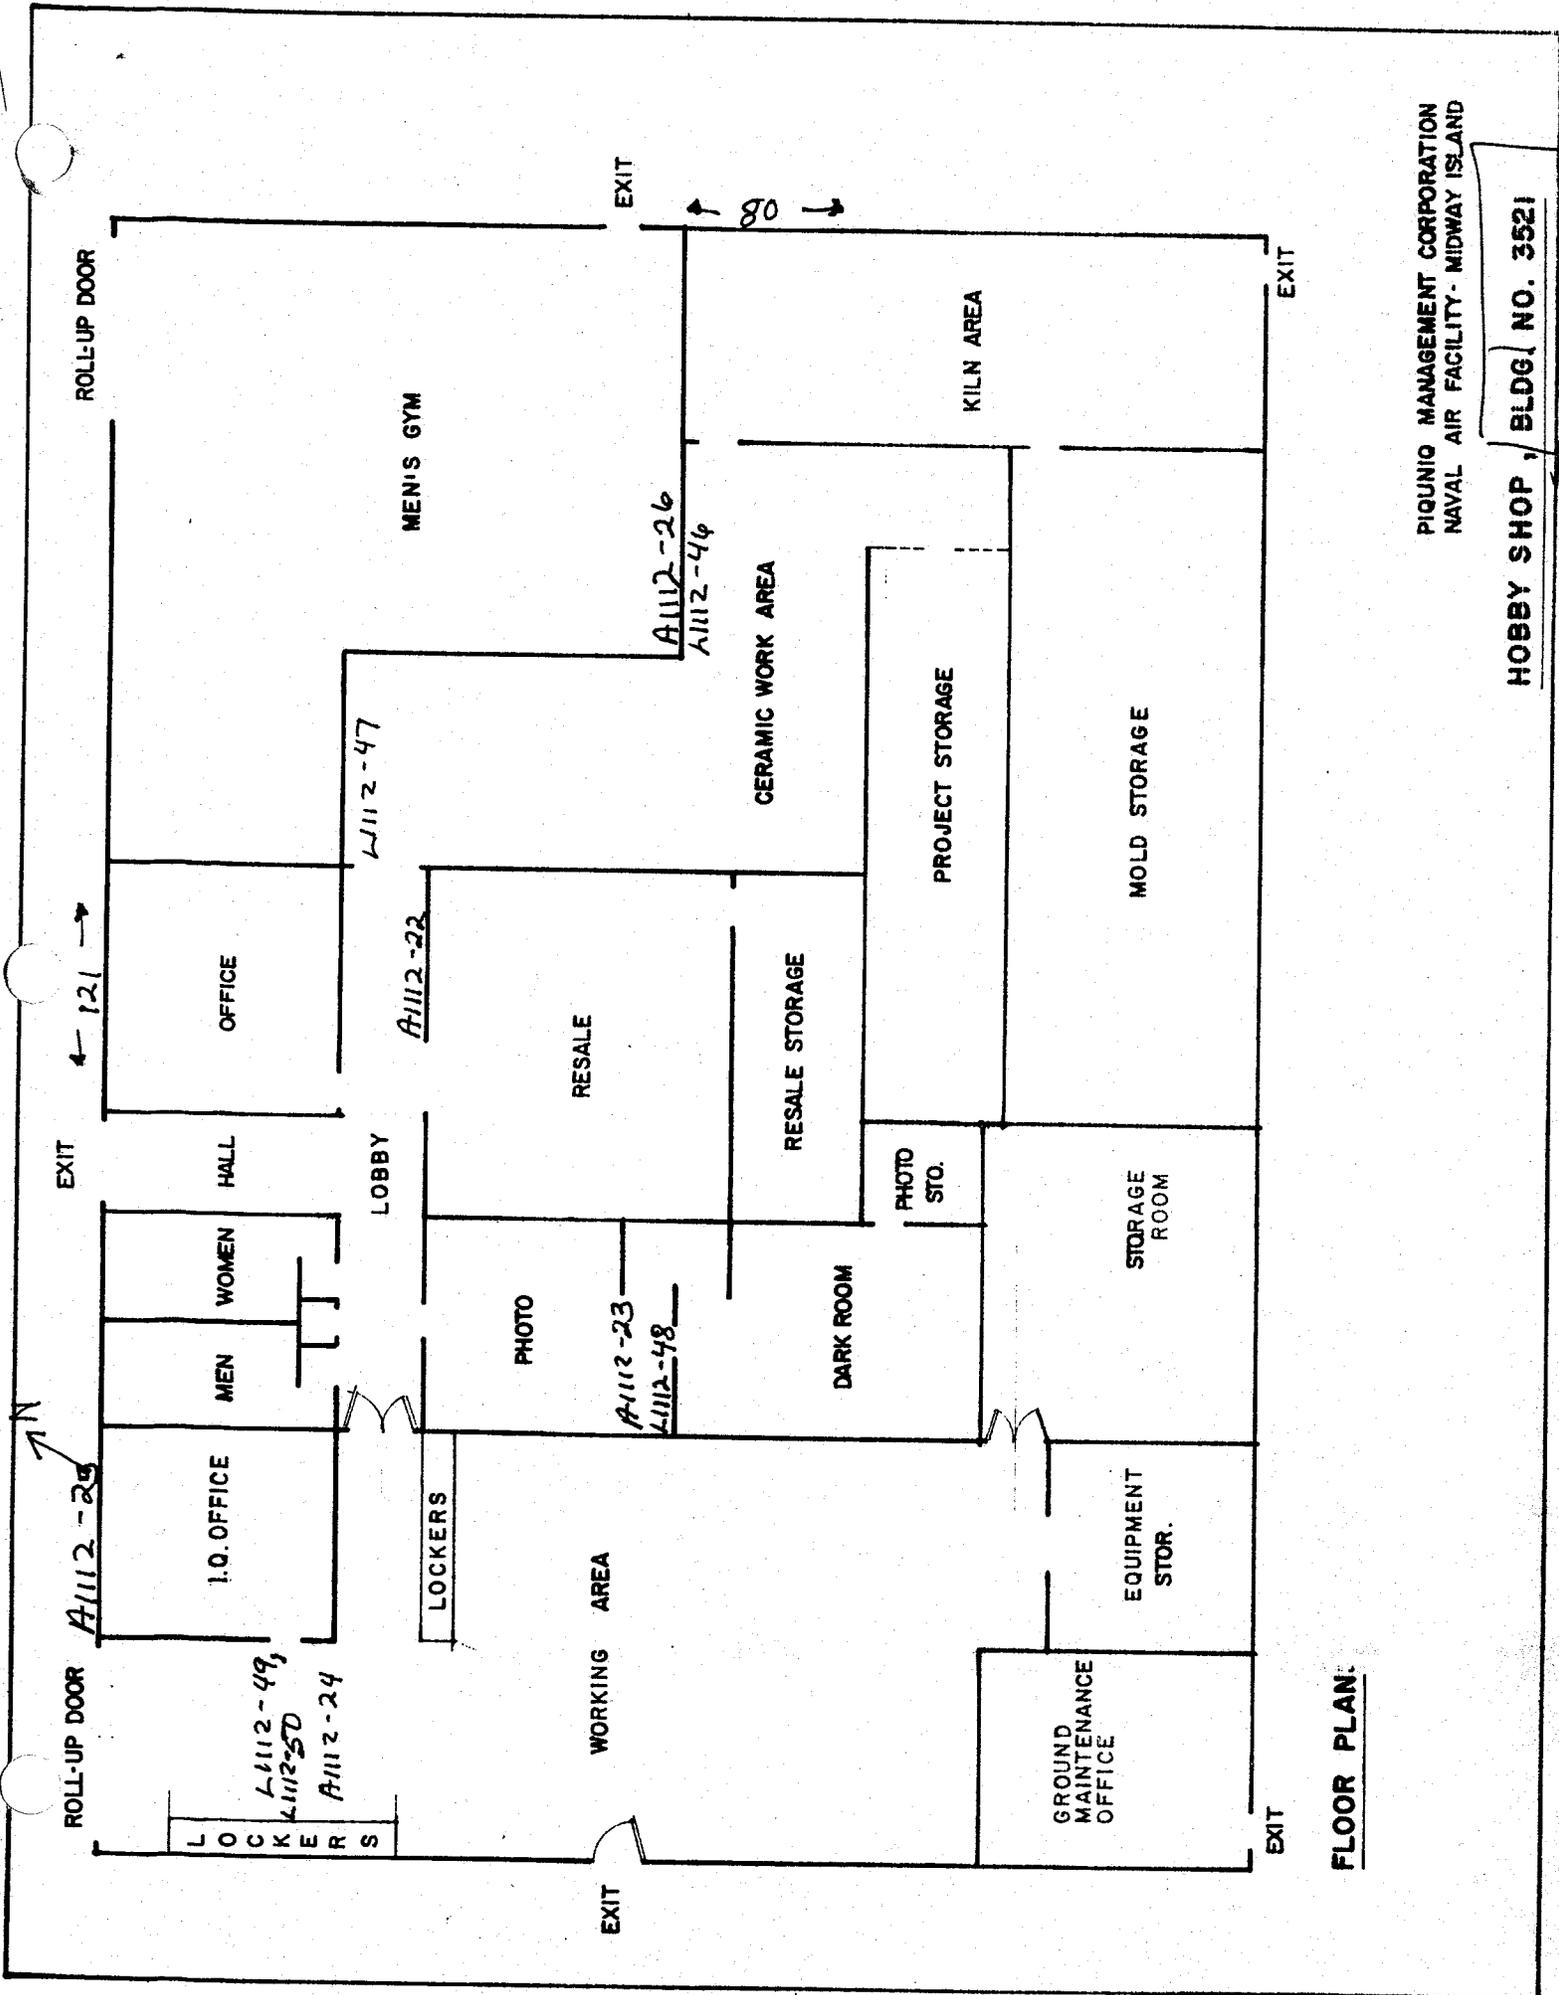
FLOOR PLAN:

PIQUINO MANAGEMENT CORPORATION
 NAVAL AIR FACILITY - MIDWAY ISLAND

SAMPLE ID NO	SAMPLE LOCATION / DESCRIPTION	ANALYTICAL RESULTS (PPM)	CONDITION	AMOUNT								
<table border="1" style="width: 100%; border-collapse: collapse;"> <tr> <td style="width: 30%;">BUILDING NUMBER 3521</td> <td style="width: 35%;">BUILDING NAME MWR Hobby Shop</td> <td colspan="2">BUILDING DESCRIPTION 1 Story</td> </tr> <tr> <td>TSC PROJECT NUMBER 865</td> <td>TSC INSPECTOR J. Kain and B. Kain</td> <td colspan="2">TSC LABORATORY ID No. 112393A</td> </tr> </table>					BUILDING NUMBER 3521	BUILDING NAME MWR Hobby Shop	BUILDING DESCRIPTION 1 Story		TSC PROJECT NUMBER 865	TSC INSPECTOR J. Kain and B. Kain	TSC LABORATORY ID No. 112393A	
BUILDING NUMBER 3521	BUILDING NAME MWR Hobby Shop	BUILDING DESCRIPTION 1 Story										
TSC PROJECT NUMBER 865	TSC INSPECTOR J. Kain and B. Kain	TSC LABORATORY ID No. 112393A										
	INTERIOR:											
L1112-46	Ceramic work area Light green paint on wall	161.9	Good	15,000 sq. ft.								
L1112-47	Ceramic work area Dark green paint on door	327.9	Good	3,000 sq. ft.								
L1112-48	Photo room Eggshell paint on wall	255.7	Good	600 sq. ft.								
L1112-49	Working area White paint on ceiling	451.0	Fair	2,500 sq. ft.								
L1112-50	Working area White with yellow paint below on conduit	1,427.2	Poor	125 sq. ft.

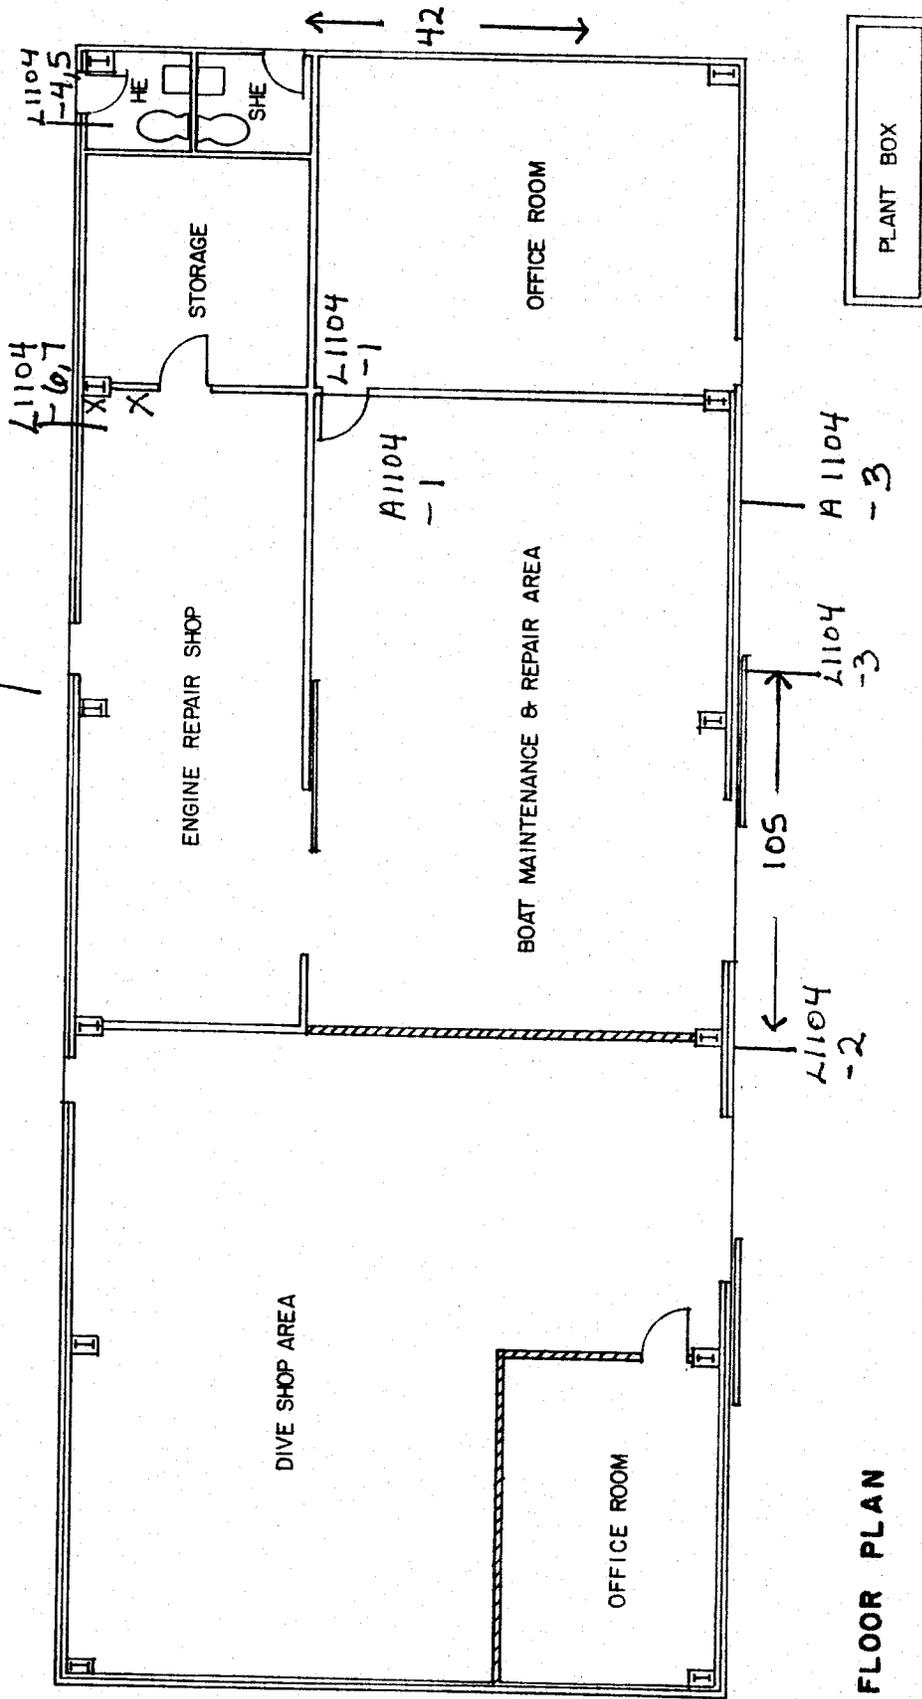
FLOOR PLAN

PIQUINIC MANAGEMENT CORPORATION
 NAVAL AIR FACILITY - MIDWAY ISLAND

SAMPLE ID NO	SAMPLE LOCATION / DESCRIPTION	ANALYTICAL RESULTS (PPM)	CONDITION	AMOUNT
BUILDING NUMBER 3522		BUILDING NAME Boat House		BUILDING DESCRIPTION 1 Story
TSC PROJECT NUMBER 865		TSC INSPECTOR J. Kain and B. Kain		TSC LABORATORY ID No. 111693B
L1104-1	Interior office Gray paint on deck	21.8	Fair	650 sq. ft.
L1104-2	Exterior south side White paint on wood	None detected	Poor	3,600 sq. ft.
L1104-3	Exterior south side Brown paint on sliding door	4.4	Poor	3,000 sq. ft.
L1104-4	Interior north restroom Red deck paint	165.1	Fair	150 sq. ft.
L1104-5	Interior north restroom White paint on wall	None detected	Good	800 sq. ft.
L1104-6	Interior workshop Dark gray paint on shop wall	3,064.8	Good	1,100 sq. ft.
L1104-7	Interior fire sprinkler in workshop Red paint on pipe	86,710.5	Good	400 lin. ft.

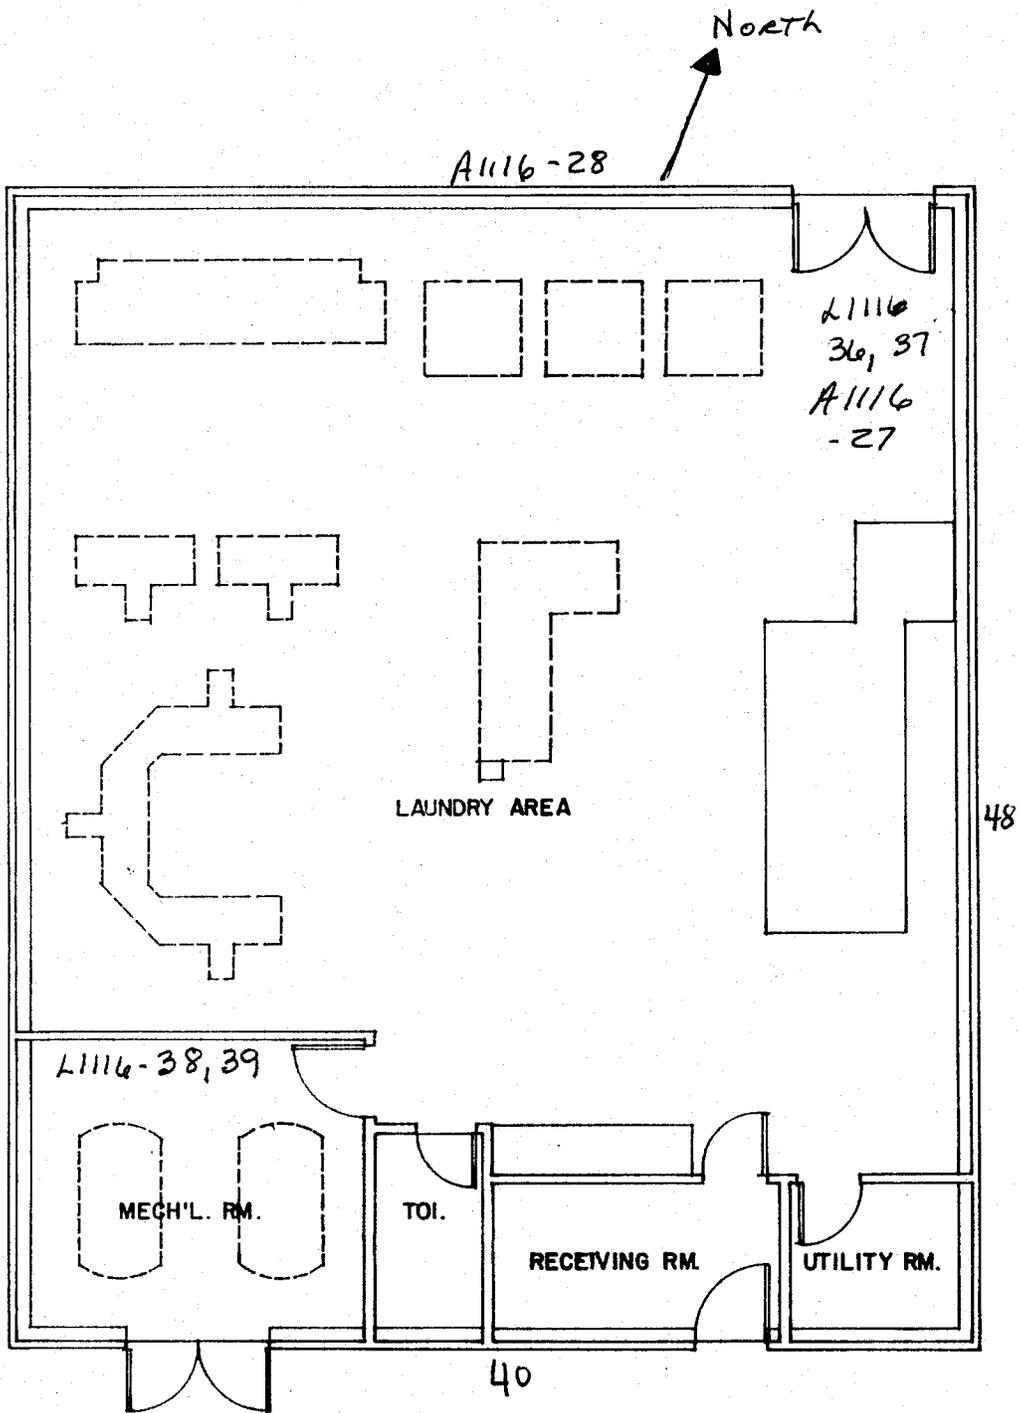
FLOOR PLAN

PIQUINQ MANAGEMENT CORPORATION
 NAVAL AIR FACILITY- MIDWAY ISLAND
BASE LAUNDRY, BLDG. NO. 3529
