**Midway Atoll National Wildlife Refuge Seawall Repair Project –
Conservation Measures Plan**

September 27, 2018

Project Description

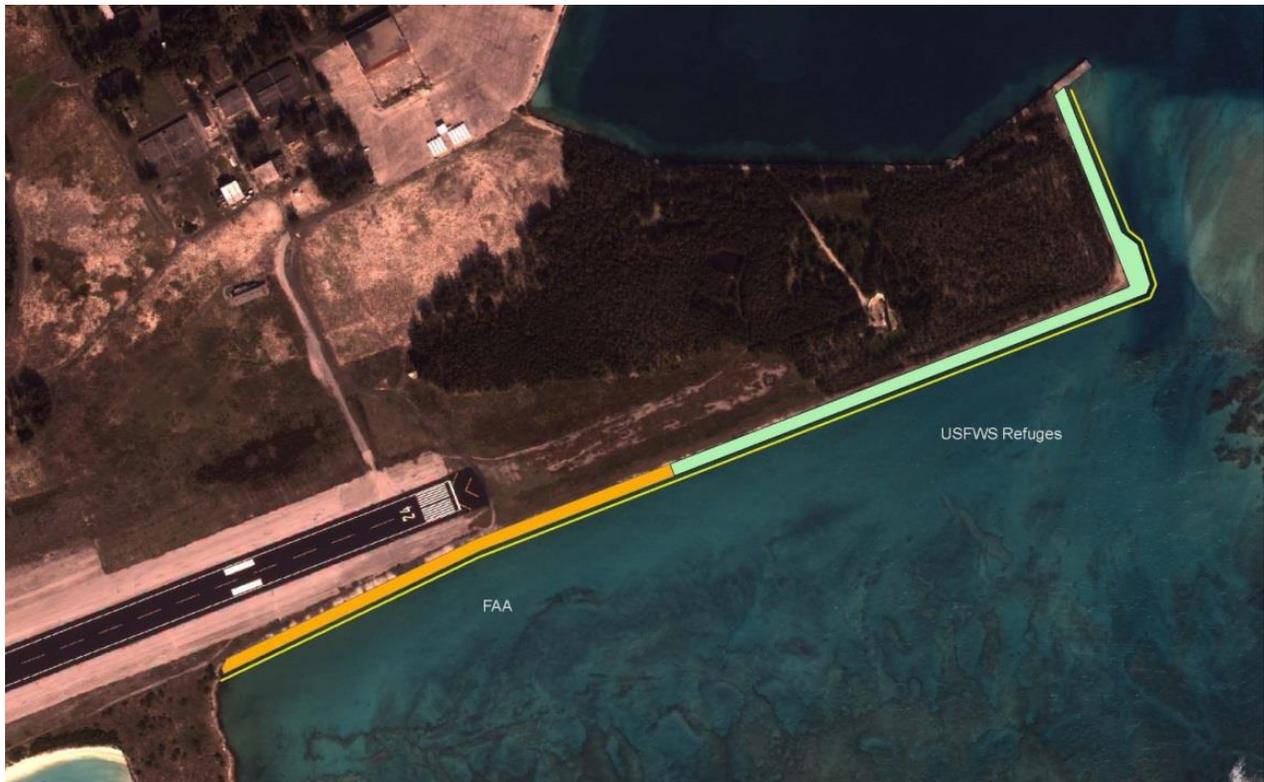
Figure 1. Potential footprint of project impacts, including silt curtain boundary (yellow line). Sand Island, Midway Atoll NWR. The FAA administered portion of the seawall is shown in orange and the FWS administered portion of the seawall is shown in green.

placed within marine waters (6.6 acres) and a 50-ft. construction footprint on uplands adjacent to the seawall (6.6 acres) for a total area of 13.2 acres (Figure 1). Repairs would take place on an annual cycle following the Implementation Plan (Appendix B of the Environmental Assessment for the Seawall Long-Term Maintenance Project). To avoid impacts to breeding birds, construction would generally occur from mid-August through October of any given year, depending on consultations with refuge staff and necessary agencies. Because repairs would be made on an as-needed basis, some years may have little to no active construction while other years may have multiple or large repairs.

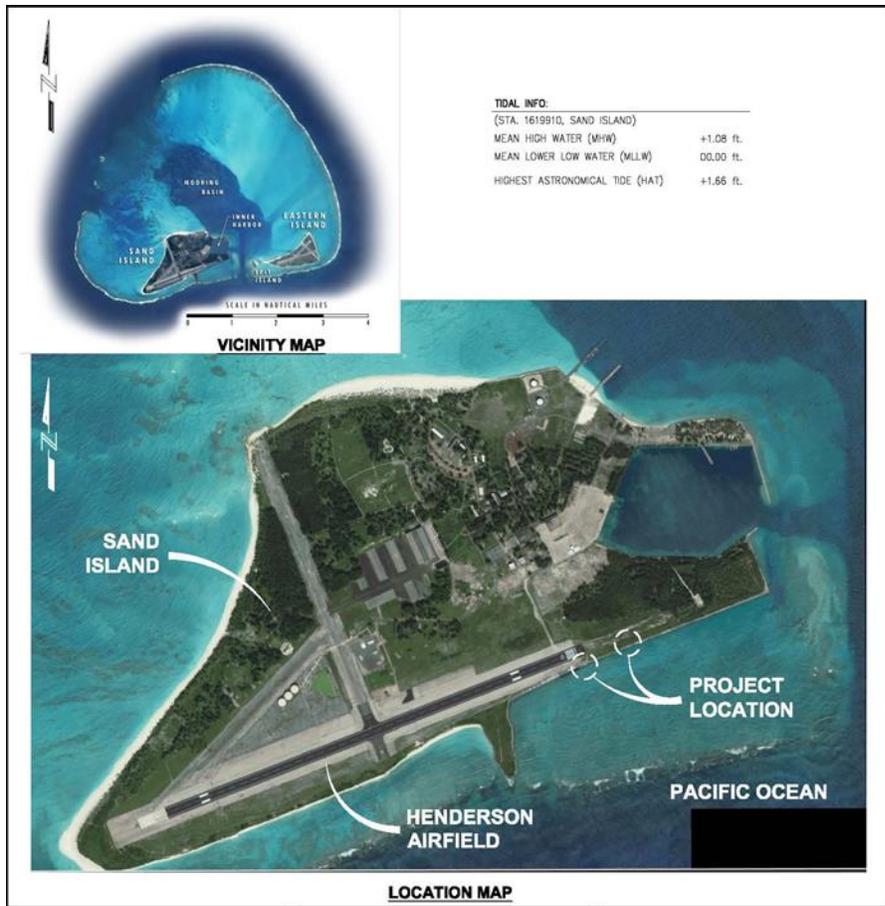
Figure 3. Sand Island, Midway Atoll National Wildlife Refuge, Henderson airfield and two of the priority seawall repair site locations A and B. Figure taken form EA.

Henderson Airfield is an active runway and serves as a backup runway and emergency landing site for commercial airliners that experience trouble on transpacific flights. The runway is located along the southern coastline of Sand Island, extending from the island's southwestern tip and ending near the harbor (Figure 3). The shoreline is completely man-made, and was made from dredge spoils from around the island during U.S. Navy occupation after World War II. During construction the shoreline was hardened by a metal sheet pile design that is now failing in several places, leading to the erosion of land upland of the seawall. The erosion seriously affects the functioning capability of the runway, and has also become an entrapment hazard for wildlife. Multiple sections of the existing southern seawall have been identified as extremely corroded and in need of immediate repair (Figure 3).

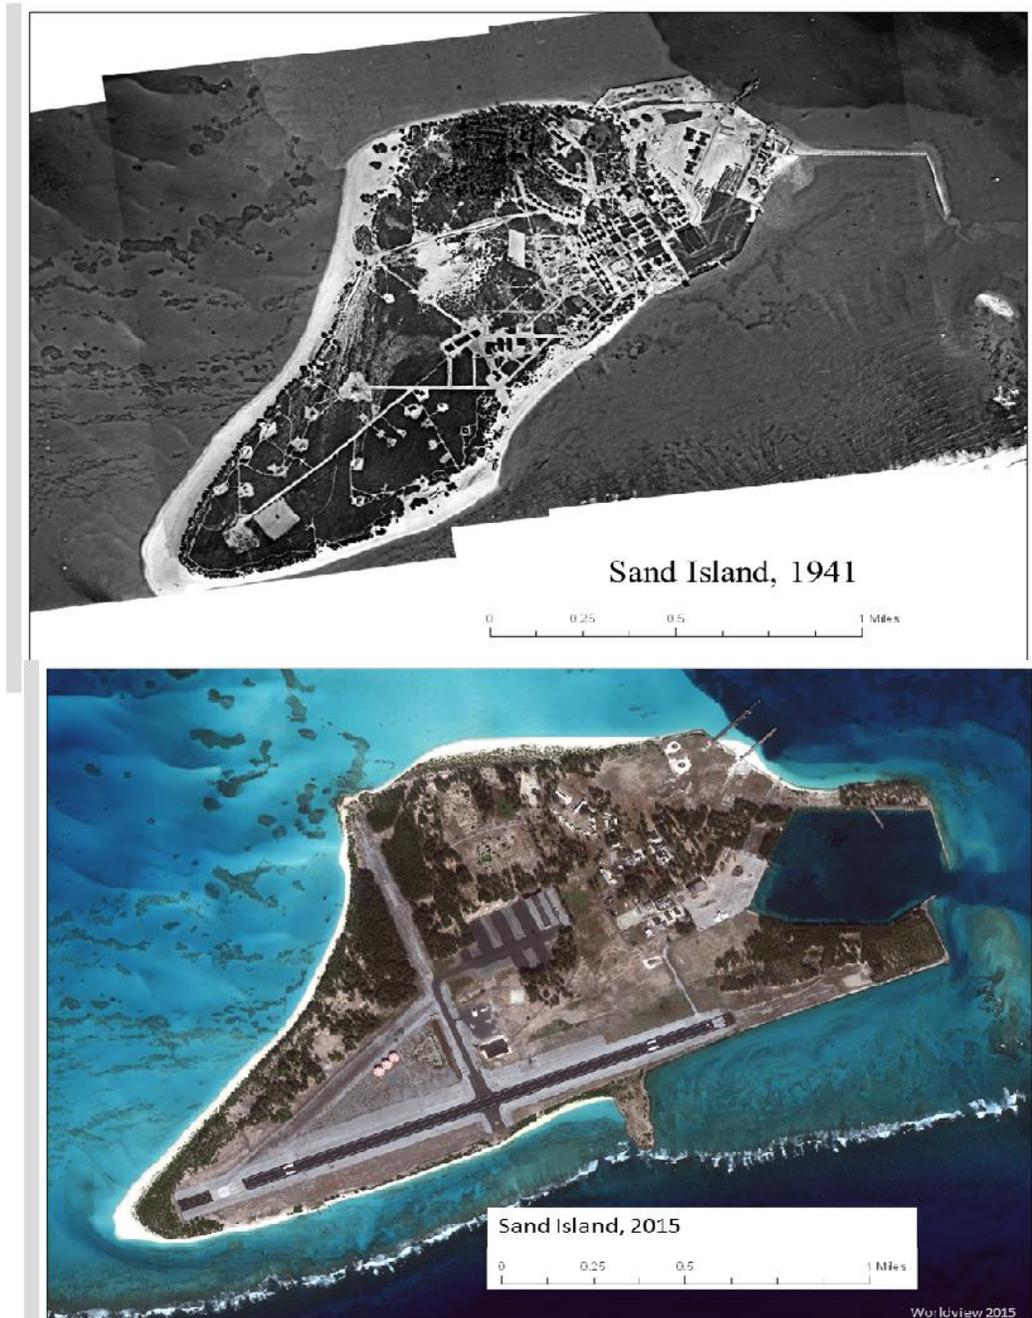
Figure 4. Sand Island in 1941 before the creation of the seawall and Henderson Field. Sand Island in 2015 showing the creation of Henderson Field runway and seawall that extends down to the boat harbor.

The current steel sheet pile seawall was installed by the US Navy in 1957-58 and was only expected to last 5-10 years. The seawall was placed in the water and filled behind with sand from the surrounding area to increase the size of Sand Island to accommodate the landing strip (Figure 4). The soils behind the seawall consist of unconsolidated fill that has eroded quickly after previous seawall breaches. The purpose of the action is to control this erosion and to protect Refuge resources, including Henderson Field taxiway, runway, and runway safety area (RSA).

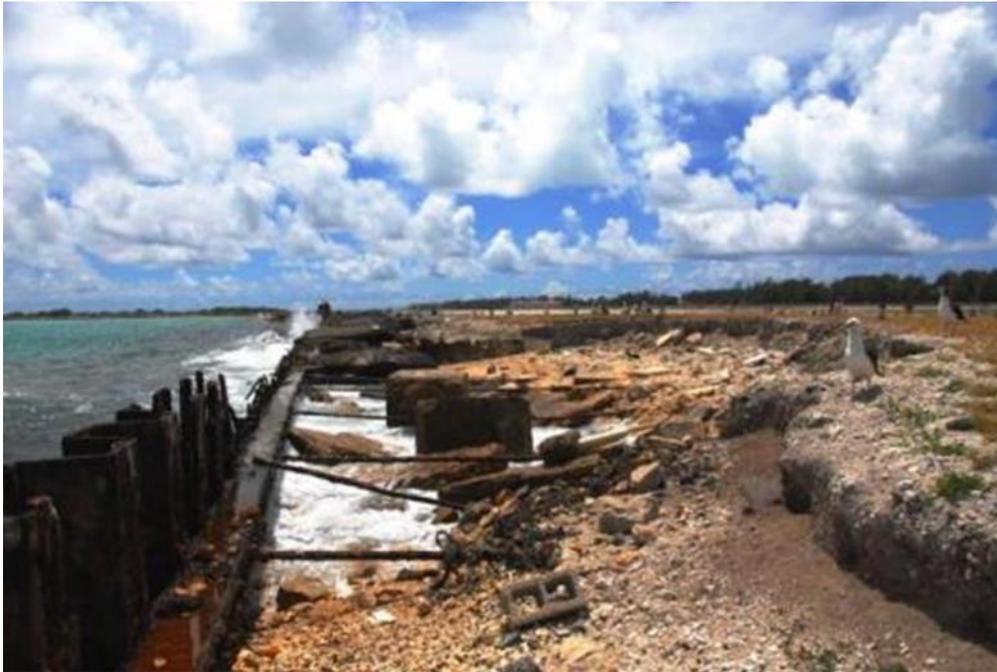
Figure 5. A portion of failed seawall. This area was repaired in 2014 using an armor rock revetment.

The metal sheet pile seawall has been severely corroded by the marine environment, causing large gaps in the wall (Figure 5). In its present state, the seawall provides an entrapment hazard for Hawaiian monk seals and green sea turtles. If seals and turtles are swimming or foraging near the seawall breach, there exists the possibility of waves washing them through the gaps in the seawall where they could become trapped. Although to date no marine animals have been

A previous repair effort was made in 2014, addressing a 75-ft gap in the seawall. One hundred feet of the sea wall were replaced with an armor rock revetment similar to the current proposed project. The 2016 Fish and Wildlife Coordination Act (FWCA) site survey revisited this section and found that the gradual slope appeared to be a better wave absorber than the previous vertical sheet pile wall. Albatross chicks and seabird burrows were present within 10 feet of the repairs. The priority areas for the future repair effort were noted to be in use for seabird breeding, nesting, feeding, and growth until fledging. A large hole covered with metal mesh was viewed at one of the two sites that could pose an entrapment threat. (USFWS PIFWO 2016). During a site visit in 2017 biologist found and freed three Laysan Albatross fledglings that were entrapped in the metal mesh covered area.

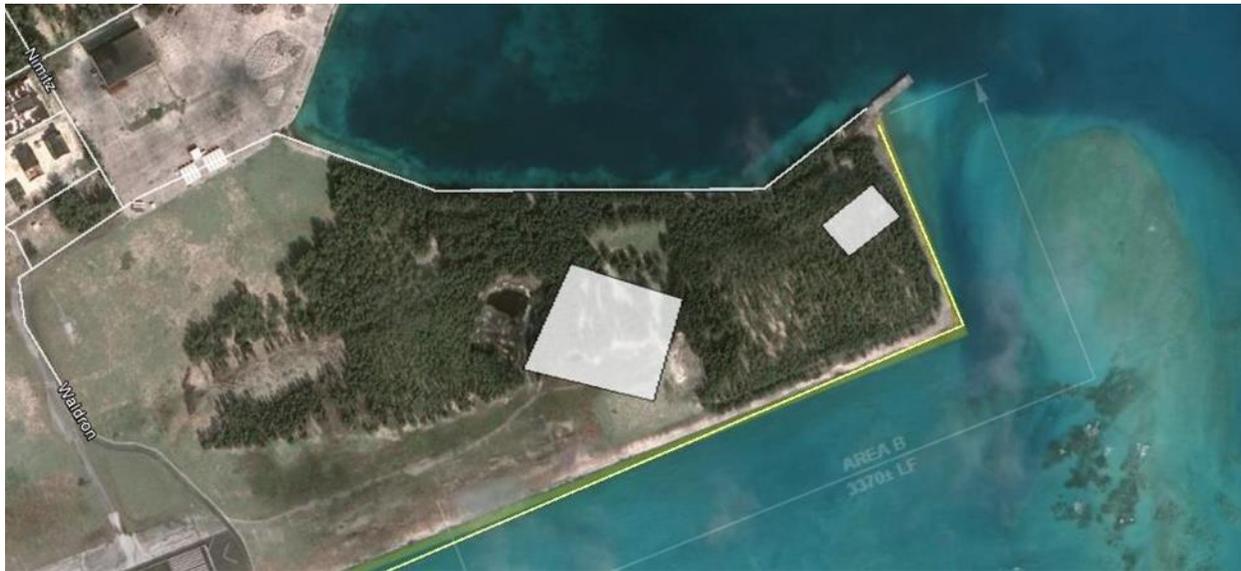
Figure 6. “No dig” areas adjacent to the seawall repair project site. Taken from the EA.

A Hazardous Materials Inspection Report identified two “no dig” areas inland from the existing seawall (Jones and Jones 2008, shown in Figure 6). The proposed action includes no work within this area. However, if the seawall were to fail, all of the contaminants and hazardous materials within these areas would be exposed and potentially washed out into the marine environment.

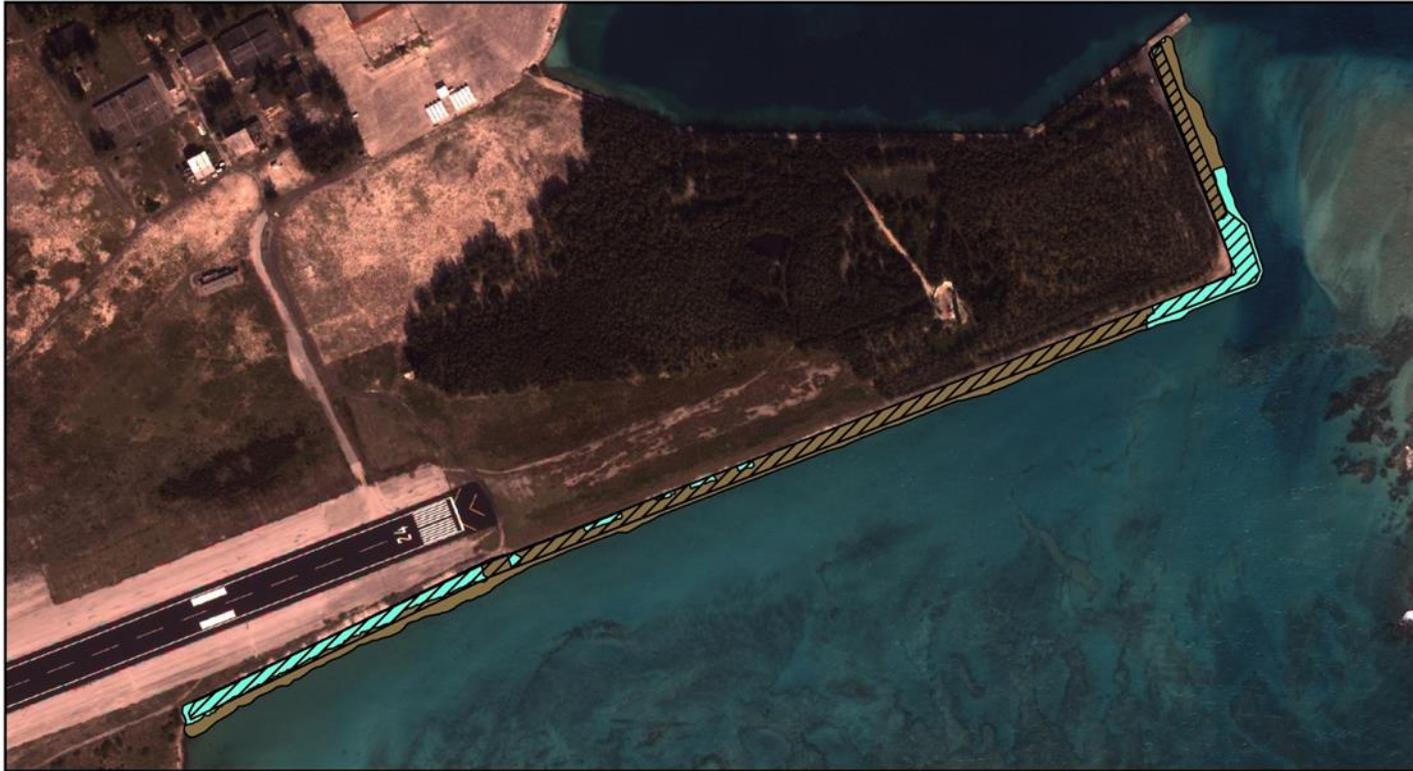
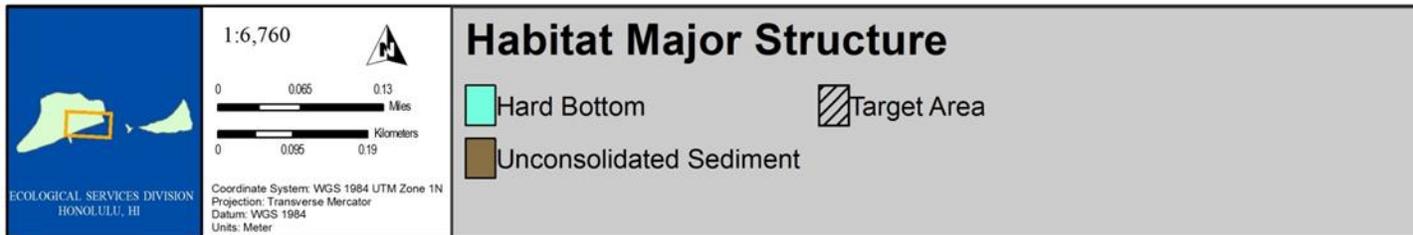
Figure 7. Major habitat structures within the project area.

The substrate in the project area adjacent to the seawall is categorized as hard bottom and unconsolidated sediment (Figure 7). Unconsolidated sediment is defined as an area comprised of sand, mud, rubble, or cobble without isolated scattered coral/ rocks or large corals. The hard bottom in the “corner” of the seawall on the eastern portion of the map is an area where debris and rip rap has been dropped over the years in an attempt to combat the erosion problem due to the failing seawall. There is no longer natural bottom in that section as it has been replaced by artificial cover. The hard bottom on the western end of the project area is comprised of rip rap that was placed in the marine environment over time to prevent erosion of the coastline adjacent to the operational runway (Figure 7). In addition debris and sections of rip rap were observed throughout the majority of the benthic habitat adjacent to the sheet pile seawall.

Table 1 identifies the areas of Habitat Zone, Major Structure, Sediment and Habitat Structure within the area surveyed as approximately 8.02 acres (32,441 meters squared (m²)), the survey area was larger than the proposed project foot print. The major habitat structures within the area surveyed consist of approximately 5 acres (20,289 m²) of unconsolidated sediment and 3 acres (12,151 m²) of hard bottom. As seen in Figure 7 the hard bottom is the artificial structure comprised of debris and rip rap. Within the unconsolidated sediment major structure habitat layer, approximately 4.24 acres (17,176 m²) was sand and rubble and 0.77 (3,112 m²) acres was only sand. The areas that were classified as “Artificial” are the areas of shoreline represented as

hard bottom in Figure 7 above. There is no contiguous natural hard bottom in the project footprint.

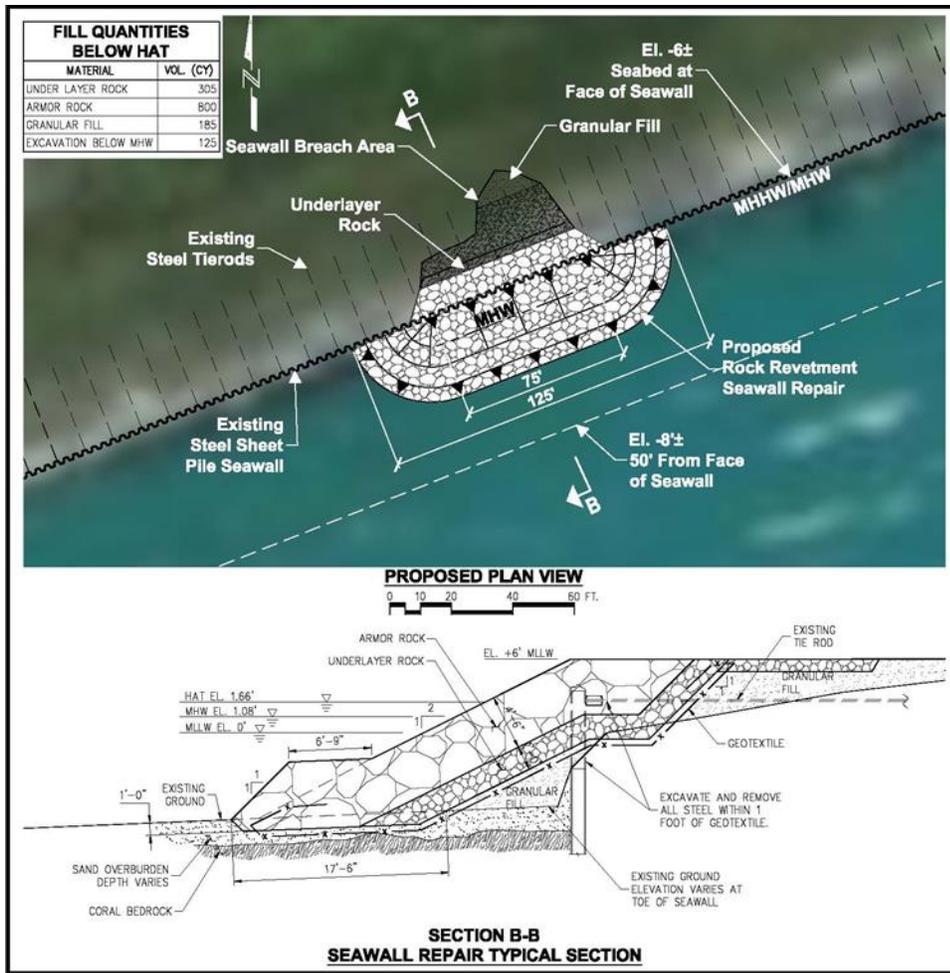
Figure 8. Example of a repair site, figure copied from the EA.

The recommended concept level design armor rock section for open ocean exposure at Midway is a revetment sloping at 2 horizontal: 1 vertical (Figure 8). The median armor rock size is 1500 pounds, and the cover layer is two stones (4 feet total) thick. The underlayer rock has a median rock size of 150 pounds and is an essential part of the system, interlocking with the armor rock cover. The underlayer rock is 2 feet thick total. A geotextile filter fabric separates the underlayer and granular fill material and prevents migration of the sediments through voids in the overlying rock. It typically has a long life requiring periodic maintenance to re-position rock as needed. Typical maintenance might be on the order of a 10-year cycle.

A similar repair was performed on Sand Island in 2014. Armor revetment has been proven to be an effective means of erosion protection. U.S. Army Corps of Engineers (USACE) permitted construction-related activities for the Midway seawall breach repair, which was undertaken by Chugach Alaska in June 2014 and completed in July 2014 (Corps Reference Number POH-2013-173). Personnel completed the rock revetment in the 100 ft. section of shoreline to stabilize the structure (Figure 8 and 9).

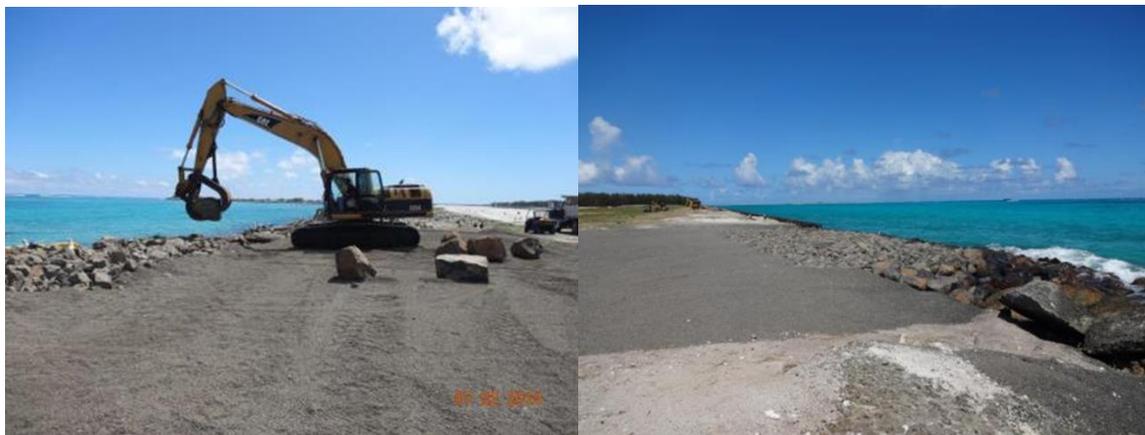
Figure 9. A) Repairing the failed site in 2014. B) After the repair 2014.

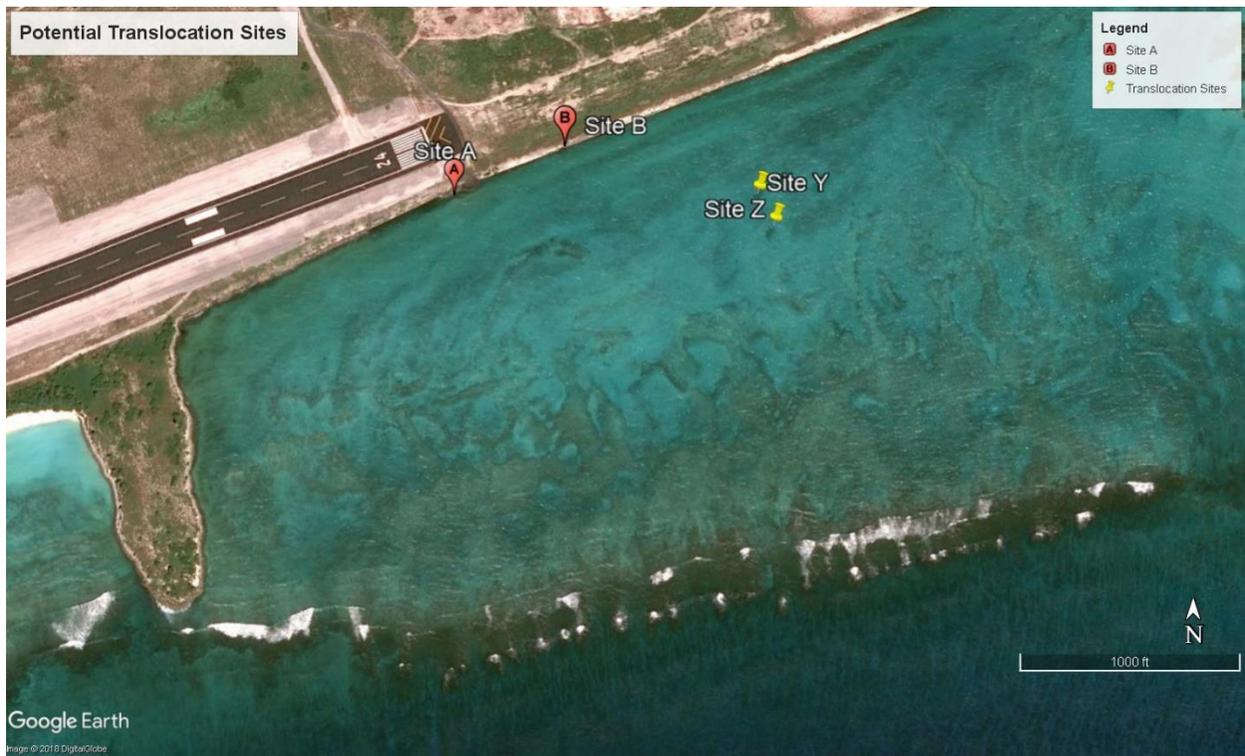
Figure 10. Coral translocation sites for seawall repair sites A and B.

Patch reefs to the south of the sea wall have been identified as potential translocation sites. These areas have been categorized by the NOAA Atlas of Shallow-Water Benthic Habitats of the Northwestern Hawaiian Islands as both uncolonized hardbottom, and uncolonized linear reef (NOAA 2003). The sites are approximately 450 ft. to over 1000 ft. from the sea wall, and well outside of the project foot print (Figure 10). Since the sites are somewhat close to the seawall, while remaining a safe distance away from the project area, these sites share many of the same environmental conditions as the harvest site of the seawall. Previous translocation sites are illustrated in figure 10. Site Y and Z were selected as the translocation sites for repair areas A and B (Figure 10). These sites are both long and narrow ridge patch reefs about 50 meters long and lie in 10 ft of water at low tide. The east facing side of the reefs are elevated off of the sand and have a higher elevation than the surrounding benthic structure that was scouted in the area. Site Y is roughly 1400 ft from site A, and 100 ft from site B. Two transects were surveyed at both site Y and Z, where every coral on the reef was counted. Site Y and Z had a total of 93 and 79 established corals respectively from three species *P. damicornis*, *P. meandrina* and *P. lobata*. As the repair project progresses, new translocation sites will be established on suitable patch reefs in the general area.
