Rose Atoll Wreck

Rose Atoll Marine National Monument

Overview

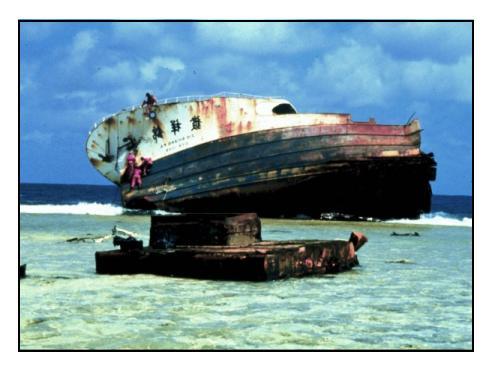
Jin Shiang Fa on the western reef of Rose Atoll. (Photo: USFWS)

Between 1999 and April 2000, an additional 105 tons of remaining metal debris was cut and re-

moved by hand by Moon Divers, a local American Samoa contractor hired by USFWS. An additional 30 tons of debris were removed after being washed ashore following a January 2004 hurricane. All but two tons of debris were removed between August 2004 and June 2005. The final two tons were eventually removed in 2007, nearly 15 years after the initial wreck.

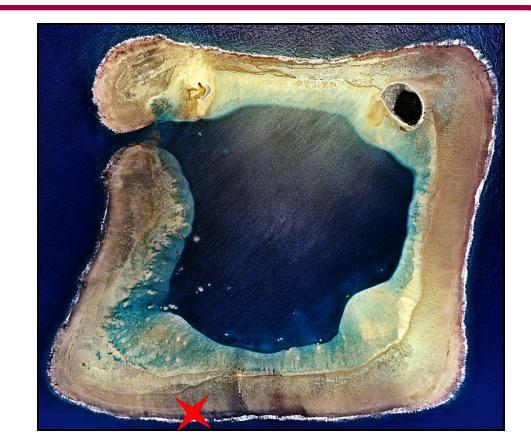
Rose Atoll . Red X marks the approximate location of the wreck. (Photo: Air Survey Hawaii)
