**Maryland Stream Survey:
Bankfull Discharge and Channel
Characteristics of Streams in the
Allegheny Plateau and the Valley
and Ridge Hydrologic Regions**

*CBFO-S03-01
May 2003*

By: Tamara L. McCandless

U.S. Fish and Wildlife Service
Chesapeake Bay Field Office

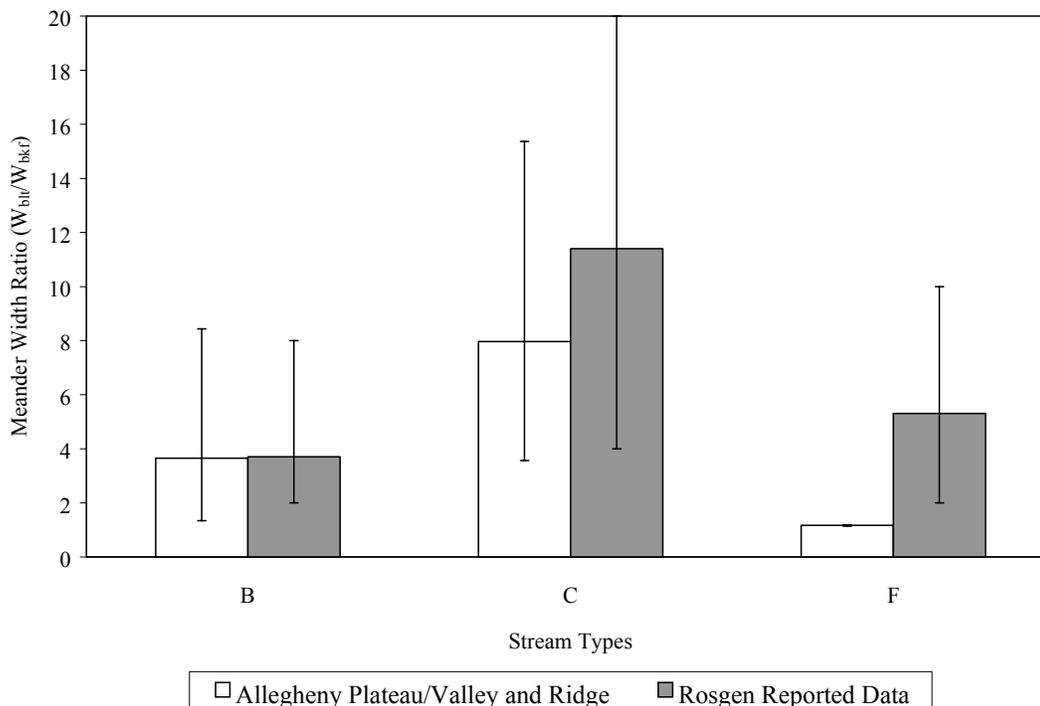
Figure 3. AP/VR meander width ratios compared to Rosgen (1996) (columns indicate average values and vertical lines represent ranges).

Rosgen (1994, 1996) has published average and range values for dimensionless meander belt widths (W_{blt}/W_{bkf}), also termed meander width ratios (MWR), by major stream type categories. The average MWR values for C and F type streams in the AP/VR are lower than those presented by Rosgen (Figure 3). The difference is particularly large for F type streams, where the average MWR is almost one fifth of that reported by Rosgen, and for which there is no overlap in the ranges of MWR. One F stream (No. 9), has confining bedrock in the study reach and the other F stream (No. 2) has very large boulders through the study reach. The average MWR for AP/VR C type streams is a little less than half that reported by Rosgen, although there is some overlap between the MWR data. As in the Maryland Piedmont, the existence of bedrock outcrops in the AP/VR (found at nearly 60 percent of the study reaches) may be the dominant confinement factor at the study reaches.

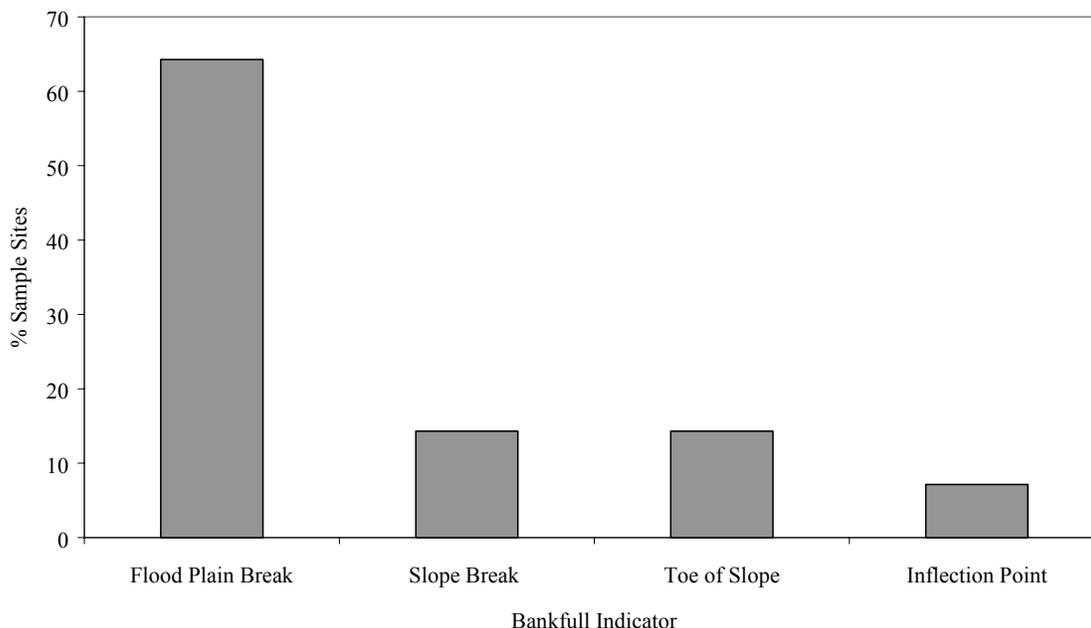
Figure 6. Percent of sites exhibiting primary bankfull indicators.

One objective in developing regional relationships was to interpret bankfull indicators at the survey sites and identify the dominant feature at the elevation of the bankfull discharge. We were also curious at to other features found at this elevation. The majority of sites we surveyed in the AP/VR had the top of bank/floodplain break as the primary bankfull indicator (Figure 6). Other indicators, depending on site-specific characteristics of the stream, were present at the corresponding height above water surface. The primary bankfull indicator was the top of bank/floodplain break at 64 percent of the sites, the toe of slope or a slope break at 29 percent of the sites, and the inflection point at 7 percent of the sites. We also observed several other secondary indicators at most sites. Overall, we consistently observed six distinct geomorphic indicators of bankfull stage (Figure 7). At 93 percent of the sites, both the elevation of the floodplain break and slope breaks on the bank indicated, at some points along the reach, the bankfull stage. Both the toe of slope and the inflection point indicated bankfull stage at 71 percent of the sites, the top of bench or a scour line indicated bankfull at 36 and 21 percent of the sites, respectively.

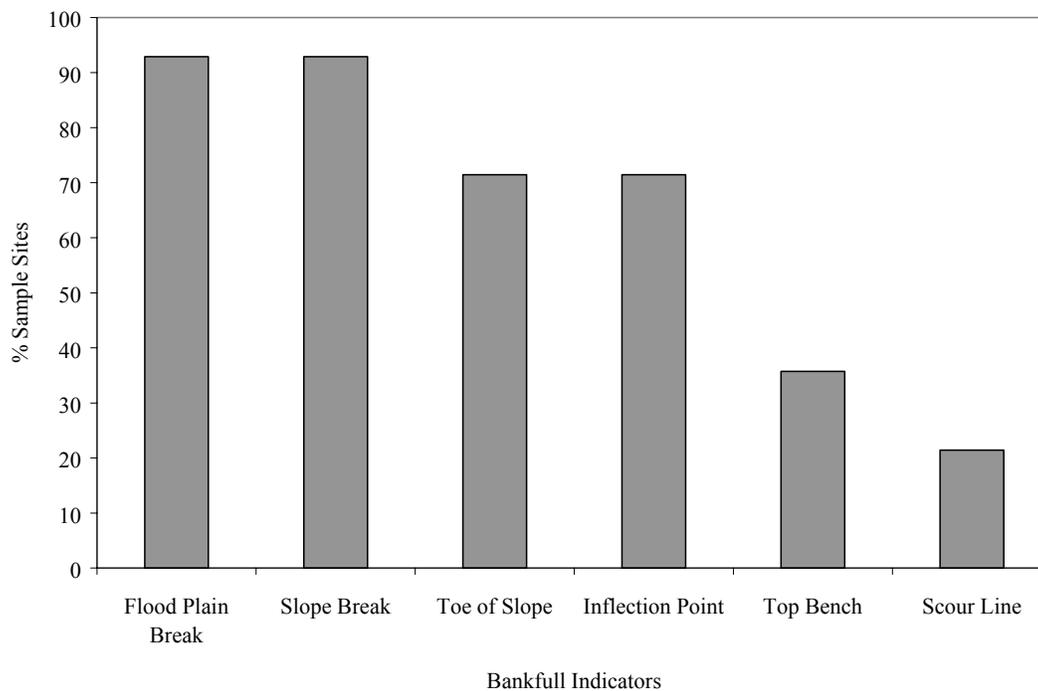
Figure 7. Percent of sites exhibiting geomorphic indicators of bankfull stage.

As in the Maryland Piedmont physiographic region, our survey of geomorphic indicators strongly suggests a physical feature; in particular, the floodplain break, is associated with bankfull discharge. While a number of other indicators were present at the same relative elevation as the primary indicators, these other indicators were not consistently seen as representing the bankfull stage throughout the study reach. For example, the scour line is often discussed as an indicator of the elevation of the bankfull discharge. We found that this feature is

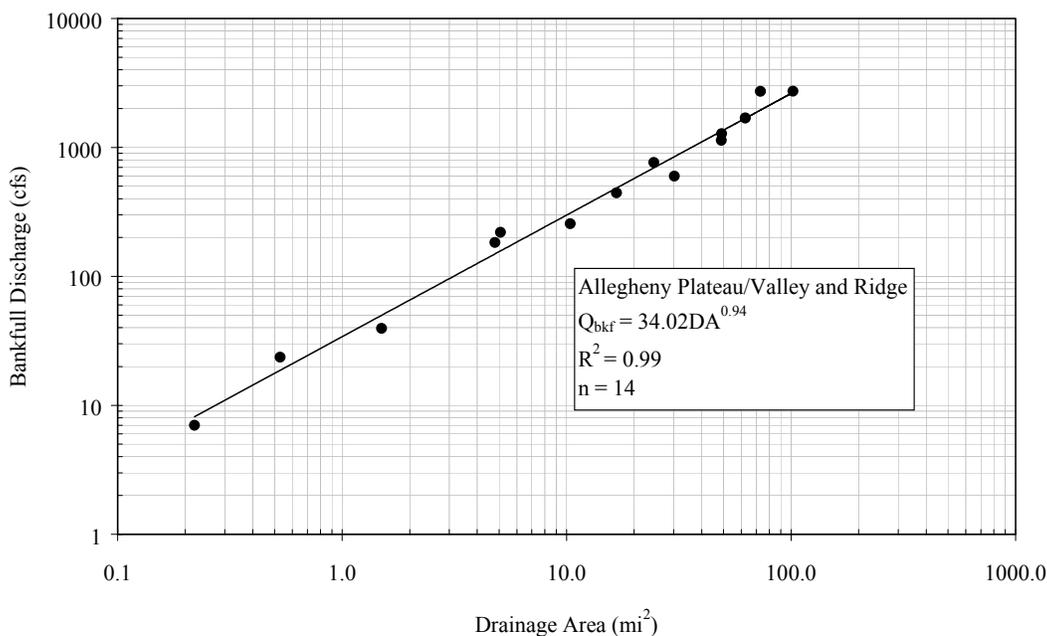
Figure 8. Bankfull discharge as a function of drainage area for AP/VR survey sites.

The AP/VR drainage area and bankfull discharge relationship compares fairly well with previous studies in the East for drainage areas greater than 50 mi² (Table 6). Table 6 is corrected from what was reported in McCandless and Everett (2002), two studies (Wolman and Leopold 1957 and Brush 1961) were recalculated with different sample sizes. With the exception of the Kilpatrick and Barnes relationship (1964), the difference between the predicted value for bankfull discharge and the value from the bankfull survey range from 2 - 28 percent for the drainage areas 50 - 100 mi². Only one relationship, Wolman and Leopold (1957), compares fairly well for drainage areas 5 - 25 mi², with a 3 - 28 percent difference. The Brush (1961) relationship, also conducted in the AP/VR but in central Pennsylvania, has similar intercept and slope with a 28 percent difference in predicted versus surveyed bankfull discharge.

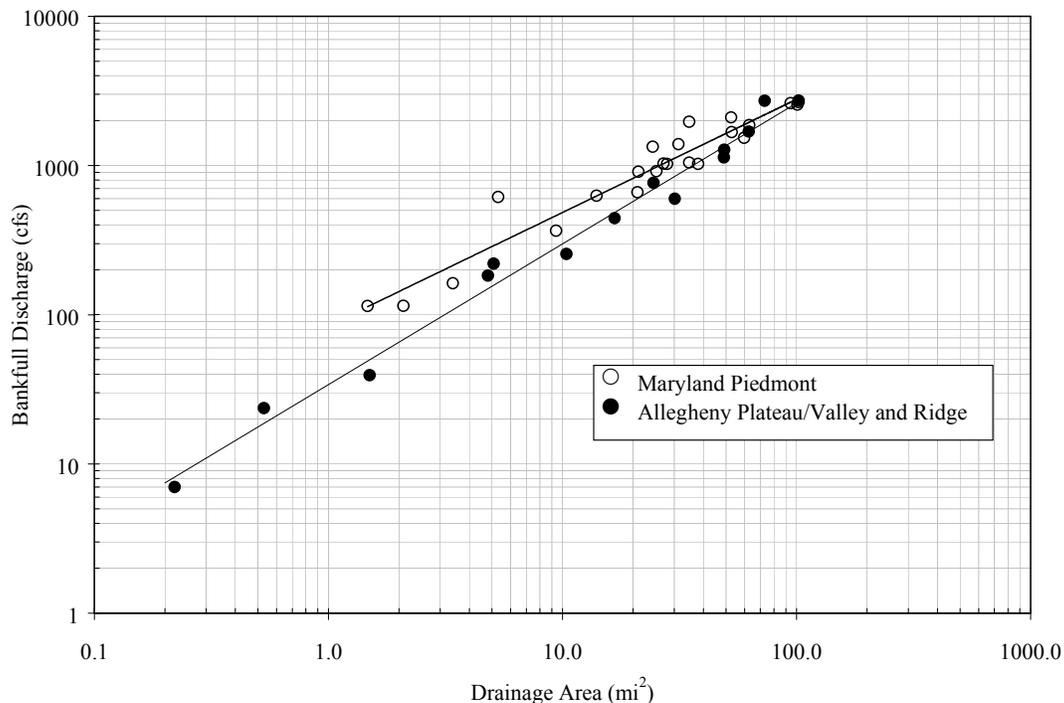
Figure 10. Comparison of bankfull discharge as a function of drainage area partitioned by AP/VR and Maryland Piedmont survey sites.

Comparison of the two regressions reveals that they are significantly different ($p > 0.05$), and that the AP/VR has less bankfull discharge per unit drainage area than the Maryland Piedmont (Figure 10). This is consistent with previous work by USGS (Dillow 1996) which developed regression relationships between the Maryland physiographic regions for the 2-year through 500-year discharge events. Using the AP/VR and the Maryland Piedmont regression equations to calculate the bankfull discharge for drainage areas between 1 - 100 mi² results in a difference of 3 - 148 percent. The percent difference decreases with increasing drainage area (Figure 10).

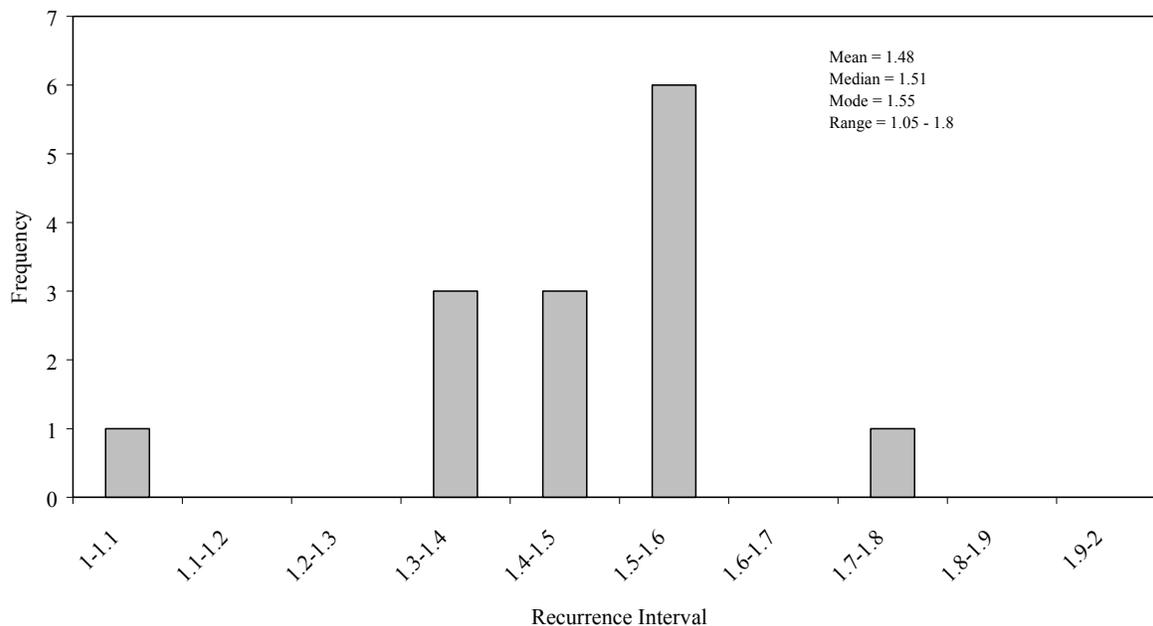
Figure 11. Frequency of recurrence interval for field-estimated bankfull discharge.

Recurrence intervals for field-estimated bankfull discharges, calculated from the annual maximum discharge series following the *Guidelines for Determining Flood Flow Frequency* (Interagency Advisory Committee 1982), range from 1.05 - 1.8 years, and average 1.48 years (Figure 11). For some of the surveyed sites, USGS used a high-outlier adjustment (Interagency Advisory Committee 1982) and developed weighted peak estimates using regional regression equations (Dillow 1996) in the log-Pearson flood frequency analysis. The regression equations are used for comparing data from a particular station with stations in the region. Weighting the estimates between the station data and regression equation data is useful for stations with relatively short periods of record (discontinued crest gage sites), because it builds a regional component into the frequency estimate that often includes stations with longer periods of record. Appendix A provides the period of record and information on the log-Pearson analysis for each site.

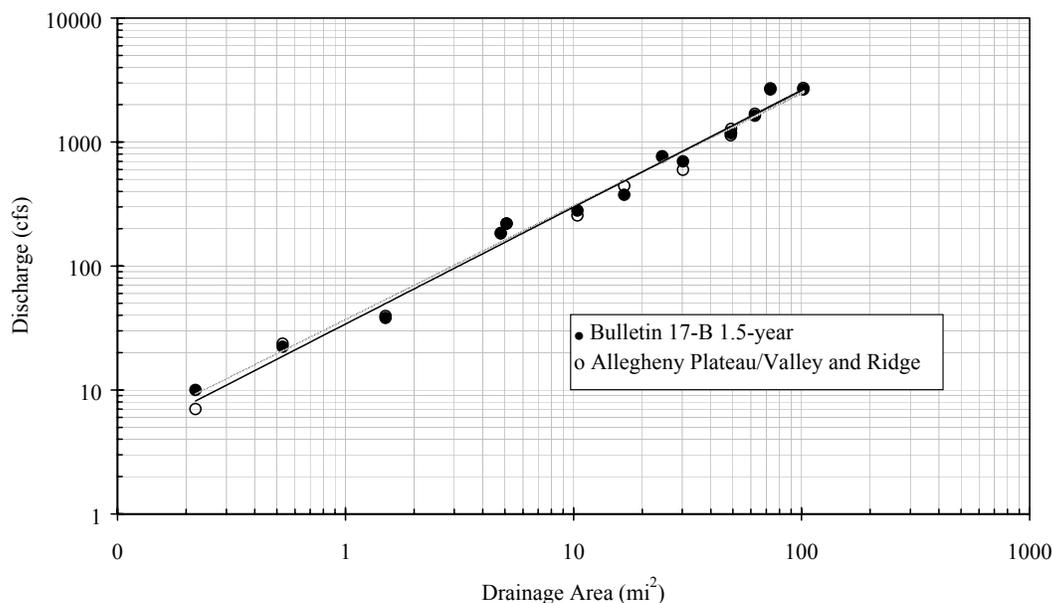
Figure 12. Drainage area versus discharge: AP/VR field-determined bankfull and Bulletin 17-B 1.5-year recurrence interval.

While the range of bankfull discharge recurrence intervals is slightly greater for the AP/VR compared to the Maryland Piedmont (1.26 - 1.75), the average for each is essentially the same, 1.48 versus 1.5. In both regions, the bankfull discharge is also closely approximated by the Bulletin 17-B 1.5-year recurrence interval. One site in the AP/VR, has a recurrence interval of 1.05. This site, Youghiogheny River tributary near Friendsville, MD, is a discontinued crest gage with the smallest drainage area surveyed (0.22 mi^2) at which the previous rating was approximated to the more recent discharge measurements by determining the elevation when the discharge would break out of the channel. The Bulletin 17-B 1.5-year discharge is 10 cfs, about a 30 percent difference from the survey. Sixty-one percent of the drainage is forest/brush cover with the remainder in agriculture/grassland, one of the highest in the data set for agriculture/grassland cover. Removing this from the analysis gives a recurrence interval range of 1.33 – 1.8 with an average of 1.51 (sd = 0.12).

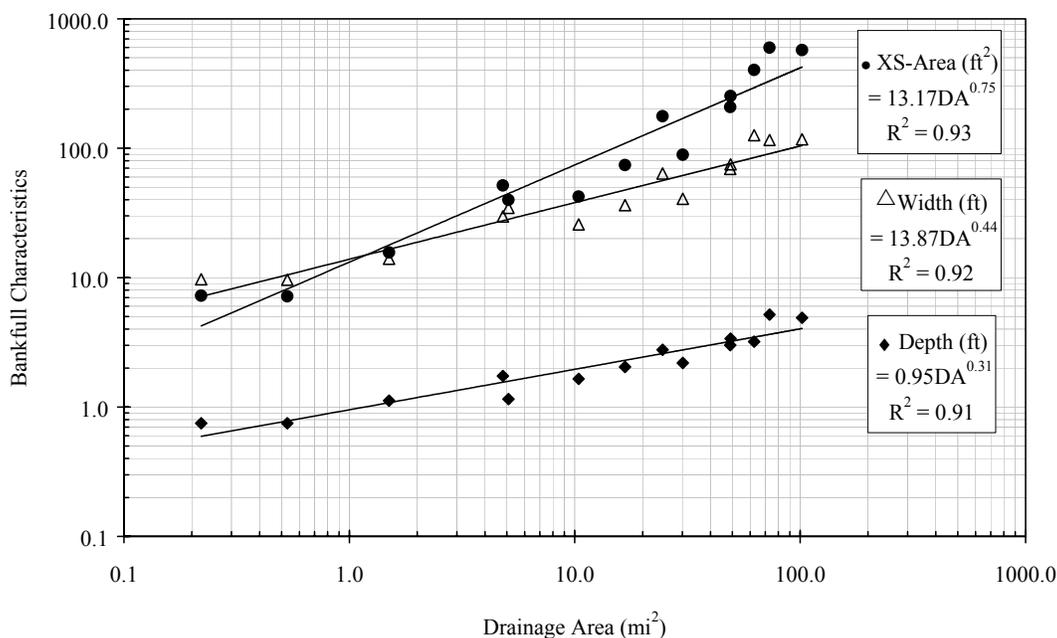
Figure 13. Bankfull channel dimensions as a function of drainage area for AP/VR survey sites ($n = 14$).

N	Regression Equation	R^2	se (%)	F	p
14	Cross-sectional Area = $13.17DA^{0.75}$	0.93	17.3	169.4	<.0001
14	Width = $13.87DA^{0.44}$	0.92	11.5	129.7	<.0001
14	Mean Depth = $0.95DA^{0.31}$	0.91	8.4	123.7	<.0001

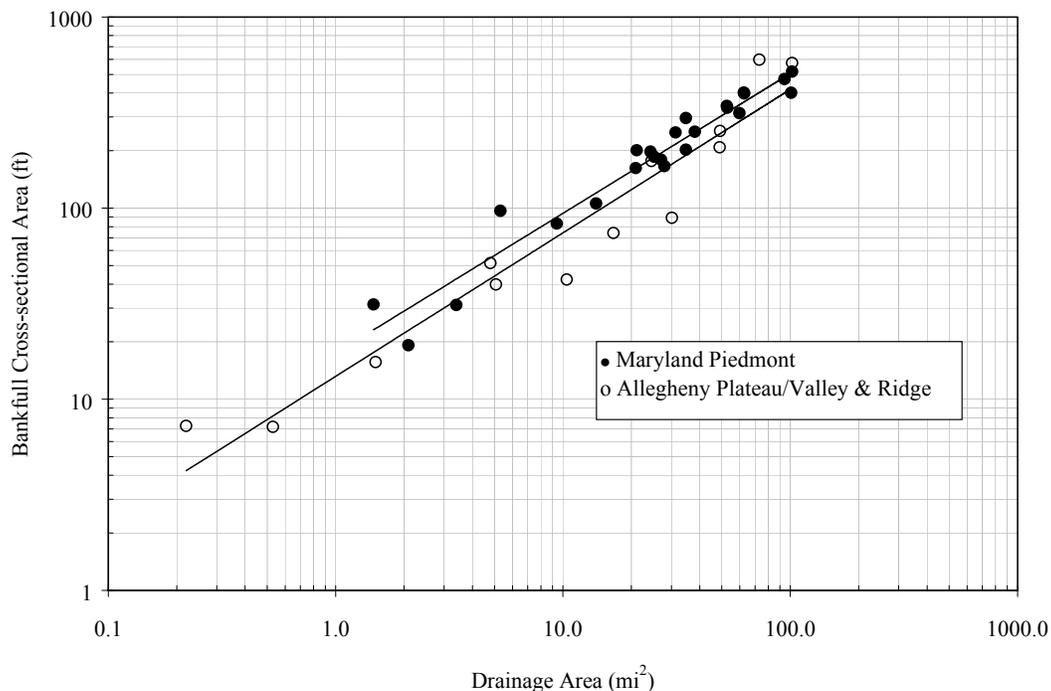
Figure 14. Comparison of AP/VR with Maryland Piedmont (McCandless and Everett 2002) survey sites for bankfull cross-sectional area by drainage area.

As one would expect, given a smaller bankfull discharge per unit drainage area, the streams in the AP/VR have less bankfull cross-sectional area per unit drainage area compared to the Maryland Piedmont streams (Figure 14). The two regression lines have the same slopes but different intercepts ($t = -5.17$, $n = 34$, $p > 0.05$), indicating that the increase in area with increasing drainage area follows the same relationship in both regions. As with cross-sectional area, the regression lines for depth have the same slopes but different intercepts ($t = -5.17$, $n = 34$, $p > 0.05$), while there is no statistical difference between the regions with respect to bankfull width (Figure 15). Thus, for a given drainage area, measured AP/VR streams have larger width/depth ratios, since the widths are similar, but depths are less than in the Piedmont ($t = 3.84$, $n = 34$, $p > 0.05$) (Figure 16). These results are also paralleled by the results from the Rosgen stream type classification criteria. Removing the two smaller drainage basins (Site Numbers 13 and 14) outside the range of the Maryland Piedmont sample from the AP/VR data set does not change the results above.

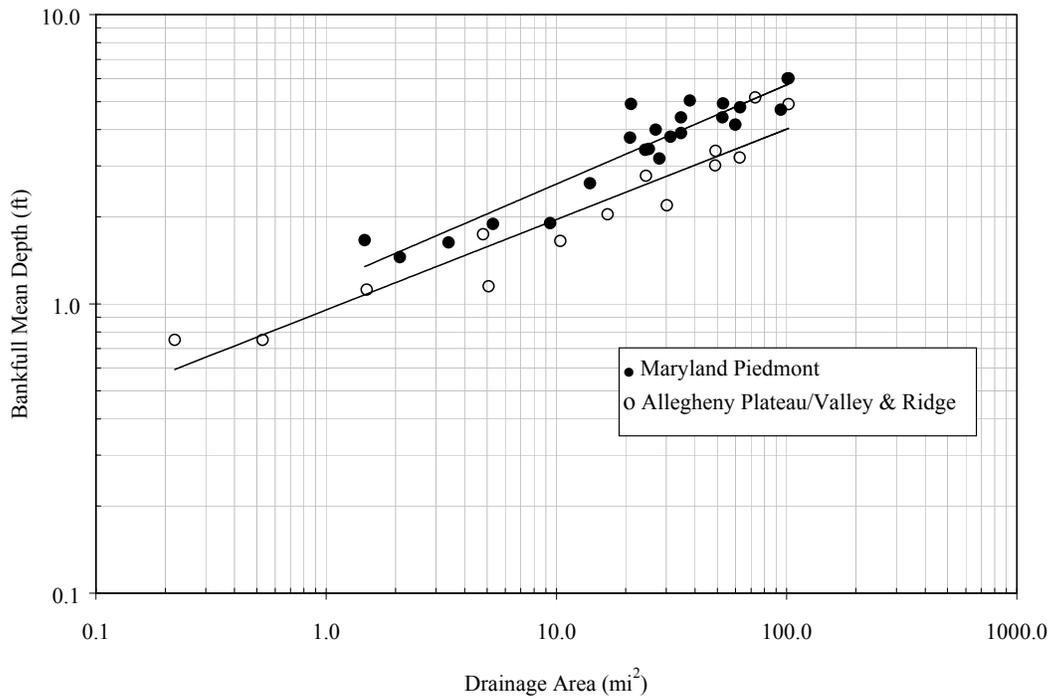
Figure 15. Comparison of AP/VR with Maryland Piedmont survey sites for bankfull mean depth by drainage area.

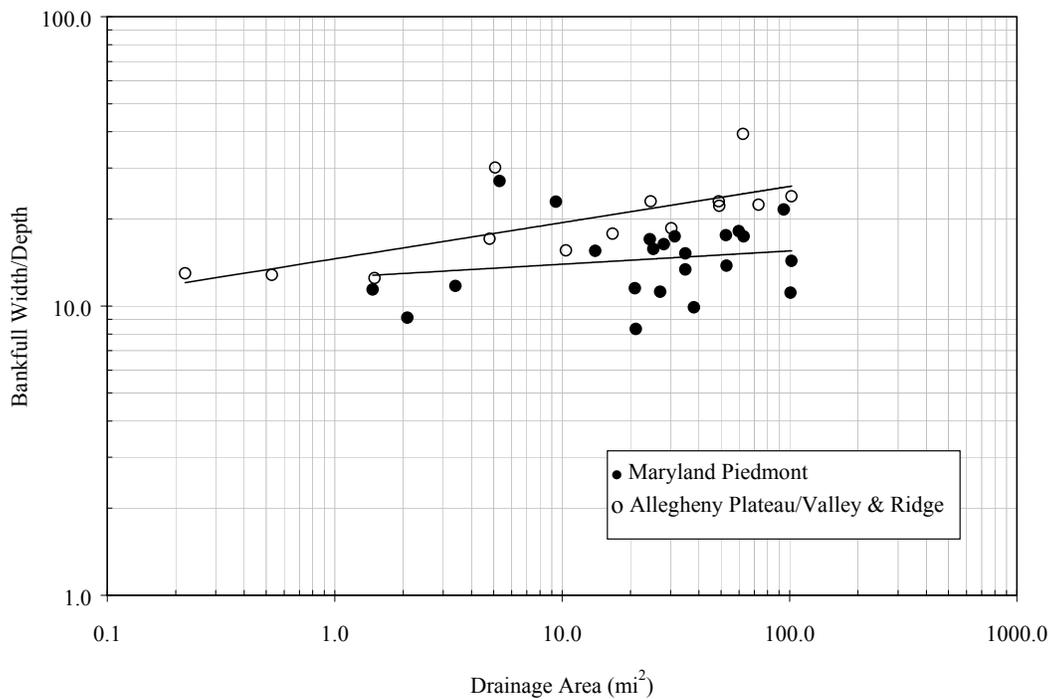
Figure 16. Comparison of AP/VR with Maryland Piedmont survey sites for bankfull width/depth ratio by drainage area.

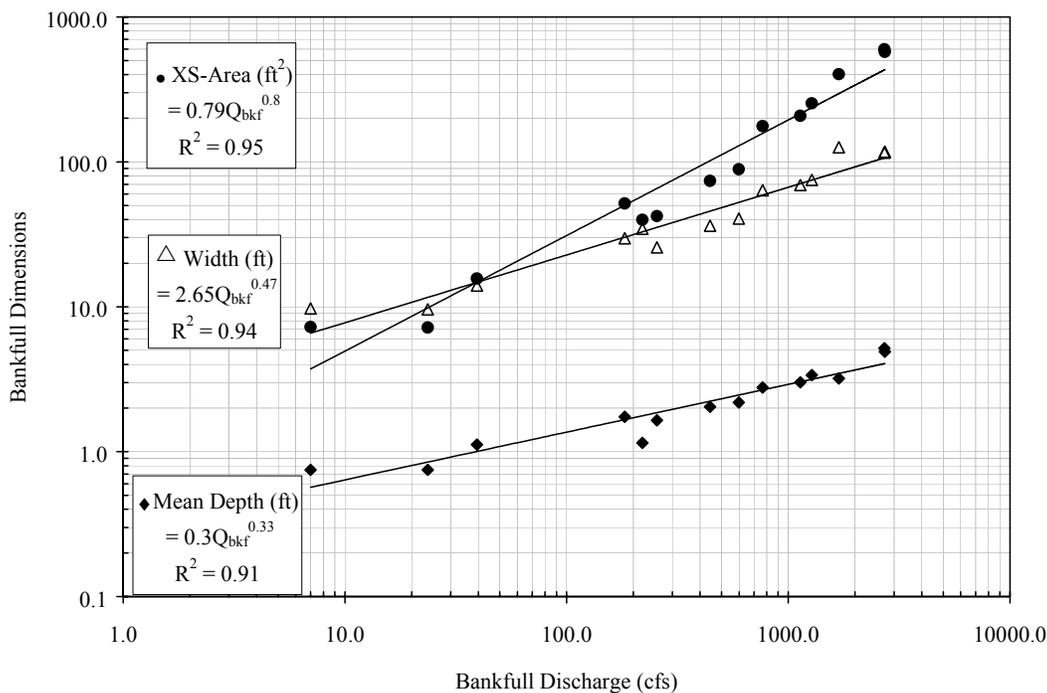
Figure 17. Bankfull channel dimensions as a function of bankfull discharge for AP/VR survey sites ($n = 14$).

N	Regression Equation	R^2	se (%)	F	p
14	Cross-sectional Area = $0.79Q_{\text{bkf}}^{0.8}$	0.95	15	230.3	<.001
14	Width = $2.65Q_{\text{bkf}}^{0.47}$	0.94	9.6	191.3	<.001
14	Mean Depth = $0.3Q_{\text{bkf}}^{0.33}$	0.91	8.3	128.7	<.001

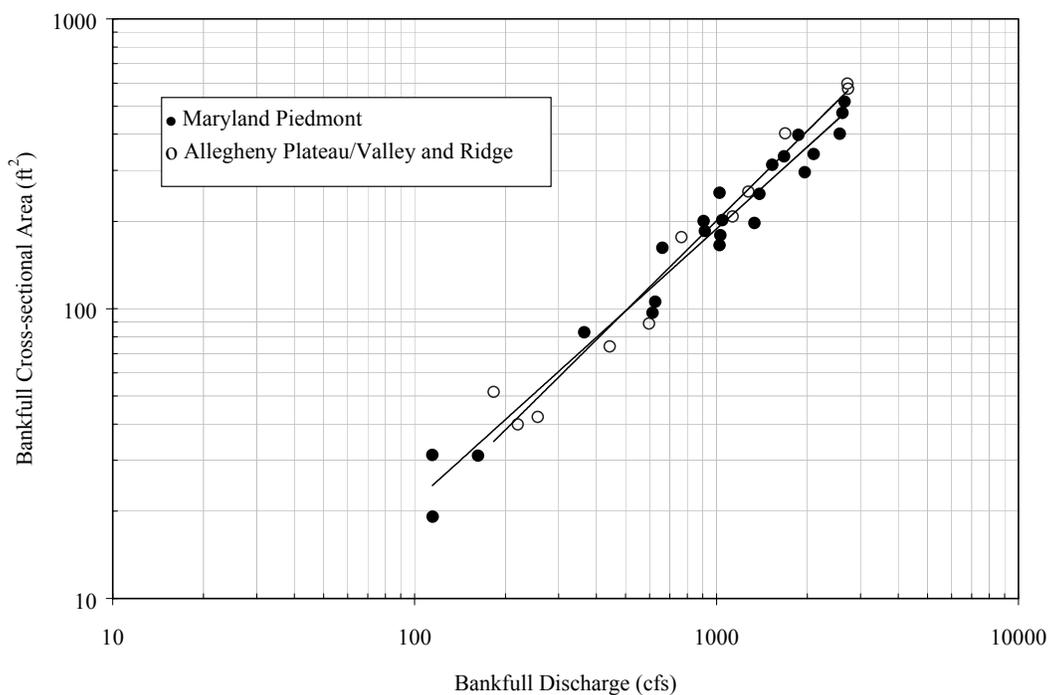
Figure 18. Comparison of AP/VR with Maryland Piedmont survey sites for bankfull cross-sectional area by bankfull discharge.

The streams in the AP/VR have similar cross-sectional area per unit bankfull discharge as the Maryland Piedmont streams (Figure 18). The two regression lines have similar slopes and elevations. Three sites (Site Numbers 10, 13, 14) from the AP/VR data set were outside the range of discharges found in the Maryland Piedmont and were excluded from this analysis.

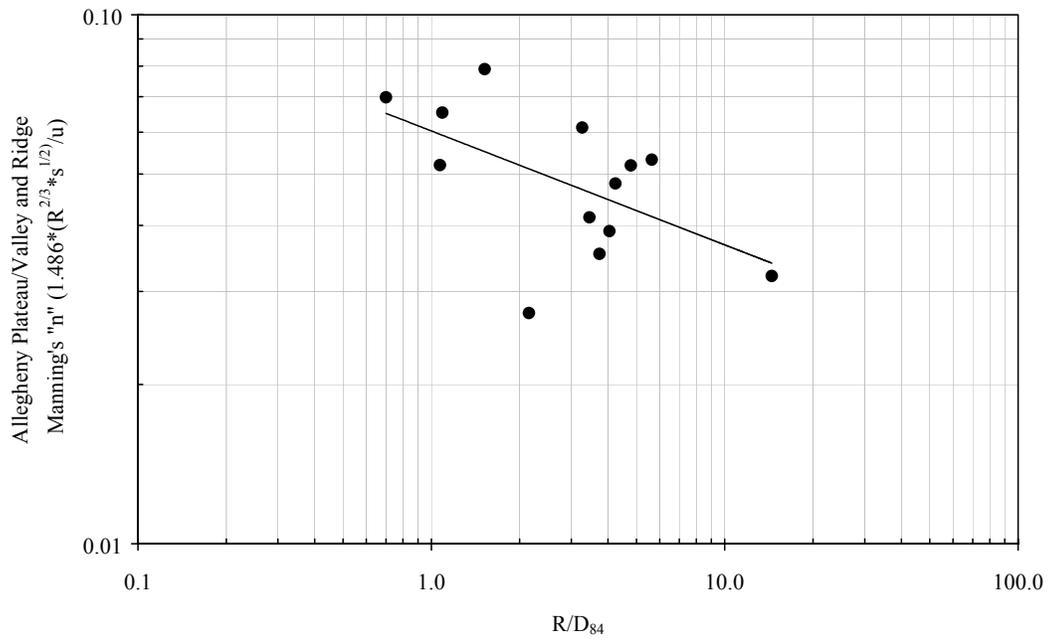
Figure 20. Manning's "n" as a function of relative roughness (R/D_{84}) for AP/VR survey sites.

N	Regression Equation	R^2	se (%)	F	p
13	“n” = $0.06(R/D_{84})^{-0.22}$	0.31	1.3	6.1	<.001

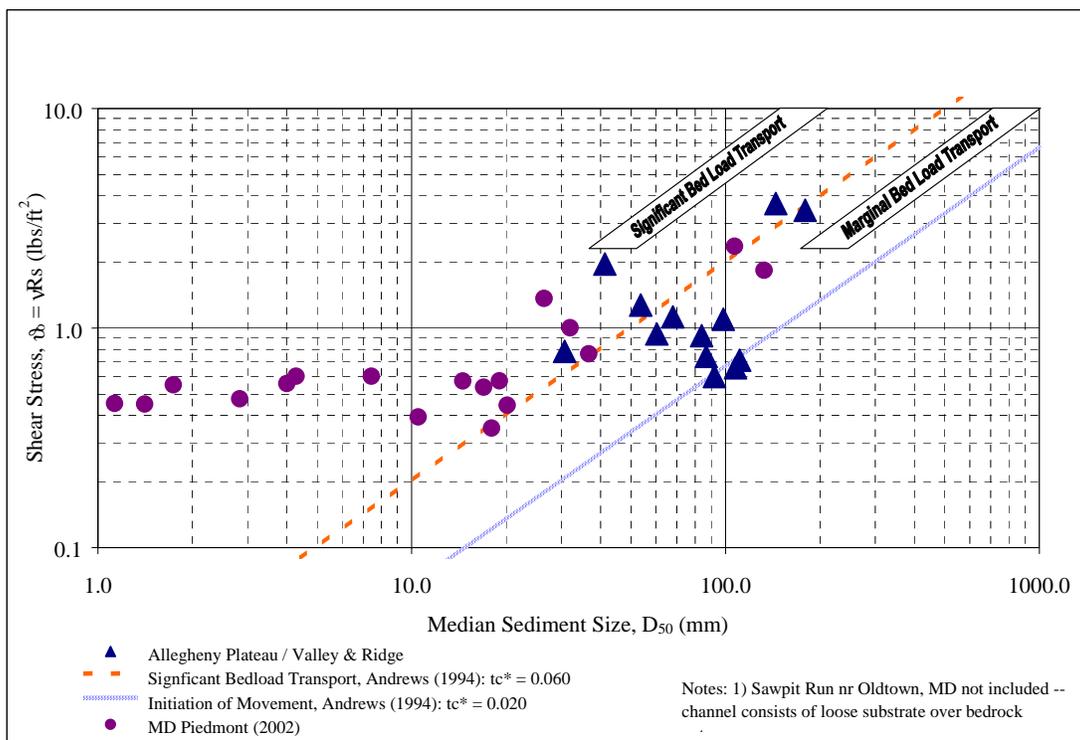
Figure 22. Comparison of estimated average boundary shear stress and median particle size for the AP/VR and Maryland Piedmont (McCandless and Everett 2002) survey sites.

The figure shows that bankfull discharge in the AP/VR streams is capable (or very close to capable) of generating marginal bed load transport in all streams. Because of finer grain sizes, bankfull discharges in the Maryland Piedmont streams are generally capable of mobilizing the entire bed. The point of the exercise is simply to develop a coarse estimate of the degree to which the bed materials are likely subject to movement at or near the estimated bankfull stage. With these caveats, the comparison suggests that, for those sites plotting above the line of initiation of movement, bed materials are likely mobile at or near the bankfull stage.

The low τ_0 for the observed particle size distribution does not strongly suggest that there may be an incipient shift in sediment transport dynamics at these sites. The two sites plotting with the greatest τ_0 are Bear Creek at Friendsville, MD and Crabtree Creek near Swanton, MD. Both of these sites have steep gradients, 2 and 3 percent respectively, and large bed material. The median particle diameter, or D_{50} , for each site is 0.5 and 0.6 feet respectively, while the D_{84} and D_{95} are 1.9 and 1.8, and 3.2 and 4.6 feet, respectively. Carling (1988) has shown that steep channels with large, armored bed material are susceptible to general mobilization of bed clasts only at flows that significantly exceed bankfull.

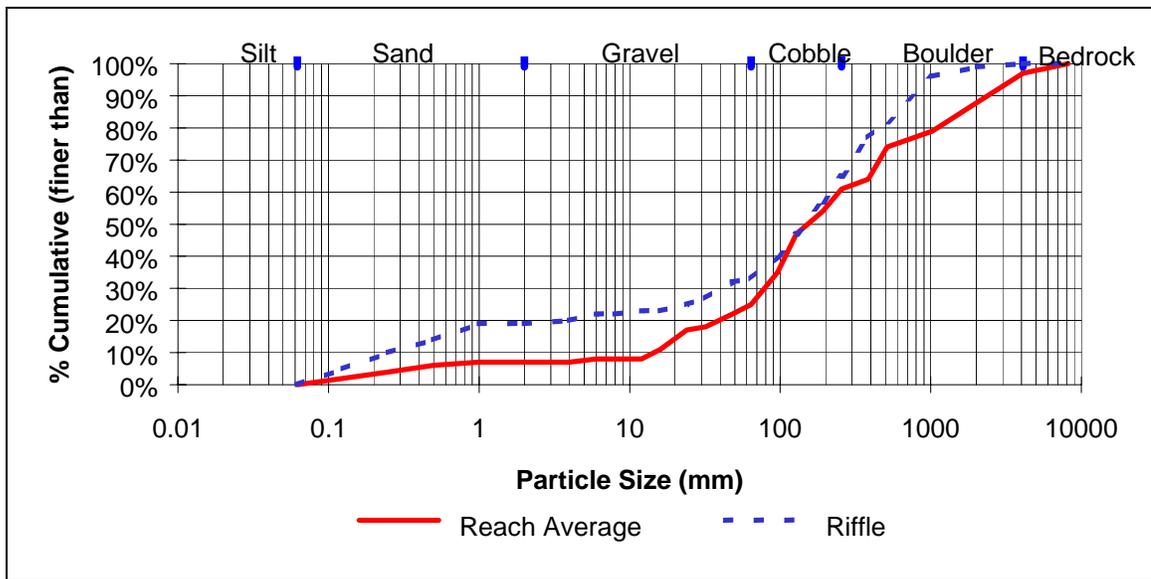
BEAR CREEK AT FRIENDSVILLE, MD PARTICLE SIZE DISTRIBUTION

Particle Size (m m)		
Finer Than	Reach	Riffle
D ₁₆	22.43	0.66
D ₃₅	96.00	71.86
D ₅₀	152.29	144.56
D ₈₄	1505.01	565.29
D ₉₅	BEDROCK	974.54

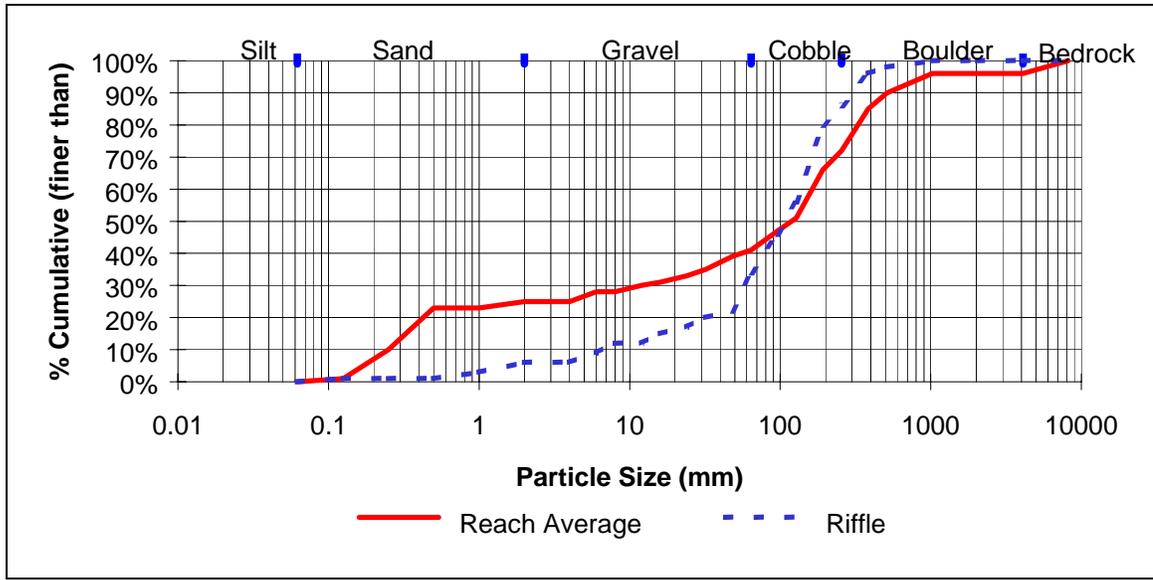
BIG PINEY RUN NEAR SALISBURY, PA PARTICLE SIZE DISTRIBUTION

Particle Size (m m)		
Finer Than	Reach	Riffle
D ₁₆	0.34	19.60
D ₃₅	32.00	66.20
D ₅₀	119.12	107.71
D ₈₄	372.21	232.59
D ₉₅	912.28	368.74

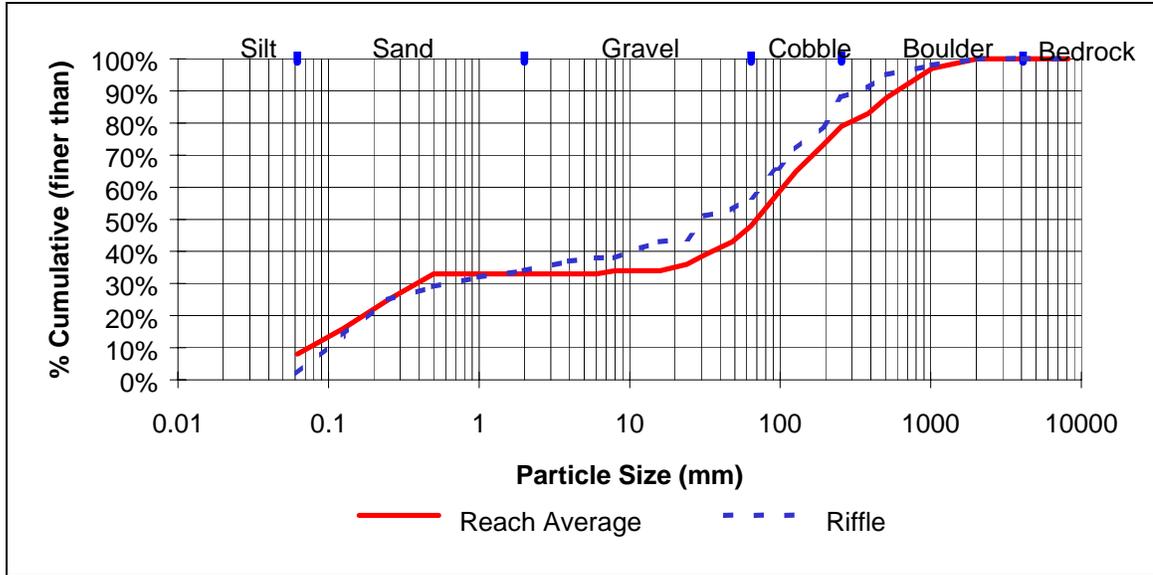
CASSELMAN RIVER AT GRANTSVILLE, MD PARTICLE SIZE DISTRIBUTION

Particle Size (m m)		
Finer Than	Reach	Riffle
D ₁₆	0.13	0.14
D ₃₅	19.60	2.52
D ₅₀	69.41	30.71
D ₈₄	406.74	225.27
D ₉₅	877.82	521.00

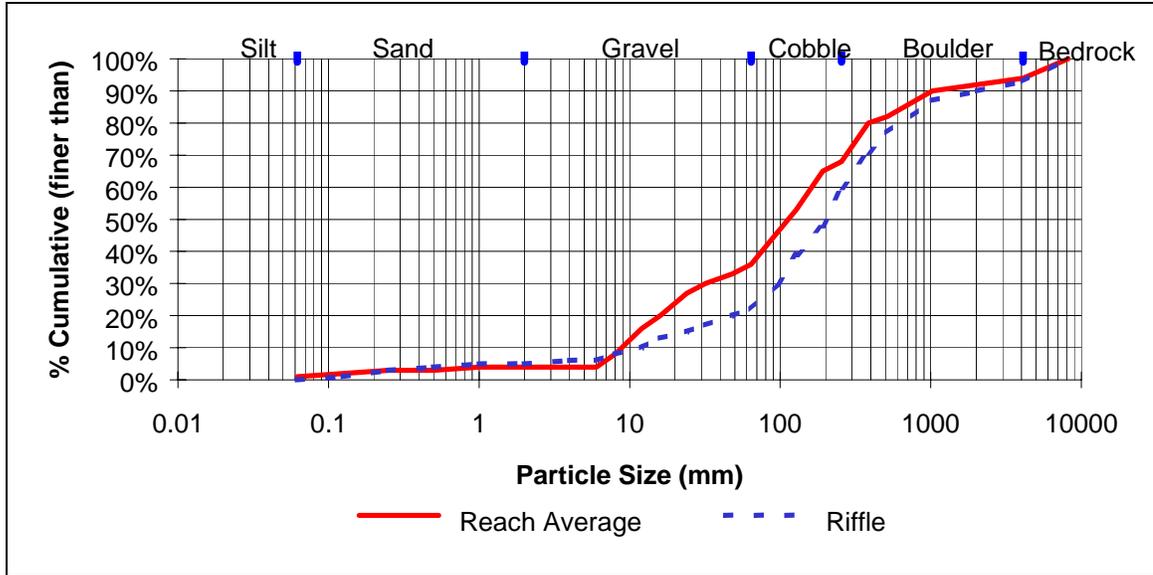
CRABTREE CREEK NEAR SWANTON, MD PARTICLE SIZE DISTRIBUTION

Particle Size (m m)		
Finer Than	Reach	Riffle
D ₁₆	12.00	23.42
D ₃₅	58.15	104.15
D ₅₀	113.15	179.45
D ₈₄	608.87	553.33
D ₉₅	BEDROCK	1398.83

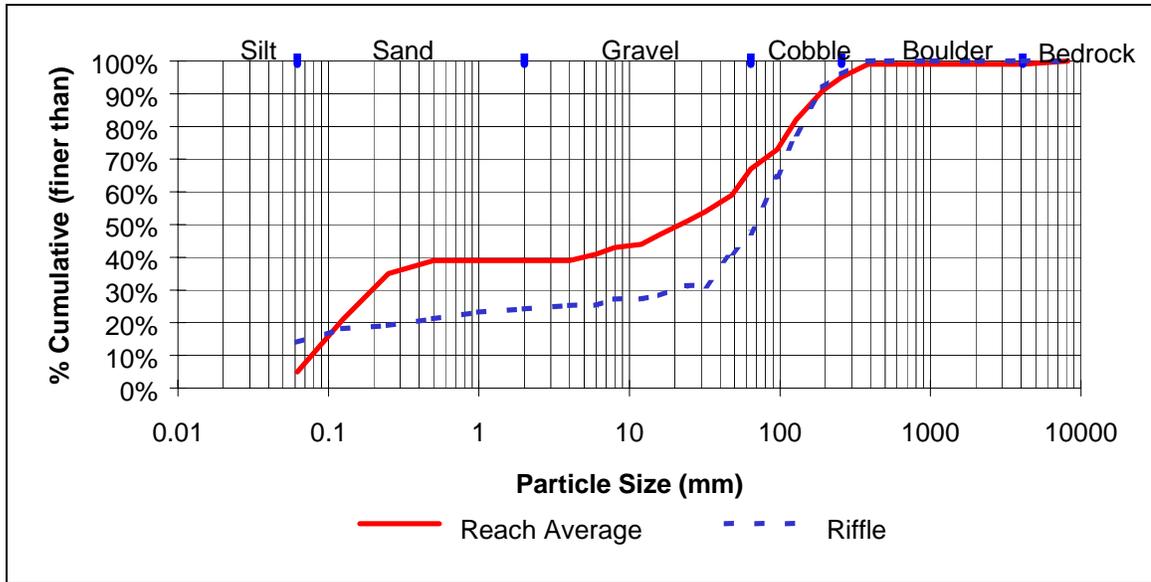
DITCH RUN NEAR HANCOCK, MD PARTICLE SIZE DISTRIBUTION

Particle Size (m m)		
Finer Than	Reach	Riffle
D ₁₆	0.10	0.09
D ₃₅	0.25	37.10
D ₅₀	21.69	67.93
D ₈₄	140.07	153.00
D ₉₅	256.00	239.09

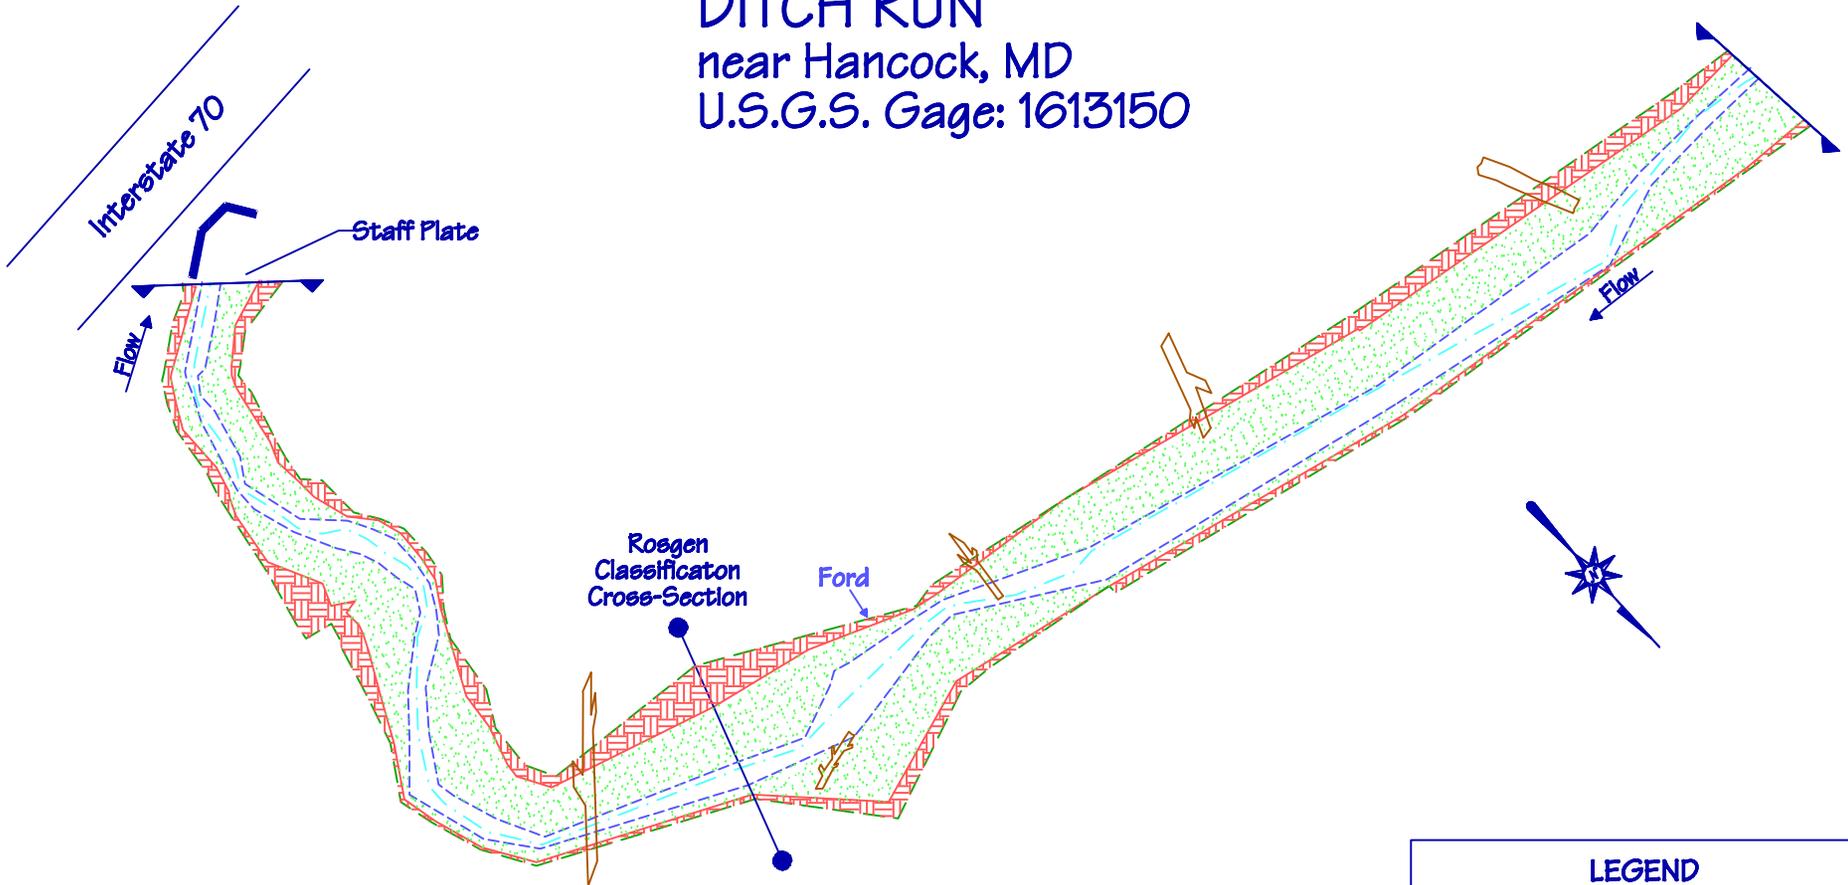
near Hancock, MD
U.S.G.S. Gage: 1613150

Survey Date: 9/5/00 & 9/6/00
Study Reach Length: 761'

General Study Reach Description: The gage reach and study reach are the same at a discontinued gage station. The stream channel has a regular meander pattern with pool/riffle features and bedrock outcrops throughout. Woody debris and bedrock cause some side bar deposition with little lateral scour. The floodplain has moderately dense overstory with hemlock, slippery elm, red maple, sycamore, and beech. The understory is sparse with mountain laurel. Land use data is not provided due to gage location in Pennsylvania.

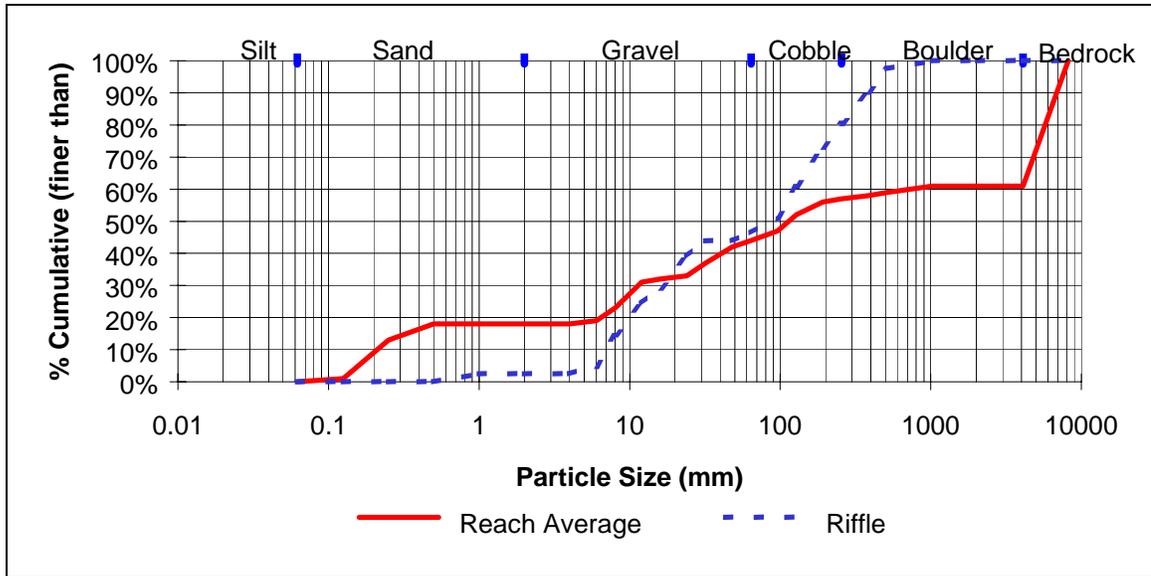
EVITTS CREEK NEAR CENTERVILLE, PA PARTICLE SIZE DISTRIBUTION

Particle Size (m m)		
Finer Than	Reach	Riffle
D ₁₆	0.38	8.47
D ₃₅	27.71	20.30
D ₅₀	114.09	86.75
D ₈₄	BEDROCK	296.23
D ₉₅	BEDROCK	462.96

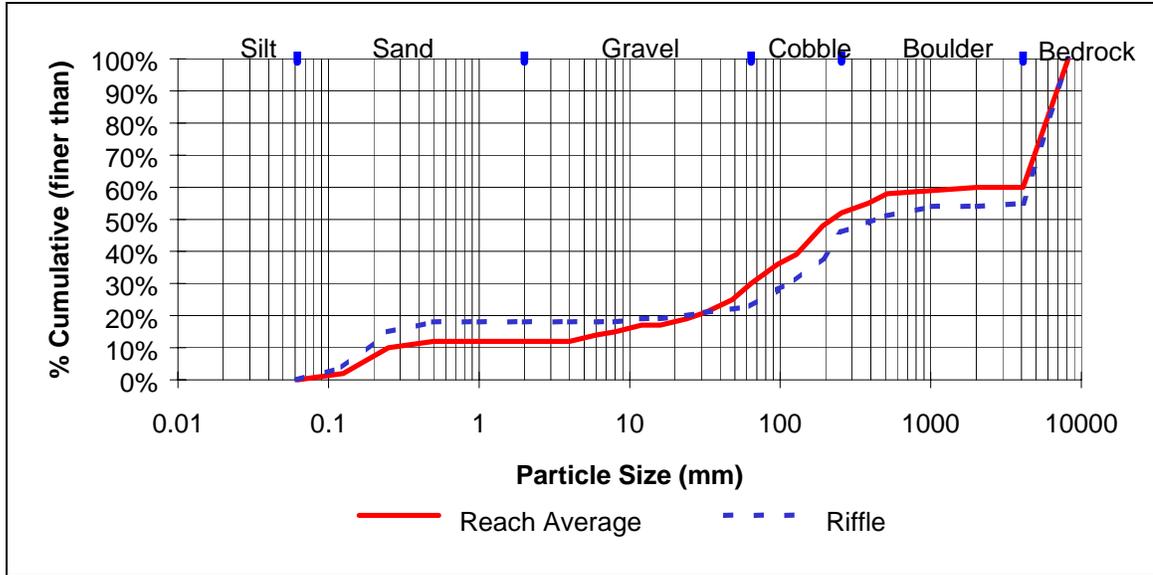
SAVAGE RIVER NEAR BARTON, MD PARTICLE SIZE DISTRIBUTION

Particle Size (m m)		
Finer Than	Reach	Riffle
D ₁₆	9.80	0.17
D ₃₅	89.73	17.71
D ₅₀	221.70	92.19
D ₈₄	BEDROCK	263.01
D ₉₅	BEDROCK	683.44

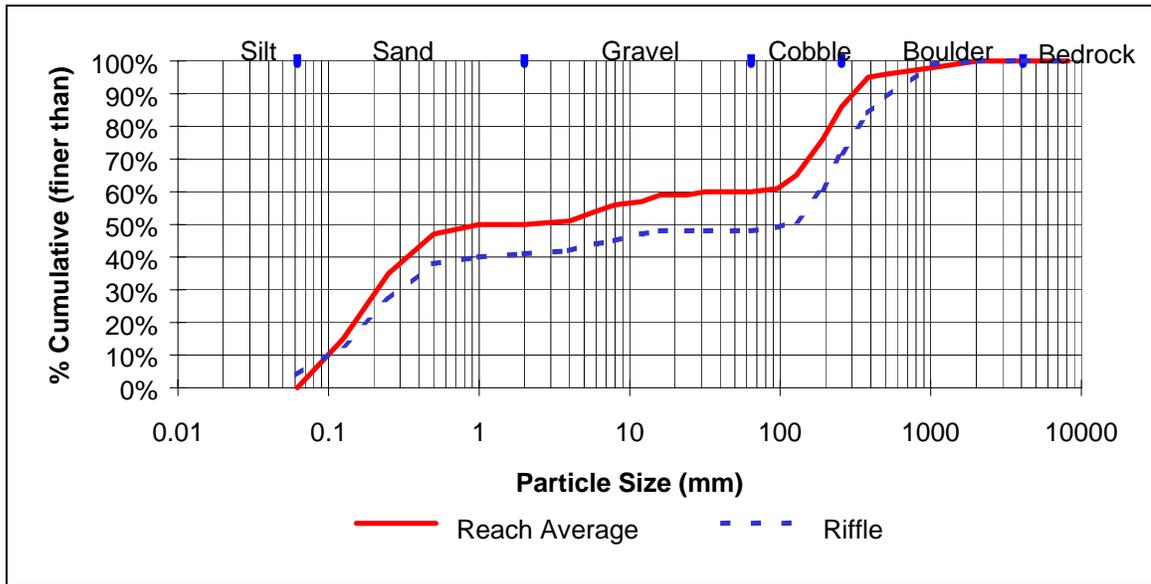
SAVAGE RIVER NEAR FROSTBURG, MD PARTICLE SIZE DISTRIBUTION

Particle Size (m m)		
Finer Than	Reach	Riffle
D ₁₆	0.13	0.15
D ₃₅	0.25	0.41
D ₅₀	2.00	110.85
D ₈₄	241.69	384.00
D ₉₅	384.00	776.05

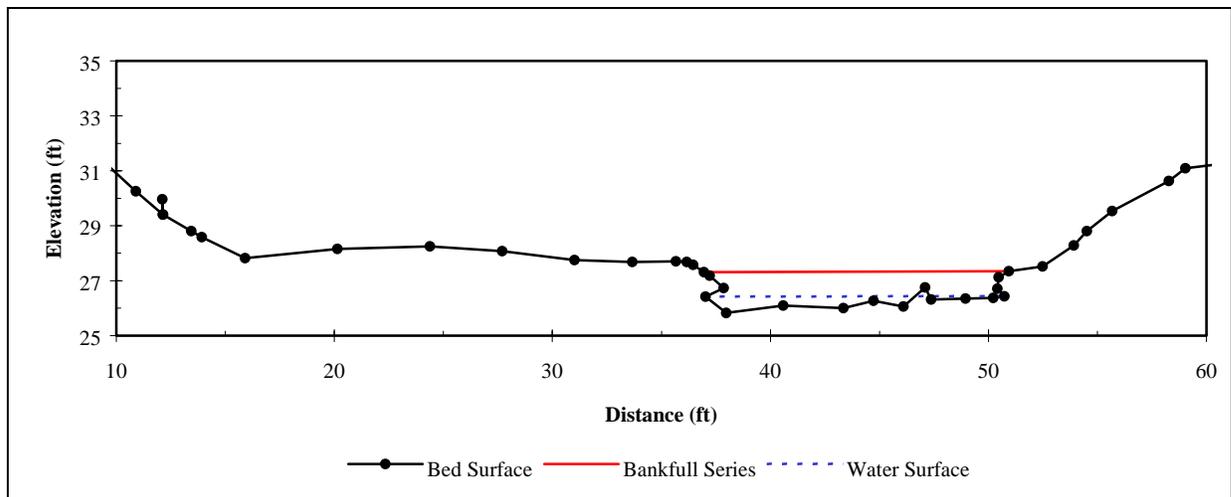
STUDY REACH CROSS SECTION

Bankfull Width (ft):	13.99	Mean Bankfull Depth (ft):	1.12
Bankfull Cross-sectional Area (ft ²):	15.66	Maximum Bankfull Depth (ft):	1.49
Hydraulic Radius (ft):	0.88	Wetted Perimeter (ft):	17.75
