Rain Garden Constructed at Shiawassee Refuge

February 13, 2009

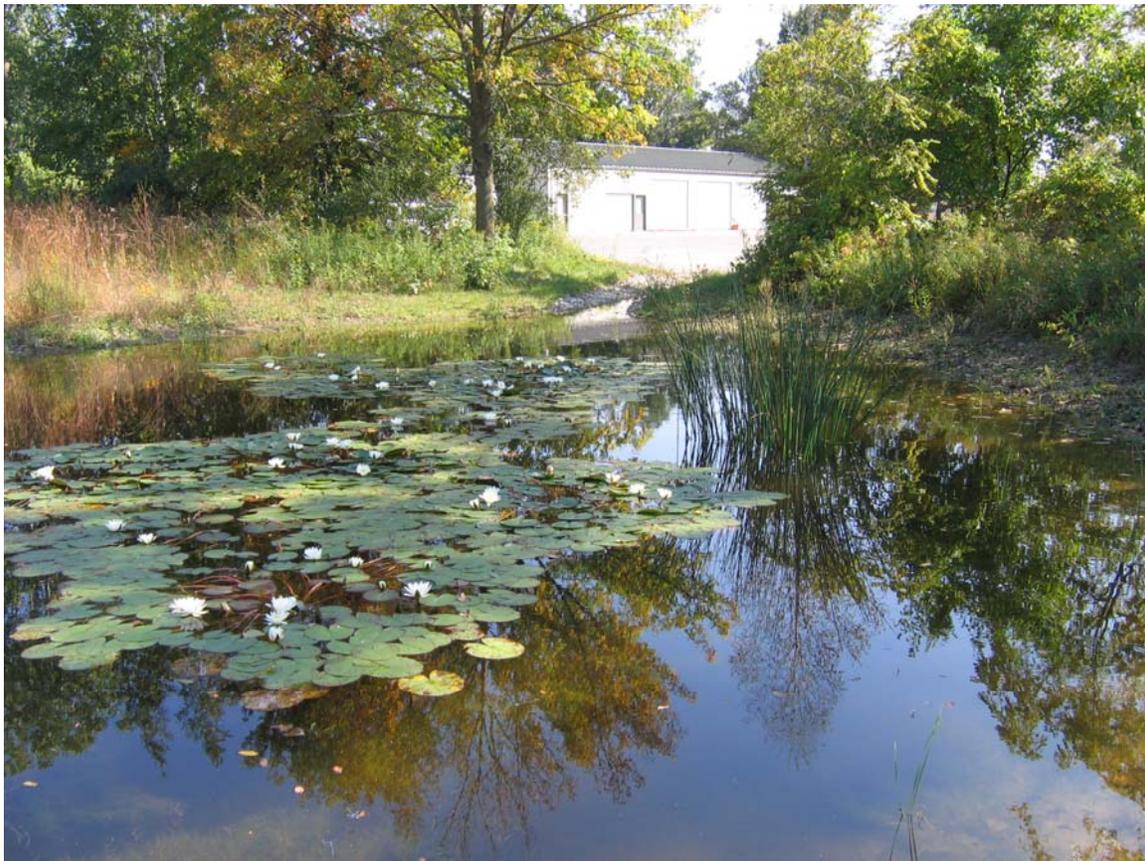
The headquarters rain garden, with the parking lot in the background, is an attractive and educational feature. Steven F. Kahl/USFWS; 10/2008

A rain garden was constructed next to the parking lot to prevent further degradation of refuge waters. Rain gardens are planted depressions that are designed to retain and absorb stormwater runoff from impervious surfaces. They prevent water degradation by allowing the vegetation to take up the excess water and filter it through the soil layers before it enters the groundwater system. The root systems of the rain garden enhance infiltration and moisture redistribution, and encourage growth of diverse microbial populations involved in biofiltration.

The refuge plans to expand the rain garden in 2009. Subsurface soils were less permeable than anticipated when the garden was constructed. Thus, a larger depression must be excavated to accept higher volumes of runoff.
