Johnson Bottom

Old Charley Wash

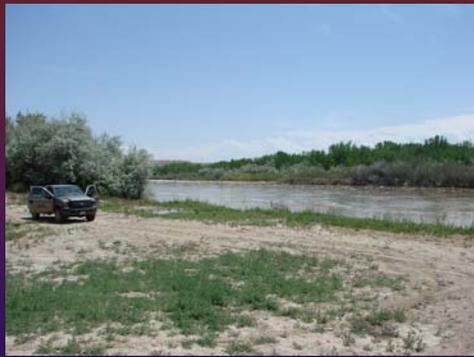
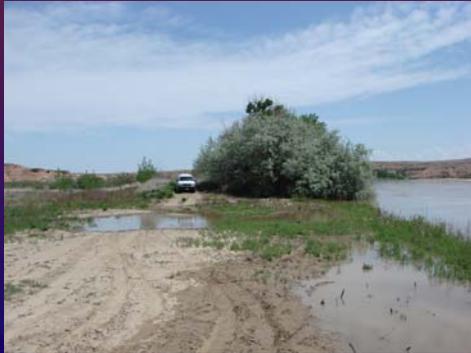
<p>051707 – River flow was 12,700 cfs. No significant inflow into downstream breach.</p>
<p>051607 - River flow was 11,900 cfs. No significant inflow into downstream breach.</p>

Johnson Bottom is on the Ouray National Wildlife Refuge at river mile 261. The levee breach is on downstream end of wetland. River located on the right side of photos.

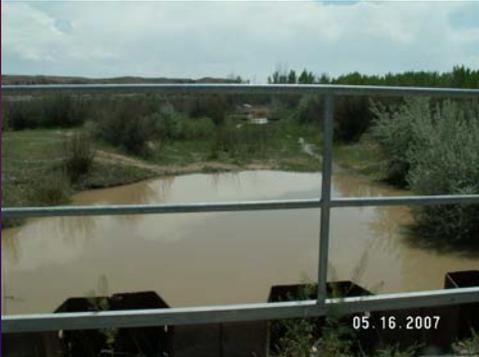
Inflow into Old Charley-Main from inlet canal. River flow was 11,500 cfs. No significant inflow.

Inlet canal gate (located near Green River RM 252) was kept closed during 2007.
Downstream outlet is a swale near and upstream of the main gated outlet.
Old Charley Wash is on the Ouray National Wildlife Refuge.

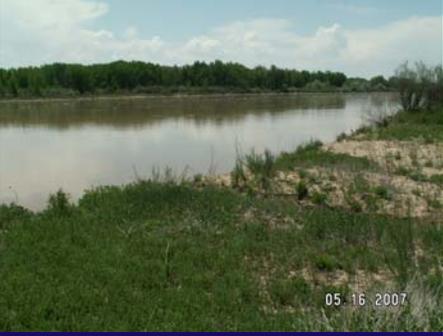
Downstream outlet – far from connection.

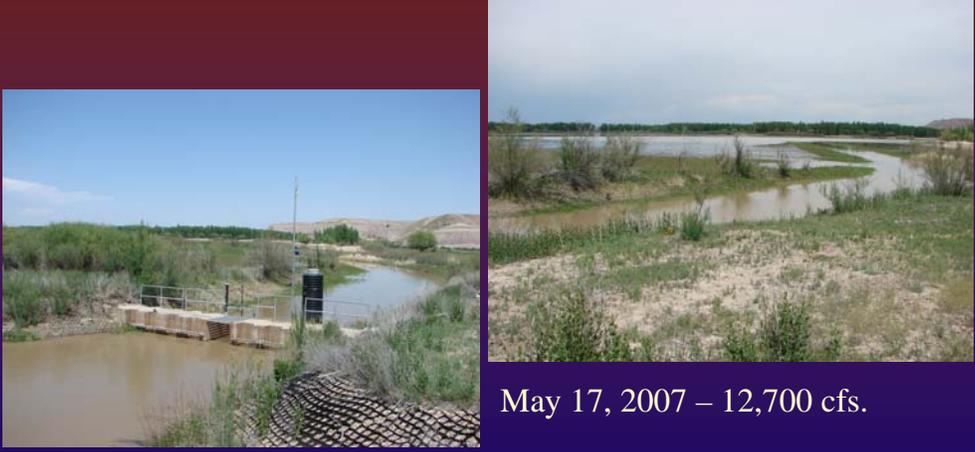
Old Charley Wash

May 16, 2007 - 11,500 cfs. River back-flowing into wetland through fish kettle

May 17, 2007 - 12,700 cfs.

Main outlet canal (located near Green River RM 250). Second photo looking towards main wetland.
